# **Assessment of Dam Safety of Coal Combustion Surface Impoundments**

**PowerSouth Energy Cooperative**

**Charles R. Lowman Power Plant**

**March 30, 2011**

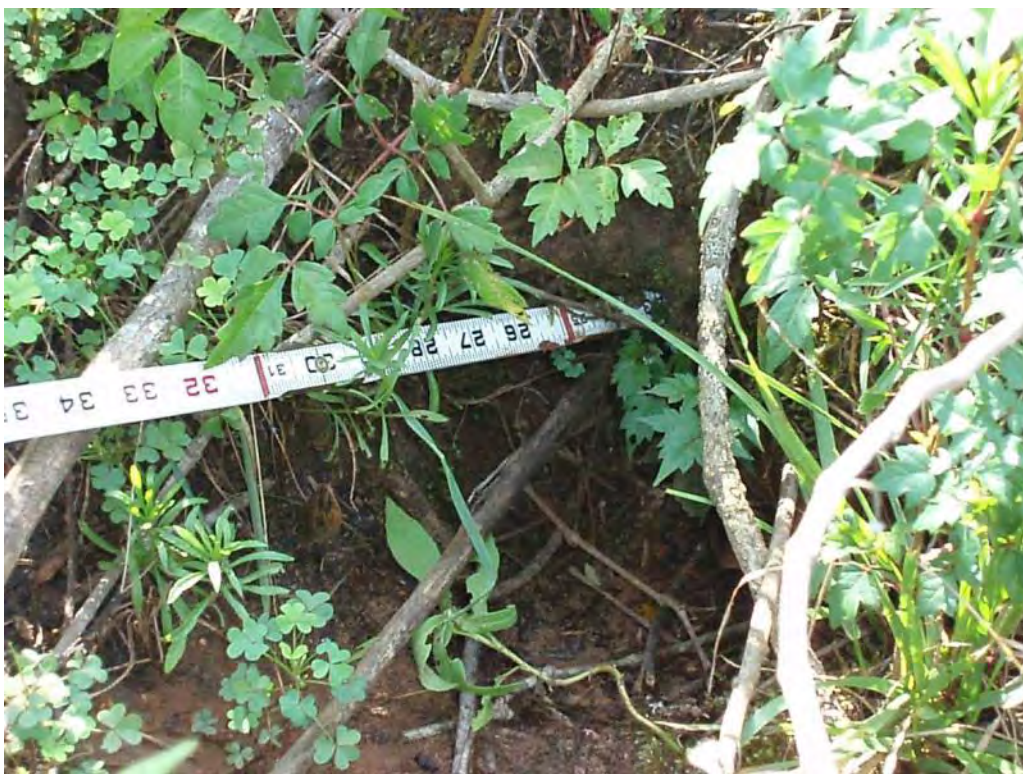
Minor surface erosion, sloughing, and scarps, as well as several animal burrow holes, were observed on the exterior slope of the west embankment within the dense vegetation (Photographs 153, 149, and 150).

**Photo No. 150: Scrubber Waste Pond – West embankment exterior slope. Looking at rodent burrow (4 inches in diameter, 26 inches deep).**

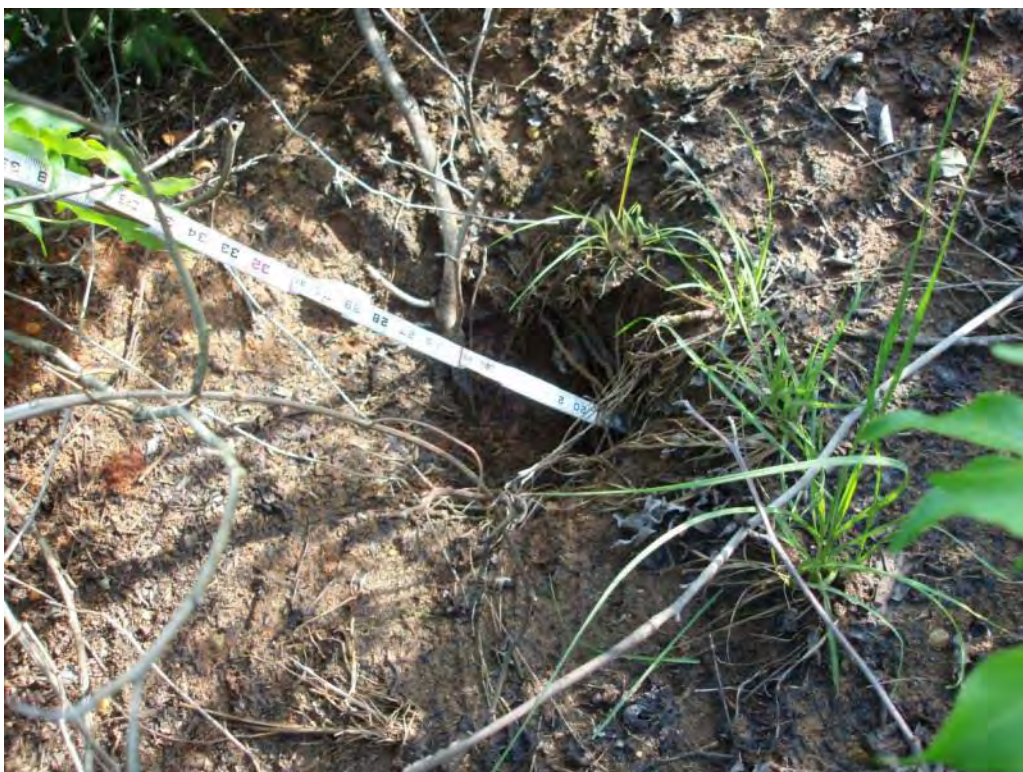
**Photo No. 154: Scrubber Waste Pond – West embankment exterior slope. Looking at rodent burrow (4 inches in diameter, 20 inches deep).**

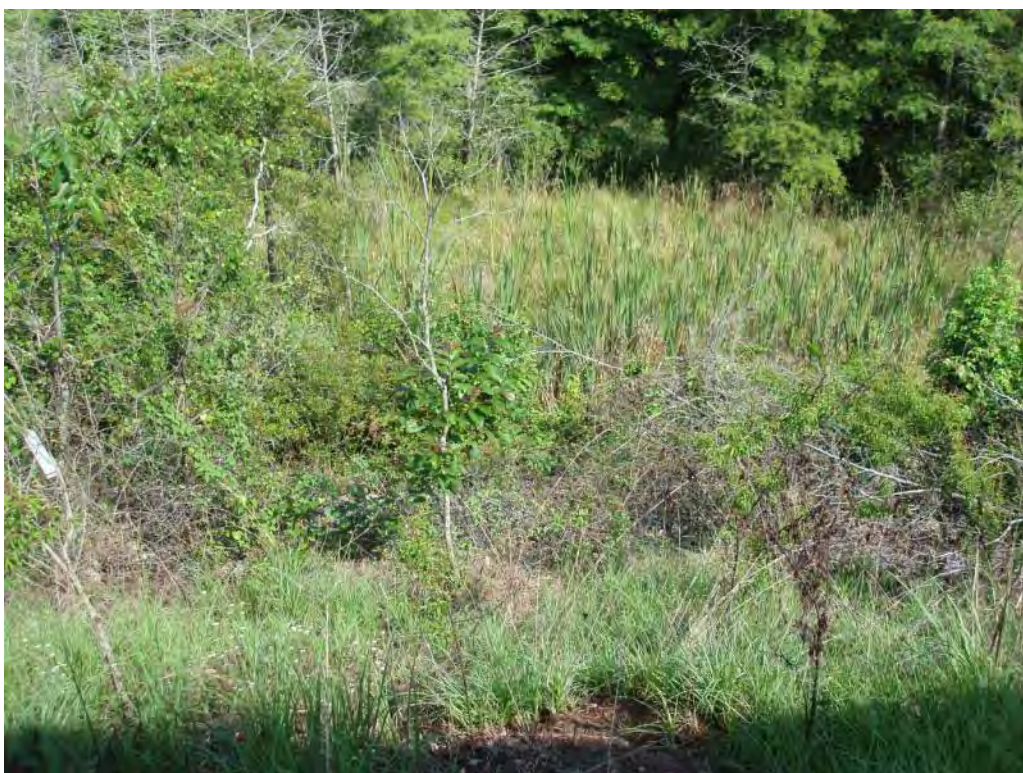
**Photo No. 156: Scrubber Waste Pond – West embankment exterior slope, looking west.  
Looking at cattails near toe.**

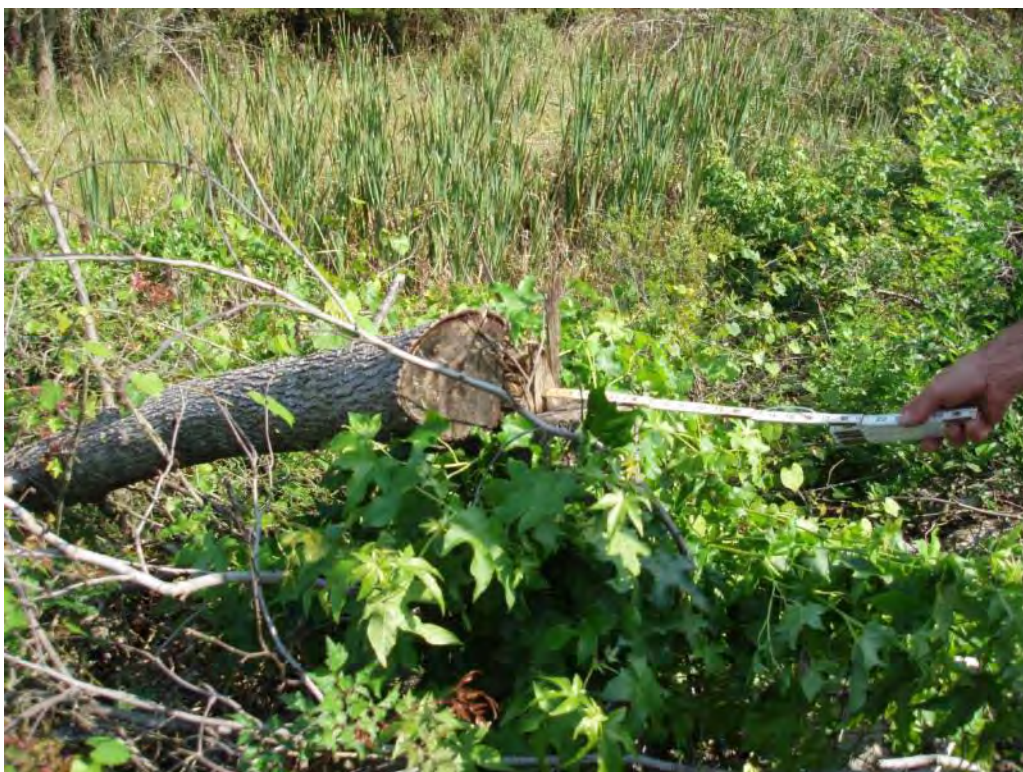
**Photo No. 158: Scrubber Waste Pond – West embankment exterior slope. Looking at 6-inch-diameter tree recently cut down.**
