Assessment of Dam Safety of Coal Combustion Surface Impoundments

Cleco Corporation

Brame Energy Center

March 14, 2011

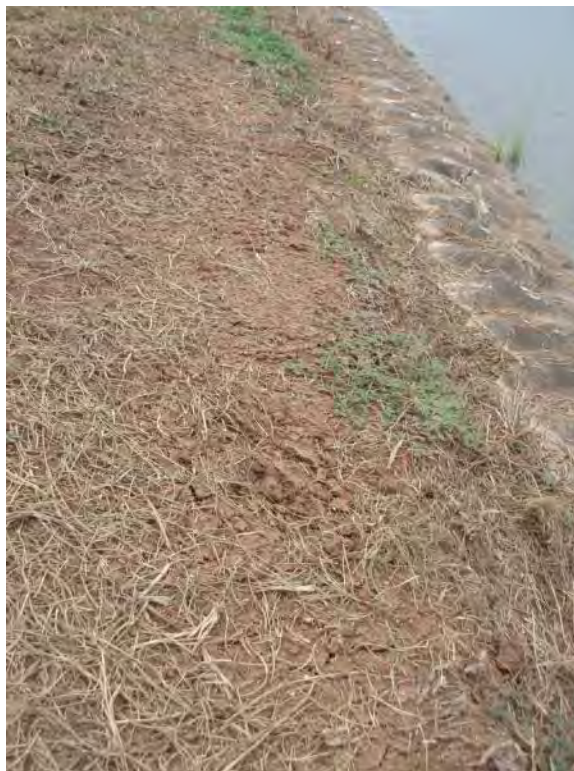
The embankment interior slopes appear to be in good condition. The interior slope was approximately 3H:1V, with cast-in-place concrete armoring (Photographs 4, 7, 8, 39 and 58) in place except at the southeast corner. Cleco representatives indicated the armoring stopped in this corner to accommodate dredging operations for the removal of bottom ash. Areas of the concrete armoring were observed to be undercut and cracked longitudinally, apparently due to wave action (Photographs 6, 7, and 52). A section, approximately 50 feet long, of the west embankment interior slope was observed where armoring had been undermined and was displaced into the pond (Photograph 52). The embankment interior slopes were generally well vegetated with grass, typically less than 6 inches in height (Photographs 1, 2, 12 and 64). Several areas were observed where grass is sparse or missing and rutting has occurred from mowing operations (Photographs 5, 12, 18, 51 and 69).

Photo No. 5: Bottom Ash Pond – East embankment interior slope, looking at sparse vegetation and surface cracks.

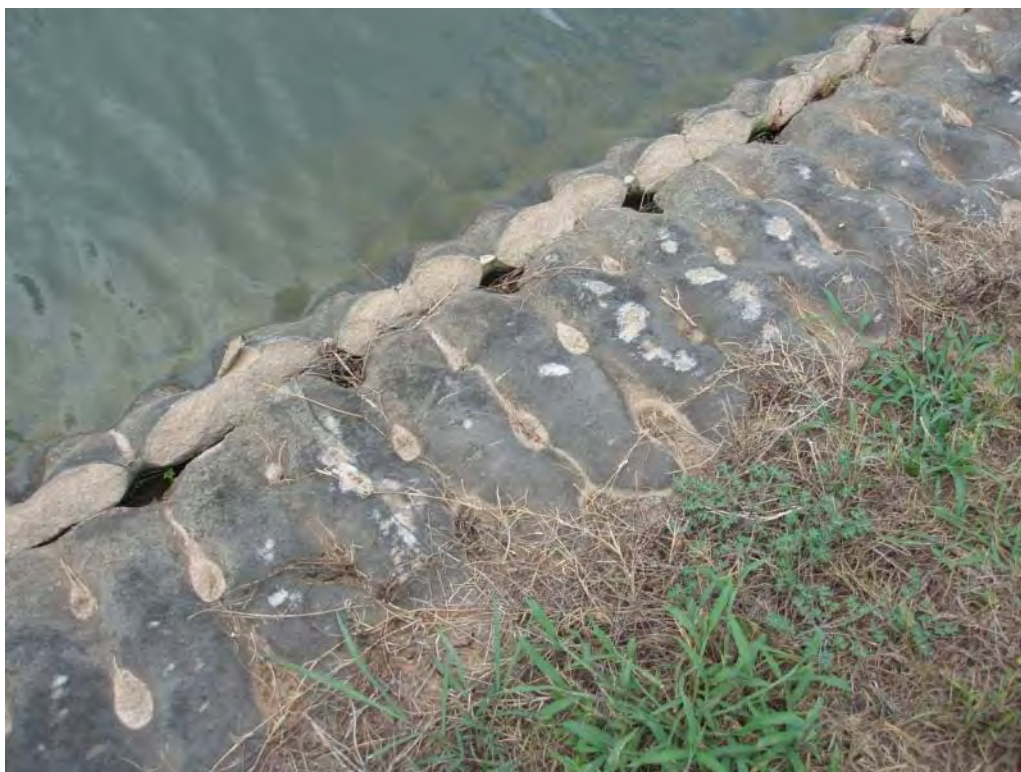
Photo No. 6: Bottom Ash Pond – East embankment interior slope, fracture of concrete armor.

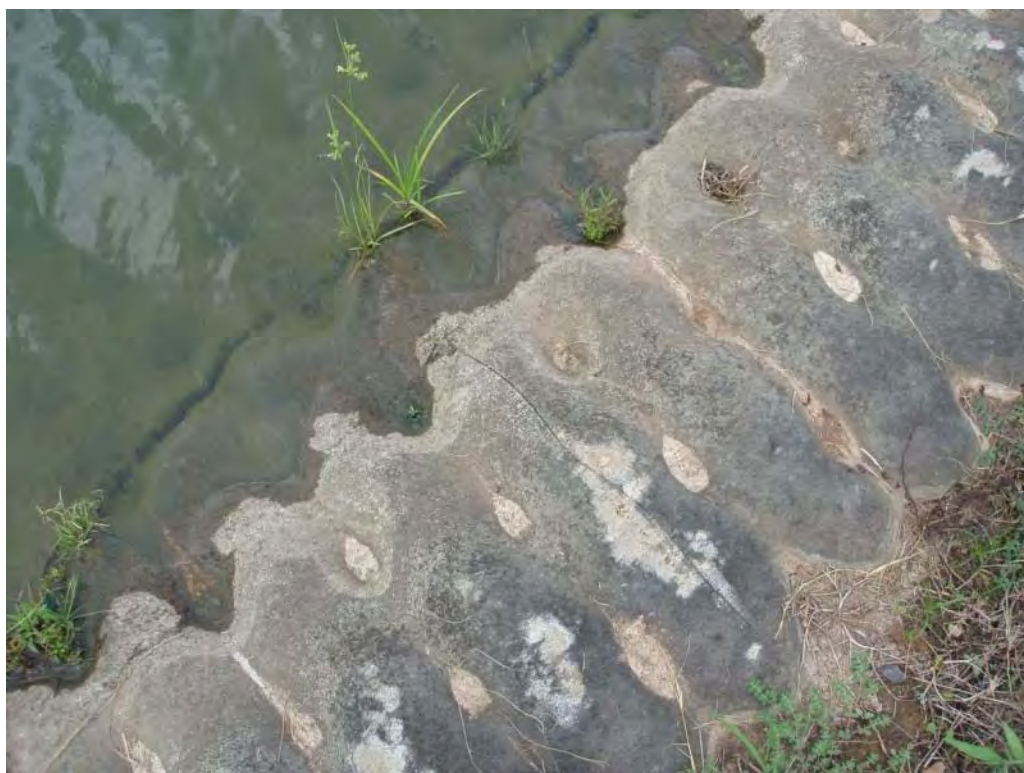
Photo No. 8: Close-up of fracture in concrete armor below waterline, at east embankment interior slope.

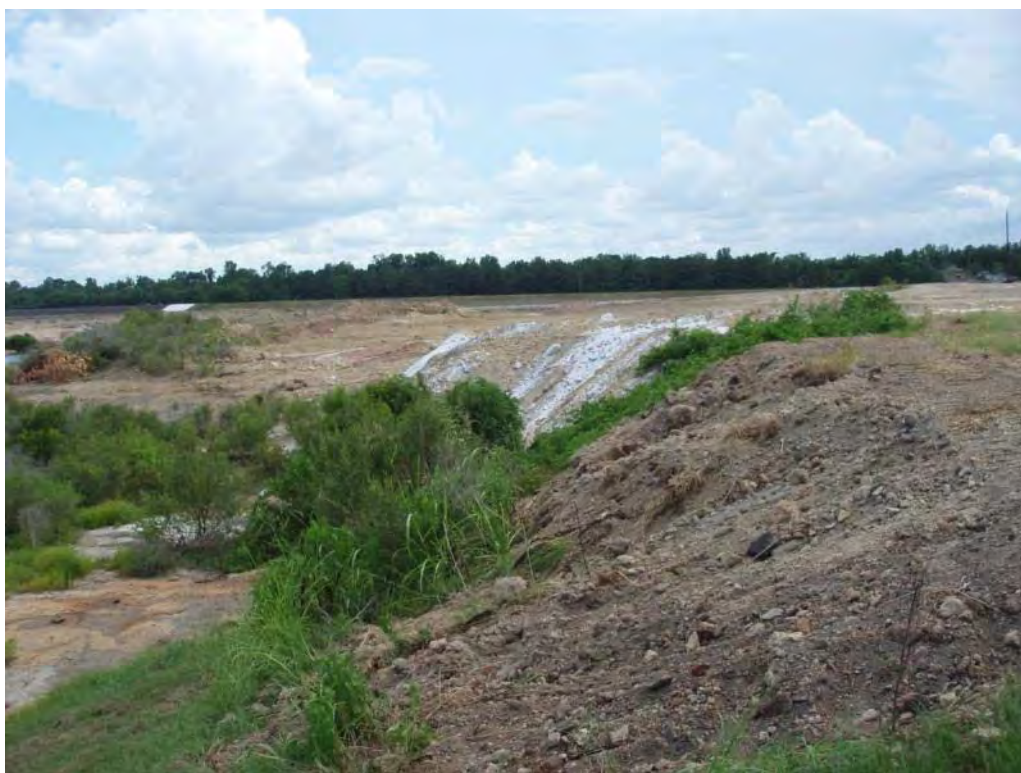
The east (divider) embankment exterior slope was covered with ash product and could not be observed (Photographs 9, 10 and 73). The south (divider) embankment exterior slope was backfilled with ash product hauled by trucks and deposited in the fly ash storage and could not be observed (Photograph 66).

Photo No. 10: Fly Ash Pond - West embankment interior slope, looking southwest. Fill material covering slope.

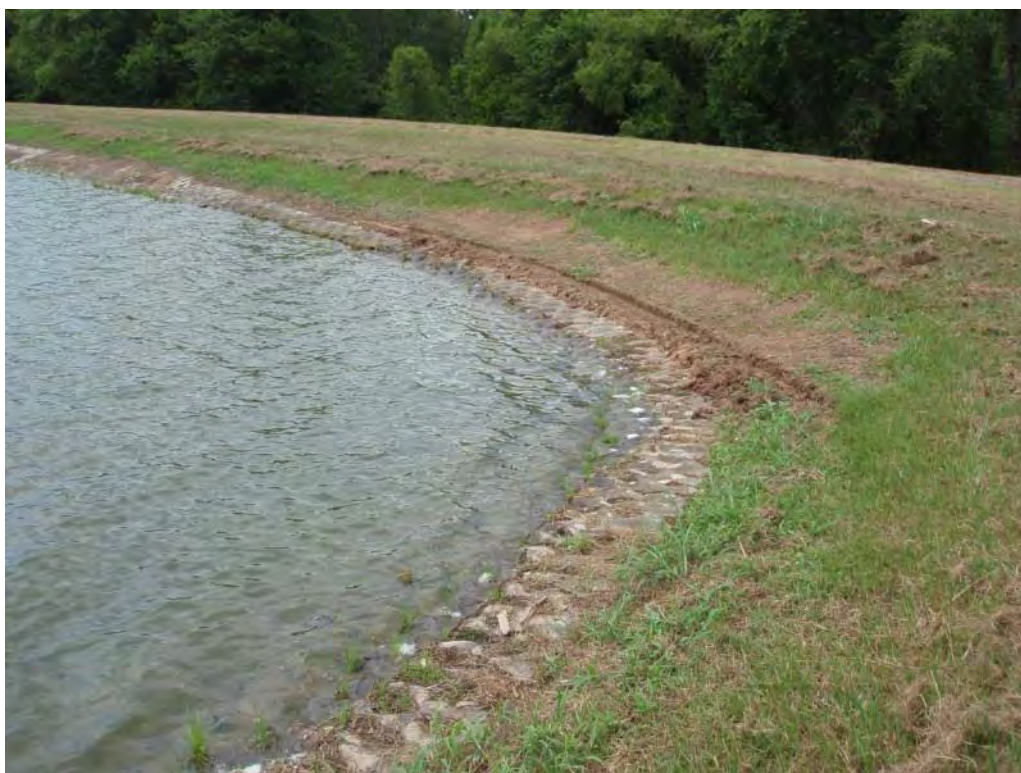
Photo No. 12: Bottom Ash Pond - Northeast corner interior slope. Note ruts and areas void of vegetation/protective cover.

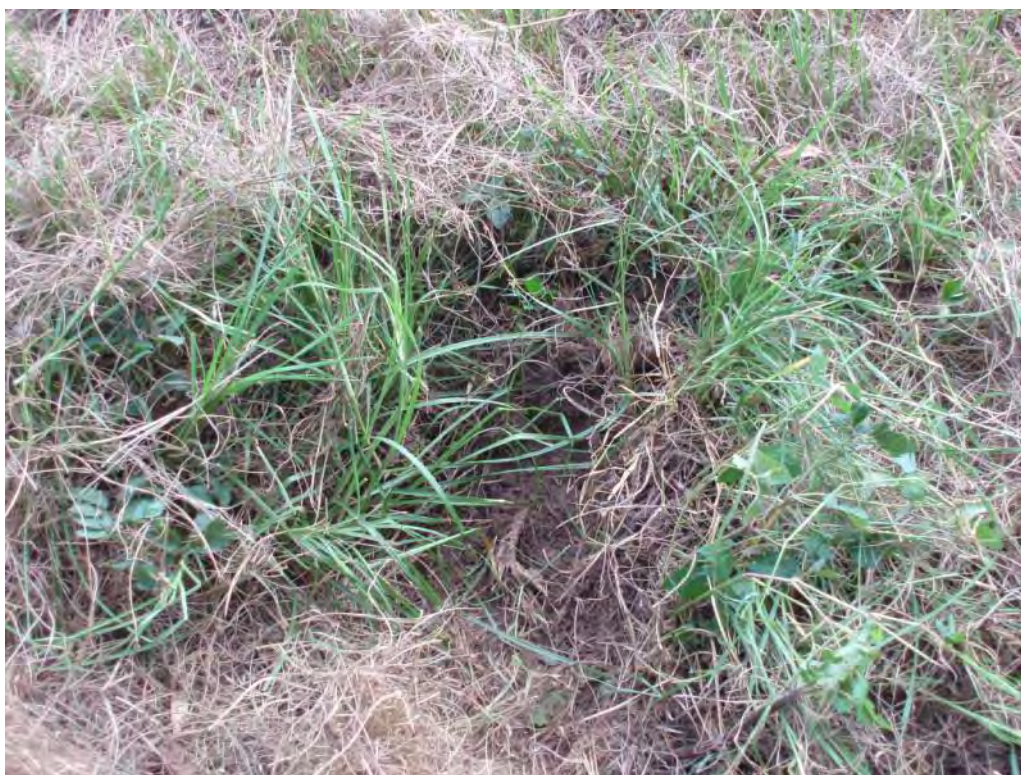
Photo No. 16: Bottom Ash Pond - North embankment exterior slope, typical vegetation.

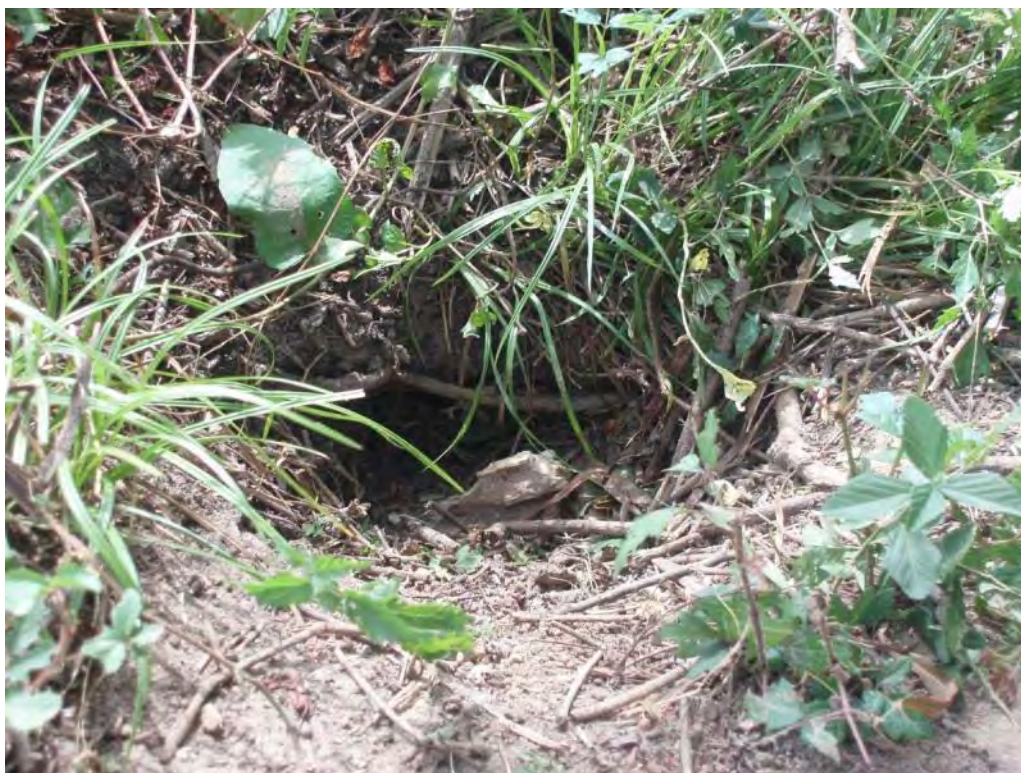
Photo No. 21: Bottom Ash Pond - North embankment exterior slope. Looking at rodent burrow.

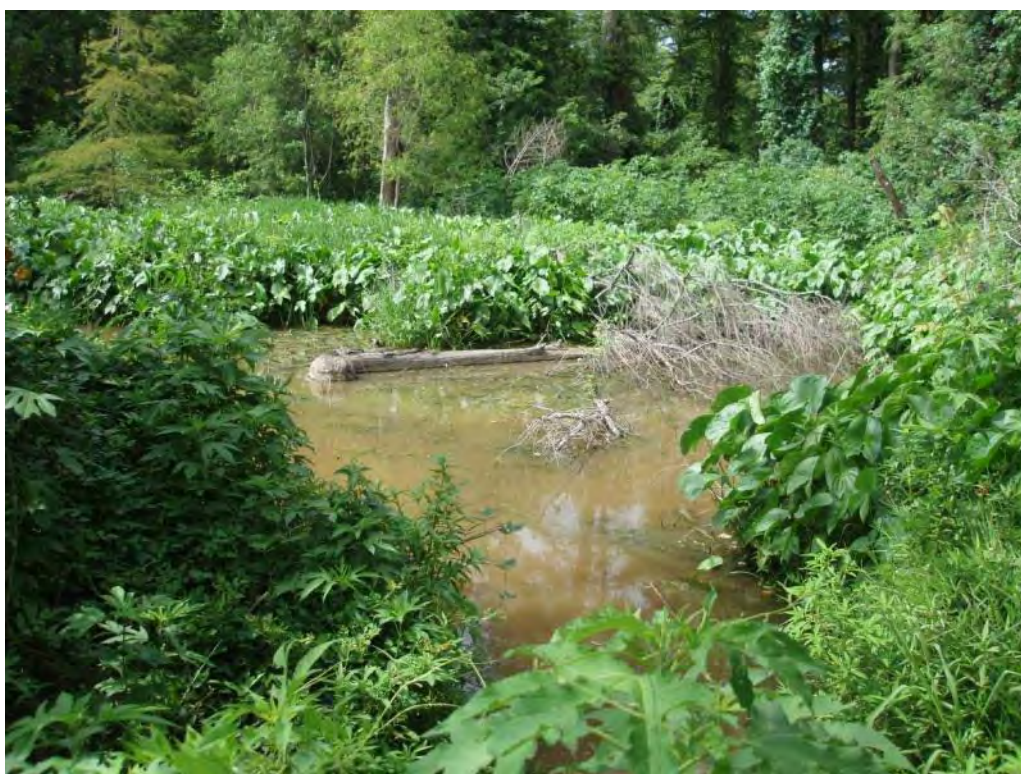
Evidence of beavers was observed along the base of the north embankment exterior slope, including numerous tree cuttings (Photographs 26, 27 and 28). An area of ponded water was observed which extended more than 300 feet along the toe of the exterior slope of the north embankment (Photographs 28, 30 and 31). Although not observed due to the depth of the water and the dense vegetation, it was presumed that beavers had constructed a dam on a small stream that runs parallel to the embankment. The presence of heavy vegetation precluded observation of erosion features, additional animal burrows, or seepage on the lower third of the exterior slope of the north embankment.

Photo No. 28: Bottom Ash Pond – North embankment exterior toe, looking north. Standing water near toe. Note beaver activity on downed tree.

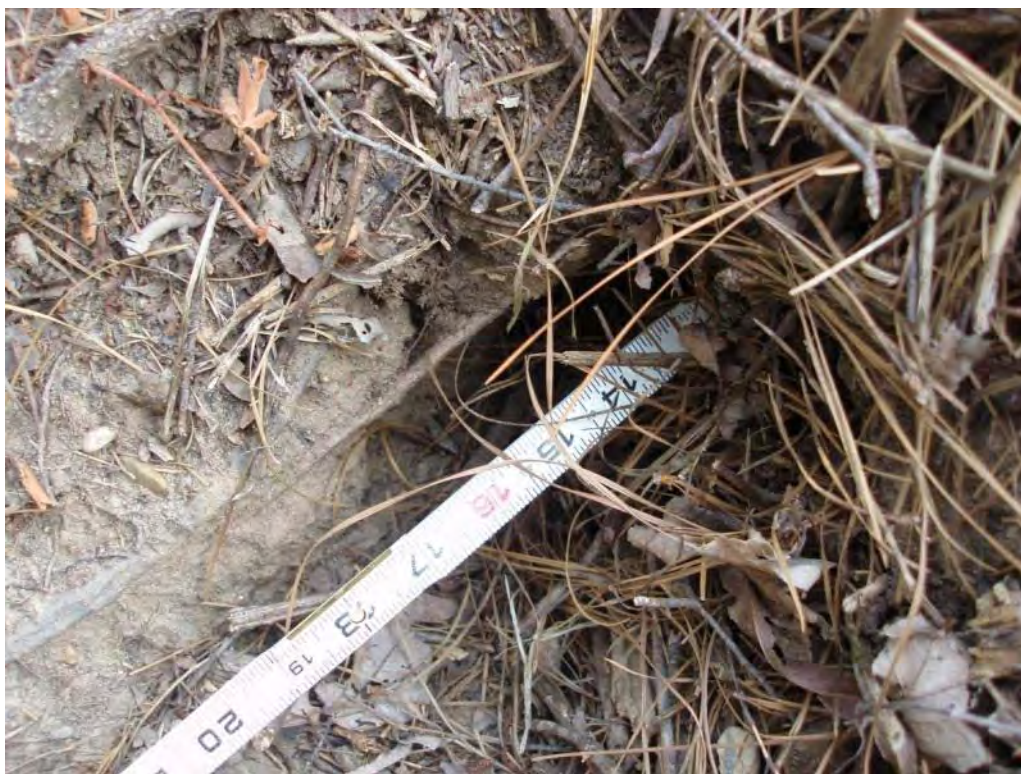
The embankment exterior slopes of the Bottom Ash Pond appeared to be in fair condition. The exterior slopes were approximately 4H:1V. The upper two-thirds of the north embankment exterior slope was generally covered with grass approximately 4 inches in height (Photographs 13, 14 and 35). The lower third of the north embankment slope, extending to the toe, was heavily vegetated with shrubs, brush and trees up to 18 inches in diameter (Photographs 20, 22, 25 and 42). Several rodent burrows were observed along the edge of the heavily vegetated area of the north embankment slope (Photographs 21 and 34). In addition, numerous holes up to 16 inches in depth and 4 inches in diameter were observed on the north embankment exterior slope, which Cleco personnel speculated was evidence of wild boar rooting (Photographs 15, 16, 23, 24, 34 and 37).

Photo No. 34: Bottom Ash Pond – North embankment exterior slope. 2-inch-diameter, 16-inch-deep rodent burrow.

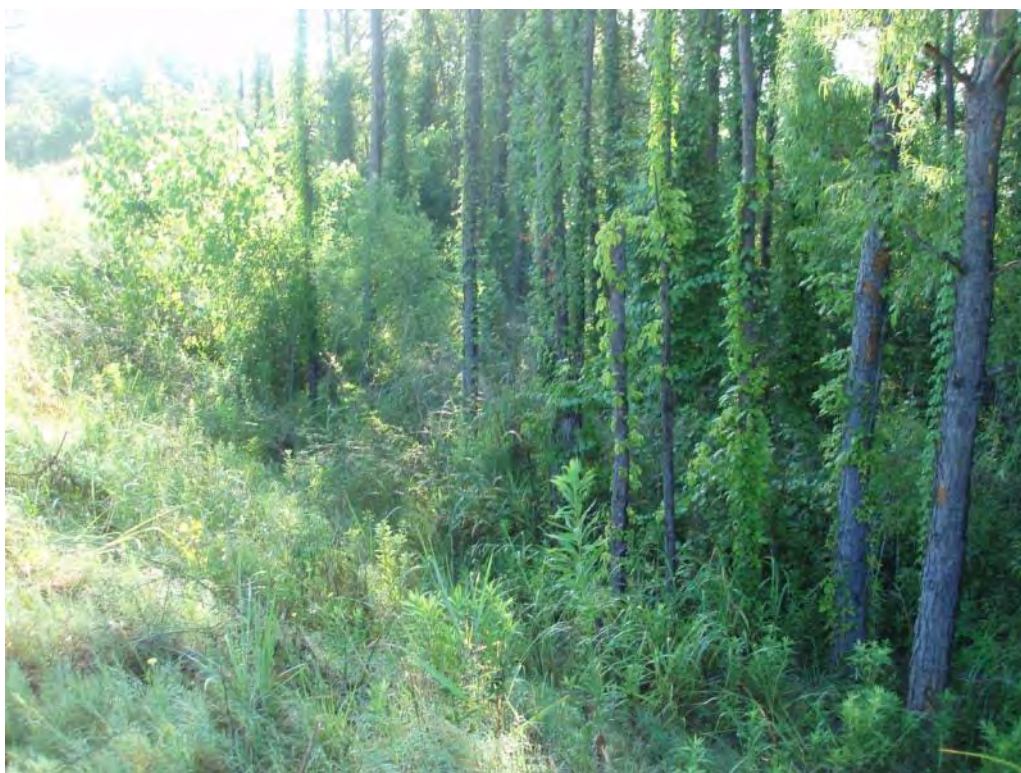
Photo No. 42: Bottom Ash Pond - West of west embankment toe, looking northeast. Trees growing approximately 50 feet west of crest

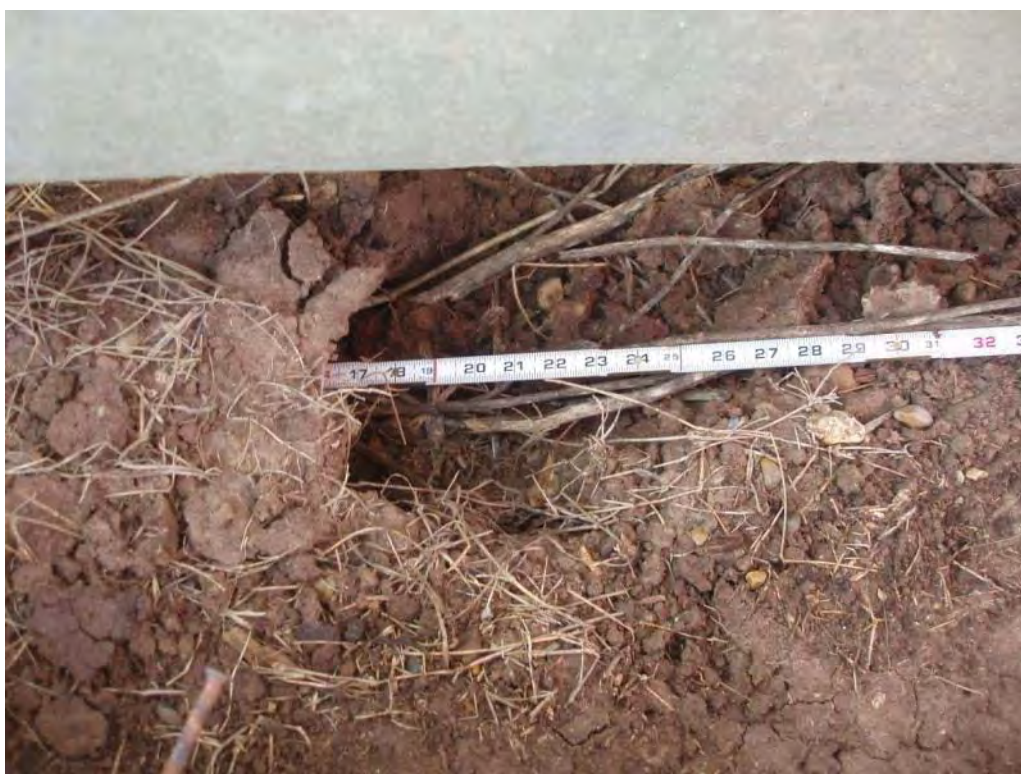
A possible rodent burrow or a localized sink hole was observed at the edge of the concrete/steel frame outlet structure on the west embankment (Photograph 44).

Photo No. 44: Bottom Ash Pond – Outlet structure, looking at erosion hole 24 inches deep on northwest side of outlet structure.

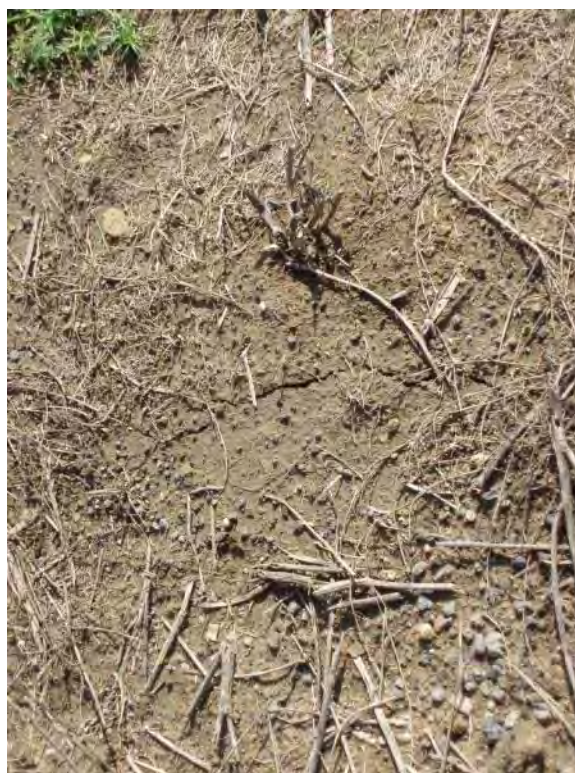
Photo No. 56: Bottom Ash Pond - South embankment interior slope. Looking at small crack (less than 1/2 inch wide).

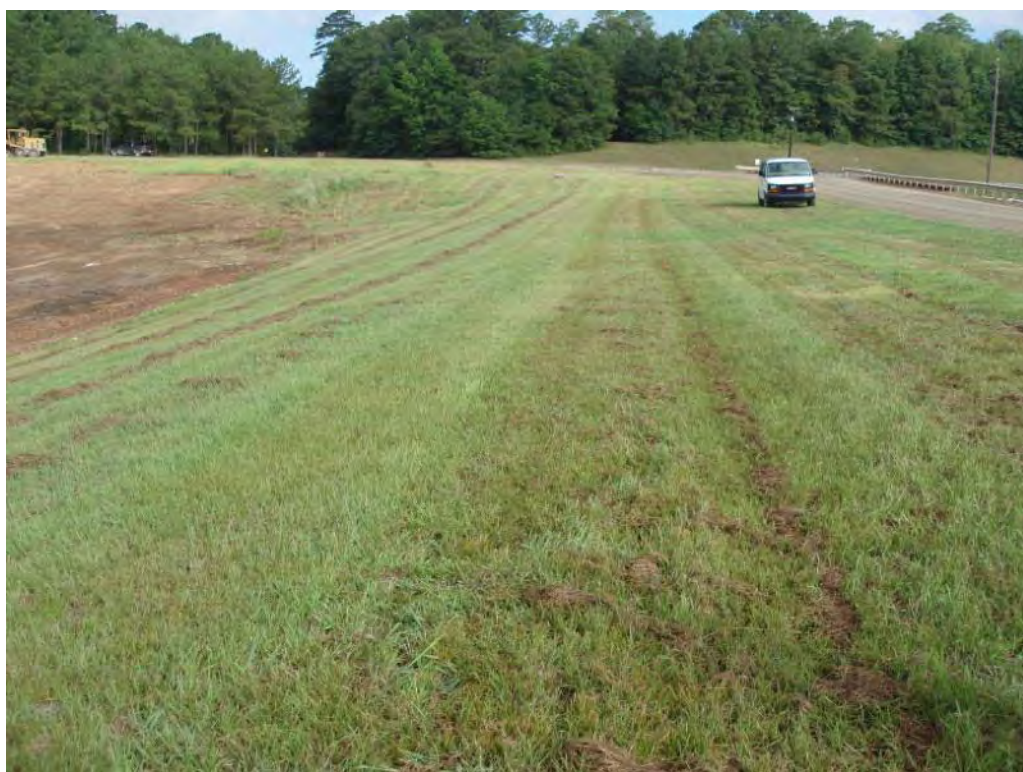
Photo No. 66: Bottom Ash Pond - South embankment exterior slope, looking northwest. Note exterior slope has been backfilled up to crest elevation.

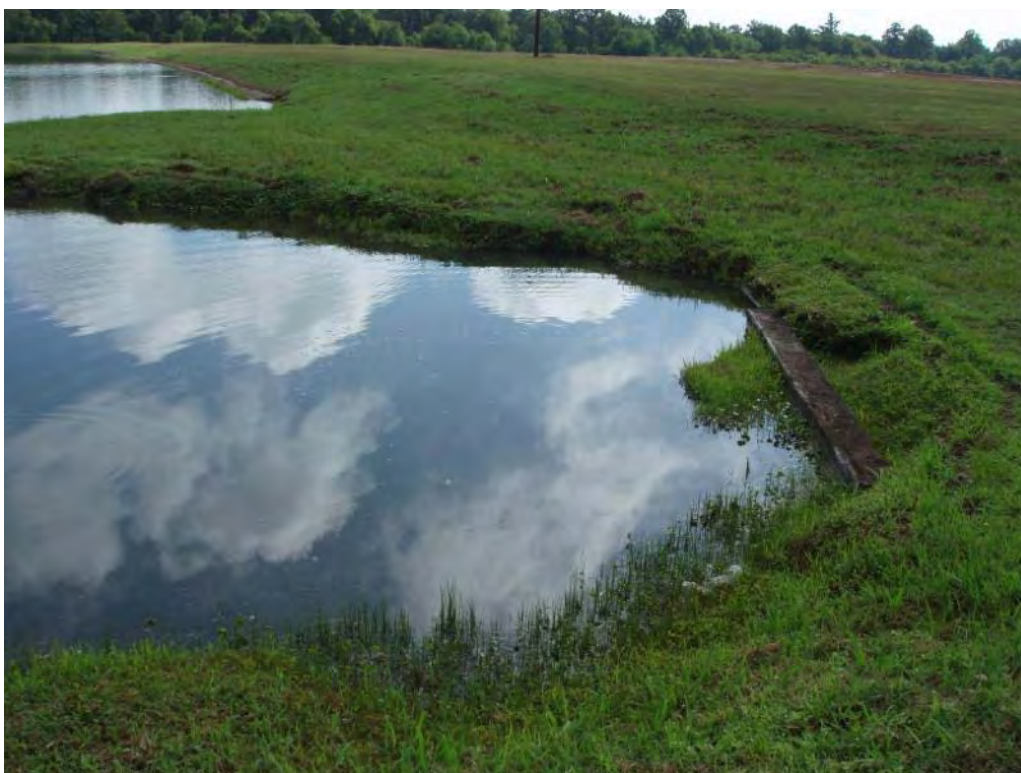
Photo No. 72: Bottom Ash Pond - East embankment interior slope, looking northeast. Note concrete armoring missing from the slope.

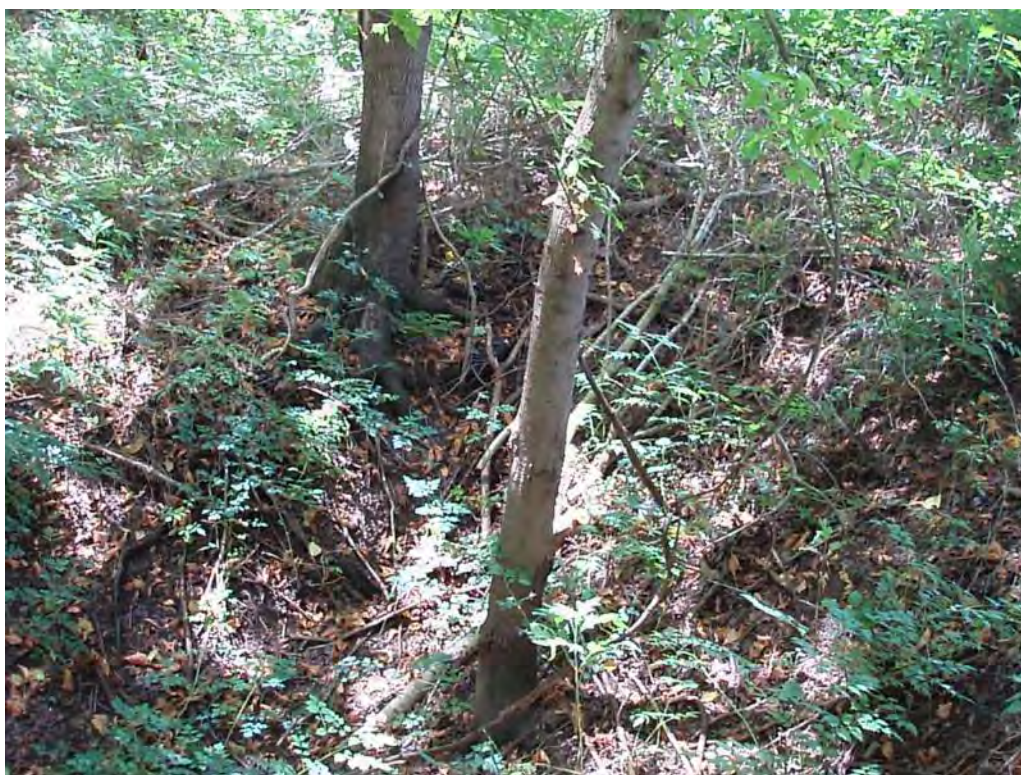
Photo No. 88: Fly Ash Pond - North embankment exterior slope. Looking at area of surface erosion located outside the slope toe.

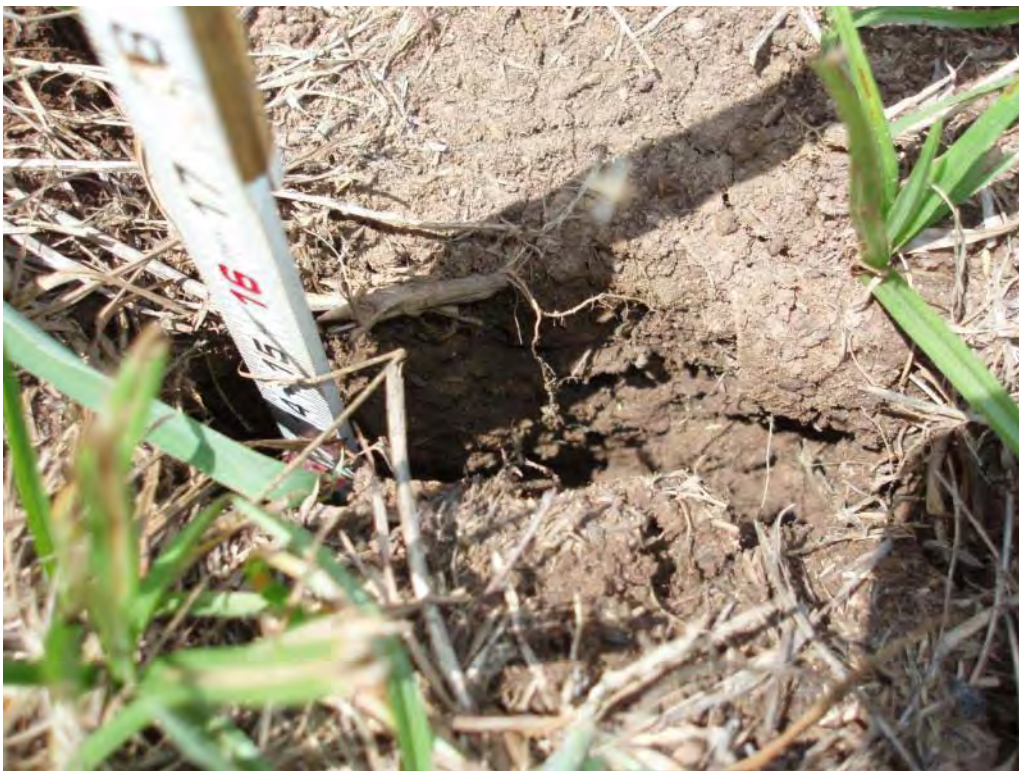
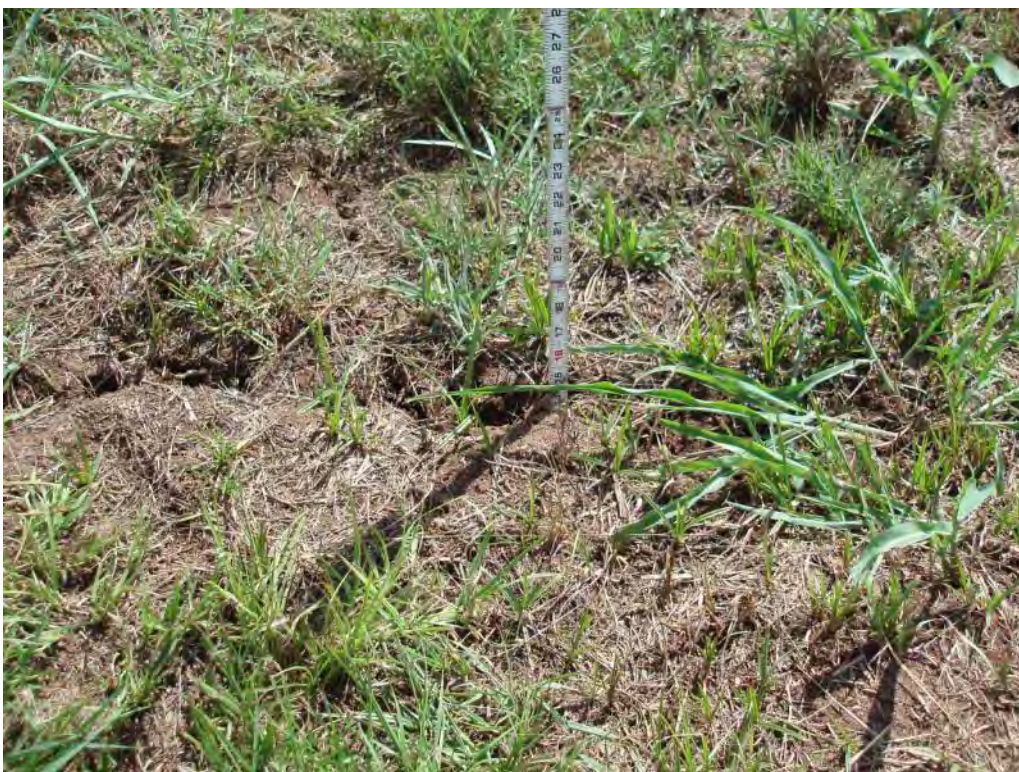
Photo No. 91: Fly Ash Pond – North embankment interior slope. Looking at crack in soils (approximately 2 inches wide and 15 inches deep).

Photo No. 92: Fly Ash Pond – North embankment interior slope. Looking at crack in soils (also shown in Photo No. 91).

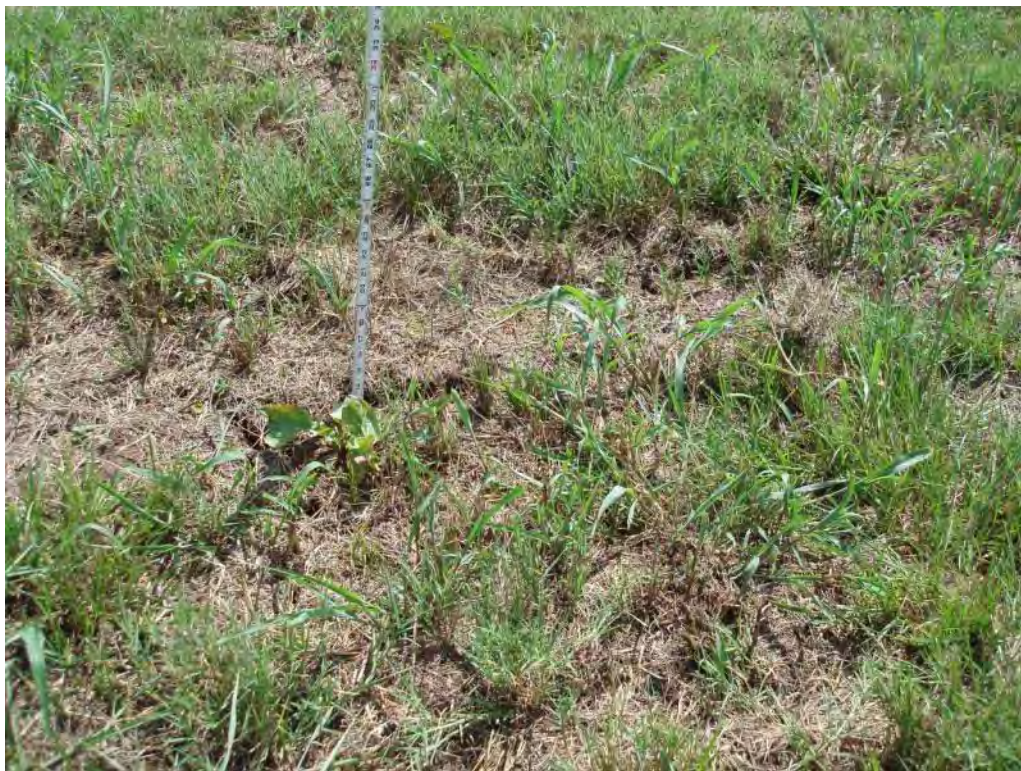
Photo No. 93: Fly Ash Pond - North embankment interior slope. Second location of cracks in soil (approximately 2 inches wide and 14 inches deep).

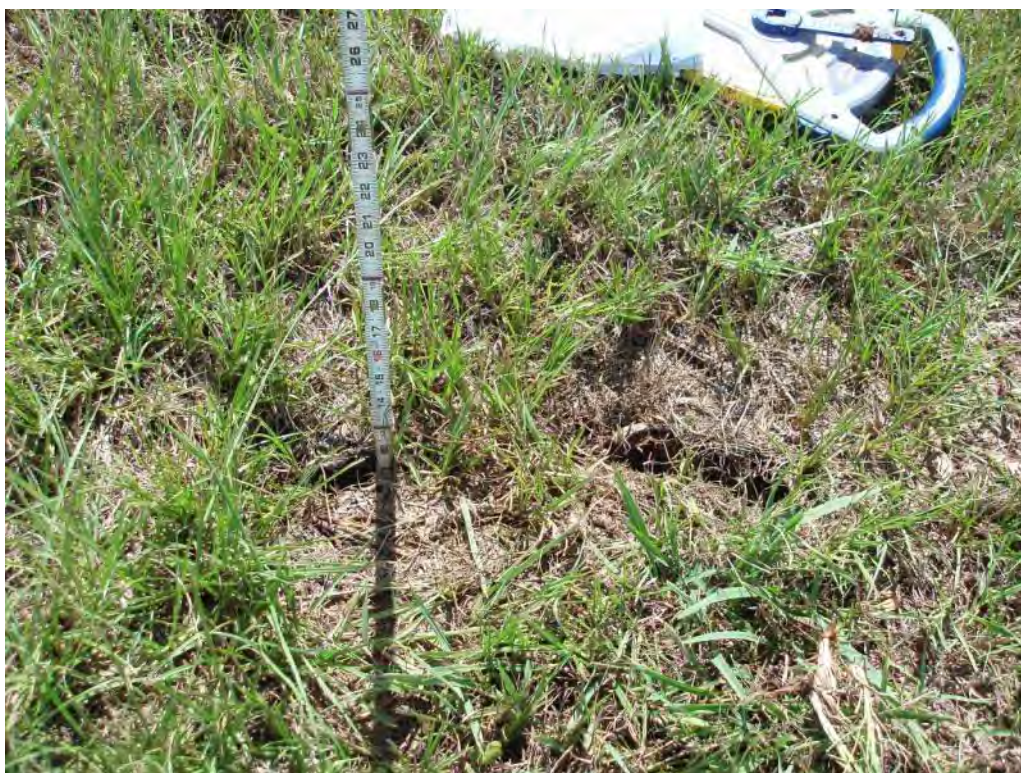
Photo No. 96: Fly Ash Pond - North embankment interior slope. Looking at crack in soils (approximately 2 inches wide and 12 inches deep).

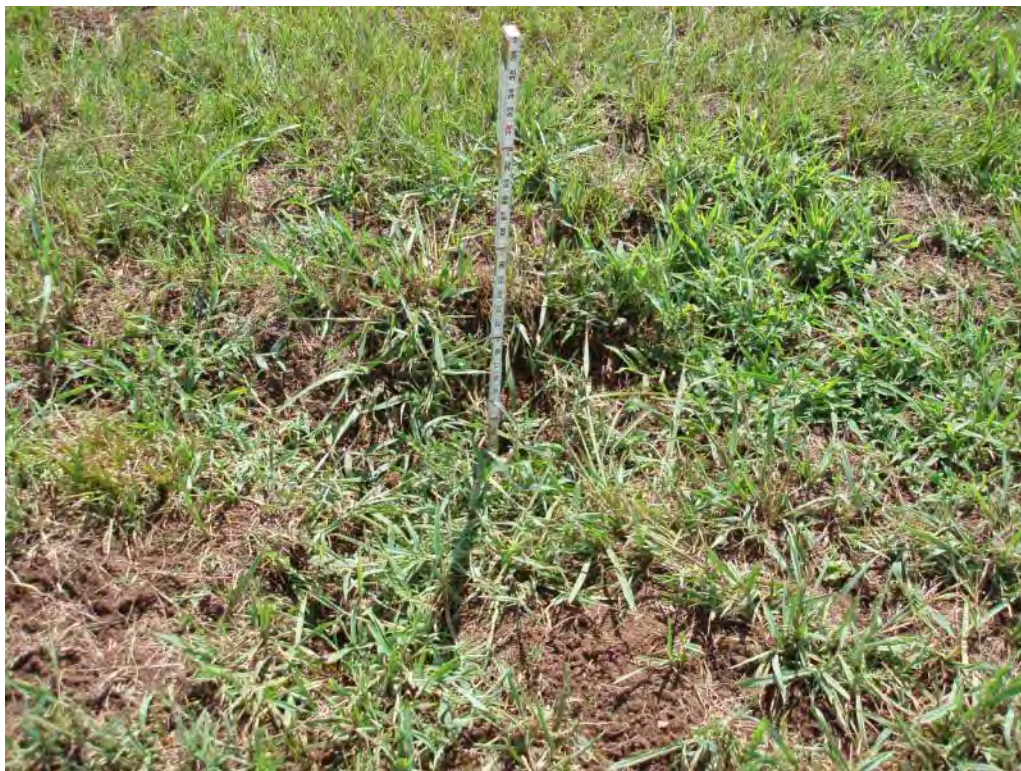
Photo No. 97: Fly Ash Pond – North embankment interior slope. Looking at crack in soils (approximately 2 inches wide and 11 inches deep).

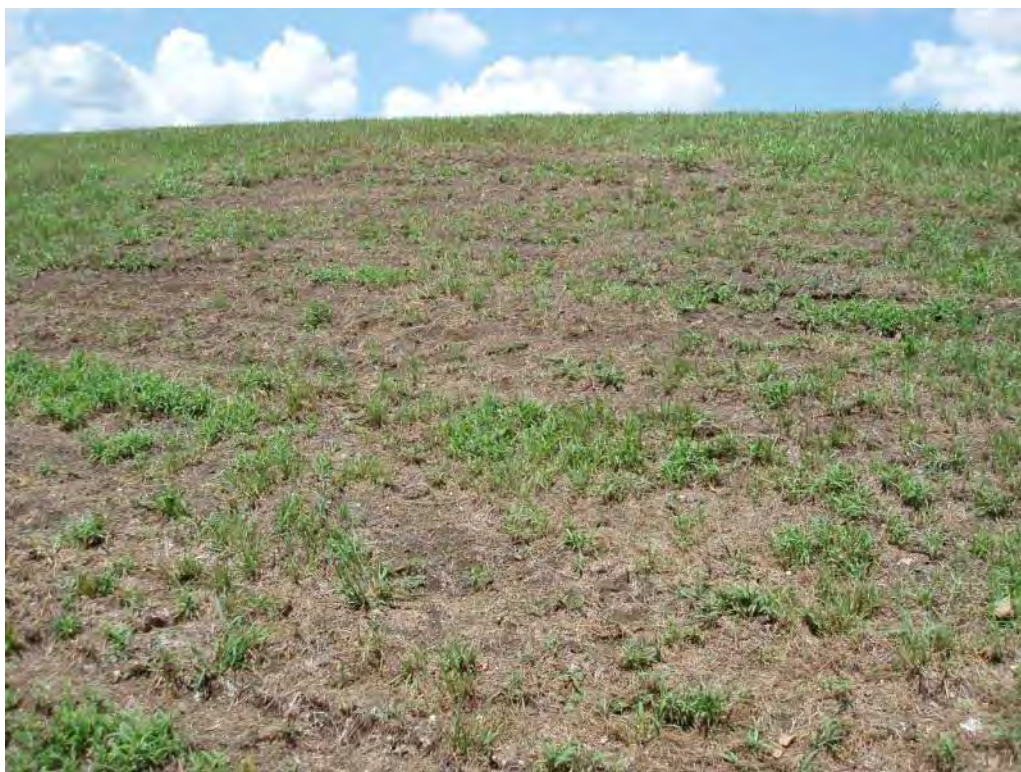
Photo No. 98: Fly Ash Pond – North embankment exterior slope. Looking at minor rutting and loss of grass cover.

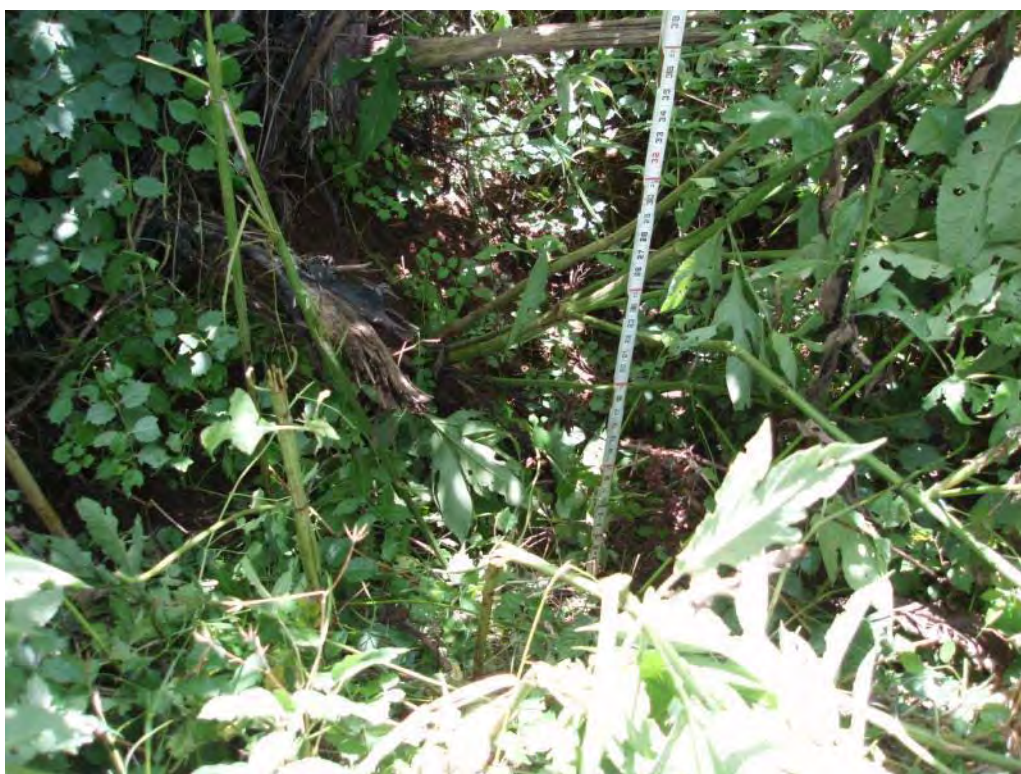
Photo No. 100: Fly Ash Pond - East embankment exterior slope, downed tree near toe created depression and erodible soils.

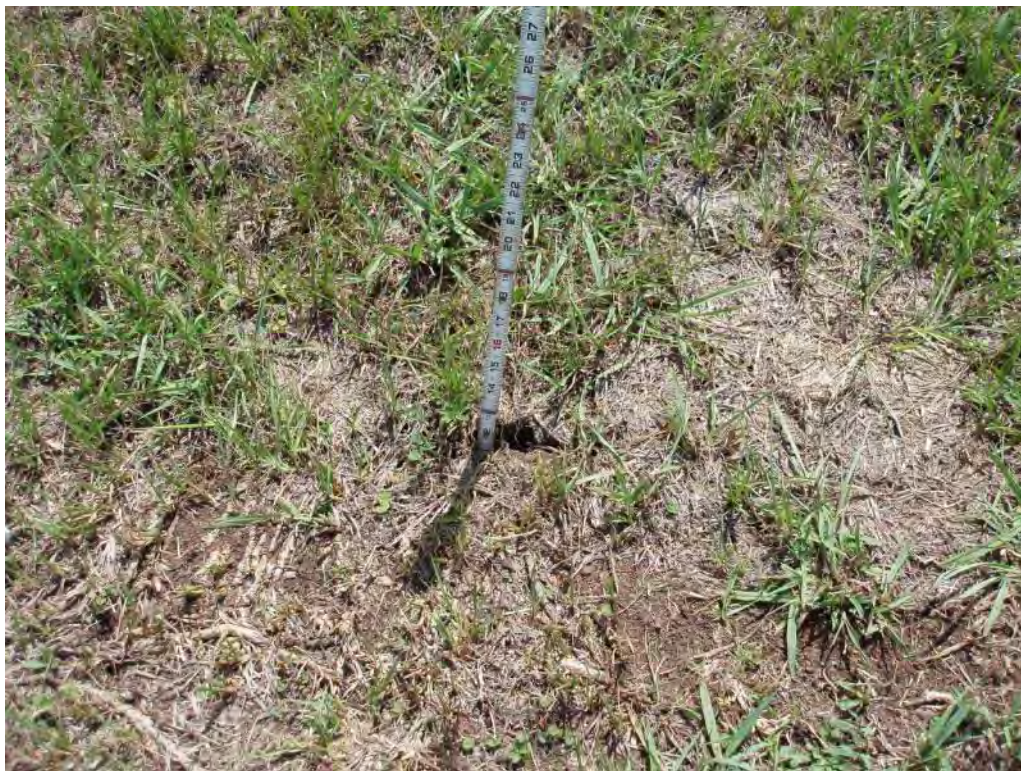
Photo No. 101: Fly Ash Pond - East embankment interior slope. Looking at crack in soils (approximately 2 inches wide and 11 inches deep).

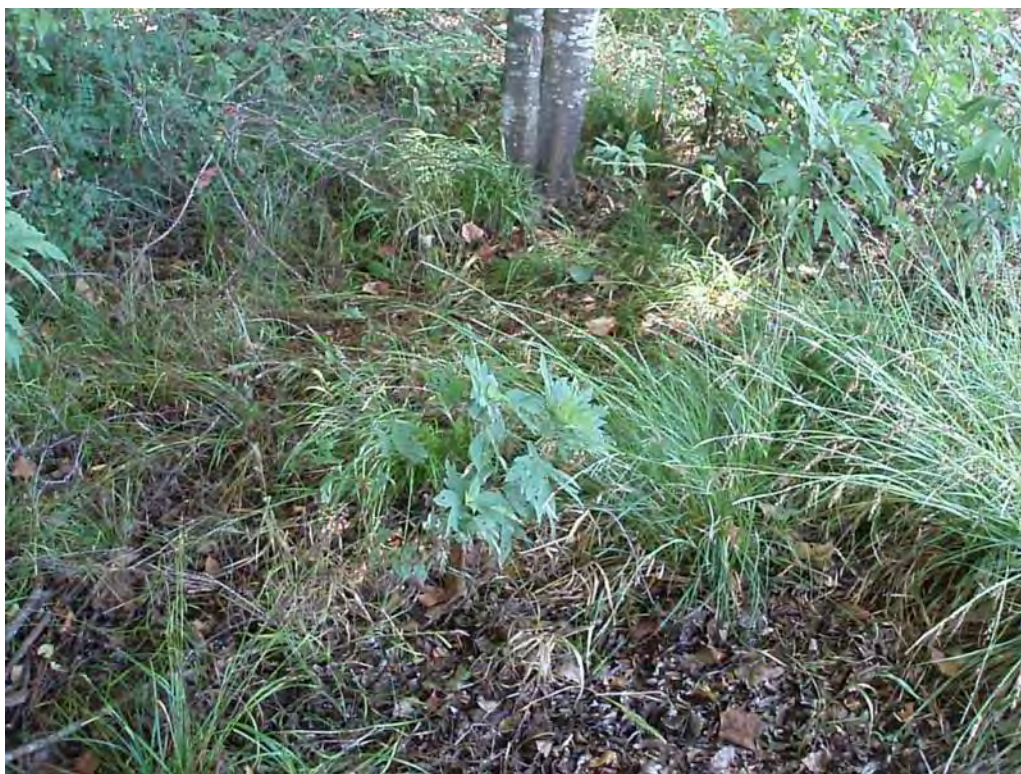
Photo No. 102: Fly Ash Pond - East embankment exterior slope. Looking at vegetation growing on lower third of slope.

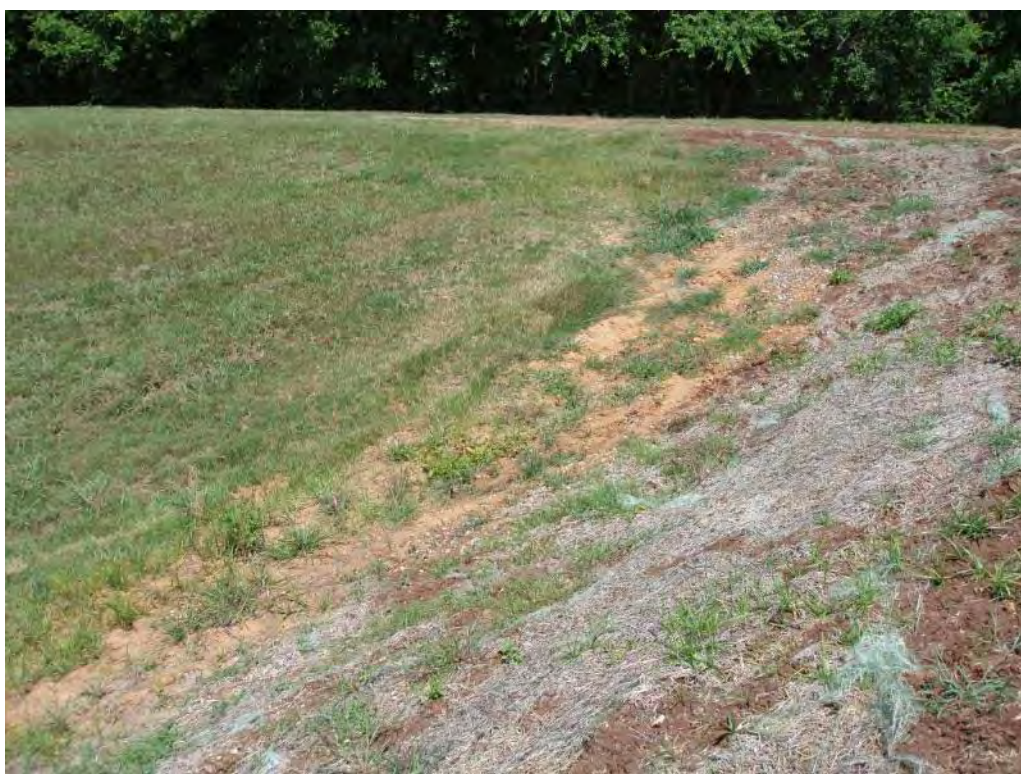
The interior slopes appear to be in fair condition. The embankment interior slopes range from approximately 4H:1V to 5H:1V. In general, the embankment's north and east interior slopes are well vegetated with various species of grass, typically 3 to 5 inches in height (Photographs 73, 77, and 90). The eastern 700 feet of the south embankment interior slope had been re-seeded recently and grass had not yet been reestablished. TRM placed on the exposed soil for erosion protection appeared to be effective (Photographs 103, 105, 106, 112 and 115).

Photo No. 106: Fly Ash Pond - Southeast corner interior slope, looking southeast. Note
surface erosion.

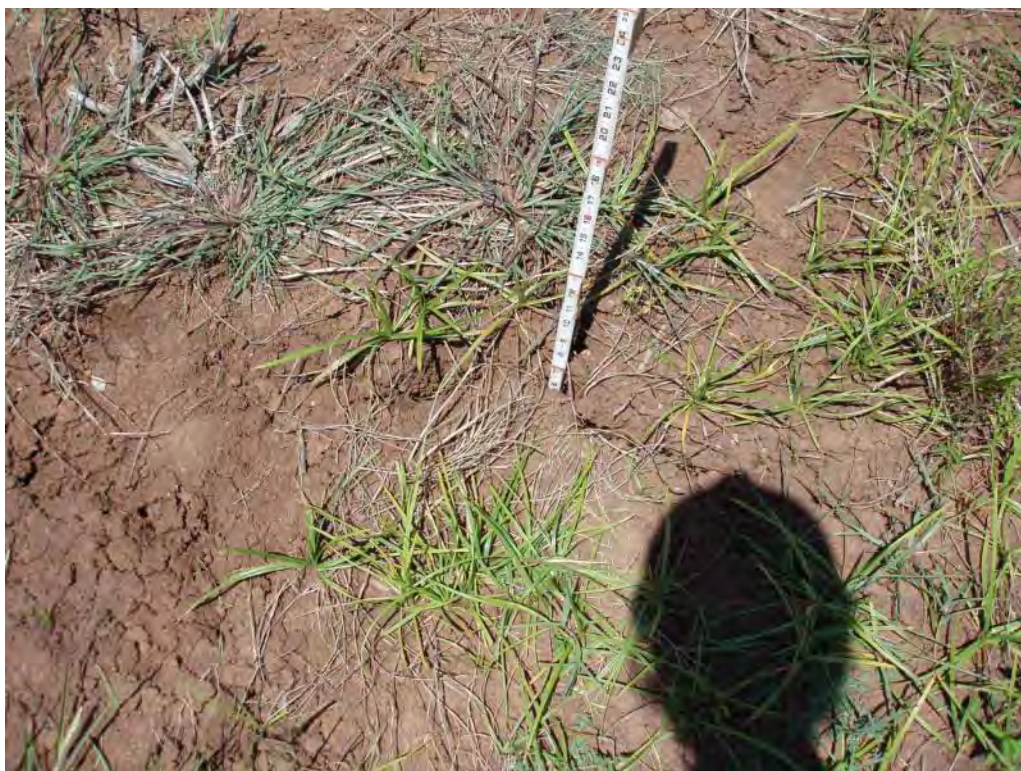
Photo No. 109: Fly Ash Pond – South embankment exterior slope. Looking at cracks in soils (approximately 1 inch wide and 6 inches deep).

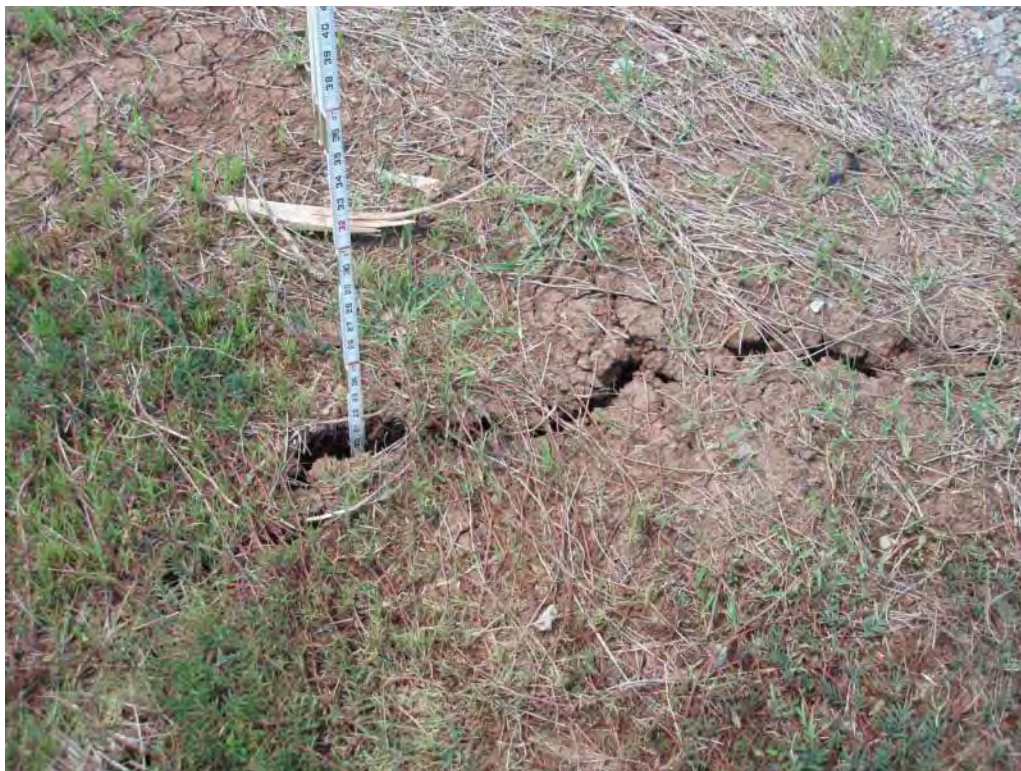
and 20 inches deep, was observed in several locations along the west embankment crest (Photographs 113 and 142).

Photo No. 113: Fly Ash Pond – South embankment exterior slope. Looking at cracks in soil (approximately 2 inches wide and 21 inches deep).
