Assessment of Dam Safety of Coal Combustion Surface Impoundments

Cleco Corporation

Brame Energy Center

March 14, 2011

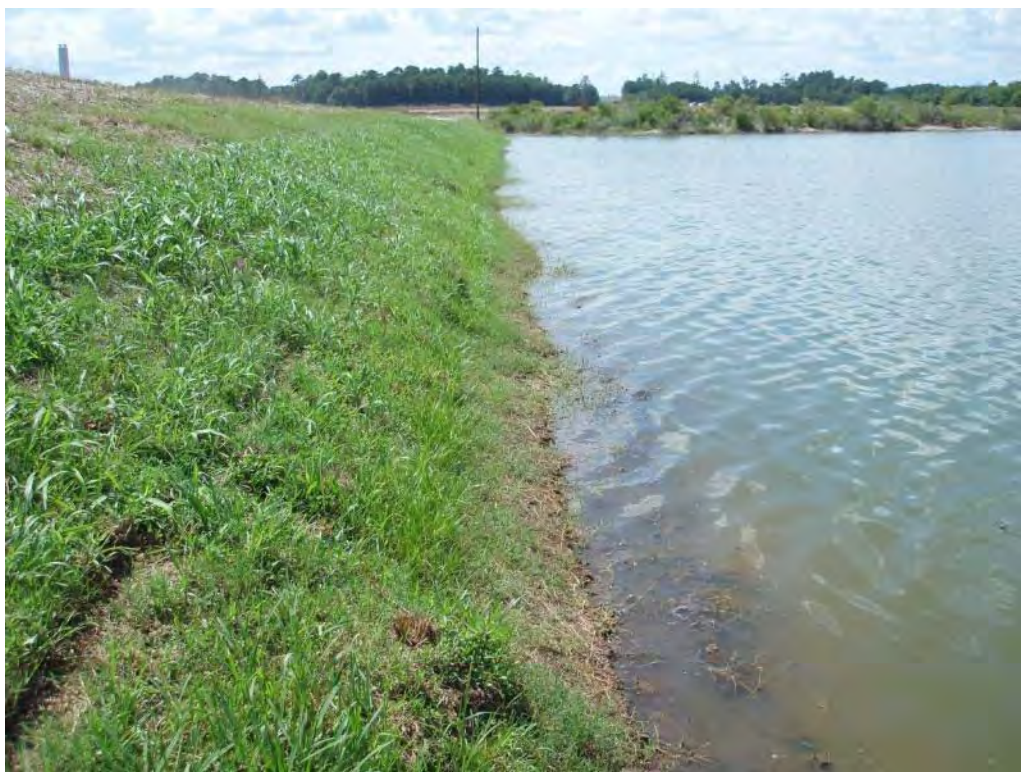
The interior embankment did not have erosion protection or armoring along the waterline (Photographs 76, 90, 114, 116 and 117). Erosion of the unprotected north and south embankment interior slope was observed (Photographs 76, 111, and 117). Numerous longitudinal cracks, approximately 1 to 2 inches wide and extending approximately 15 inches below grade, were observed on the north and east embankment interior slopes (Photographs 92, 93, 96, 97 and 101). The cracks appeared to be located in fill material placed over the original embankment cross section.

Photo No. 114: Fly Ash Pond – South embankment interior slope, looking northwest. Note erosion near water line and ruts on slope.

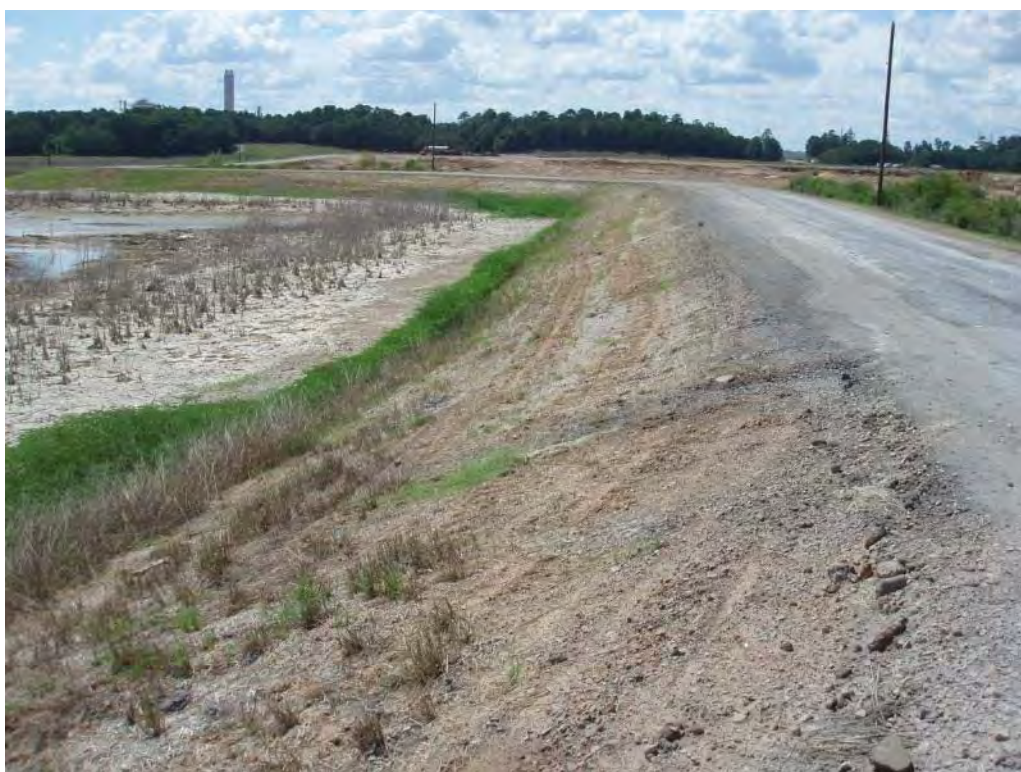
Photo No. 118: Fly Ash Pond - South embankment exterior slope, looking northwest. Note missing vegetation.

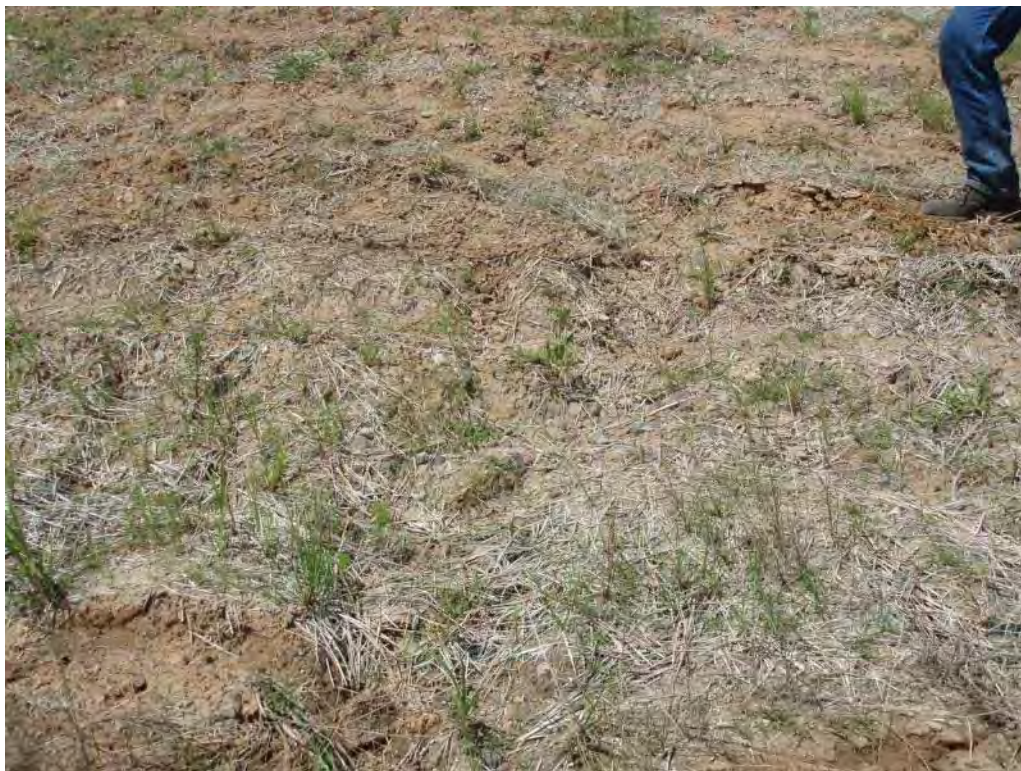
Photo No. 119: Fly Ash Pond - South embankment exterior slope, looking northeast. Note missing vegetation and ruts.

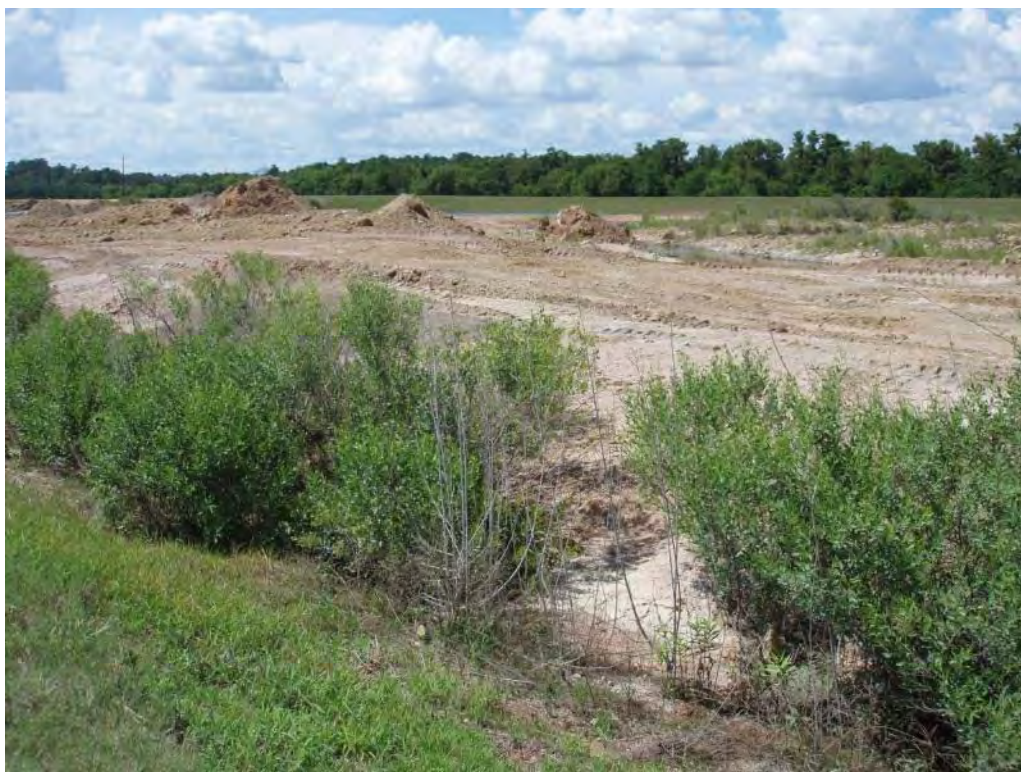
Photo No. 120: Fly Ash Pond - South embankment interior slope, looking northwest. Note ash material placed on slope.

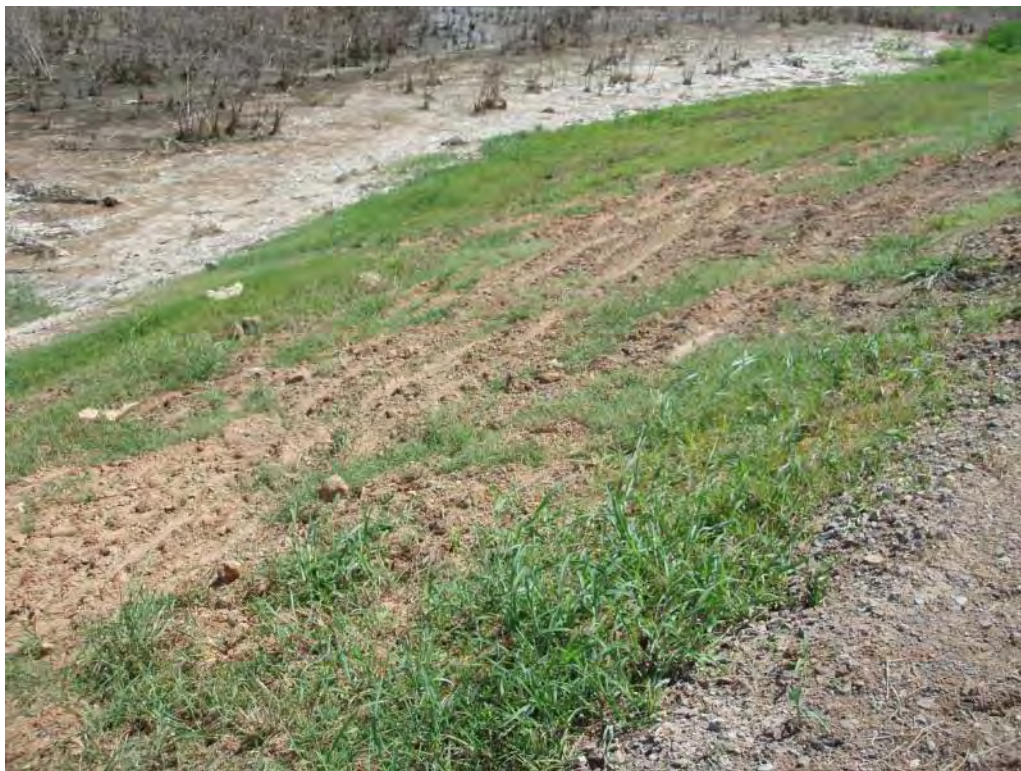
Photo No. 121: Fly Ash Pond - South embankment exterior slope, looking southwest. Note ruts and missing vegetation.

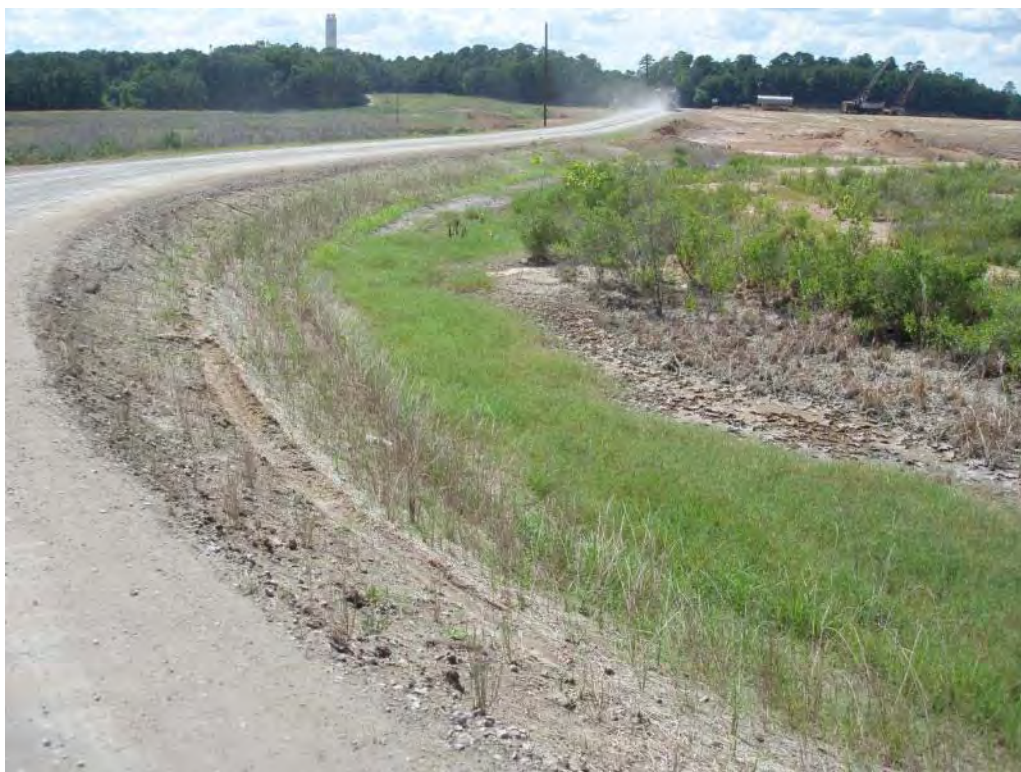
Photo No. 122: Fly Ash Pond - South embankment interior slope, looking northwest. Note ash material placed on slope.

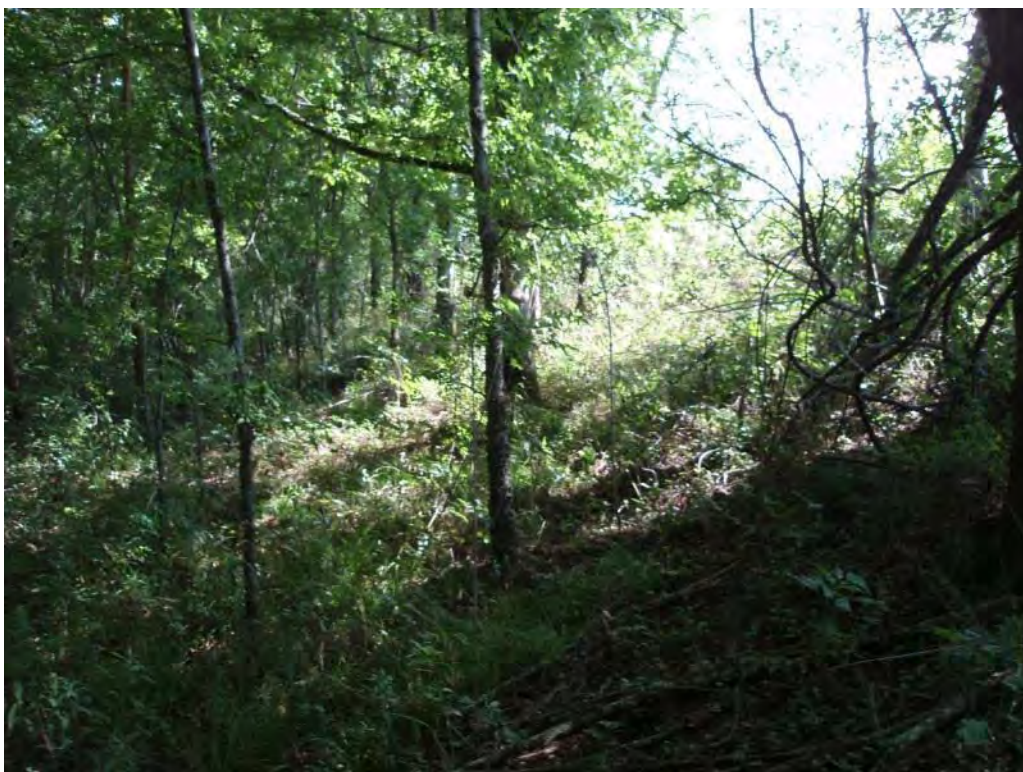
Photo No. 134: Leachate Pond - East embankment exterior slope. Looking at dense vegetation covering slope.

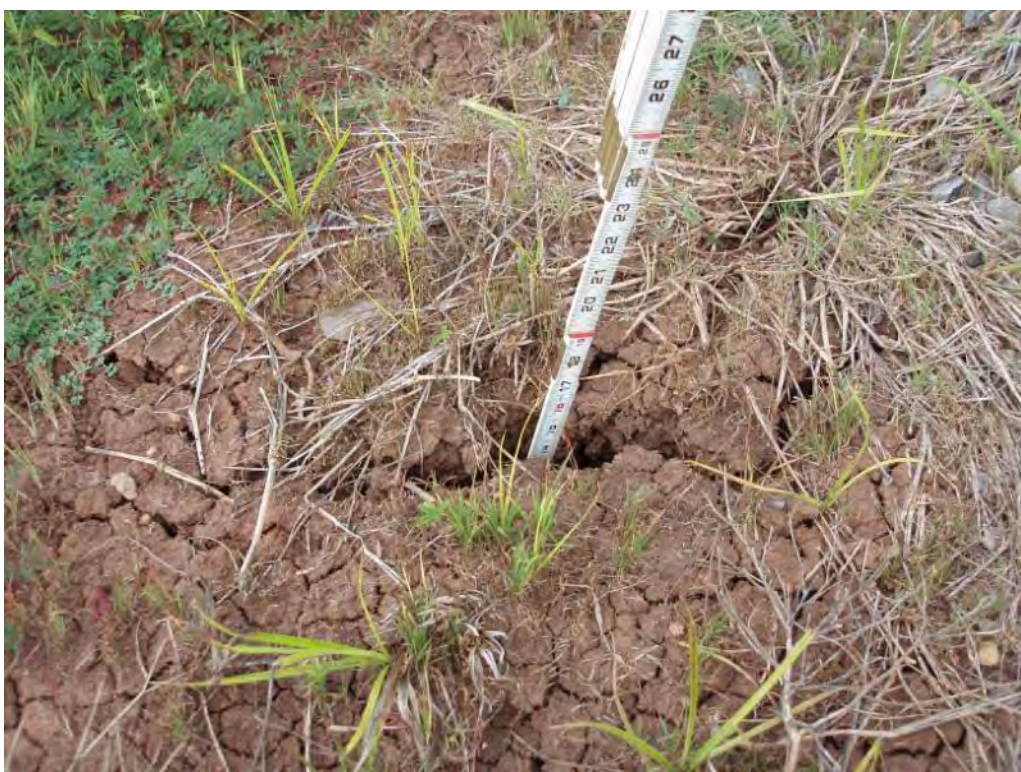
and 20 inches deep, was observed in several locations along the west embankment crest (Photographs 113 and 142).

Photo No. 142: Leachate Pond - West embankment exterior slope. Note cracks in soil (approximately 2 inches wide and 14 inches deep).
