### **CCW IMPOUNDMENTS INSPECTION REPORT**

#### **ROXBORO STEAM ELECTRIC PLANT PERSON COUNTY, NORTH CAROLINA**

**PROJECT NO. 09-4157  
OCTOBER, 2009**

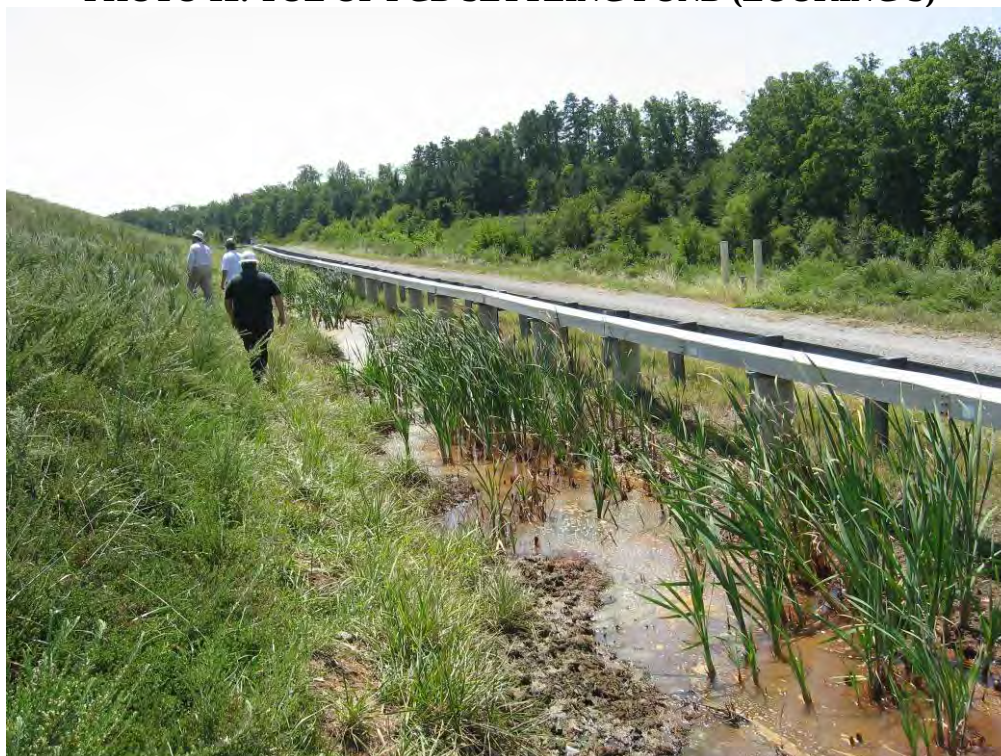
**PHOTO 12: TOE OF FGD SETTLING POND (LOOKING S)**

Seepage is present along the toe of the exterior slope. See **Photo 12, Appendix A**. This seepage is carried in a toe ditch to a sump where it is pumped back into the pond. Seepage is generally clear; however small boils and deposits of fines indicate that piping of materials is occurring. (**Photo 14, Appendix A**). Monitoring of the seepage should be continued until the repairs are initiated.

Continue to monitor the seepage at the toe of the Settling Pond Dike until the pond is taken out of service for repairs.

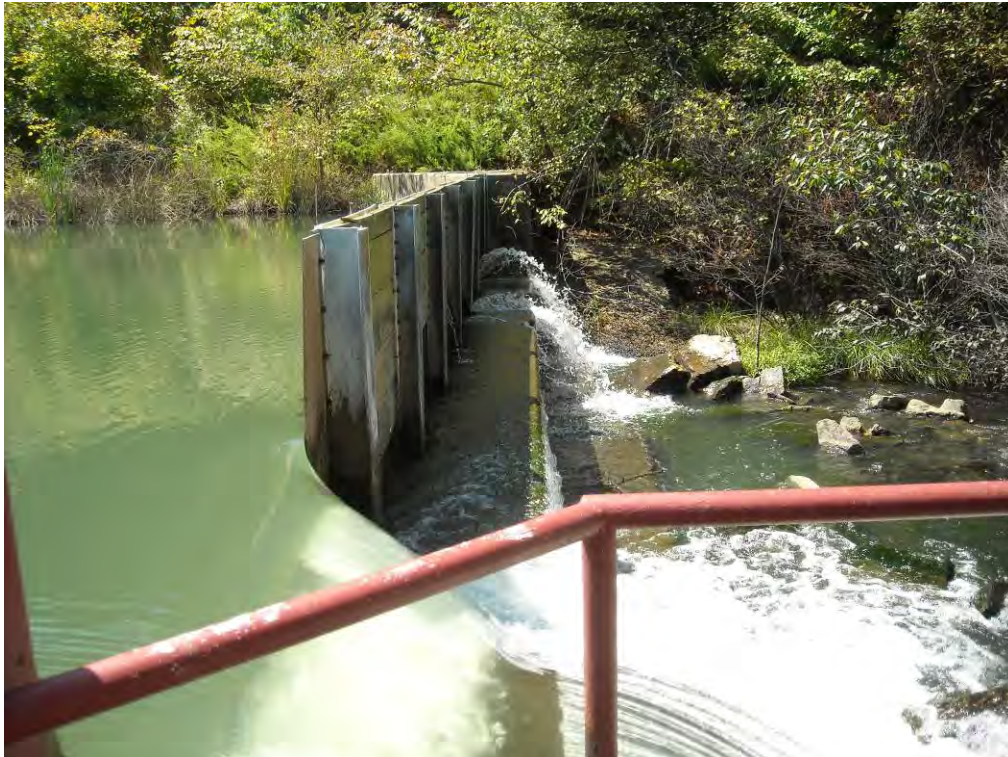
**PHOTO 27: CLOSE UP OF WEST ASH POND DAM DISCHARGE WEIR  
STRUCTURE**

The discharge weir structure is the NPDES Permit NC-0003425 discharge point. (See **Photo 27, Appendix A**). At the time of inspection clear water was freely flowing from the canal to Hyco Lake. Significant seepage was noted flowing from beneath the concrete abutment on the right (East) side of the structure. The flow appears to be coming through the rock foundation. The *2007 Report of Limited Field Inspection* by MACTEC noted this concern and offered assistance in developing and implementing a repair plan for the condition. RIZZO recommends that this action be taken along with monitoring the flow on a monthly basis concurrent with existing scheduled inspections.

Follow-up to developing and implementing a repair plan for the seepage at the NPDES Discharge Point.
