### **CCW IMPOUNDMENTS INSPECTION REPORT**

#### **ROXBORO STEAM ELECTRIC PLANT PERSON COUNTY, NORTH CAROLINA**

**PROJECT NO. 09-4157  
DECEMBER, 2009**

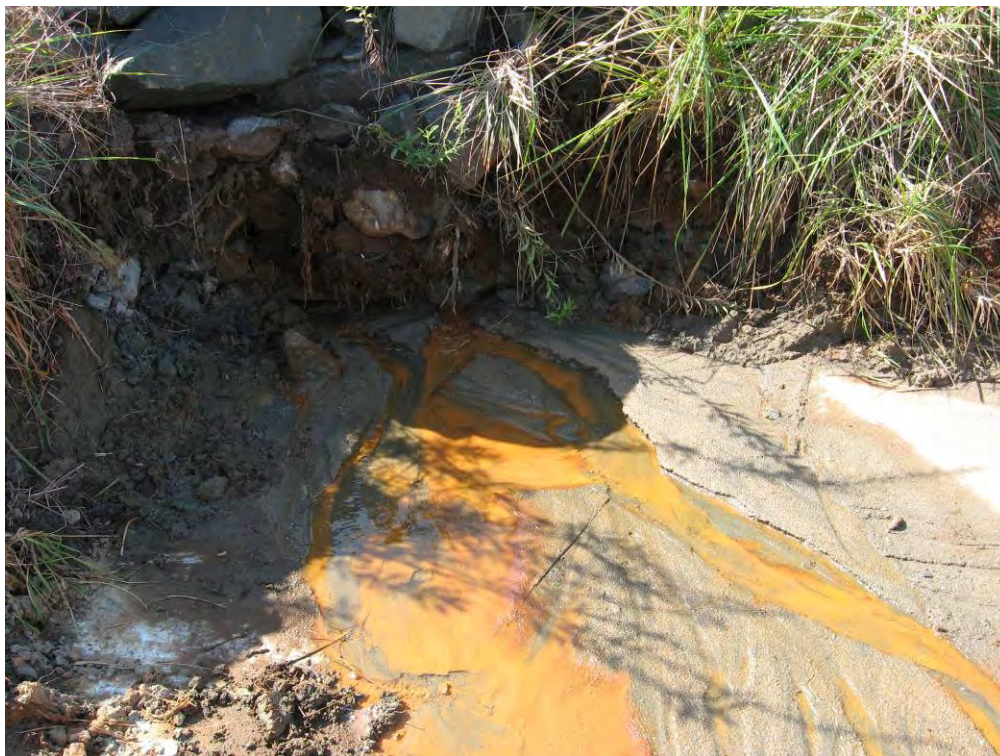
**PHOTO 3: CHIMNEY DRAIN AT TOE OF WEST ASH POND DAM**

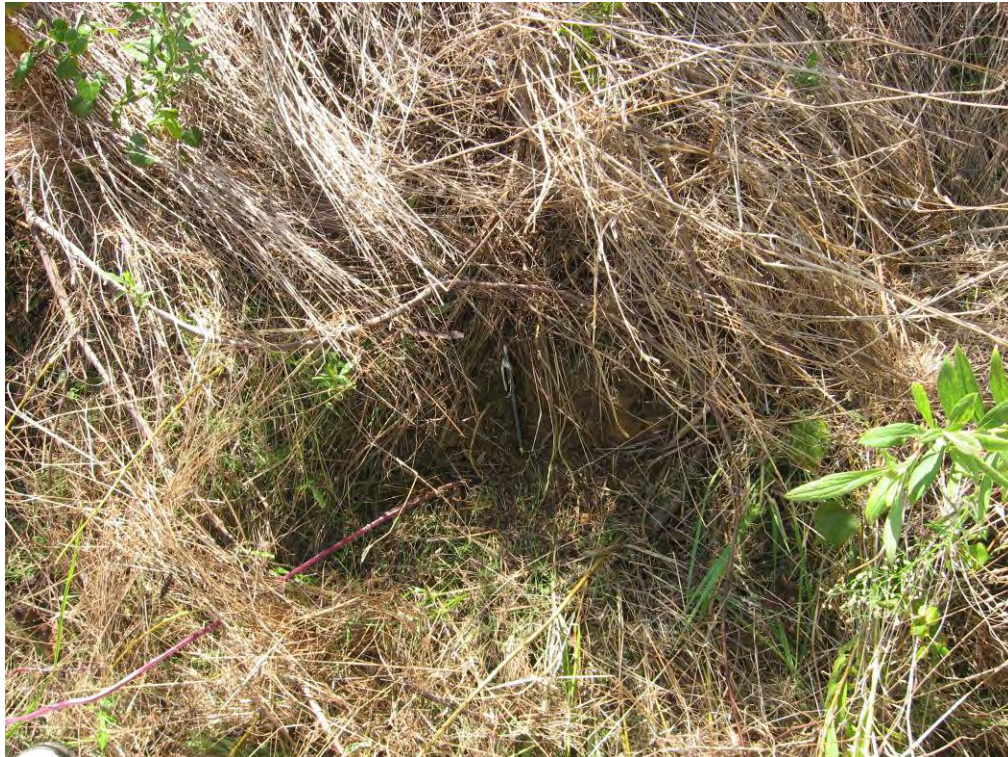
**PHOTO 5: SMALL SCARP LOCATED BETWEEN SECOND AND THIRD  
DRAIN OUTLETS OF WEST ASH POND DAM**

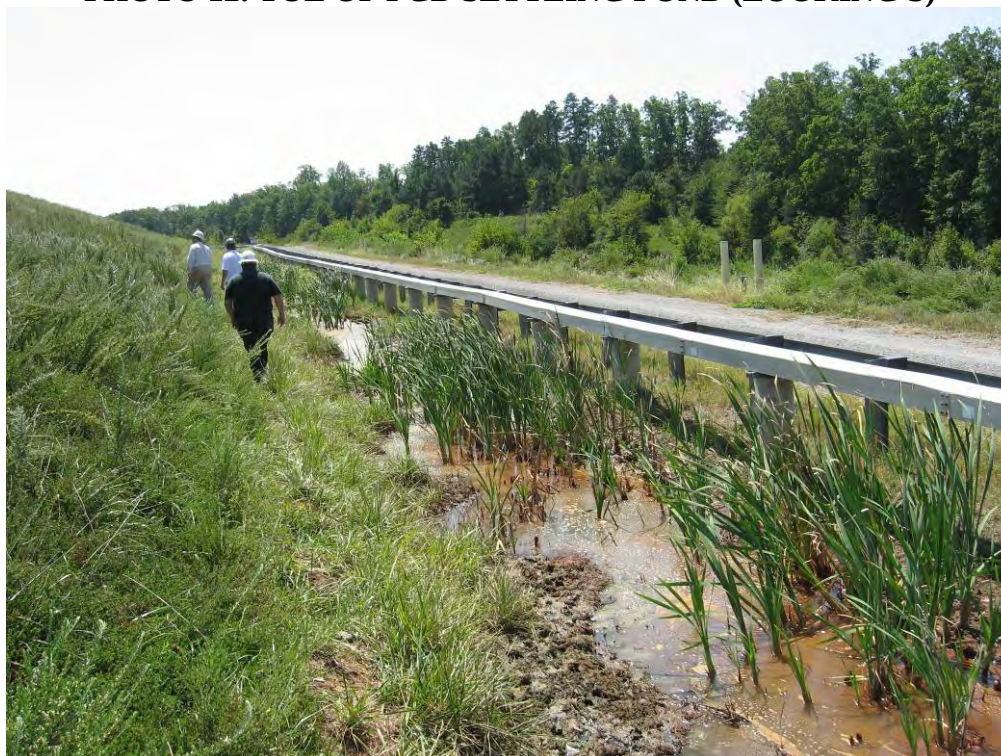
**PHOTO 12: TOE OF FGD SETTLING POND (LOOKING S)**

Seepage is present along the toe of the exterior slope. See **Photo 12, Appendix A**. This seepage is carried in a toe ditch to a sump where it is pumped back into the pond. Seepage is generally clear; however small boils and deposits of fines indicate that piping of materials is occurring. **Photo 14, Appendix A**. Monitoring of the seepage should be continued until the repairs are initiated.

Continue to monitor the seepage at the toe of the Settling Pond Dike until the pond is taken out of service for repairs.

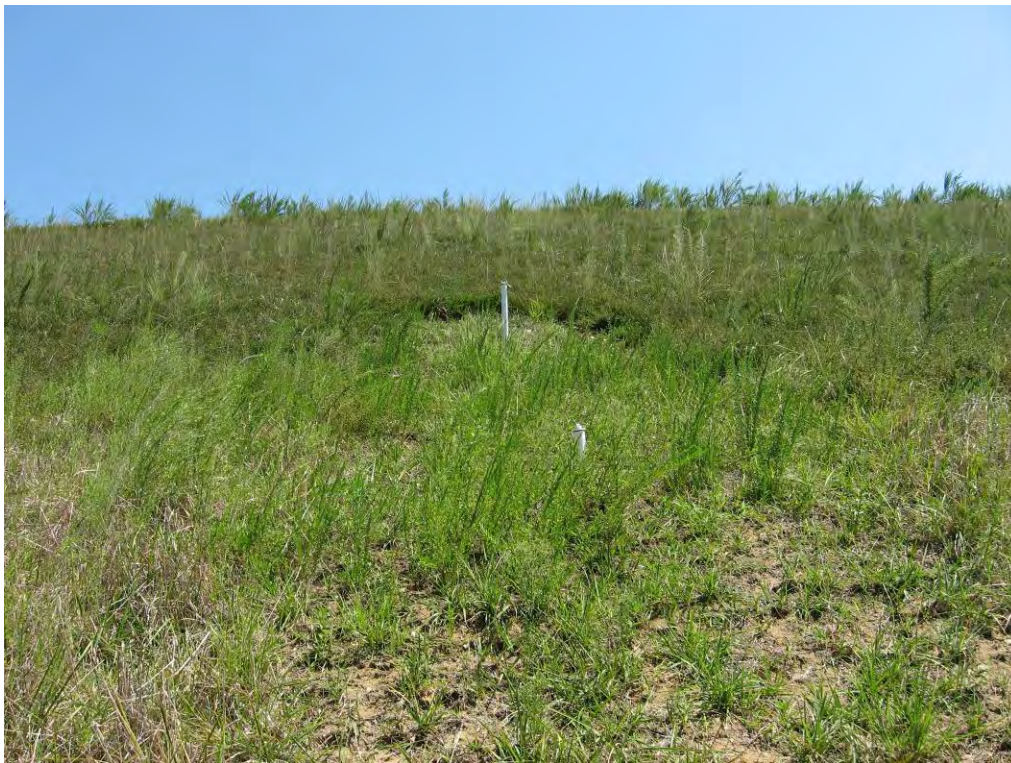
**PHOTO 13: DOWNSTREAM EMBANKMENT OF FGD SETTLING POND**

The crest of the structure has a hard surface that is relatively new and showed no signs of cracking, settlement or rutting. The interior slope is covered by riprap and appeared to be uniform with no sloughing, bulging, or scarps. The exterior slope is generally uniform and well grassed with the exception of isolated sloughs that had been patched following the seepage event. See *Photo 13, Appendix A*.

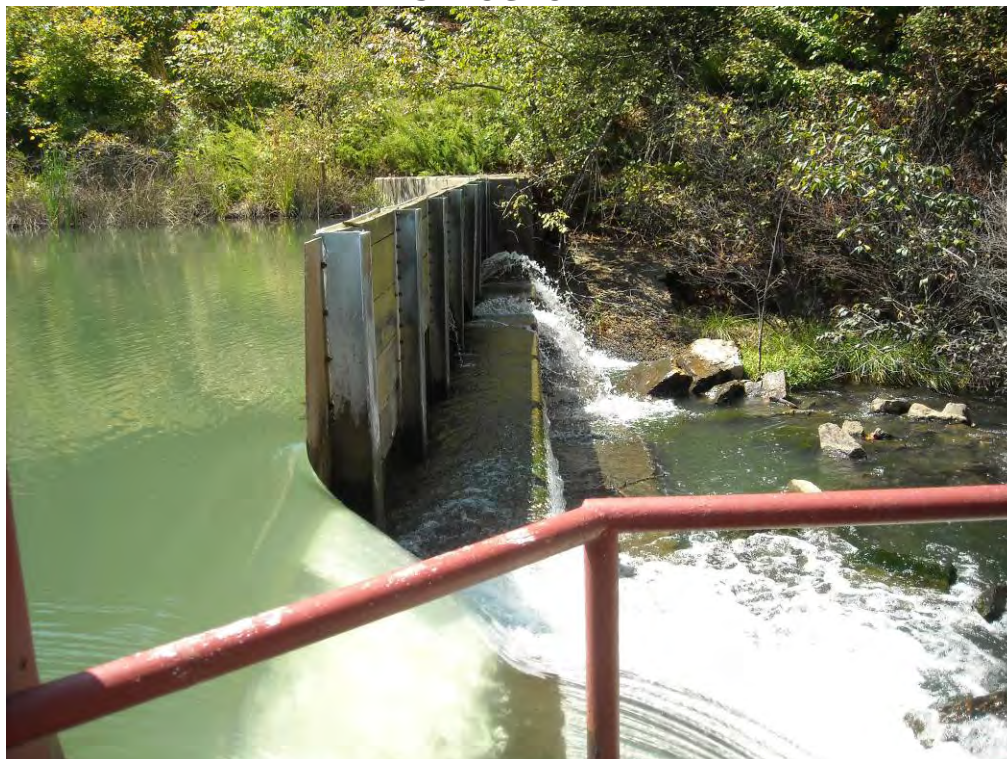
**PHOTO 27: CLOSE UP OF WEST ASH POND DAM DISCHARGE WEIR  
STRUCTURE**

The discharge weir structure is the NPDES Permit NC-0003425 discharge point. See **Photo 27, Appendix A**. At the time of inspection clear water was freely flowing from the canal to Hyco Lake. Significant seepage was noted flowing from beneath the concrete abutment on the right (East) side of the structure. The flow appears to be coming through the rock foundation. The *2007 Report of Limited Field Inspection* by MACTEC noted this concern and offered assistance in developing and implementing a repair plan for the condition. RIZZO recommends that this action be taken along with monitoring the flow on a monthly basis concurrent with existing scheduled inspections.

Follow-up to developing and implementing a repair plan for the seepage at the NPDES Discharge Point.
