# ASSESSMENT OF DAM SAFETY OF COAL COMBUSTION SURFACE IMPOUNDMENTS – DRAFT REPORT

**San Miguel Electric  
Cooperative, Inc.  
San Miguel Electric Plant  
Christine, Texas**

Prepared for  
*U.S. Environmental  
Protection Agency  
Washington, D.C.*

November 2012  
Revision 2, December 2013

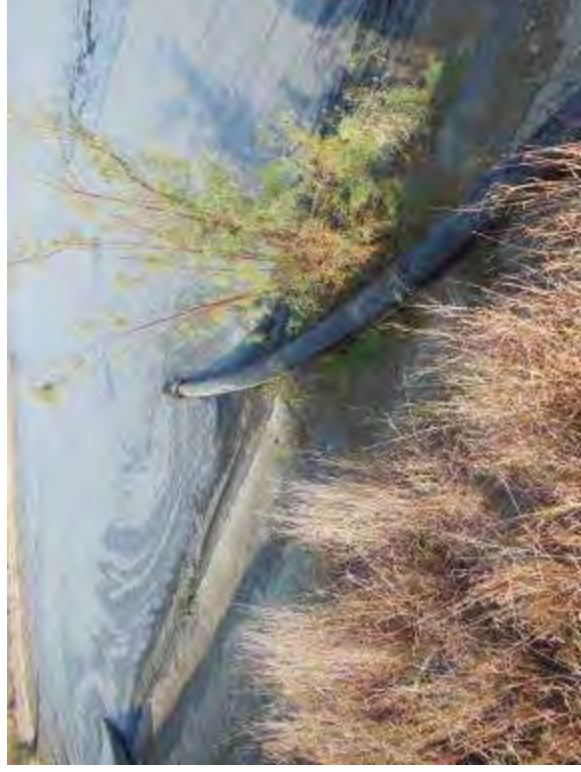
Photo 14: 6-inch-diameter inlet from Sludge Basin near southeast corner interior slope.

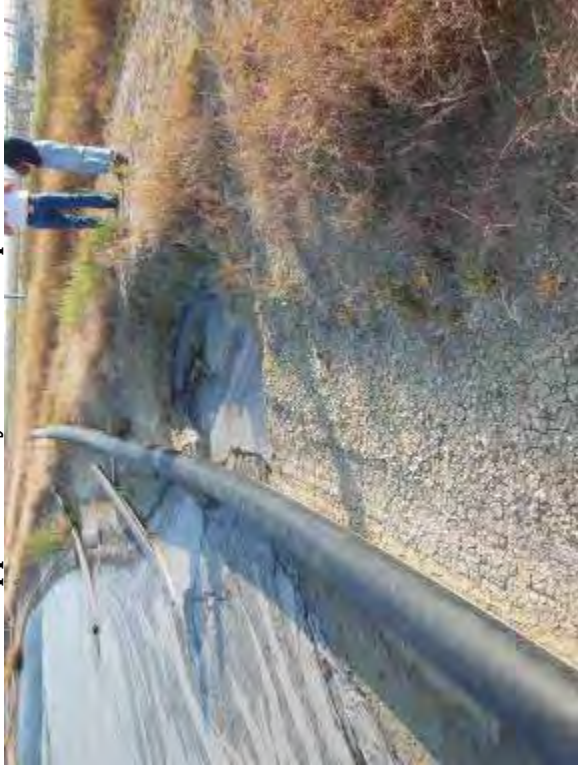
Pond embankments. An area of erosion, approximately 5 feet wide, was also observed on the interior slope of the Ash Pond's east embankment. According to San Miguel representatives this erosion was a result of leakage from a water well pipe traversing the Ash Pond embankment. The water well pipe had been repaired at the time of the site assessment.

Photo 15: Erosion of east embankment interior slope from leaking water well pipe.

- Surface erosion - Structural fill should be placed and compacted, graded to adjacent existing contours, and sodded or reseeded. Alternatively, riprap or other armoring could be used. Riprap or other armoring is recommended for the west, north, and east interior slopes to reduce the potential for erosion.

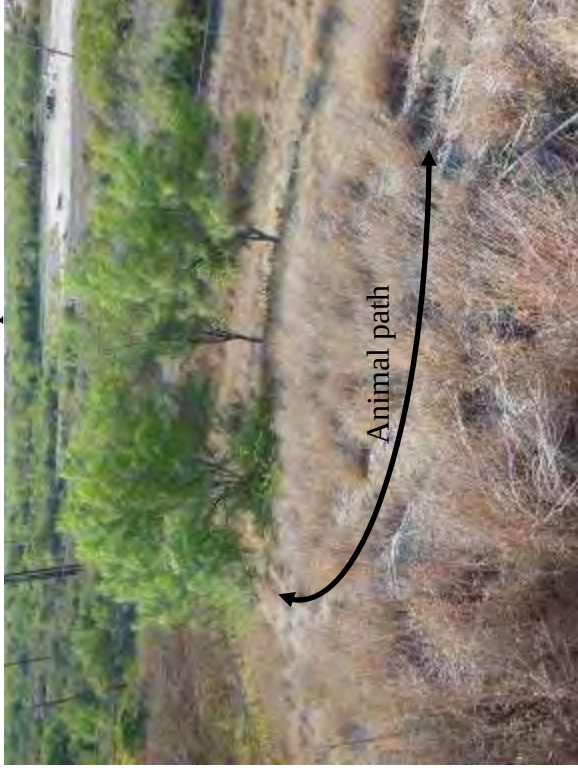
Photo 16: Southeast corner exterior embankment showing animal path and trees, looking southeast.
