# ASSESSMENT OF DAM SAFETY OF COAL COMBUSTION SURFACE IMPOUNDMENTS FINAL REPORT

**San Miguel Electric  
Cooperative, Inc.  
San Miguel Electric Plant  
Christine, Texas**

Prepared for  
*U.S. Environmental  
Protection Agency  
Washington, D.C.*

March 2014  
Revision 1, April 2014

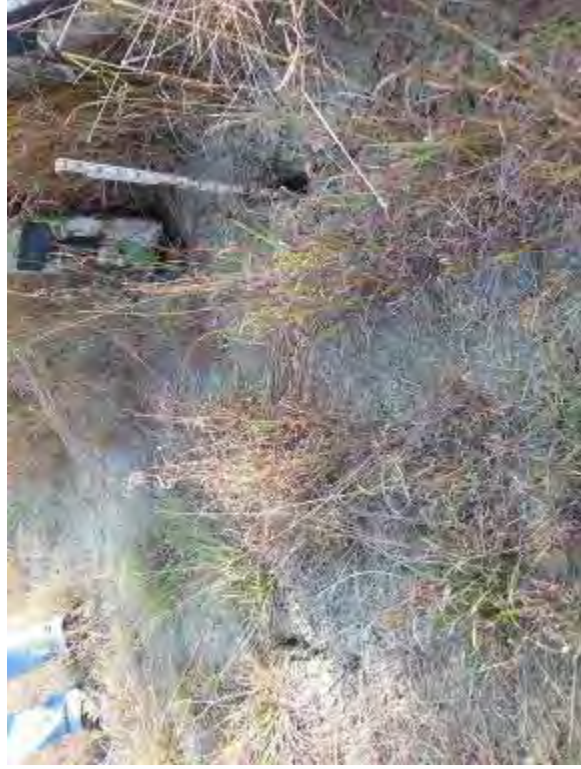
Photo 13: East embankment crest tension or desiccation cracks approximately 15 inches deep.

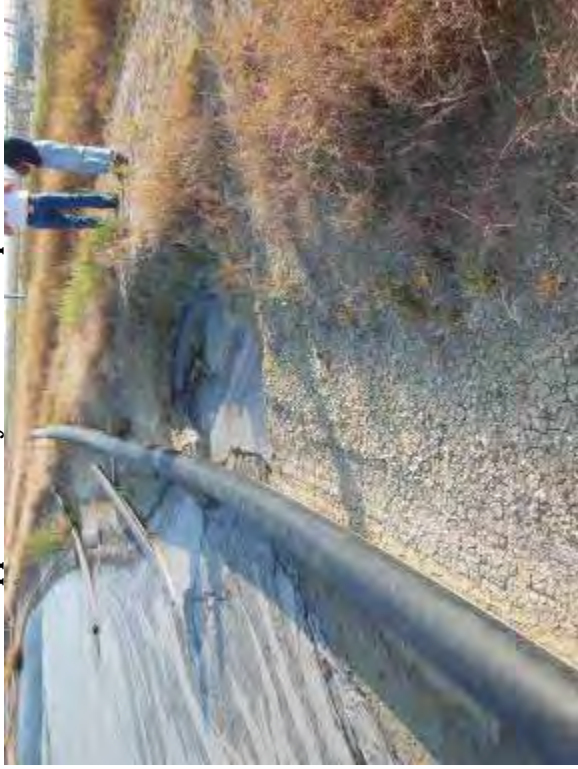
Pond embankments. An area of erosion, approximately 5 feet wide, was also observed on the interior slope of the Ash Pond's east embankment. According to San Miguel representatives this erosion was a result of leakage from a water well pipe traversing the Ash Pond embankment. The water well pipe had been repaired at the time of the site assessment.

Photo 15: Erosion of east embankment interior slope from leaking water well pipe.

- Surface erosion - Structural fill should be placed and compacted, graded to adjacent existing contours, and sodded or reseeded. Alternatively, riprap or other armoring could be used. Riprap or other armoring is recommended for the west, north, and east interior slopes to reduce the potential for erosion.

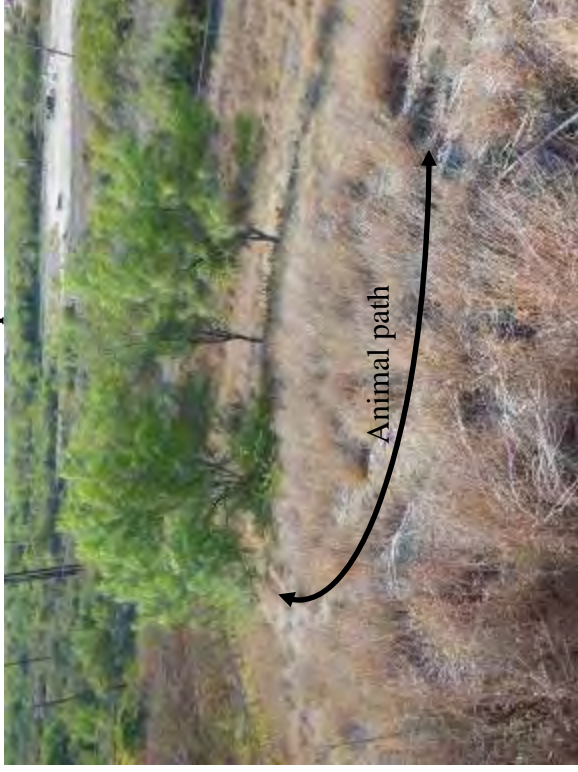
Photo 16: Southeast corner exterior embankment showing animal path and trees, looking southeast.
