**Coal Combustion Residue Impoundment
Round 9 - Dam Assessment Report**

Cross Generating Station

Santee Cooper
Pineville, South Carolina

Dewberry & Davis, LLC
Fairfax, Virginia

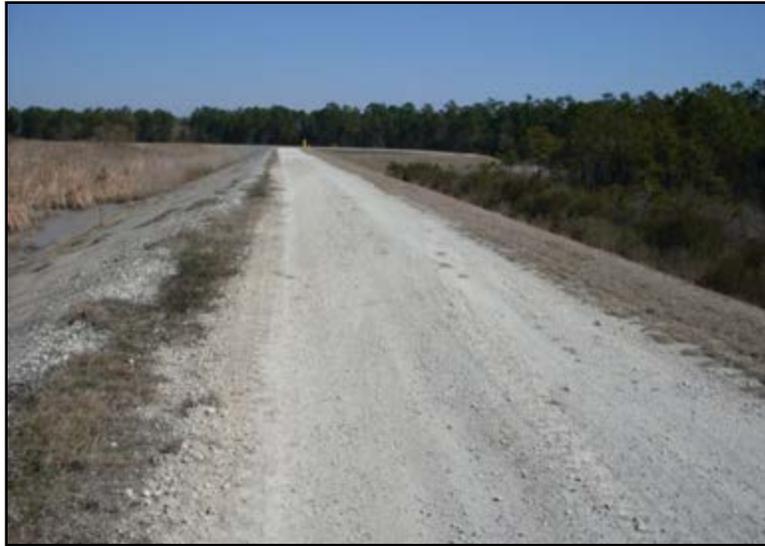
A typical view of the perimeter dike embankment crest of Bottom Ash Pond 1 is shown in Photograph 5.1. The limerock-surfaced crest appeared to be in satisfactory condition with no major sags, depressions, or other signs of significant settlement. No tension cracks which might suggest soil shear failure were observed in the crest or along the edge of the crest. The crest of the dike on the northeast side of Bottom Ash Pond 1 is shown in Photograph 5.2, as viewed from the southeast end toward the location of the notch spillway through this dike. A sparse grass cover has become established on this part of the crest, apparently due to low traffic on this dead-end section. The grass appeared to be maintained.

Photograph 5.1. View of crest and inside slope, southeast side looking northeast.

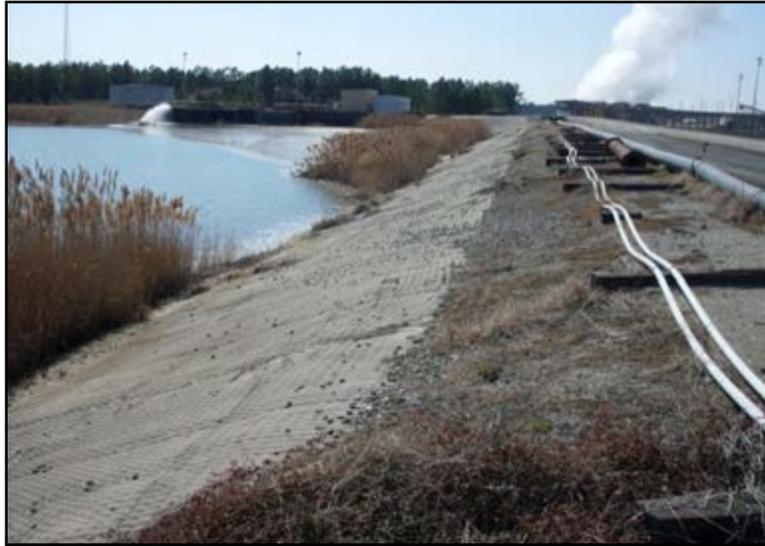
A typical view of the upstream slope of Bottom Ash Pond 1 is shown in Photograph 5.3. (Note the wider crest with pipelines on the northwest side of Bottom Ash Pond 1.) The Fabriform revetment that overlies the original riprap on the upstream slope was observed to have slight unevenness in its surface, but it appeared to be sound and generally free of

deterioration. Patches of vegetation (primarily the reed, *Phragmites*) were observed on the upstream slopes, generally along and just above the water line or ash sediment line. No slumps, slides, or other signs of shear failure were observed in the visible parts of the slopes above the water surface or ash surface.

Photograph 5.3. Typical view of inside slope, northwest side looking southwest.

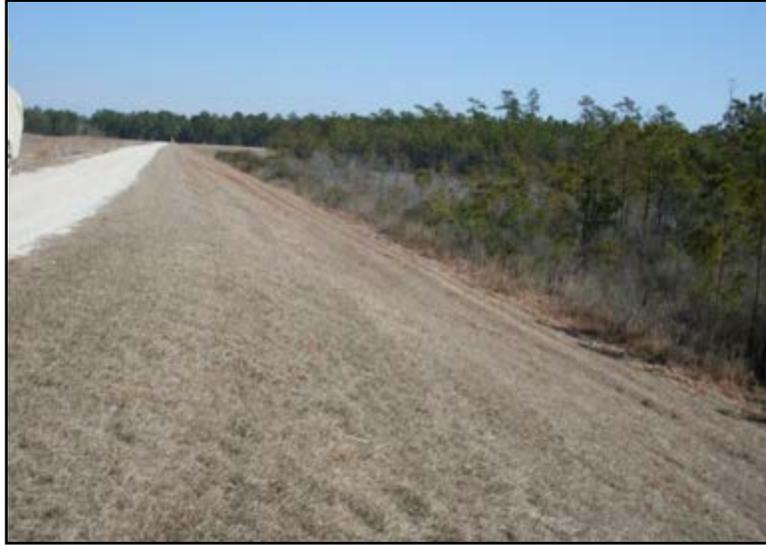
A typical view of the outside slope of Bottom Ash Pond 1 is shown in Photograph 5.4. As shown, the grass was observed to be maintained in relatively good condition. Minor erosion from mowing equipment was observed on the slope. No areas of significant erosion were observed. No obvious signs of slumps, slides, bulges, tension cracks, seepage, or animal holes were observed.

The area along the outside toe of the dike on the southeast side was observed to be covered in woody vegetation (Photograph 5.4). The outside slope of the dike on the northwest side was observed to be covered with mowed grass; however, some erosion was observed along the outside toe of this section of the dike, as shown in Photograph 5.5. There were no indications of seepage.

Photograph 5.4. Typical view of outside slope, southeast side looking northeast.

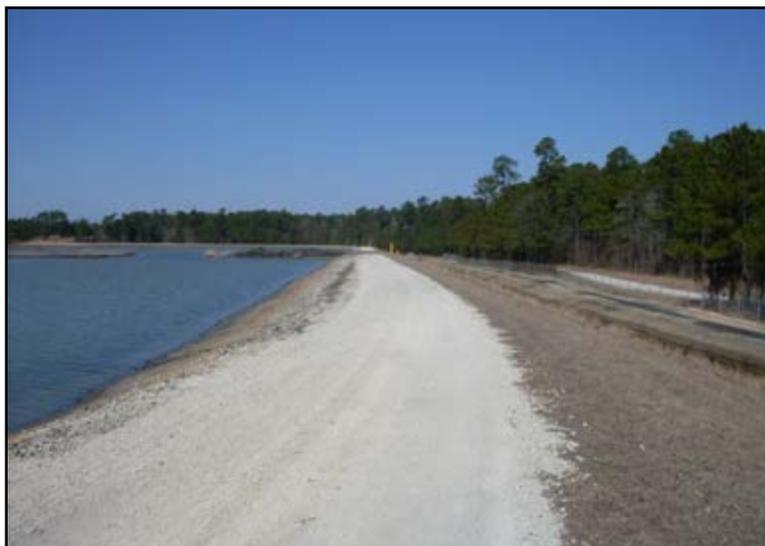
Typical views of the perimeter dike embankment crest of Bottom Ash Pond 2 are shown in Photographs 5.6a and 5.6b. The ash finger dike in the pond is visible in Photographs 5.6a. The limerock-surfaced crest was observed to be in satisfactory condition. No major sags, depressions, or other signs of significant settlement were observed in the crest. No tension cracks or other signs of insipient mass soil movement were observed in the crest or along the edge of the crest.

Photograph 5.6a. Typical view of crest and inside slope, northeast side looking northwest.

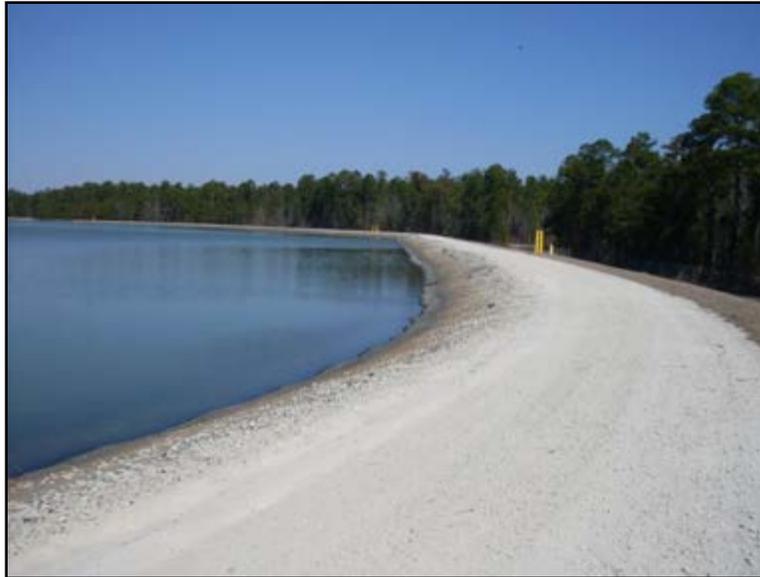
A typical view of the inside slope of Bottom Ash Pond 2 is shown in Photograph 5.6b (see also Photograph 5.6a). The Fabriform revetment on the upstream inside slopes appeared to be serviceable and in generally satisfactory condition with no major depressions and no significant areas of deterioration. Patches of vegetation (primarily Phragmites) were observed on the upstream slopes, generally along and just above the water line or ash sediment line, as shown in Photograph 5.6c. No slumps, slides, or other signs of shear failure were observed in the visible parts of the slopes above the water surface or ash surface.

Photograph 5.6b. Typical view of inside slope and crest, east side looking north.

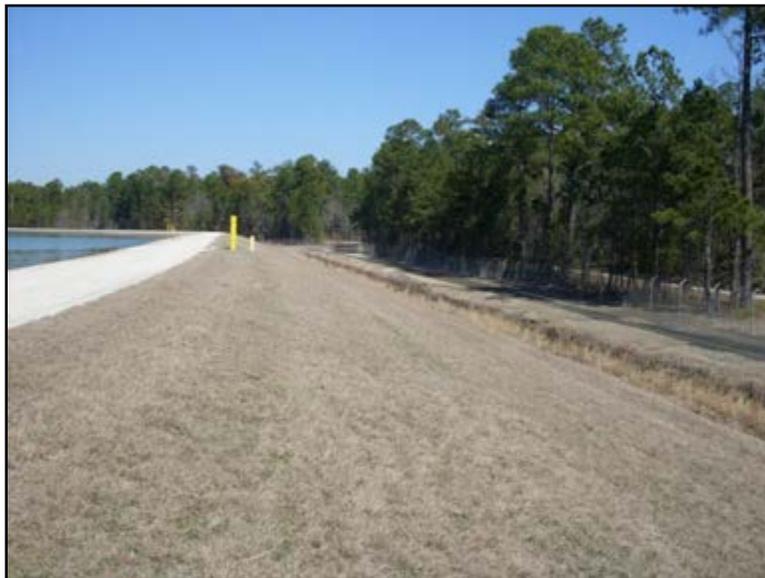
number of locations, typically along the toe, as shown by a typical view in Photograph 5.7b. Santee Cooper personnel indicated that topsoil was not used on the outside slope for vegetation establishment. No areas of major erosion were observed. No obvious signs of slumps, slides, bulges, tension cracks, seepage, or animal holes were observed on the outside slope.

Photograph 5.7a. Typical view of outside slope and toe, east side looking north.

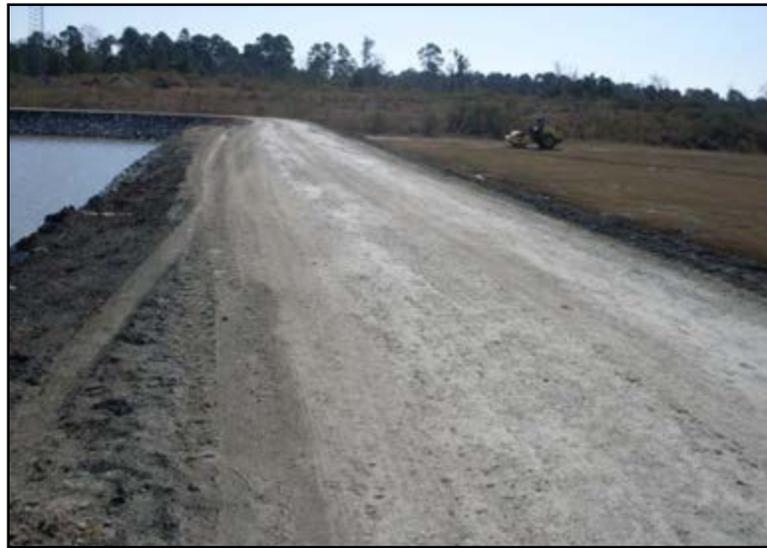
A typical view of the perimeter dike embankment crest of the Gypsum Pond is shown in Photograph 5.8. The finger dike embankment used for excavating/hauling equipment access is shown in Photograph 5.9a. The crest was observed to be in satisfactory condition. It appeared to be somewhat wider than the 15-foot design width. No major sags, depressions, or other signs of significant settlement were observed in the crest. No tension cracks were observed in the crest or along the edge of the crest.

Photograph 5.8. Typical view of crest, southwest side looking southeast.

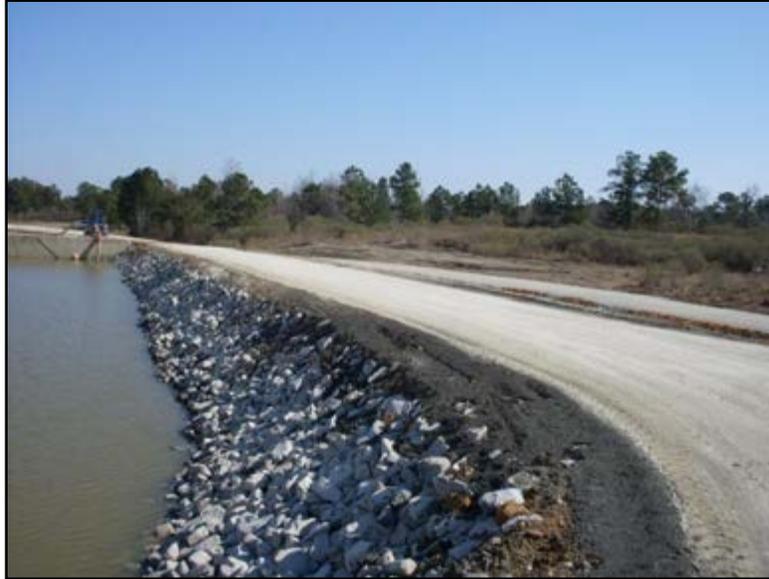
The slope of the riprap above the water level appeared steeper than the 3H to 1V design slope of the embankment. The slopes of the finger dike within the pond were observed to be bare earth. No slumps, slides, or other signs of shear failure were observed in the visible parts of the slopes above the water surface.

Photograph 5.9b. Typical view of inside slope, southeast side looking northeast.

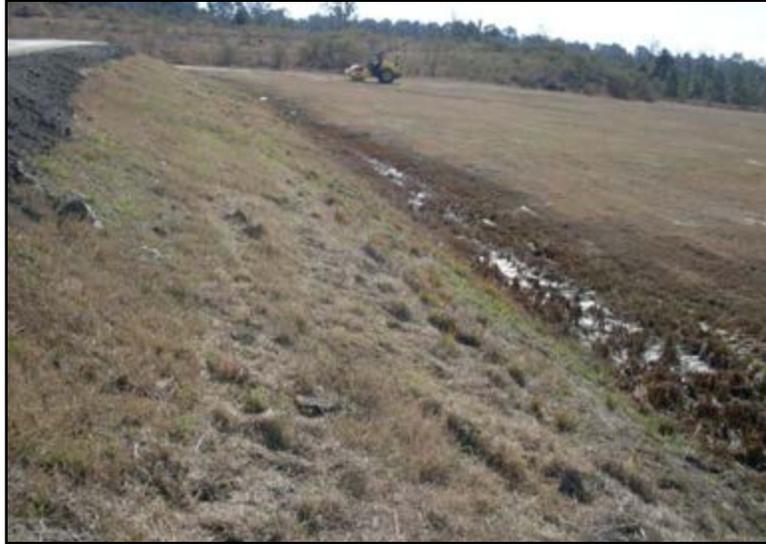
A drainage ditch along the outside toe of the pond conveys runoff to a ditch downstream of the emergency overflow outfall. There were no obvious signs of seepage from the toe.

Photograph 5.10. View of outside slope and toe, southwest side looking southeast.

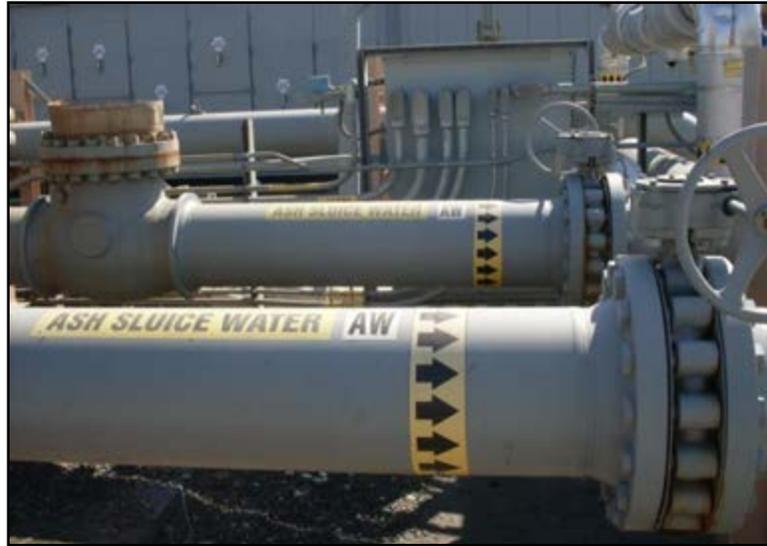
Pump structures are located on the southeast side dike of the pond. Water is pumped from Bottom Ash Pond 1 through two systems back to the plant for reuse. One system is the ash sluice system and the other is the ash seal system. Photograph 5.13 shows several ash sluice system pipes from the pond. The pipes and equipment appeared to be well maintained. It appeared that one pump (of many) had been removed for service. The visible part of the bulkhead around the pump platform appeared to be in sound condition.

Photograph 5.13. Ash sluice lines to plant.

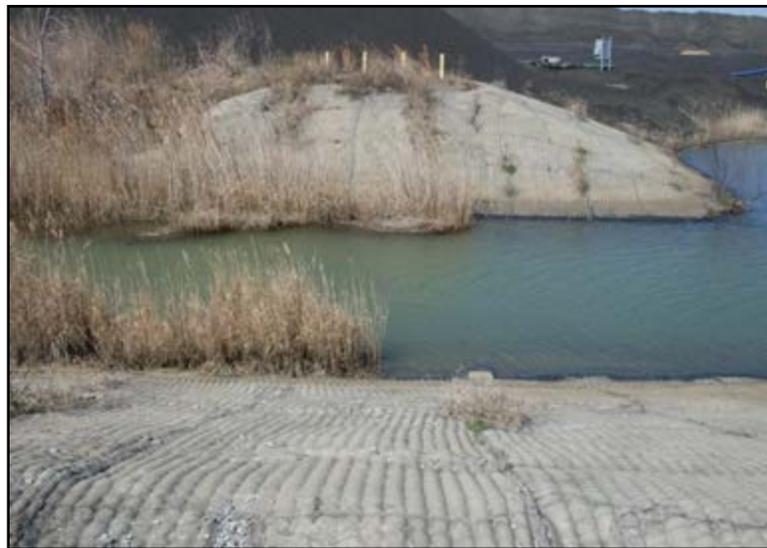
Water flows from Bottom Ash Pond 2 to Bottom Ash Pond 1 through a trapezoidal notch weir (spillway). A view of the notch weir is shown in Photograph 5.14. The Fabrifform-armored notch appeared to be in overall satisfactory condition with no major depressions, displacements, or deterioration. It was observed that some vegetation has become established on the Fabrifform revetment, particularly along the seams.

Photograph 5.14. Trapezoidal notch weir.

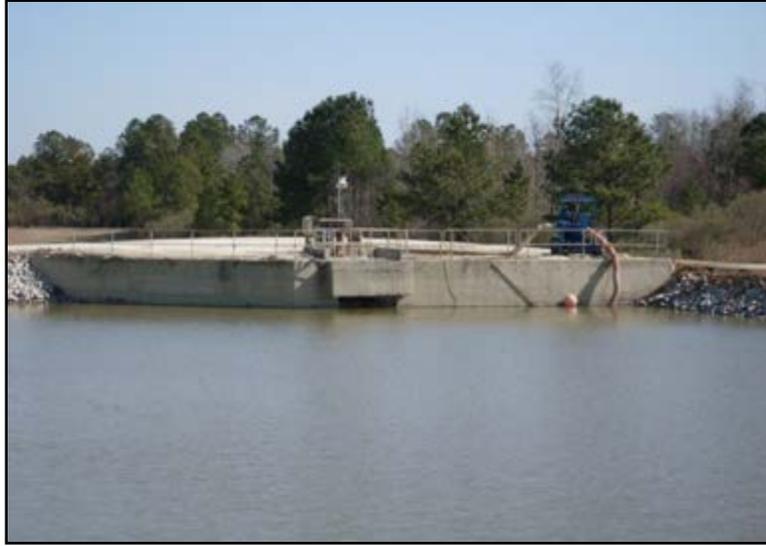
Photograph 5.17. View of discharge pump structure and auxiliary pump, looking northeast.
