Coal Combustion Waste Impoundment

Round 5 - Dam Assessment Report

Jefferies Generating Station (Site # 002)

Santee Cooper

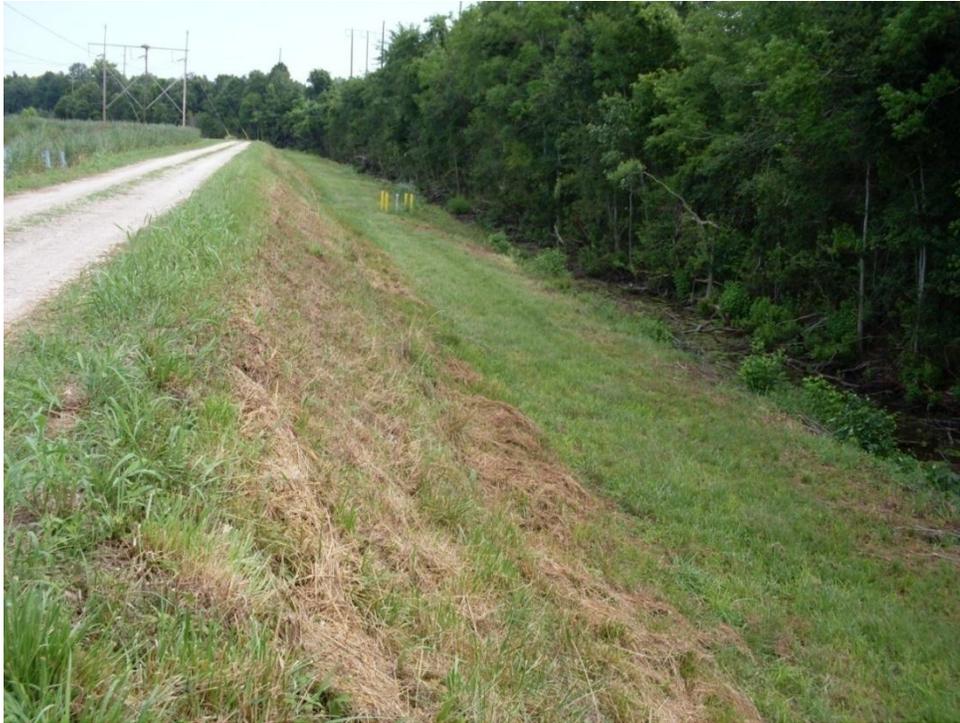
Photo BA-5: Ash Pond A Outside Slope and Toe of East Embankment - Viewed North.

The outside slope of the east embankment of Ash Pond A is visible in Photo BA-5. As shown, the grass on the outside slope typically was observed to be maintained. The lower part of the outside slope of the cross dike was observed to be submerged by the water in Ash Pond B (see Photos BA-3 and BA-4). No areas of significant erosion were observed. No obvious signs of slumps, slides, bulges, tension cracks, seepage, or animal holes were observed.

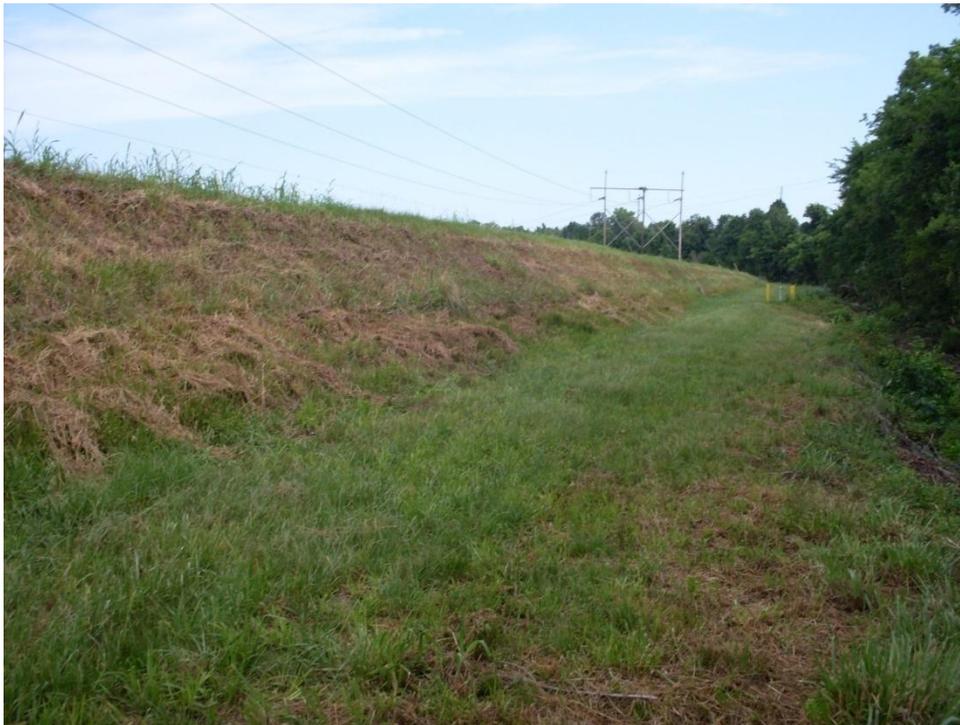
Photo BA-6: Ash Pond A Outside Toe of East Embankment- Viewed North.

The top of the berm along the outside toe of the east embankment below the southeast corner of the pond near the cross dike is shown in Photo BA-6. As shown, the grass on the berm and slope above are maintained; no signs of slope failure or seepage were observed. The perimeter ditch along the outside toe berm of the east embankment is shown in Photo BA-7. The width of the berm was observed to vary somewhat from the 12 feet shown in the typical section (Exhibit 1). No active erosion was observed along the perimeter ditch.

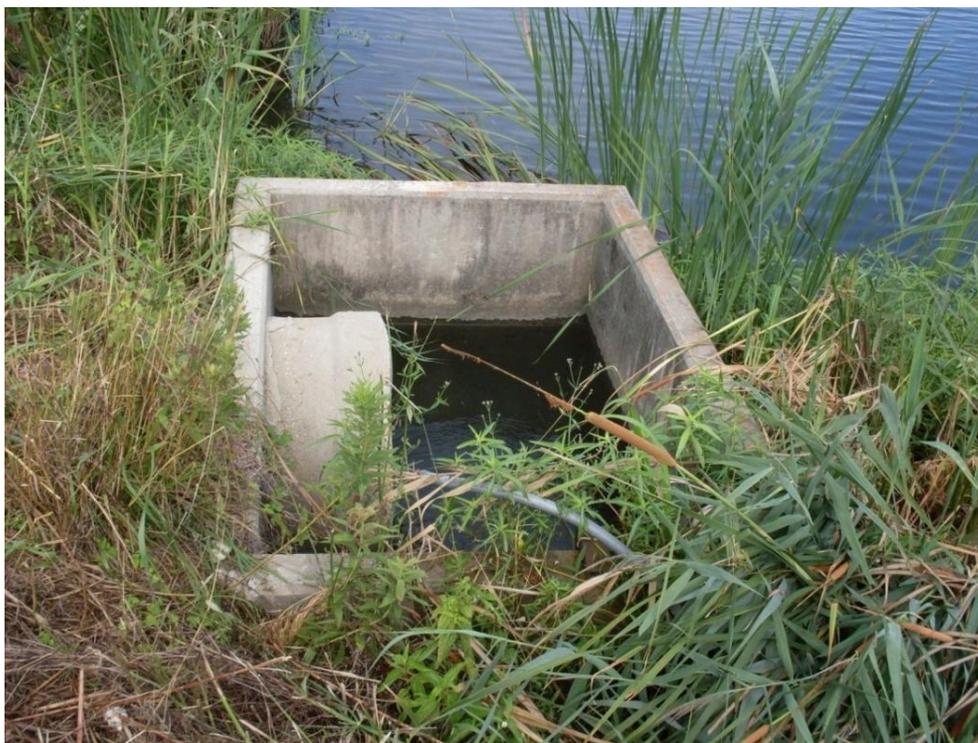
Photo BA-12: Ash Pond A: View of Inlet End of the RCP through Cross Dike that Divides Ash Pond A from Ash Pond B.

There is no overflow structure in Ash Pond A. The inlet end of the circular RCP that extends through the cross dike at the southeast corner of Ash Pond A is shown in Photo BA-12. The concrete skimmer box surrounding the inlet was observed to be in good condition. Water was flowing under the walls of the skimmer box and into the inlet end of the RCP, which appeared to be about 30 inches (I.D.). The RCP structure was discharging the flow into Ash Pond B. There was no sign of clogging and the water exiting the outlet was observed to be flowing clear.

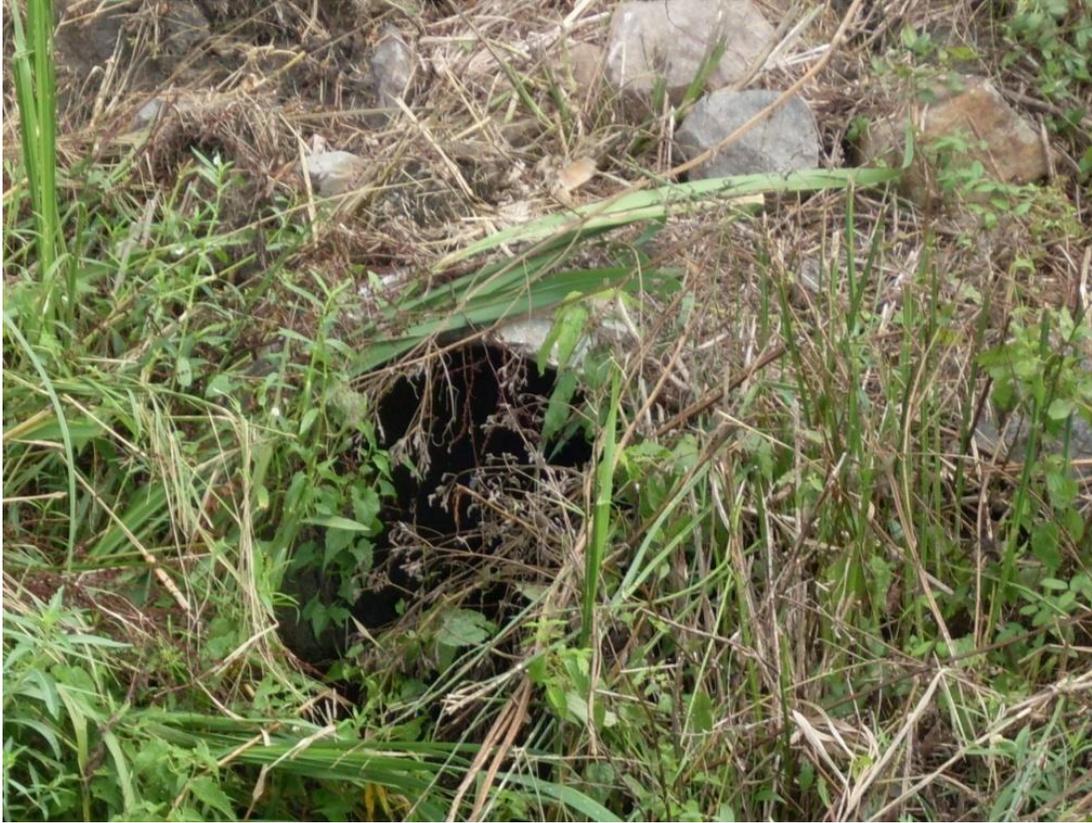
As previously described, the circular RCP extends through the cross dike into Ash Pond B. The outlet pipe is buried all along its length to its outfall end. Riprap lines the surrounding slopes of the outlet location. The outlet end appeared to be in good condition and operating normally. A small build up of vegetation was observed, as seen in Photo BA-13, but there was no sign of clogging and the water exiting the outlet was observed to be flowing clear, as noted above. A fish net was observed just beyond the outlet end of the discharge pipe; Santee Cooper indicated that the fish net was placed to keep the grass carp from migrating out of Ash Pond B into Ash Pond A.

Photo BA-13: Ash Pond B: View of outlet end of the RCP through Cross Dike that divides Ash Pond A from Ash Pond B

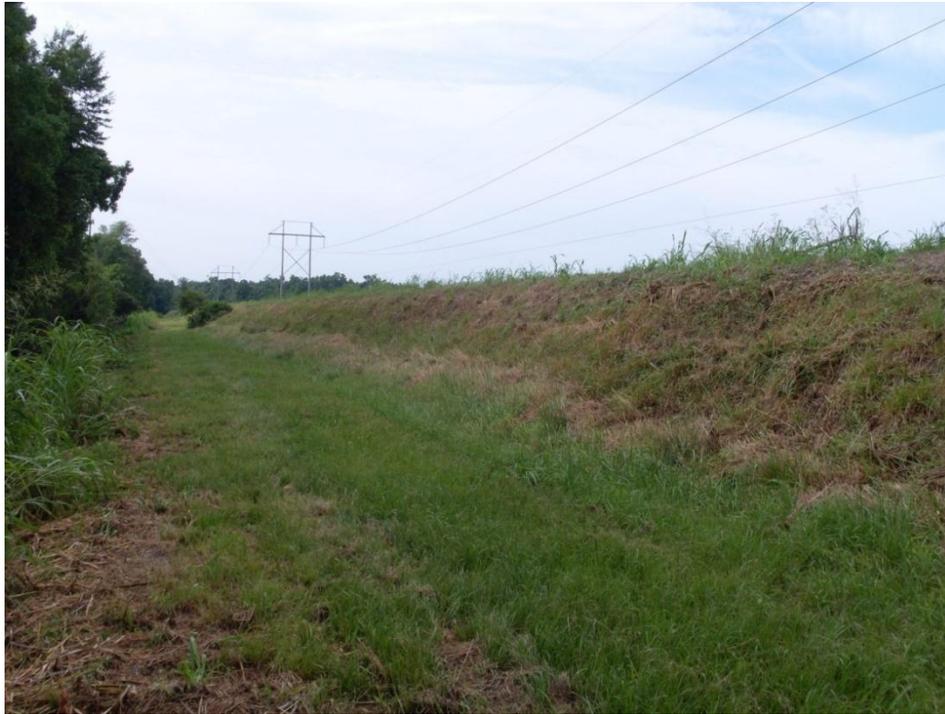
Photo BB-3: Ash Pond B: Outside Toe of East Embankment- Viewed South.

The outside slope of the east and south embankment of Ash Pond B is visible in Photos BB-3 and BB-4, respectively; the toe berm is also visible in these photos. As shown, the grass on the outside slope and berm typically was observed to be maintained. The lower part of the outside slope of the cross dike (relative to Ash Pond B) is submerged by water in Ash Pond A (see Photos BA-3 and BA-4). No areas of significant erosion were observed. No obvious signs of slumps, slides, bulges, tension cracks, seepage, or animal holes were observed.

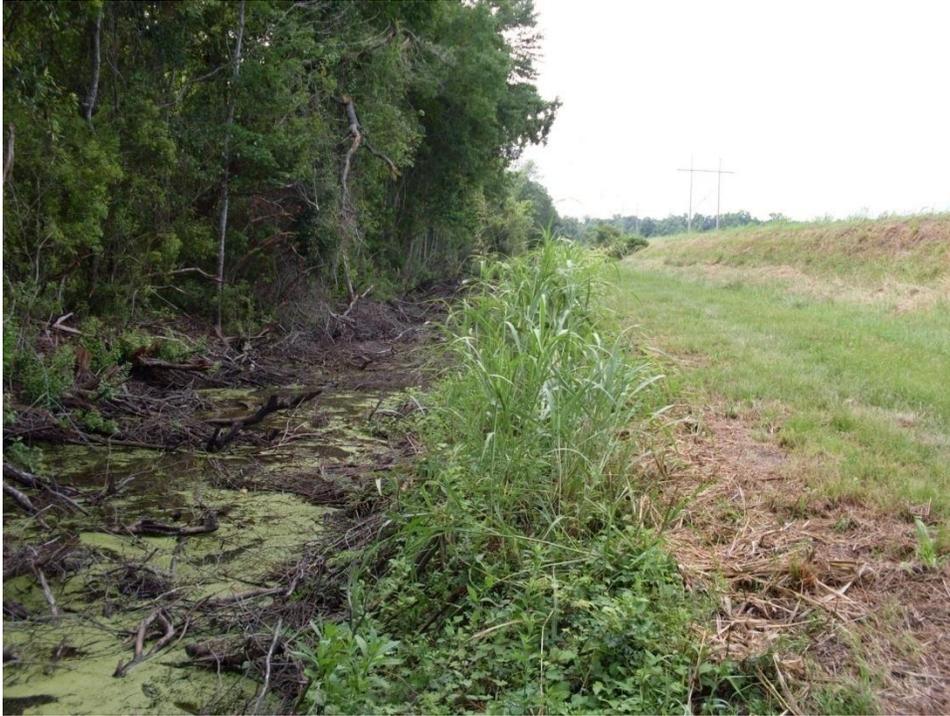
The perimeter ditch along the outside toe berm of the east embankment is shown in Photo BB-5. The width of the berm here was also observed to vary somewhat from the 12 feet shown in the typical section (Exhibit 1). No active erosion was observed along the perimeter ditch.

Photo BB-5: Ash Pond B: Crest and Outside Slope of Embankment at Northeast Corner of Basin Near Cross Dike – Viewed South.
