**Coal Combustion Waste Impoundment
Round 5 - Dam Assessment Report**

Jefferies Generating Station (Site #002)

Santee Cooper
Moncks Corner, South Carolina

Dewberry & Davis, LLC
Fairfax, Virginia

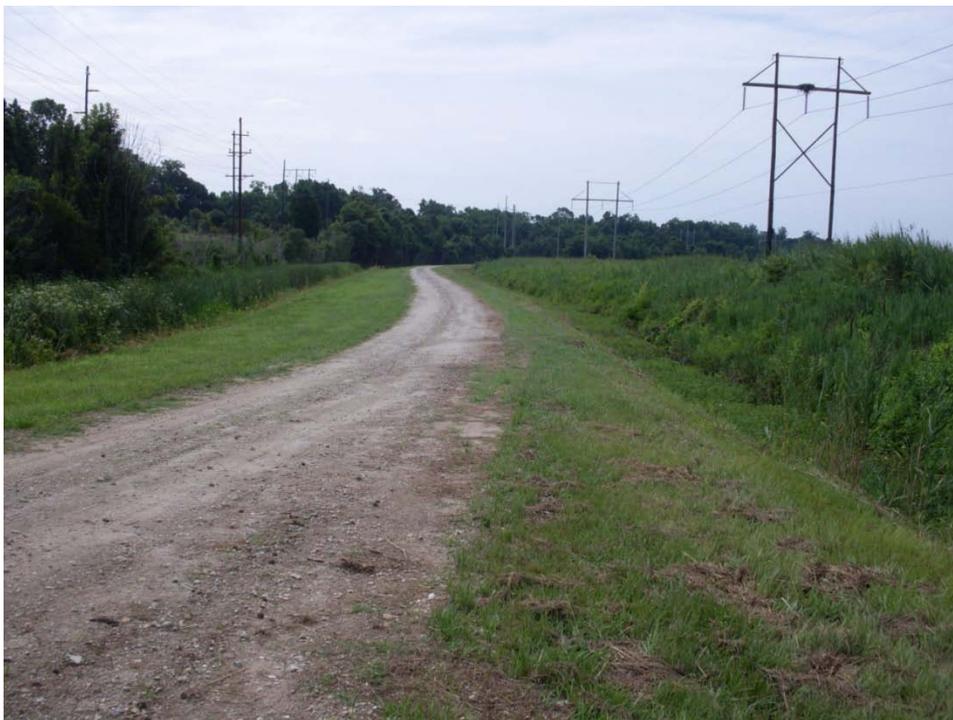
Photo BA-1: Ash Pond A Beginning of Crest of East Embankment – Viewed South.

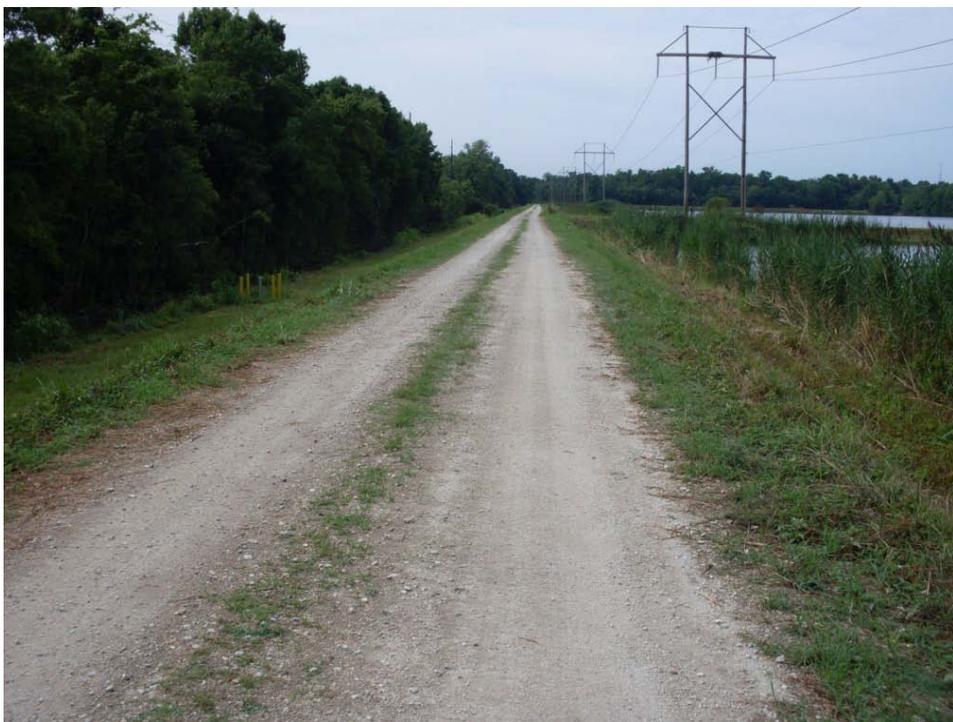
Photo BA-2: Ash Pond A - Crest of East Embankment– Viewed South.

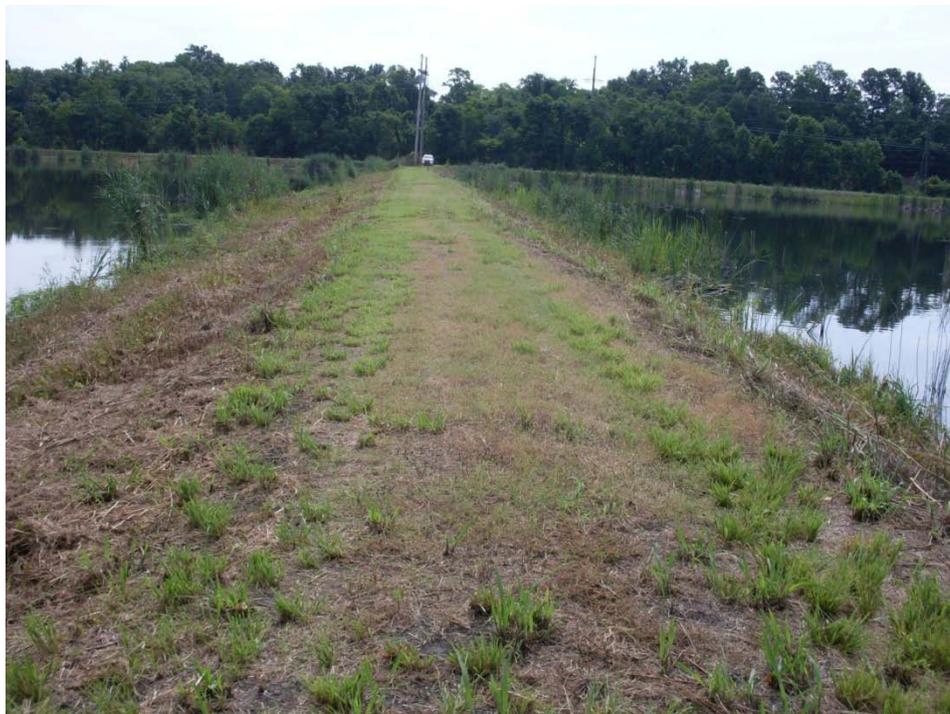
Photo BA-3: Crest of Cross Dike - Viewed East.

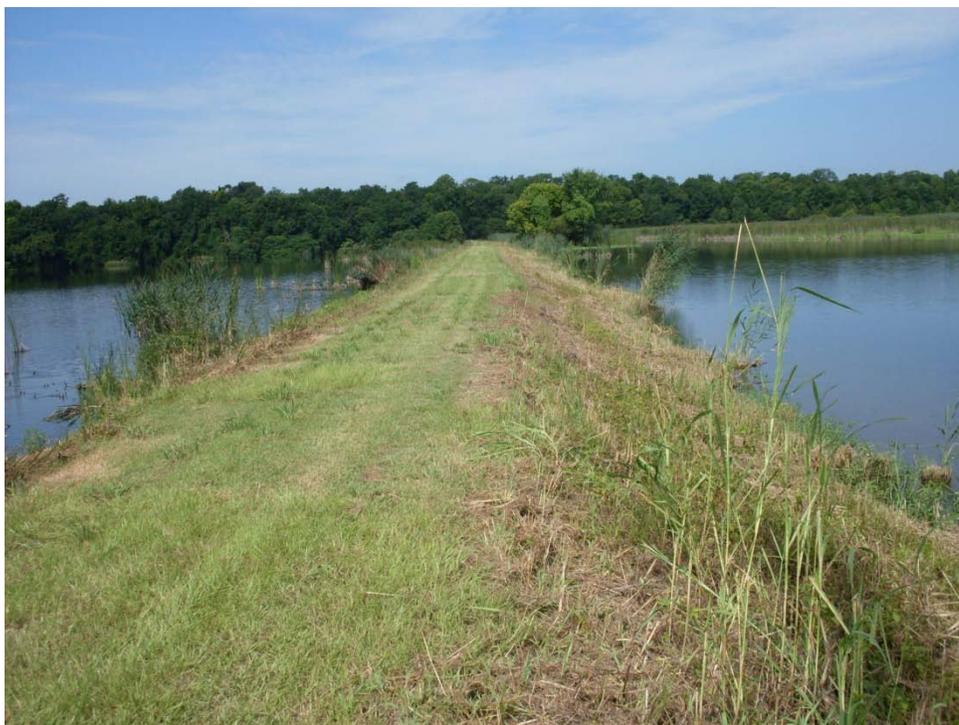
Photo BA-4: Crest of Cross Dike - Viewed West.

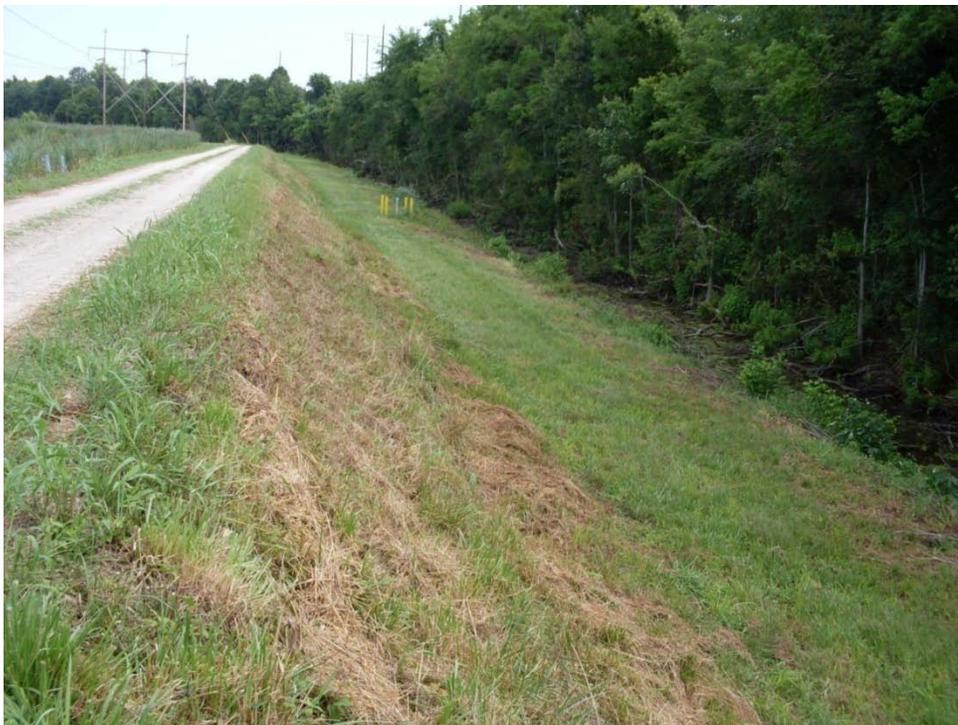
The outside slope of the east embankment of Ash Pond A is visible in Photo BA-5. As shown, the grass on the outside slope typically was observed to be maintained. The lower part of the outside slope of the cross dike was observed to be submerged by the water in Ash Pond B (see Photos BA-3 and BA-4). No areas of significant erosion were observed. No obvious signs of slumps, slides, bulges, tension cracks, seepage, or animal holes were observed.

Photo BA-5: Ash Pond A Outside Slope and Toe of East Embankment - Viewed North.

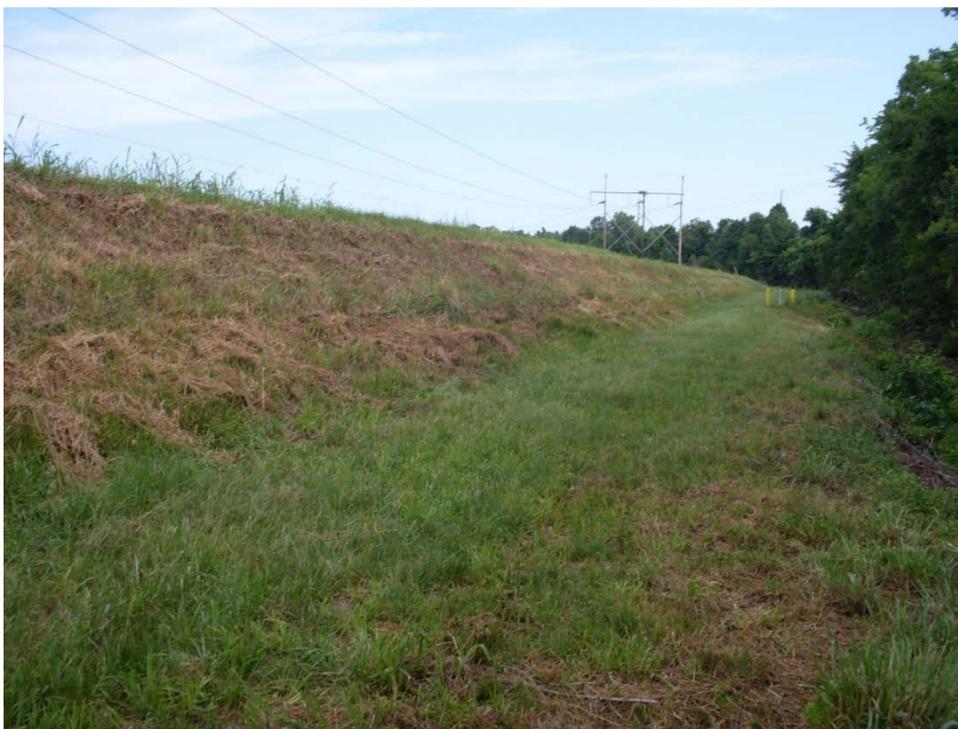
The top of the berm along the outside toe of the east embankment below the southeast corner of the pond near the cross dike is shown in Photo BA-6. As shown, the grass on the berm and slope above are maintained; no signs of slope failure or seepage were observed. The perimeter ditch along the outside toe berm of the east embankment is shown in Photo BA-7. The width of the berm was observed to vary somewhat from the 12 feet shown in the typical section (Exhibit 1). No active erosion was observed along the perimeter ditch.

Photo BA-6: Ash Pond A Outside Toe of East Embankment- Viewed North.

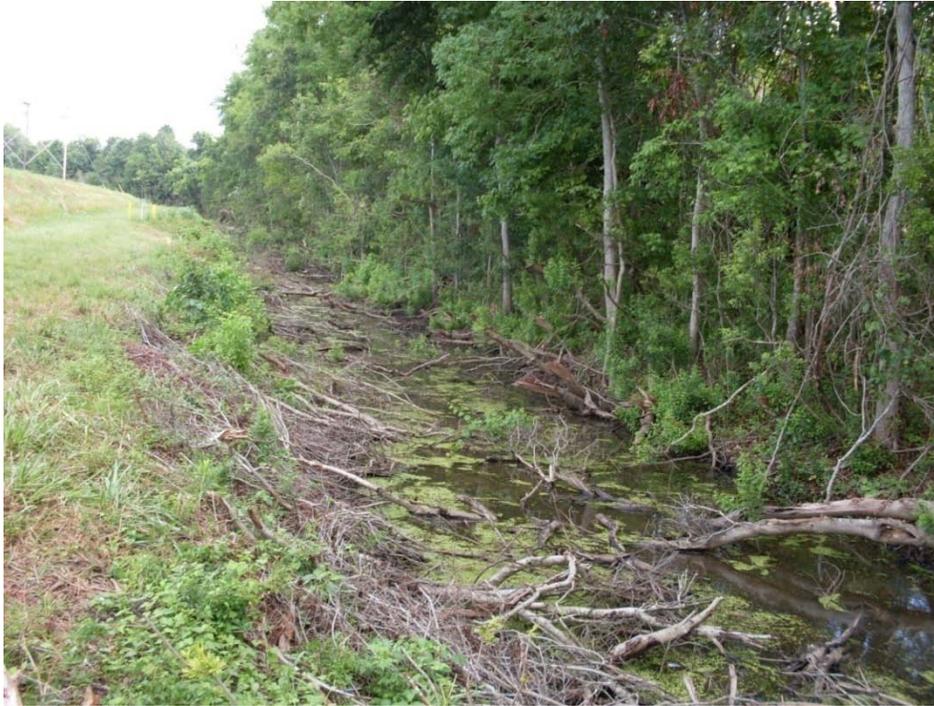
Photo BA-7: Ash Pond A Perimeter Ditch Downstream of Embankment- Viewed North.

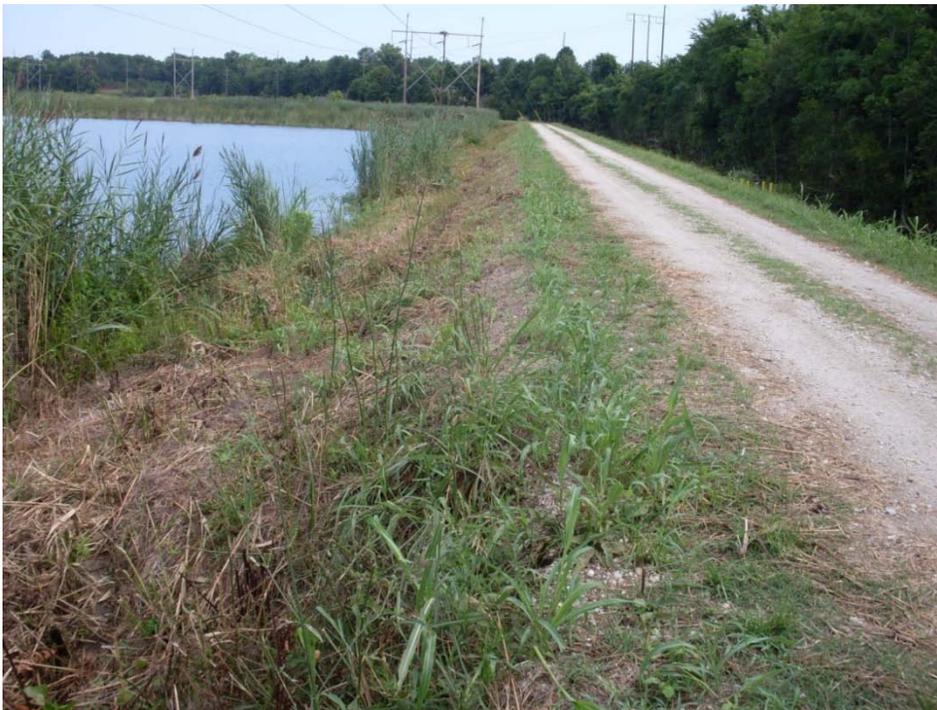
Photo BA-8: Ash Pond A Crest and Inside Slope of East Embankment South End - Viewed North.

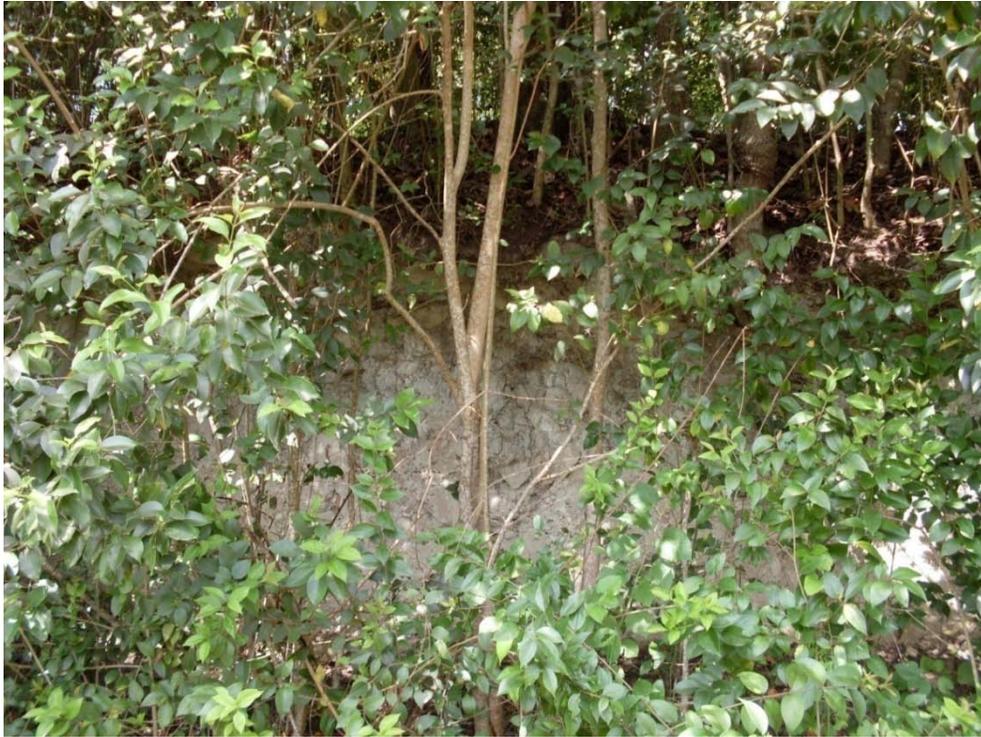
Photo BA-9: Inside Slope of West Embankment at the Cross Dike - Viewed West.

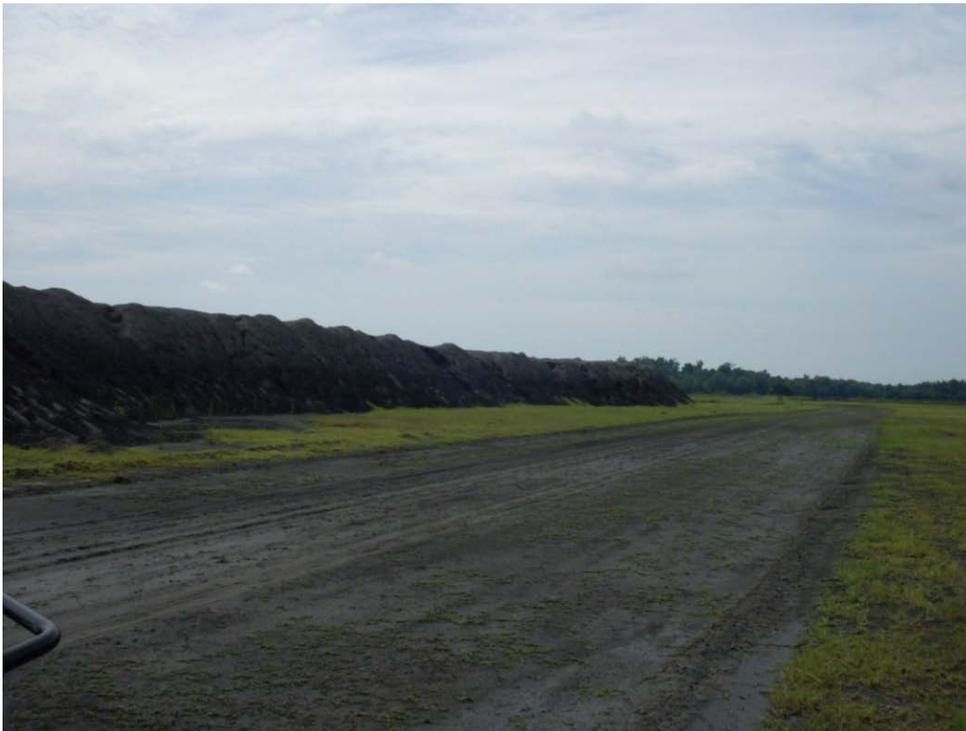
Photo BA-10: Ash Pond A North End Area where Ash is Sluiced into Basin – Viewed South.

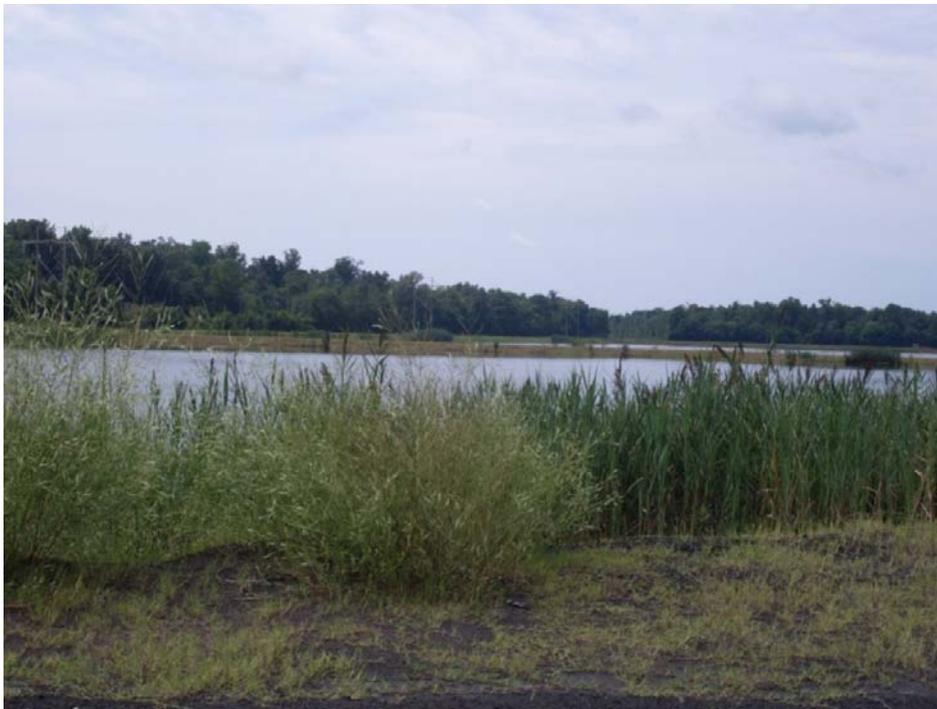
Photo BA-11: Ash Pond A Central Area North of Cross Dike where normal pool begins– Viewed South.

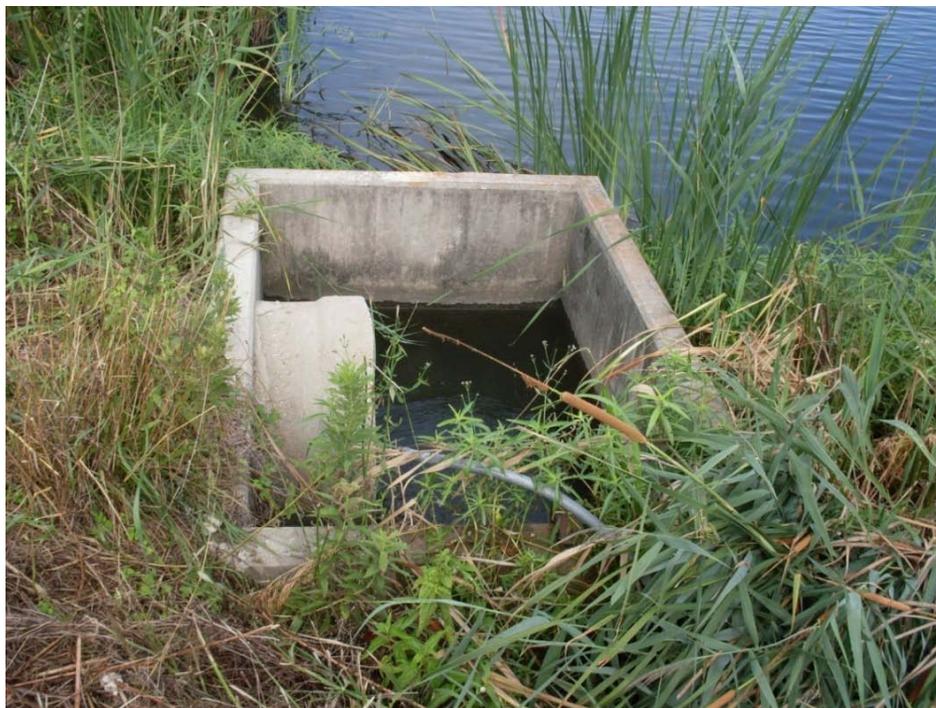
Photo BA-12: Ash Pond A: View of Inlet End of the RCP through Cross Dike that Divides Ash Pond A from Ash Pond B.

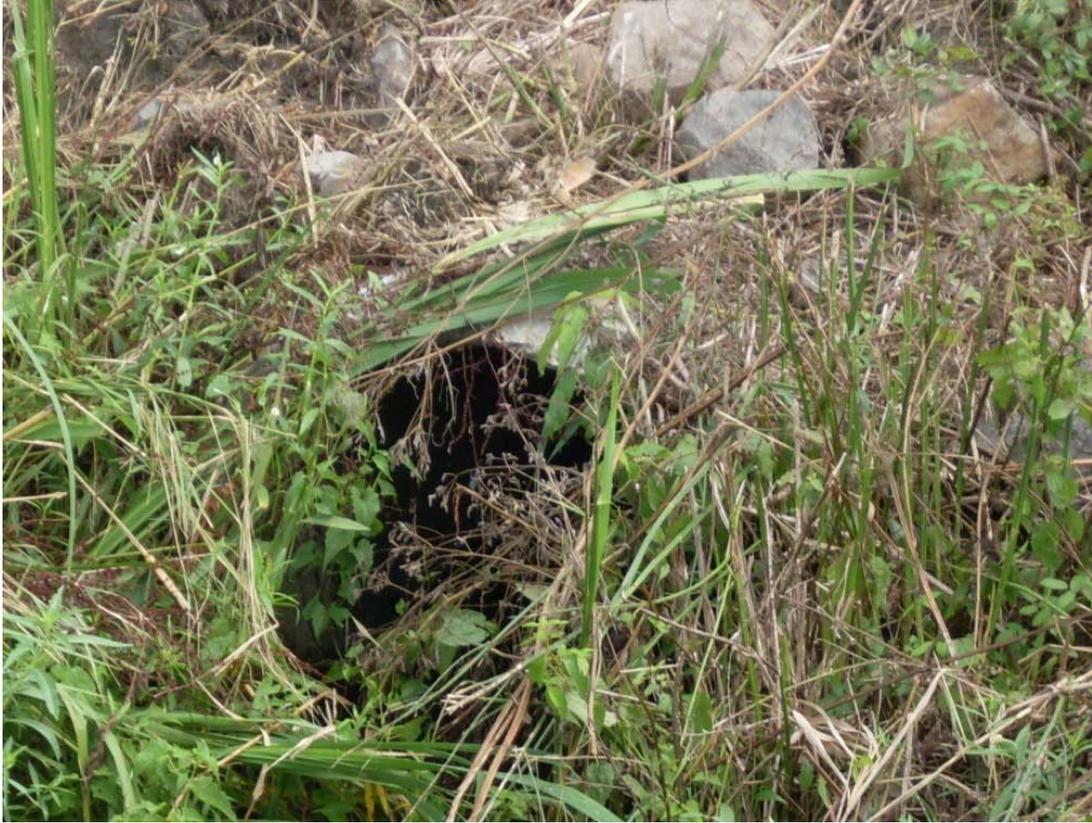
Photo BA-13: Ash Pond B: View of outlet end of the RCP through Cross Dike that divides Ash Pond A from Ash Pond B

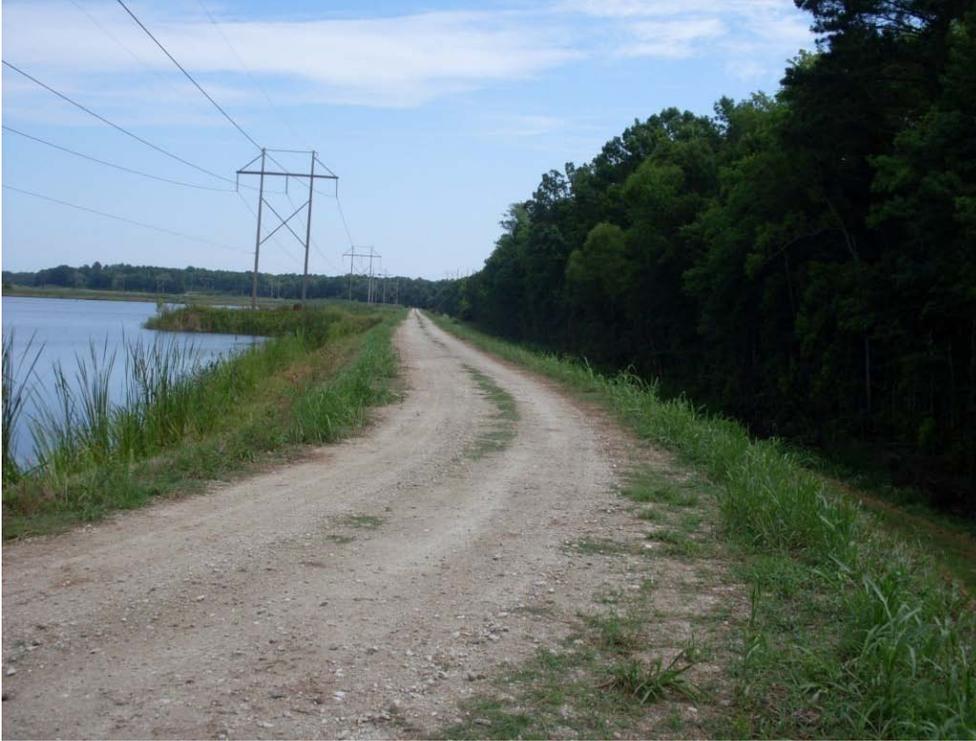
Photo BB-1: Ash Pond B: Crest of Embankment – Viewed North

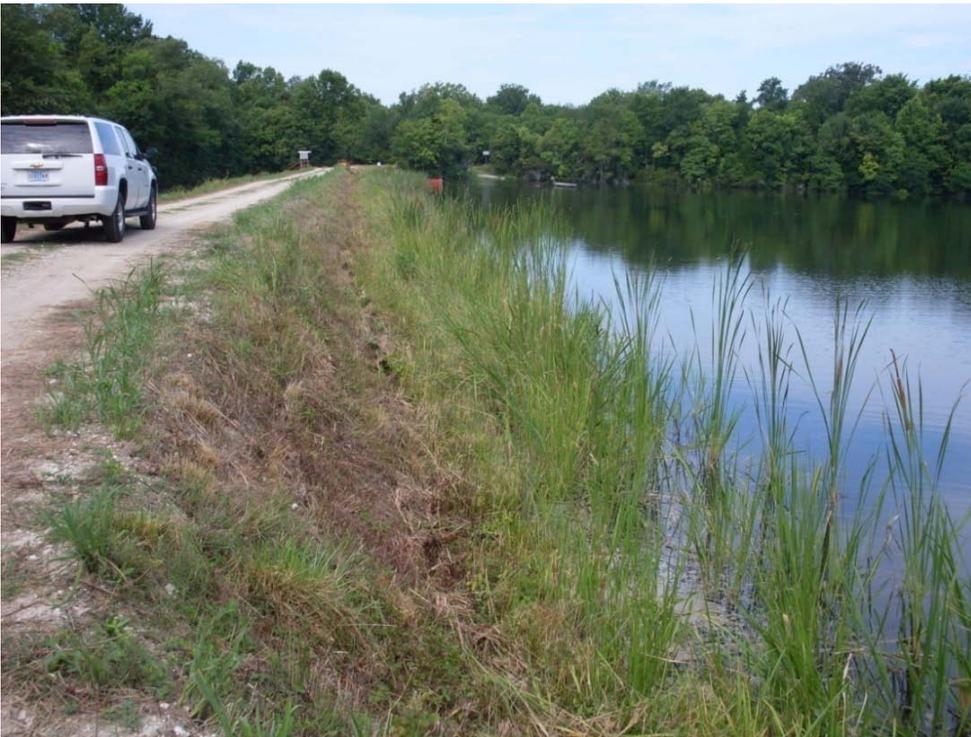
Photo BB-2: Ash Pond B: Crest and Inside Slope of Embankment – Viewed West

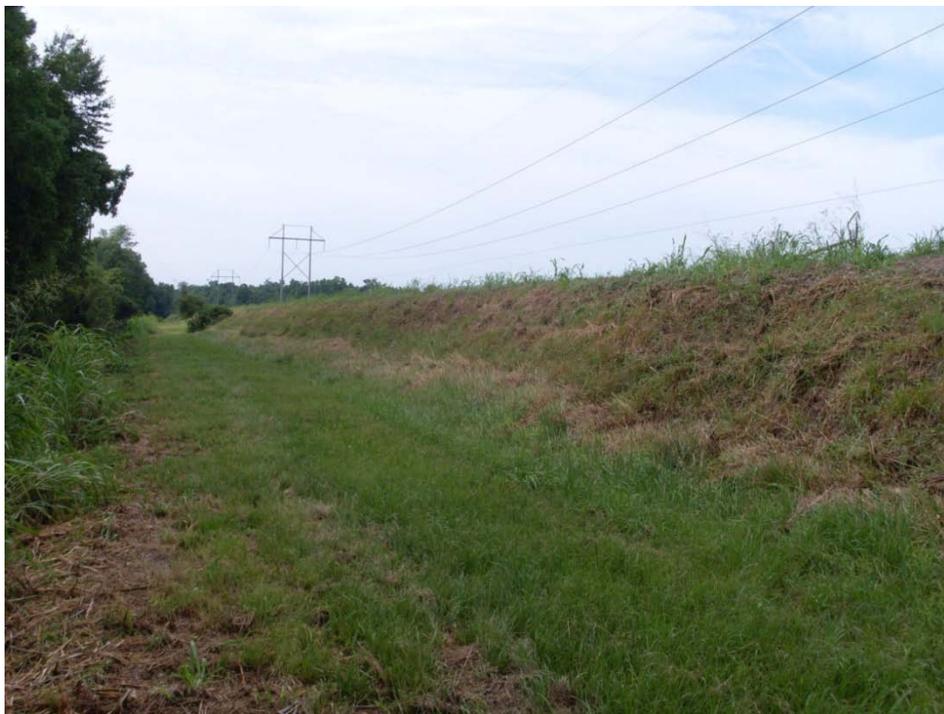
Photo BB-3: Ash Pond B: Outside Toe of East Embankment- Viewed South.

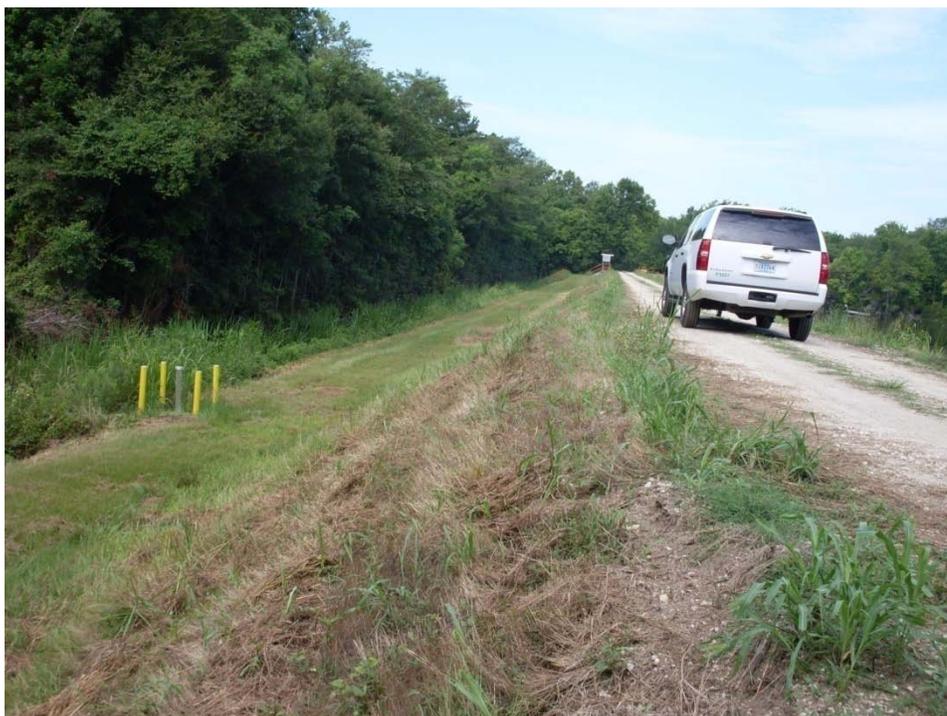
Photo BB-4: Ash Pond B: Crest and Outside Slope of Embankment – Viewed West.

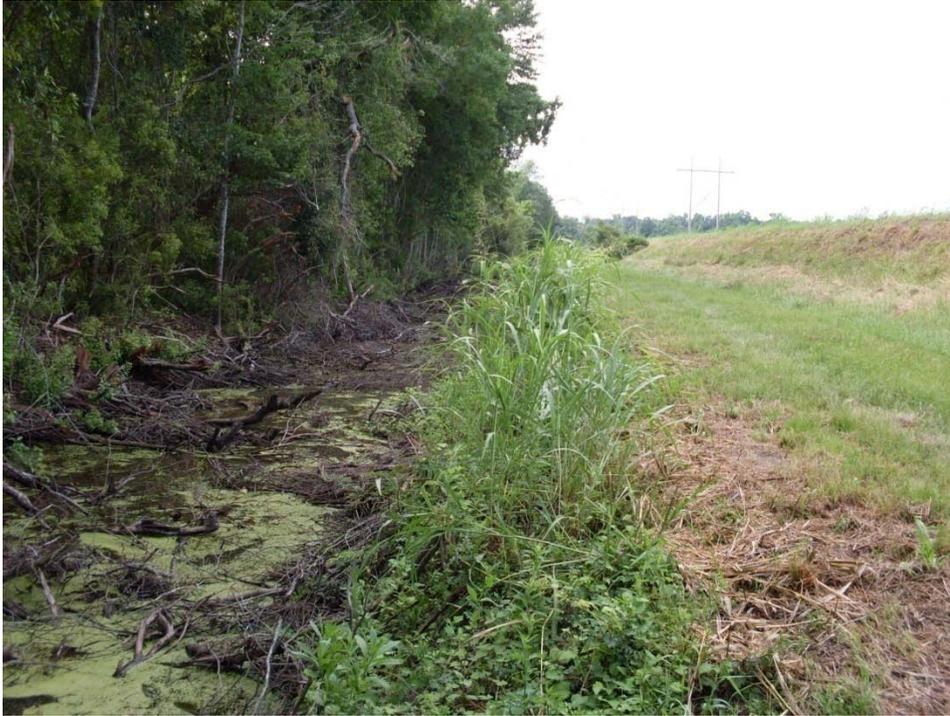
Photo BB-5: Ash Pond B: Crest and Outside Slope of Embankment at Northeast Corner of Basin Near Cross Dike – Viewed South.

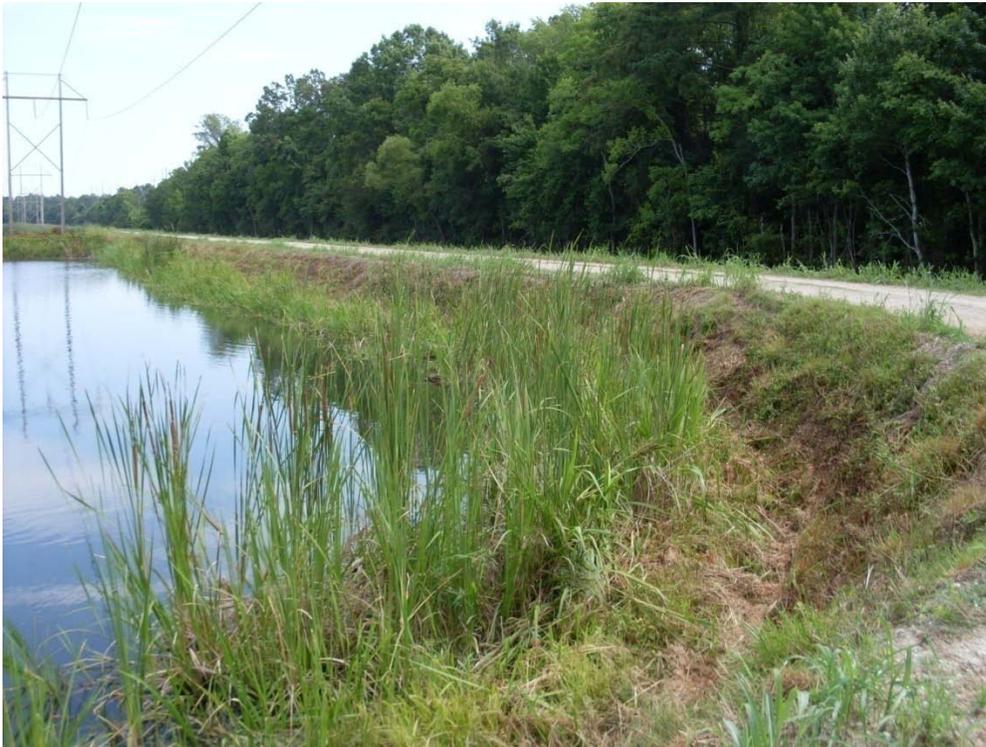
Photo BB-6: Ash Pond B: Inside Slope of Embankment – Viewed East

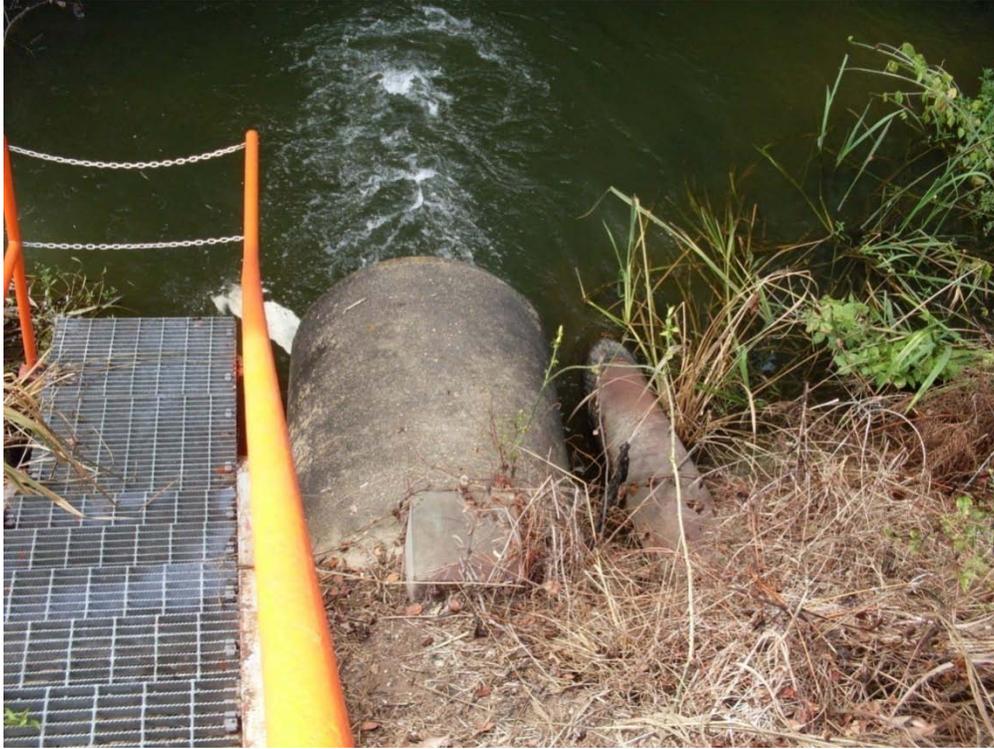
Ash Pond B – There have been no significant repairs/rehabilitation made to this basin since the original construction. Relatively minor repairs were made to the metal skimmer box at the outlet within the past 10 years when the skimmer dropped down on one side.

Photo BB-7: Ash Pond B: Outlet Structure at the Southwest Corner of the Basin.

recommended that internal inspection of the main outlet structure at Ash Pond B be performed at a frequency of at least once every 5 years and be documented with a written report.

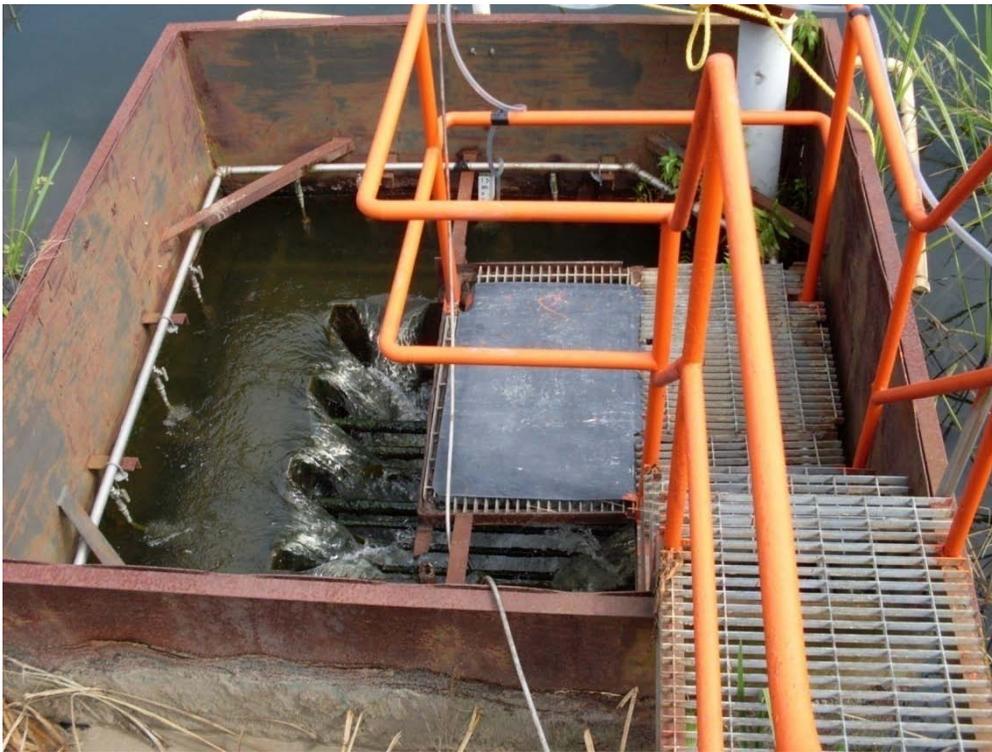
Photo BB-8: Ash Pond B: Outlet Pipe Discharging Water into the Perimeter Ditch.
