Subject: South Carolina Electric & Gas Company  
Canadys Steam Power Station  
Coal Combustion Residue Impoundment  
Round 9 – Dam Assessment Report (May 2011)

**Coal Combustion Residue Impoundment  
Round 9 - Dam Assessment Report**

*Canadys Steam Power Station  
Ash Pond Embankments  
South Carolina Electric & Gas  
Canadys, South Carolina*

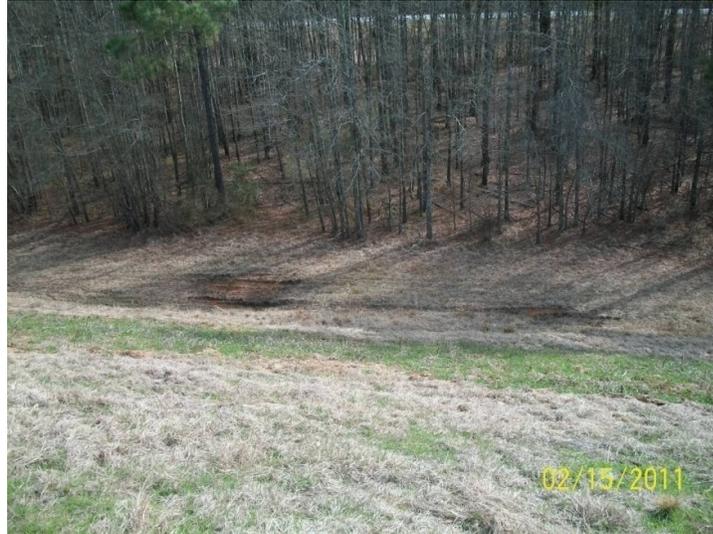
Photo 1. Standing water in vehicular traffic ruts

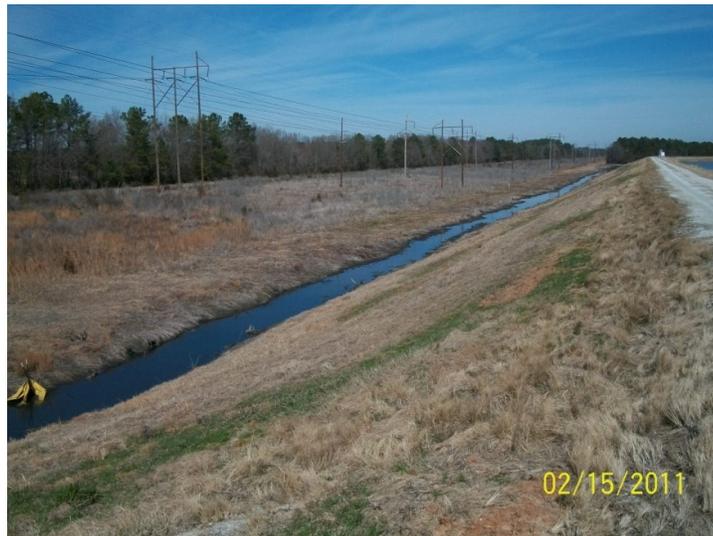
There were signs of surficial sloughing particularly along the downstream slope. Wetlands and a waterway channel are located along the downstream toe of the embankments. (See Photos 1, 2, and 3.)

Photo 2. Channel along the downstream toe

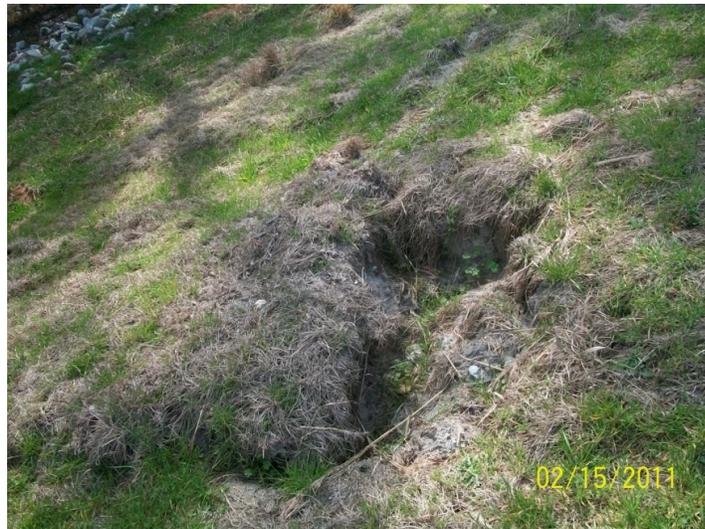
The overall visual assessment of the ash pond embankment system was that it was in satisfactory condition; however, surficial sloughing was observed along the Ash Pond's downstream slope. Embankments visually appear structurally sound.

**Photo 3. Surficial sloughing along downstream slope**

- Develop an action plan to increase the factors of safety for the ash pond embankments to meet or exceed the minimum requirement for factors of safety for seismic loading conditions.
- Develop an action plan to address surficial sloughing along downstream slope. Perform remediation along downstream slopes where surficial sloughing is occurring.

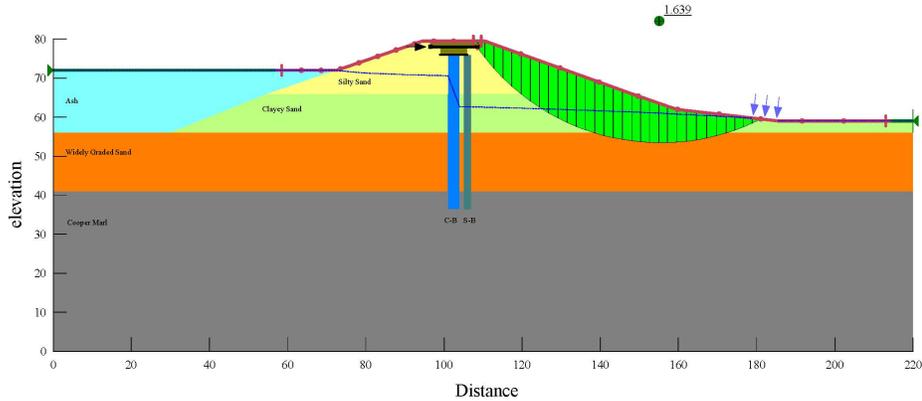
## Stability Analysis - 95-Acre Ash Storage Pond, Canadys, SC

Factors of safety for seismic loading conditions are listed in table 7.1.4b and do not meet the minimum required standard of 1.1. It was concluded by CDM that a deep-seated failure that would compromise the overall integrity of the dike during the design earthquake is not likely and that the dike will be capable of retaining the coal ash during and immediately following the design earthquake event. However, significant deformation of the dike slopes during the design earthquake is likely to occur, particularly for the upstream slope. These deformations could threaten the longer term integrity of the dike as a containment facility and not allow the impoundment pond to remain functional following the design seismic event until repairs are made. (Appendix A: Doc 11 – Seismic Slope Stability Analysis).

Table 7.1.4b Factor of Safety against Slope Failure (Seismic Conditions)			
Slope	Failure Mode	Factor of Safety Low Water	Factor of Safety High Water
Upstream	Localized and Surficial Failure	0.19	0.18
	Major and Deep Seated Failure	1.12	1.16
Downstream	Localized and Surficial Failure	0.87	0.80
	Major and Deep Seated Failure	1.01	1.00
