**Coal Combustion Residue Impoundment  
Round 9 - Dam Assessment Report**

*Canadys Steam Power Station  
Ash Pond Embankments  
South Carolina Electric & Gas  
Canadys, South Carolina*

Dewberry & Davis, LLC  
Fairfax, Virginia

Under Contract Number: EP-09W001727  
**May 2011**

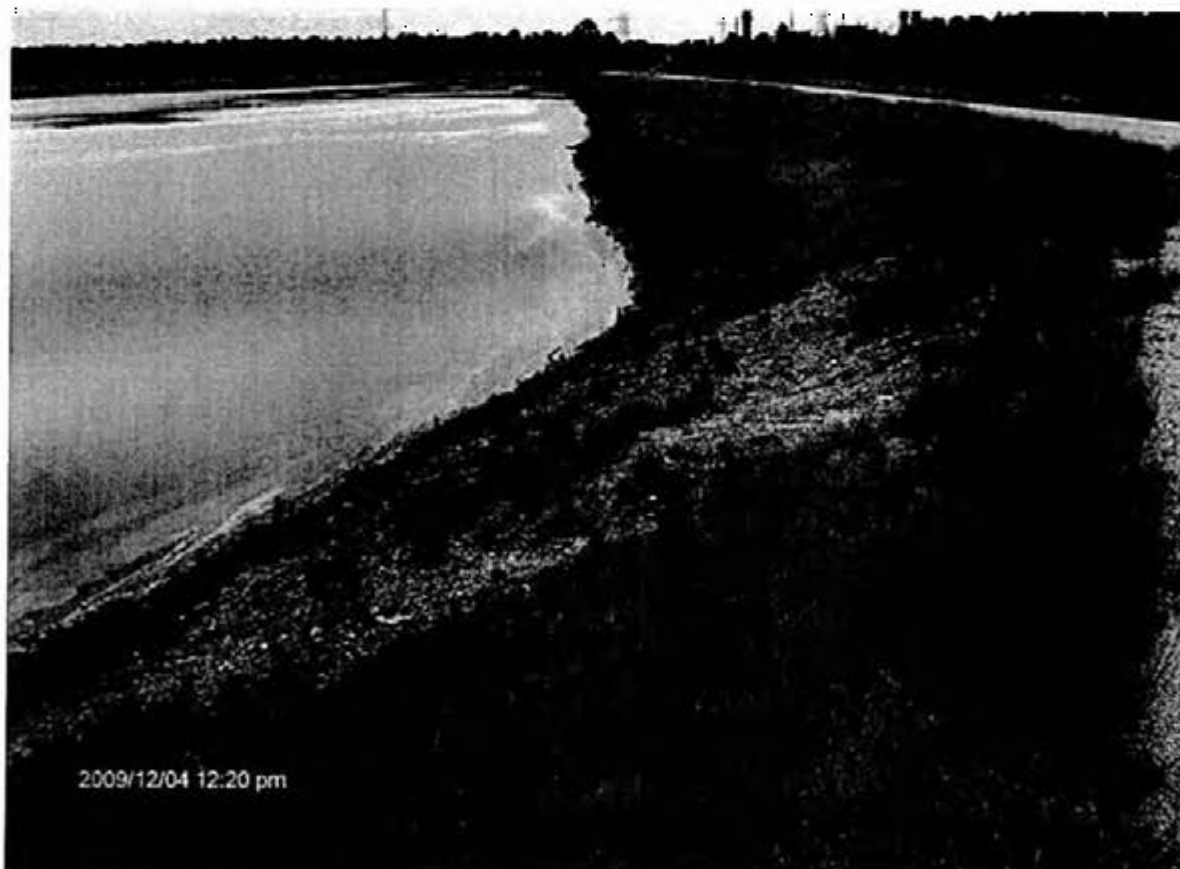
**Figure 6: Erosion Damage and Lack of Vegetation Interior of Active Pond**

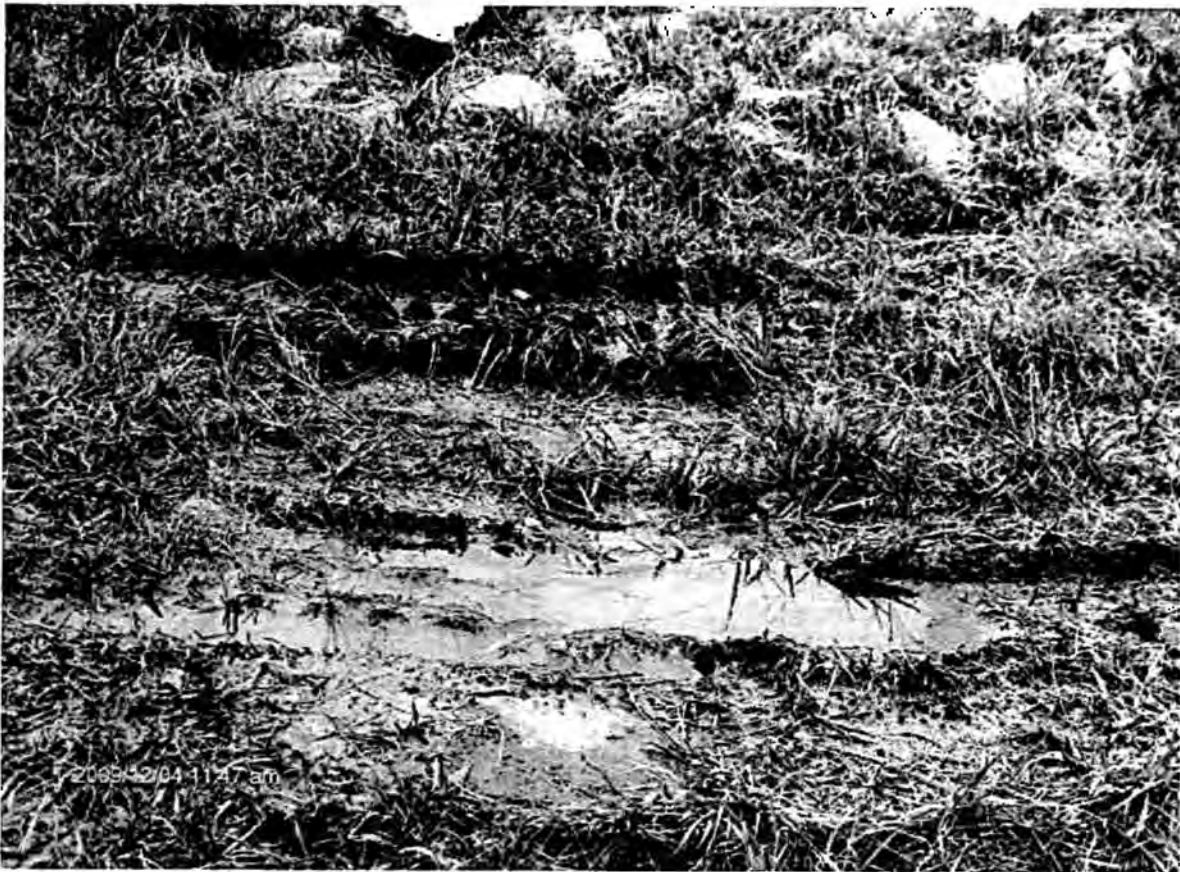
**Figure 7: Example of Area of Standing Water along Toe of Active Pond West Berm**

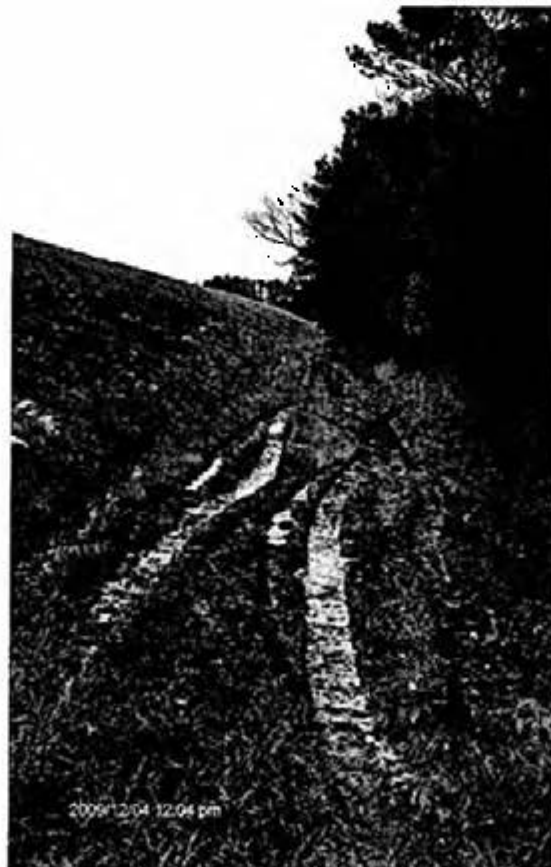
**Figure 10: Example Damage from Driving Pick-Up Truck on Toe of Berm**

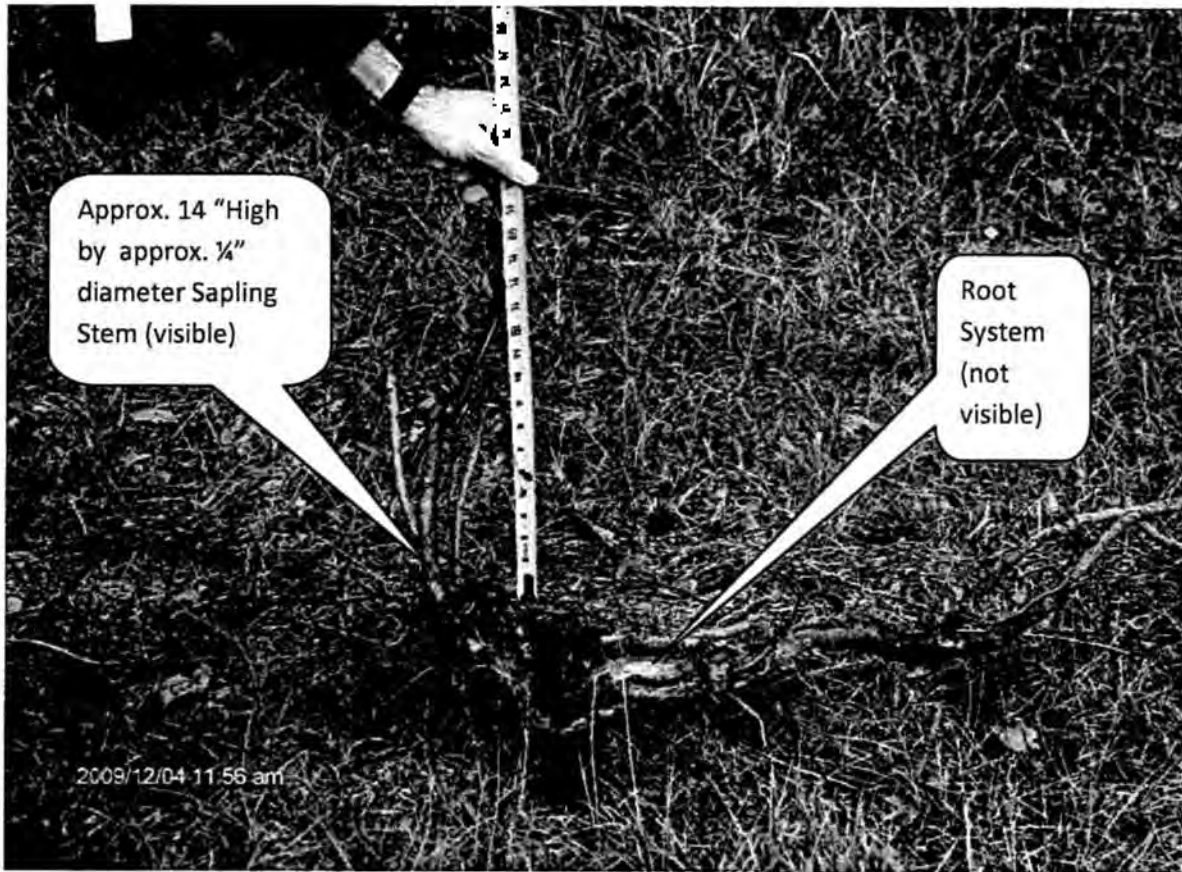
**Figure 11: Example of Woody Vegetation Growing on Downstream Side of Berm**
