**Coal Combustion Residue Impoundment  
Round 9 - Dam Assessment Report**

***Canadys Steam Power Station  
Ash Pond Embankments  
South Carolina Electric & Gas  
Canadys, South Carolina***

**December 2011**

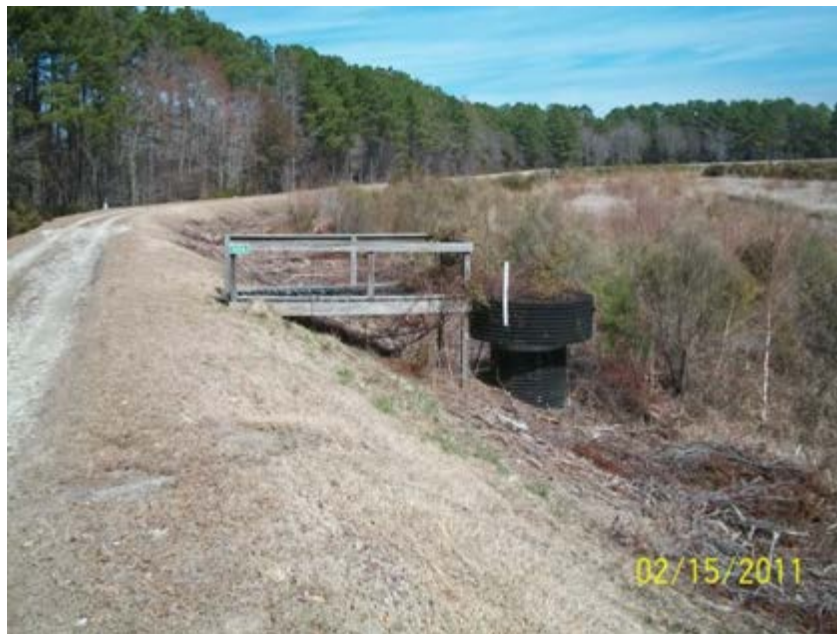
Photo 4. Upstream slope

The interior of the pond is heavily vegetated and it appears the upstream slopes at one point in time had woody vegetation that was recently removed (see Photo 4). No scarps, sloughs, depressions, bulging or other indications of slope instability or signs of erosion were observed.

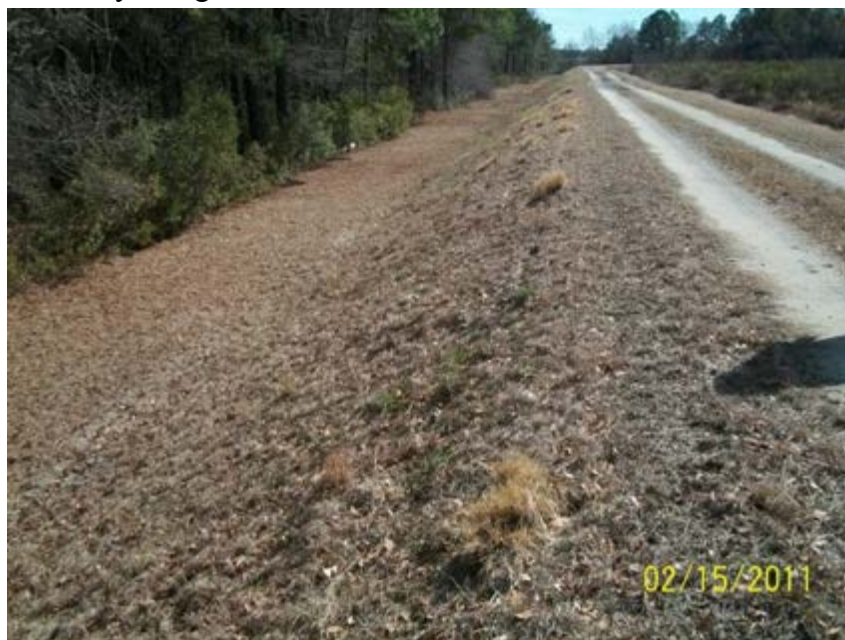
Photo 5. Downstream slope

No scarps, sloughs, depressions, bulging or other indications of slope instability or signs of erosion were observed.

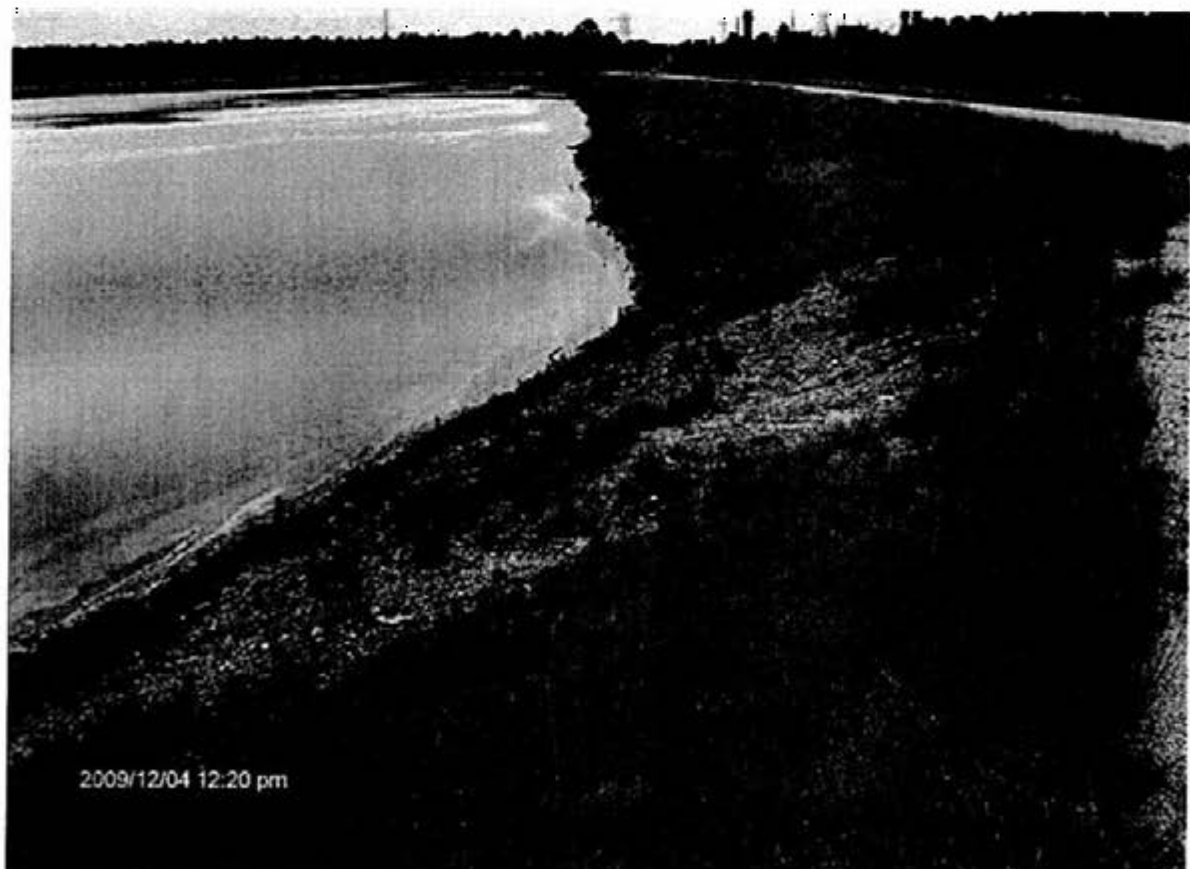
**Figure 6: Erosion Damage and Lack of Vegetation Interior of Active Pond**

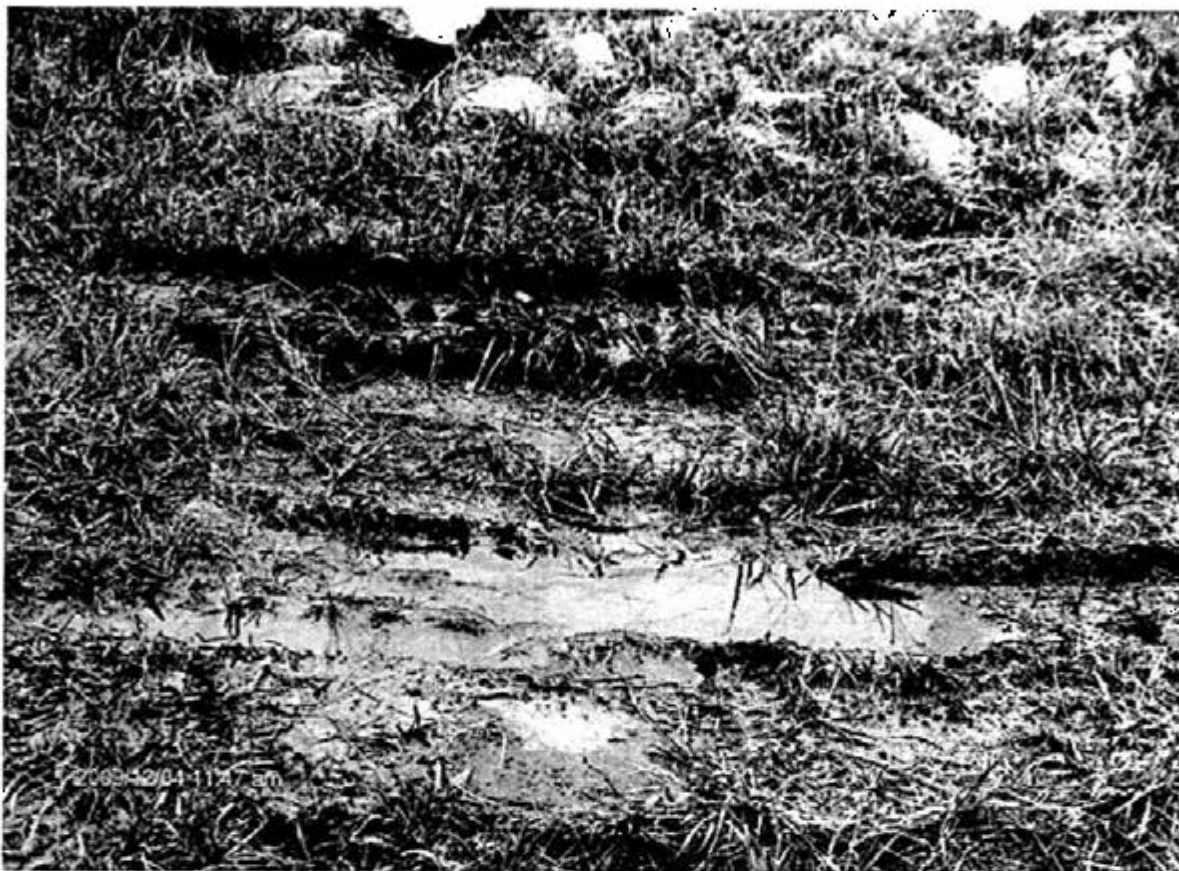
**Figure 7: Example of Area of Standing Water along Toe of Active Pond West Berm**

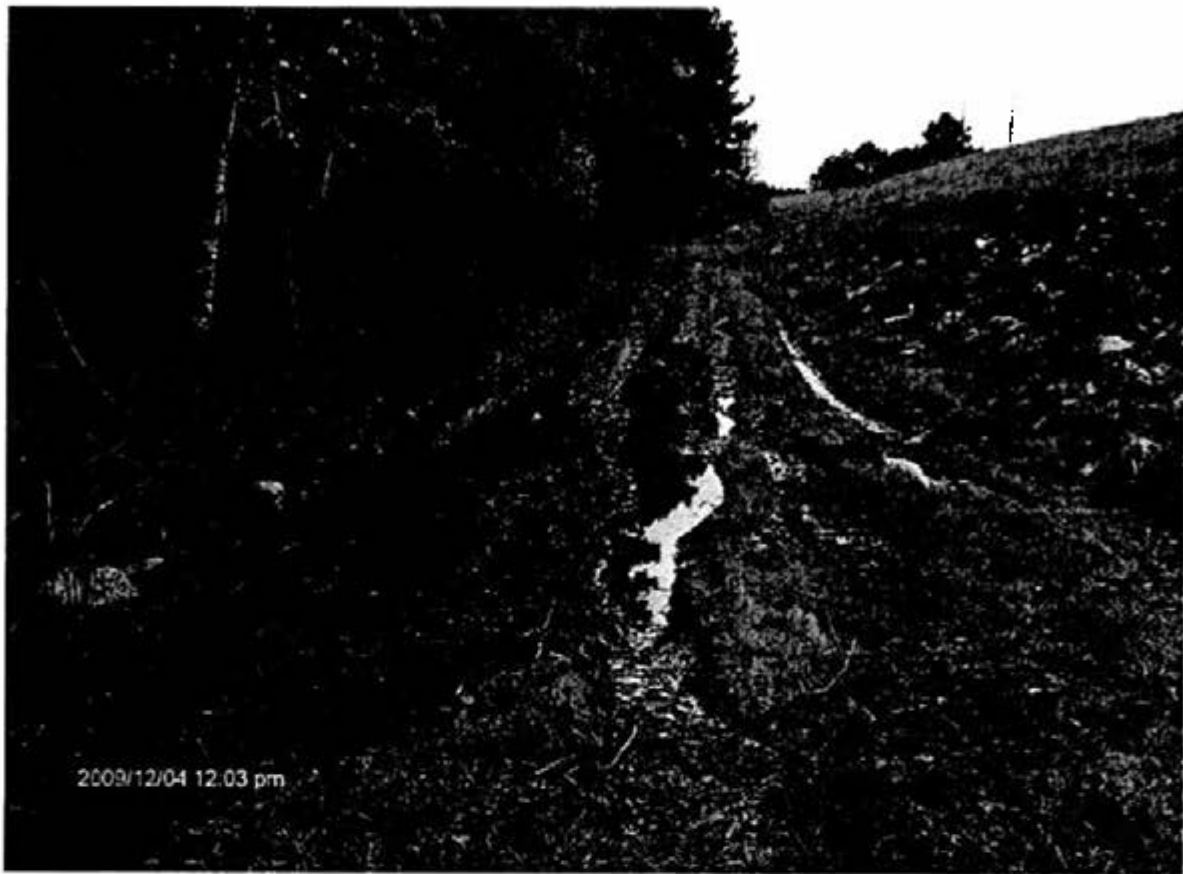
**Figure 9: Example Damage from Driving Pick-Up Truck on Toe of Berm**

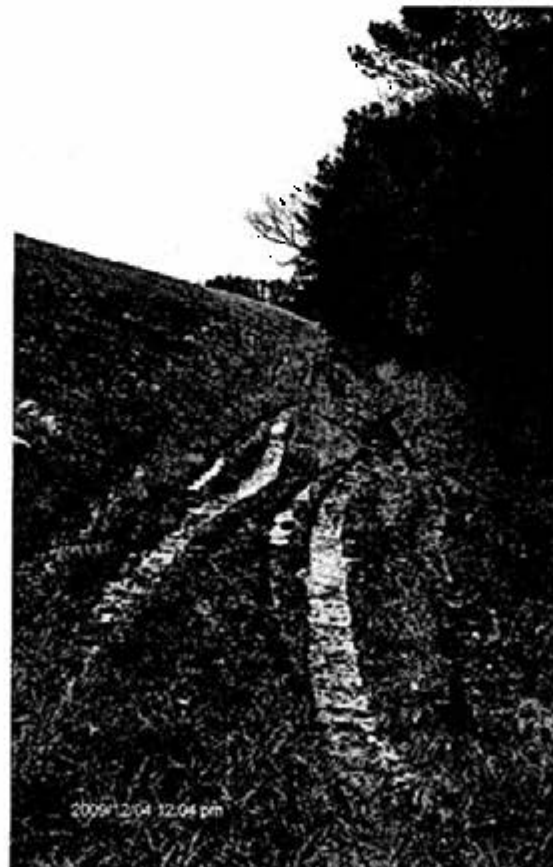
**Figure 10: Example Damage from Driving Pick-Up Truck on Toe of Berm**

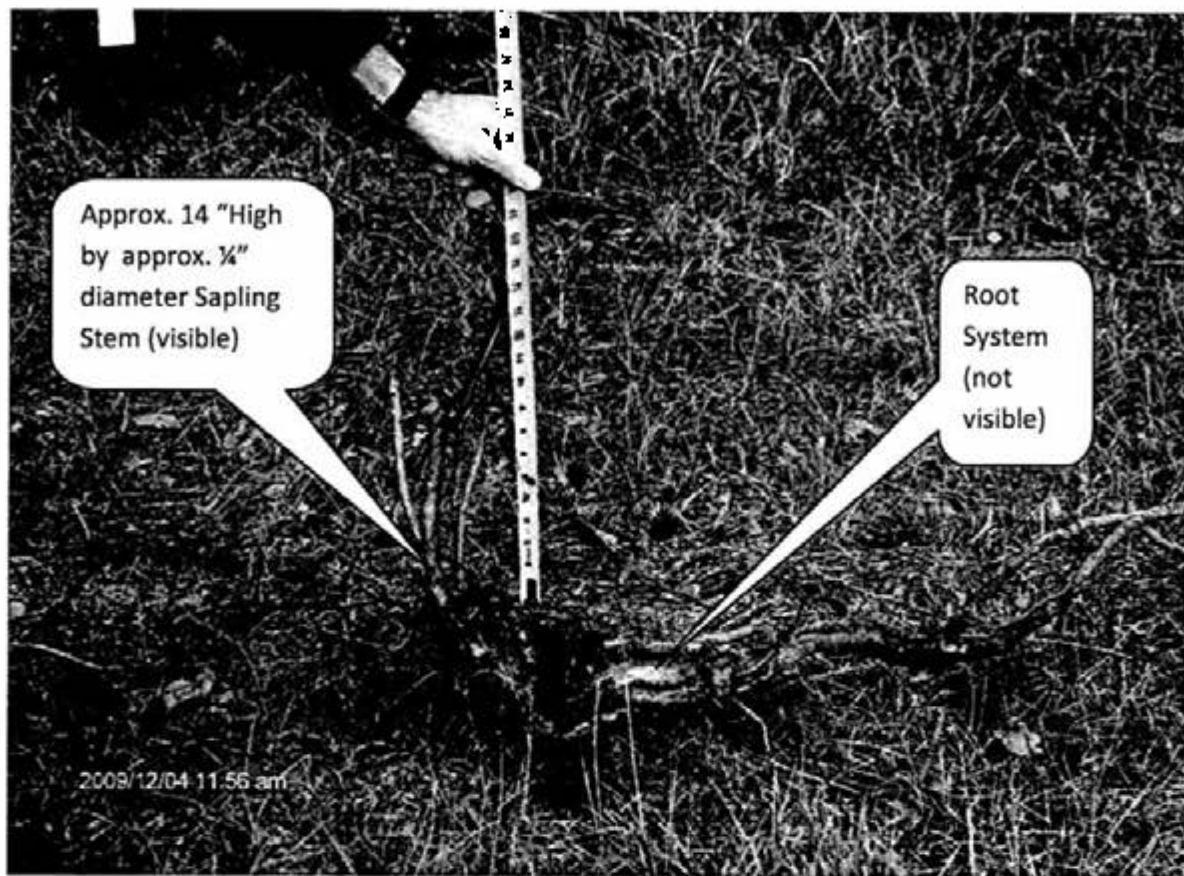
**Figure 11: Example of Woody Vegetation Growing on Downstream Side of Berm**
