Subject: South Carolina Electric & Gas Company  
Urquhart Generating Station  
Coal Combustion Residue Impoundment  
Round 9 – Dam Assessment Report (April 2011)

**Coal Combustion Residue Impoundment  
Round 9 - Dam Assessment Report**

*Urquhart Generating Station*  
*Ash Ponds*  
*South Carolina Electric & Gas*  
*Beech Island, South Carolina*

Dewberry & Davis, LLC  
Fairfax, Virginia

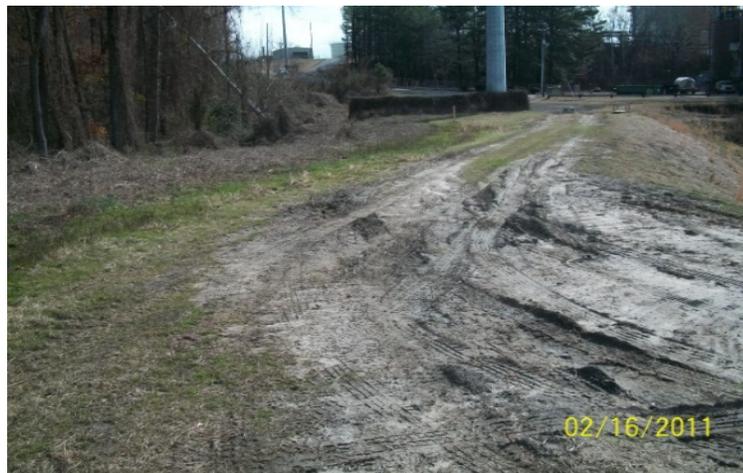
Photo 5-1. Rutting along crest

The crest had no signs of depressions, tension cracking, or other indications of settlement or shear failure, and appeared to be in satisfactory condition. Minor rutting was observed along portions of the crest (See Photo 5-1.).

- Remove brush from the downstream slope
- Address minor rutting along crest and avoid vehicular traffic along crest

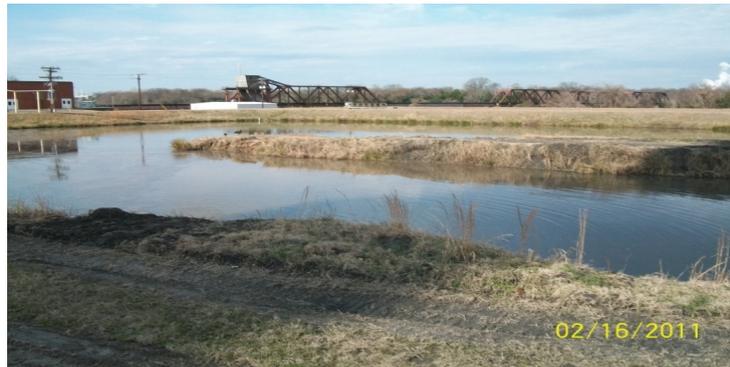
Photo 5-2. Overall view of interior of ash pond

The upstream slopes are mostly vegetated with tall grasses and other wetland vegetation. No scarps, sloughs, depressions, bulging or other indications of slope instability or signs of erosion were observed (See Photo 5-2.).

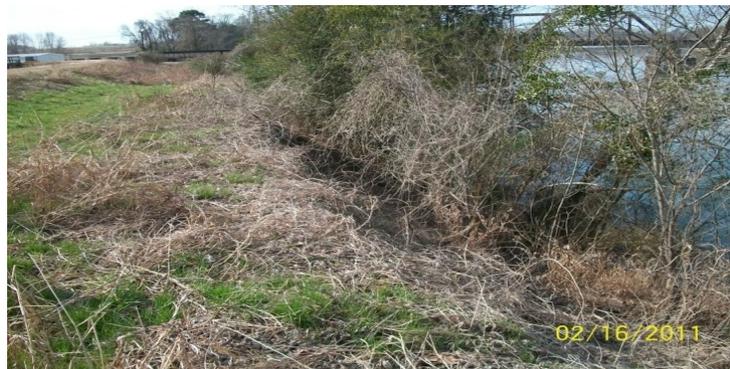
Photo 5-3. Brush along southeastern downstream slope

No scarps, sloughs, depressions, bulging or other indications of slope instability or signs of erosion were observed. Brush was observed along the southeastern section of the downstream slope (See Photo 5-3.).

An action plan should be developed to address removal of woody vegetation along the downstream slope. Specifically, SCE&G needs to:
