Coal Combustion Residue Impoundment

Round 9 - Dam Assessment Report

Urquhart Generating Station

Ash Ponds

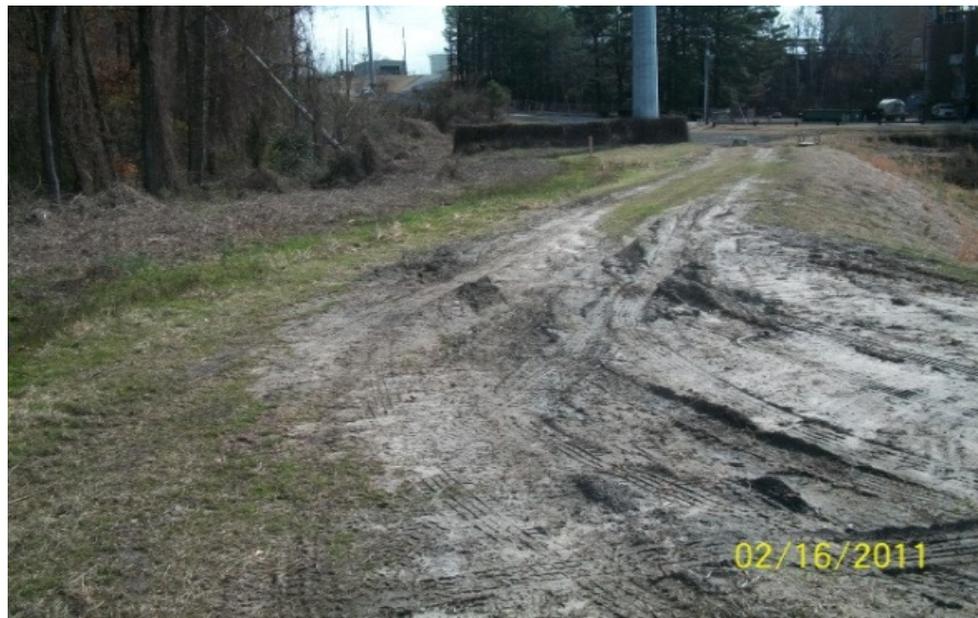
Photo 5-1. Rutting along crest

The crest had no signs of depressions, tension cracking, or other indications of settlement or shear failure, and appeared to be in satisfactory condition. Minor rutting was observed along portions of the crest (See Photo 5-1.).

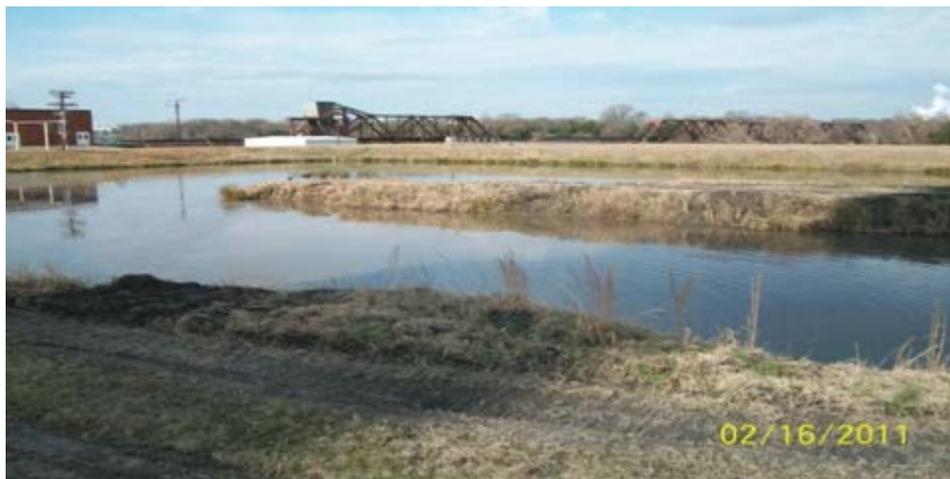
Photo 5-2. Overall view of interior of ash pond

The upstream slopes are mostly vegetated with tall grasses and other wetland vegetation. No scarps, sloughs, depressions, bulging or other indications of slope instability or signs of erosion were observed (See Photo 5-2.).

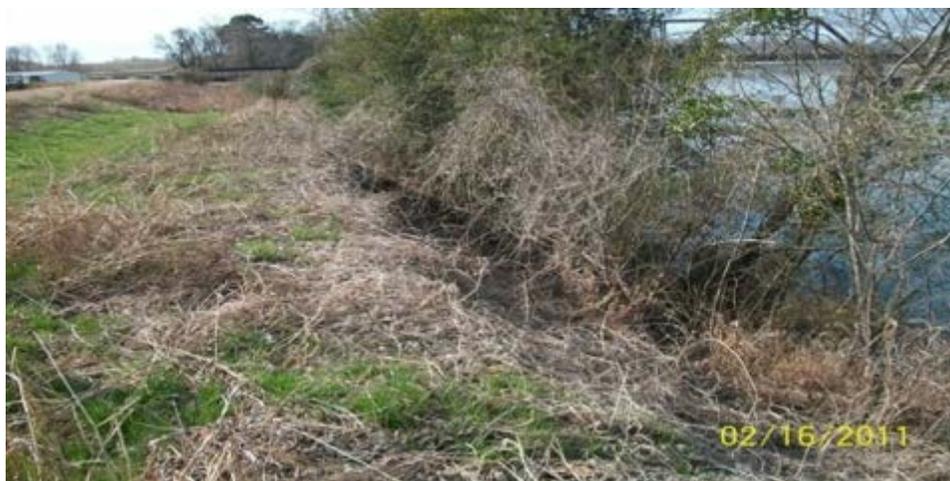
Photo 5-3. Brush along southeastern downstream slope

No scarps, sloughs, depressions, bulging or other indications of slope instability or signs of erosion were observed. Brush was observed along the southeastern section of the downstream slope (See Photo 5-3.).

The current maintenance and methods of operation appear to be adequate for the fly ash management unit. There was no evidence of significant embankment repairs or prior releases observed during the field inspection. Vegetation removal is required on the downstream slope.

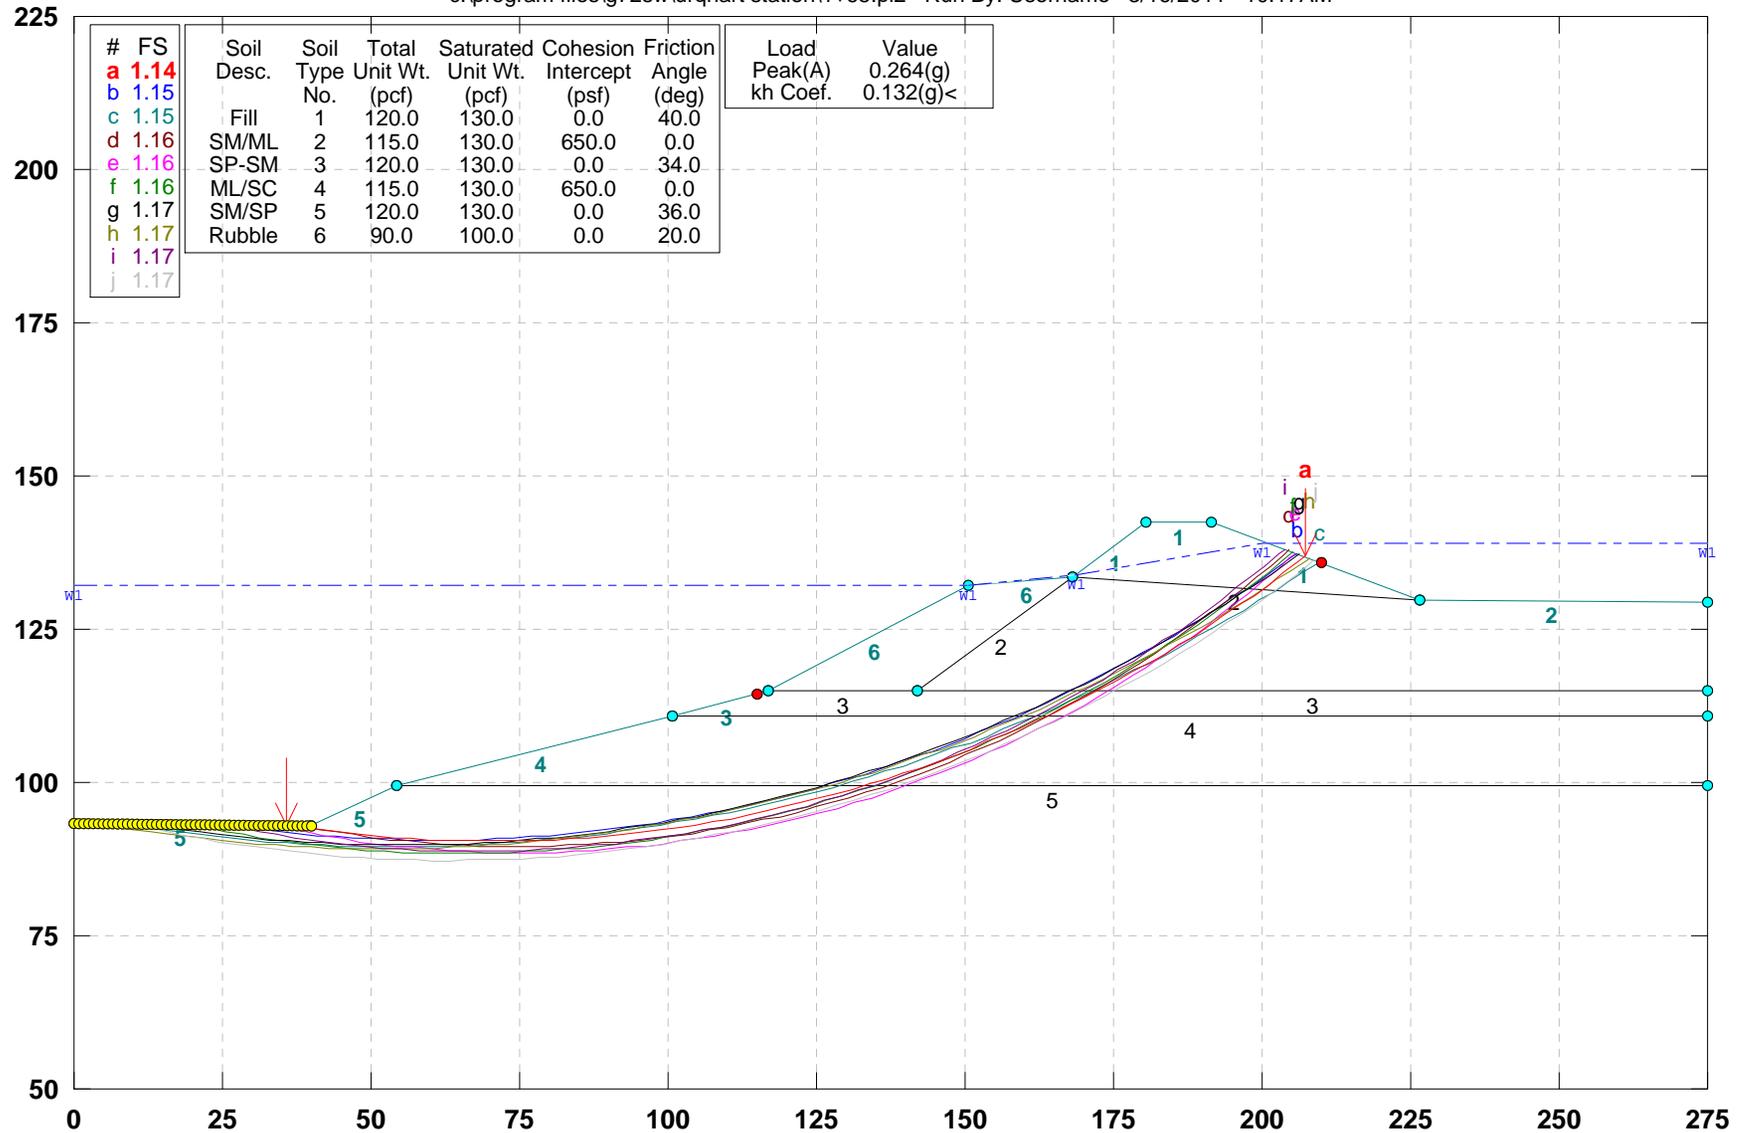
GSTABL7 v.2 FSmin=1.14
