# **Coal Combustion Residue Impoundment Round 9 - Dam Assessment Report**

Ash Ponds
South Carolina Electric & Gas
Beech Island, South Carolina

Dewberry & Davis, LLC Fairfax, Virginia

Under Contract Number: EP-09W001727 **November 2011**

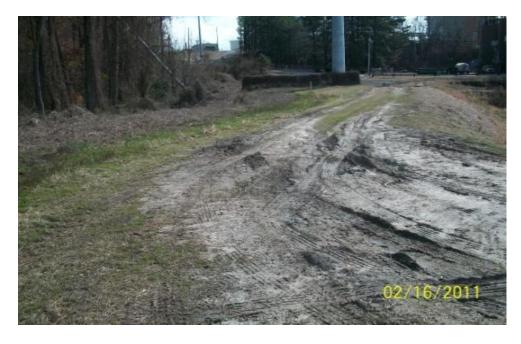
The crest had no signs of depressions, tension cracking, or other indications of settlement or shear failure, and appeared to be in satisfactory condition. Minor rutting was observed along portions of the crest (See Photo 5-1.).

Photo 5-1. Rutting along crest

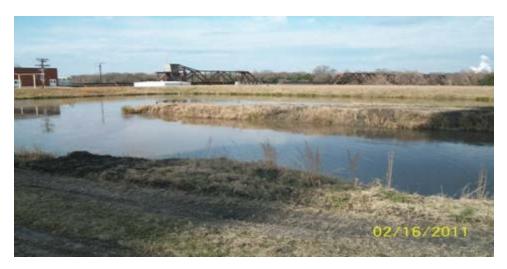
The upstream slopes are mostly vegetated with tall grasses and other wetland vegetation. No scarps, sloughs, depressions, bulging or other indications of slope instability or signs of erosion were observed (See Photo 5-2.).

Photo 5-2. Overall view of interior of ash pond

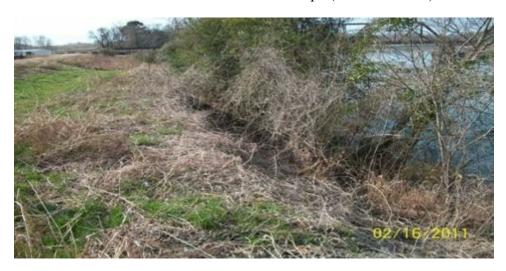
No scarps, sloughs, depressions, bulging or other indications of slope instability or signs of erosion were observed. Brush was observed along the southeastern section of the downstream slope (See Photo 5-3.).

Photo 5-3. Brush along southeastern downstream slope

The current maintenance and methods of operation appear to be adequate for the fly ash management unit. There was no evidence of significant embankment repairs or prior releases observed during the field inspection. Vegetation removal is required on the downstream slope.
