DRAFT REPORT

Dam Safety Assessment of CCW Impoundments

Sikeston Power Station

May 27, 2010

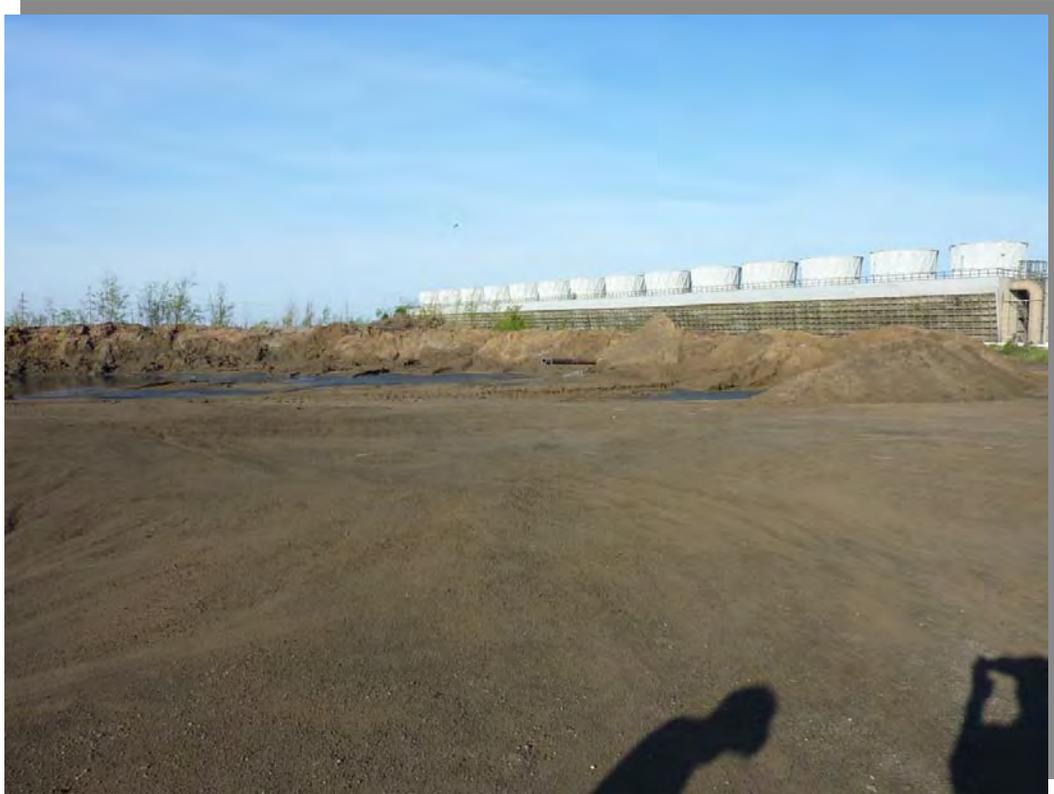
Photo 1 – Northwestern corner, note effluent pipe in background.

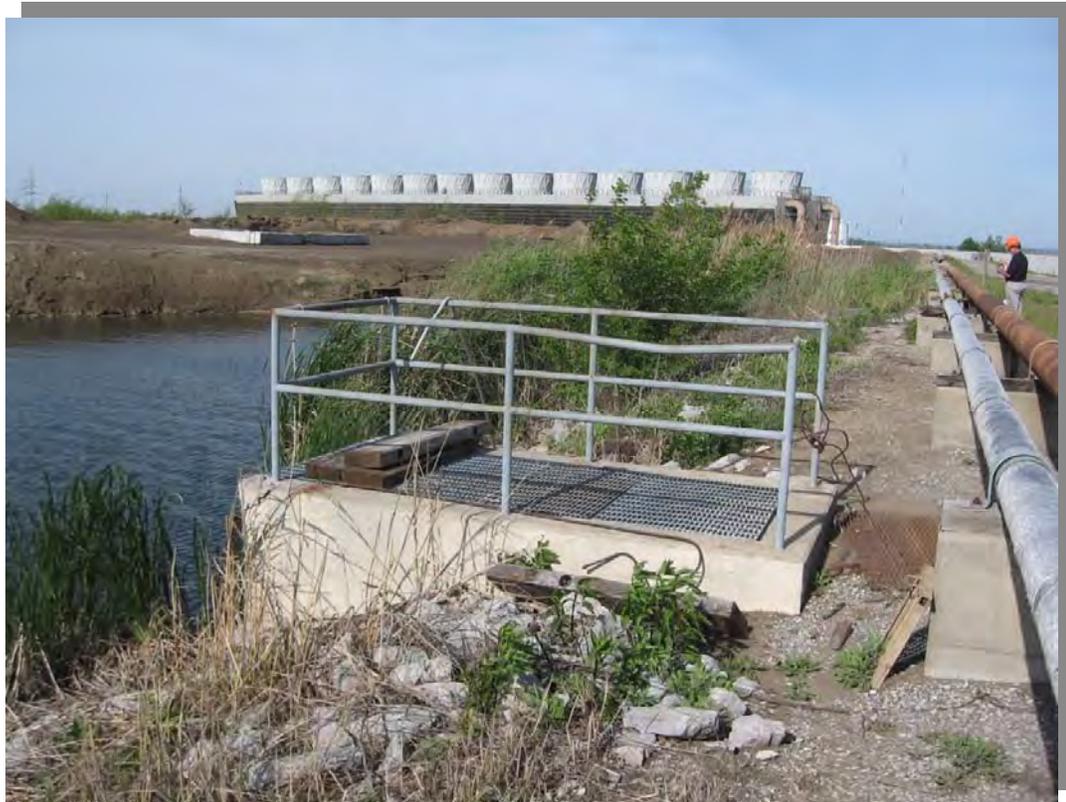
- The outlet structure appeared to be in good condition and functioning normally (Appendix B – Photo 1).

Photo 2 –Outlet structure.

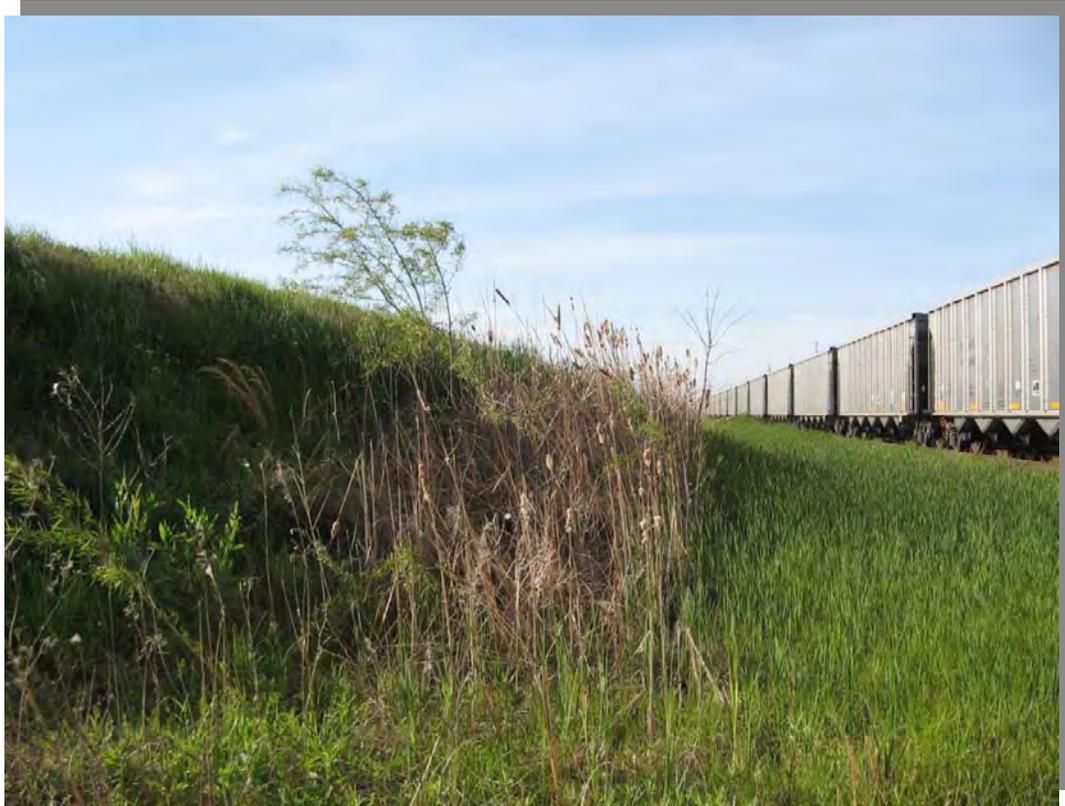
- A drainage ditch runs along the length of the outboard toe. Due to the flat topography of the site, the ditch was constructed with very little pitch and consequently drains poorly. Standing water was present throughout the length of the ditch and it appears to have caused a small portion of the northwestern corner of the outboard toe of the embankment to become spongy (Appendix B – Photo 3).

Photo 3 – Outside slope of northwestern corner.
Note reedy grass growth, some wet areas observed in this location.

- Outboard slopes – remove deleterious vegetation and continue regular maintenance of the slopes.
- Outboard toe – Implement plan to replace the ditch with drain piping along the toe to improve drainage.
- Inboard slopes – remove the small trees growing along the northern portion of the embankment. Keep vegetation under control to allow for visual inspection of the exposed portion of the slope above the waterline.
- Additional studies – perform geotechnical investigation, cross-sectional topographic survey, and slope stability analyses of critical slopes. Install piezometers to monitor phreatic levels within the embankment. Analyze for normal pool with steady state seepage, maximum surcharge pool, and seismic loading conditions.

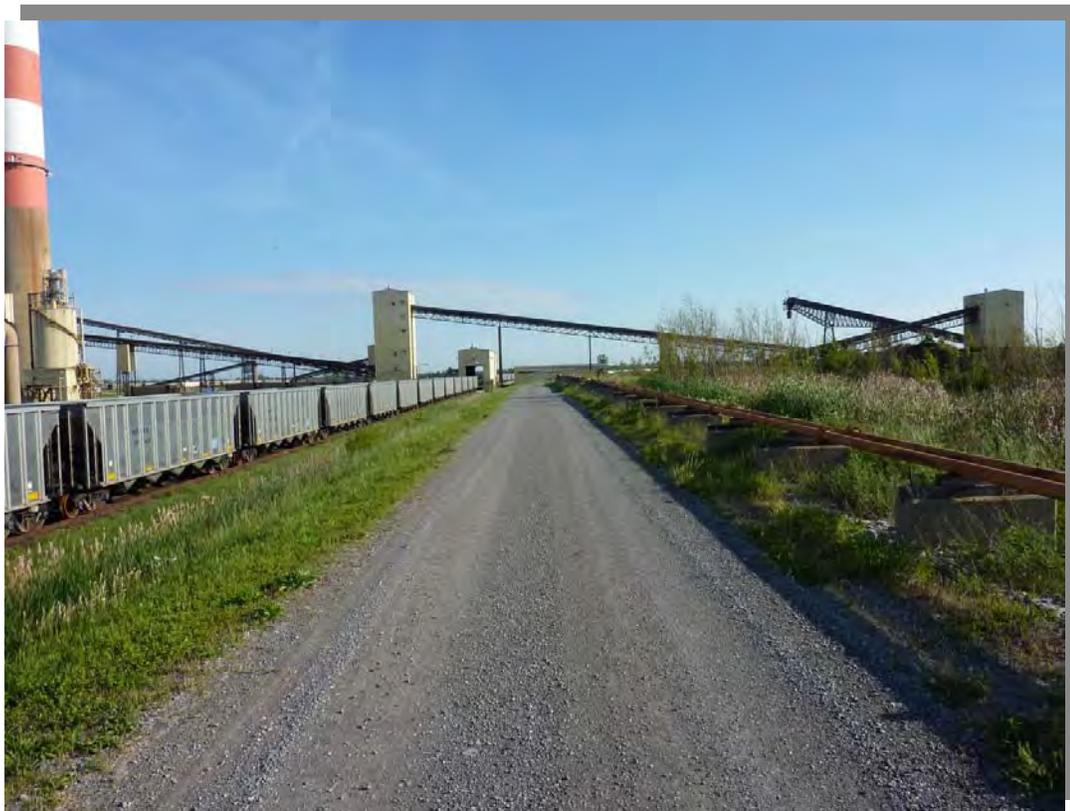
Photo 4 – Western embankment looking north.
Note vegetative growth on outboard slope.

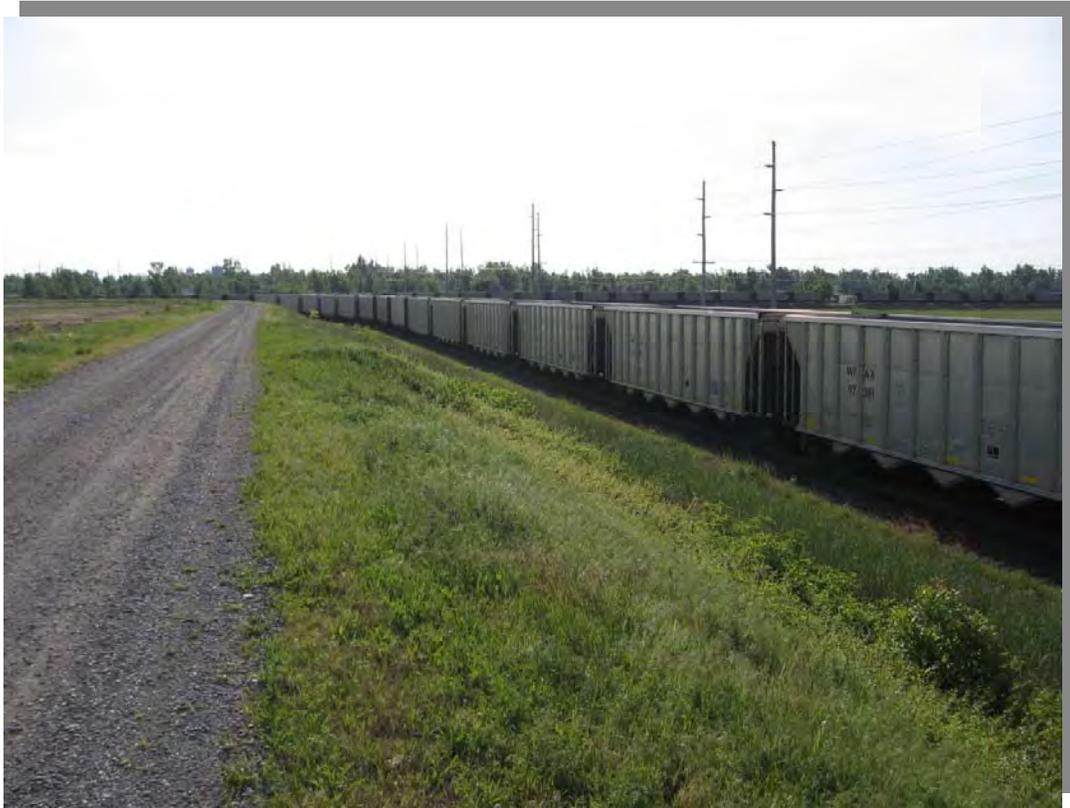
Photo 5 – South embankment, looking east.

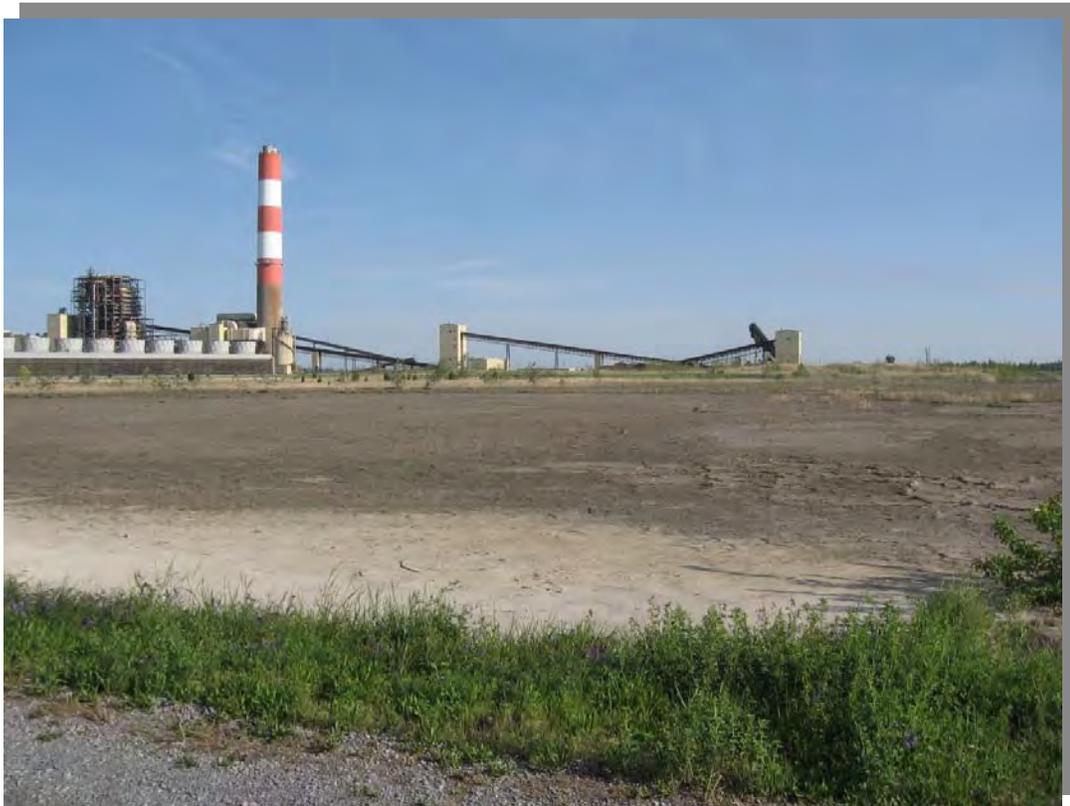
Photo 6 – Interior of Bottom Ash Pond filled with CCW.

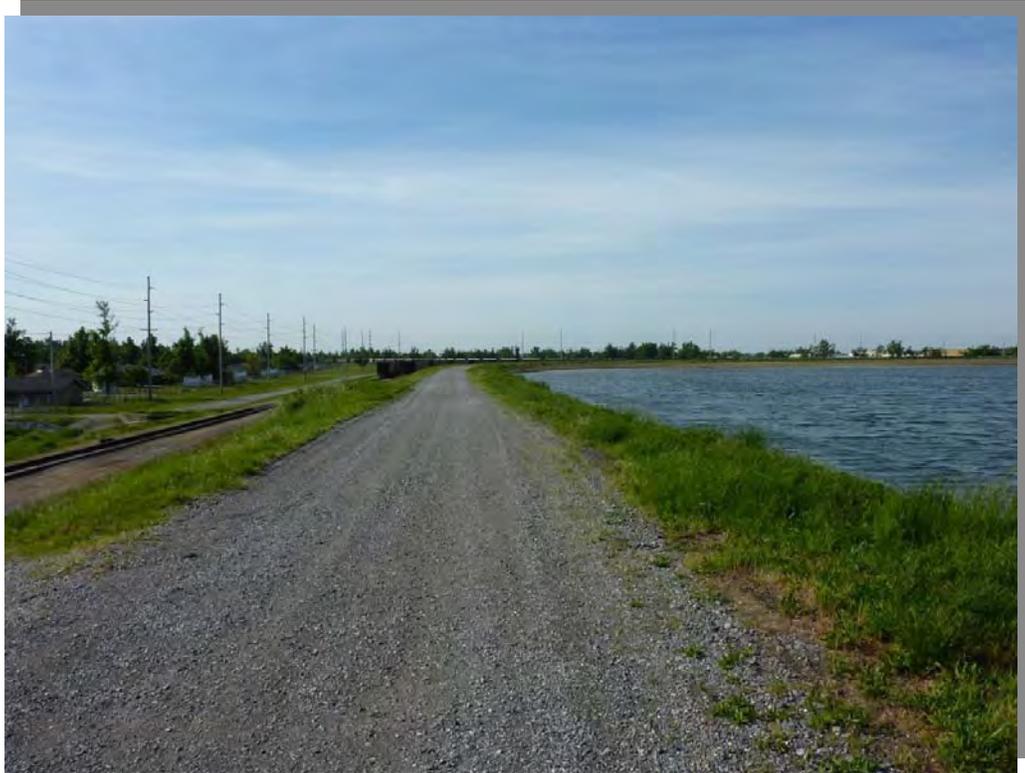
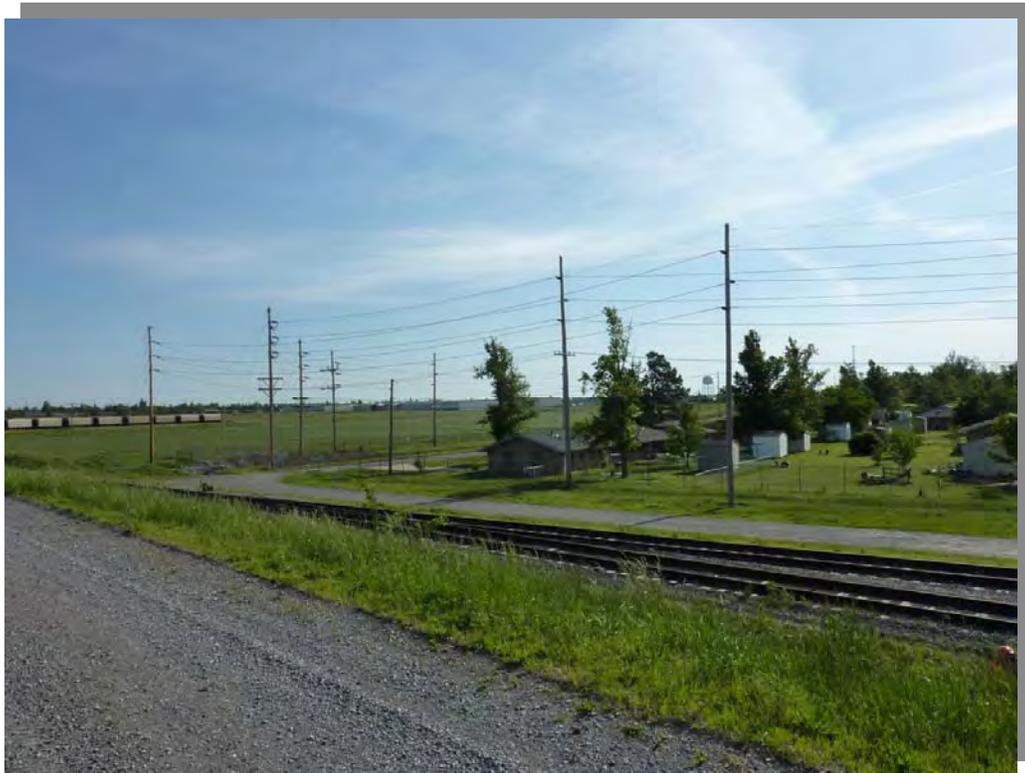
- A residential neighborhood is located to the southeast of the impoundment; this neighborhood represents the hazard area that could potentially be inundated by a release of sluice water and CCW from the Bottom Ash Pond (Appendix B – Photos 7 & 8).

Photo 7 – East embankment, looking south.
Note residences near impoundment.

Photo 8 – Residences adjacent to the Bottom Ash Pond.

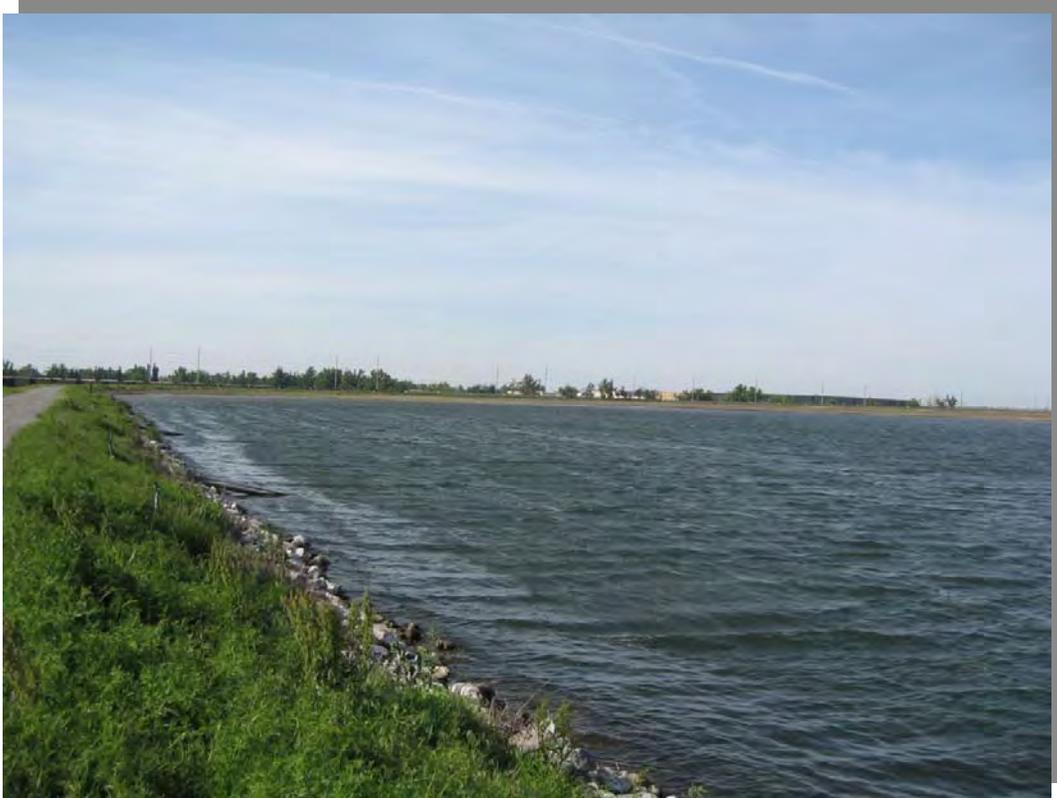
Photo 9 – Inboard slope of east embankment. Note riprap at waterline.

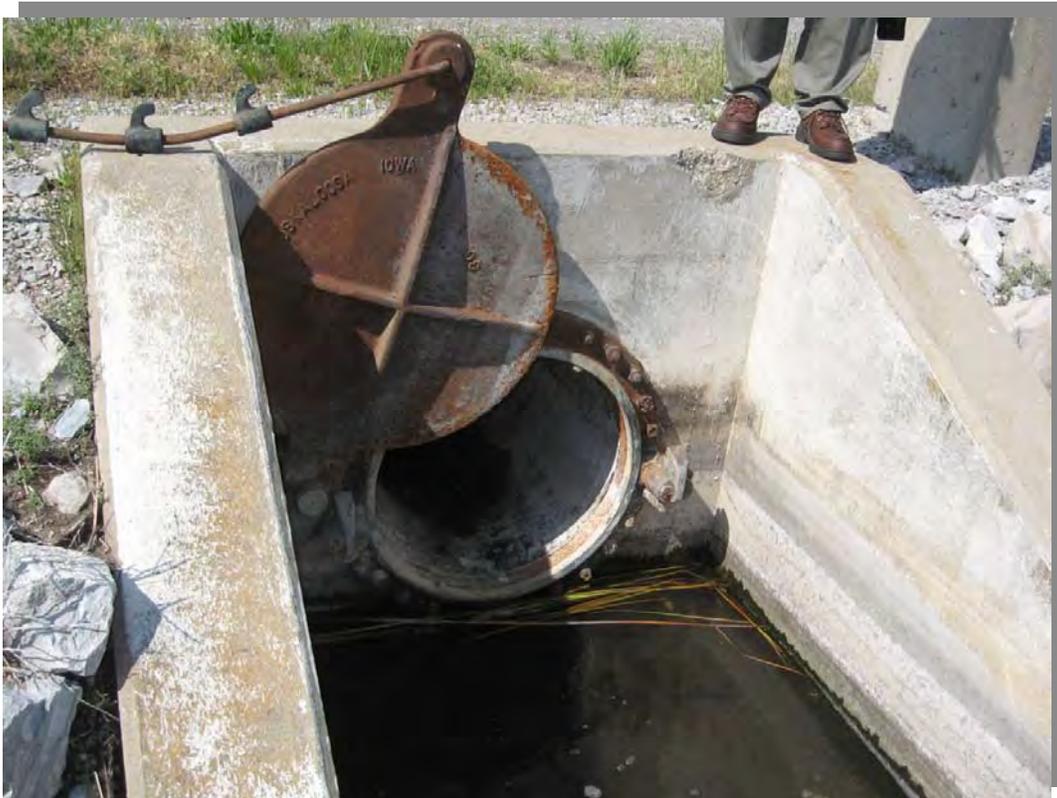
- The swing gate on the 30-inch connecting line between the Bottom Ash and Fly Ash Ponds was open but the water surface elevation was below the invert of the pipe (Appendix B – Photo 10). The structure appears to be in good condition.

Photo 10 – 30-inch connecting pipe through the Dividing Dike. Swing gate in open position.

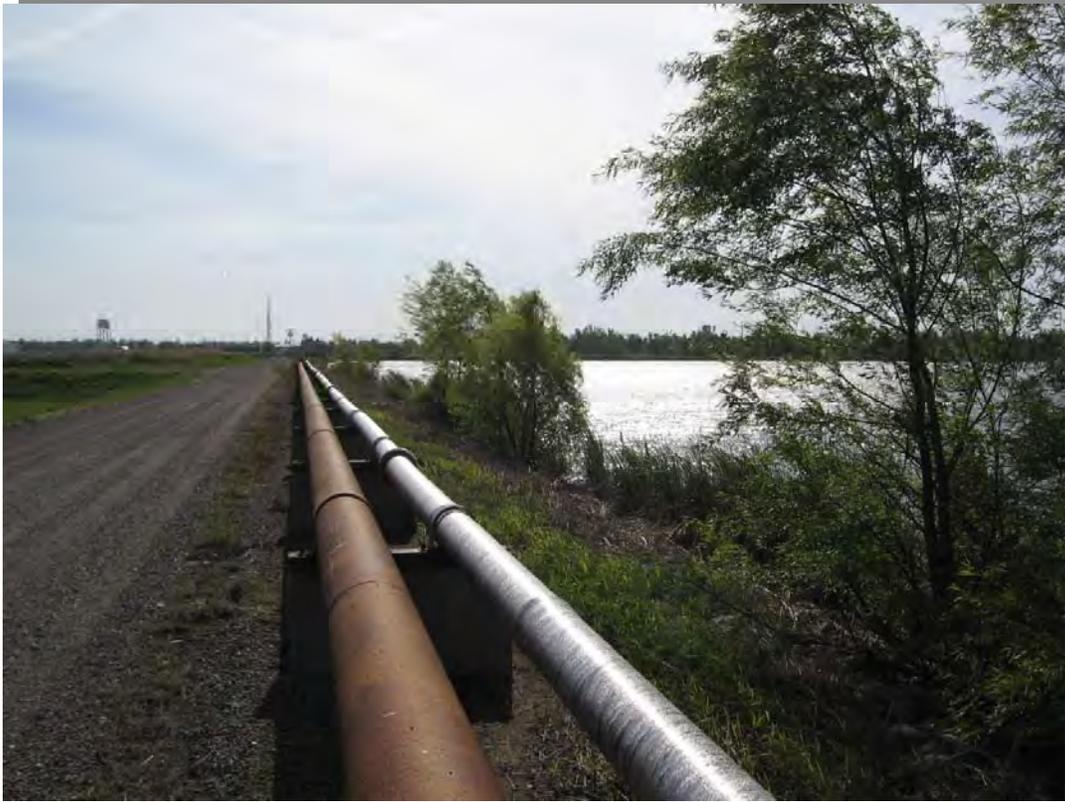
- The embankment appears to have been constructed steeper than 2H:1V at the corner.
- The inboard slope is either obscured/covered with CCW, or well vegetated, with riprap visible along the normal pool water surface elevation (Appendix B – Photo 9). Several small (approx. 6" diameter) trees were observed growing on the inboard slope near the outlet structure (Appendix B – Photo 11).

Photo 11 – Dividing Dike, looking east. Note trees growing on Bottom Ash side of Dike.

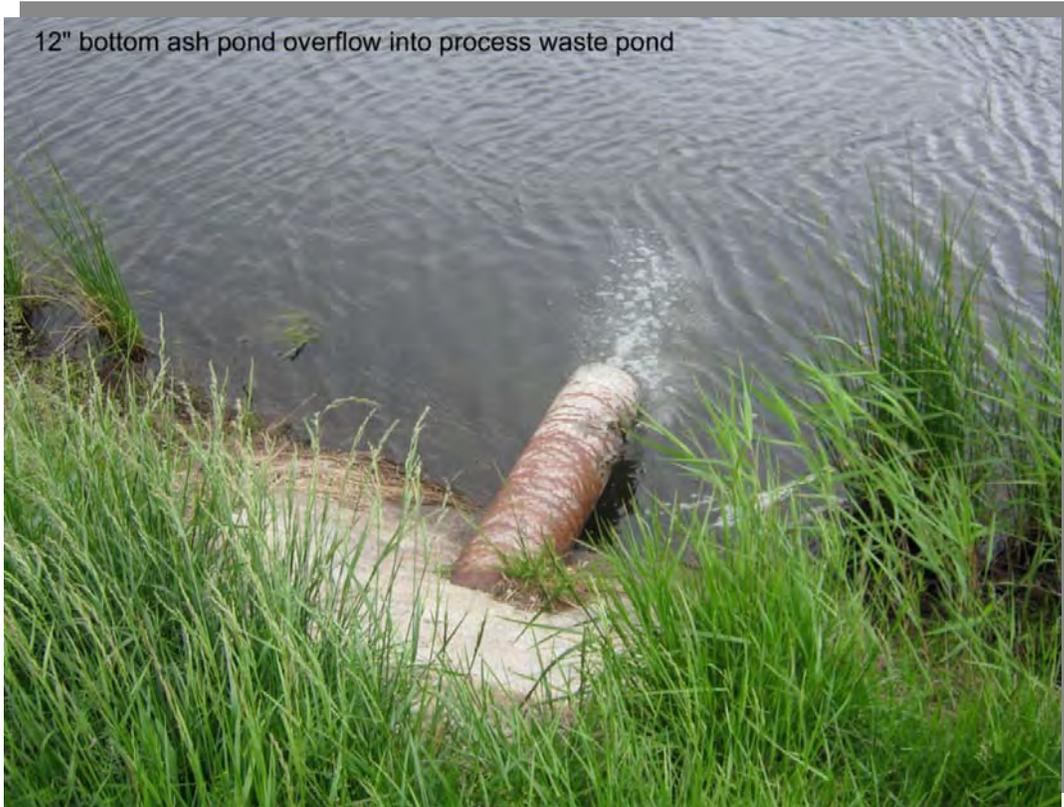
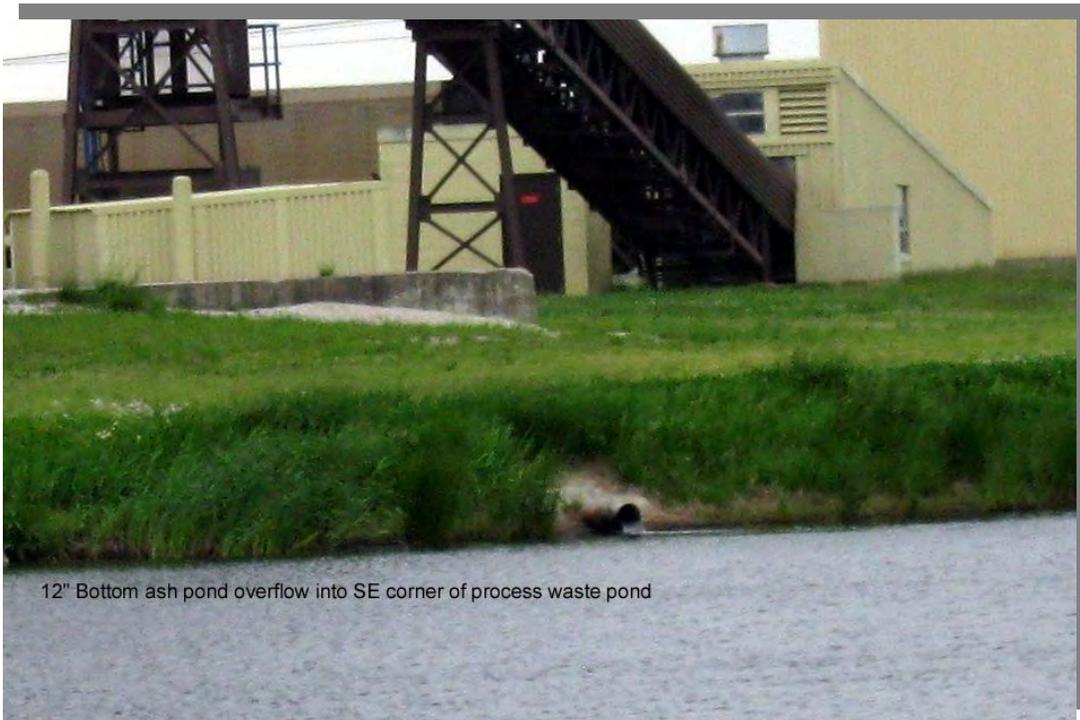
Photos 12 & 13– Discharge from Bottom Ash Pond into the Process Waste Pond.

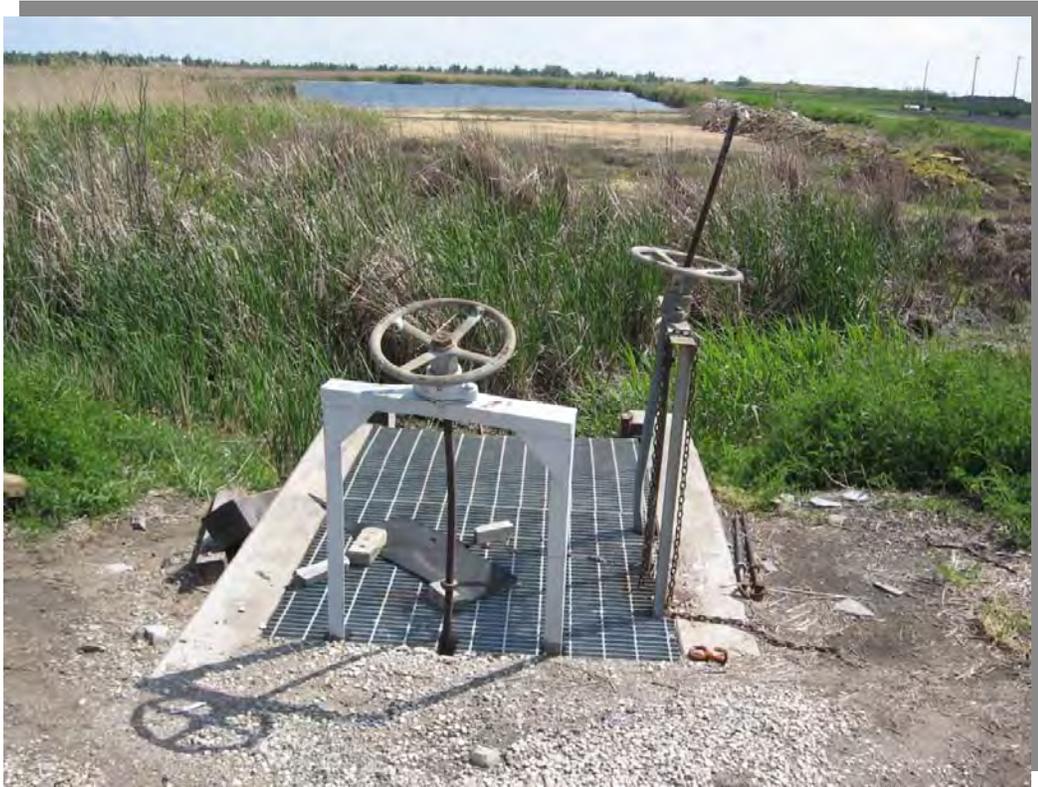
- Water exits the pond through a concrete weir structure near the northwestern corner of the impoundment. The structure allows for discharge into the Process Waste Pond (normal condition) or directly out to West Westfield Avenue. The operators for the Outlet Structure's slide gates are bent and appear to be inoperable (Appendix C – Photos 1 - 3).

- The drainage ditch that runs along the outboard toe was not constructed with an adequate slope to properly drain stormwater runoff.
- A more significant wet area was observed at the outboard toe near the outlet structure.
- The outlet structures slide gate operator stems are bent and appear to be inoperable.

Photo 1 – Outlet structure. Note bent gate operator stems.

- Inboard slopes – keep vegetation under control to allow for visual inspection of the exposed portion of the slope above the waterline.
- Repair or replace the slide gate operator stems.

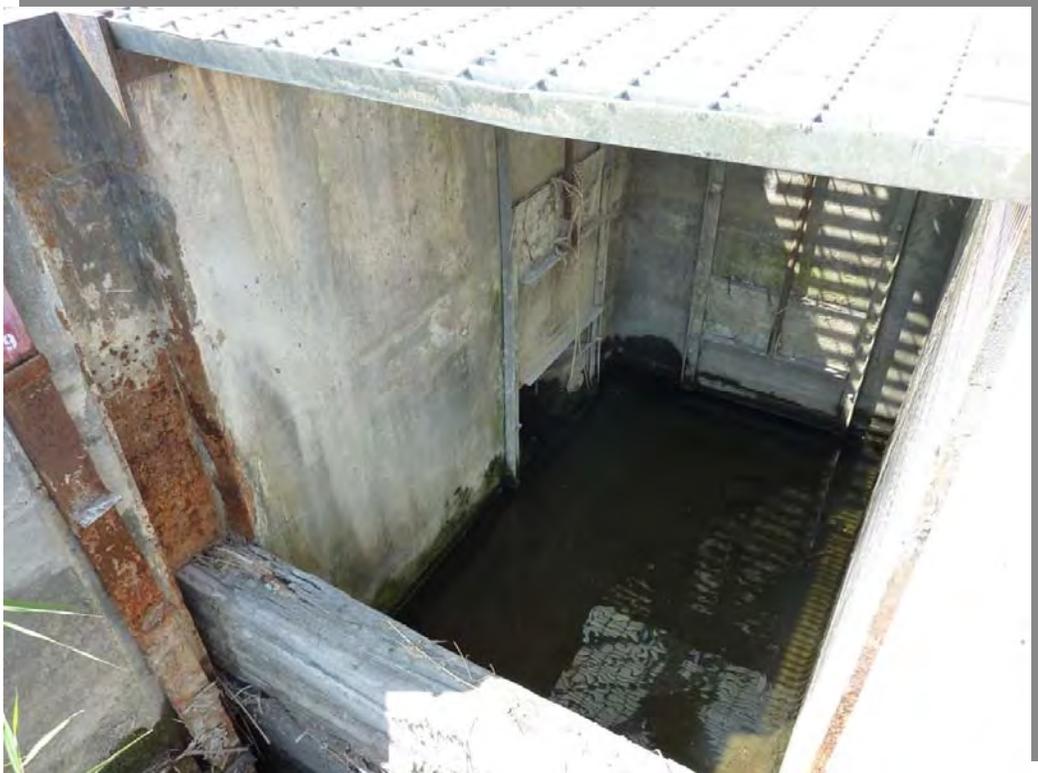
Photo 2 –Interior of Outlet structure.
Flow discharges through open gate on the left to the Process Waste Pond.

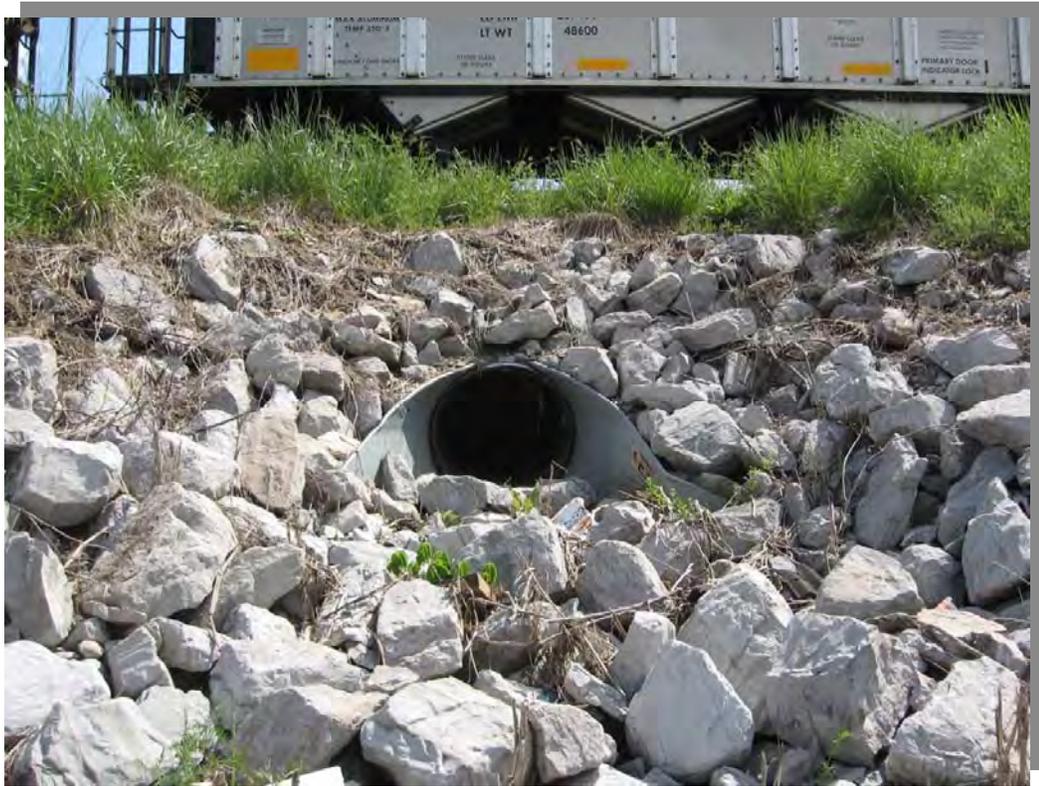
Photo 3 – Downstream end of outlet pipe from Fly Ash Pond to West Westfield Ave.

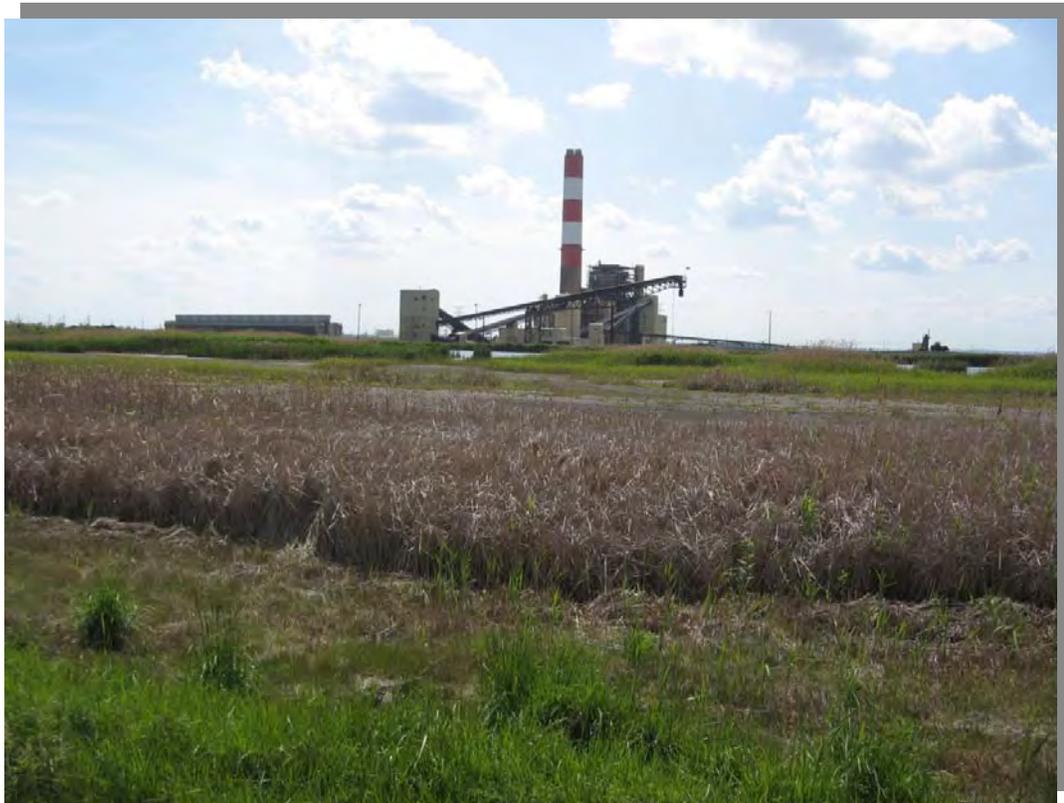
- The outlet structure appears to be in good condition and functioning normally.
- The CCW has accumulated above the normal pool level over an estimated 90 percent of the pond area. Water in the pond is isolated to primarily the northwestern corner of the pond (Figures 2 & 3, Appendix C – Photo 4).

Photo 4 – Interior of Fly Ash Pond, filled with CCW.

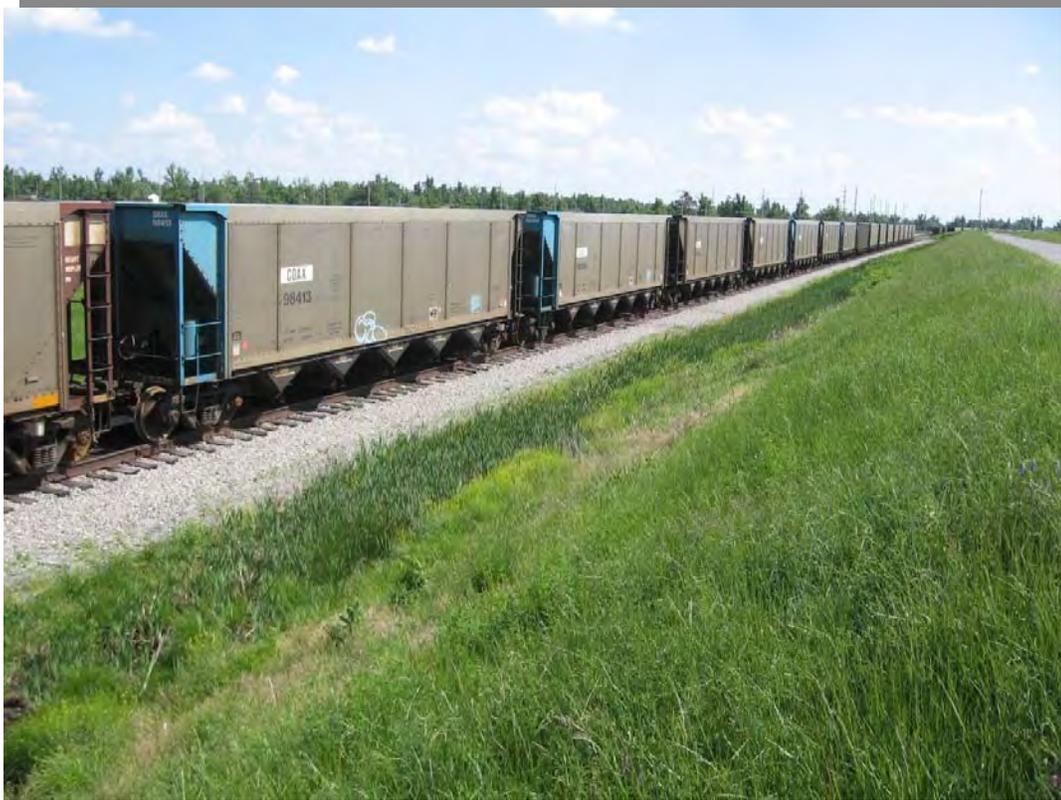
Photo 5 – East embankment. Note growth in drainage channel.

- Outboard slopes – remove deleterious vegetation and continue regular maintenance of the slopes.
- Outboard toe – Implement plan to replace the ditch with drain piping along the toe to improve drainage.

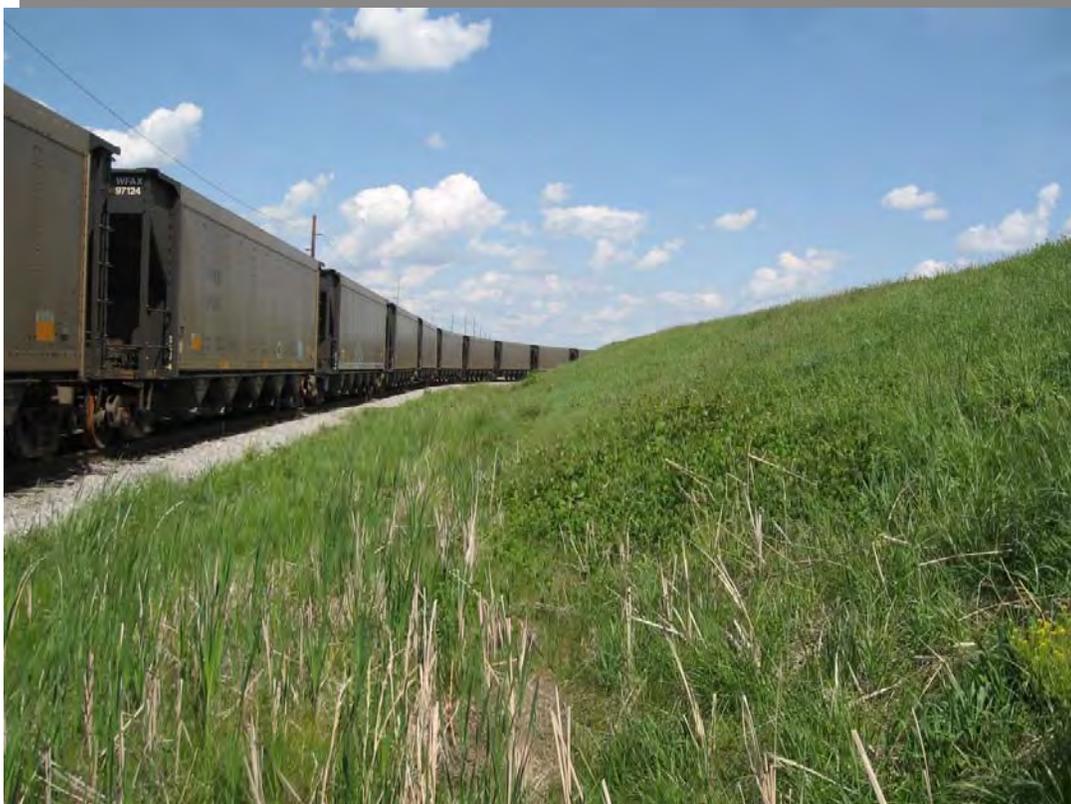
Photo 6 – North embankment.

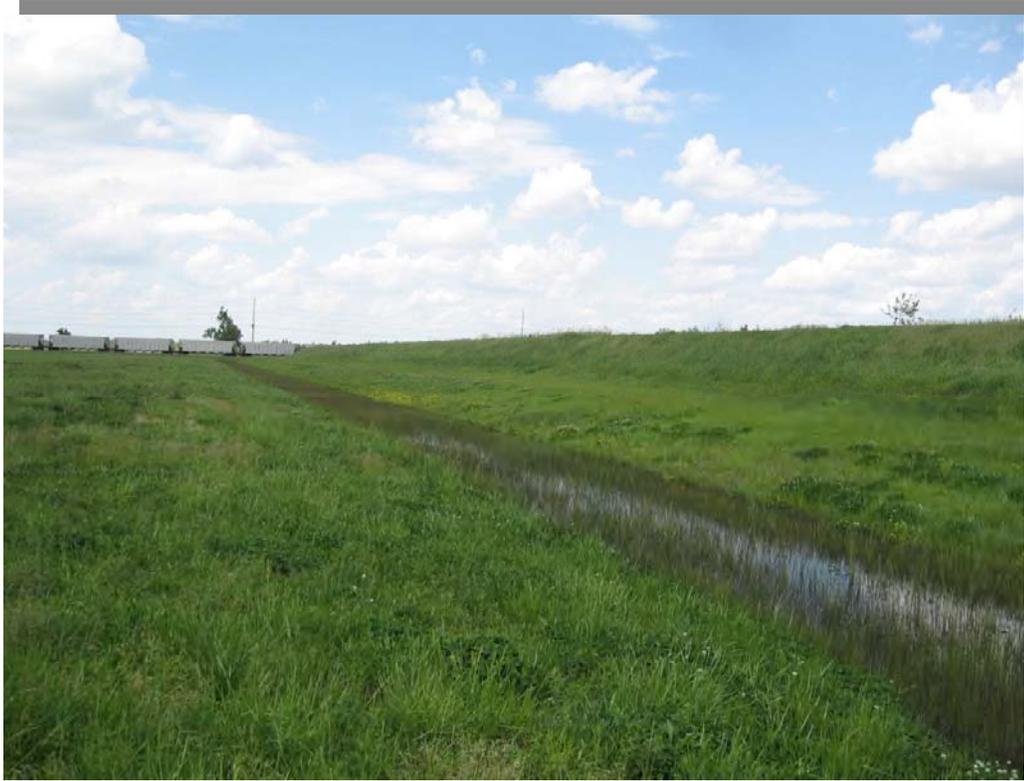
Photo 7 – West embankment, looking north.
Note standing water in drainage swale.

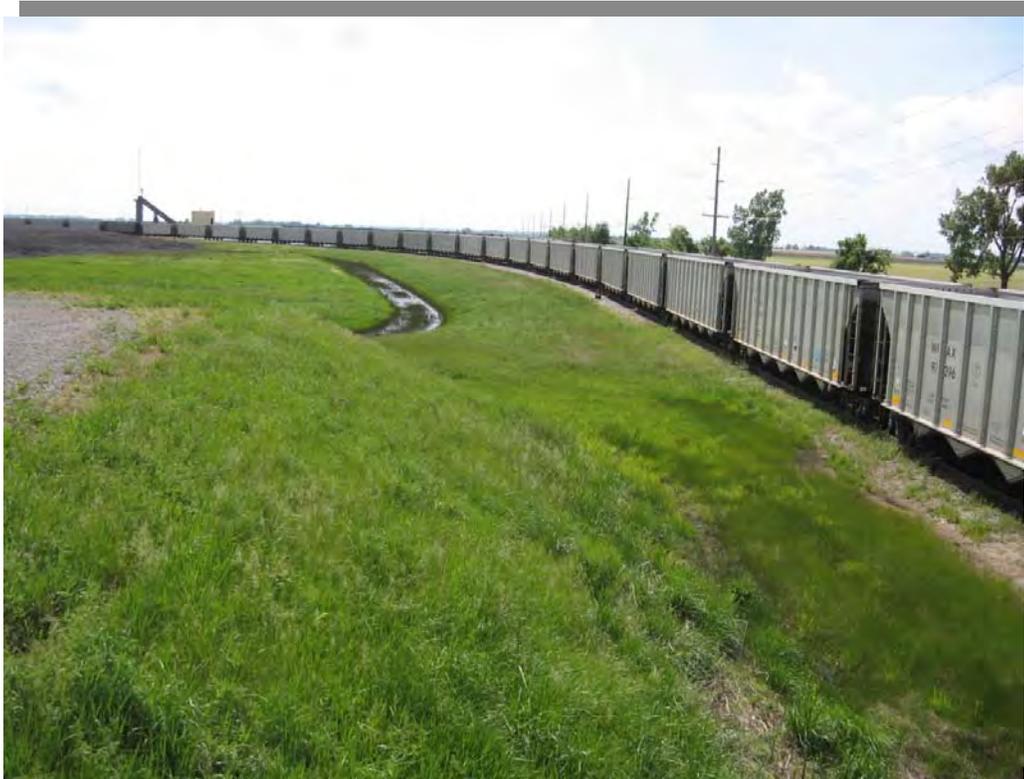
Photo 8 – Northwestern corner. Note minor erosion at toe.

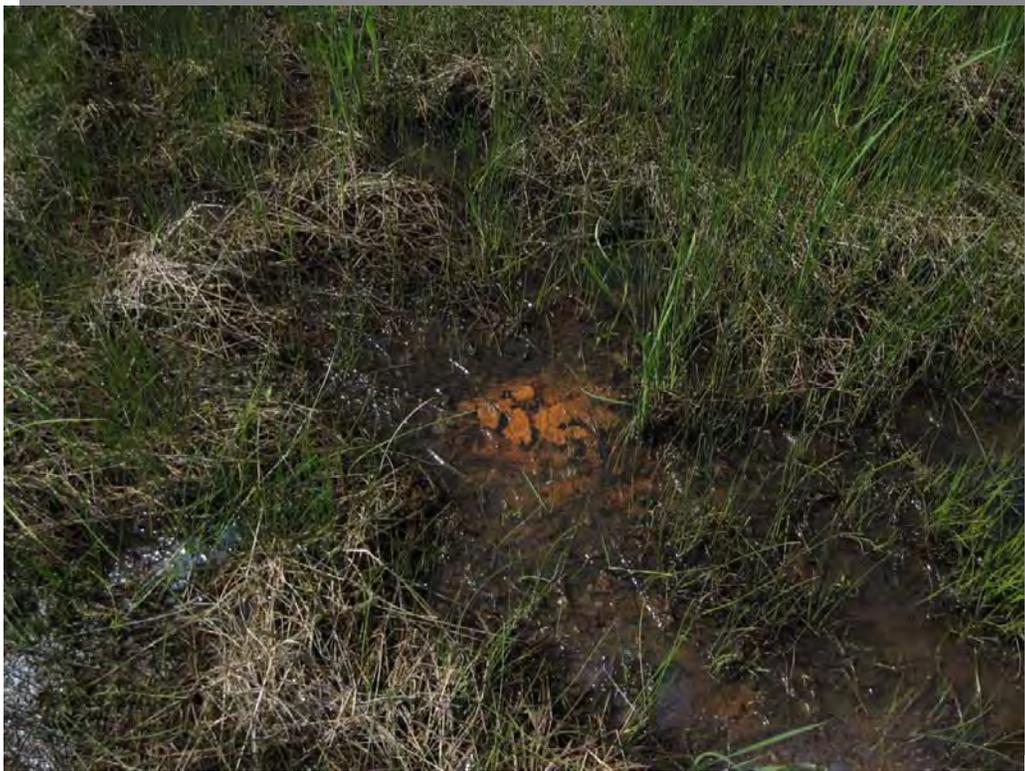
- A more significant wet area was observed on the downstream toe near the outlet structure (Appendix C - Photo 9)
- Some minor rutting, probably caused by mowing equipment, was observed at isolated areas on the outboard slopes.

Photo 9 – Standing water, outboard toe near the Outlet Structure. Note discoloration, possible indication of seepage.

- Additional studies – perform geotechnical investigation, cross-sectional topographic survey, and slope stability analyses of critical slopes. Install piezometers to check phreatic levels within the embankment. Analyze for normal pool with steady state seepage, maximum surcharge pool, and seismic loading conditions. Installation of the piezometers will help to verify if the wet area near the outlet structure is the result of seepage through or beneath the embankment or is perched groundwater or stagnant surface water.

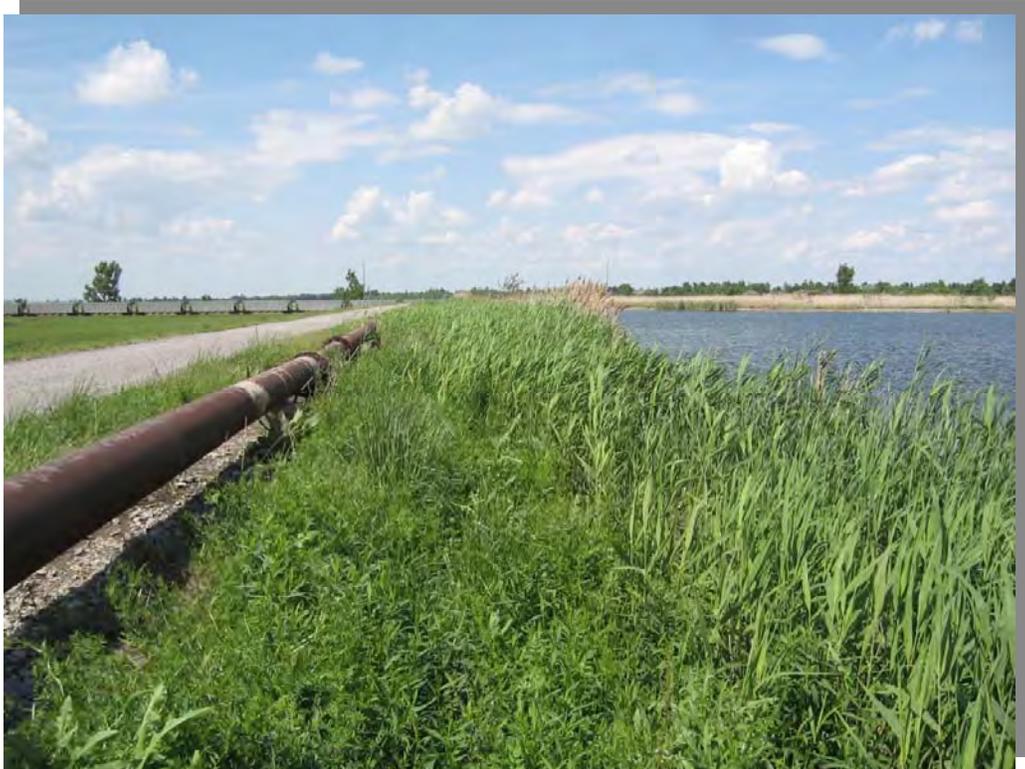
Photo 10 – Inboard slope of west embankment. Reeds have overgrown riprap slope protection.

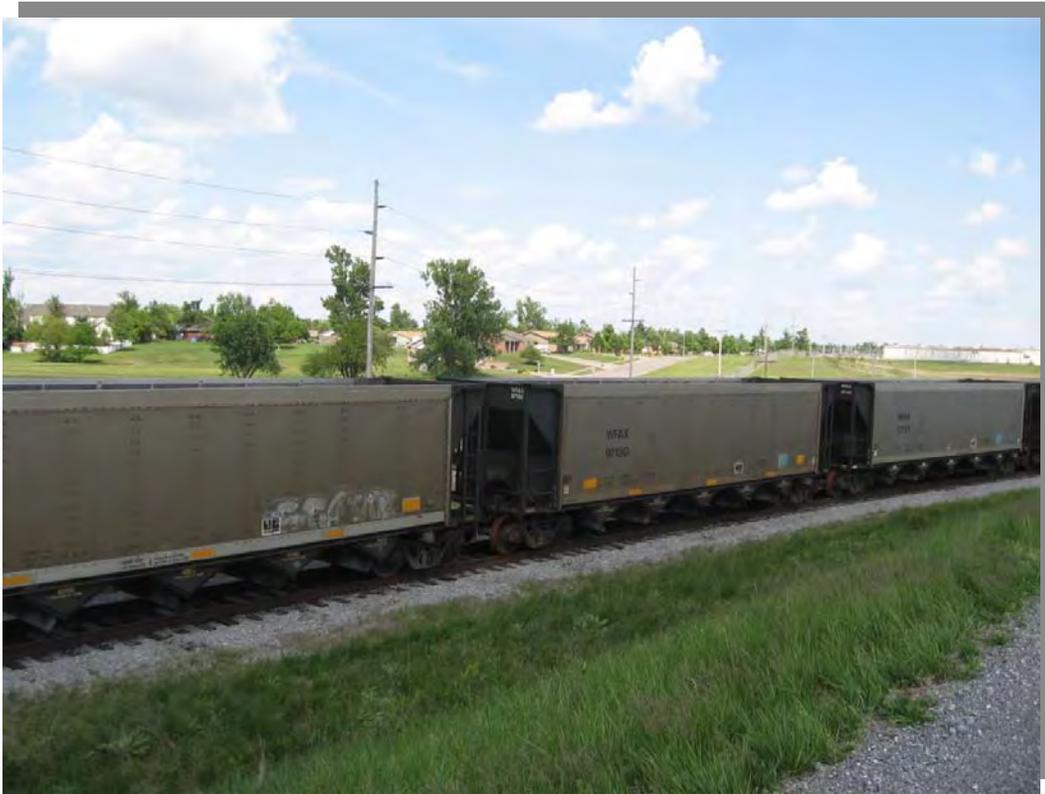
- A small residential neighborhood is located along West Westfield Avenue to the northeast of the Fly Ash Pond. The residences appear to be constructed above the normal pool elevation in the Fly Ash Pond and therefore should not represent a hazard area for the impoundment (Appendix C – Photo 11).

Photo 11 – Northeastern corner. Note residences in background, appear to be above normal pool elevation..

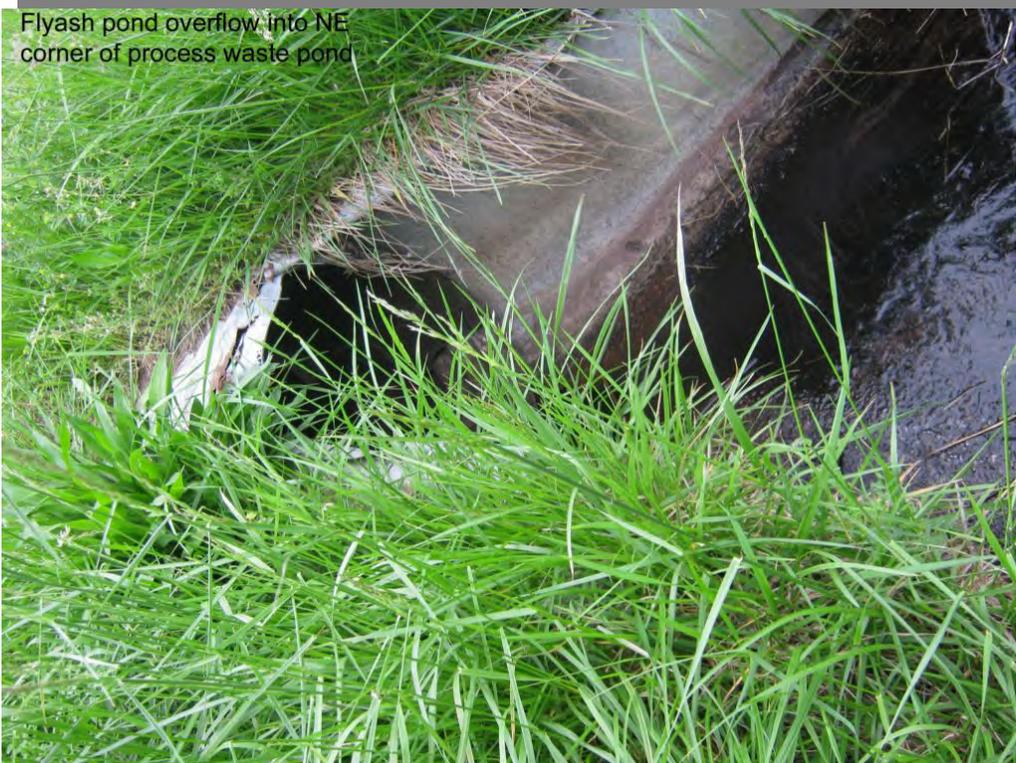
Flyash pond overflow into NE corner of process waste pond

Photo 12– Outlet of discharge pipe from the Fly Ash Pond into the Process Waste Pond.
