**COAL ASH IMPOUNDMENT  
SITE ASSESSMENT DRAFT REPORT**

**Marion Power Station  
Southern Illinois Power Cooperative  
Marion, Illinois**

**KLEINFELDER PROJECT NUMBER 118953-5**

**March 20, 2012**

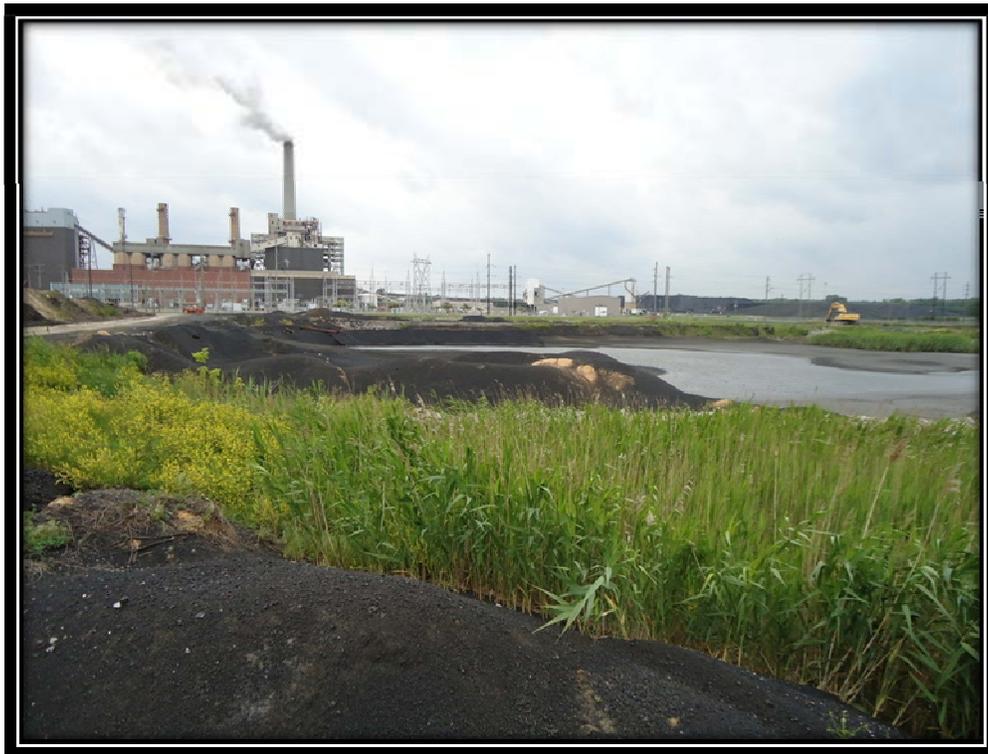
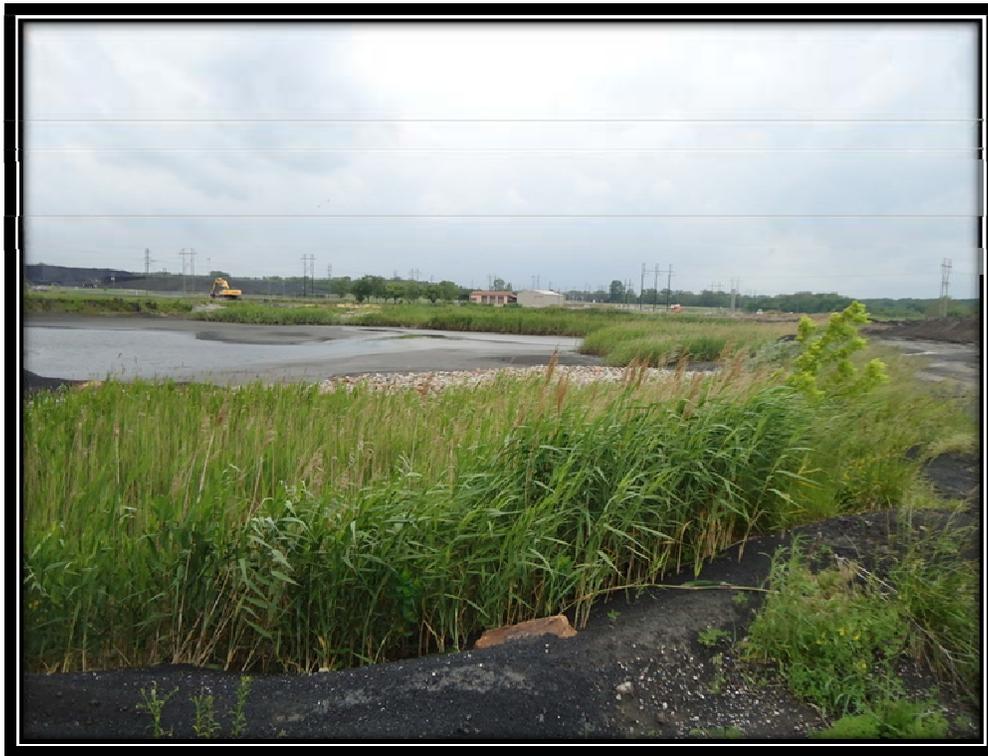
Overall, the upstream slope of the impoundment was in fair condition. Photos 7-10 in Appendix B show the condition of the upstream slope. Specific observations include:

Overall, the crest of the impoundment was in satisfactory condition. Photos 7 and 8 show the condition of the crest. Specific observations include:

- The impoundment crest is an access road.
- Sparse grasses and bushes were observed on the crest.

- No major depressions or rutting was noted on the impoundment crest.

Photo 7 – Ash Pond 2 General Conditions Photograph  
May 25, 2011 IL50160

Photo 8 – Ash Pond 2 General Conditions Photograph  
May 25, 2011 IL50160

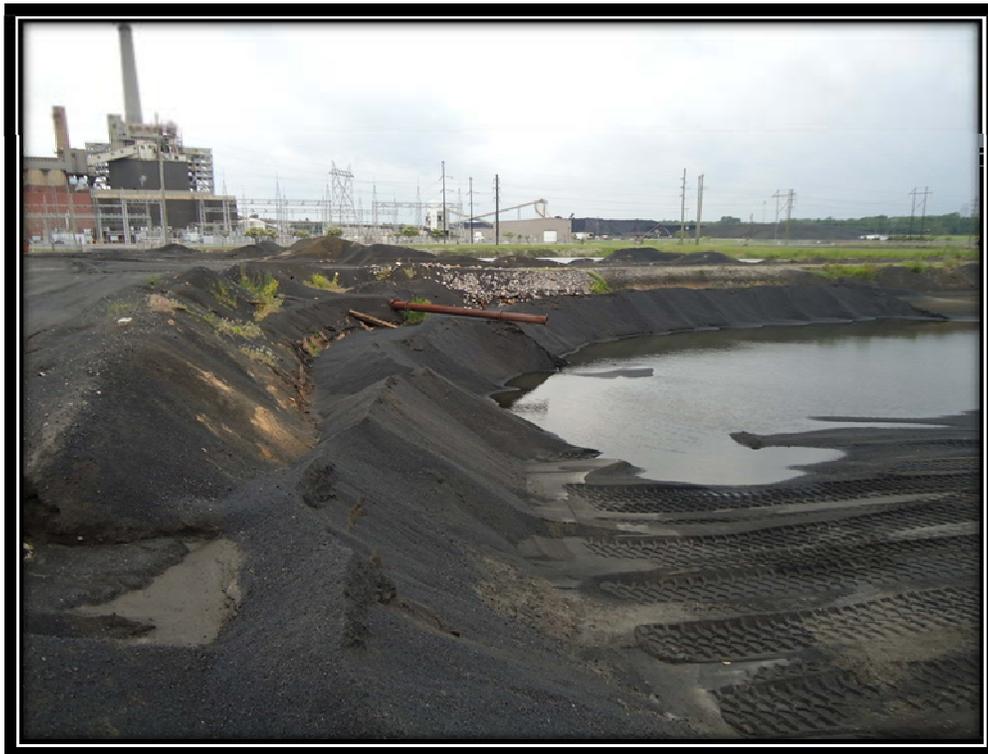
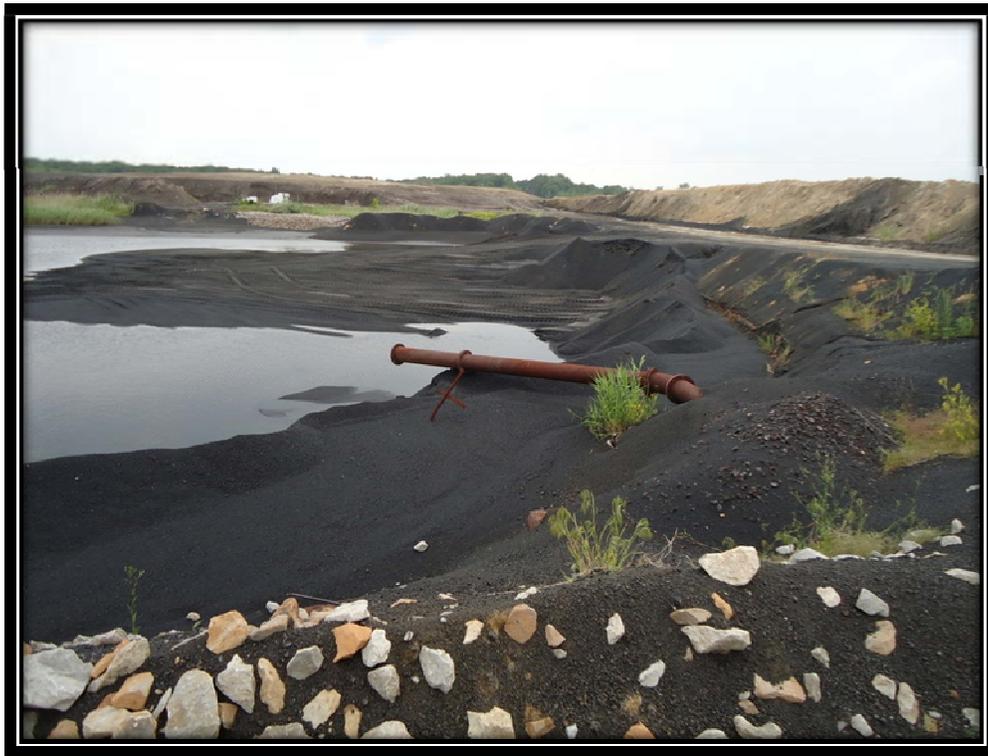
Inflow into the Pond 2 is via metal piping on the southeastern corner of the impoundment, as well as storm water runoff that flows naturally into the pond. The inlet pipe can be seen in photos 9 and 10 of Appendix B. The inlet pipe appears to be in satisfactory condition.

Photo 9 – Ash Pond 2 Inlet Sluice Pipe  
May 25, 2011 IL50160

Photo 10 – Ash Pond 2 Inlet Sluice Pipe  
May 25, 2011 IL50160

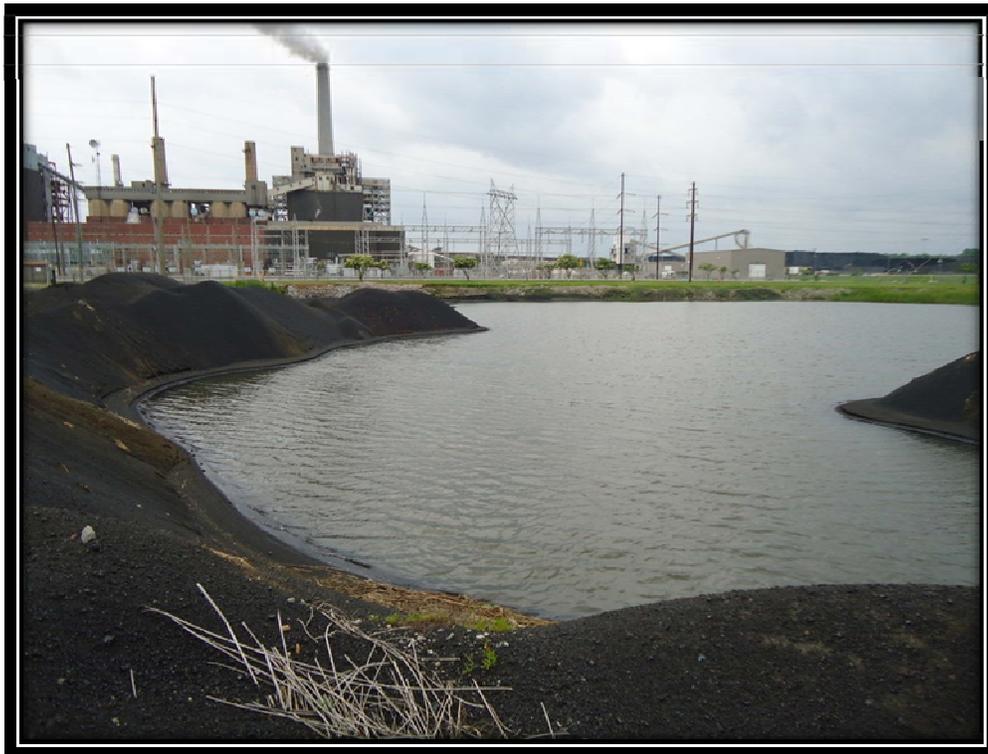
Overall, the upstream slope of the impoundment was in fair condition. Photos 11, 12, 14 and 15 in Appendix B show the conditions of the upstream slope. Figure 4 displays the location of where these photographs were taken during the assessment. Specific observations include:

Photo 11 – Ash Pond 1 General Conditions Photograph  
May 25, 2011 IL50160

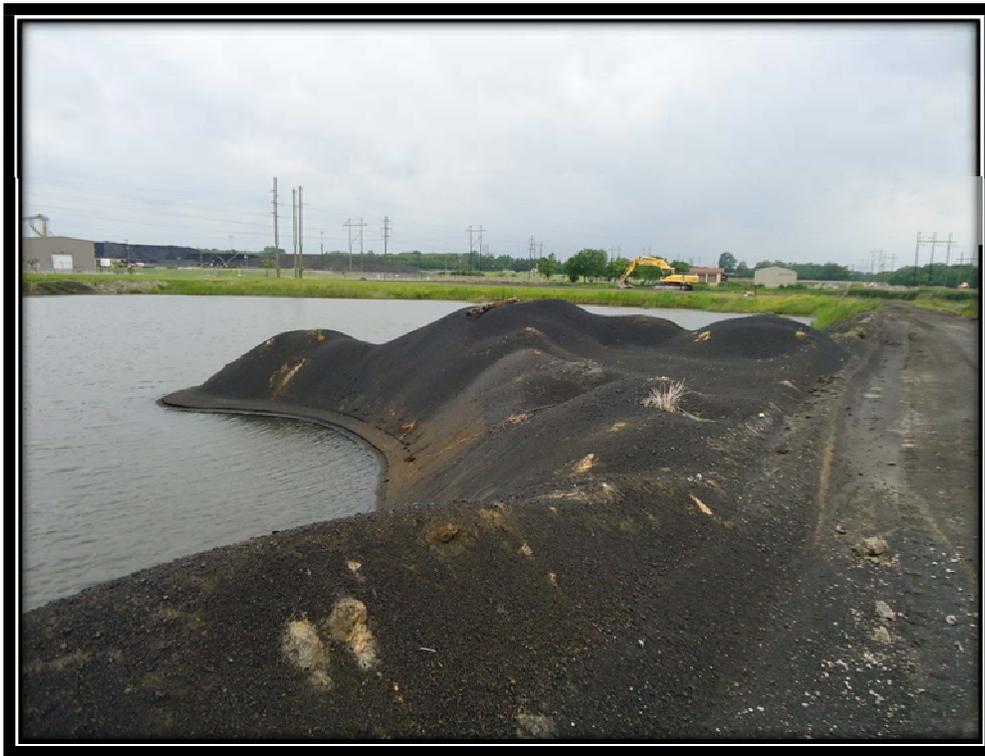
Overall, the crest of the impoundment was in satisfactory condition. Photos 12 and 15 show the condition of the crest. Specific observations include:

- Sparse grasses and bushes were observed on the crest.
- Well established sod was properly maintained on the southern and western portions of the pond.
- No major depressions or rutting was noted on the impoundment crest.

Photo 12 – Ash Pond 1 General Conditions Photograph  
May 25, 2011 IL50160

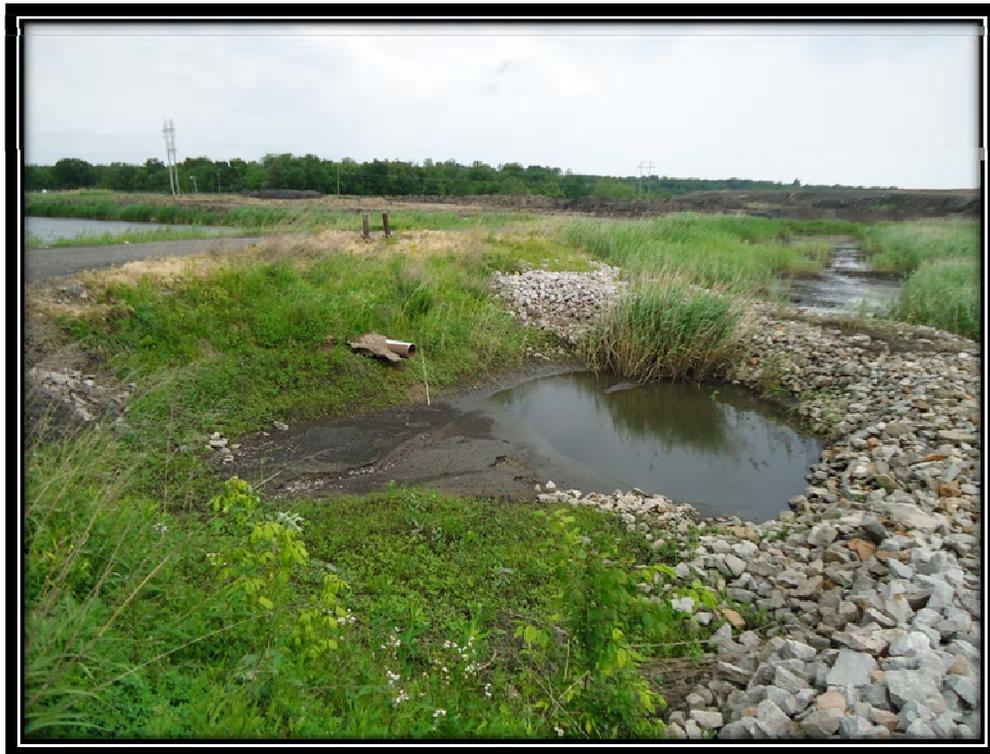
The outlet works of Pond 2 consist of a single pipe penetration through the western portion of the pond that outlets into Pond 4. This pipe is located near the southwestern corner of the pond. The elevation of this pipe could not be confirmed as there was no recent survey information available at the time of assessment. In addition, the as built drawings did not reference a specific vertical datum. This pipe is not controlled and does not utilize a trash rack. Photo 13 shows the condition of the outlet pipe. Specific observations include:

Photo 13 – Ash Pond 2 Discharge Pipe into Ash Pond 4  
May 25, 2011 IL50160

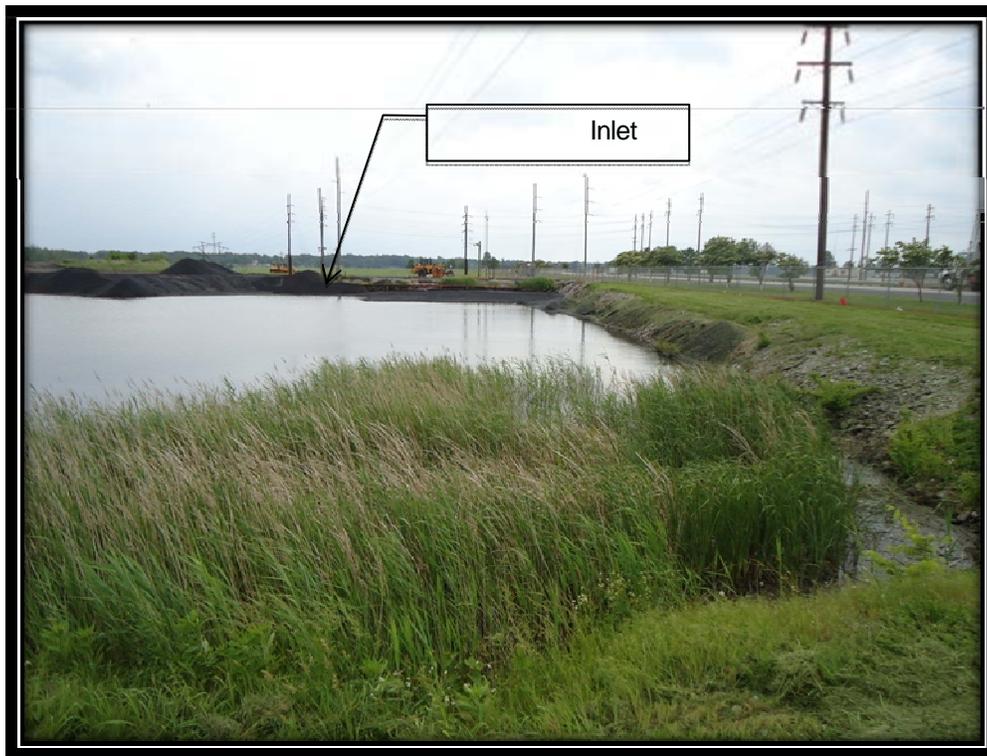
Inflow into the Pond 1 is via metal piping on the southeastern corner of the impoundment, as well as storm water runoff that flows naturally into the pond. The inlet pipe can be seen in photo 14 of Appendix B. The inlet pipe appears to be in satisfactory condition.

Photo 14 – Ash Pond 1 General Conditions Photograph (Note Inlet Sluice Pipe)  
May 25, 2011 IL50160

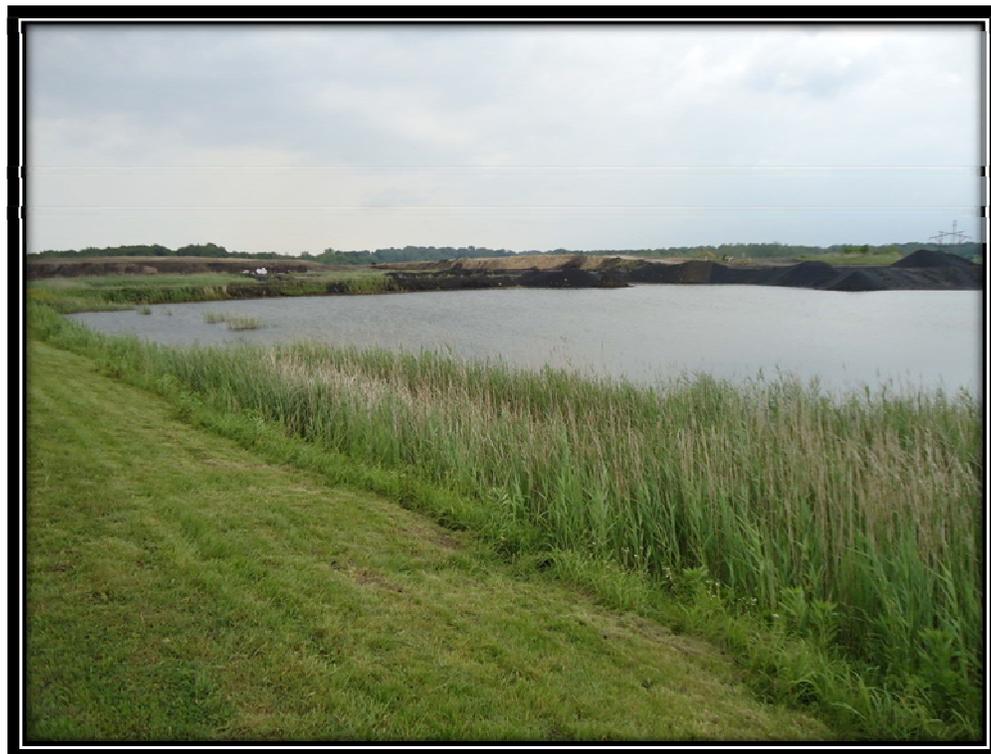
Photo 15 – Ash Pond 1 General Conditions Photograph  
May 25, 2011 IL50160

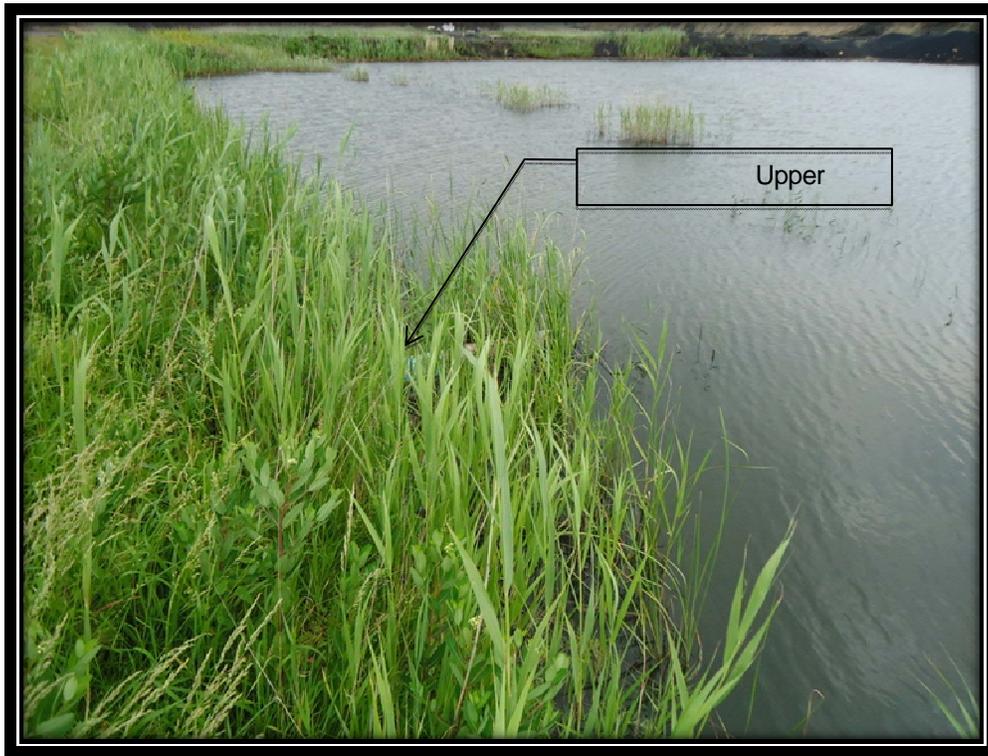
datum, or show a second discharge pipe into Pond 4. These pipes are not controlled by valves or gates and do not utilize trash racks. Photo 16 shows the condition of the outlet pipes. Specific observations include:

- The intake location of the lower outlet pipe was not able to be observed as it was inundated at the time of assessment.
- No video monitoring of the pipe was available at the time of assessment.
- Overall, the outlet works system appears to be functioning as intended at this time.

Photo 16 – Ash Pond 1 Upper Discharge Pipe into Pond 4  
May 25, 2011 IL50160

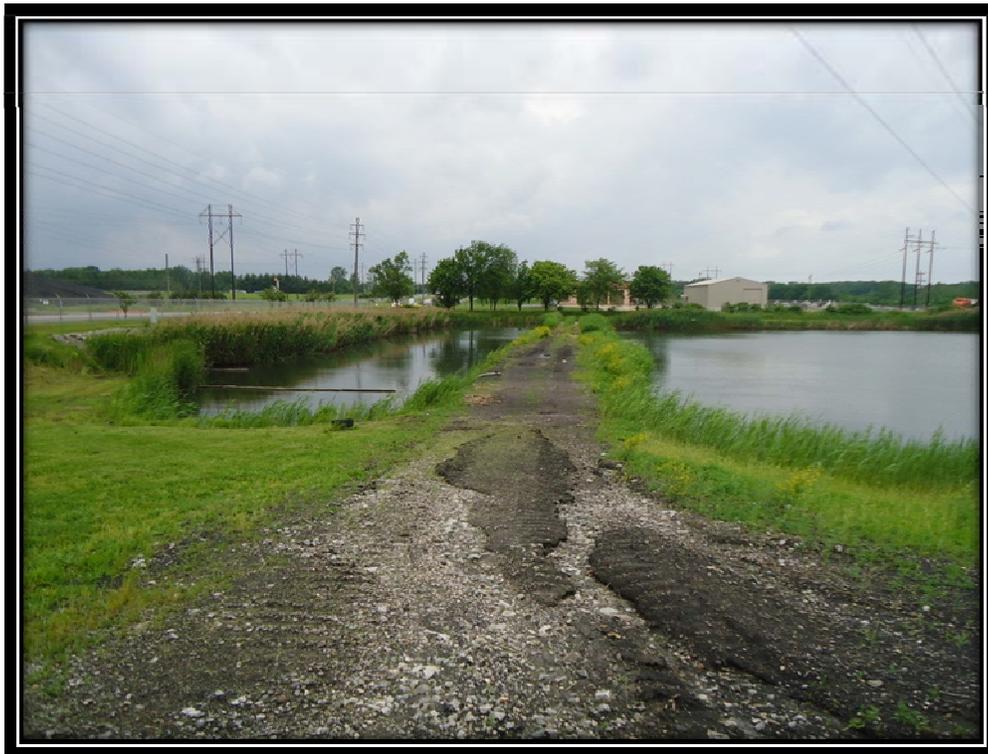
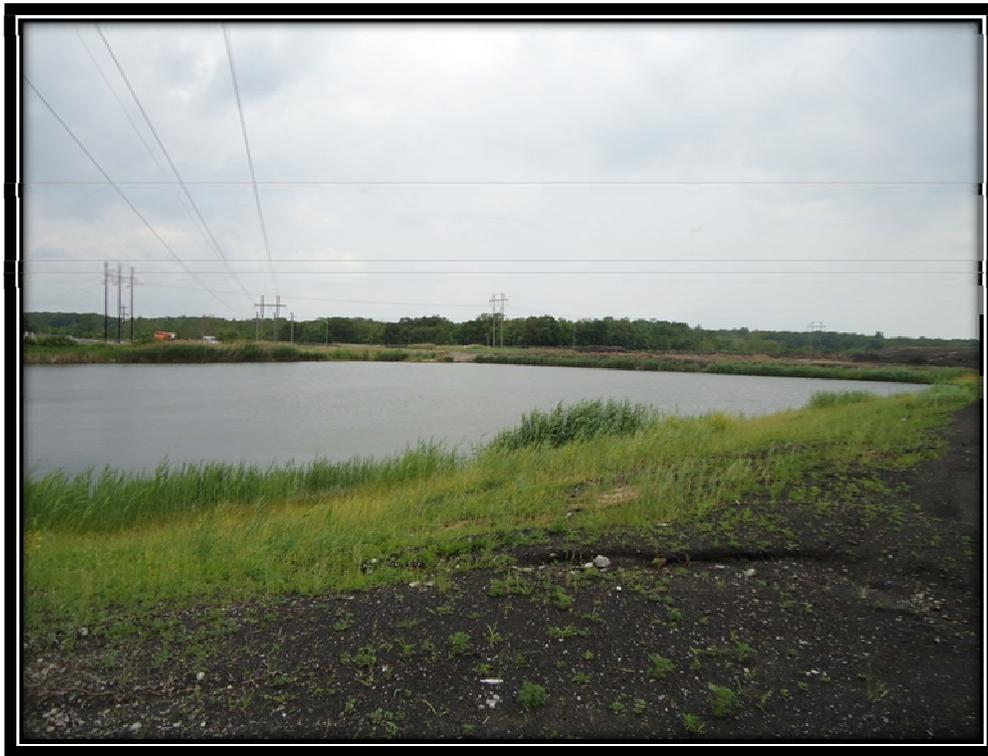
Overall, the crest of the impoundment was in satisfactory condition. Photos 17, 18 and 22 show the condition of the crest. Specific observations include:

- The impoundment crest is an access road.
- Well established grasses were observed on the crest.
- No major depressions or rutting was noted on the impoundment crest.

Photo 17 – Pond 4 General Conditions Photograph  
May 25, 2011 IL50160

Photo 18 – Pond 4 General Conditions Photograph  
May 25, 2011 IL50160

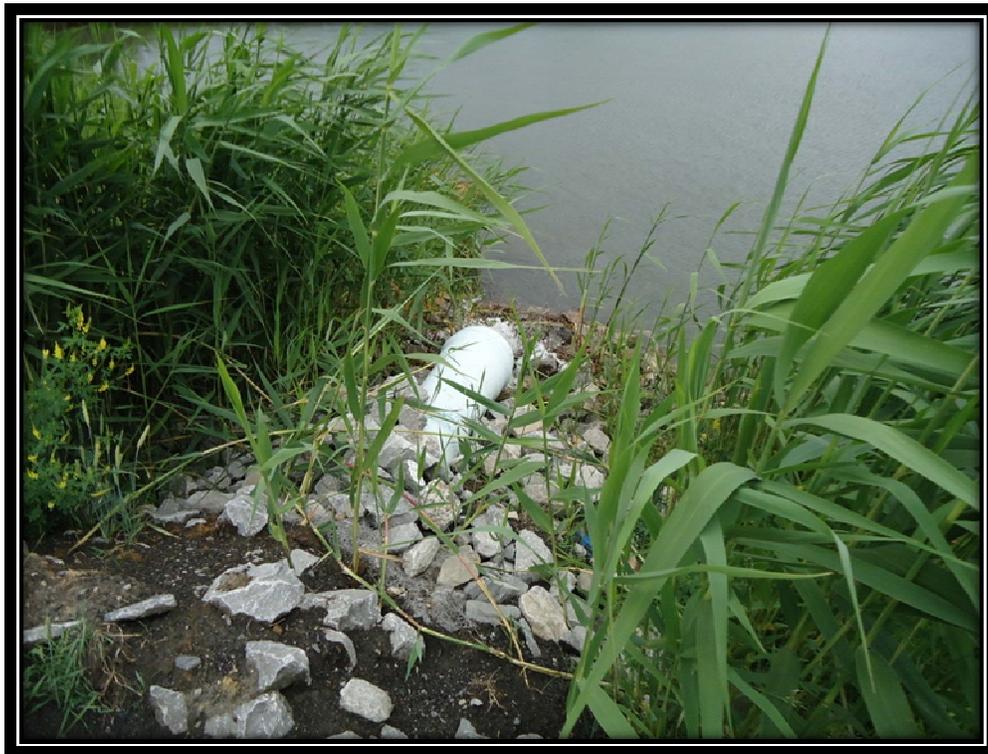
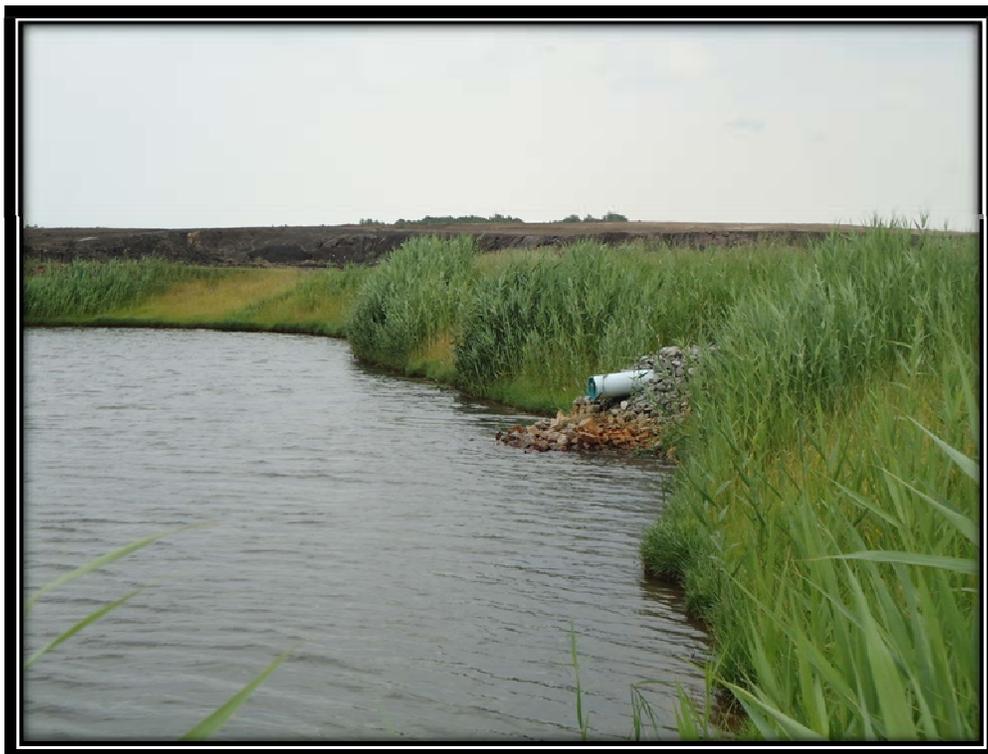
Inflow into Pond 4 is via multiple inlet pipes on the east side of the pond from Ponds 1 and 2, as well as inlet pipes on the west side of the pond from Pond S-6. In addition, storm water runoff flows naturally into the pond from a relatively small drainage basin. Pipes that inlet into Pond 4 are surrounded by riprap to prevent erosion from their discharge. The inlet pipes appeared to be in functional condition. Photos 20 and 21 show the condition of the inlet pipes.

Photo 20 – Discharge Pipe from Ash Pond 1 into Pond 4  
May 25, 2011 IL50160

Photo 21 – Discharge Pipe from Ash Pond 2 into Pond 4  
May 25, 2011 IL50160

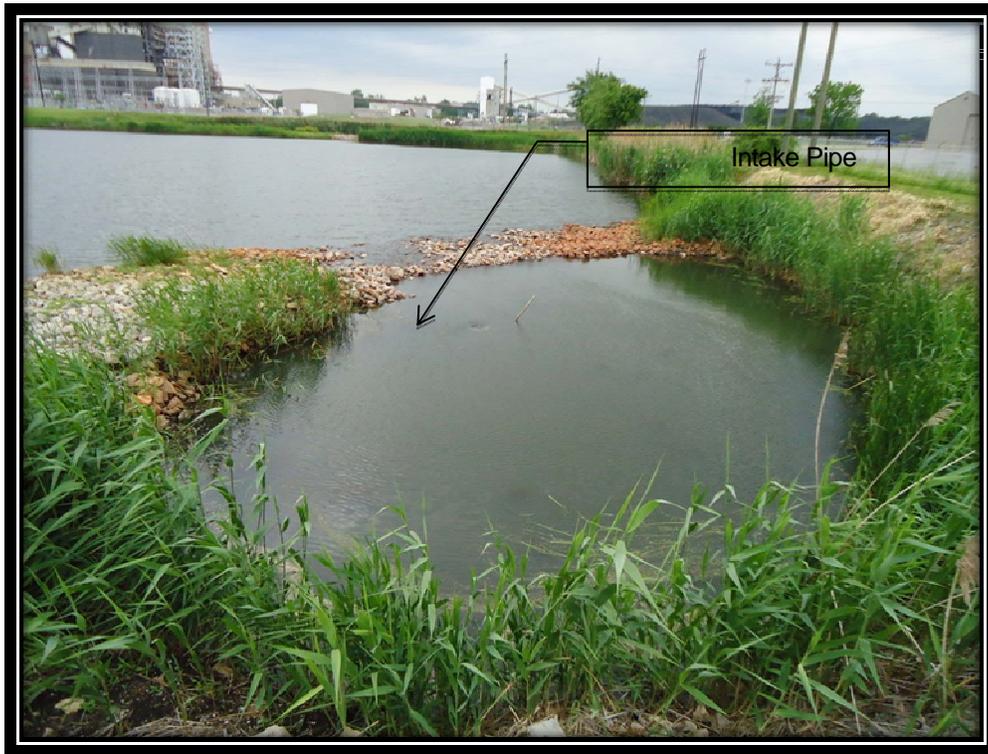
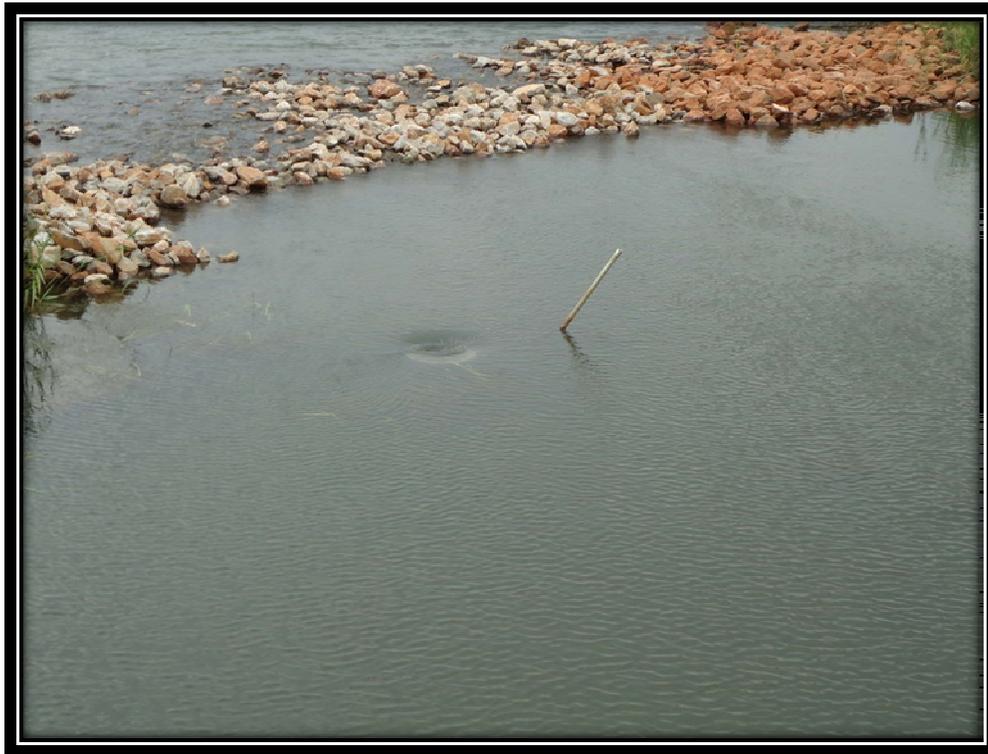
The outlet works consist of a vertical intake pipe that is located near the northwestern corner of the impoundment, approximately 25 feet toward the center of the pond. At the time of assessment, the intake pipe was inundated, and its size and type could not be confirmed. Photos 22 and 23 show the condition of the outlet pipe. Specific observations include:

- The discharge location of the outlet pipe was not able to be observed as it was inundated at the time of assessment.
- No video monitoring of the pipe was available at the time of assessment.
- Overall, the outlet works system appeared to be functioning as intended at the time of assessment.

Photo 22 – Intake from Pond 4 to Outlet Structure  
May 25, 2011 IL50160

Photo 23 – Intake from Pond 4 to Outlet Structure (note submerged pipe)  
May 25, 2011 IL50160

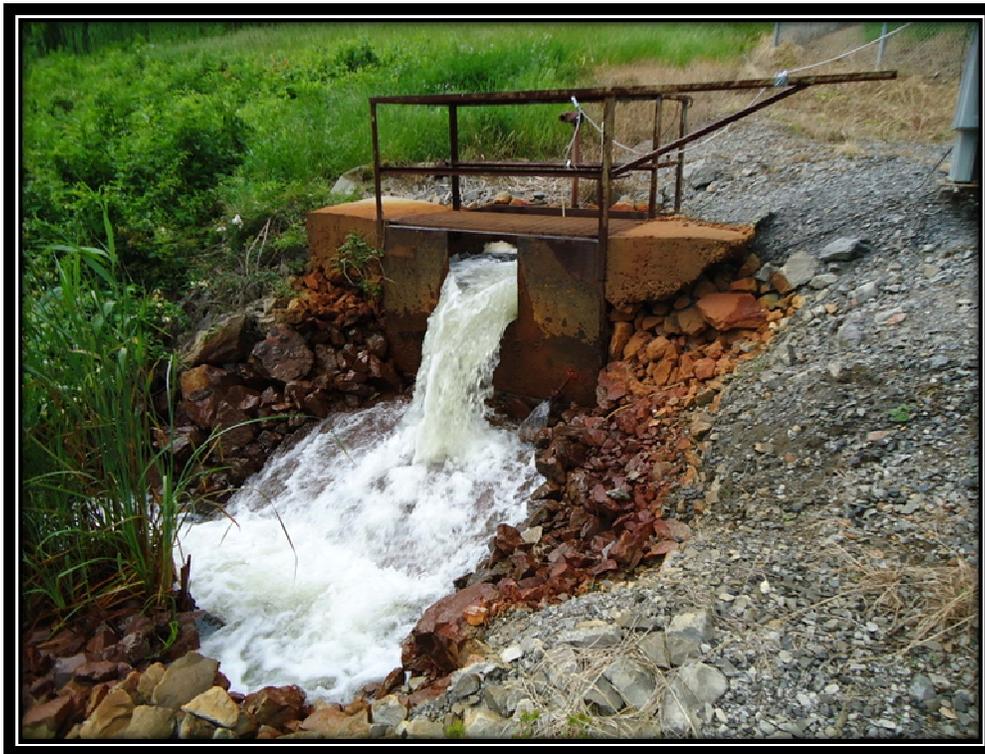
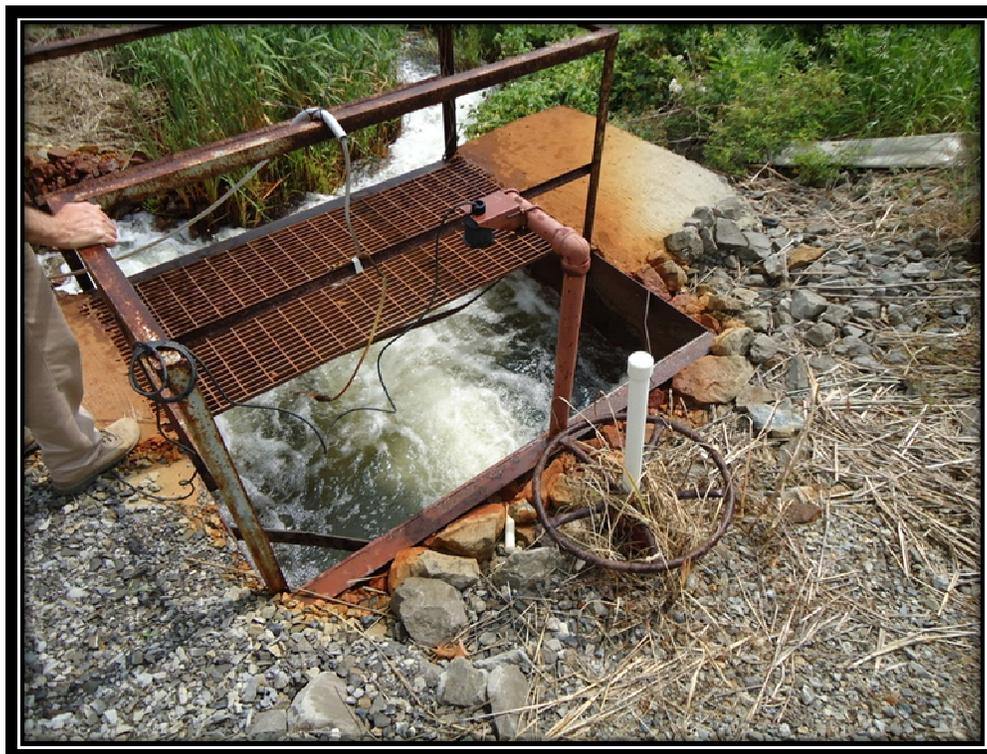
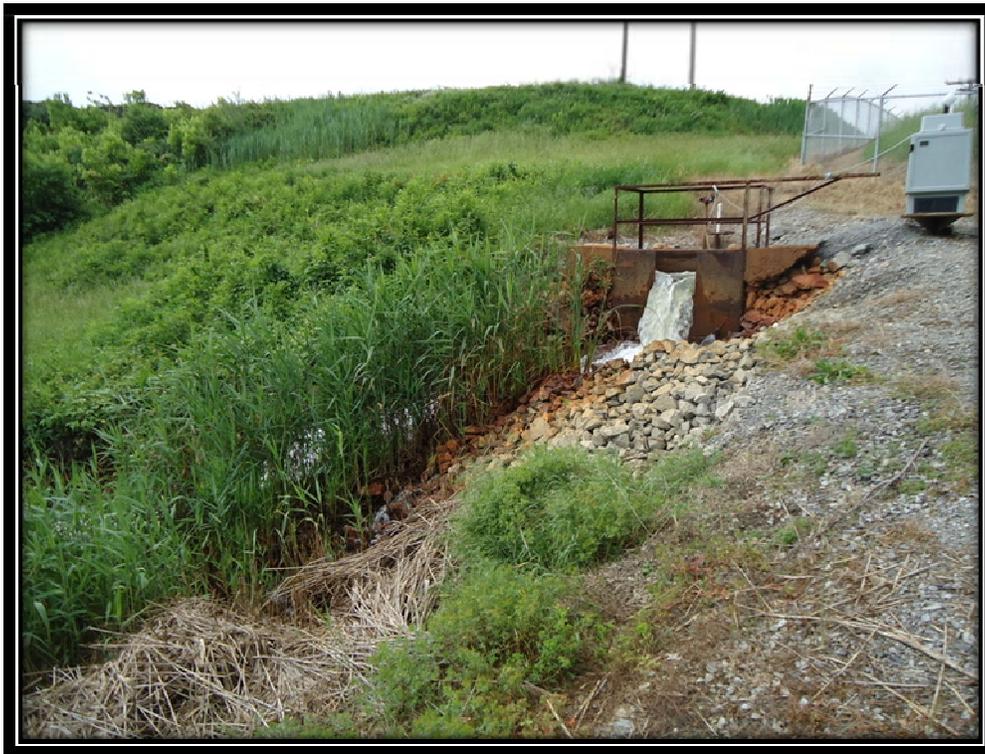
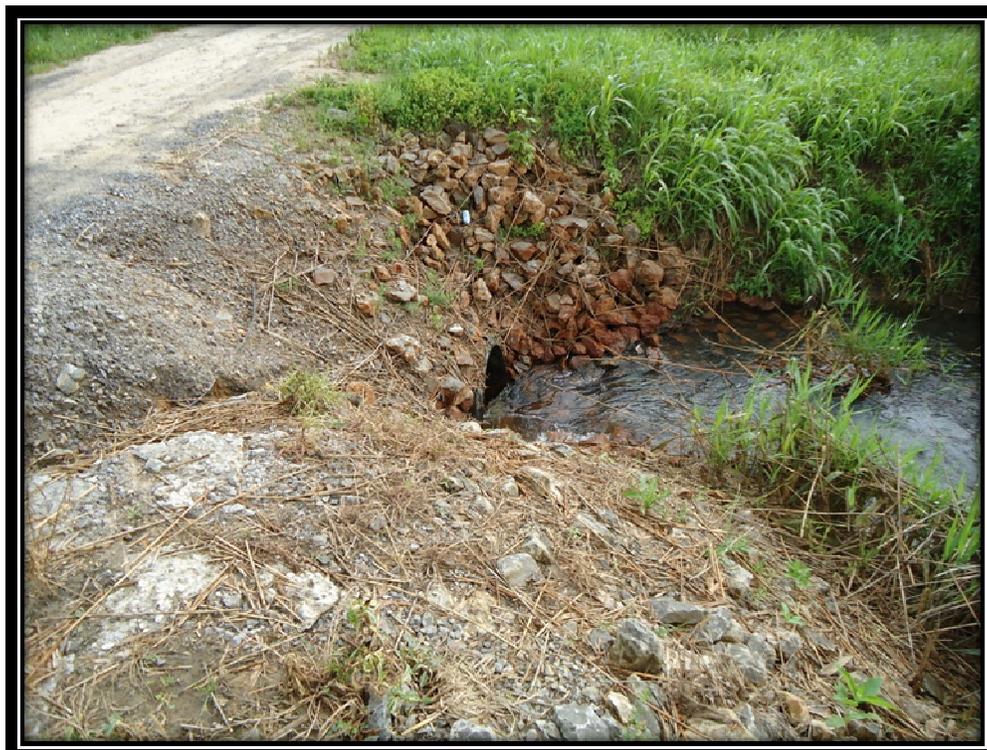
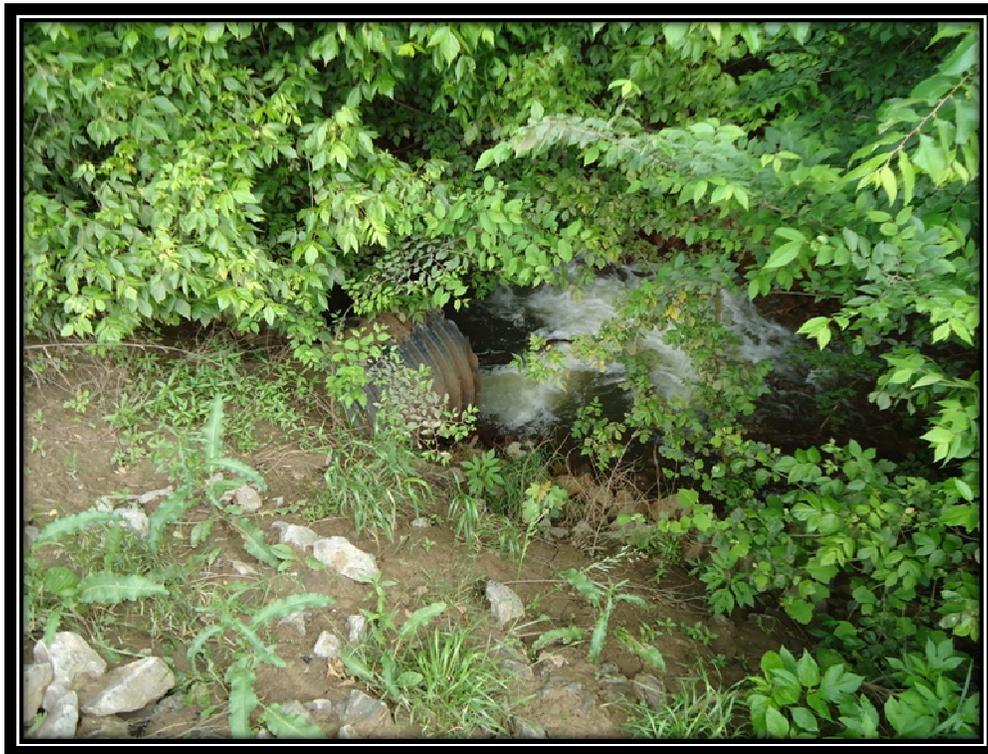
The outlet structure at the outfall location is comprised of concrete and steel in addition to a sluice gate used to control flow. This structure then discharges water into a riprap lined channel that outlets into the Little Saline Creek. The concrete that is part of this structure is free from major spalling or cracking, and the steel portions of the structure are weathered but in fair condition. Material has eroded from under the concrete access path for this structure, but it appears that access to the structure has not been affected by the erosion. Overall, the structure appeared to be functioning as intended. Photos 24 through 28 show the condition of the structure and its associated components.

Photo 24 – Outlet Structure from Ash Pond 4  
May 25, 2011 IL50160

Photo 25 – Outlet Structure from Ash Pond 4  
May 25, 2011 IL50160

Photo 26 – Outlet Structure from Ash Pond 4  
May 25, 2011 IL50160

Photo 27 – Corrugated Metal Pipe under Access Road Leading to Outfall Downstream of Pond 4  
May 25, 2011 IL50160

Photo 28 – Corrugated Metal Pipe Outfall from Ash Ponds to the South Fork of Little Saline Creek  
May 25, 2011 IL50160

1. Prepare an Emergency Action Plan (EAP) for the impoundments.
2. Perform video assessments of culvert piping.
3. Perform repairs to the eroded soil and riprap under the catwalk foundation at the Little Saline Creek outfall.

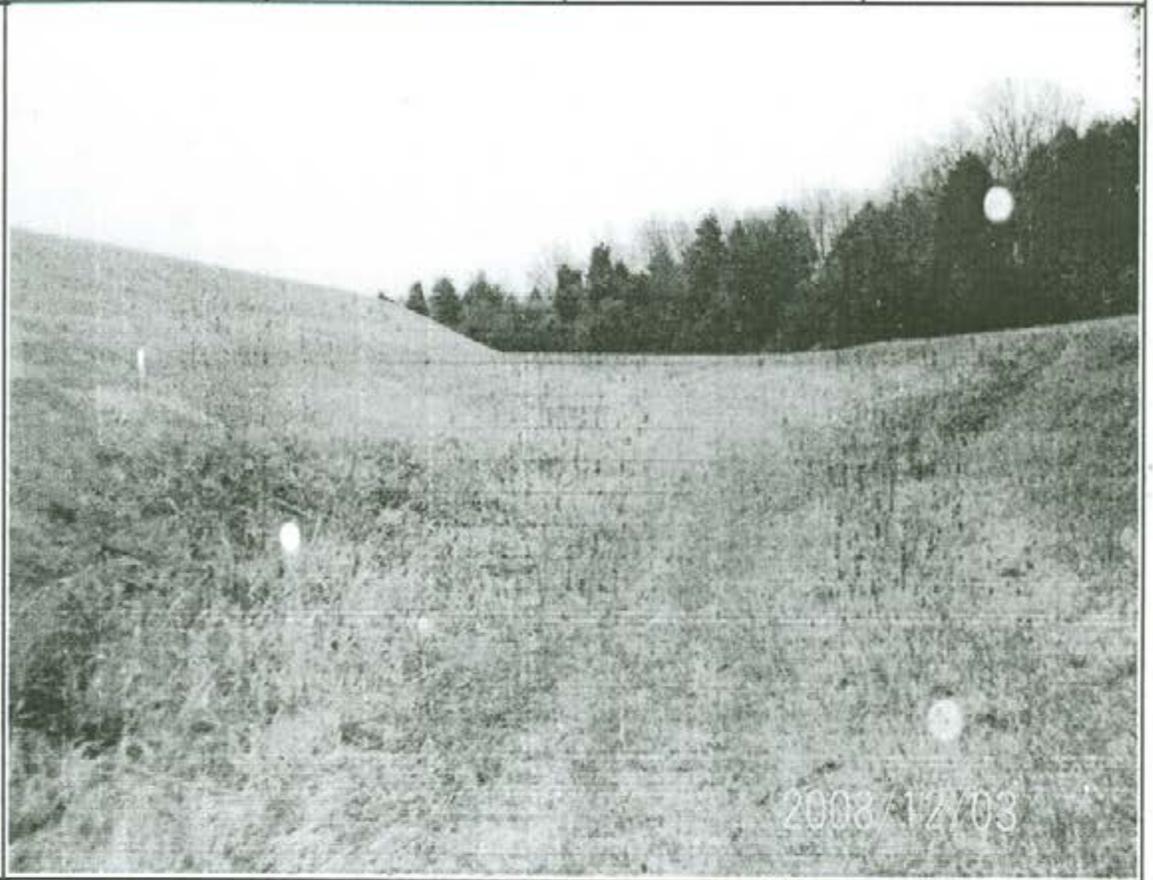
Looking at area needing  
grading.

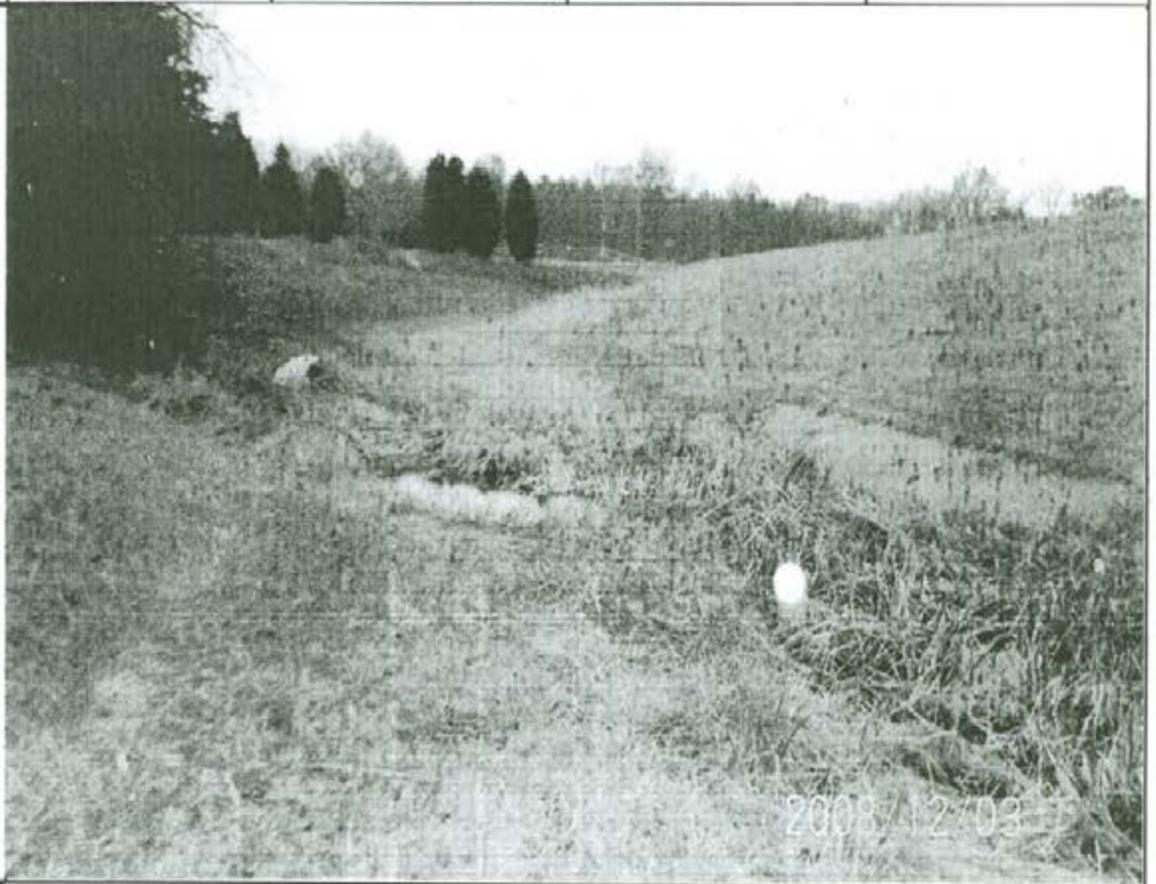
Looking west at area  
needing grading
