**COAL ASH IMPOUNDMENT
SITE ASSESSMENT FINAL REPORT**

**Marion Power Station
Southern Illinois Power Cooperative
Marion, Illinois**

KLEINFELDER PROJECT NUMBER 118953-5

February 28, 2013

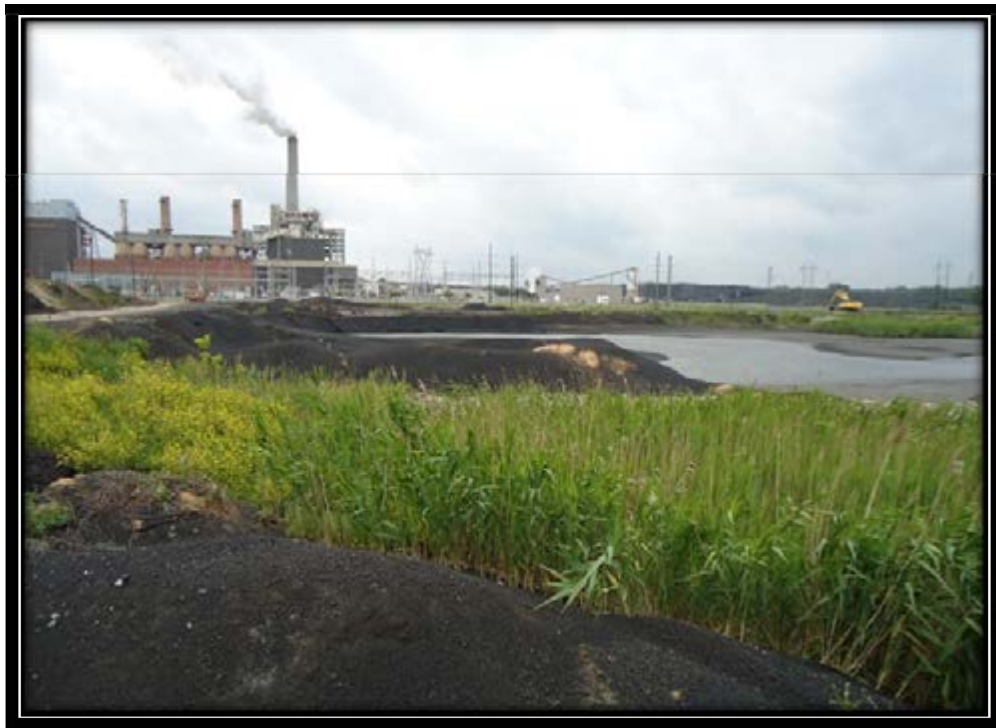
Photo 7 – Ash Pond 2 General Conditions Photograph
May 25, 2011 IL50160

Overall, the upstream slope of the impoundment was in fair condition. Photos 7-10 in Appendix B show the condition of the upstream slope. Specific observations include:

Overall, the crest of the impoundment was in satisfactory condition. Photos 7 and 8 show the condition of the crest. Specific observations include:

- The impoundment crest is an access road.
- Sparse grasses and bushes were observed on the crest.
- No major depressions or rutting was noted on the impoundment crest.

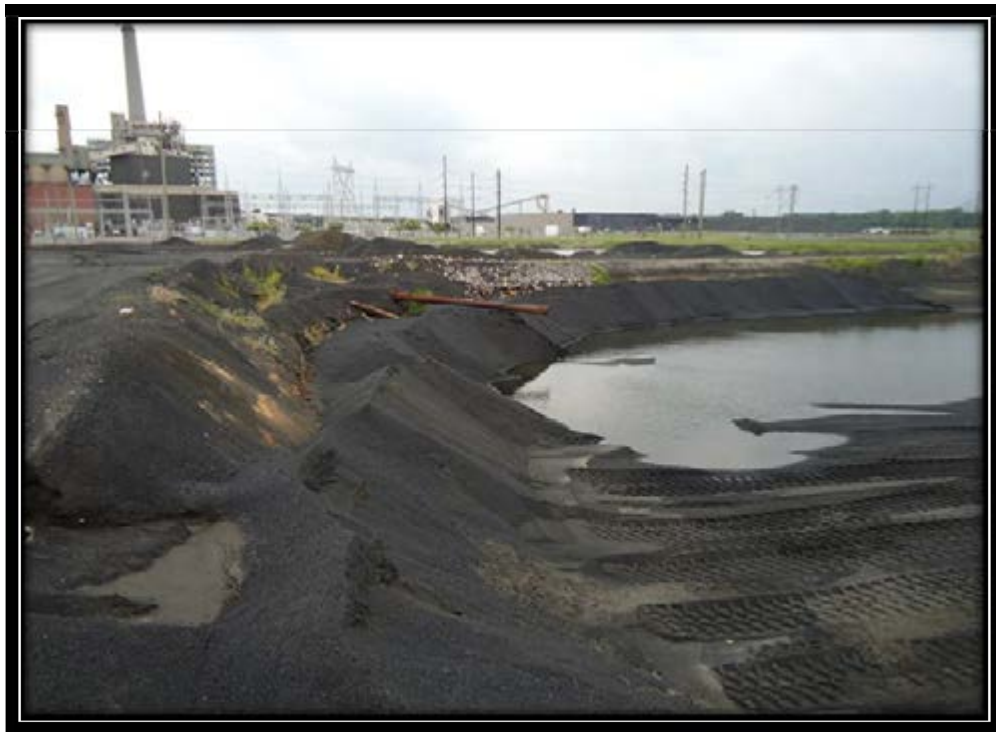
Inflow into the Pond 2 is via metal piping on the southeastern corner of the impoundment, as well as storm water runoff that flows naturally into the pond. The inlet pipe can be seen in photos 9 and 10 of Appendix B. The inlet pipe appears to be in satisfactory condition.

Photo 9 – Ash Pond 2 Inlet Sluice Pipe

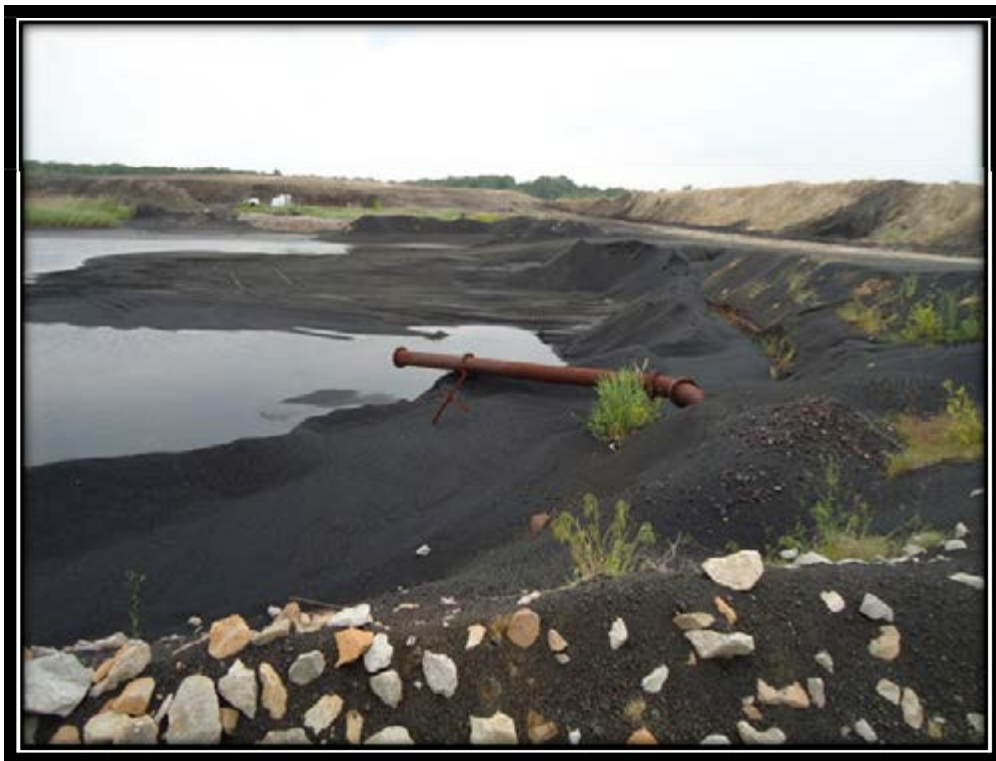
Photo 10 – Ash Pond 2 Inlet Sluice Pipe

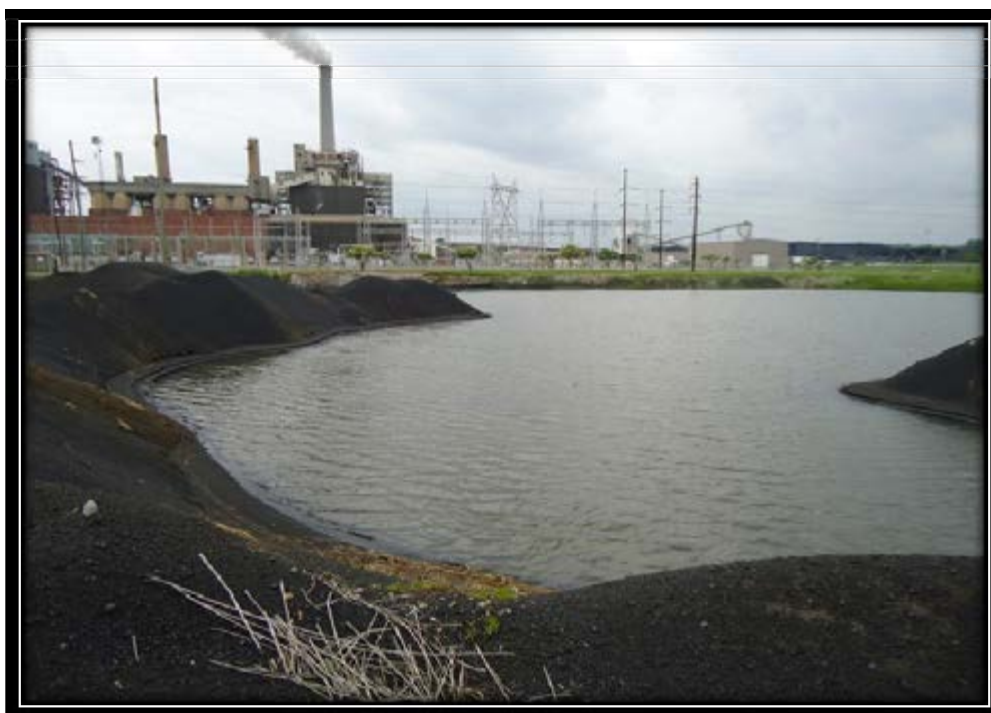
Photo 11 – Ash Pond 1 General Conditions Photograph

Overall, the upstream slope of the impoundment was in fair condition. Photos 11, 12, 14 and 15 in Appendix B show the conditions of the upstream slope. Figure 4 displays the location of where these photographs were taken during the assessment. Specific observations include:

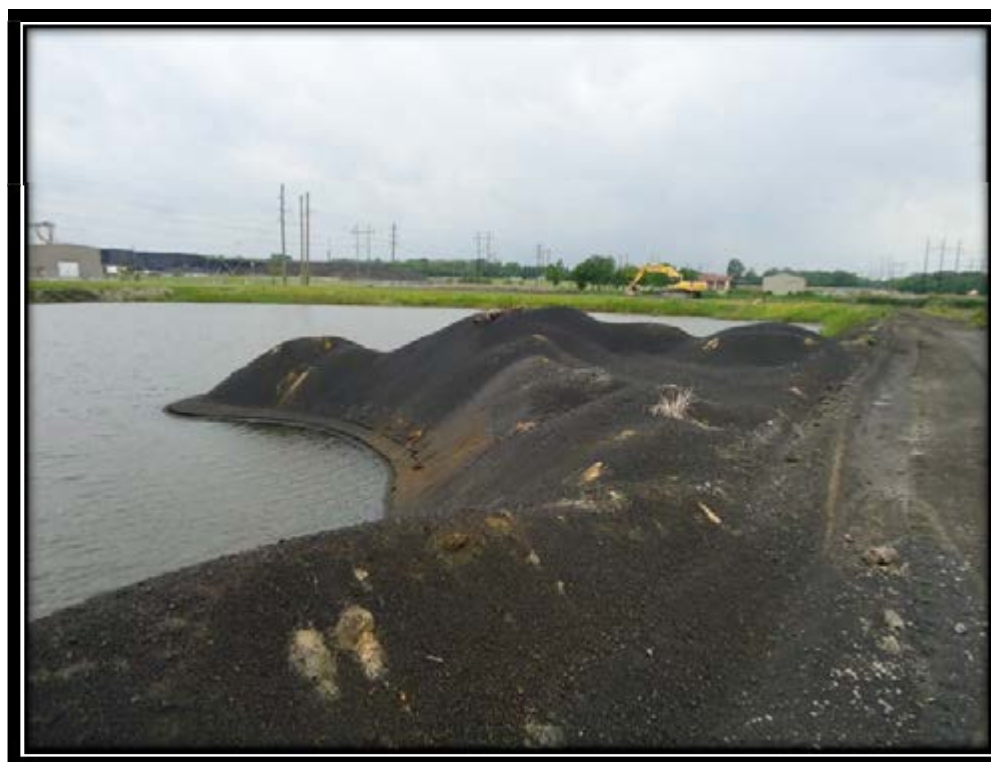
Photo 12 – Ash Pond 1 General Conditions Photograph

Overall, the crest of the impoundment was in satisfactory condition. Photos 12 and 15 show the condition of the crest. Specific observations include:

- Sparse grasses and bushes were observed on the crest.
- Well established sod was properly maintained on the southern and western portions of the pond.
- No major depressions or rutting was noted on the impoundment crest.

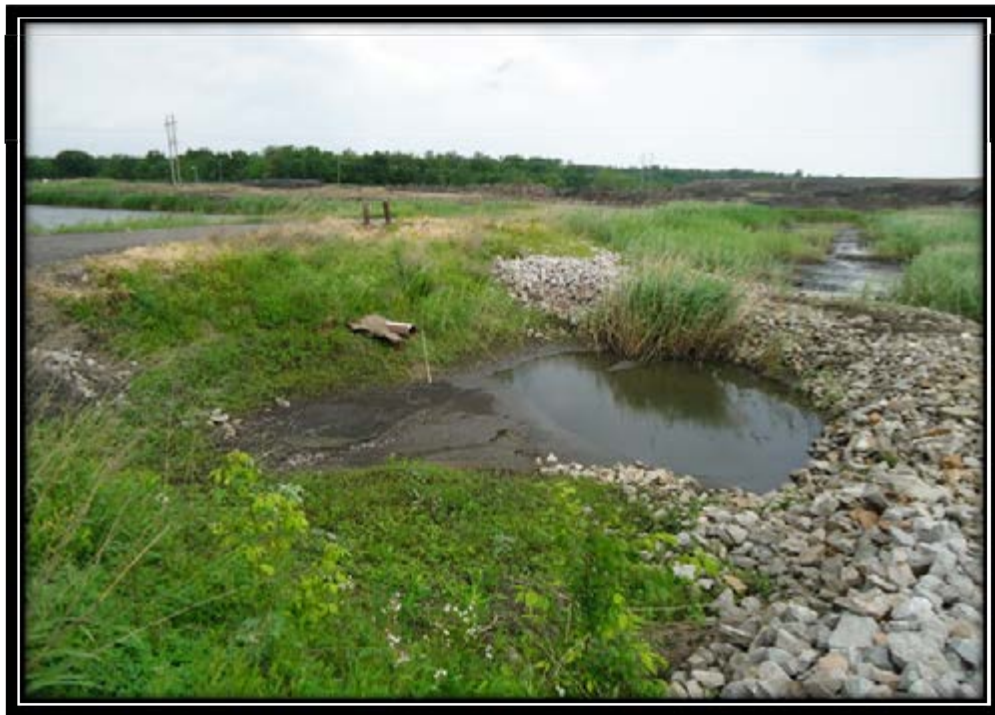
The outlet works of Pond 2 consist of a single pipe penetration through the western portion of the pond that outlets into Pond 4. This pipe is located near the southwestern corner of the pond. The elevation of this pipe could not be confirmed as there was no recent survey information available at the time of assessment. In addition, the as built drawings did not reference a specific vertical datum. This pipe is not controlled and does not utilize a trash rack. Photo 13 shows the condition of the outlet pipe. Specific observations include:

Photo 13 – Ash Pond 2 Discharge Pipe into Ash Pond 4
May 25, 2011 IL50160

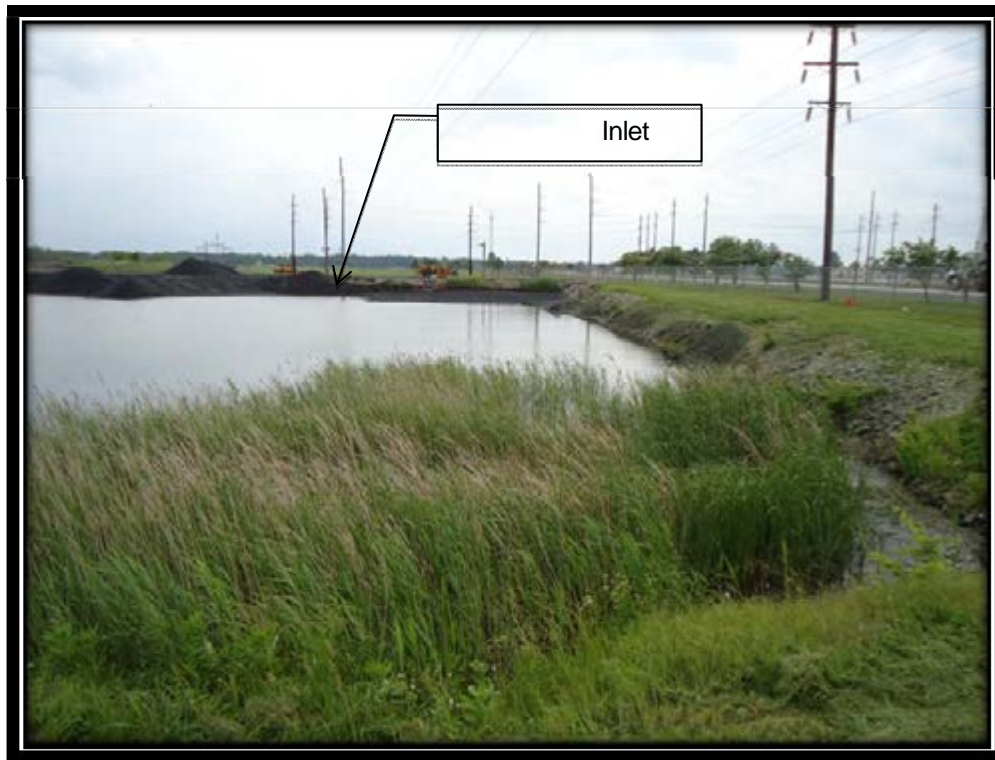
Inflow into the Pond 1 is via metal piping on the southeastern corner of the impoundment, as well as storm water runoff that flows naturally into the pond. The inlet pipe can be seen in photo 14 of Appendix B. The inlet pipe appears to be in satisfactory condition.

Photo 14 – Ash Pond 1 General Conditions Photograph (Note Inlet Sluice Pipe)
May 25, 2011 IL50160

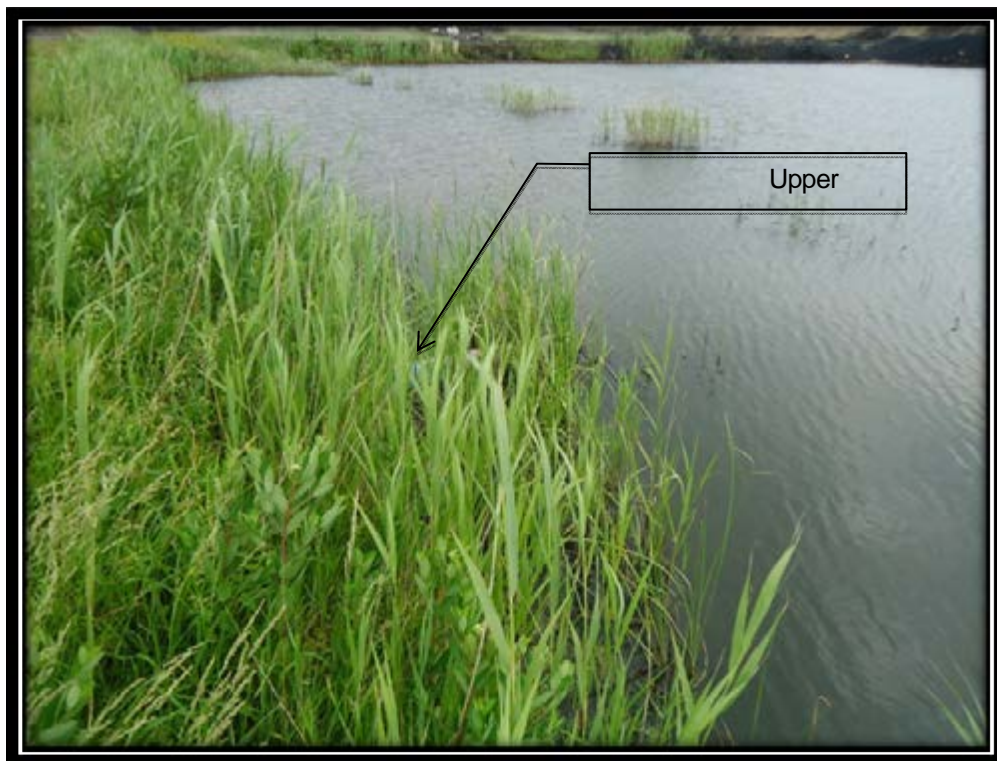
The outlet works of Pond 1 consist of two pipe penetrations through the western portion of the pond that outlet into Pond 4. These pipes are located in the same location but at different elevations. The elevations of these pipes could not be confirmed as there was no recent survey information available at the time of assessment. In addition, the as built drawings did not reference a specific vertical datum, or show a second discharge pipe into Pond 4. These pipes are not controlled by valves or gates and do not utilize trash racks. Photo 16 shows the condition of the outlet pipes. Specific observations include:

- The intake location of the lower outlet pipe was not able to be observed as it was inundated at the time of assessment.
- No video monitoring of the pipe was available at the time of assessment.
- Overall, the outlet works system appears to be functioning as intended at this time.

Photo 16 – Ash Pond 1 Upper Discharge Pipe into Pond 4

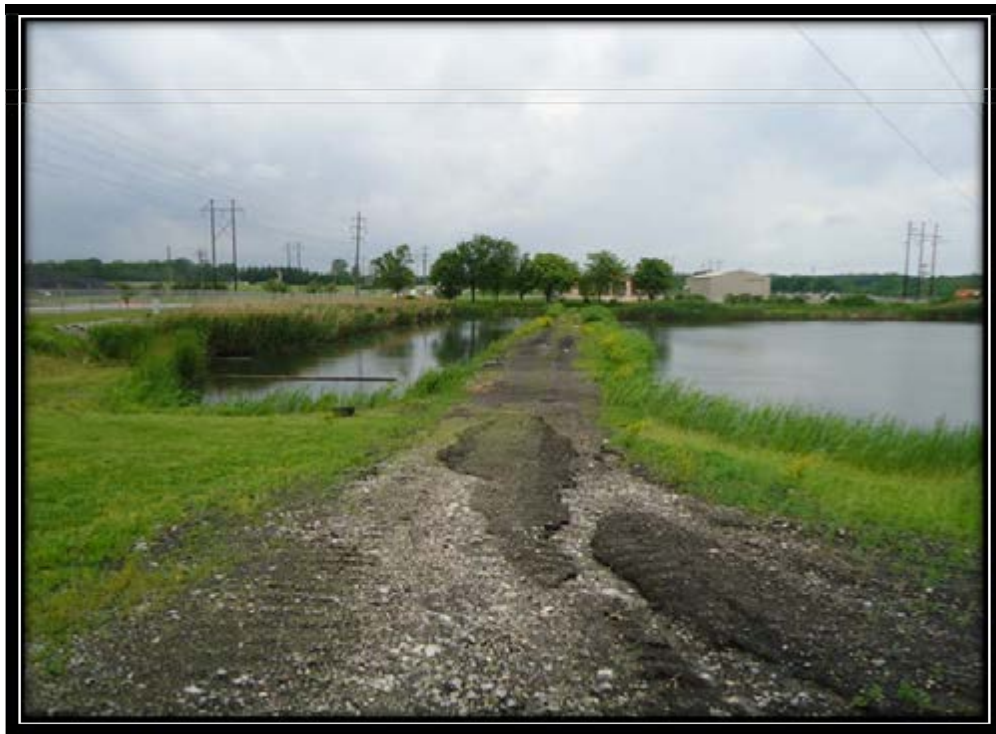
Photo 17 – Pond 4 General Conditions Photograph

Overall, the crest of the impoundment was in satisfactory condition. Photos 17, 18 and 22 show the condition of the crest. Specific observations include:

- The impoundment crest is an access road.
- Well established grasses were observed on the crest.
- No major depressions or rutting was noted on the impoundment crest.
- Mowing operations had taken place around the majority of the crest.

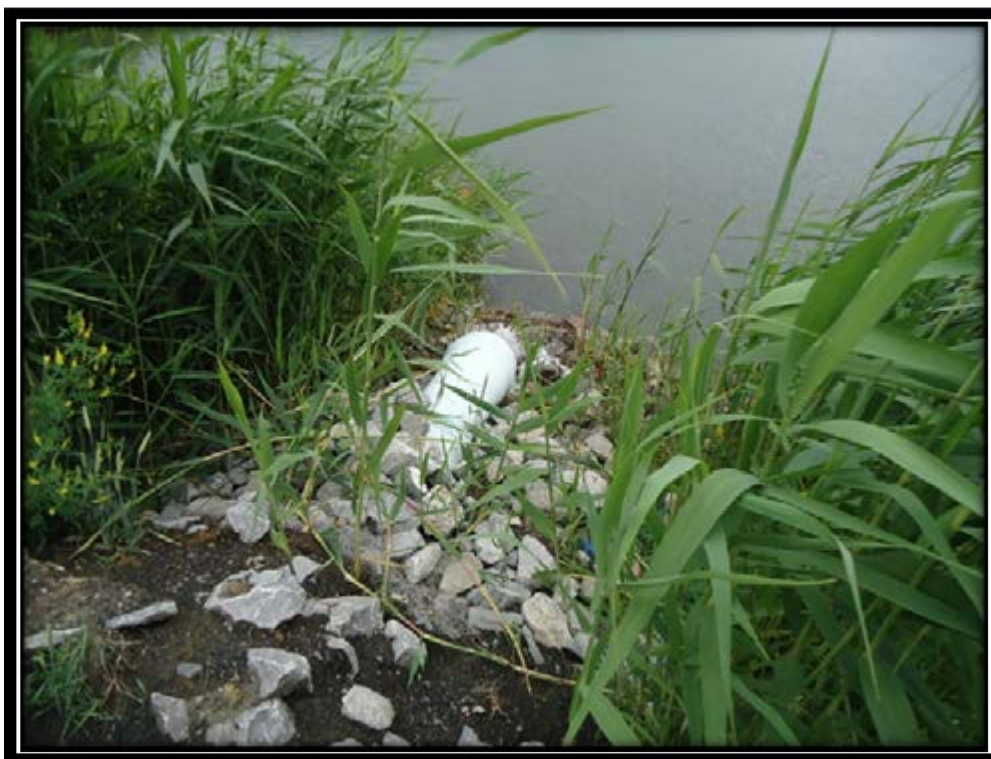
Inflow into Pond 4 is via multiple inlet pipes on the east side of the pond from Ponds 1 and 2, as well as inlet pipes on the west side of the pond from Pond S-6. In addition, storm water runoff flows naturally into the pond from a relatively small drainage basin. Pipes that inlet into Pond 4 are surrounded by riprap to prevent erosion from their discharge. The inlet pipes appeared to be in functional condition. Photos 20 and 21 show the condition of the inlet pipes.

Photo 20 – Discharge Pipe from Ash Pond 1 into Pond 4
May 25, 2011 IL50160

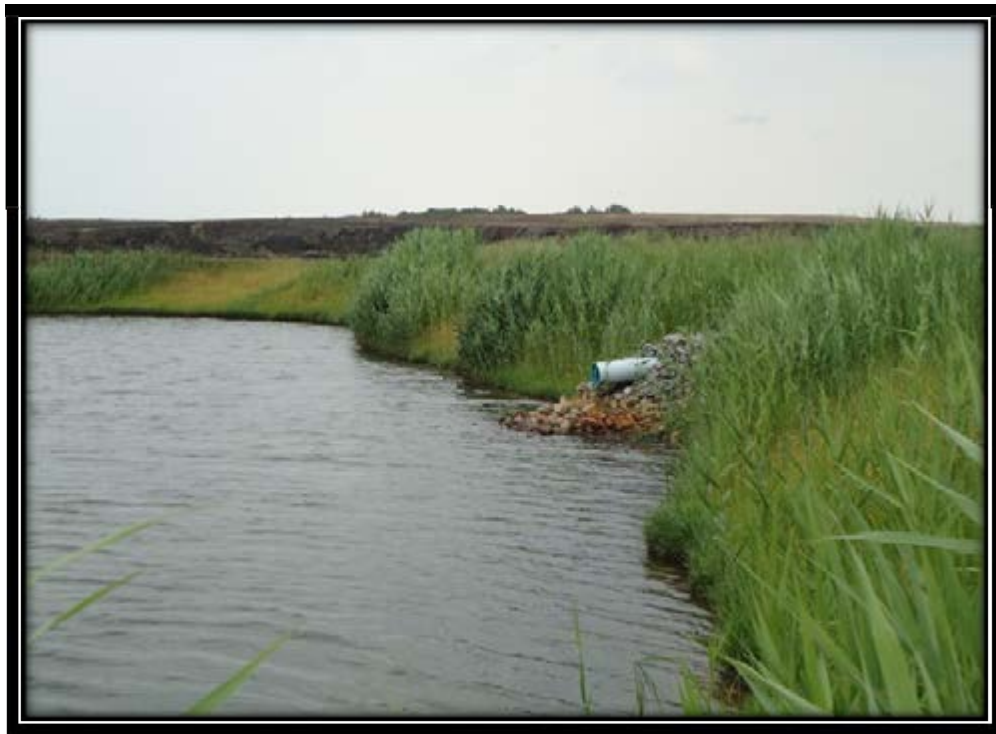
Overall, the upstream slope of the impoundment was in satisfactory condition. Photos 21 and 22 in Appendix B show the conditions of the upstream slope. Specific observations include:

- The upstream slope was laid back at approximately 2.5H:1V.
- Mowing had not been completed on the majority of the upstream slope.
- Grasses, bushes and woody debris were observed on the slope.

Photo 21 – Discharge Pipe from Ash Pond 2 into Pond 4

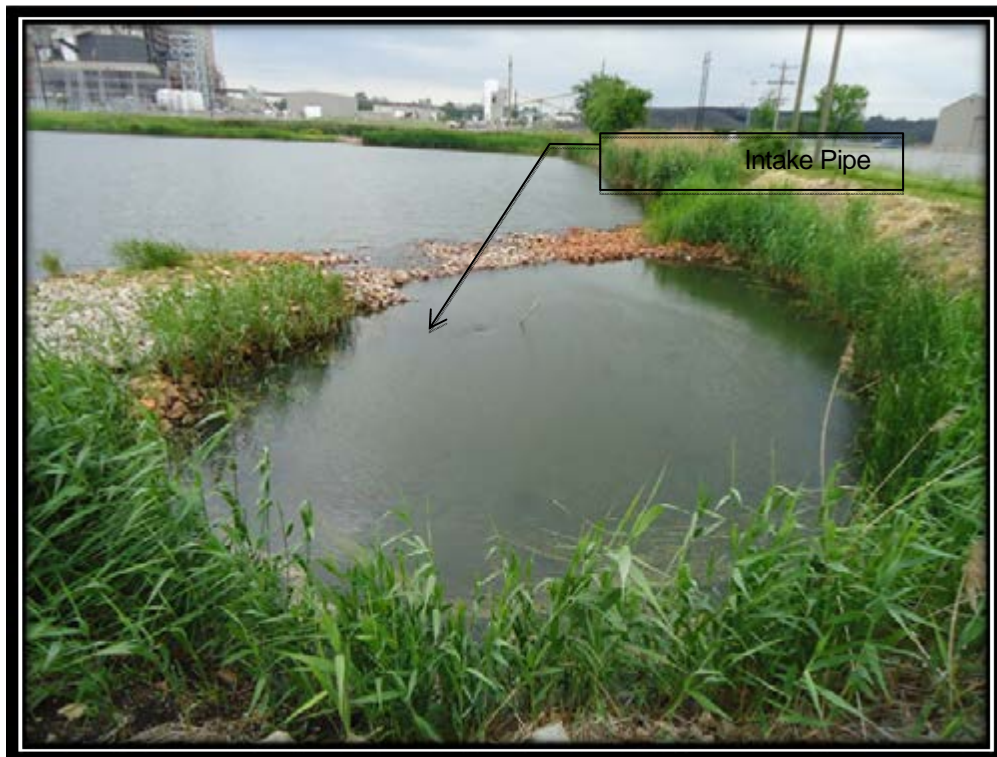
The outlet works consist of a vertical intake pipe that is located near the northwestern corner of the impoundment, approximately 25 feet toward the center of the pond. At the time of assessment, the intake pipe was inundated, and its size and type could not be confirmed. Photos 22 and 23 show the condition of the outlet pipe. Specific observations include:

- The discharge location of the outlet pipe was not able to be observed as it was inundated at the time of assessment.
- No video monitoring of the pipe was available at the time of assessment.
- Overall, the outlet works system appeared to be functioning as intended at the time of assessment.

Photo 22 – Intake from Pond 4 to Outlet Structure

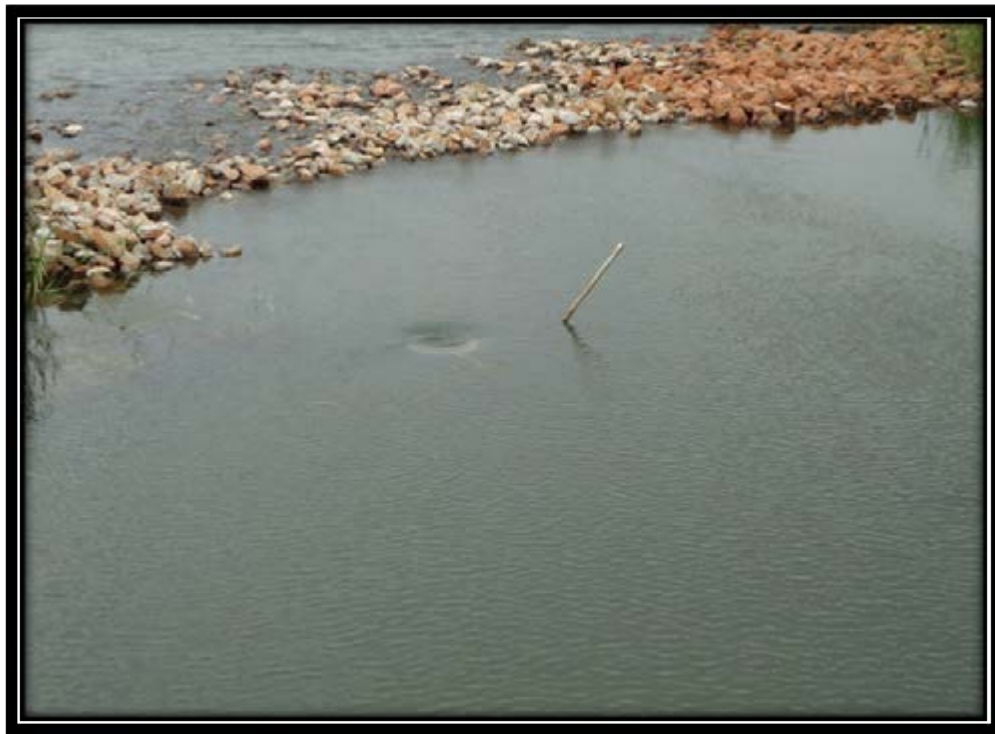
Photo 23 – Intake from Pond 4 to Outlet Structure (note submerged pipe)
May 25, 2011 IL50160

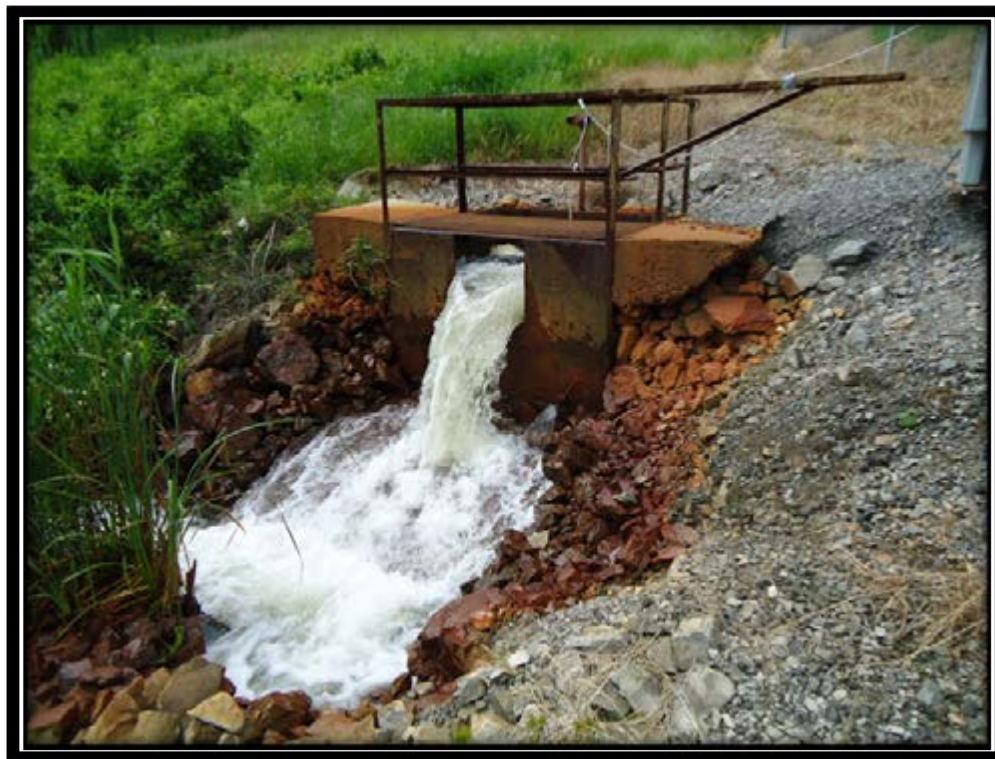
The outlet structure at the outfall location is comprised of concrete and steel in addition to a sluice gate used to control flow. This structure then discharges water into a riprap lined channel that outlets into the Little Saline Creek. The concrete that is part of this structure is free from major spalling or cracking, and the steel portions of the structure are weathered but in fair condition. Material has eroded from under the concrete access path for this structure, but it appears that access to the structure has not been affected by the erosion. Overall, the structure appeared to be functioning as intended. Photos 24 through 28 show the condition of the structure and its associated components.

Photo 24 – Outlet Structure from Ash Pond 4
May 25, 2011 IL50160

1. **Perform repairs to the eroded soil and riprap under the catwalk foundation at the Little Saline Creek outfall by 8/31/2013 (see Photo 24).**
2. **Perform a stability analysis of the impoundment embankments by 08/31/2013, including static and seismic loading conditions, use of representative soil characteristics obtained by soil sampling, and a liquefaction potential analysis if a qualitative analysis of representative soil sampling warrants such potential analysis.**
3. **Complete a hydrologic and hydraulic analysis for the site, including an overtopping analysis, by 08/31/2013.**

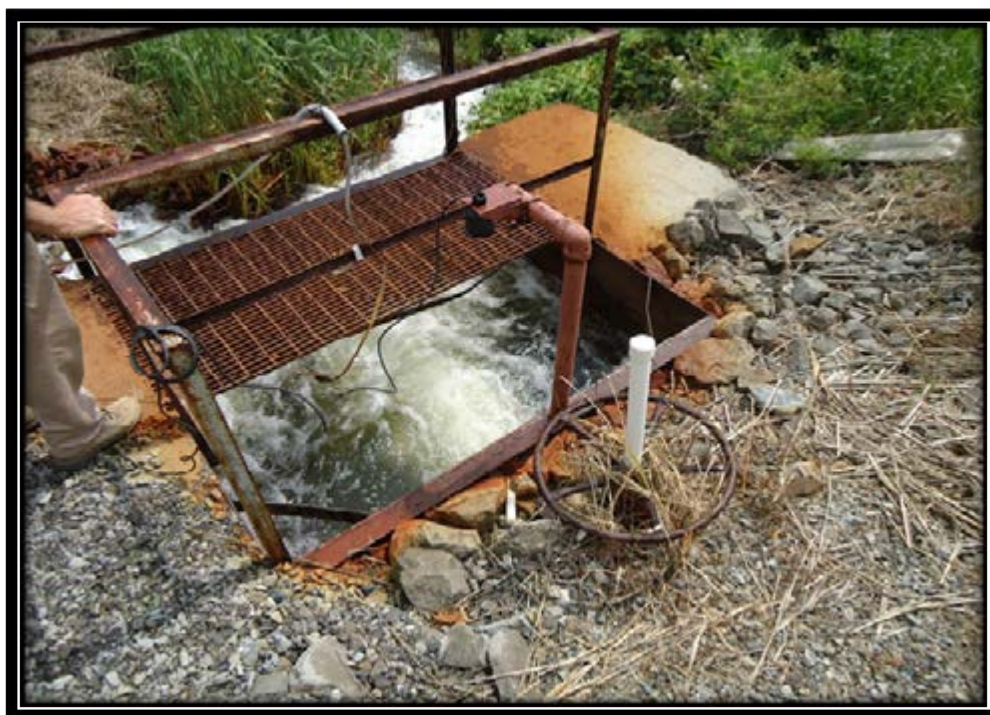
Photo 25 – Outlet Structure from Ash Pond 4

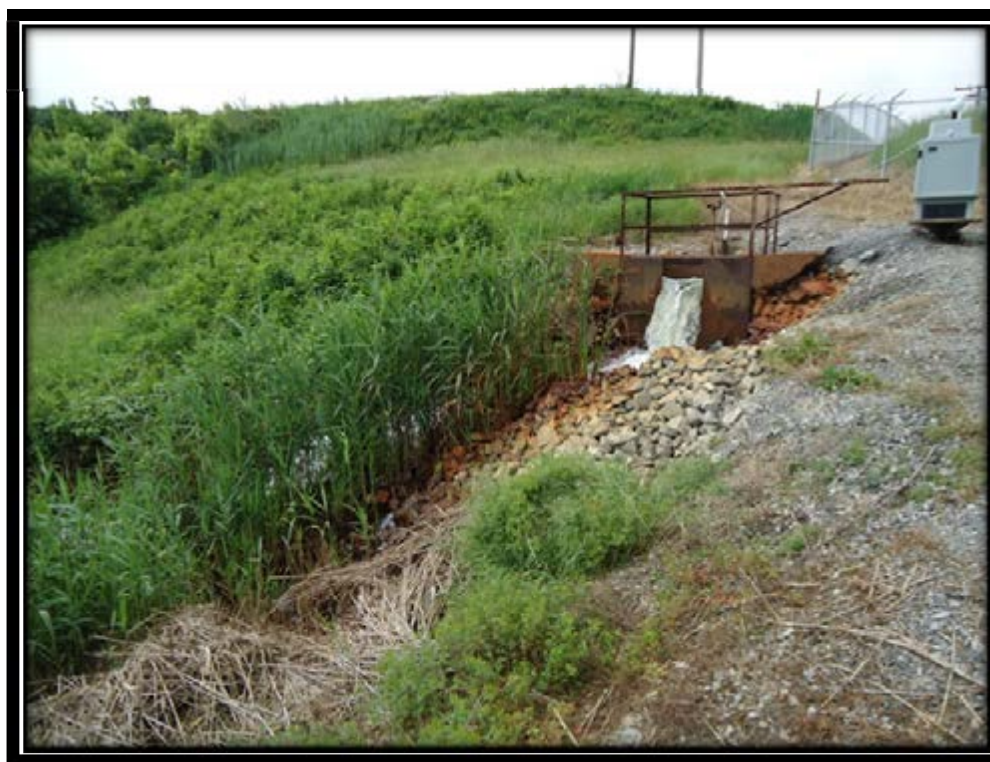
Photo 26 – Outlet Structure from Ash Pond 4

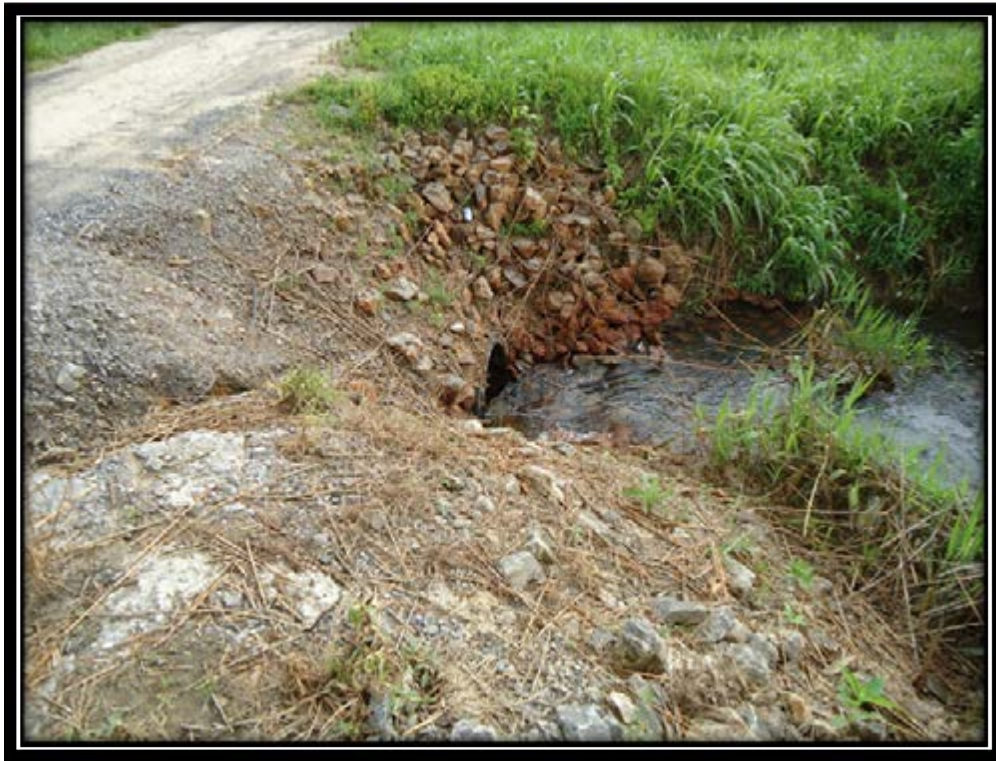
Photo 27 – Corrugated Metal Pipe under Access Road Leading to Outfall Downstream of Pond 4
May 25, 2011 IL50160

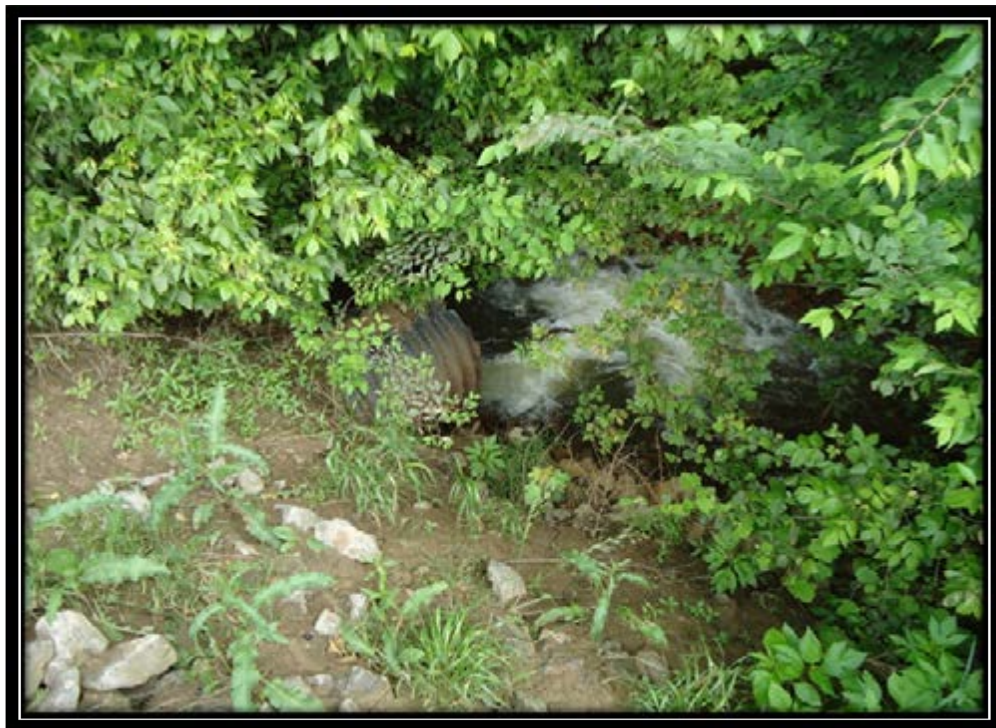
Photo 28 – Corrugated Metal Pipe Outfall from Ash Ponds to the South Fork of Little Saline Creek
May 25, 2011 IL50160

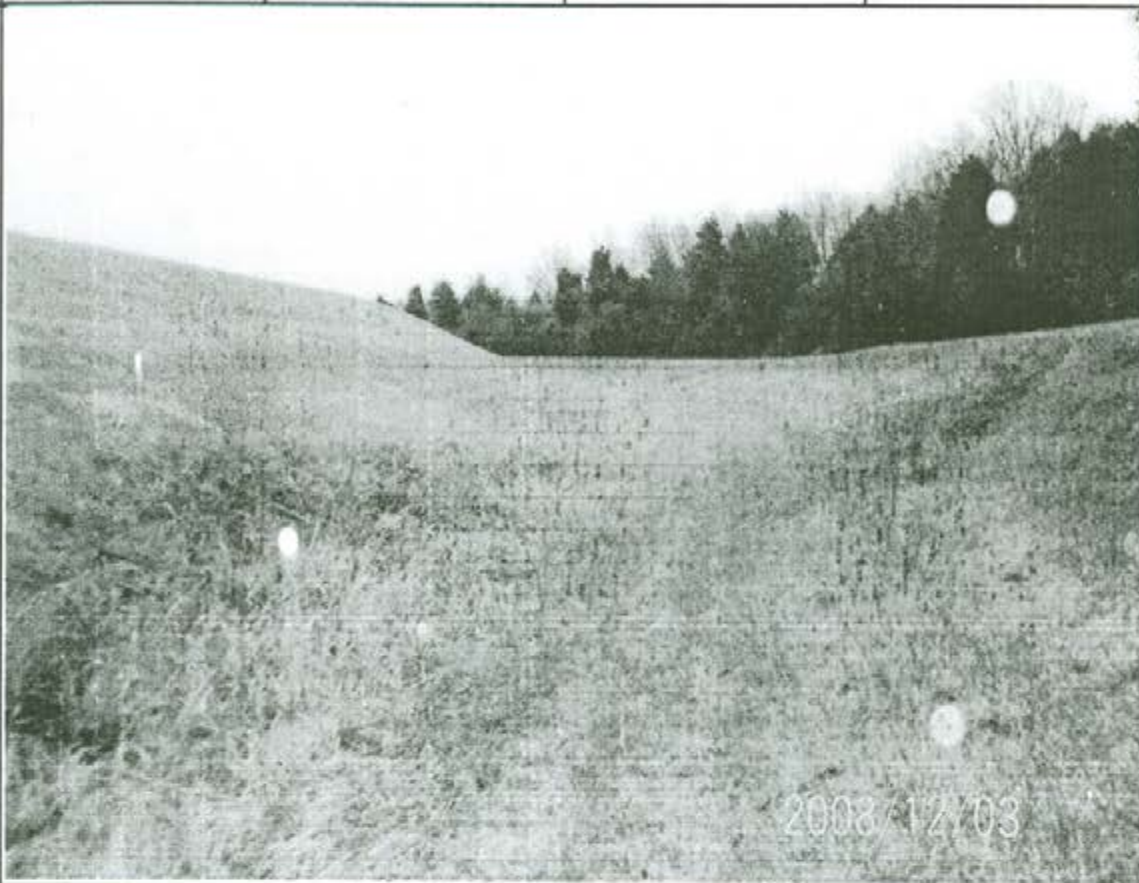
Looking at area needing
grading.

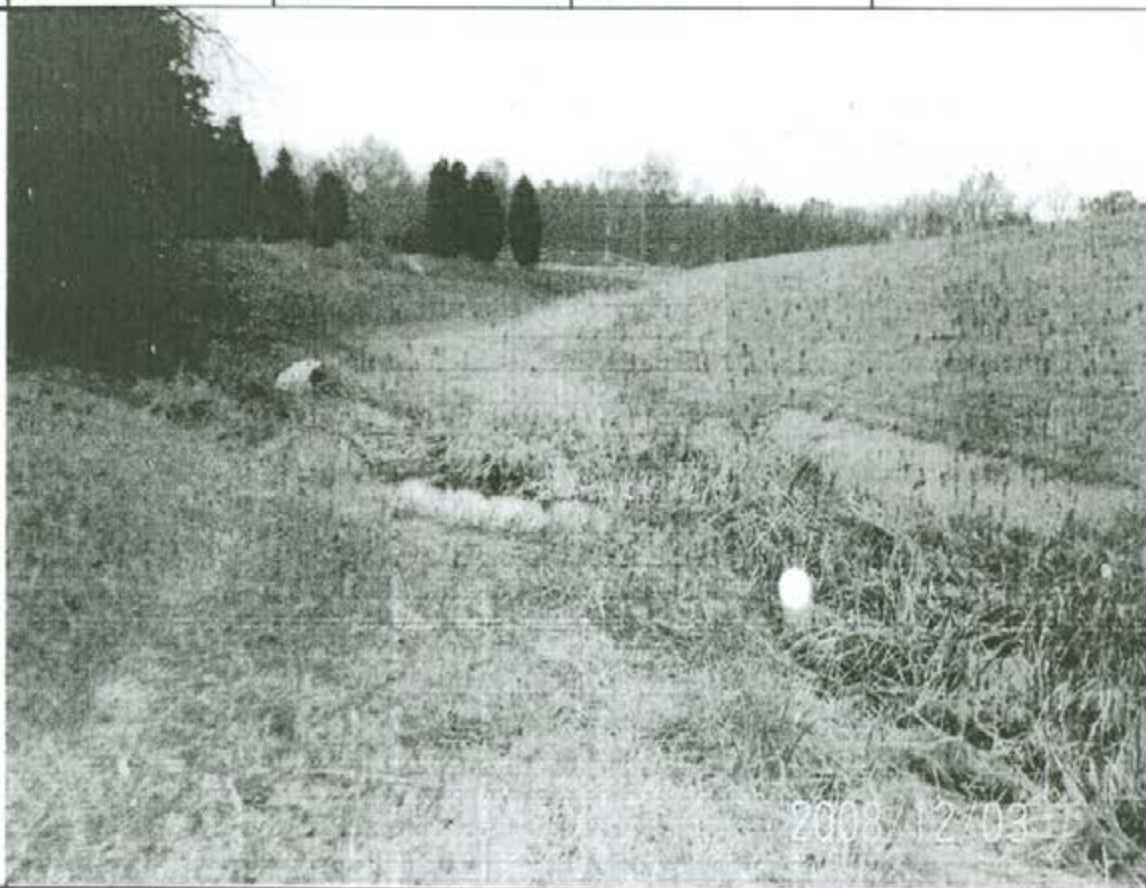
Looking west at area
needing grading
