US EPA ARCHIVE DOCUMENT

**DRAFT REPORT**

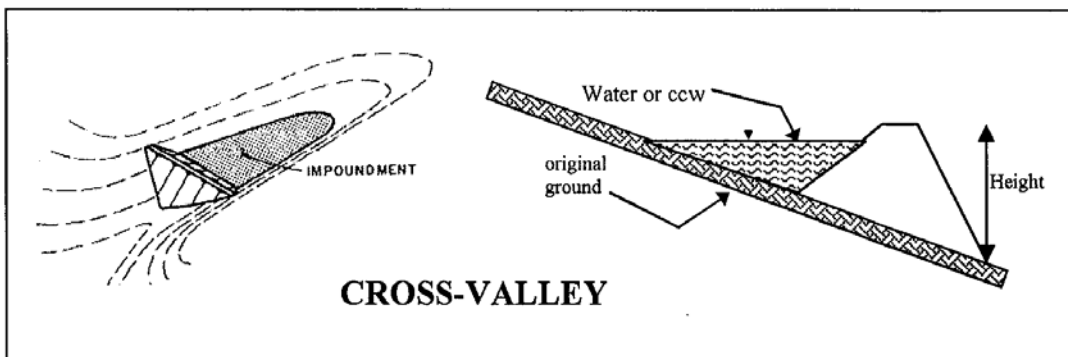
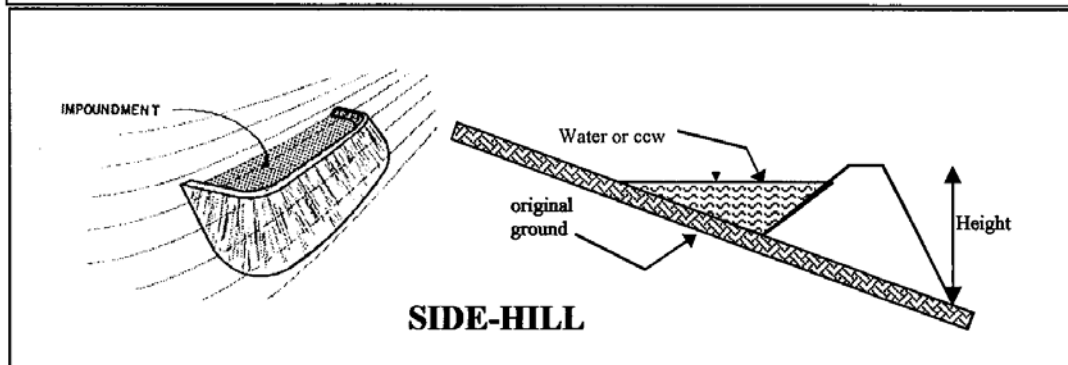
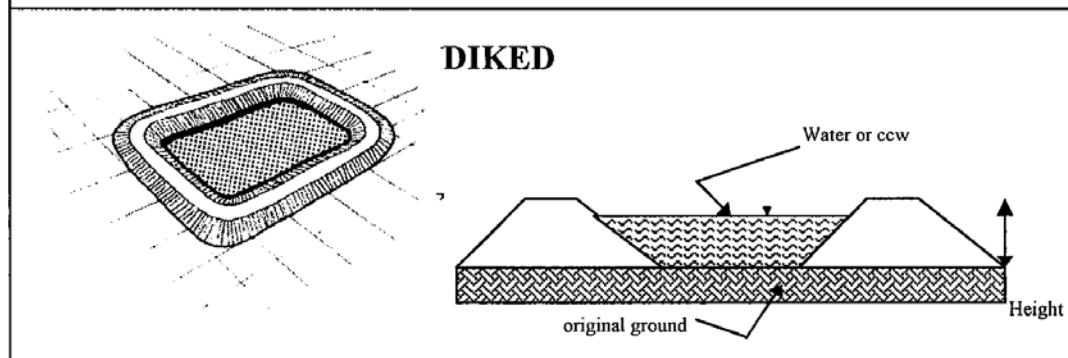
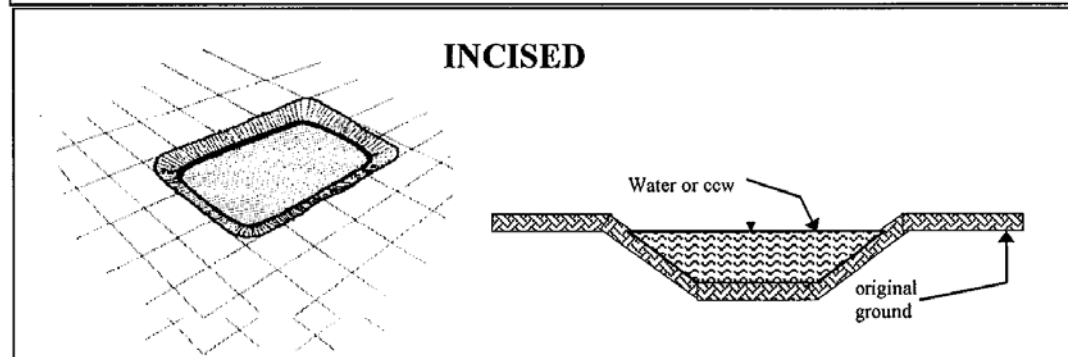
# **CONFIGURATION:**
