Draft Report

Tanner's Creek Bottom Ash Complex Assessment Report

Lockheed Martin

June 2009

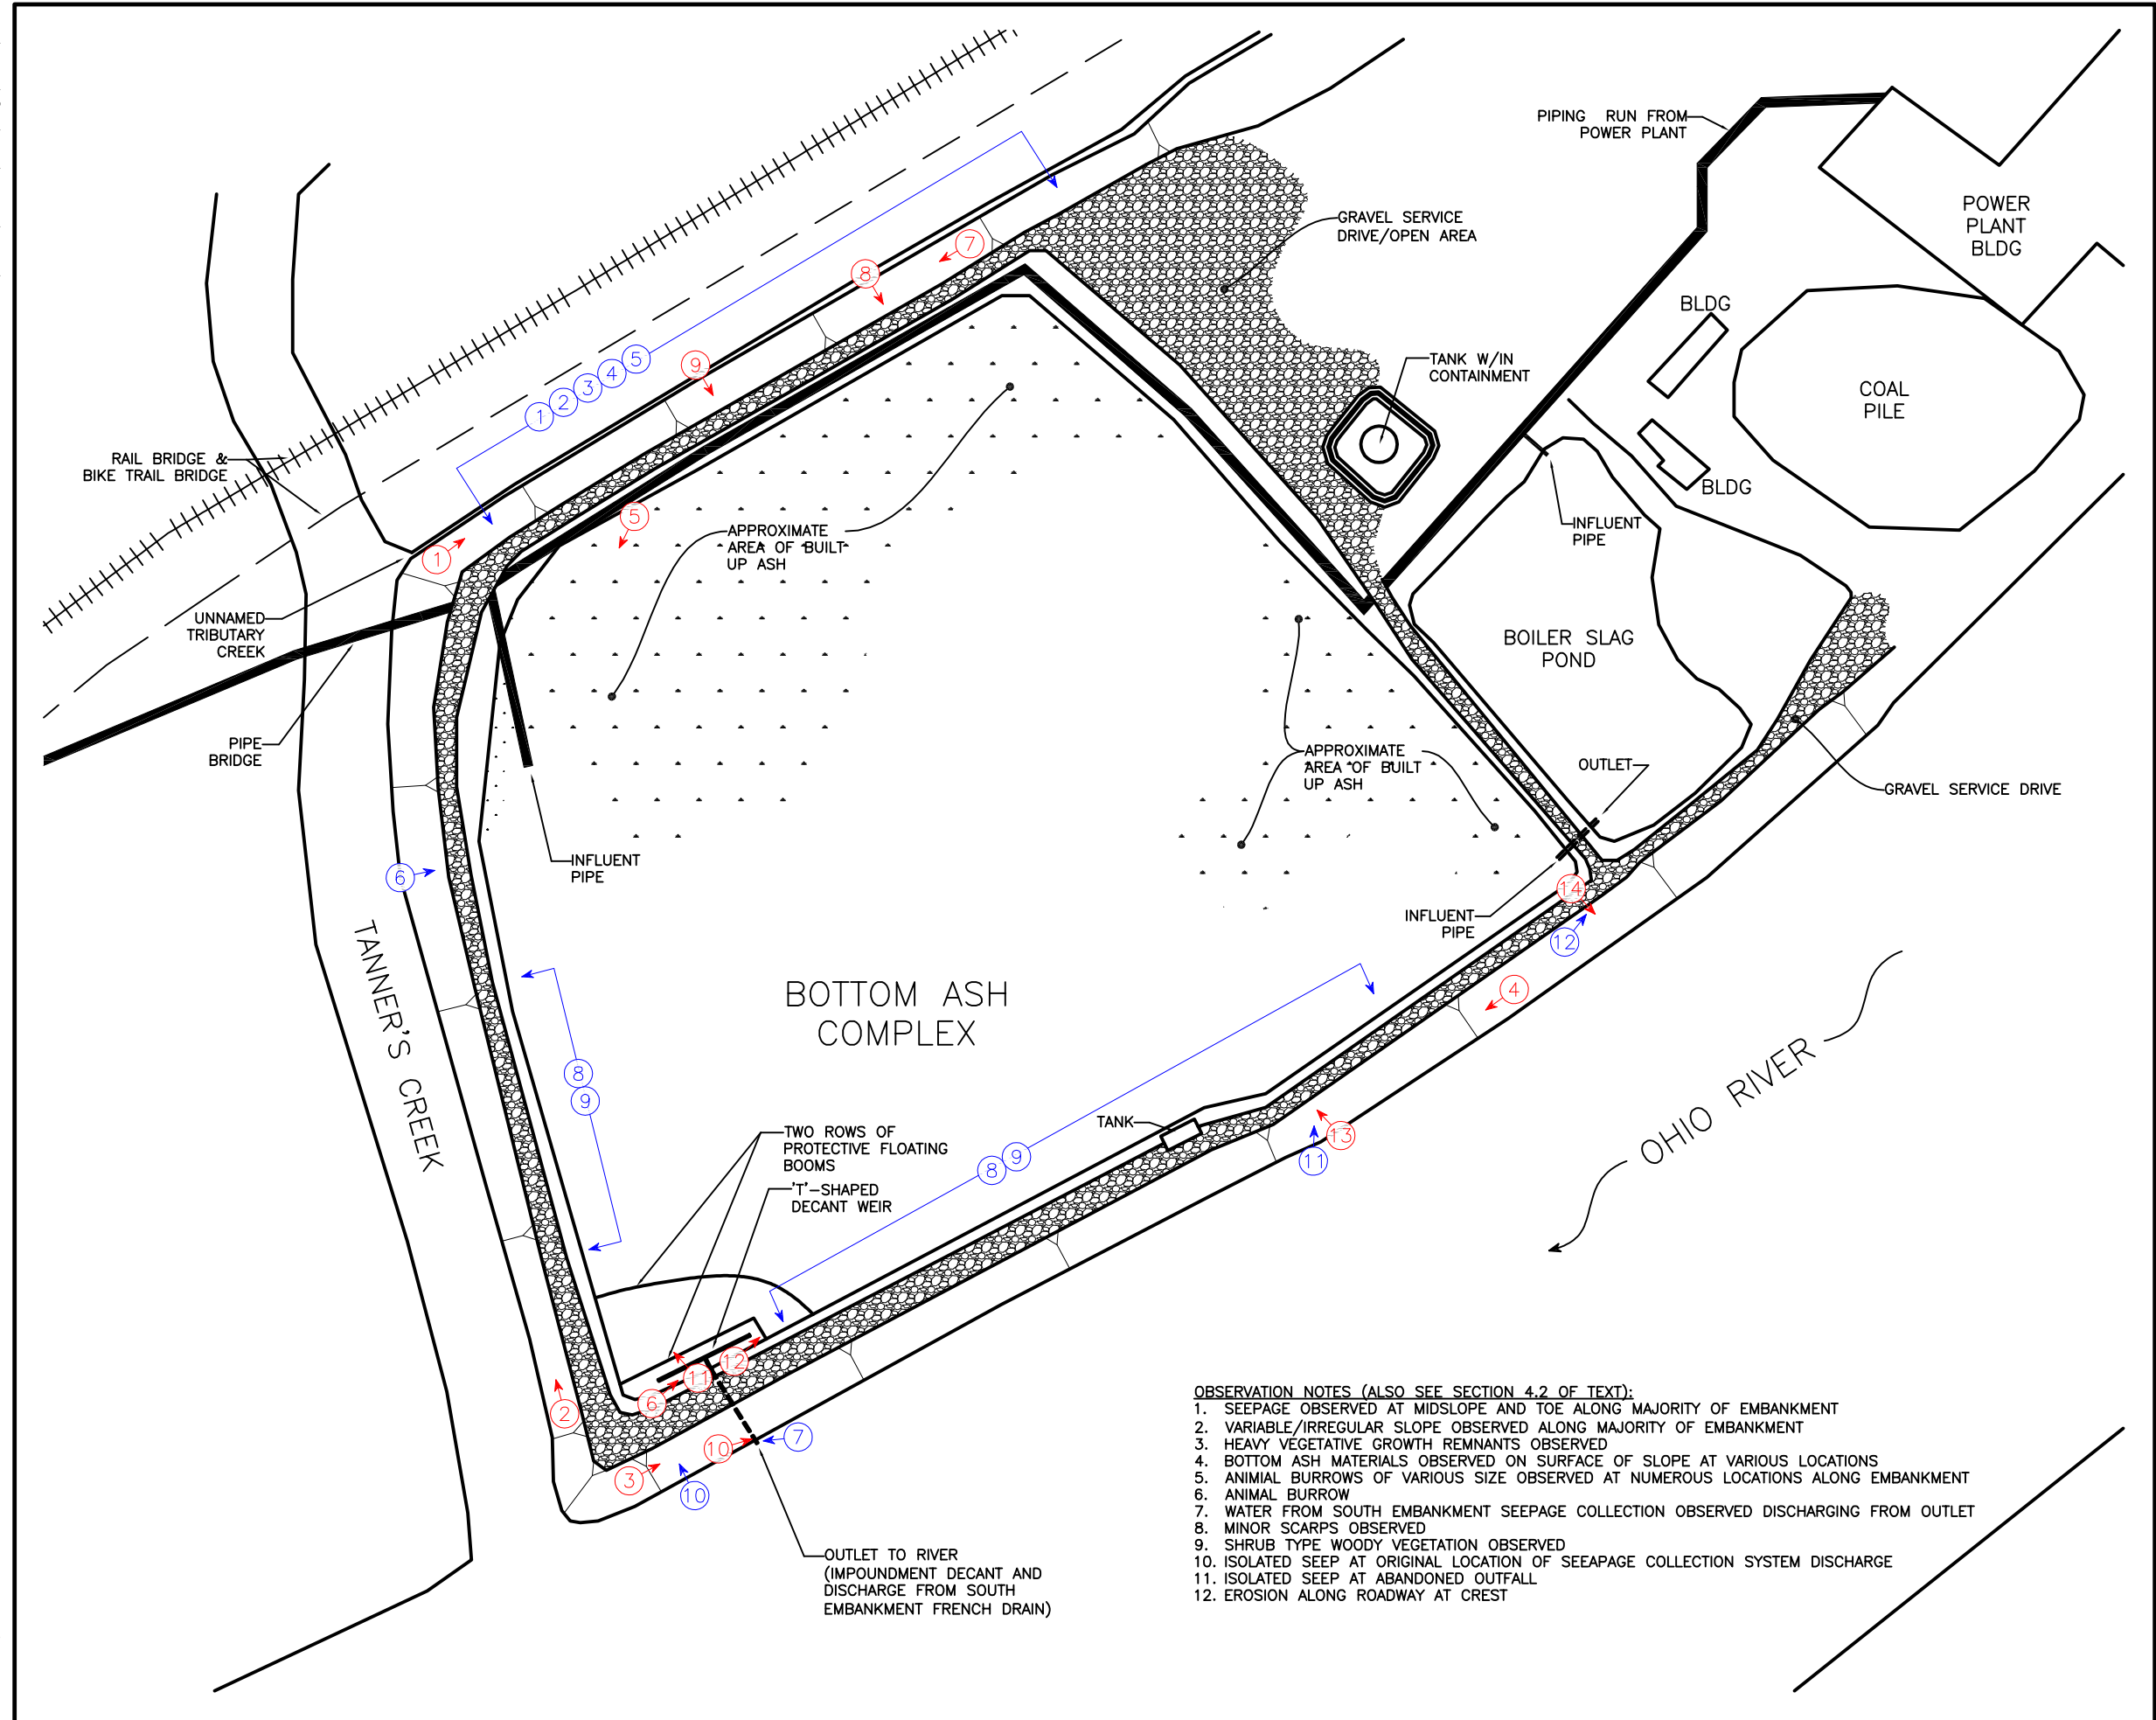
FIGURE 3

- OBSERVATION NOTES (ALSO SEE SECTION 4.2 OF TEXT):
1. SEEPAGE OBSERVED AT MIDSLOPE AND TOE ALONG MAJORITY OF EMBANKMENT
 2. VARIABLE/IRREGULAR SLOPE OBSERVED ALONG MAJORITY OF EMBANKMENT
 3. HEAVY VEGETATIVE GROWTH REMNANTS OBSERVED
 4. BOTTOM ASH MATERIALS OBSERVED ON SURFACE OF SLOPE AT VARIOUS LOCATIONS
 5. ANIMAL BURROWS OF VARIOUS SIZE OBSERVED AT NUMEROUS LOCATIONS ALONG EMBANKMENT
 6. ANIMAL BURROW
 7. WATER FROM SOUTH EMBANKMENT SEEPAGE COLLECTION OBSERVED DISCHARGING FROM OUTLET
 8. MINOR SCARPS OBSERVED
 9. SHRUB TYPE WOODY VEGETATION OBSERVED
 10. ISOLATED SEEP AT ORIGINAL LOCATION OF SEEPAGE COLLECTION SYSTEM DISCHARGE
 11. ISOLATED SEEP AT ABANDONED OUTFALL
 12. EROSION ALONG ROADWAY AT CREST

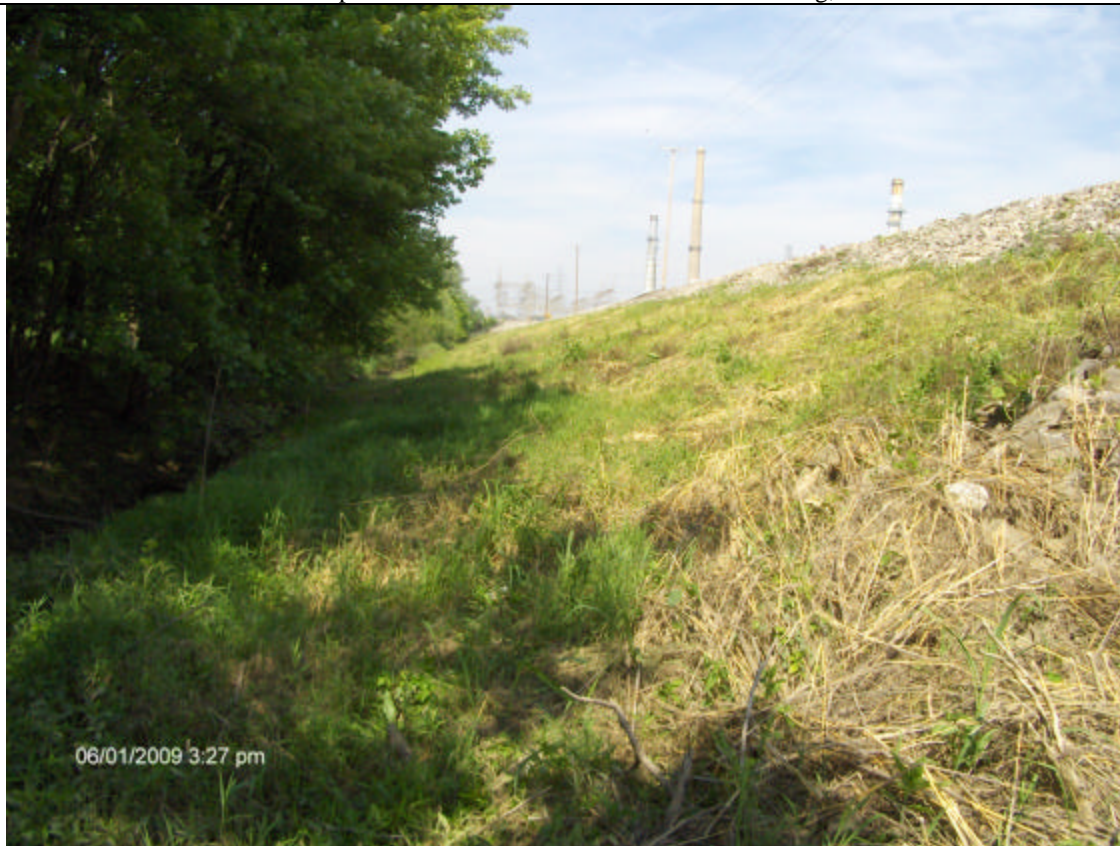
Photo Number:
1

- Animal burrows were observed at various locations on the west and south embankments.
- The remnants of heavy vegetative growth were observed along the entire west embankment. (Appendix B – Photo 1)

Description:
View along
west
embankment.
Note heavy
vegetation
recently mowed

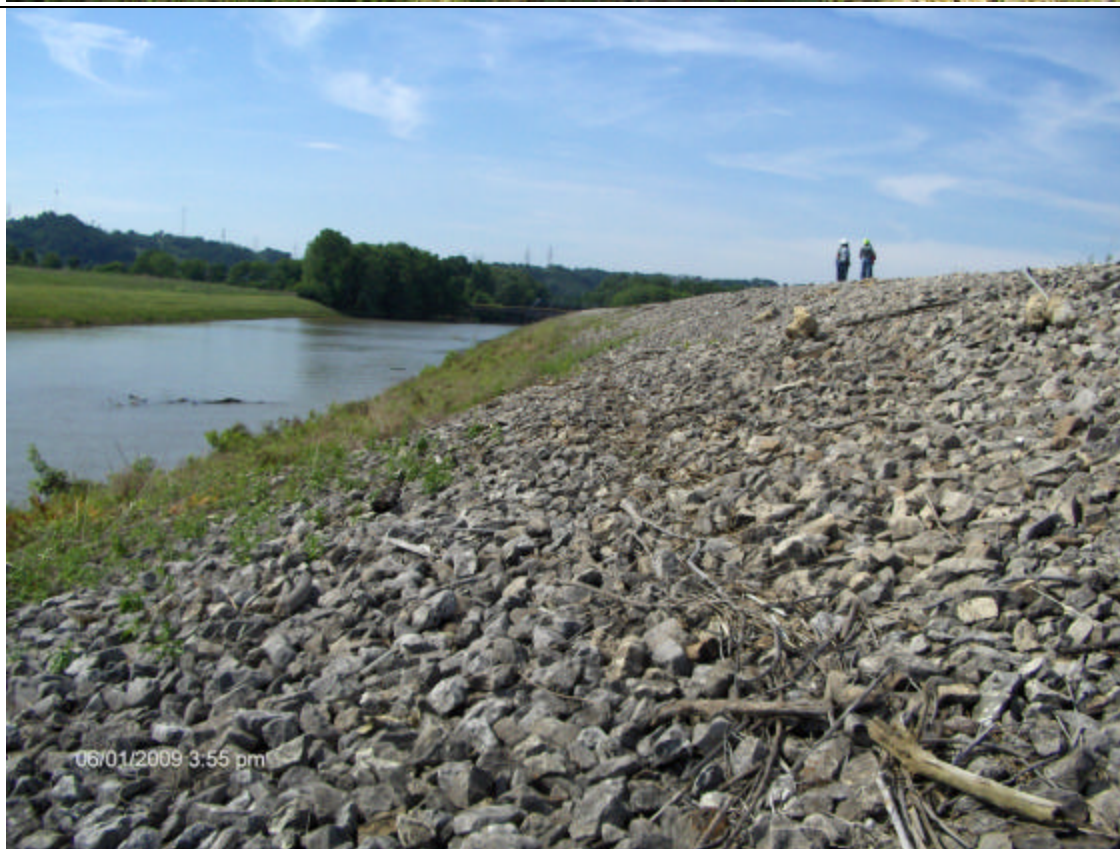
Photo Number:
2

Description:
View along
south
embankment.
Tanner's Creek
at left. Debris
collected on
slope from Ohio
River/Tanner's
Creek flooding
events.

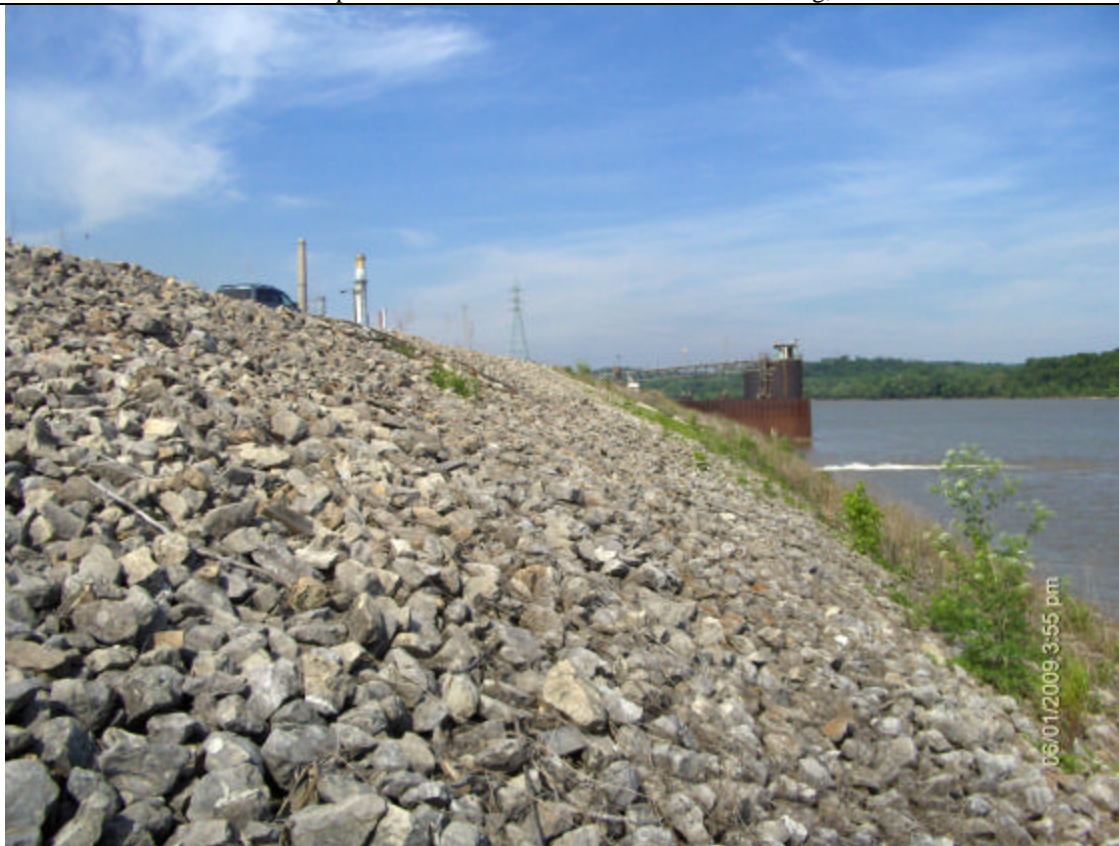
Photo Number:
3

Description:
View along east
embankment.
Ohio River at
right.

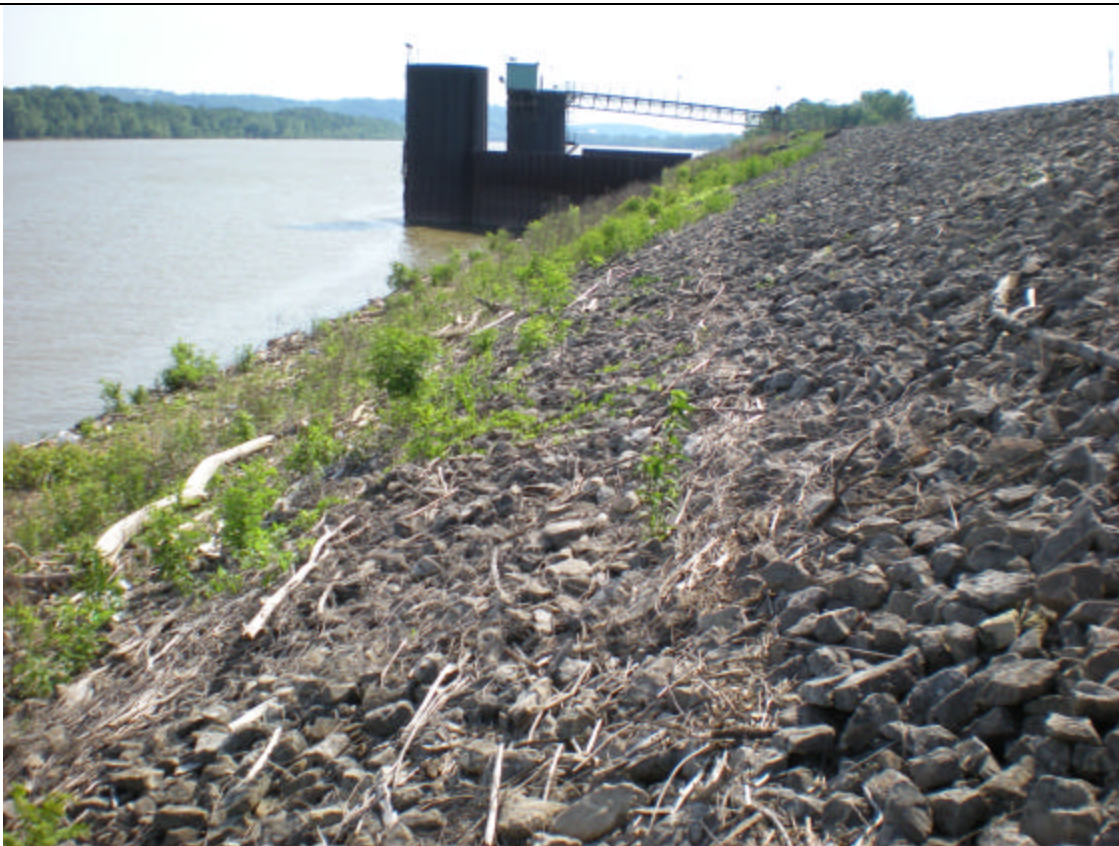
Photo Number:
4

Description:
View along east
embankment.
Ohio River at
left.

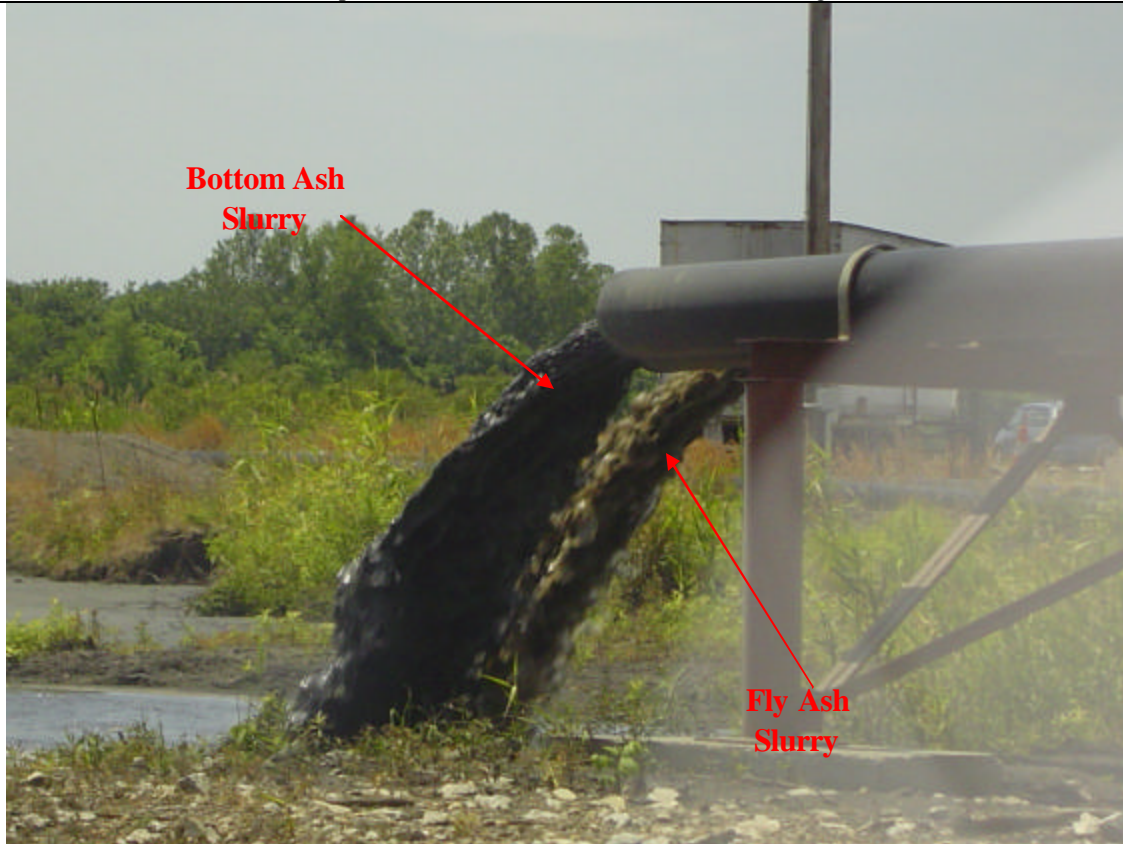
Photo Number:
5

Description:
Inlet to Bottom Ash Complex. Note light and dark slurries being pumped. At time of inspection, fly ash and bottom ash were being sent to Bottom Ash Complex.

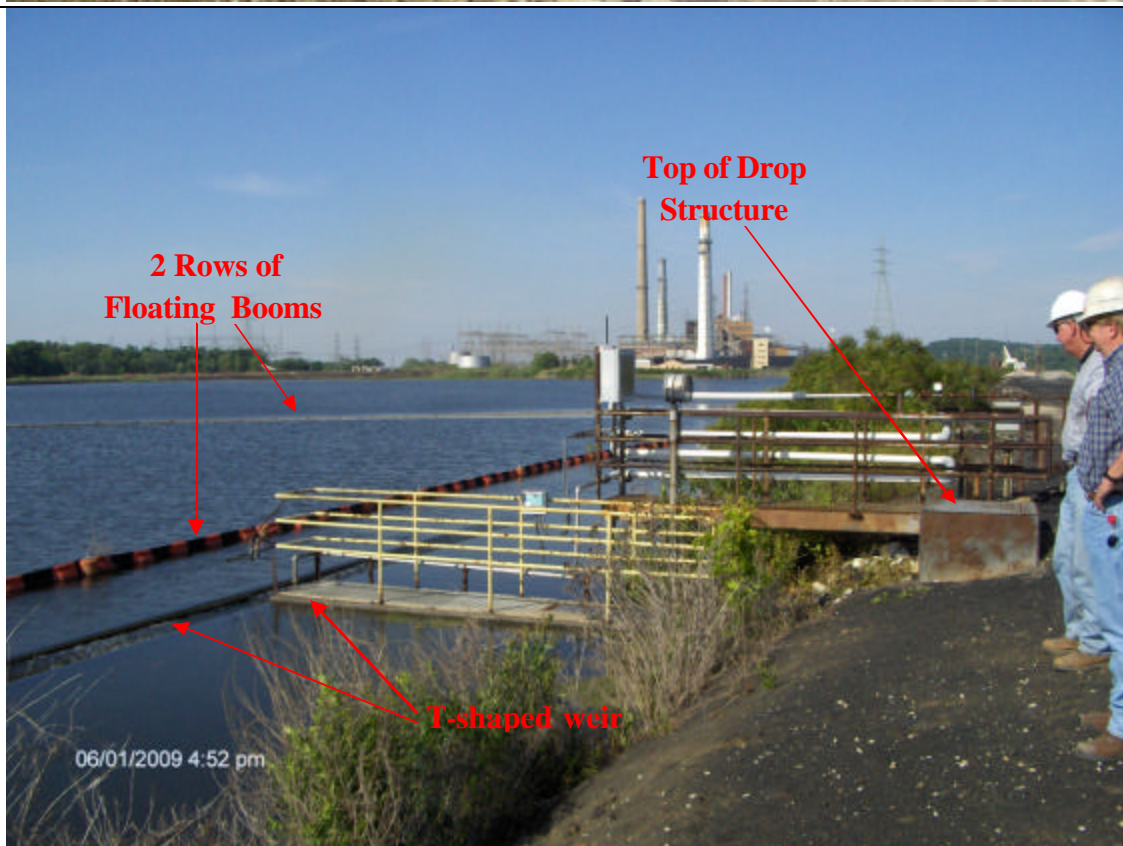
Photo Number:
6

Description:
Decant weir. See sketch in Appendix A for additional details.

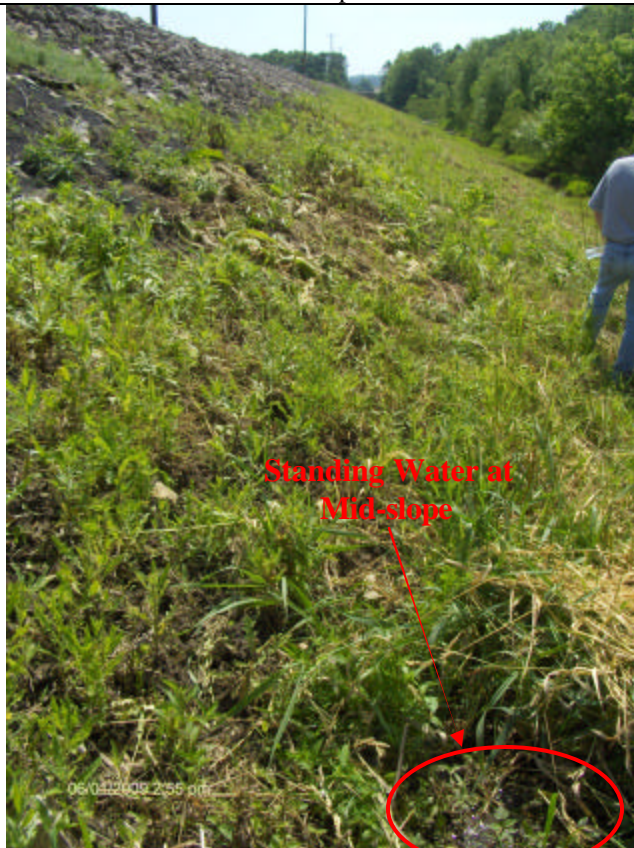
Photo Number:
7

- Seepage was observed at the mid-slope and toe along a majority of the west embankment. (Appendix B – Photos 7 and 8)
- A non uniform slope was observed along the entire west embankment and is likely related to existing seepage and past growth of woody vegetation.

Description:
Typical seepage
at mid-slope of
west
embankment.
Note standing
water at bottom
right.

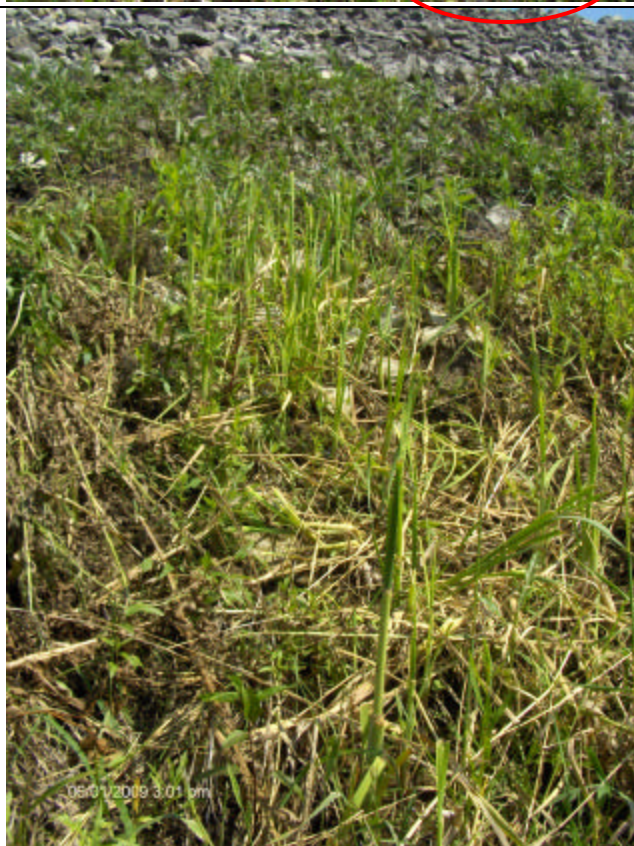
Photo Number:
8

Description:
Typical seepage
at mid-slope
along west
embankment.
Note wetland
vegetation
growing

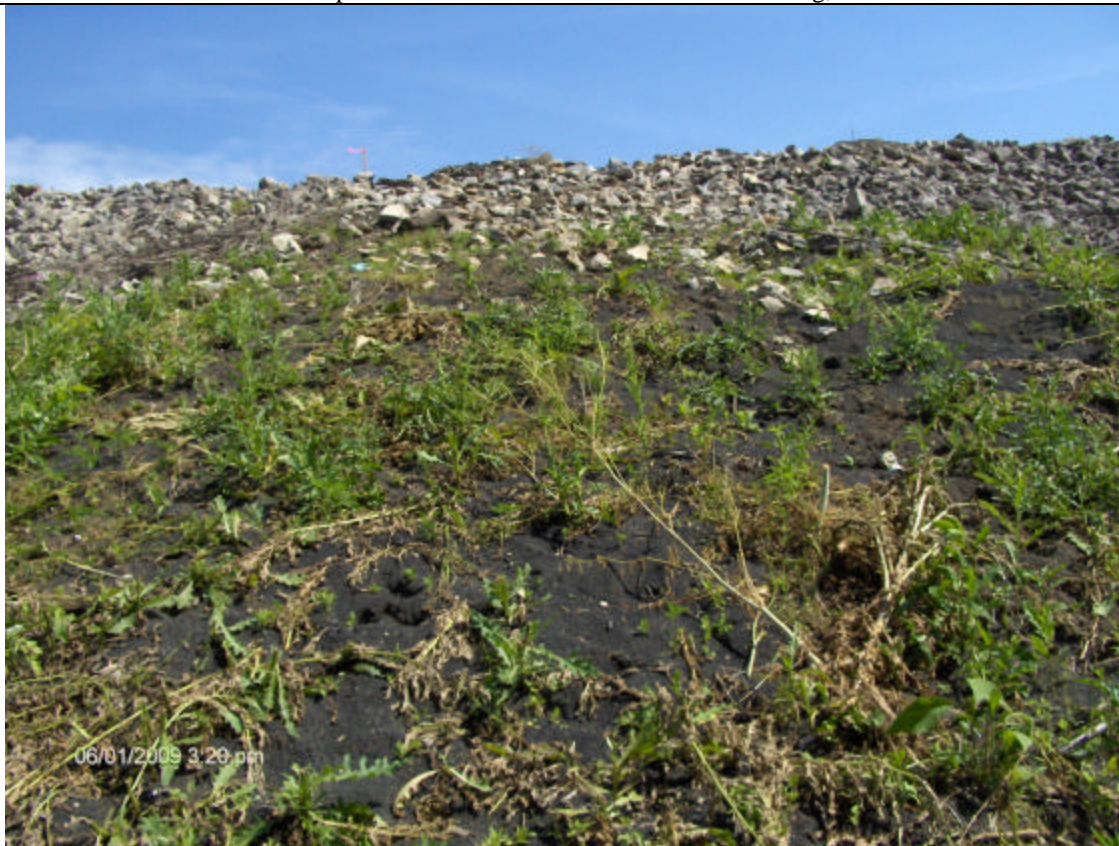
- Bottom ash materials were observed on the slope of the west embankment at various locations. These may have been a result of the 1970's addition to the embankment. (Appendix B – Photo 9)

Bottom ash on surface of west embankment slope

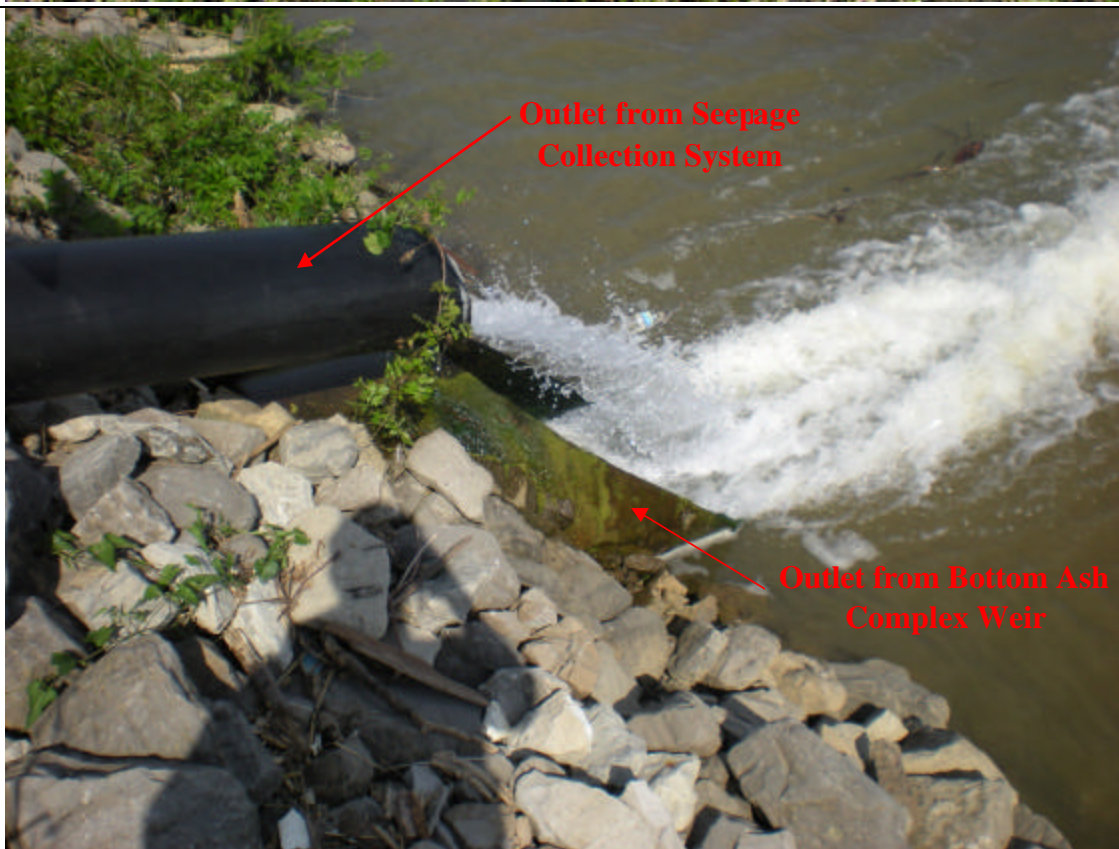
- Water from the seepage collection system in the south embankment was observed discharging from the outlet indicating that the system is, at a minimum, operational (Appendix B – Photo 10)

Discharge piping into Ohio River. Bottom pipe is decant outlet from Bottom Ash Complex. Upper pipe is outlet for french drain seepage collection system installed in south embankment.

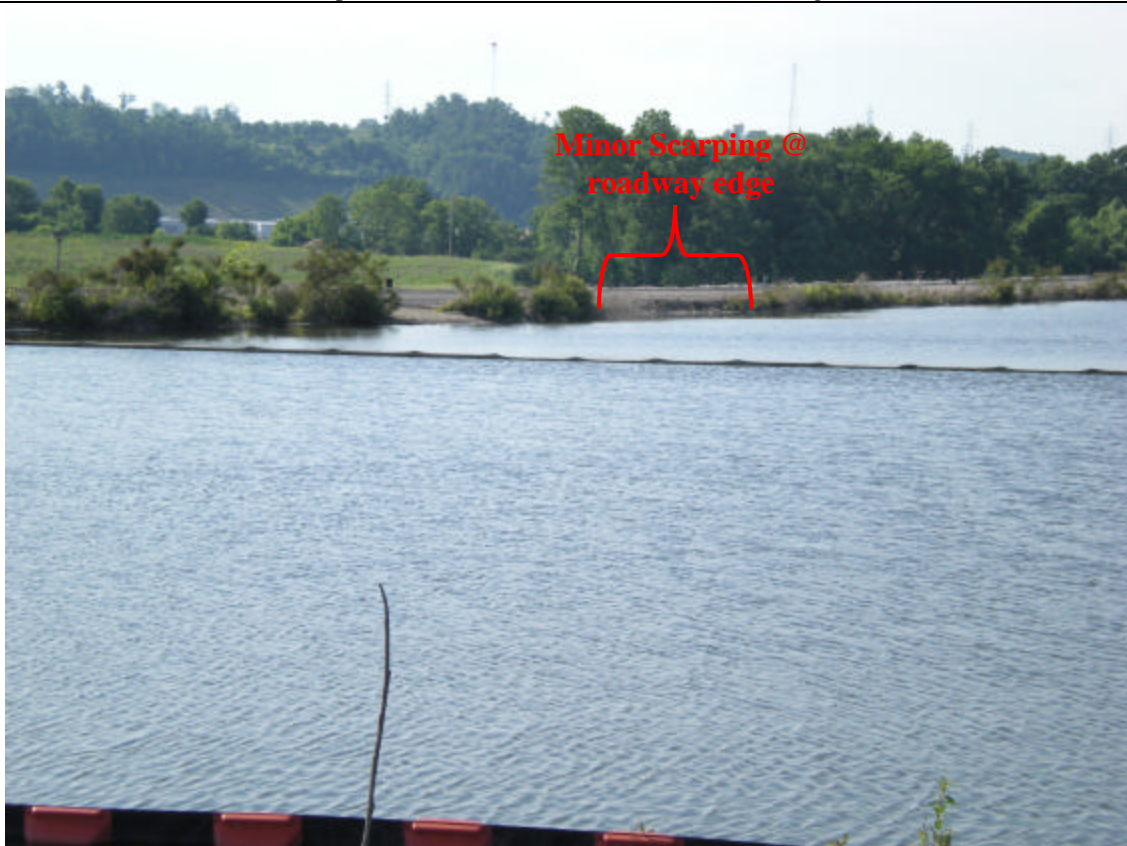
Photo Number:
11

- Minor scarps approximately three to five feet in height were observed at the top of the slope along the upstream side of the south and east embankments. (Appendix B – Photo 11)

Description:
Woody vegetation growing along upstream side of south embankment. Note minor scarping at edge of crest roadway.

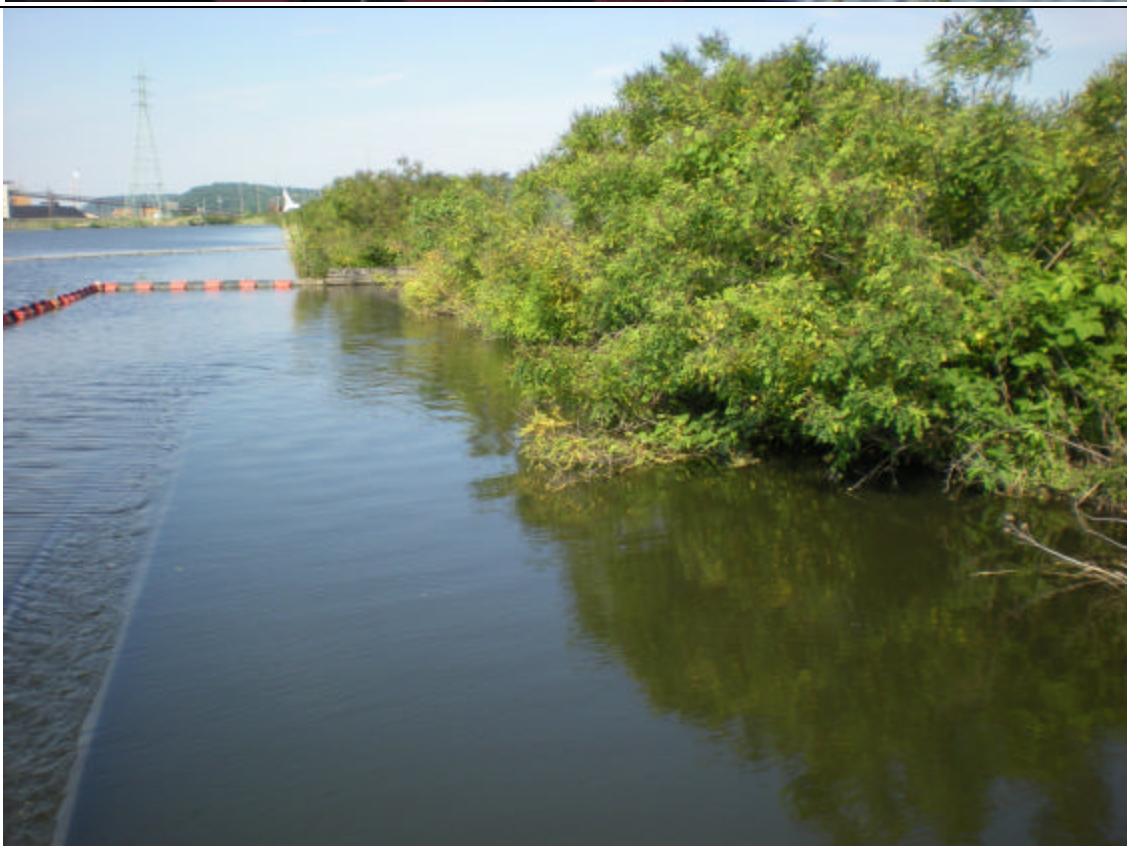
Photo Number:
12

- Shrub type growth up to 2 inch diameter was observed on the upstream side of the east embankment. (Appendix B – Photos 11 and 12)
- Isolated seeps were observed at two locations along the east embankment. One was located at a former spillway (Appendix B – Photo 13). The other was located where the south embankment seepage collection system formerly discharged. When initially constructed, the discharge from the collection system was located approximately 100' south of its current location.

Description:
Woody vegetation growing on upstream side of east embankment. Note north leg of T-shaped outlet weir at left.

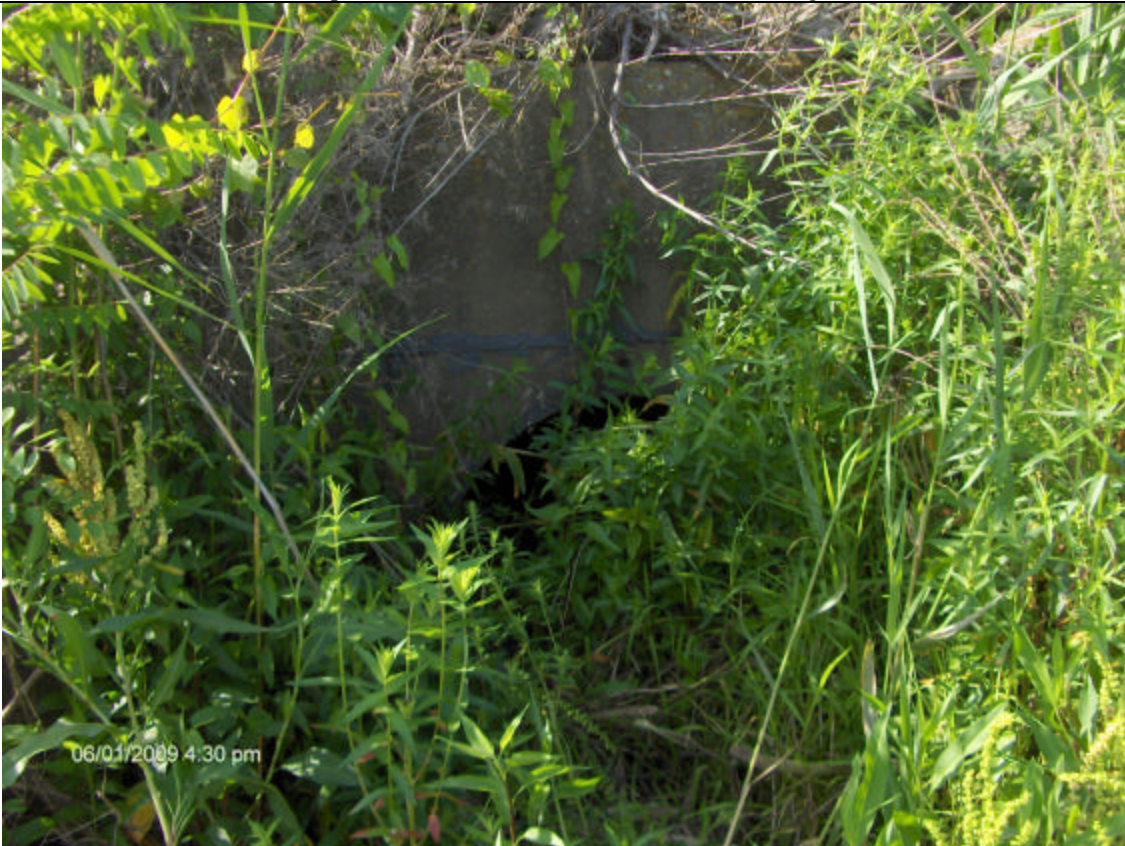
Additionally, the 2008 annual inspection noted that plant personnel desire to eliminate an isolated seepage area on the east embankment where the abandoned decant outlet from the original pond is located. At the time of the inspection, seepage was still observed at this location.

Abandoned former outfall. Seepage was noted at this location. Seepage not visible in picture.

Monitoring of the two isolated seeps noted along the east embankment should continue with the monthly inspections performed by the plant. These items have been noted in previous annual inspections and methods to repair these locations should be investigated in the event that these seeps worsen and immediate repair is needed.

The isolated seeps on the east embankment should continue to be monitored. In the event these areas are observed to worsen, they should be repaired immediately.

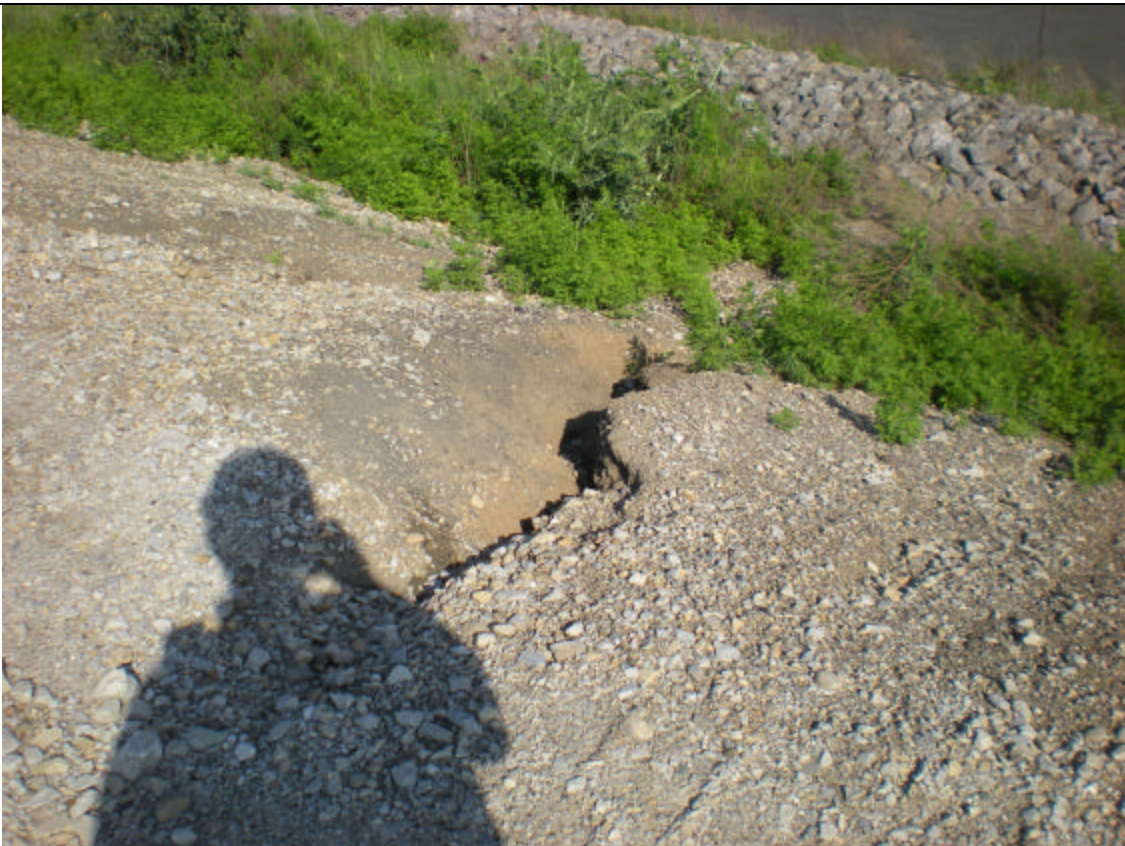
- Minor erosion was observed near the roadway on the crest along the east embankment. Eroded areas are typically less than 1-foot deep and extend five to seven feet down the slope (Appendix B – Photo 14).

Typical erosion at edge of roadway on crest of east embankment. Approximately 12" deep and 5' to 7' long
