**Tanner's Creek Bottom Ash Complex
Assessment Report**

Lockheed Martin

September 2009

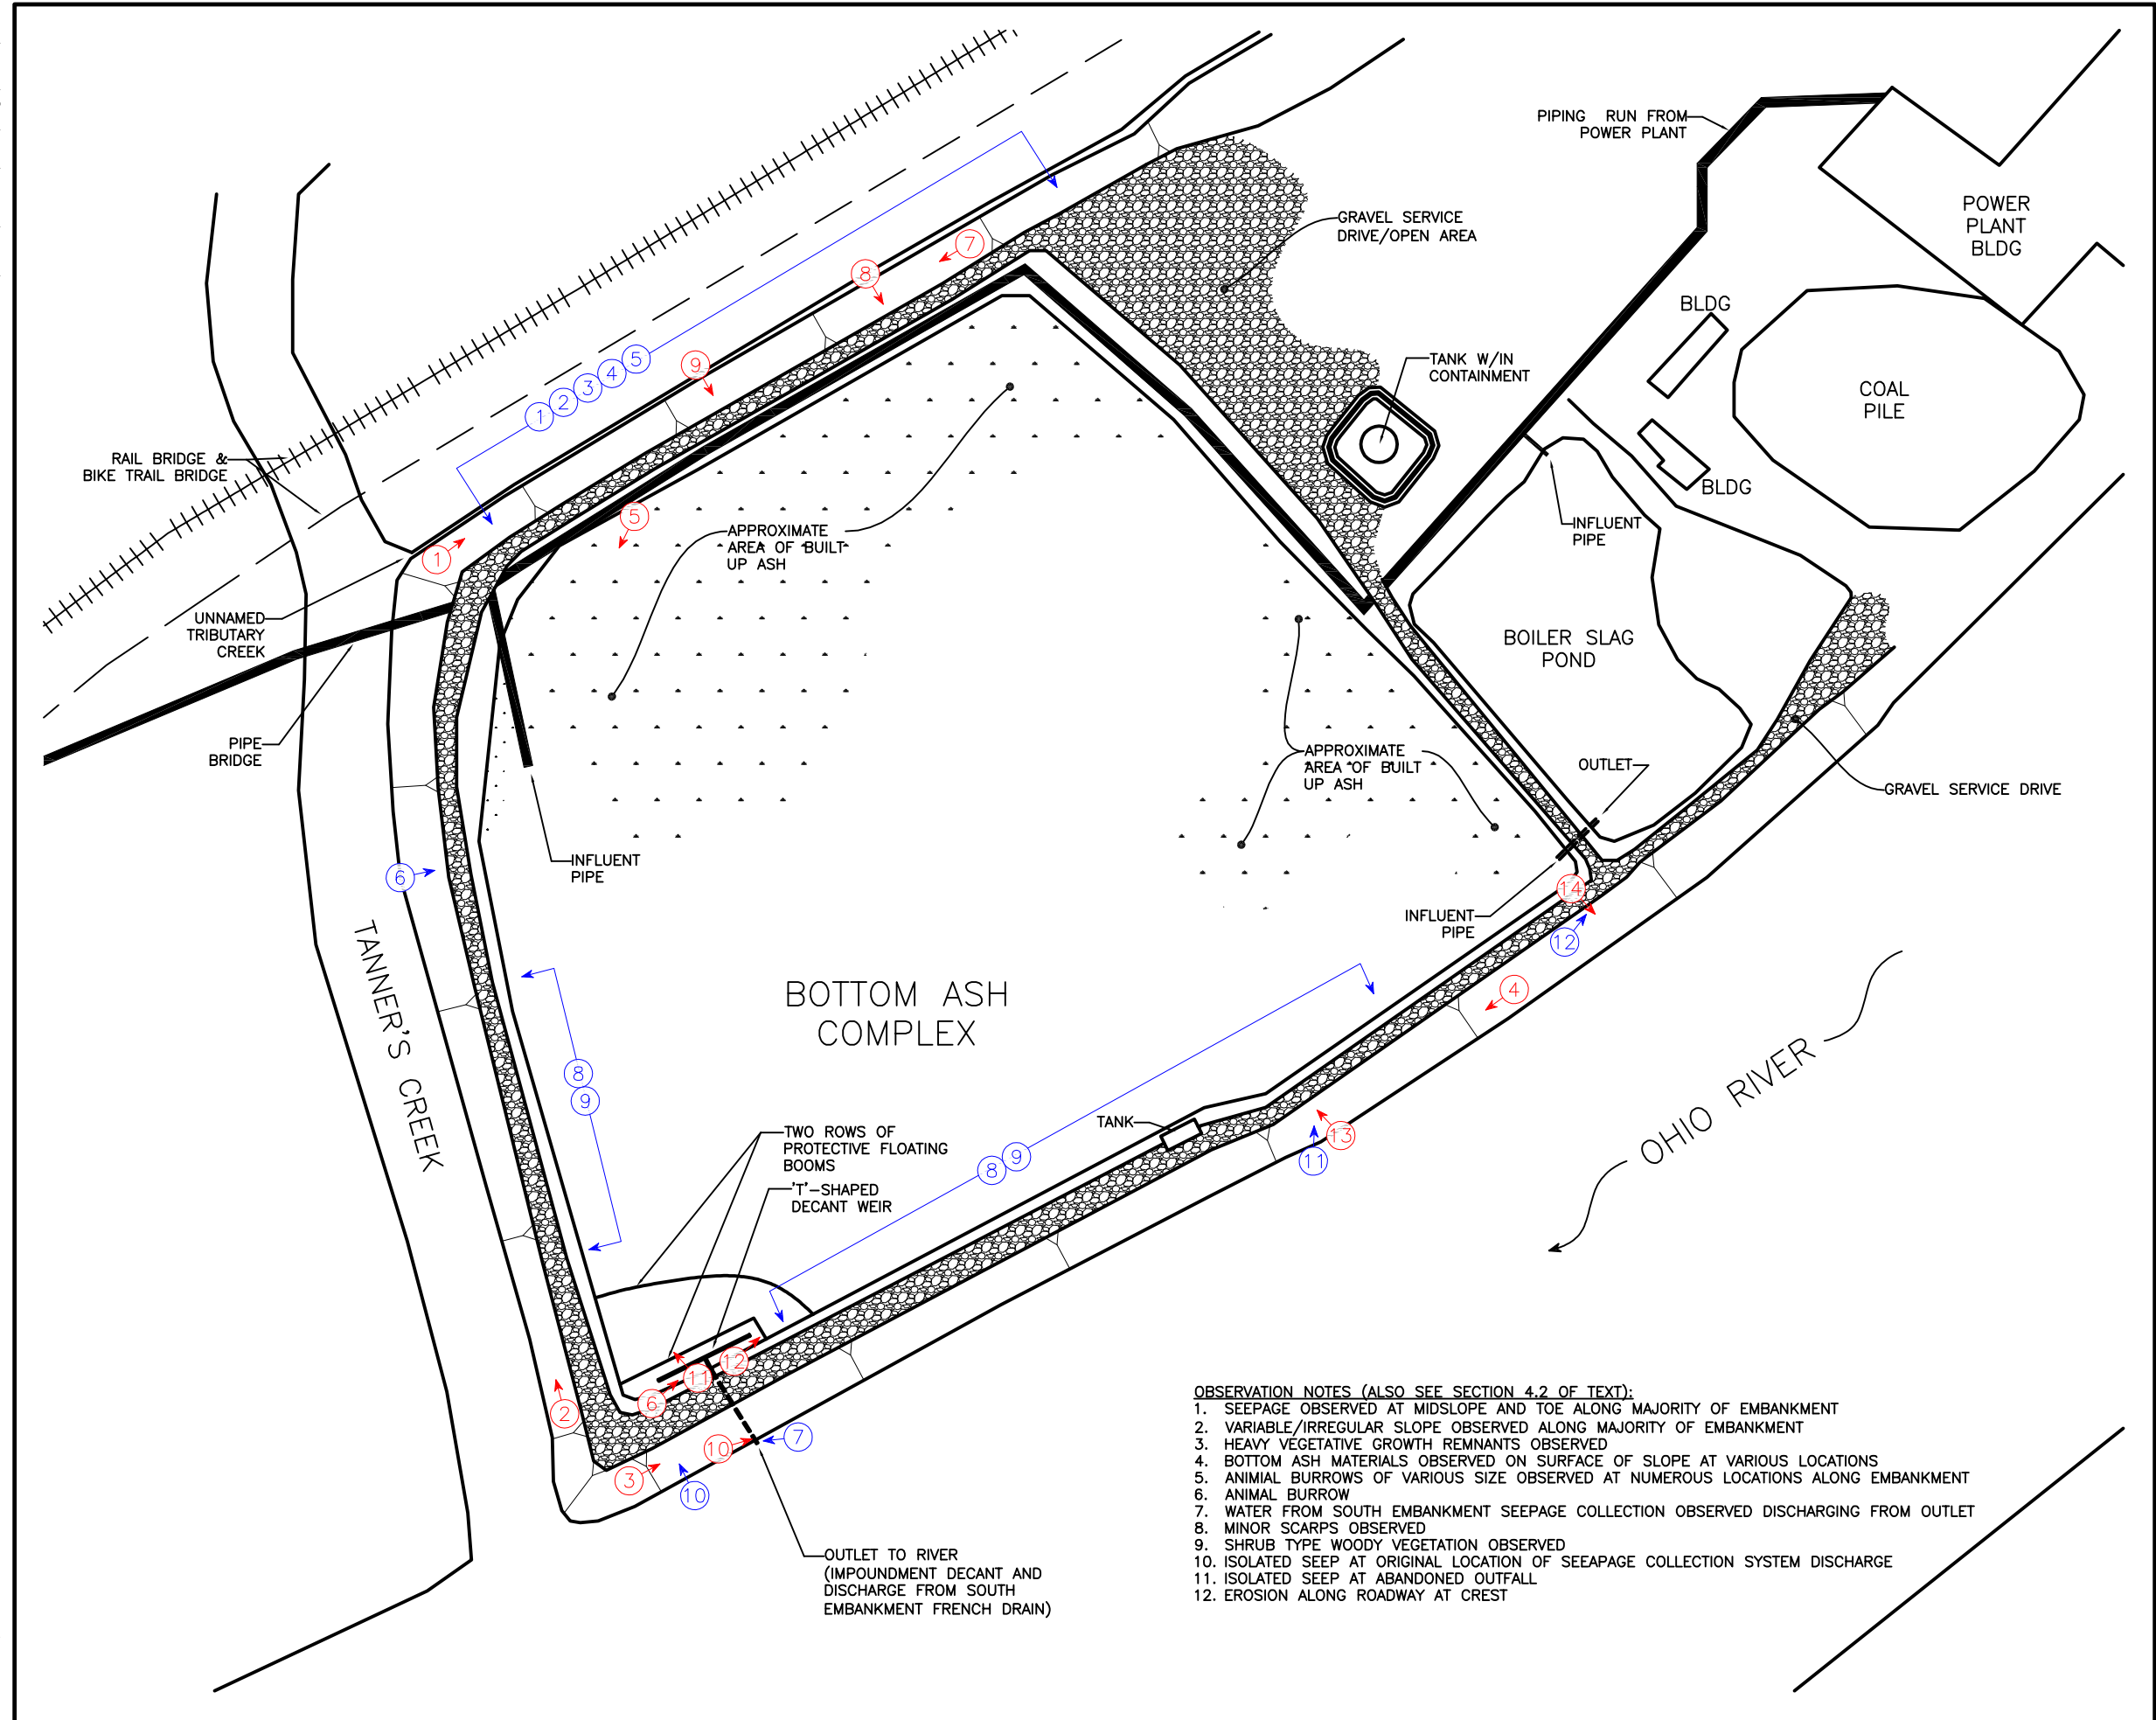
FIGURE 3

- OBSERVATION NOTES (ALSO SEE SECTION 4.2 OF TEXT):
1. SEEPAGE OBSERVED AT MIDSLOPE AND TOE ALONG MAJORITY OF EMBANKMENT
 2. VARIABLE/IRREGULAR SLOPE OBSERVED ALONG MAJORITY OF EMBANKMENT
 3. HEAVY VEGETATIVE GROWTH REMNANTS OBSERVED
 4. BOTTOM ASH MATERIALS OBSERVED ON SURFACE OF SLOPE AT VARIOUS LOCATIONS
 5. ANIMAL BURROWS OF VARIOUS SIZE OBSERVED AT NUMEROUS LOCATIONS ALONG EMBANKMENT
 6. ANIMAL BURROW
 7. WATER FROM SOUTH EMBANKMENT SEEPAGE COLLECTION OBSERVED DISCHARGING FROM OUTLET
 8. MINOR SCARPS OBSERVED
 9. SHRUB TYPE WOODY VEGETATION OBSERVED
 10. ISOLATED SEEP AT ORIGINAL LOCATION OF SEEPAGE COLLECTION SYSTEM DISCHARGE
 11. ISOLATED SEEP AT ABANDONED OUTFALL
 12. EROSION ALONG ROADWAY AT CREST

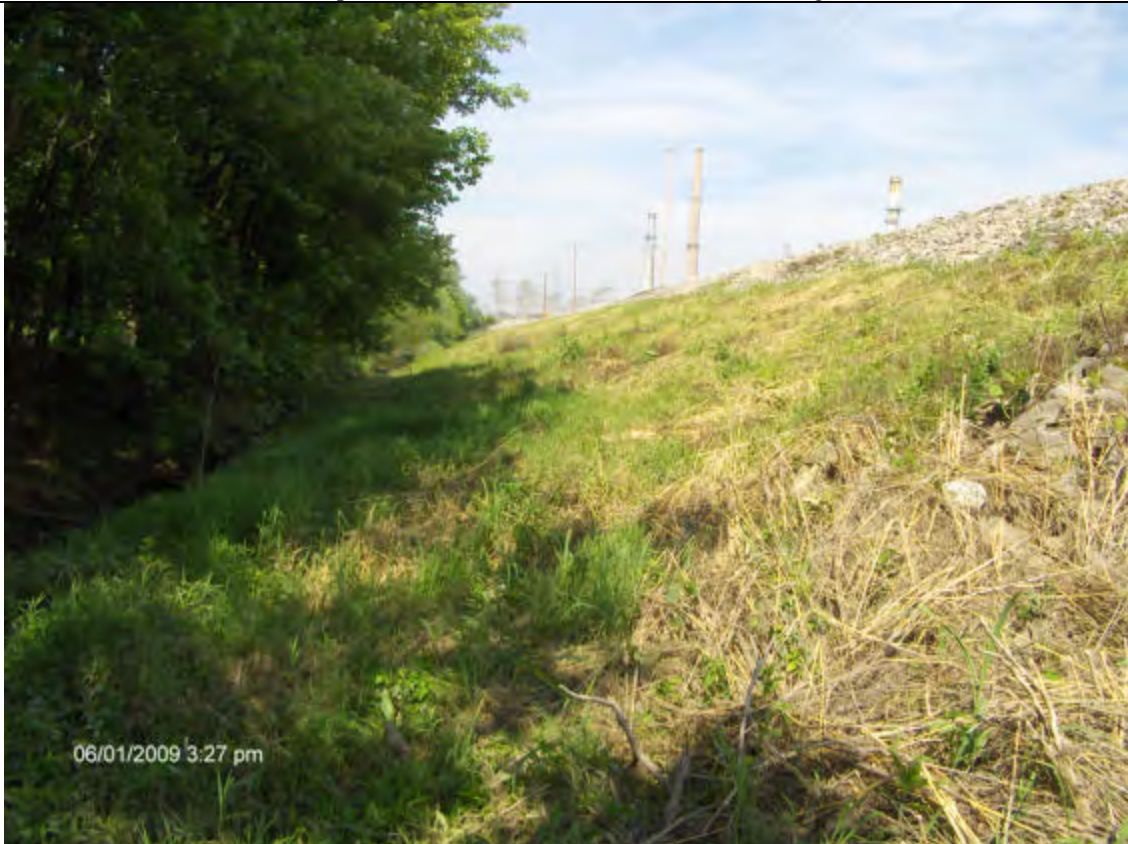
- Animal burrows were observed at various locations on the downstream slope of the west and south dike embankments.
- The remnants of heavy vegetative growth were observed along the entire west dike embankment. (Appendix B – Photo 1)

View along west embankment. Note heavy vegetation recently mowed

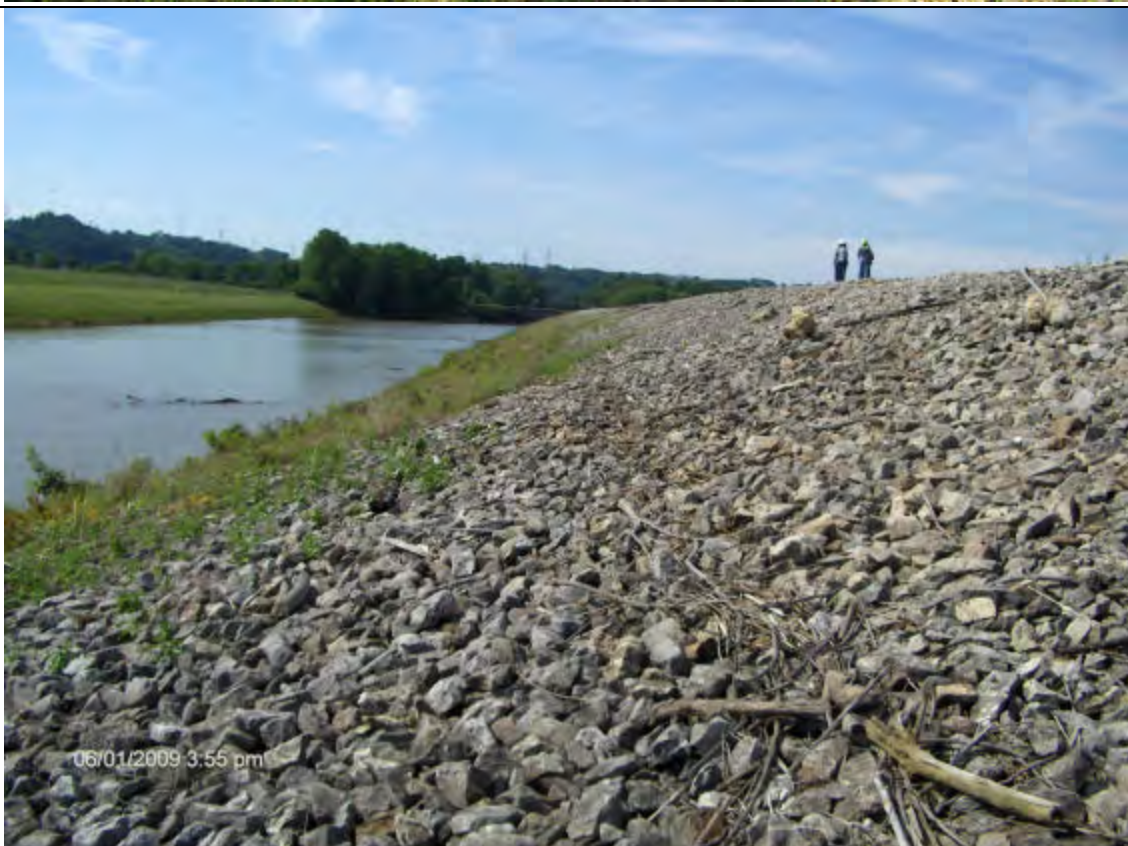
View along south embankment. Tanner's Creek at left. Debris collected on slope from Ohio River/Tanner's Creek flooding events.

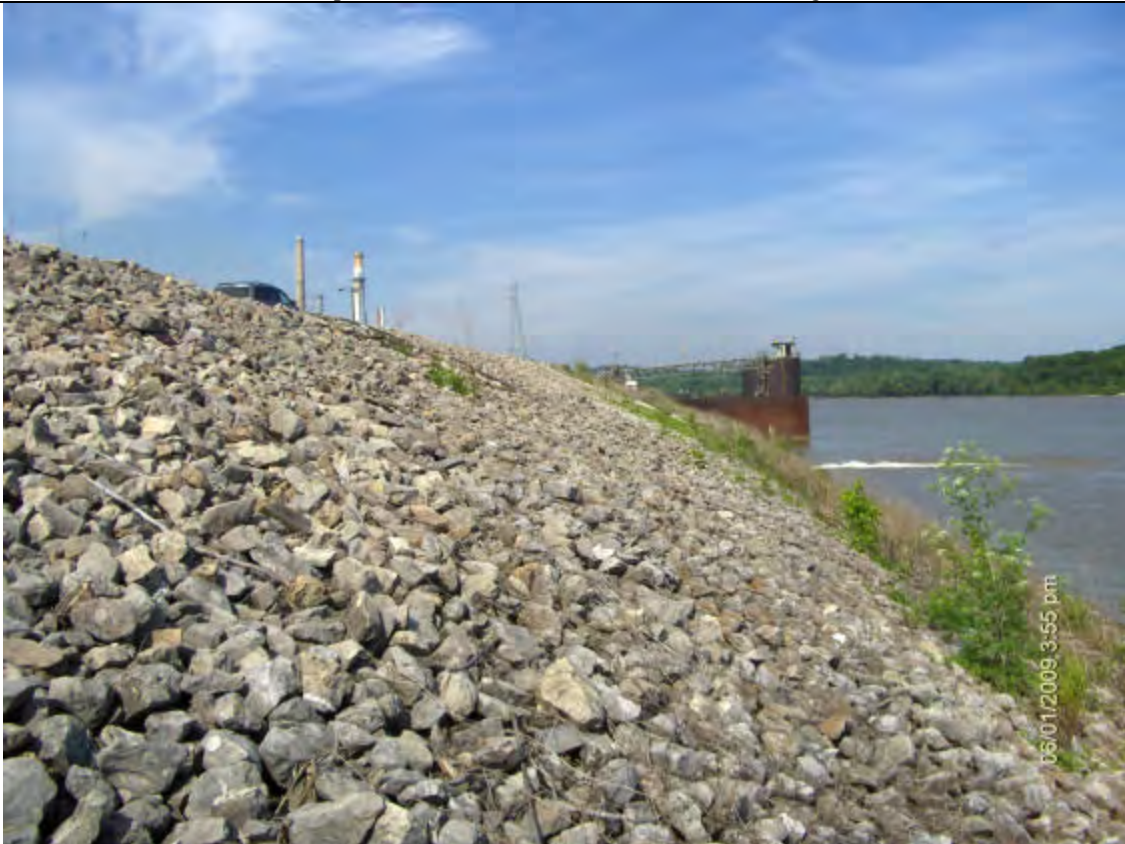
View along east embankment.
Ohio River at right.

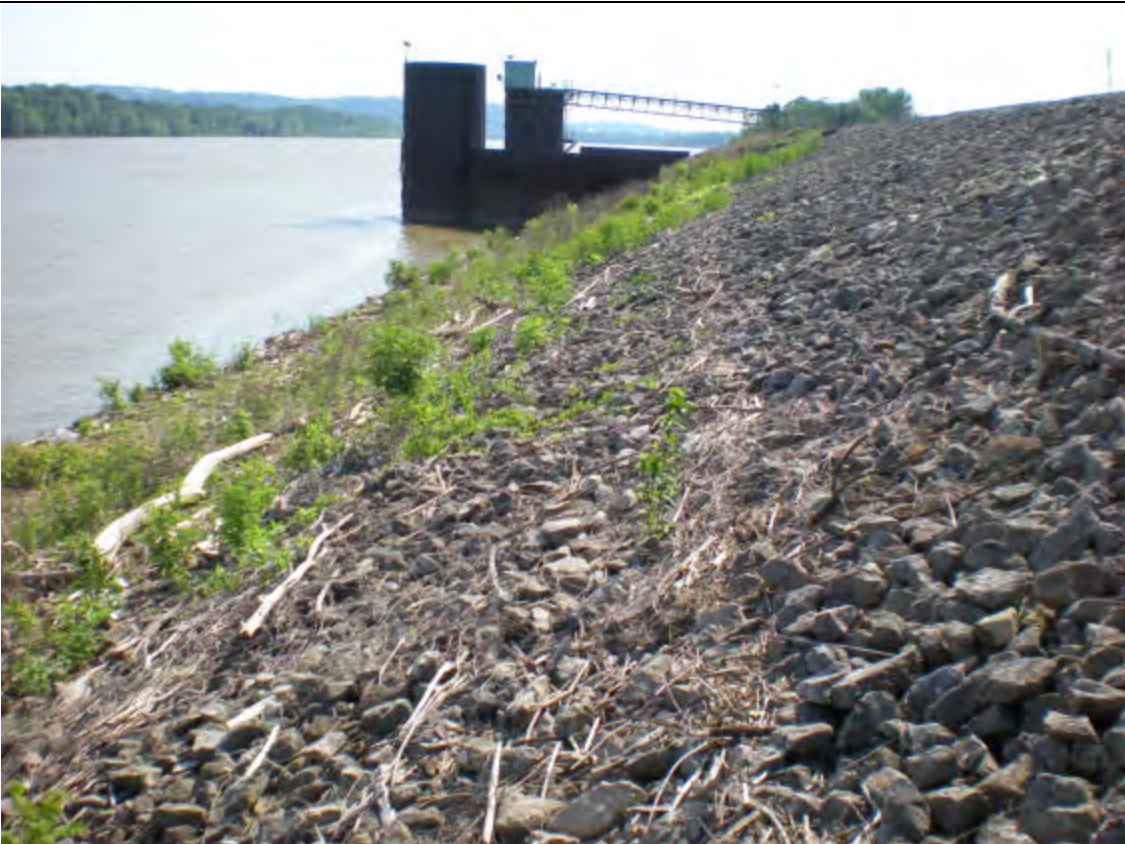
View along east embankment.
Ohio River at left.

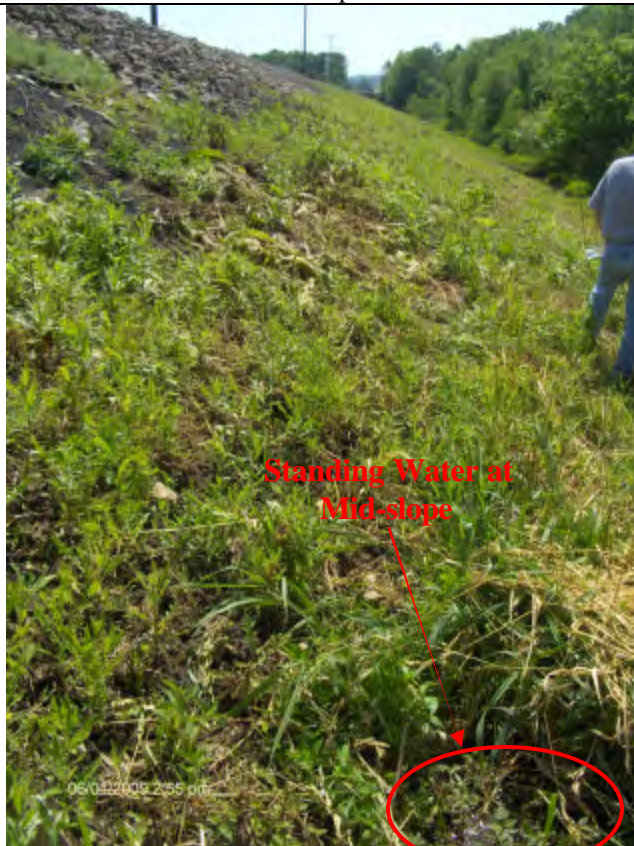
Photo Number:
7

- Seepage was observed at the mid-slope and toe along a majority of the west dike embankment. (Appendix B – Photos 7 and 8)
- Surface irregularities were observed on the downstream slope of the entire west dike embankment, likely related to existing seepage, past growth of woody vegetation and maintenance activities on the slope.

Description:
Typical seepage
at mid-slope of
west
embankment.
Note standing
water at bottom
right.

The west dike is in need of attention to address uncontrolled seepage observed on the downstream slope, animal burrows, fugitive bottom ash and remnants of woody vegetation. The stability of the west dike embankment will be improved by the installation of the proposed seepage collection system and addressing the above deficiencies during the work.

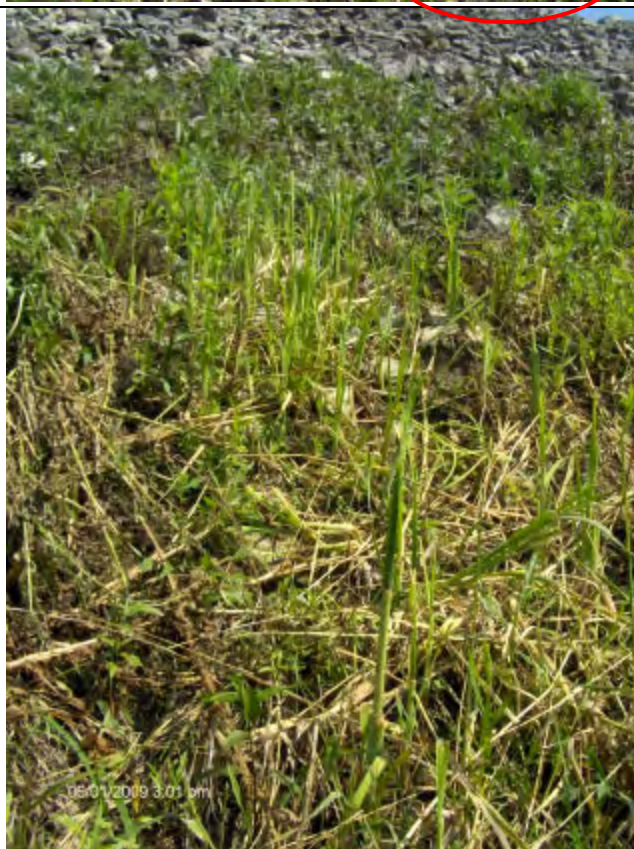
Photo Number:
8

Description:
Typical seepage
at mid-slope
along west
embankment.
Note wetland
vegetation
growing

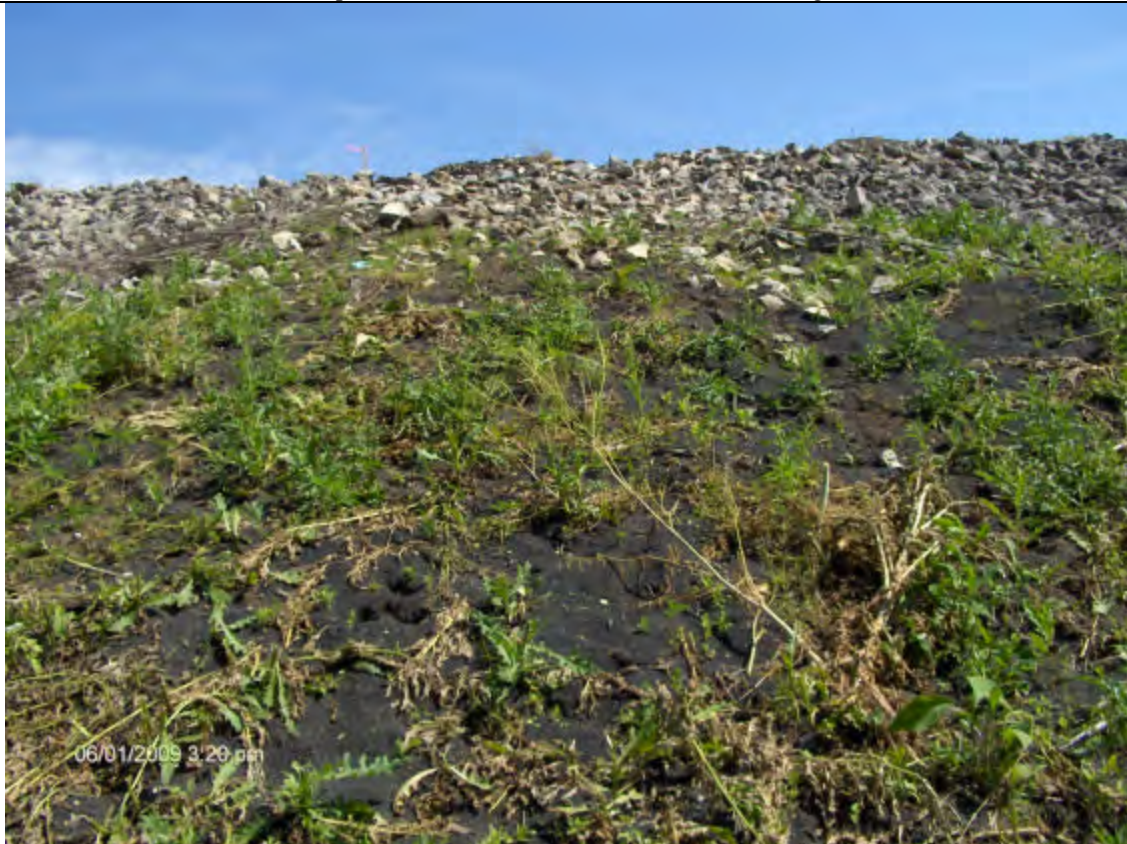
- Bottom ash materials were observed on the slope of the west dike embankment at various locations. These may have been a result of the 1970's addition to the embankment. (Appendix B – Photo 9)

Bottom ash on surface of west embankment slope

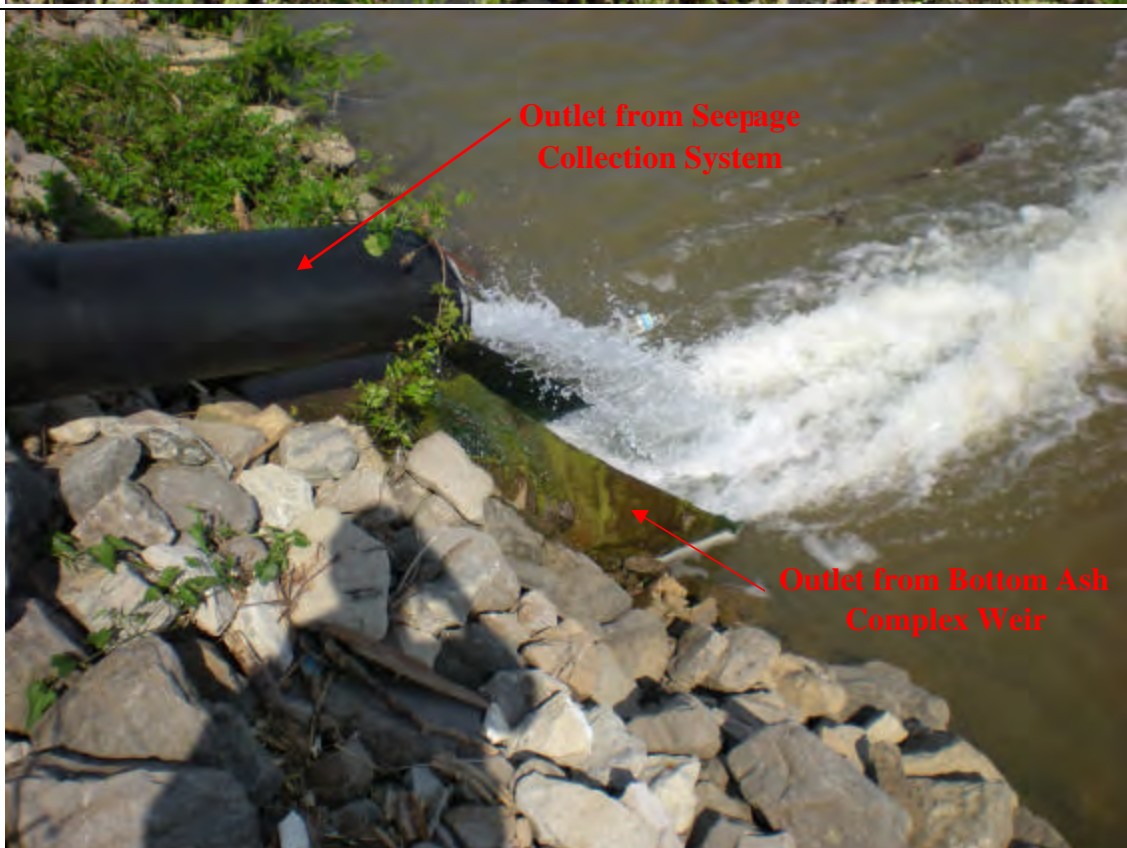
- Water from the seepage collection system in the south dike embankment was observed discharging from the outlet indicating that the system is, at a minimum, operational. (Appendix B – Photo 10)

Discharge piping into Ohio River. Bottom pipe is decant outlet from Bottom Ash Complex. Upper pipe is outlet for french drain seepage collection system installed in south embankment.

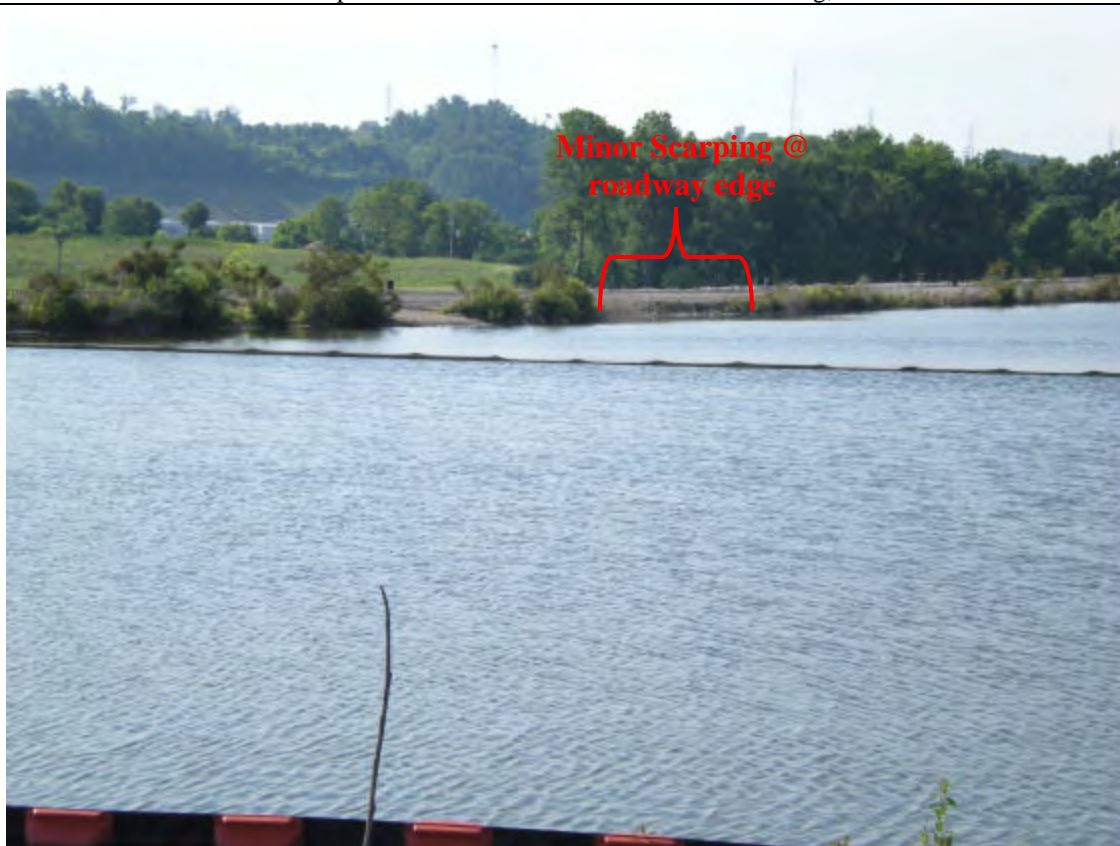
Photo Number:
11

- Minor scarps approximately three to five feet in height were observed at the top of the slope along the upstream side of the south and east dike embankments. (Appendix B – Photo 11)

Description:
Woody vegetation growing along upstream side of south embankment. Note minor scarping at edge of crest roadway.

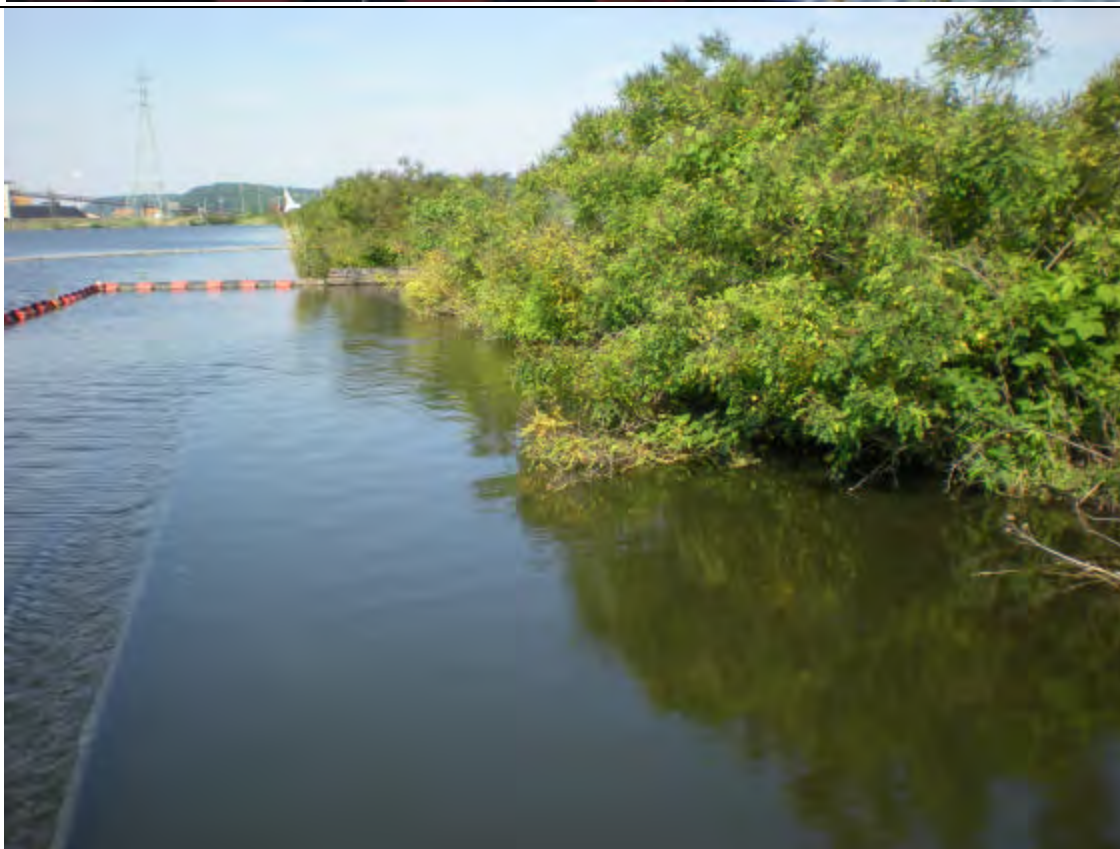
Photo Number:
12

- Shrub type growth up to 2-inch diameter was observed on the upstream side of the east dike embankment. (Appendix B – Photos 11 and 12)
- Isolated seeps were observed at two locations along the east dike embankment. One was located at a former spillway (Appendix B – Photo 13). The other was located where the south embankment seepage collection system formerly discharged. When initially constructed, the discharge from the collection system was located approximately 20' south of its current location.

Description:
Woody vegetation growing on upstream side of east embankment. Note north leg of T-shaped outlet weir at left.

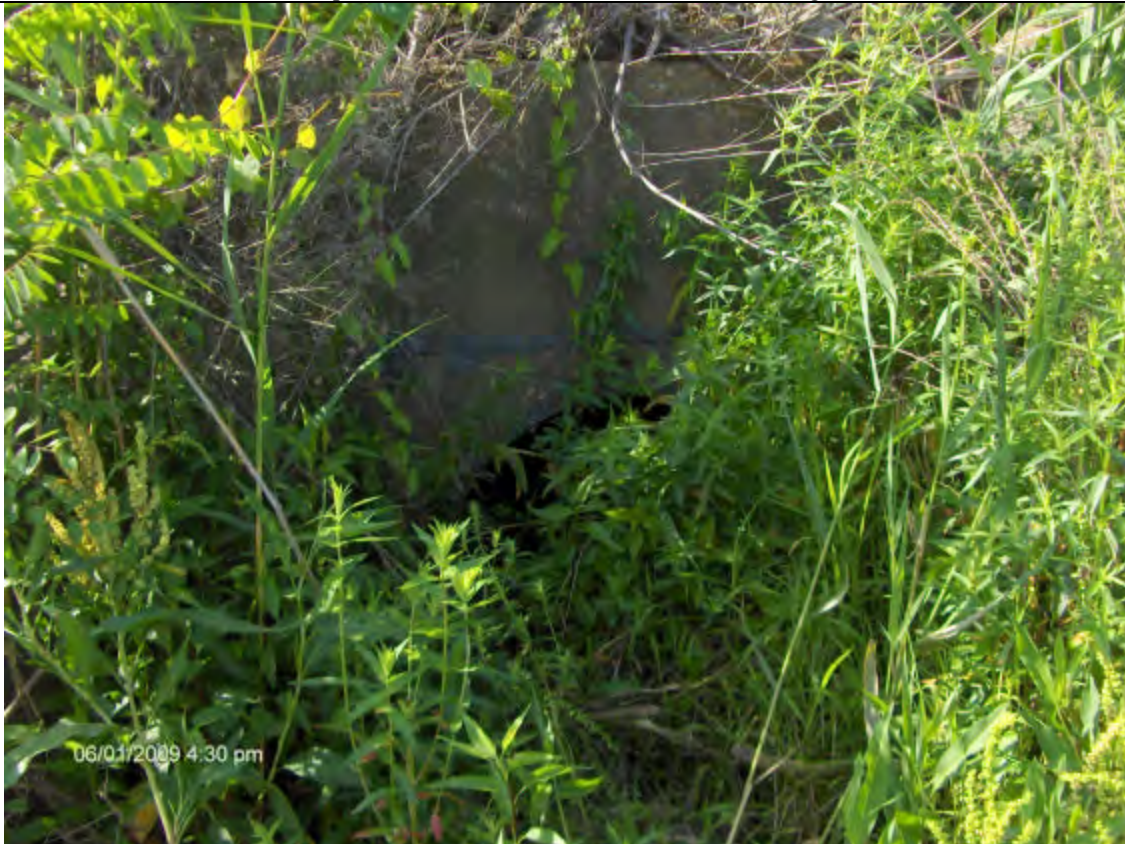
Additionally, the 2008 annual inspection noted that plant personnel desire to eliminate an isolated seepage area on the east dike embankment where the abandoned decant outlet from the original pond is located. At the time of the inspection, seepage was still observed at this location.

Abandoned former outfall. Seepage was noted at this location. Seepage not visible in picture.

Monitoring of the two isolated seeps noted along the east dike embankment should continue with the monthly inspections performed by the plant. These items have been noted in previous annual inspections and methods to repair these locations should be investigated in the event that these seeps worsen and immediate repair is needed.

The isolated seeps on the east dike embankment should continue to be monitored. In the event these areas are observed to worsen, they should be repaired immediately.

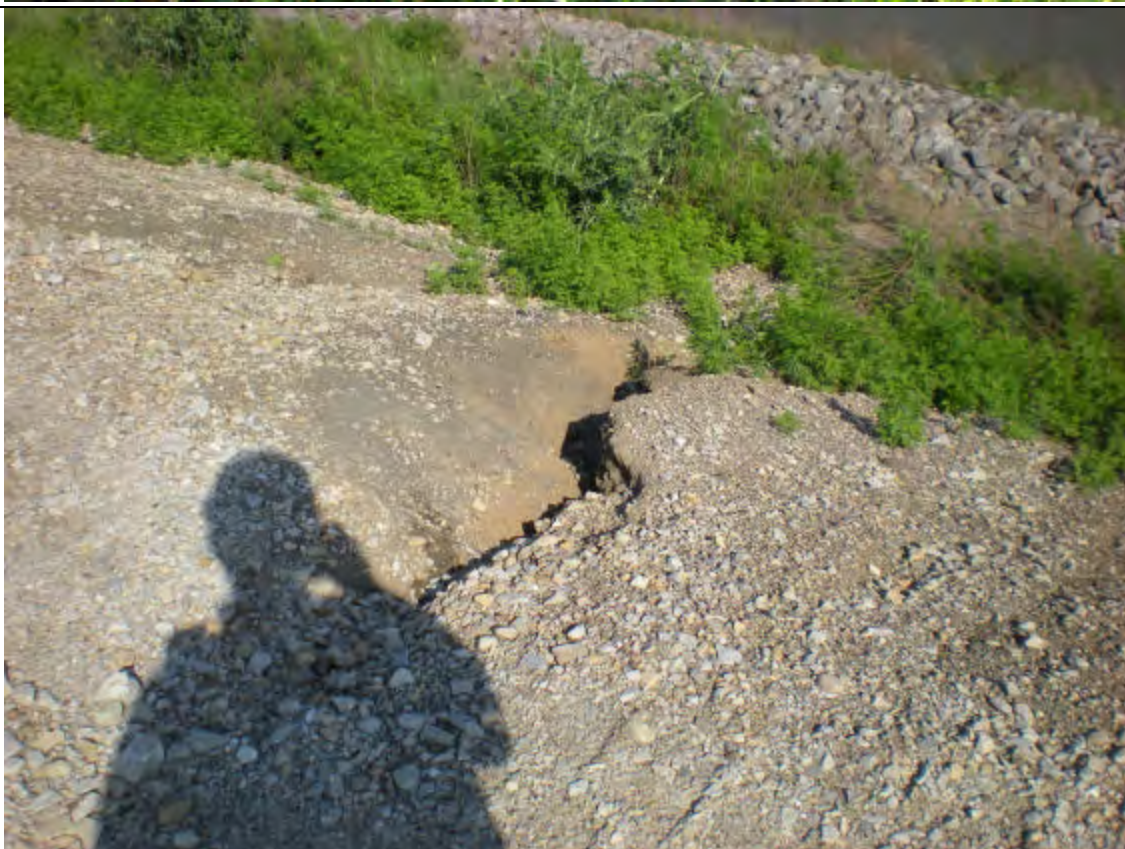
- Minor erosion was observed near the roadway on the embankment crest of the east dike. Eroded areas are typically less than 1-foot deep and extend five to seven feet down the slope (Appendix B – Photo 14).

Typical erosion at edge of roadway on crest of east embankment. Approximately 12" deep and 5' to 7' long
