**Tanner's Creek Fly Ash Pond
Assessment Report**

**Lockheed Martin
Contractor for the USEPA**

September 2009

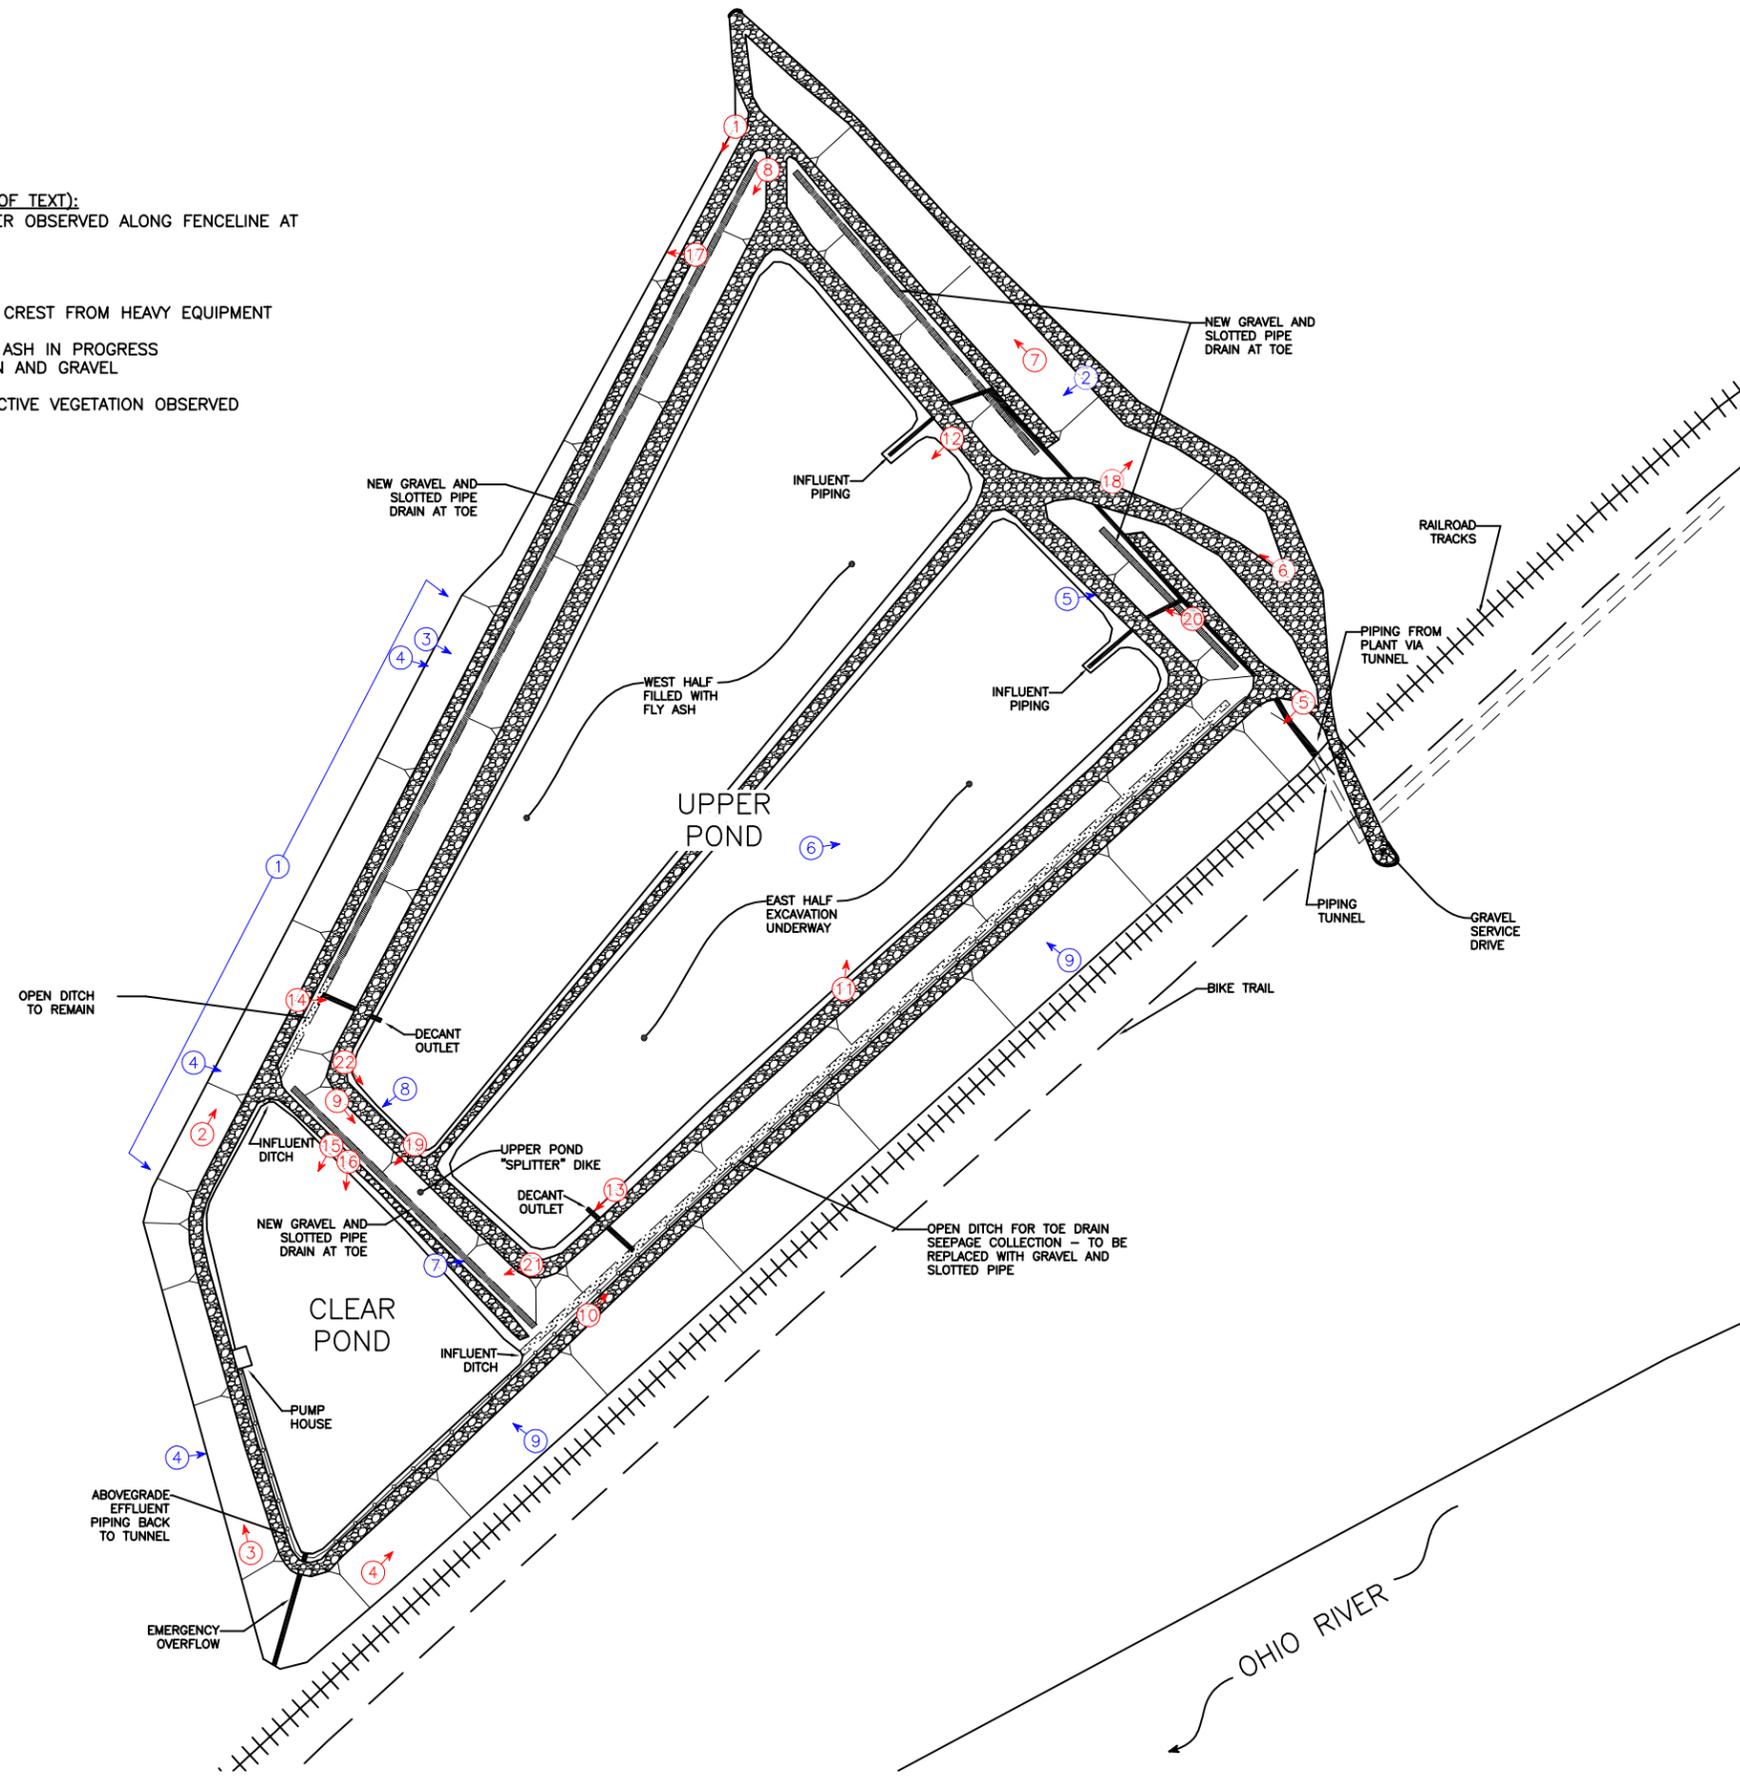
FIGURE 3

1. SHRUBBERY AND TREES UP TO 4" DIAMETER OBSERVED ALONG FENCELINE AT TOE OF WEST EMBANKMENT
2. ISOLATED SEEP
3. MULTIPLE ANIMAL BURROWS
4. ANIMAL BURROW UNDER FENCE
5. ELEVATION DIFFERENCES OBSERVED ALONG CREST FROM HEAVY EQUIPMENT TRAFFIC
6. OBSERVED EXCAVATION OF DEPOSITED FLY ASH IN PROGRESS
7. OBSERVED INSTALLATION OF SLOTTED DRAIN AND GRAVEL
8. MINOR SCARPS OBSERVED
9. EQUIPMENT RUTS AND REMOVAL OF PROTECTIVE VEGETATION OBSERVED

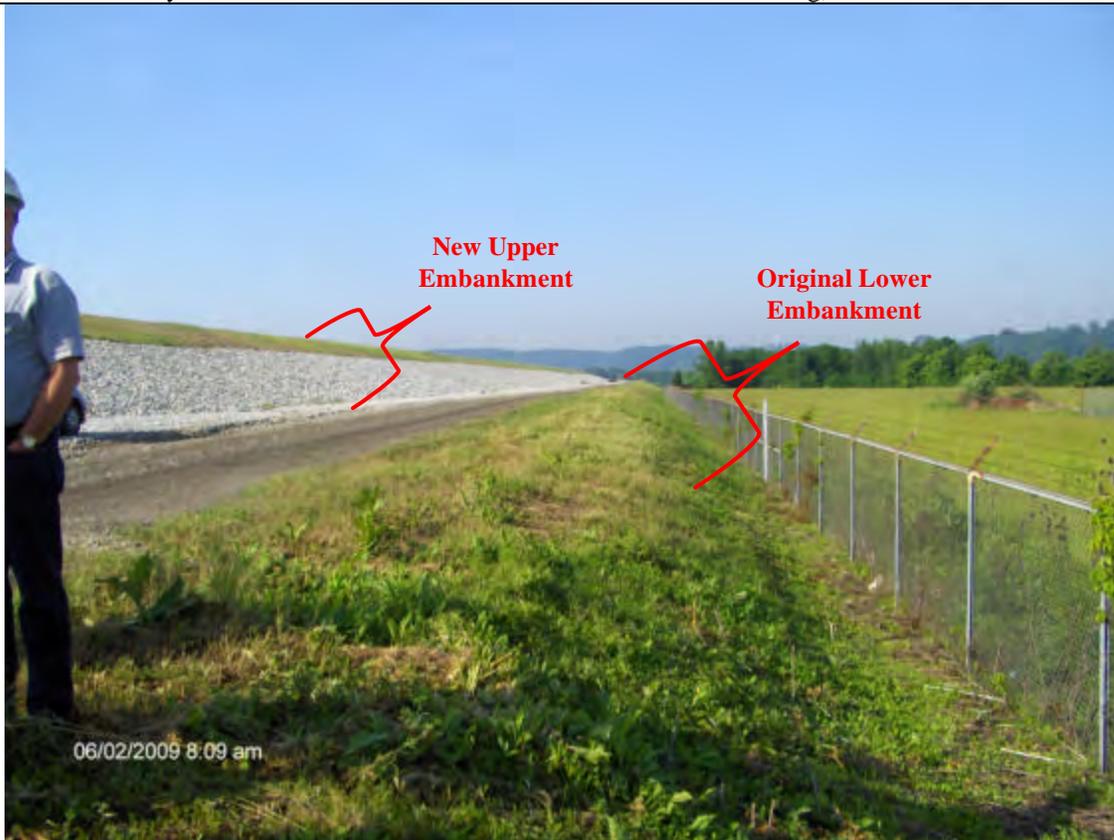
Photo Number:
 1

Description:
 View along west embankment. Note original lower embankment and new upper embankment.

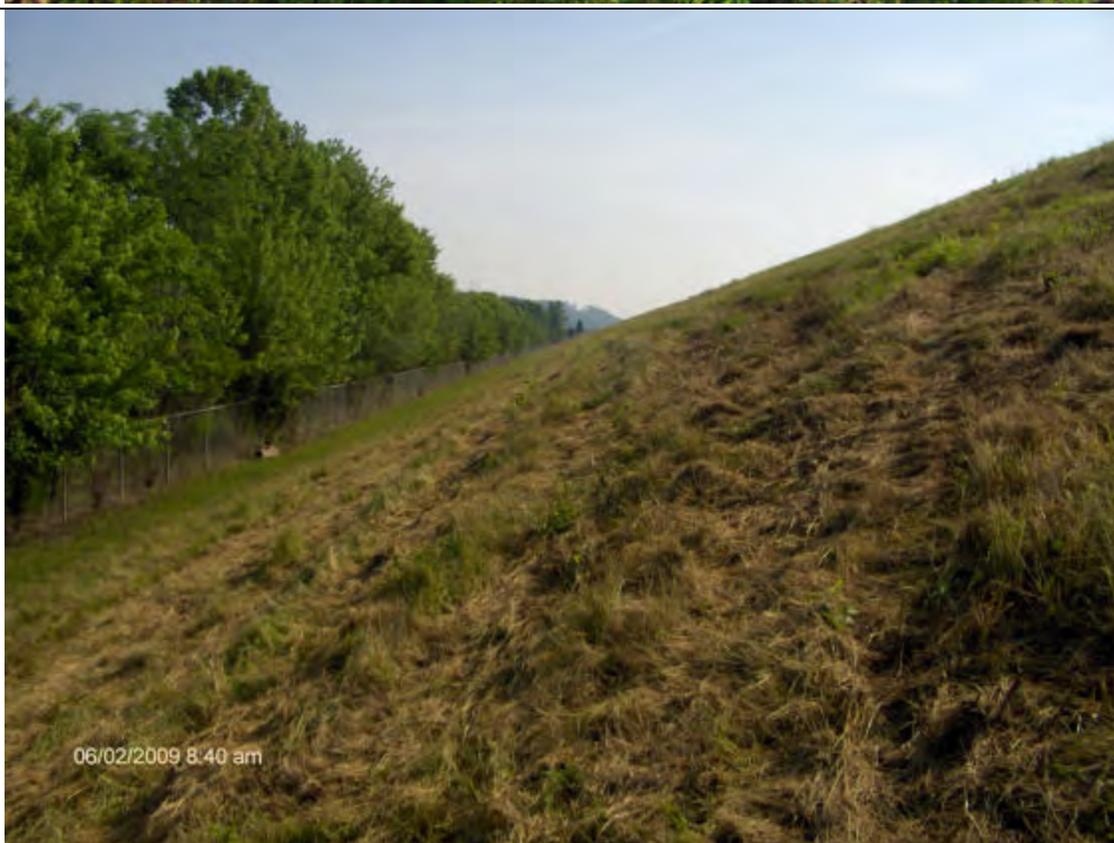
Photo Number:
 2

Description:
 View along west side of original lower embankment.

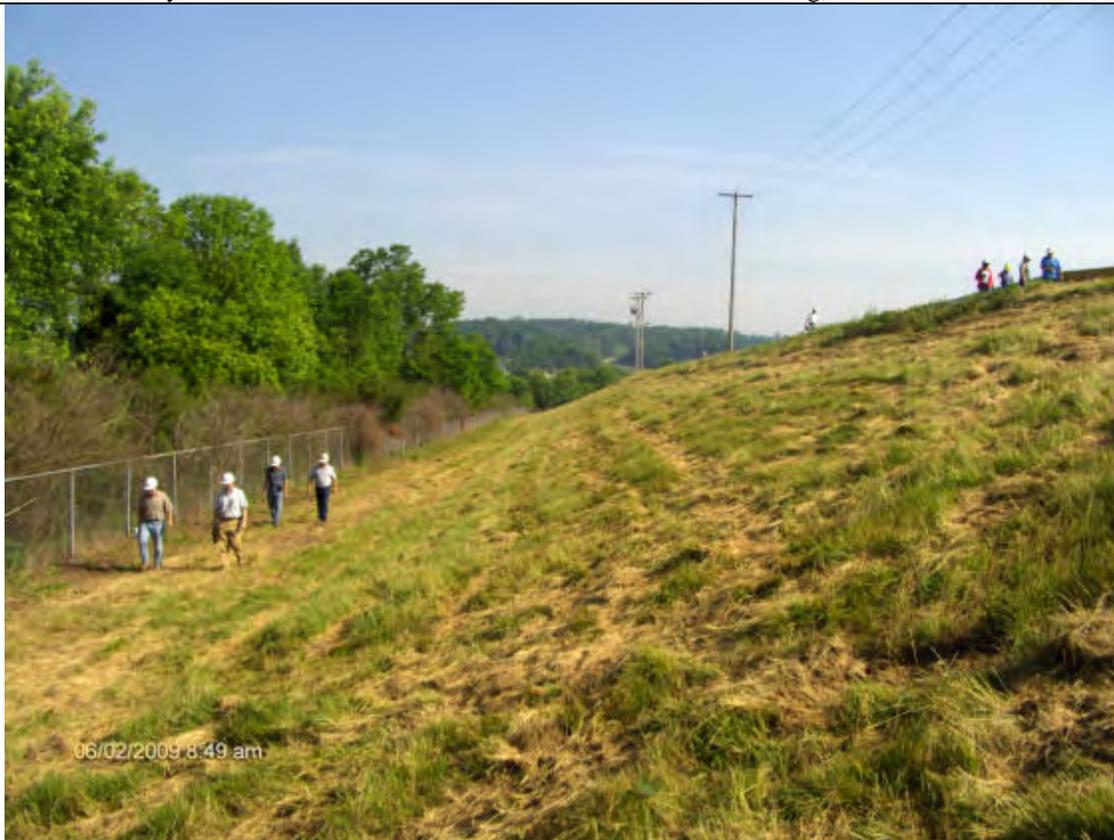
Date:
 6/2/09
 Photo Number:
 3
 Photographer:
 JPH

Orientation:
 West
 Description:
 View along south embankment of original structure.

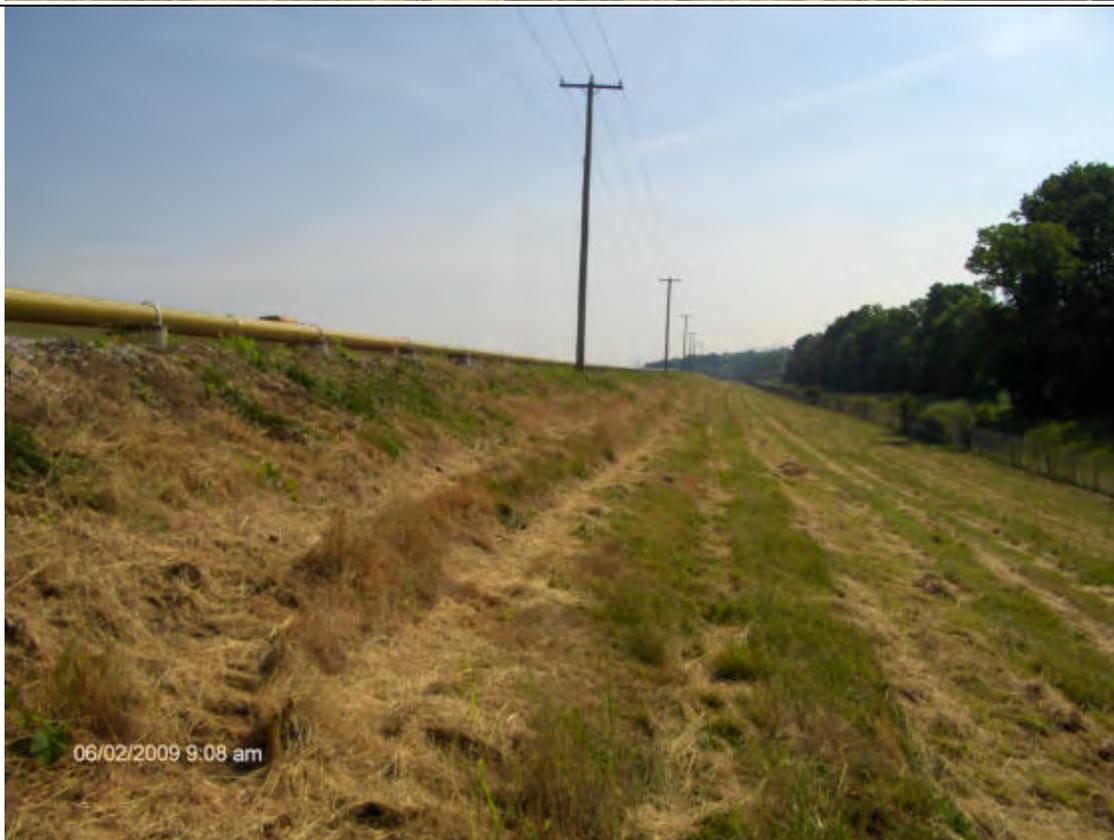
Date:
 6/2/09
 Photo Number:
 4
 Photographer:
 JPH

Orientation:
 North
 Description:
 View along east embankment of original structure. Note FRP piping along crest of original dike.

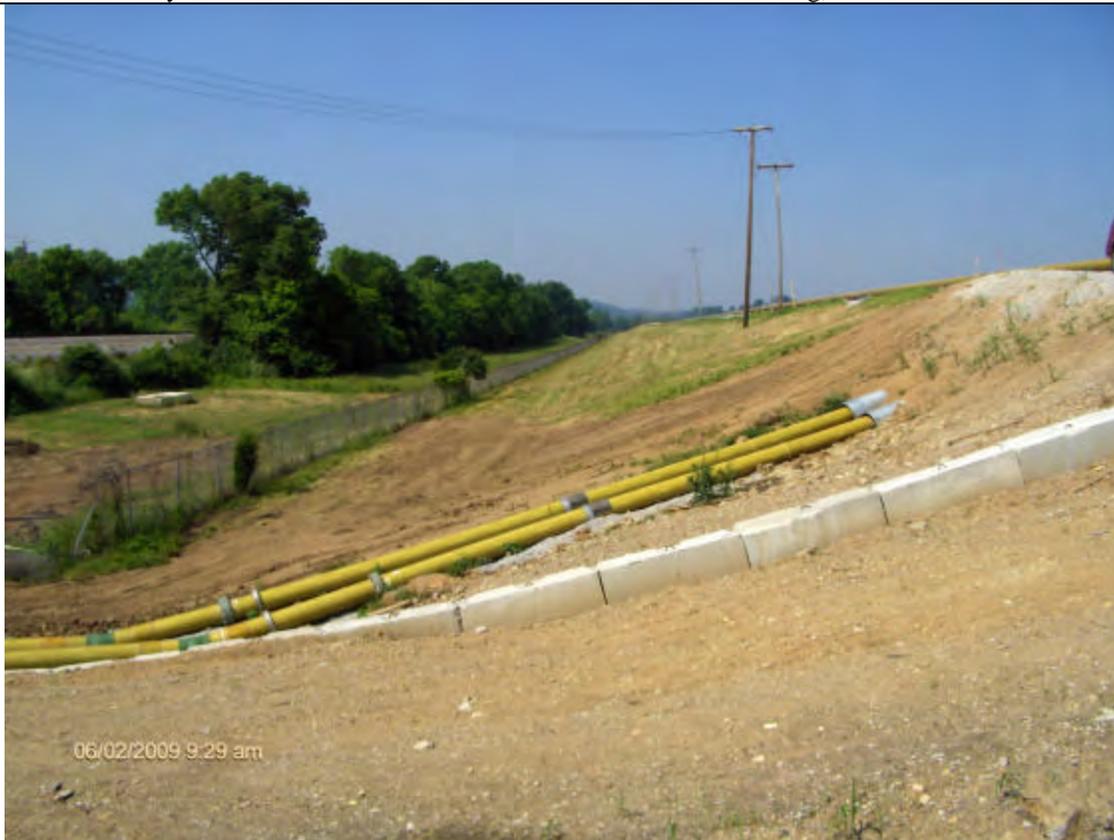
Photo Number:
 5

Description:
 View along east embankment of original structure. Note new access drive to road on crest of original dike and FRP discharge piping in foreground.

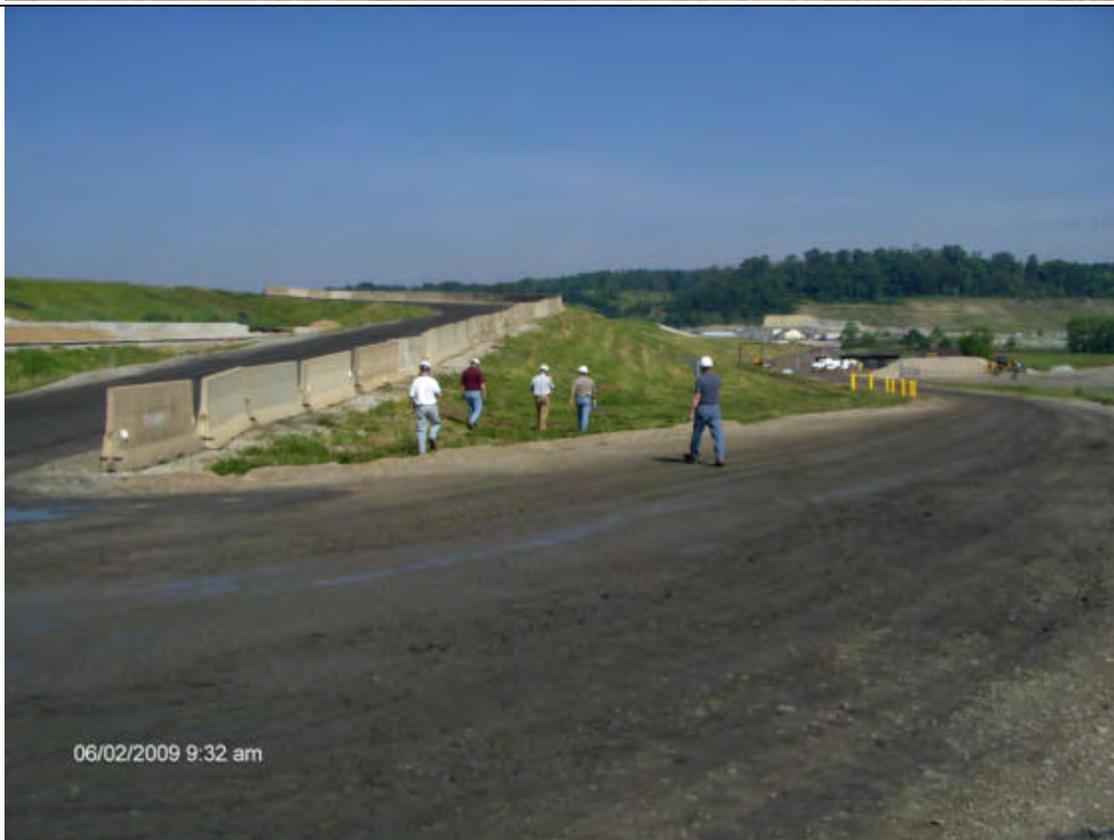
Photo Number:
 6

Description:
 View of north embankment and construction access road to Upper Pond for excavation work and transport of excavated fly ash.

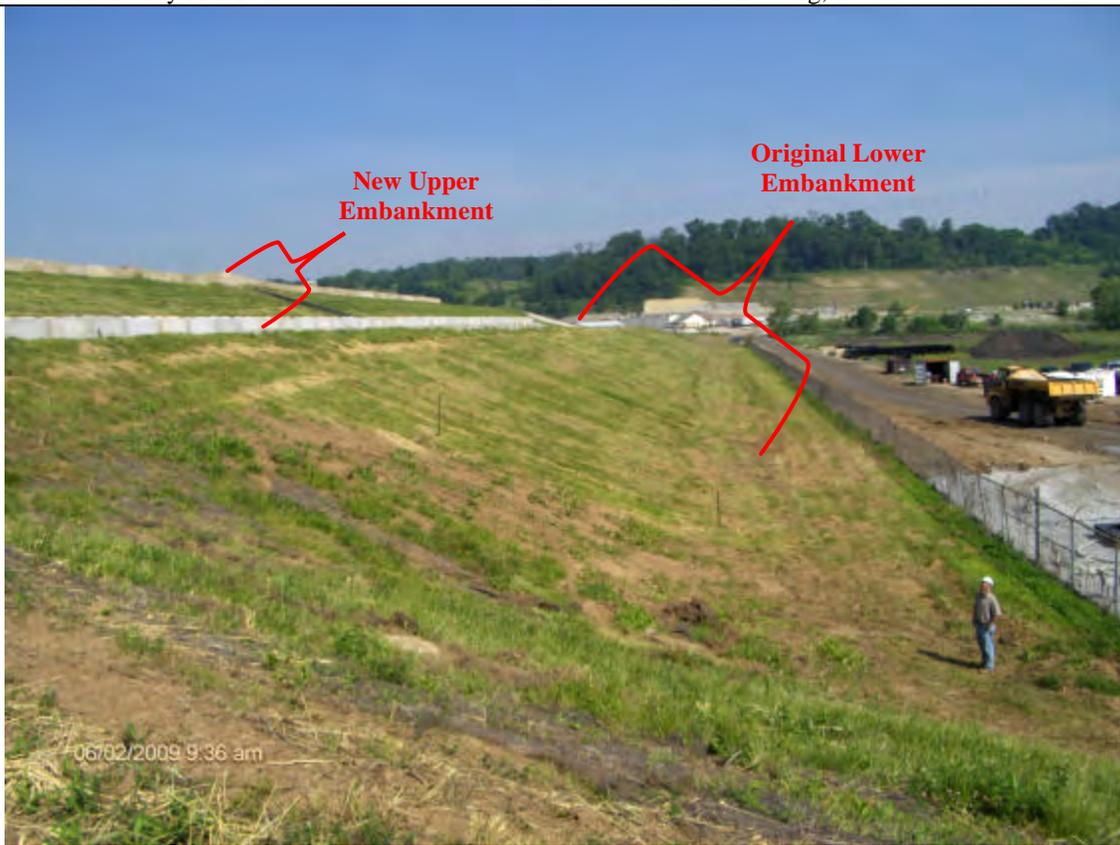
Photo Number:
7

Description:
View of north embankment. Note original lower portion and new upper portion of embankment.

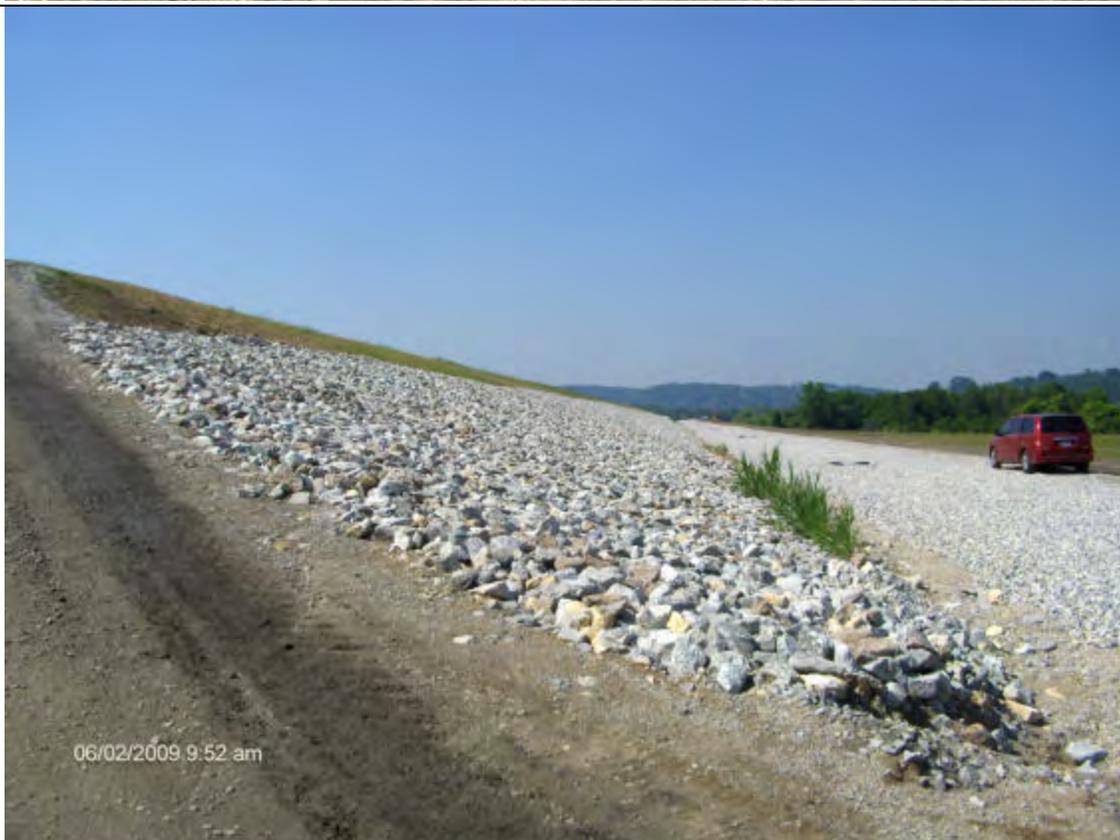
Photo Number:
8

Description:
View along west embankment of Upper Pond. Note roadway at left leads up to crest of new upper embankment.

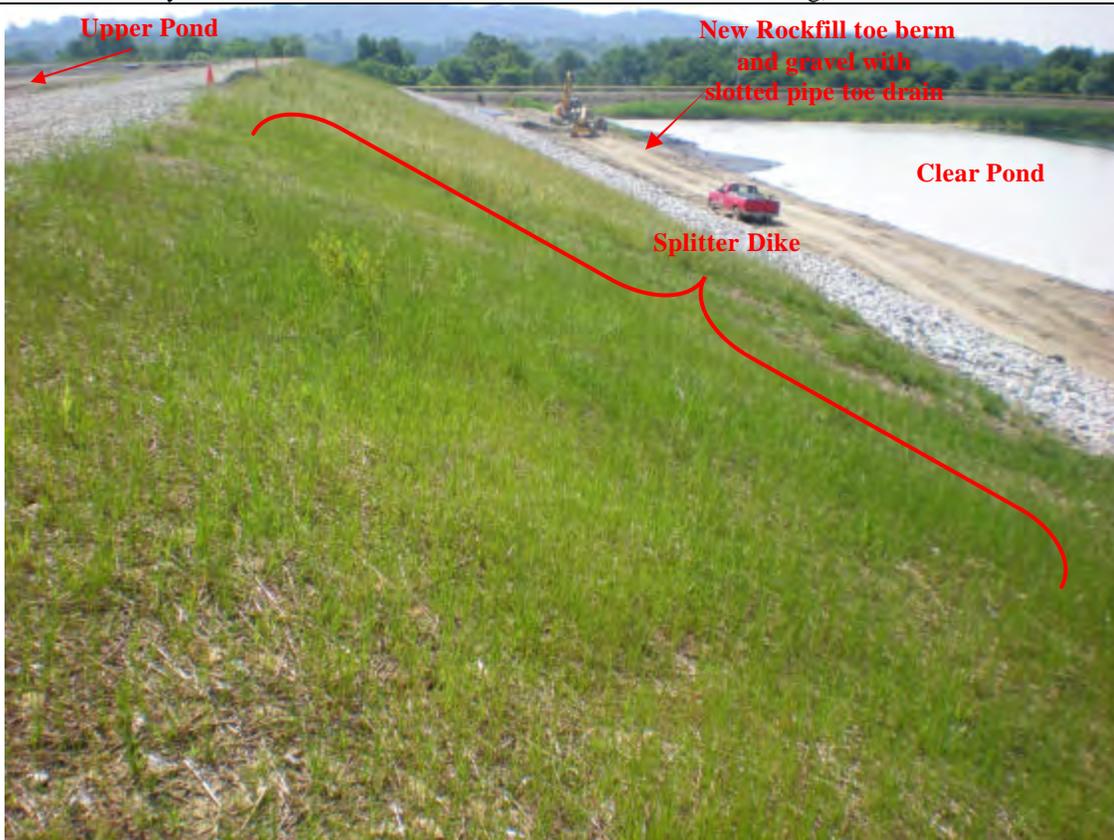
Photo Number:
 9

- Piezometers were installed upon completion of the upper dikes to monitor seepage.
- As part of the 2002 Upper Pond construction the rectangular concrete emergency spillway was added to the Clear Pond.
- The downstream slopes of the new Upper Pond were reinforced with riprap and vegetation in 2008 and 2009.
- A gravel and slotted pipe toe drain collection system is under construction and will replace the open channel that currently conveys seepage from the Upper Pond embankment toe drain to the Clear Pond. South of the Splitter Dike, an additional rockfill toe berm was added to accommodate installation of the slotted pipe collection system (Appendix B – Photo 9).

Description:
 View along splitter dike of Upper Pond. Clear pond at right, Upper Pond at top left.

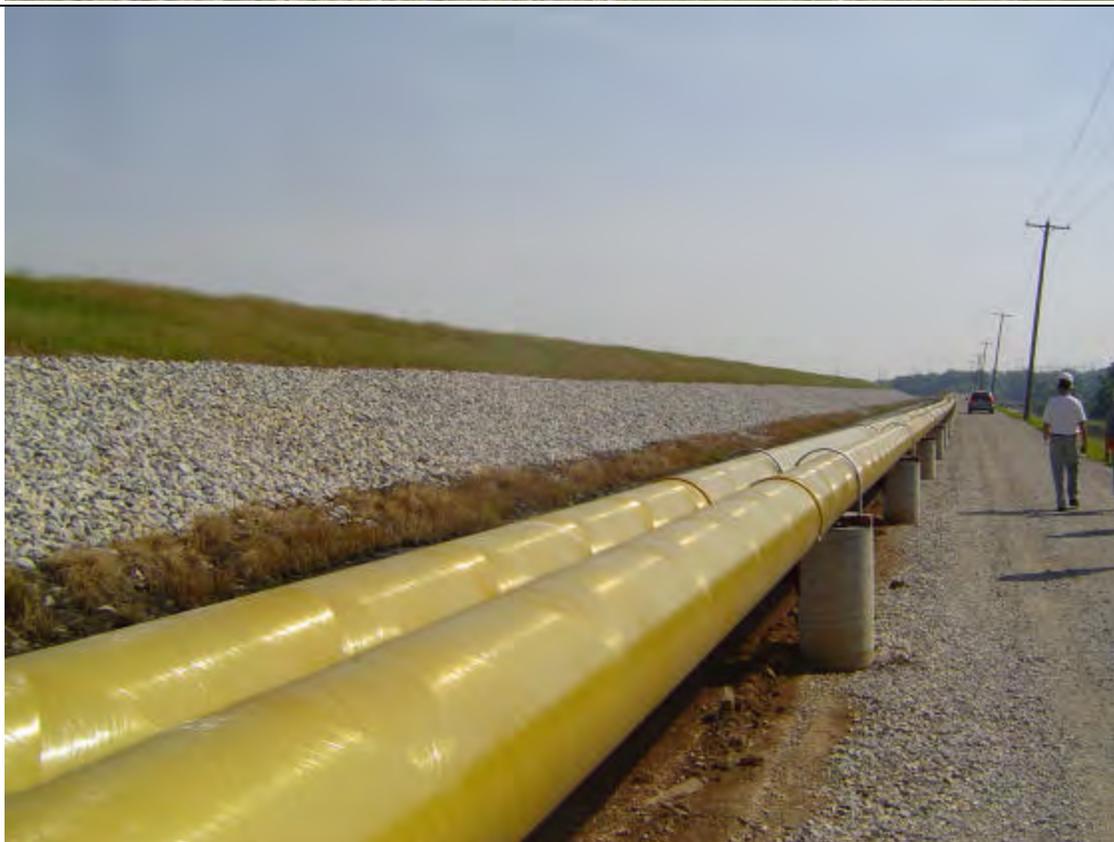
Photo Number:
 10

Description:
 View along east embankment of Upper Pond. Discharge piping from Clear Pond shown in foreground.

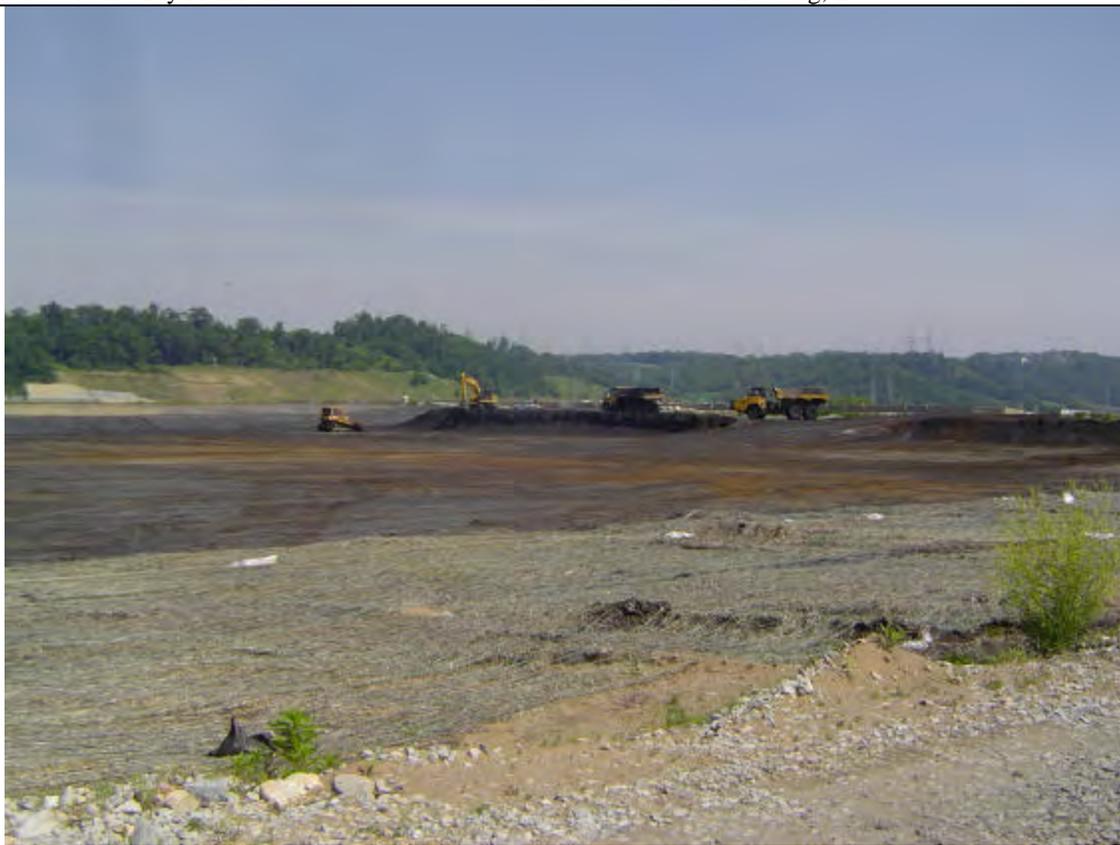
Photo Number:
11

- Minor elevation differences were noted along the crest of the Upper Pond due to heavy equipment traffic.
- Excavation of deposited fly ash was observed at the Upper Pond (Appendix B – Photo 11).

Description:
Excavation of stored fly ash from east half of Upper Pond in progress. Excavated fly ash is destined for facility's new fly ash landfill.

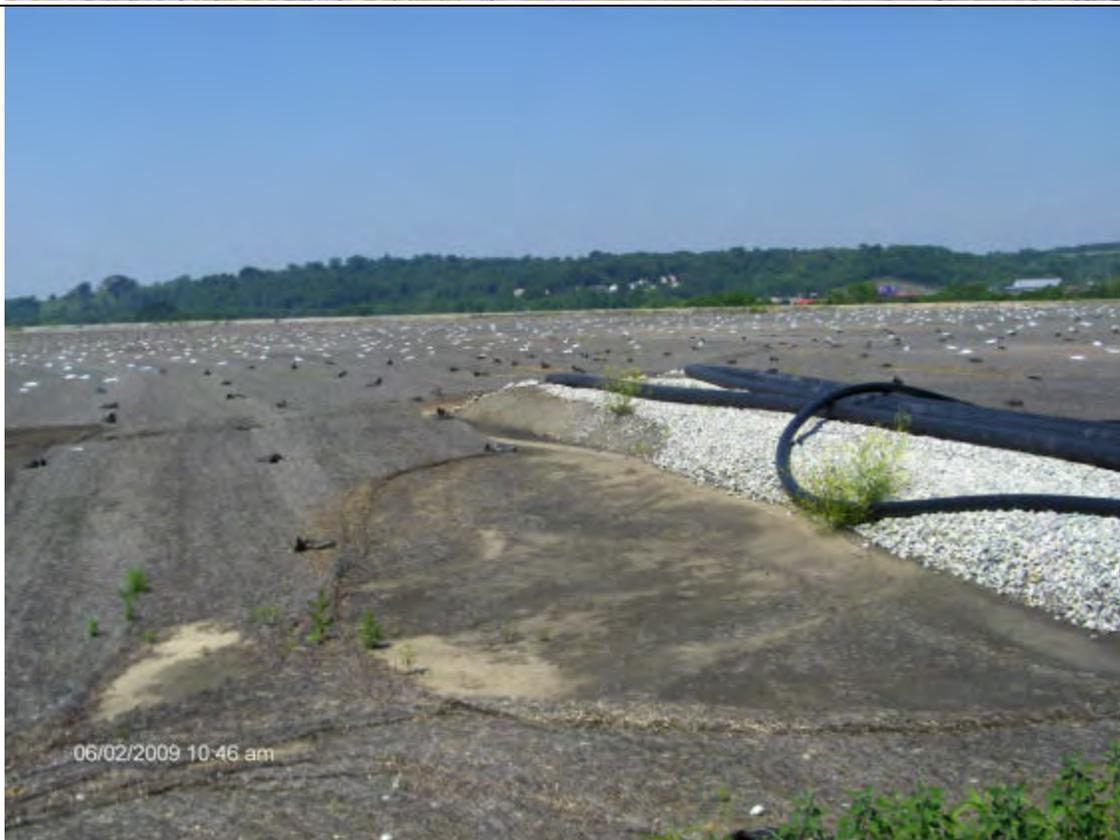
Photo Number:
12

Description:
Stored ash in west half of Upper Pond. Inlet piping shown at right. Note sandbags placed on straw matting to control dust.

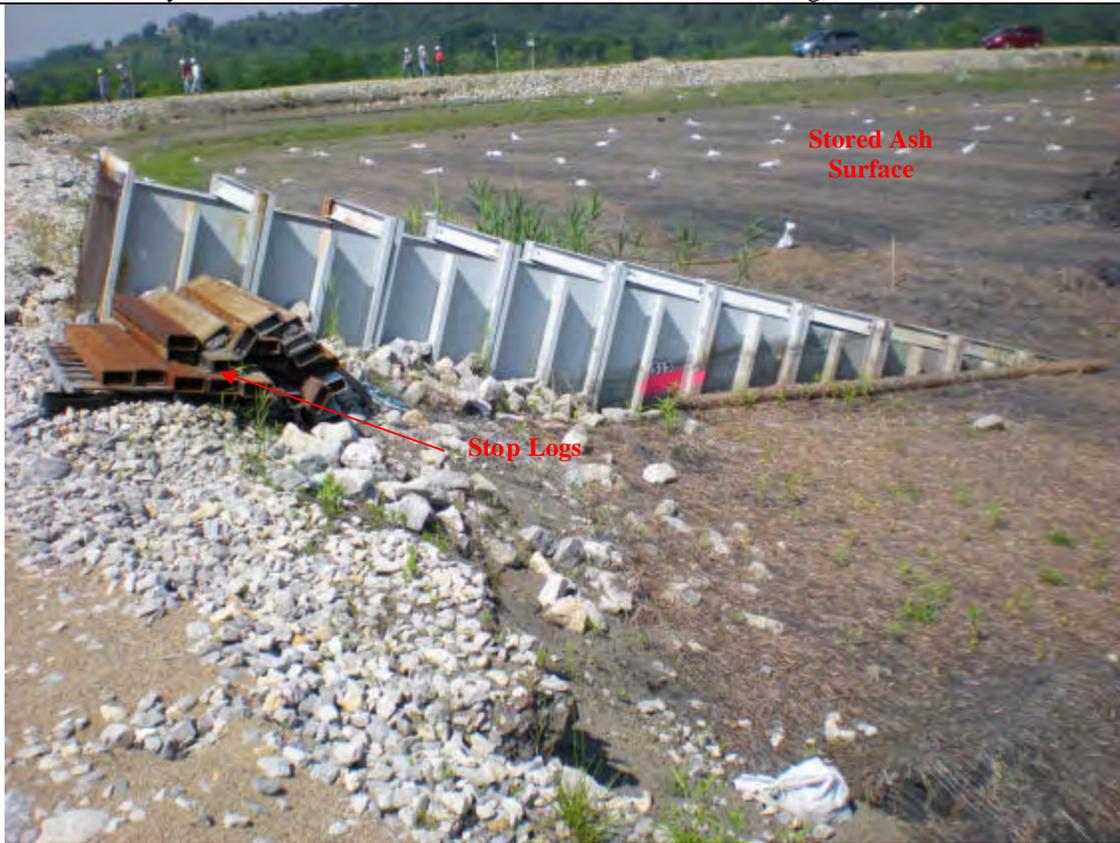
Photo Number:
 13

Description:
 Inlet to Upper Pond decant structure. Note stop logs stored at left and stored ash in picture background.

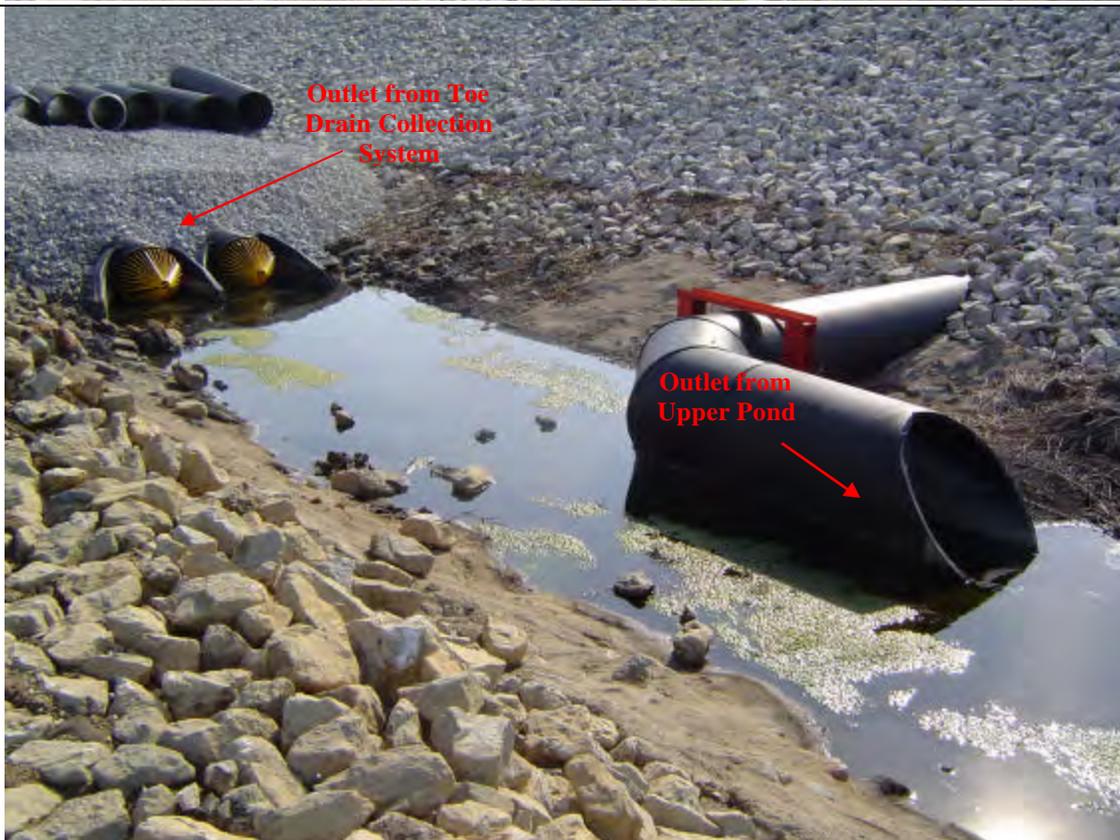
Photo Number:
 14

Description:
 Outlet from new slotted pipe toe drain collection system and outlet from Upper Pond into ditch.

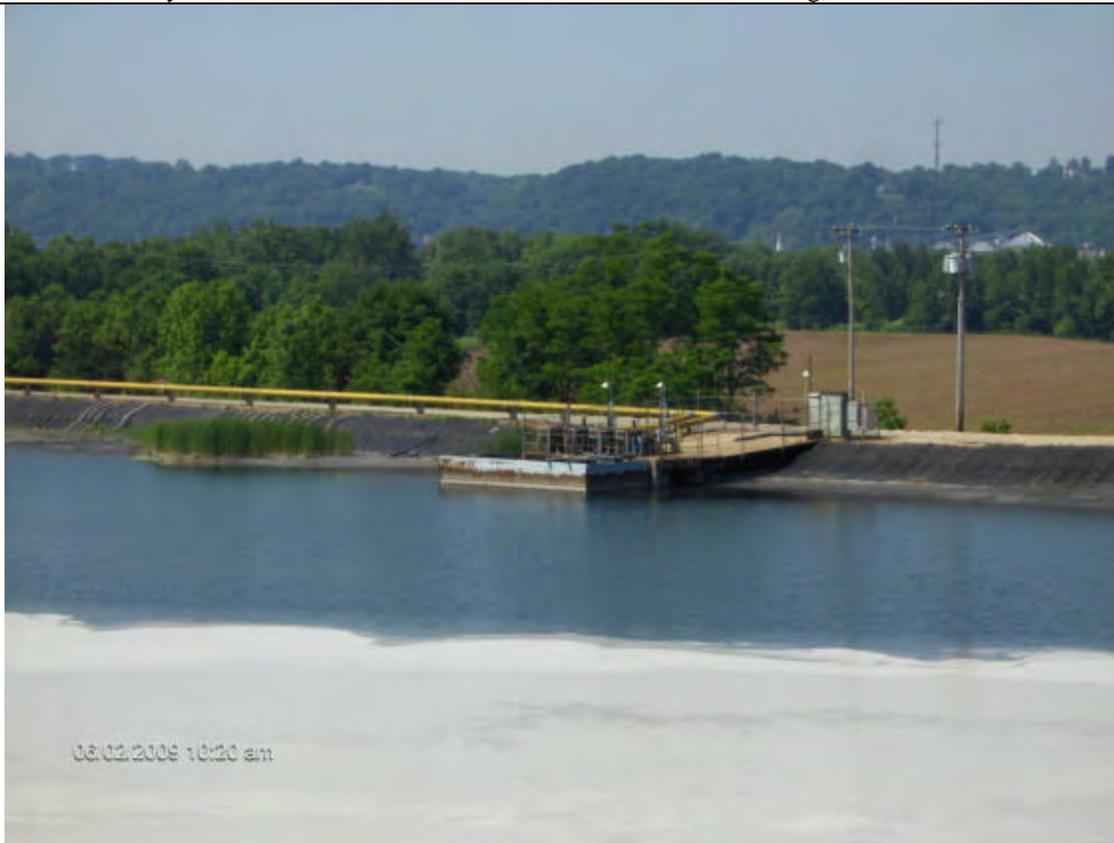
Photo Number:
 15

Description:
 Discharge
 pumping
 equipment in
 Clear Pond

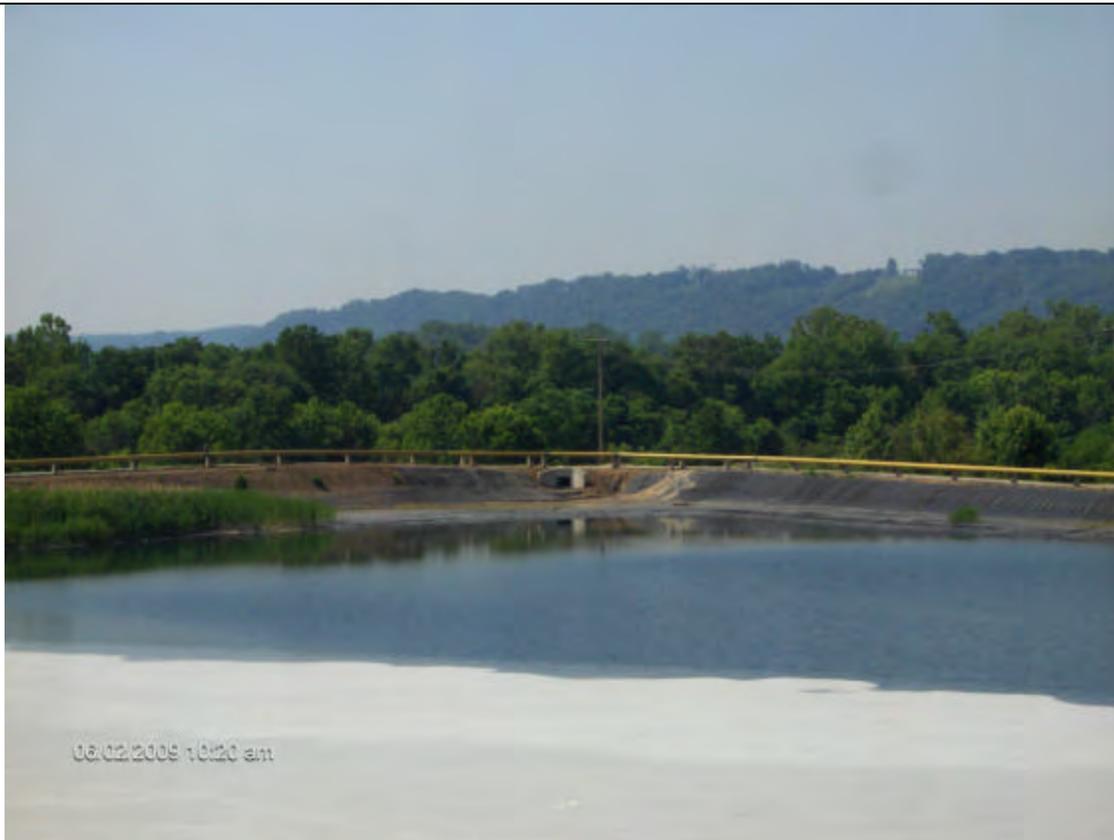
Photo Number:
 16

Description:
 Emergency
 overflow inlet at
 southeast corner
 of Clear Pond

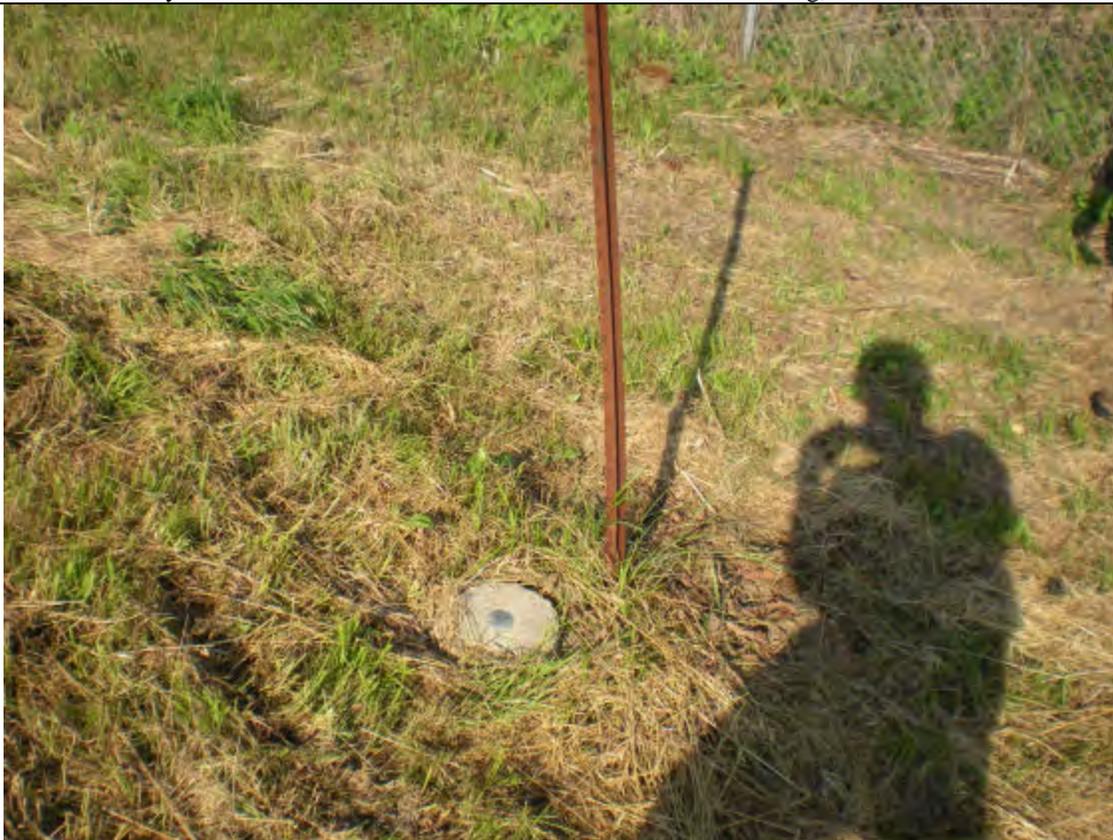
Photo Number:
 17

Description:
 Surface monitoring point located on west embankment of original structure

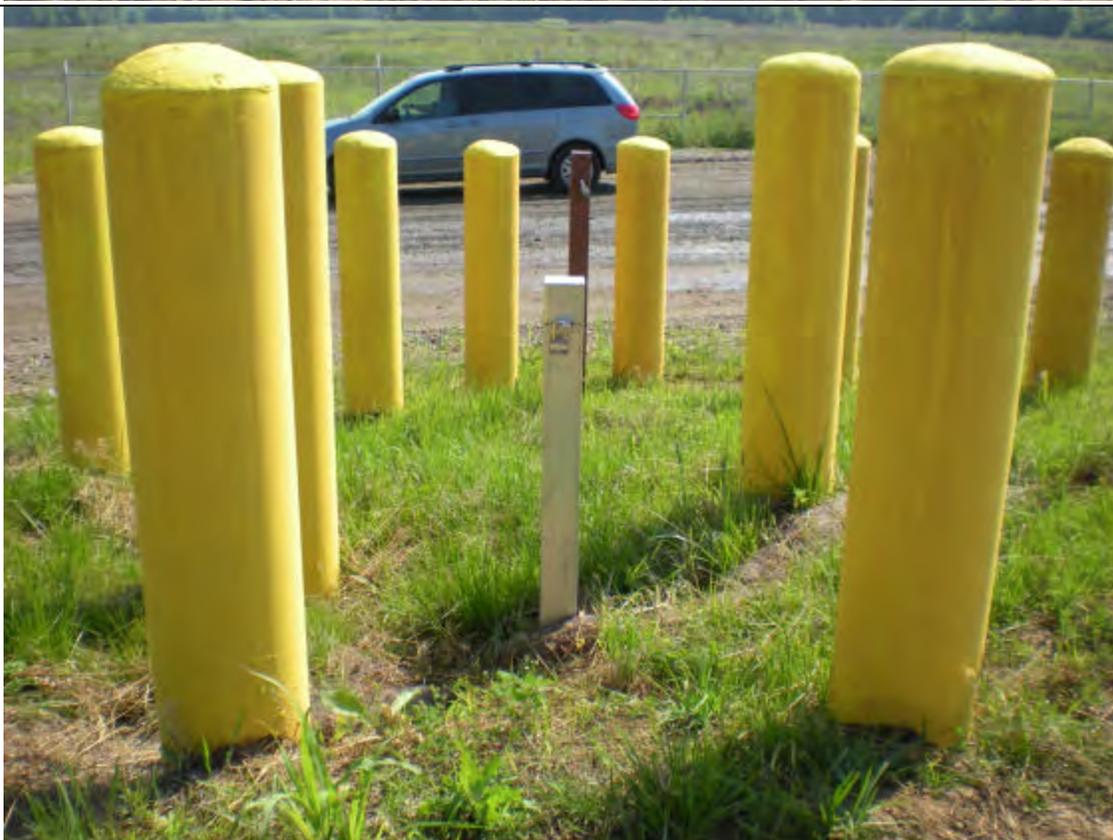
Photo Number:
 18

Description:
 Slope indicator located near toe of slope on original North Embankment. Monument is heavily protected by concrete bollards.

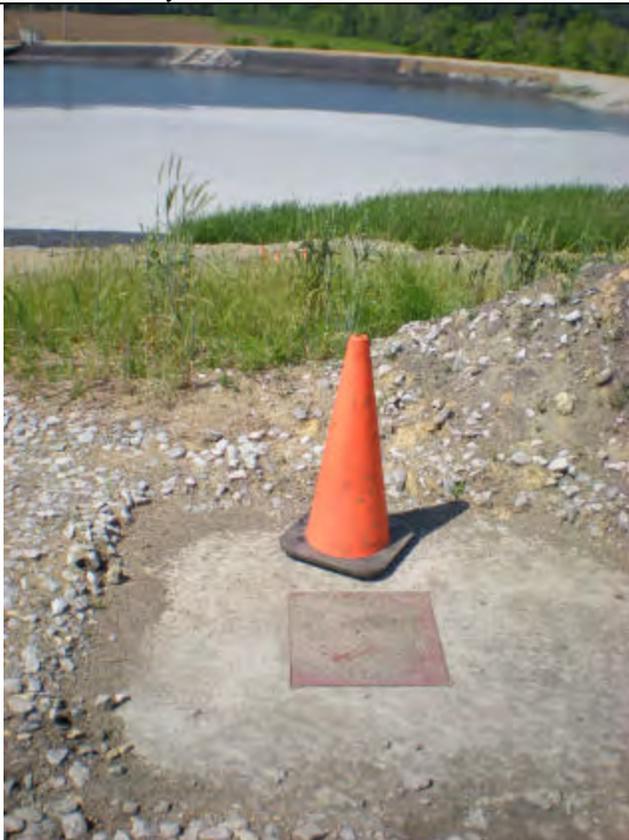
Photo Number:
 19

Description:
 Vault for
 settlement plate
 on crest of the
 Upper Pond
 splitter dike.

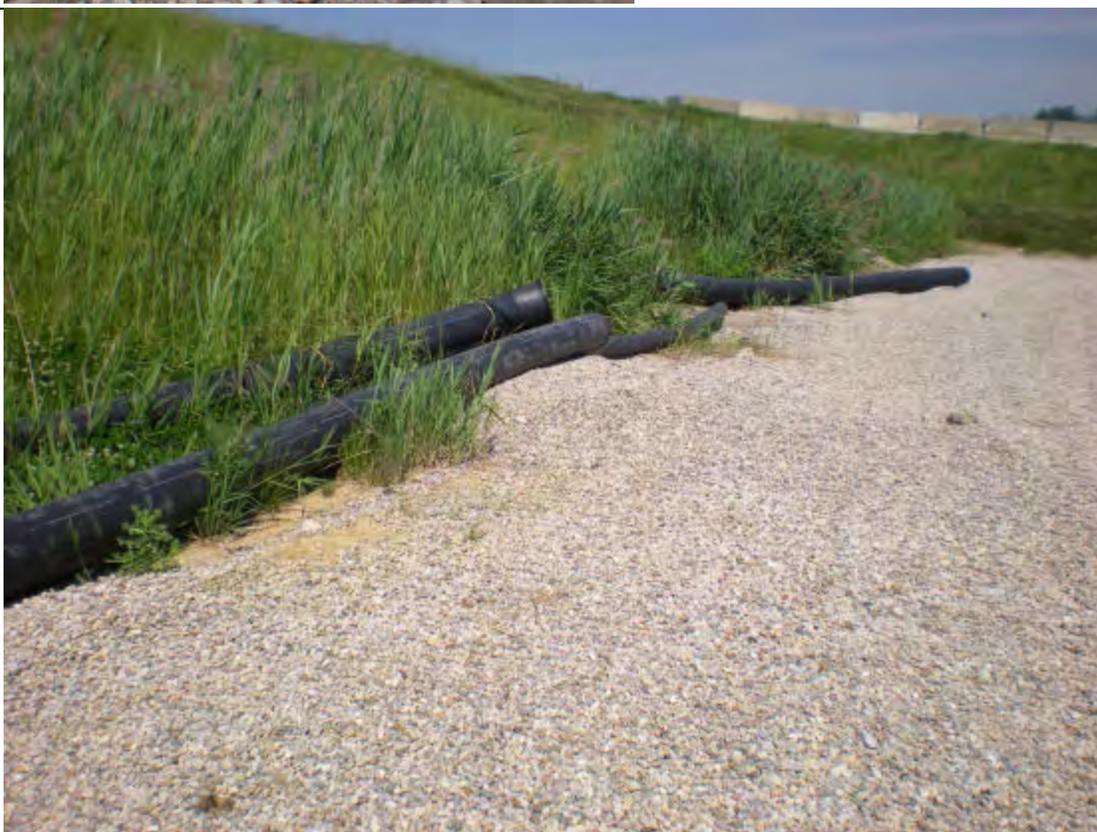
Photo Number:
 20

- An isolated seep of clear water was observed on the north slope near the construction access road (Appendix B - Photo 20).
- Areas rutted by equipment and missing vegetative cover were observed at two locations on the east slope of the original embankments.

Description:
 Wetland type
 vegetation
 growing on
 north side of
 upper
 embankment
 near isolated
 seepage at the
 toe of the slope.
