**Tanner's Creek Fly Ash Pond
Assessment Report**

**Lockheed Martin
Contractor for the USEPA**

September 2009

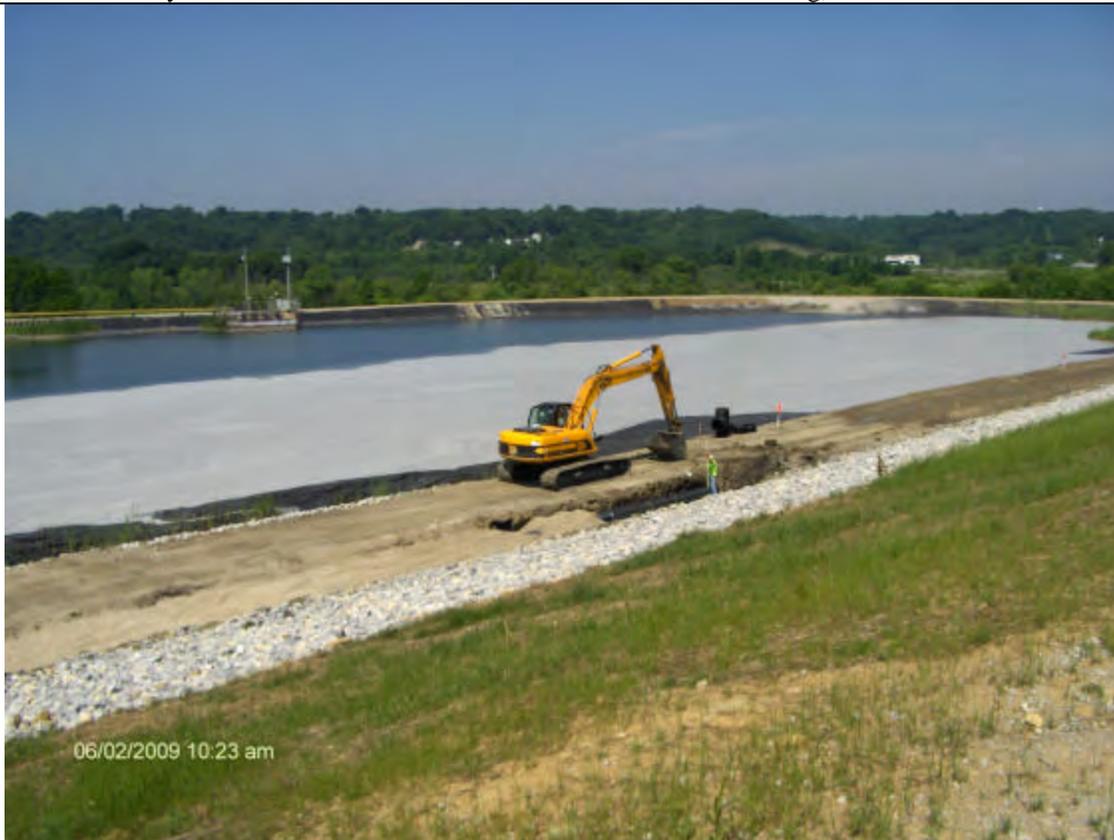
Photo Number:
 21

- Installation of the new slotted seepage collection system was observed along the splitter dike (Appendix B – Photo 21).
- Minor scarps were observed along the top of the upstream side of the east and south embankment slopes of the Upper Pond. Scarps are typically three feet in height and are made more prominent by the addition of roadway aggregate on the embankment crest (Appendix B – Photo 22).

Description:
 Installation of
 slotted pipe toe-
 drain collection
 system at toe of
 Upper Pond
 splitter dike.

A slotted pipe toe drain system is currently being installed to replace the drainage ditch which currently collects seepage from the Upper Pond. The owner should continue as planned with this modification to improve the conveyance of water away from the toe.

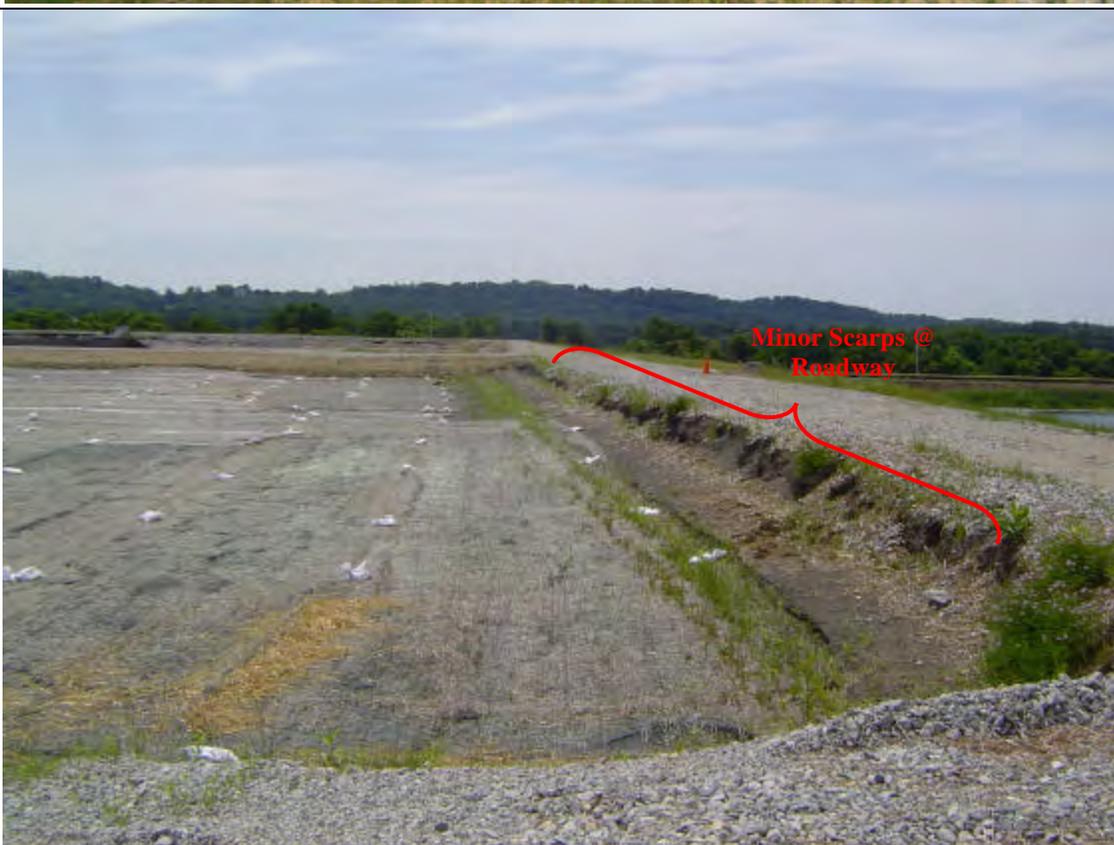
Photo Number:
 22

17	Numerous minor scarps were observed along the top of the upstream side of the 'east' and 'south' embankment slopes. Scarps are typically 3' in height and are made more prominent by the addition of roadway aggregate on the embankment crest.
20	Fly Ash Pond not in operation at time of inspection
21	The base of the dike is constructed with a porous gravel toe drain that is designed to collect embankment seepage. A slotted drainpipe is currently being installed at downstream toe around perimeter of dike to replace the existing ditch which conveys the embankment seepage to the outlet.
23	During inspection, the upper pond was filled to capacity with fly ash and fully drained of free surface water. However, when receiving new fly ash, or in an extreme precipitation event, the level of the clear pond (lower pool) may be elevated and this water may rest against the toe of the 'south' (splitter) dike.

Description:
 Minor scarps
 along roadway
 on upstream
 side of Upper
 Pond splitter
 dike.
