Coal Combustion Residue Impoundment  
Round 9 - Dam Assessment Report  
*Big Bend Power Station*  
*Ash Management Units*  
*Tampa Electric Company*  
*Hillsborough County, Florida*

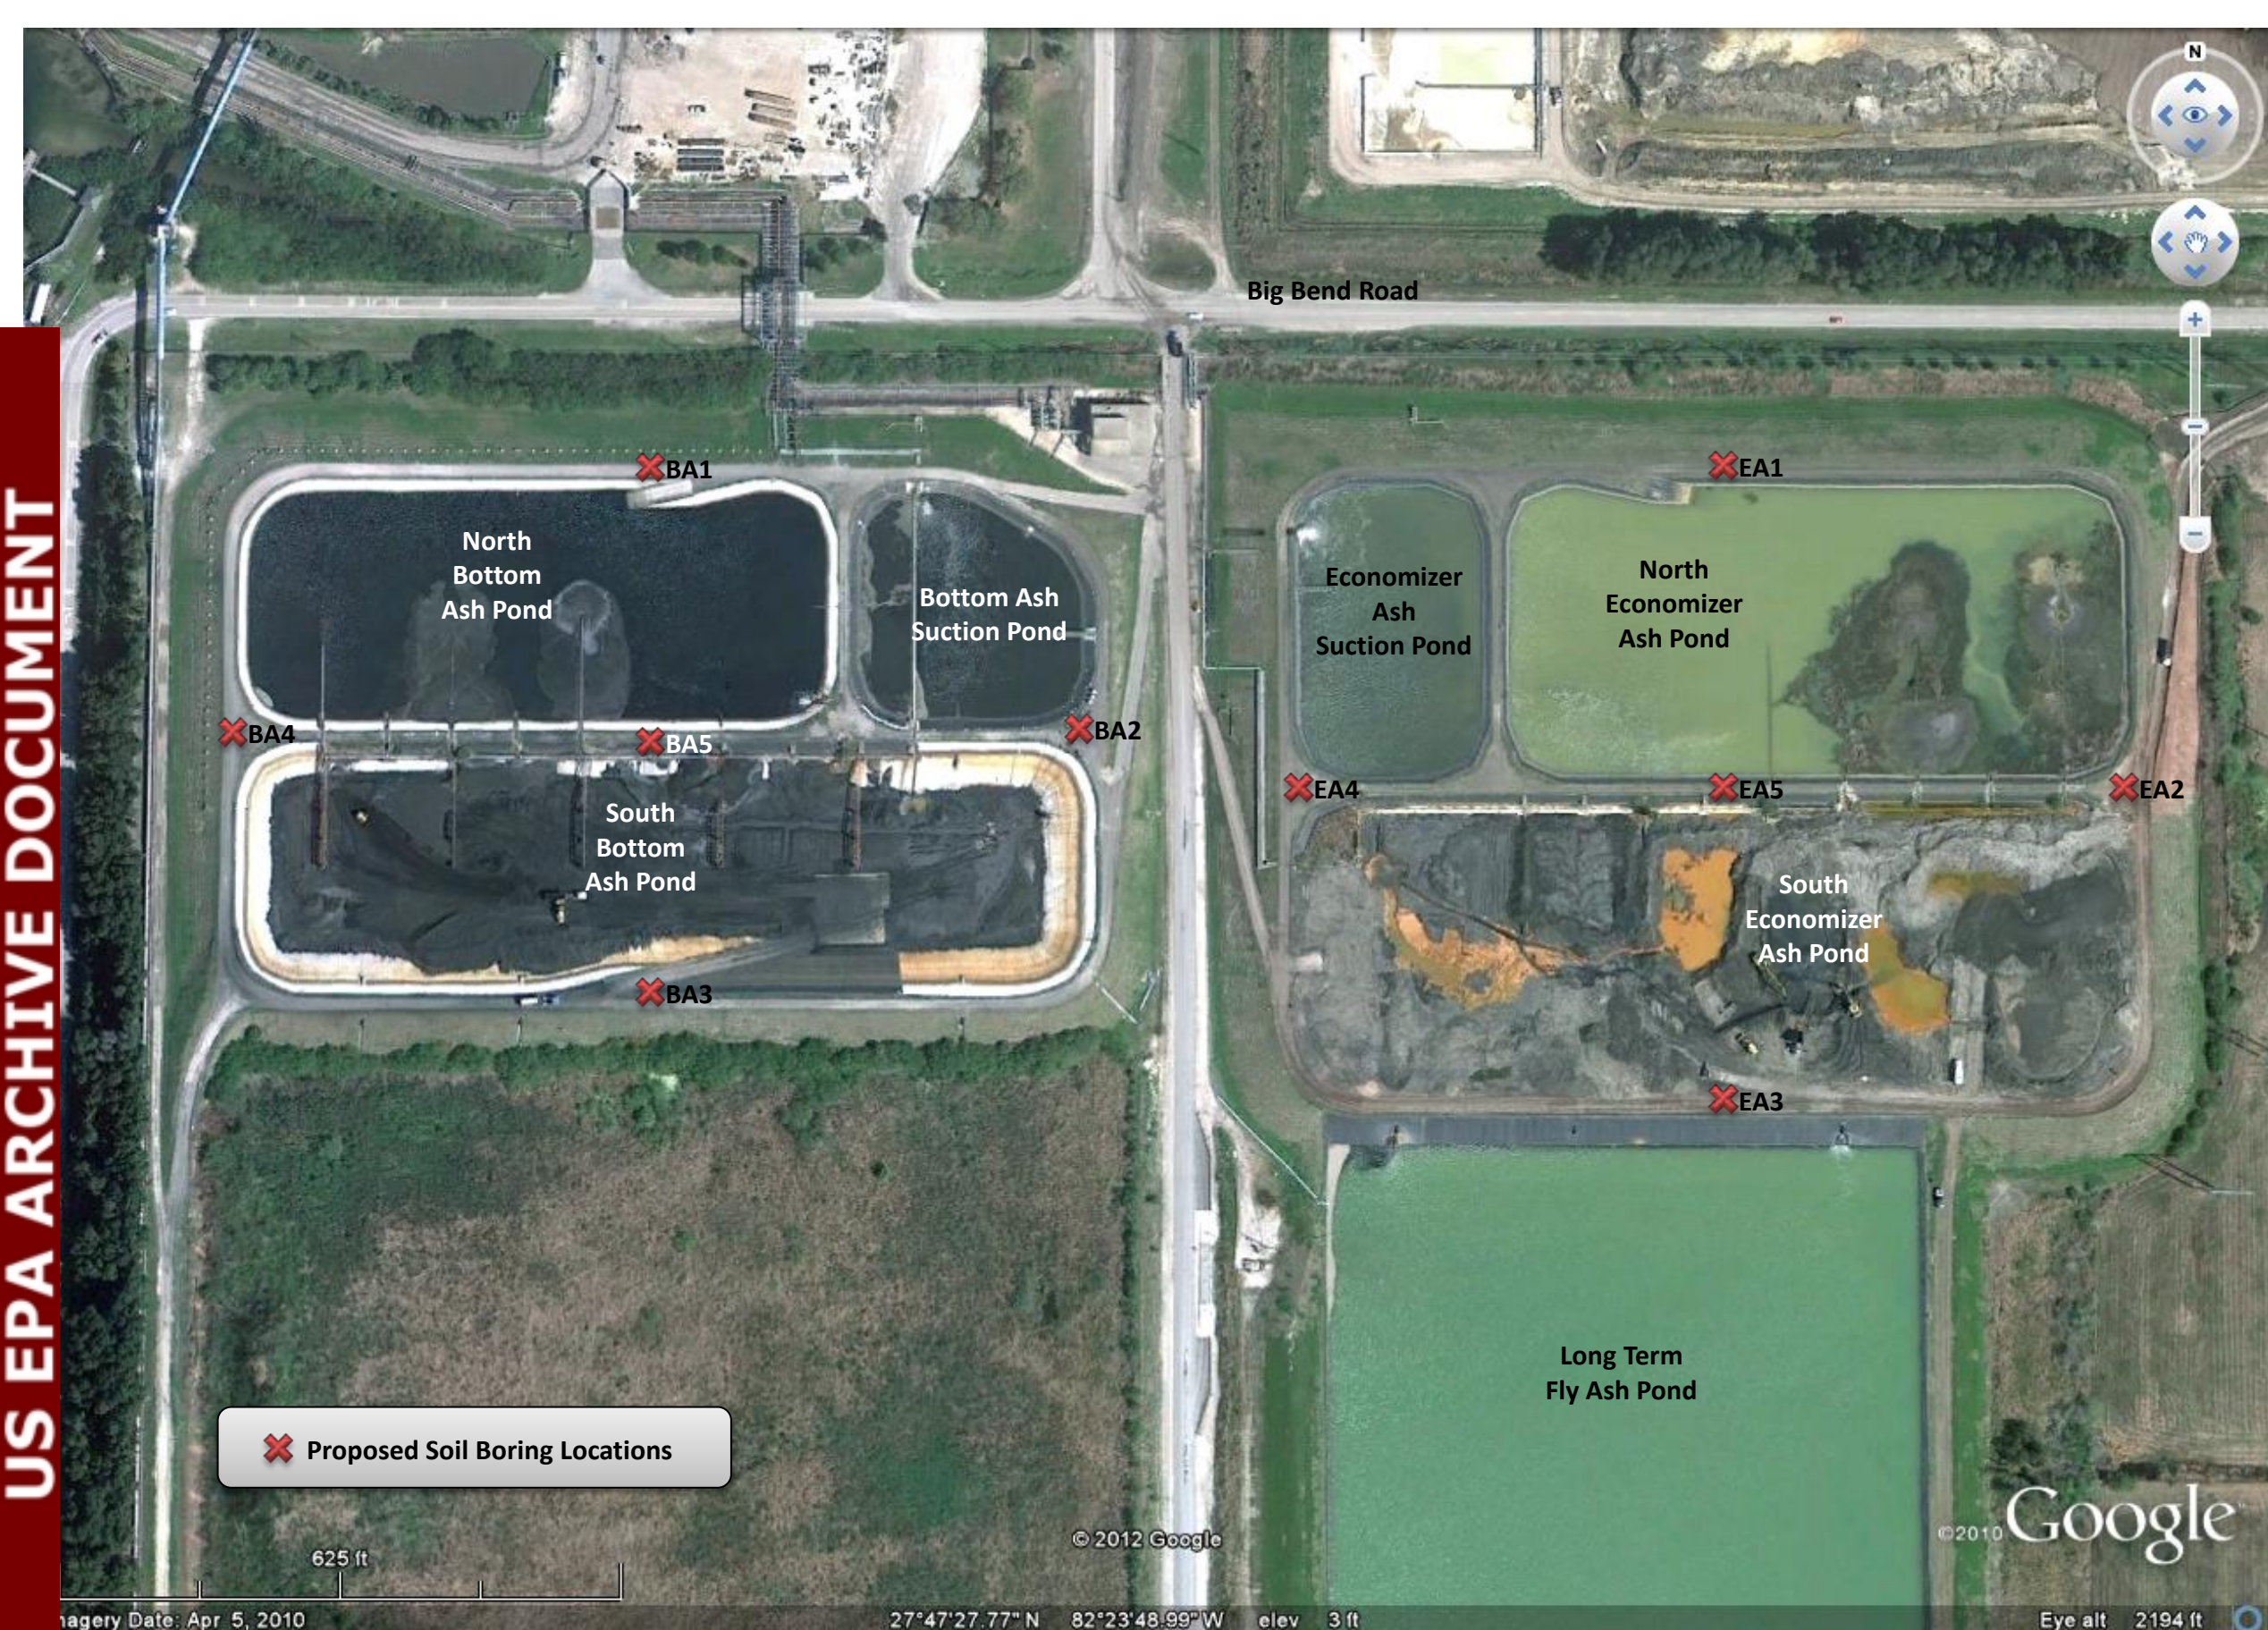
Tampa Electric Big Bend Ash Pond Boring Locations

TEC Response: TEC has hired a geotechnical engineering firm to perform systematic soil borings of the dikes for the four impoundments in question. Figure 1 illustrates the locations at which core data will be obtained and analyzed to verify that the original design assumptions and stability analyses for the dikes remain valid and to obtain phreatic surface data sufficient to perform hydraulic analyses. This work will be initiated in March 2012.

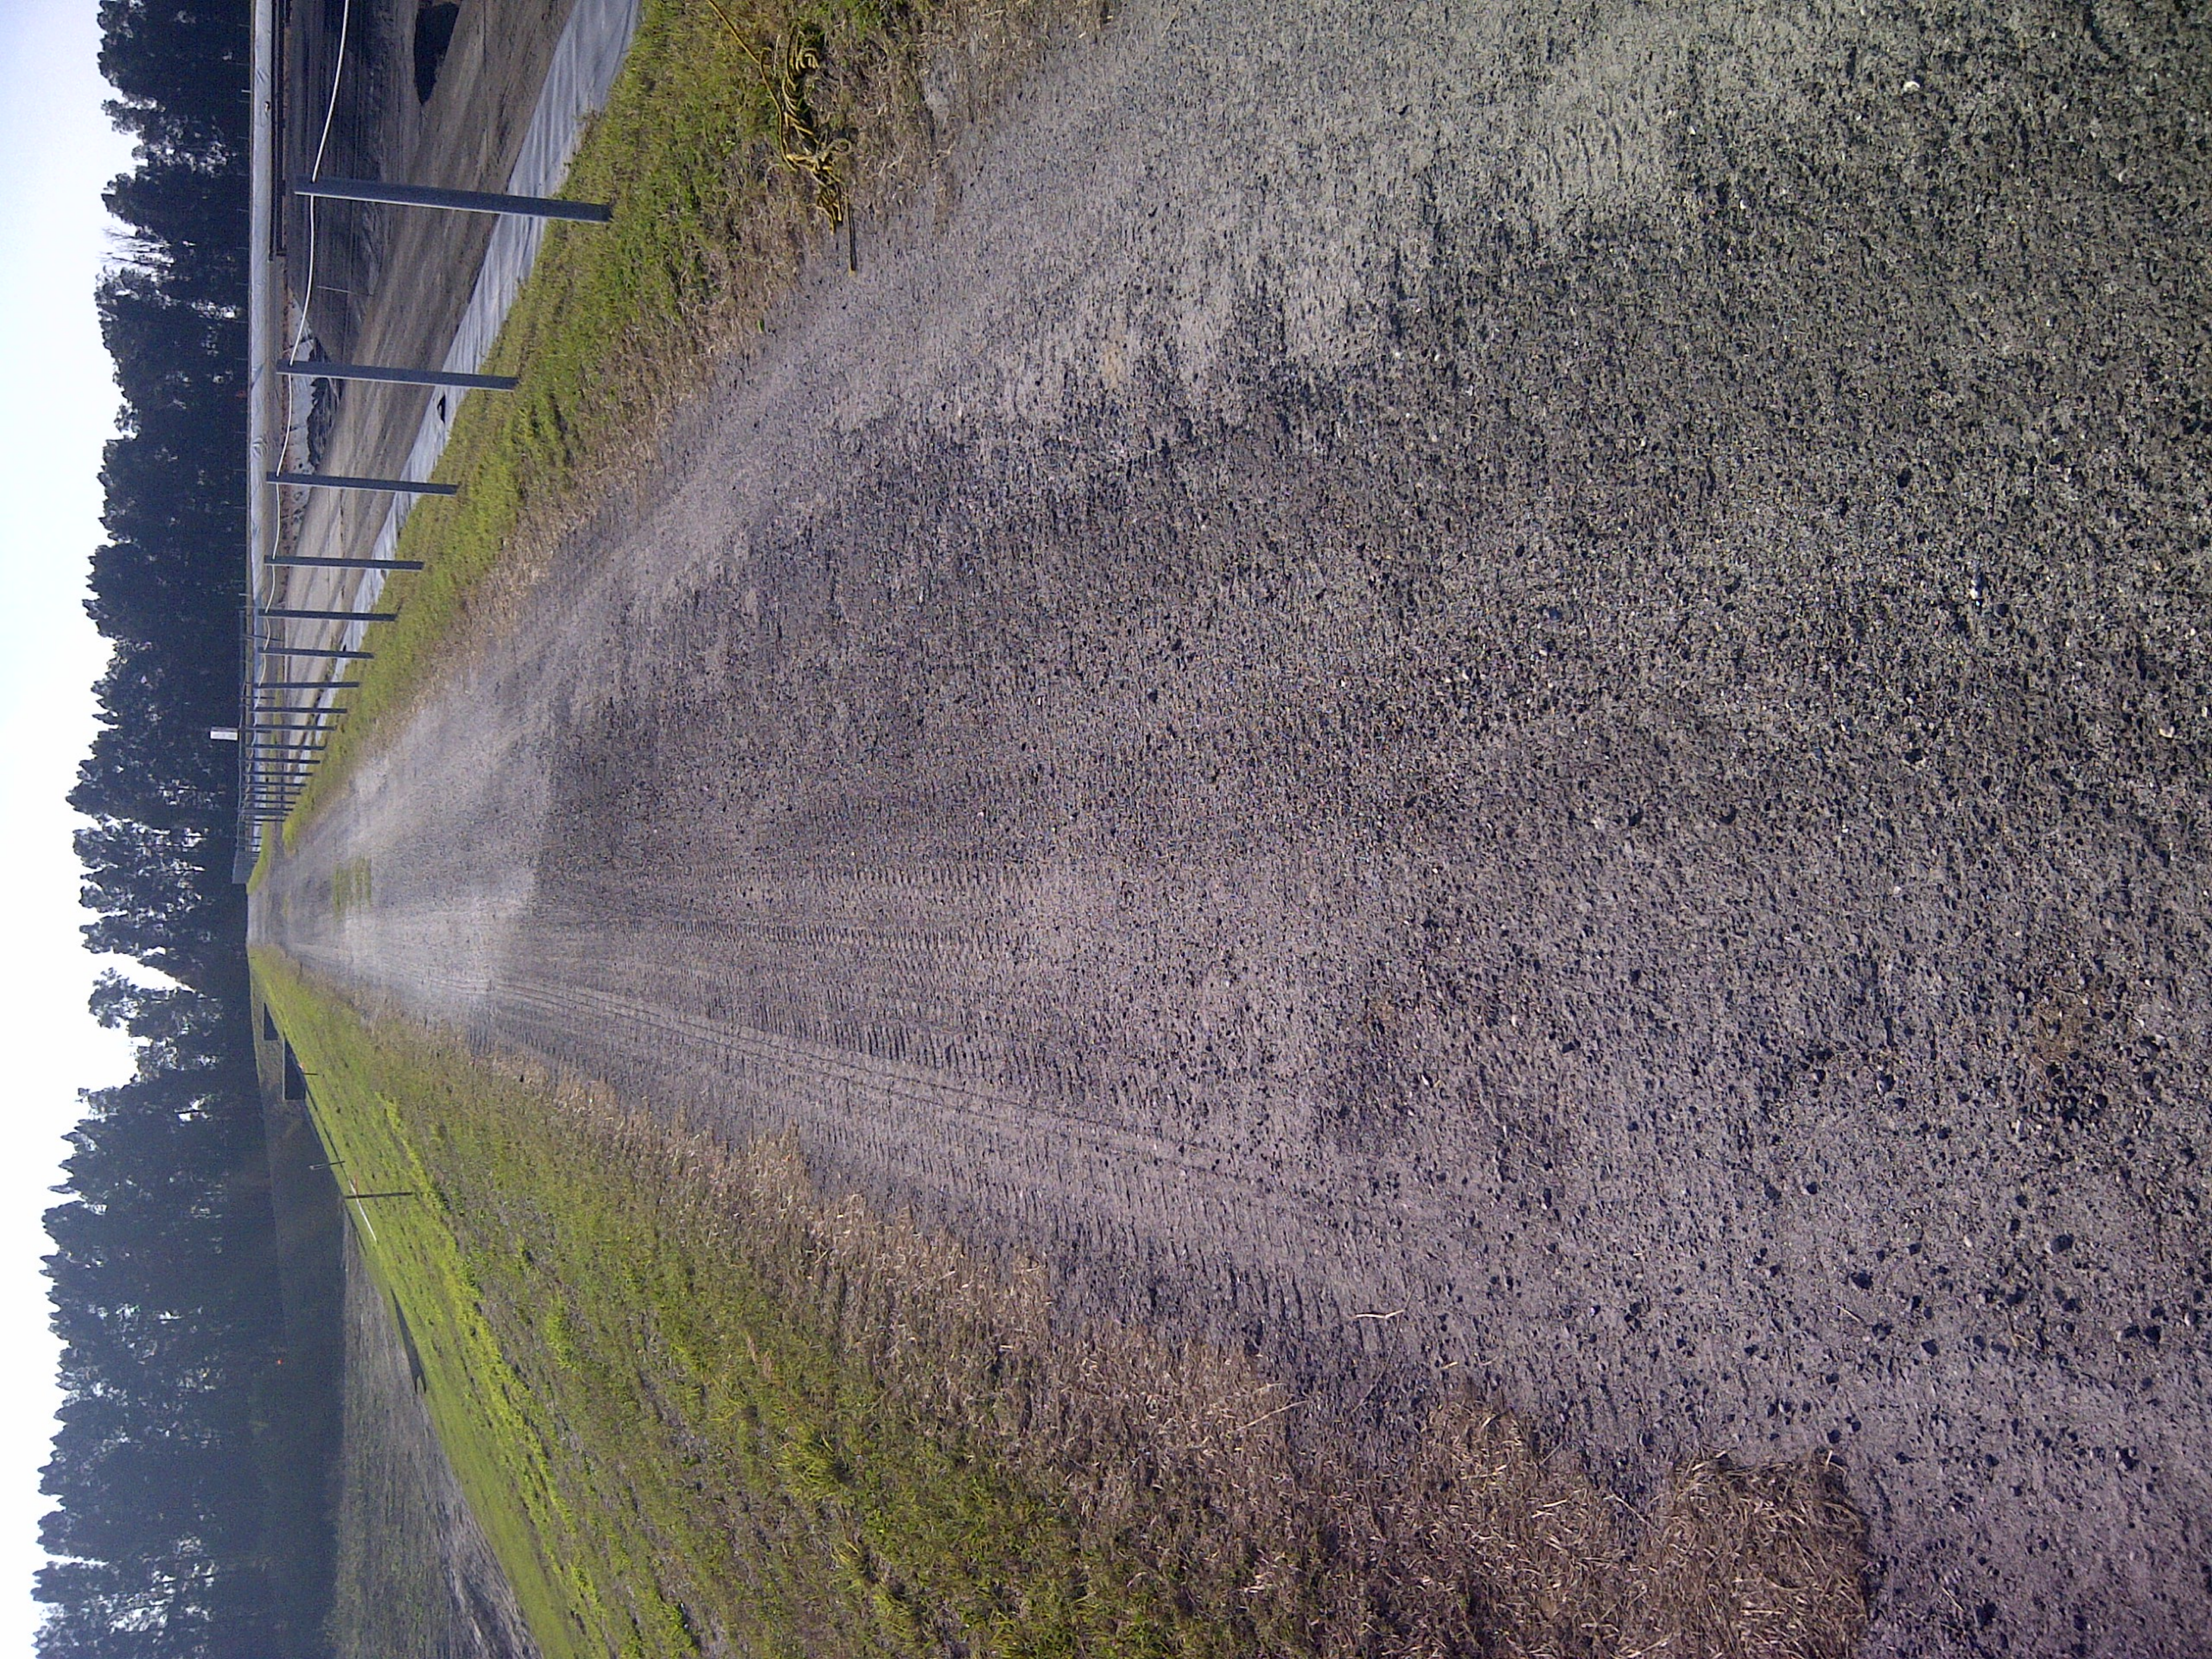
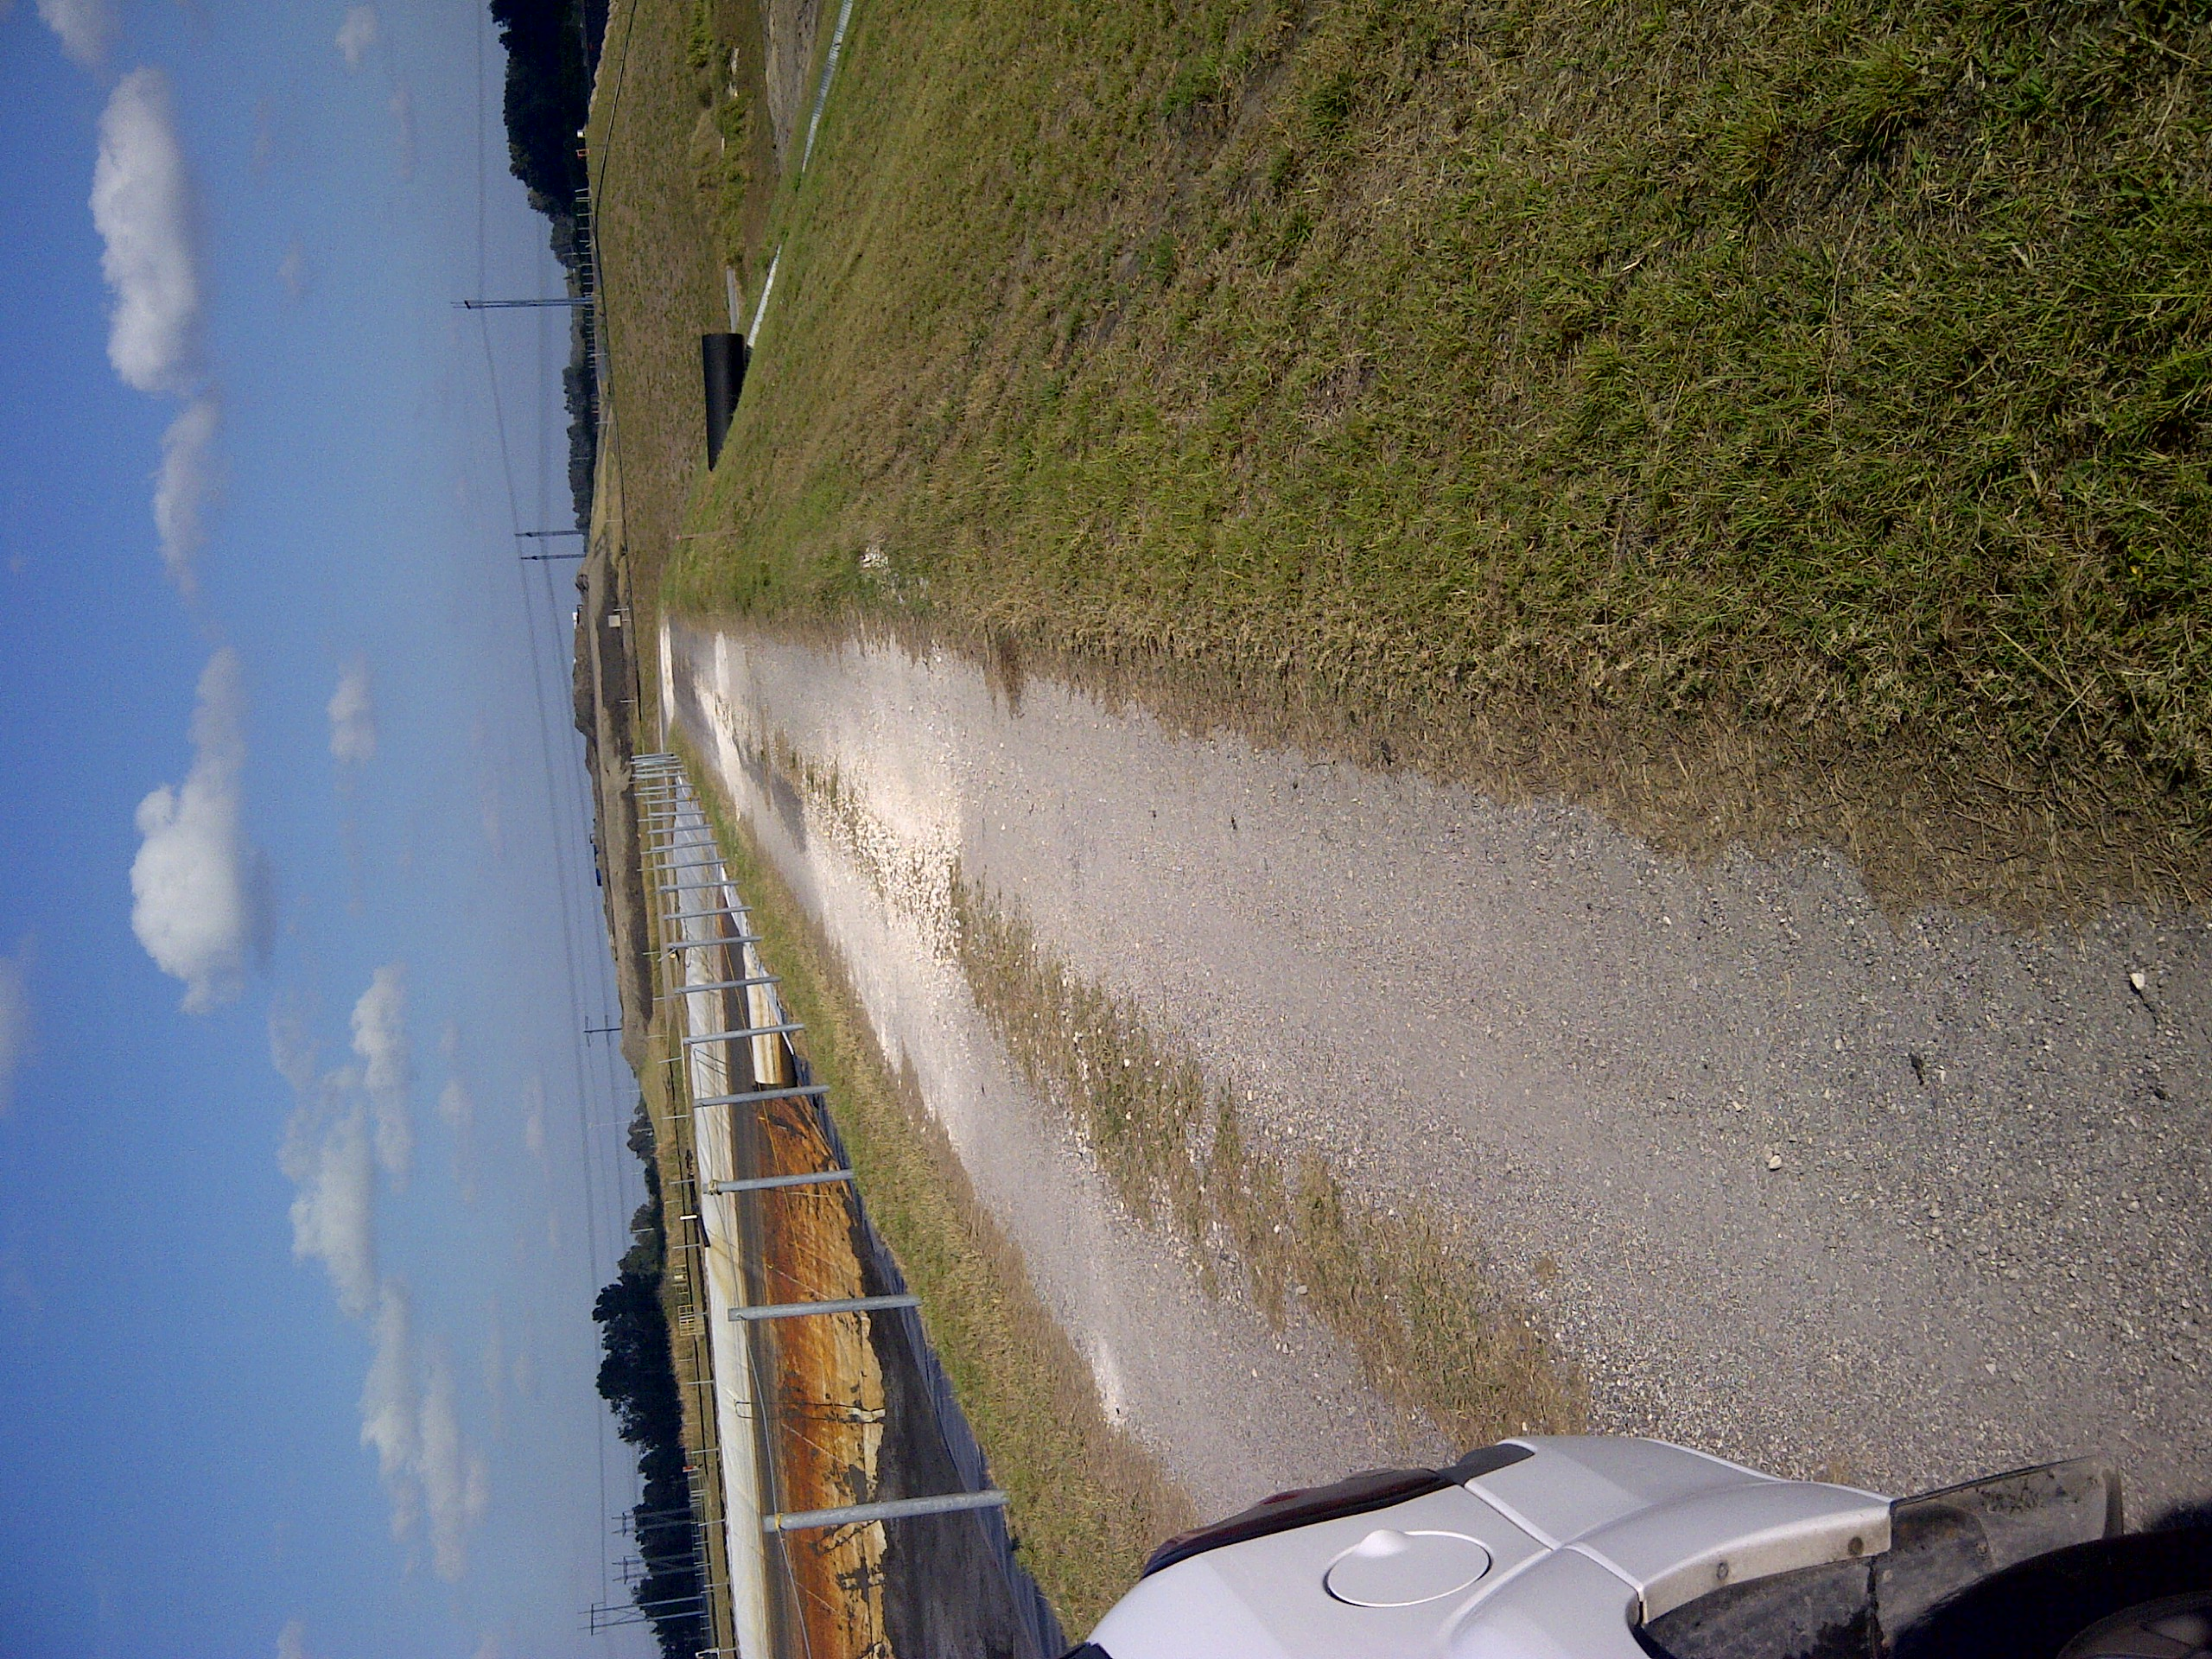
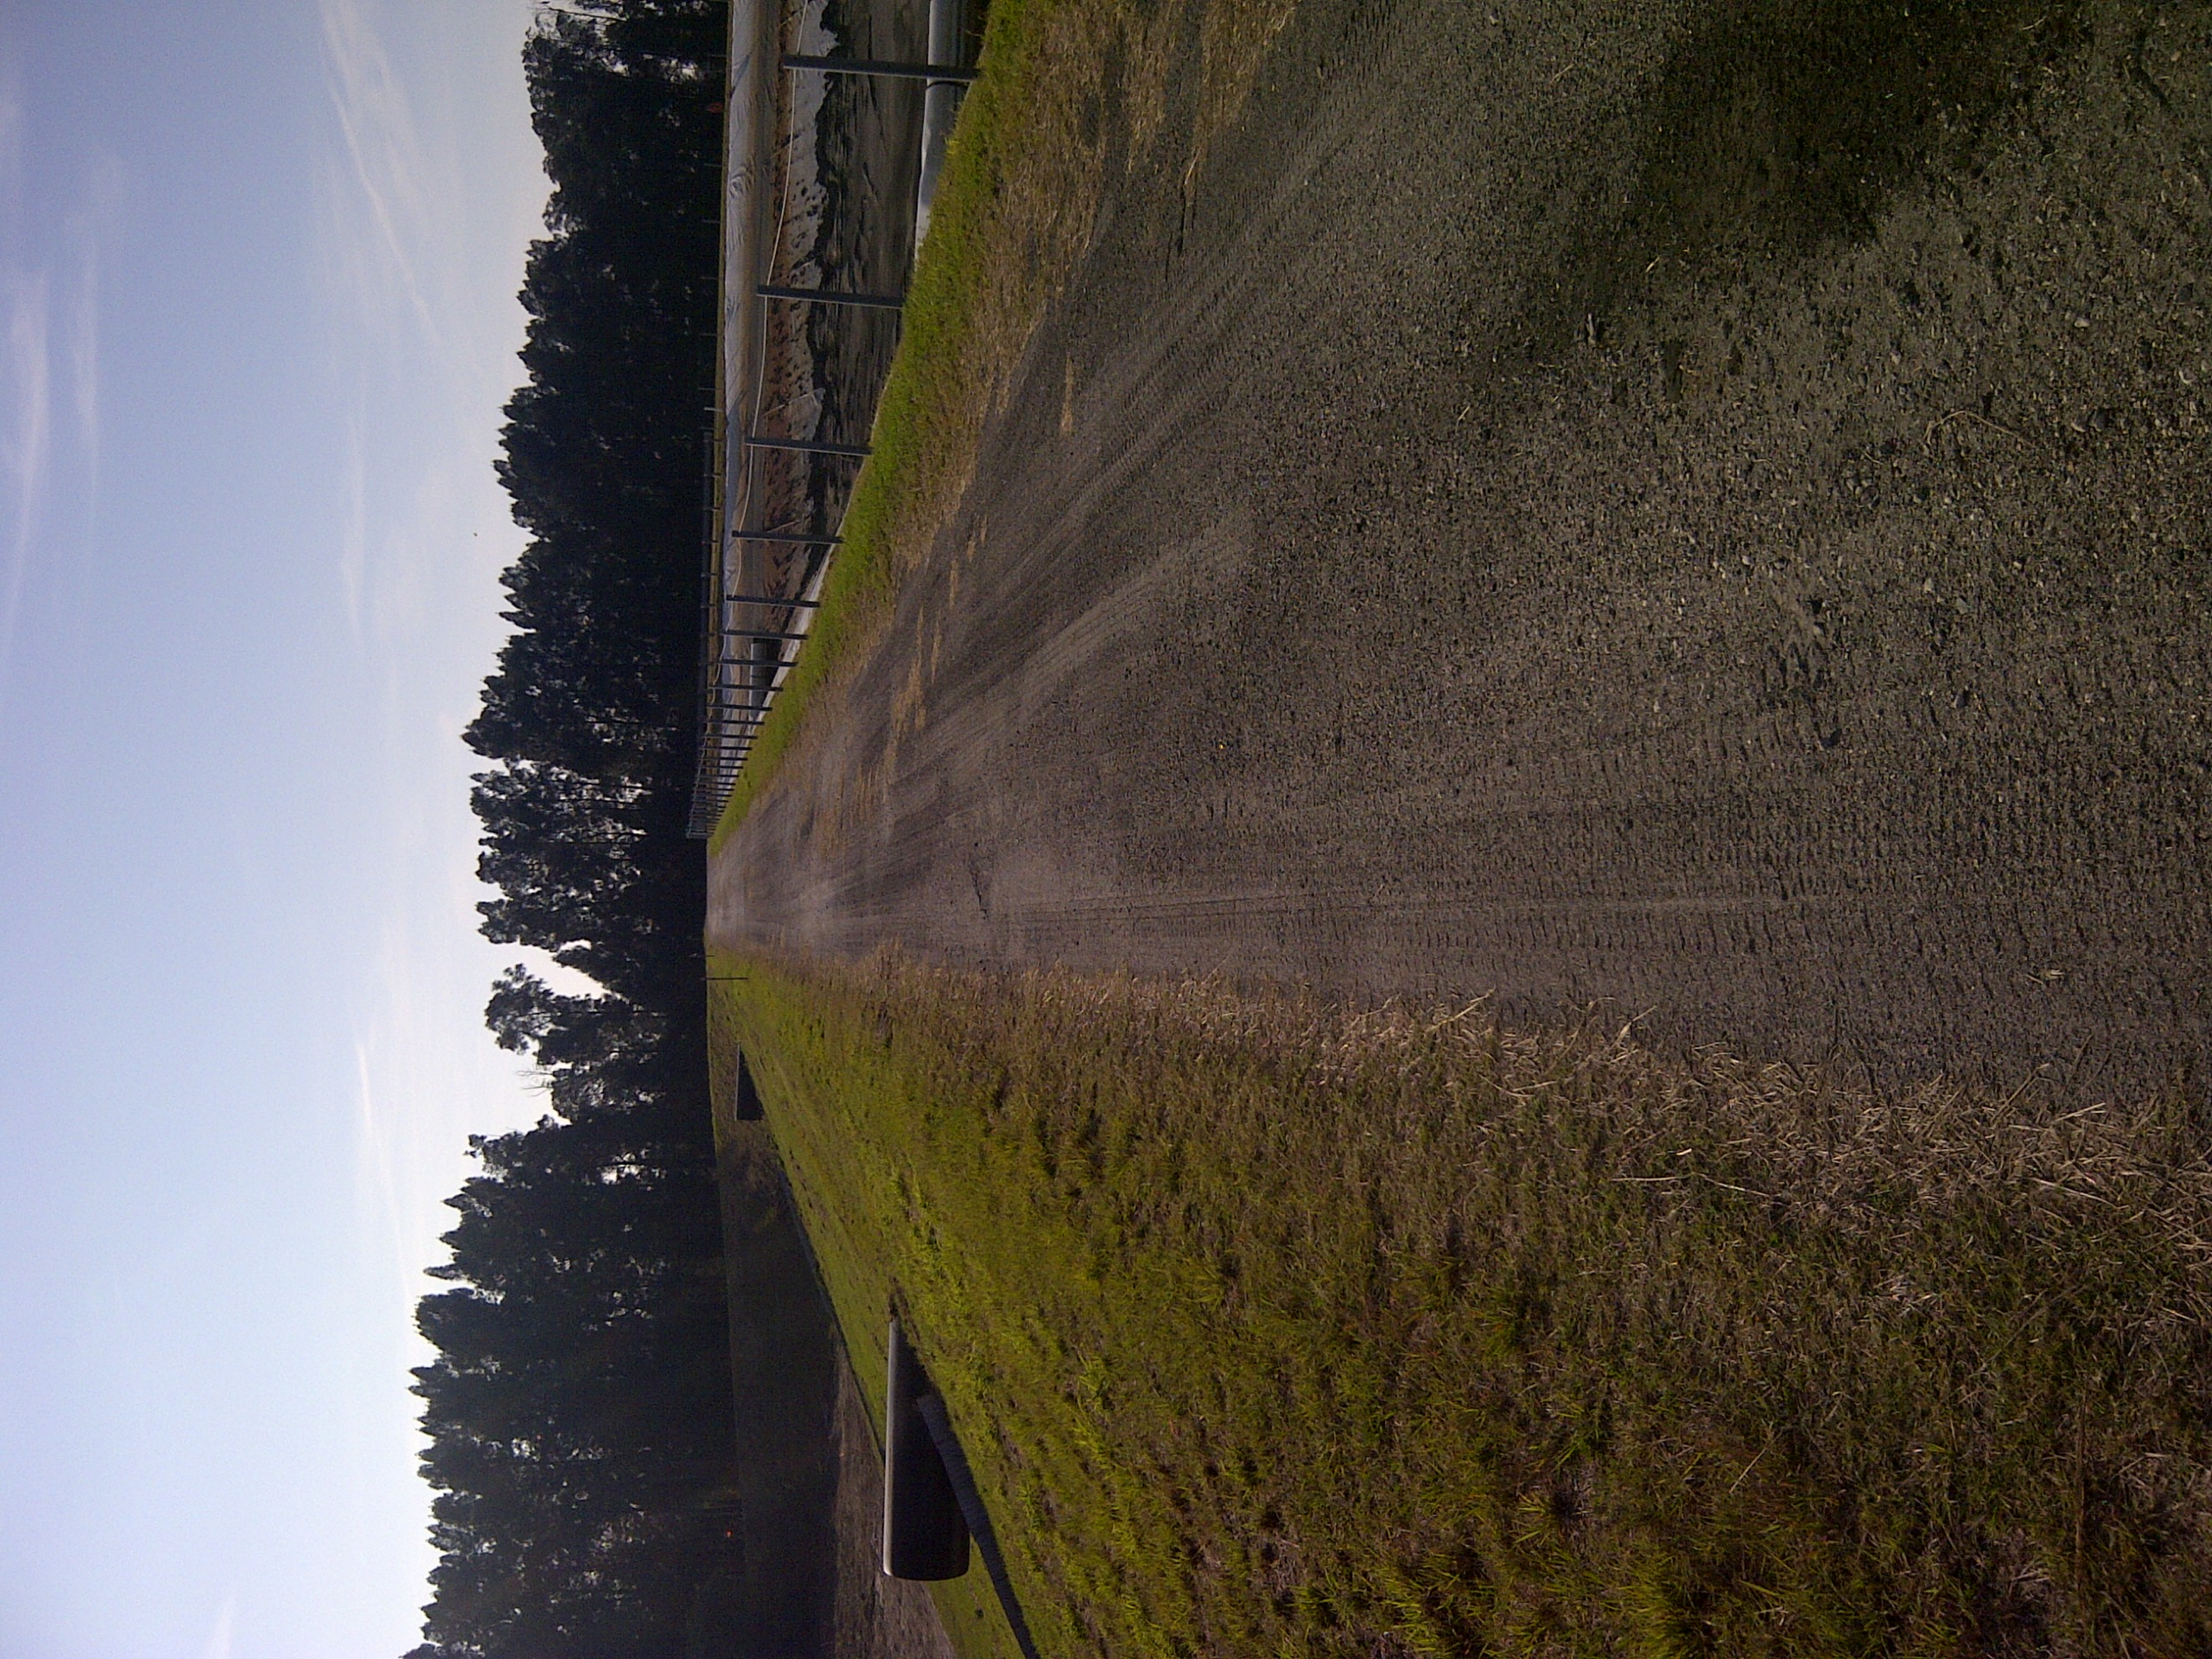
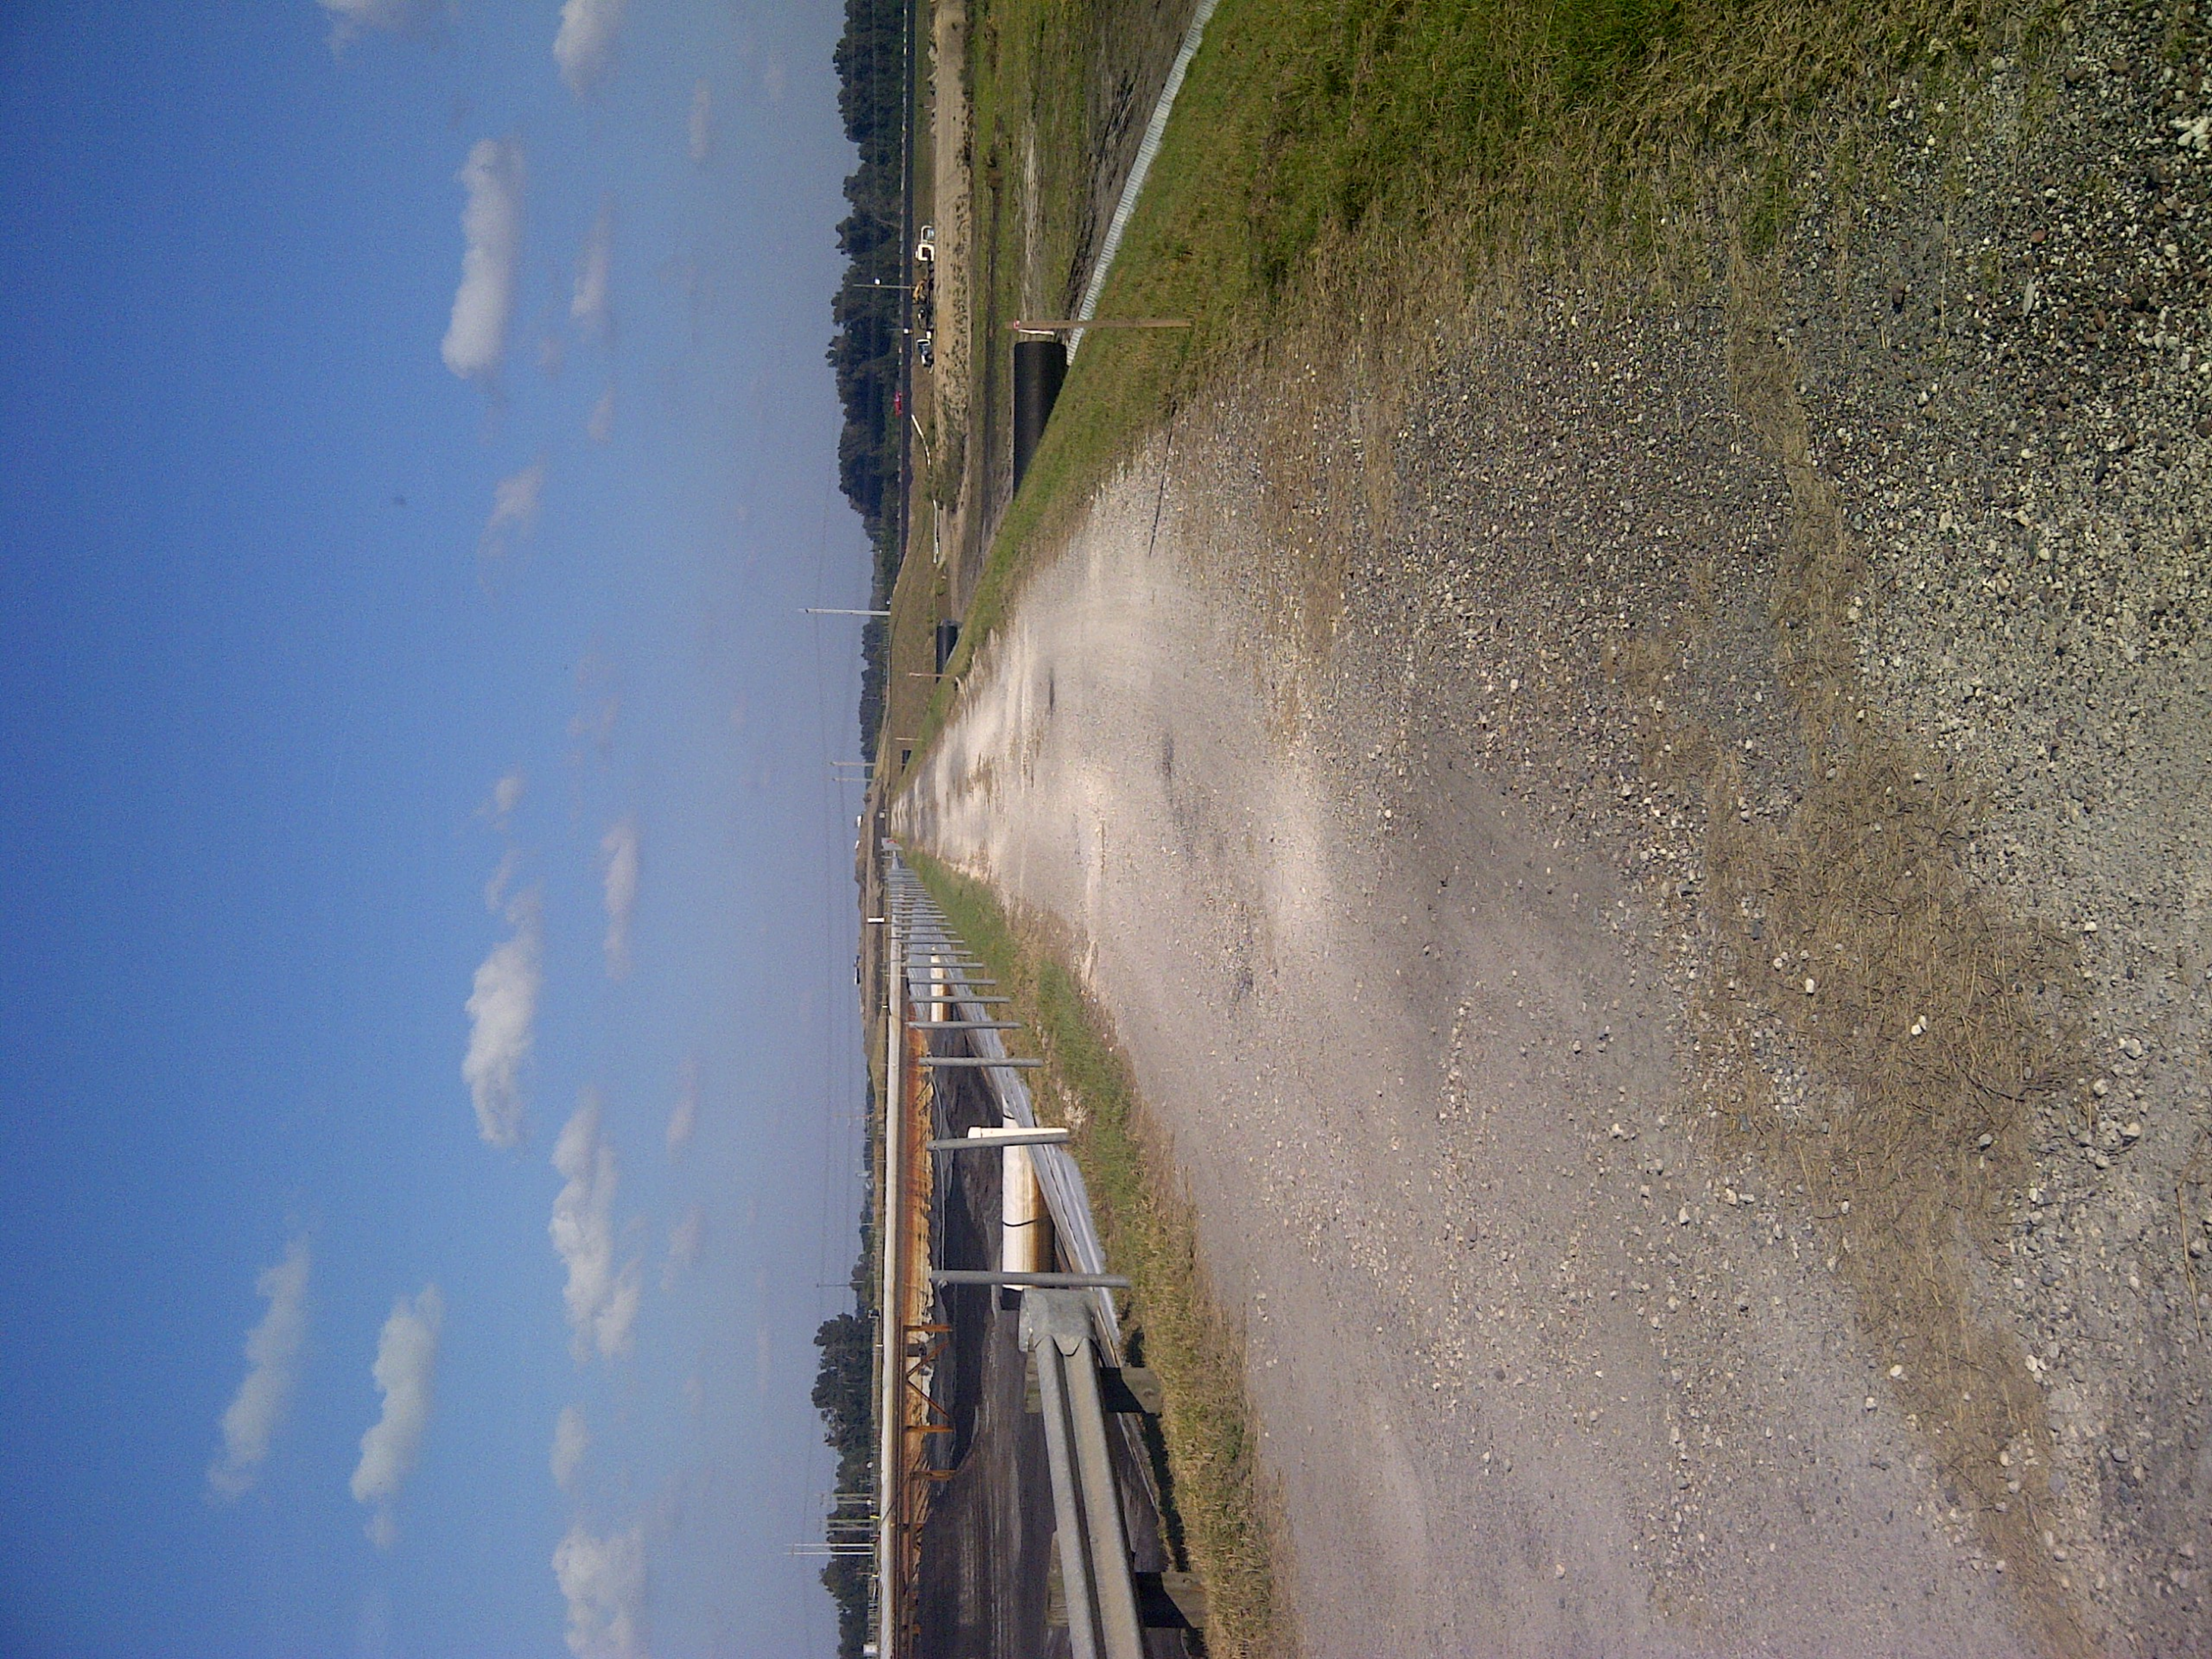
- ***Remediate the two minor depressions along the crest of the South Bottom Ash Pond;***

• ***Remediate two minor depressions in South Bottom Ash Pond crest.***

TEC Response: See Attached Photographs 1-4 for verification that the repairs of the South Bottom Ash Pond (SBAP) dike crest are complete.

TEC Response: As described above, these depressions have been repaired.
