Coal Combustion Residue Impoundment  
Round 9 - Dam Assessment Report  
*Big Bend Power Station*  
*Ash Management Units*  
*Tampa Electric Company*  
*Hillsborough County, Florida*

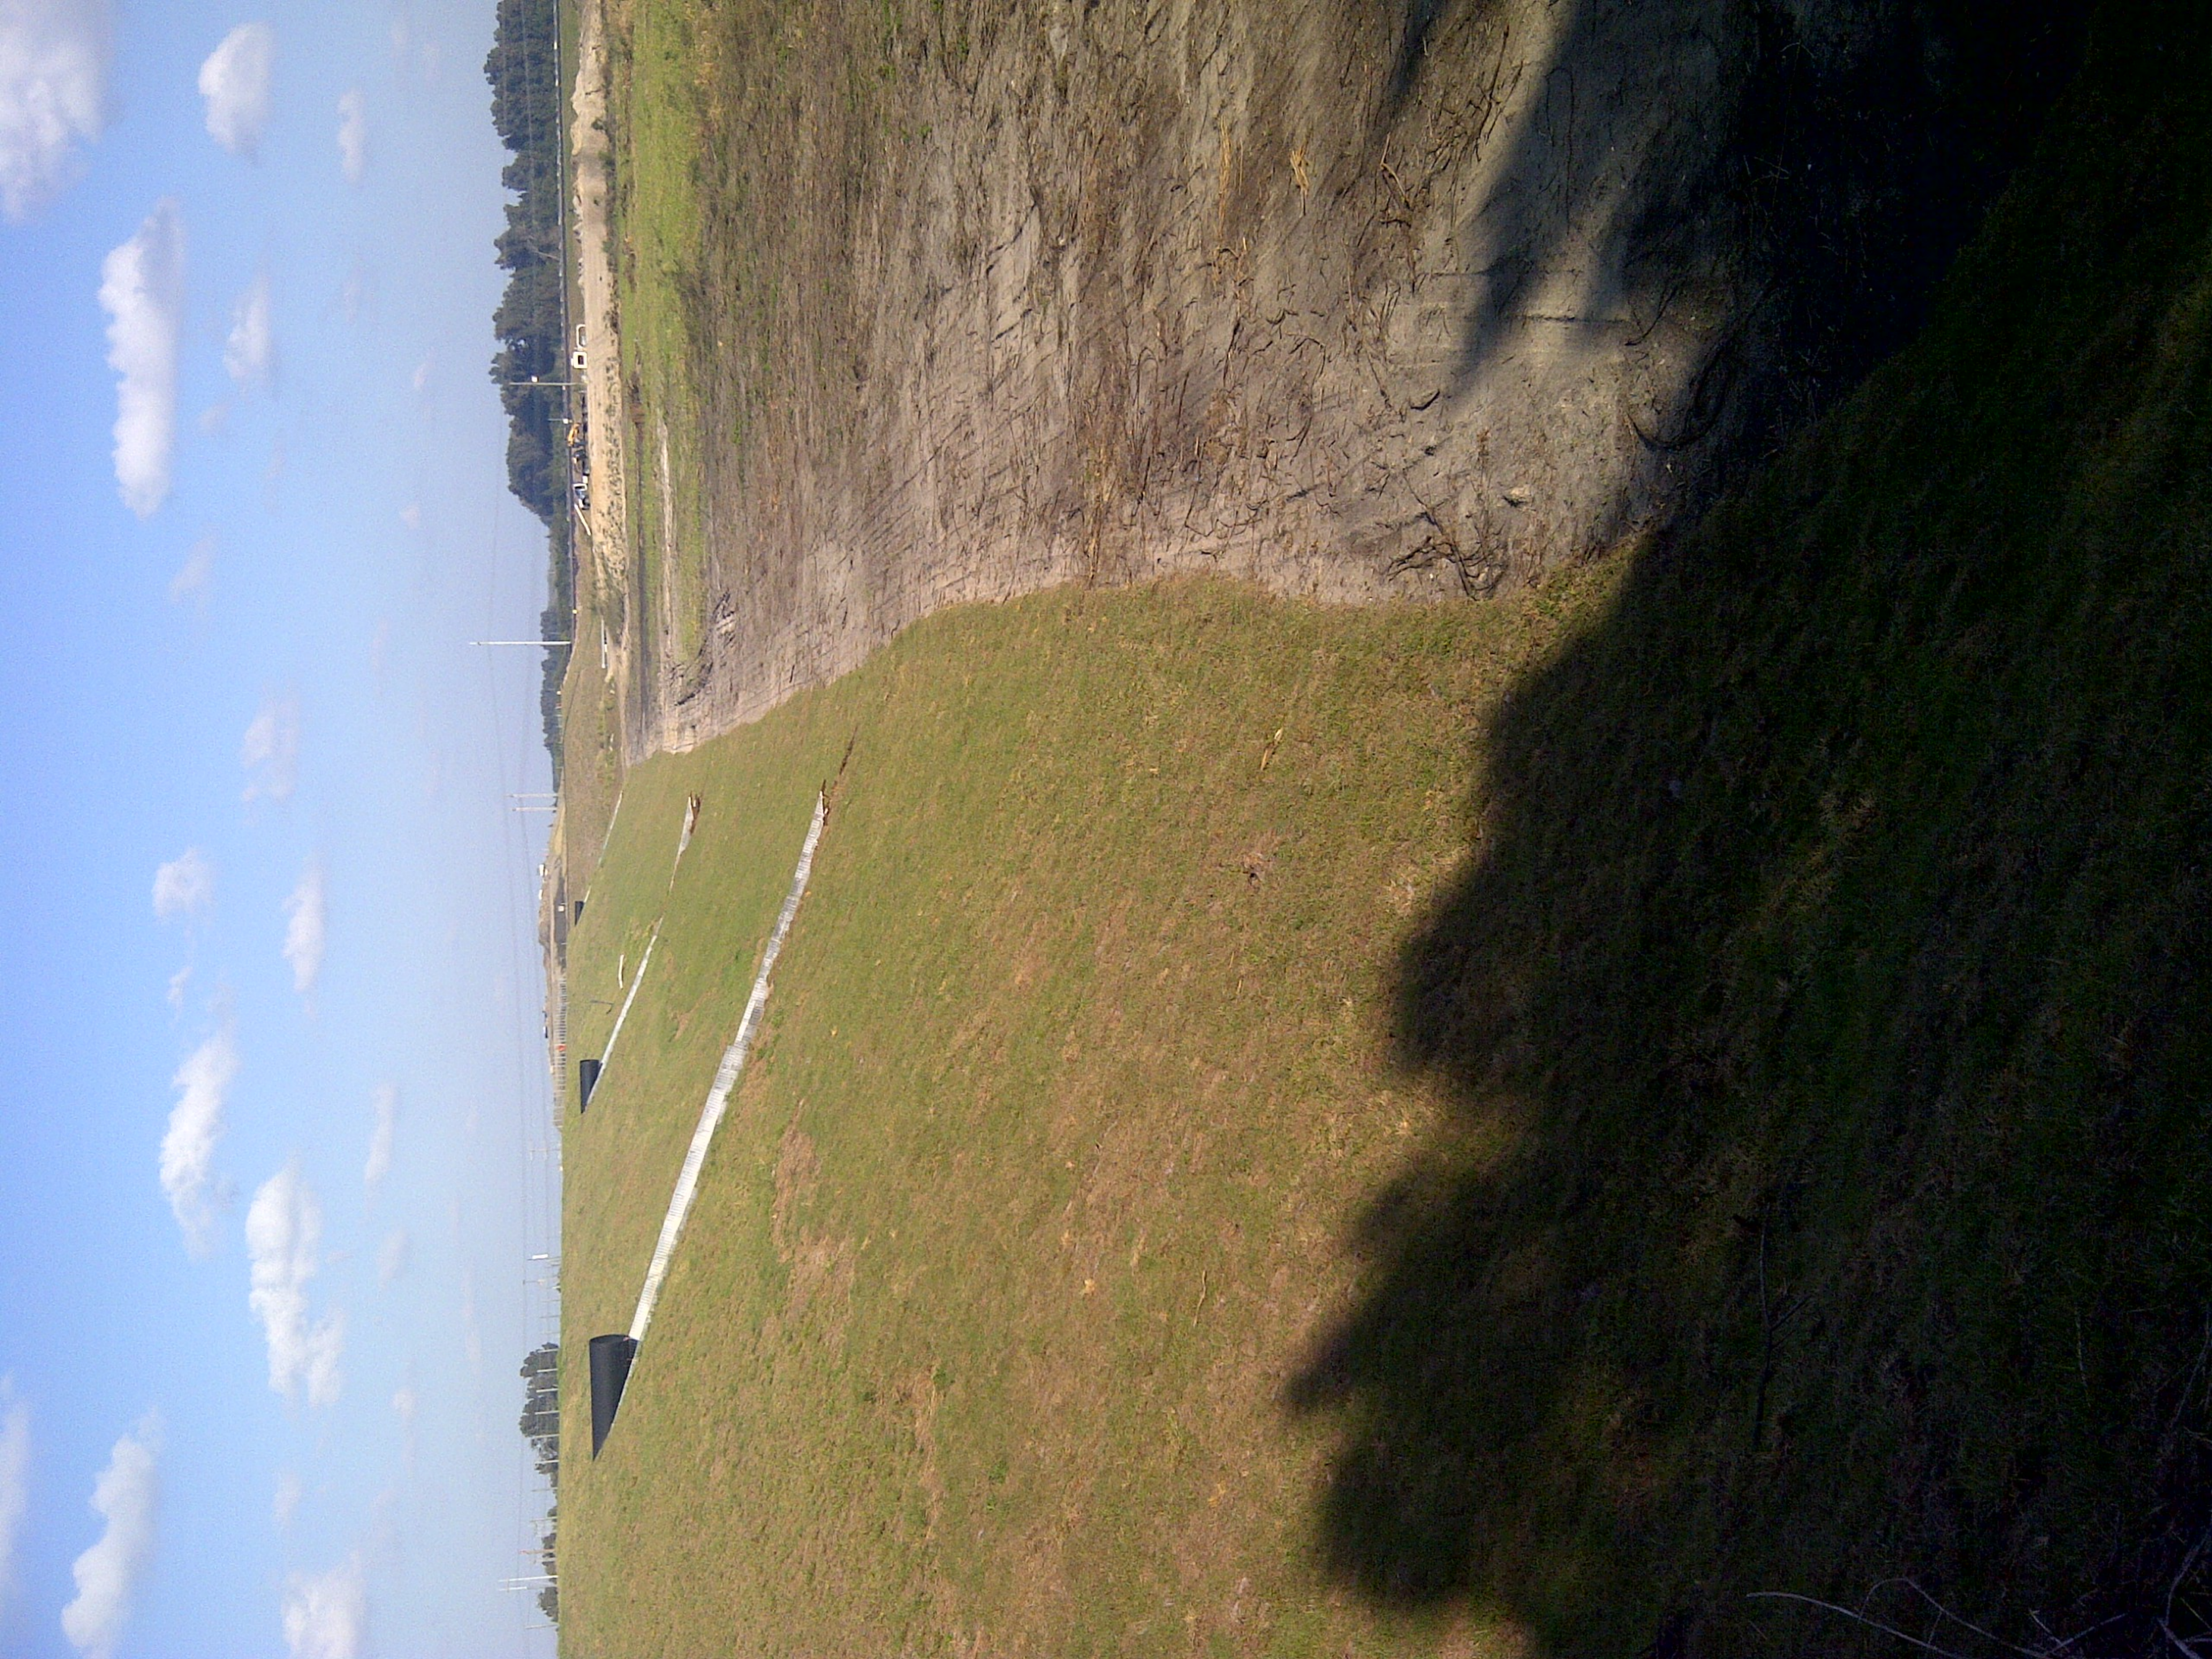
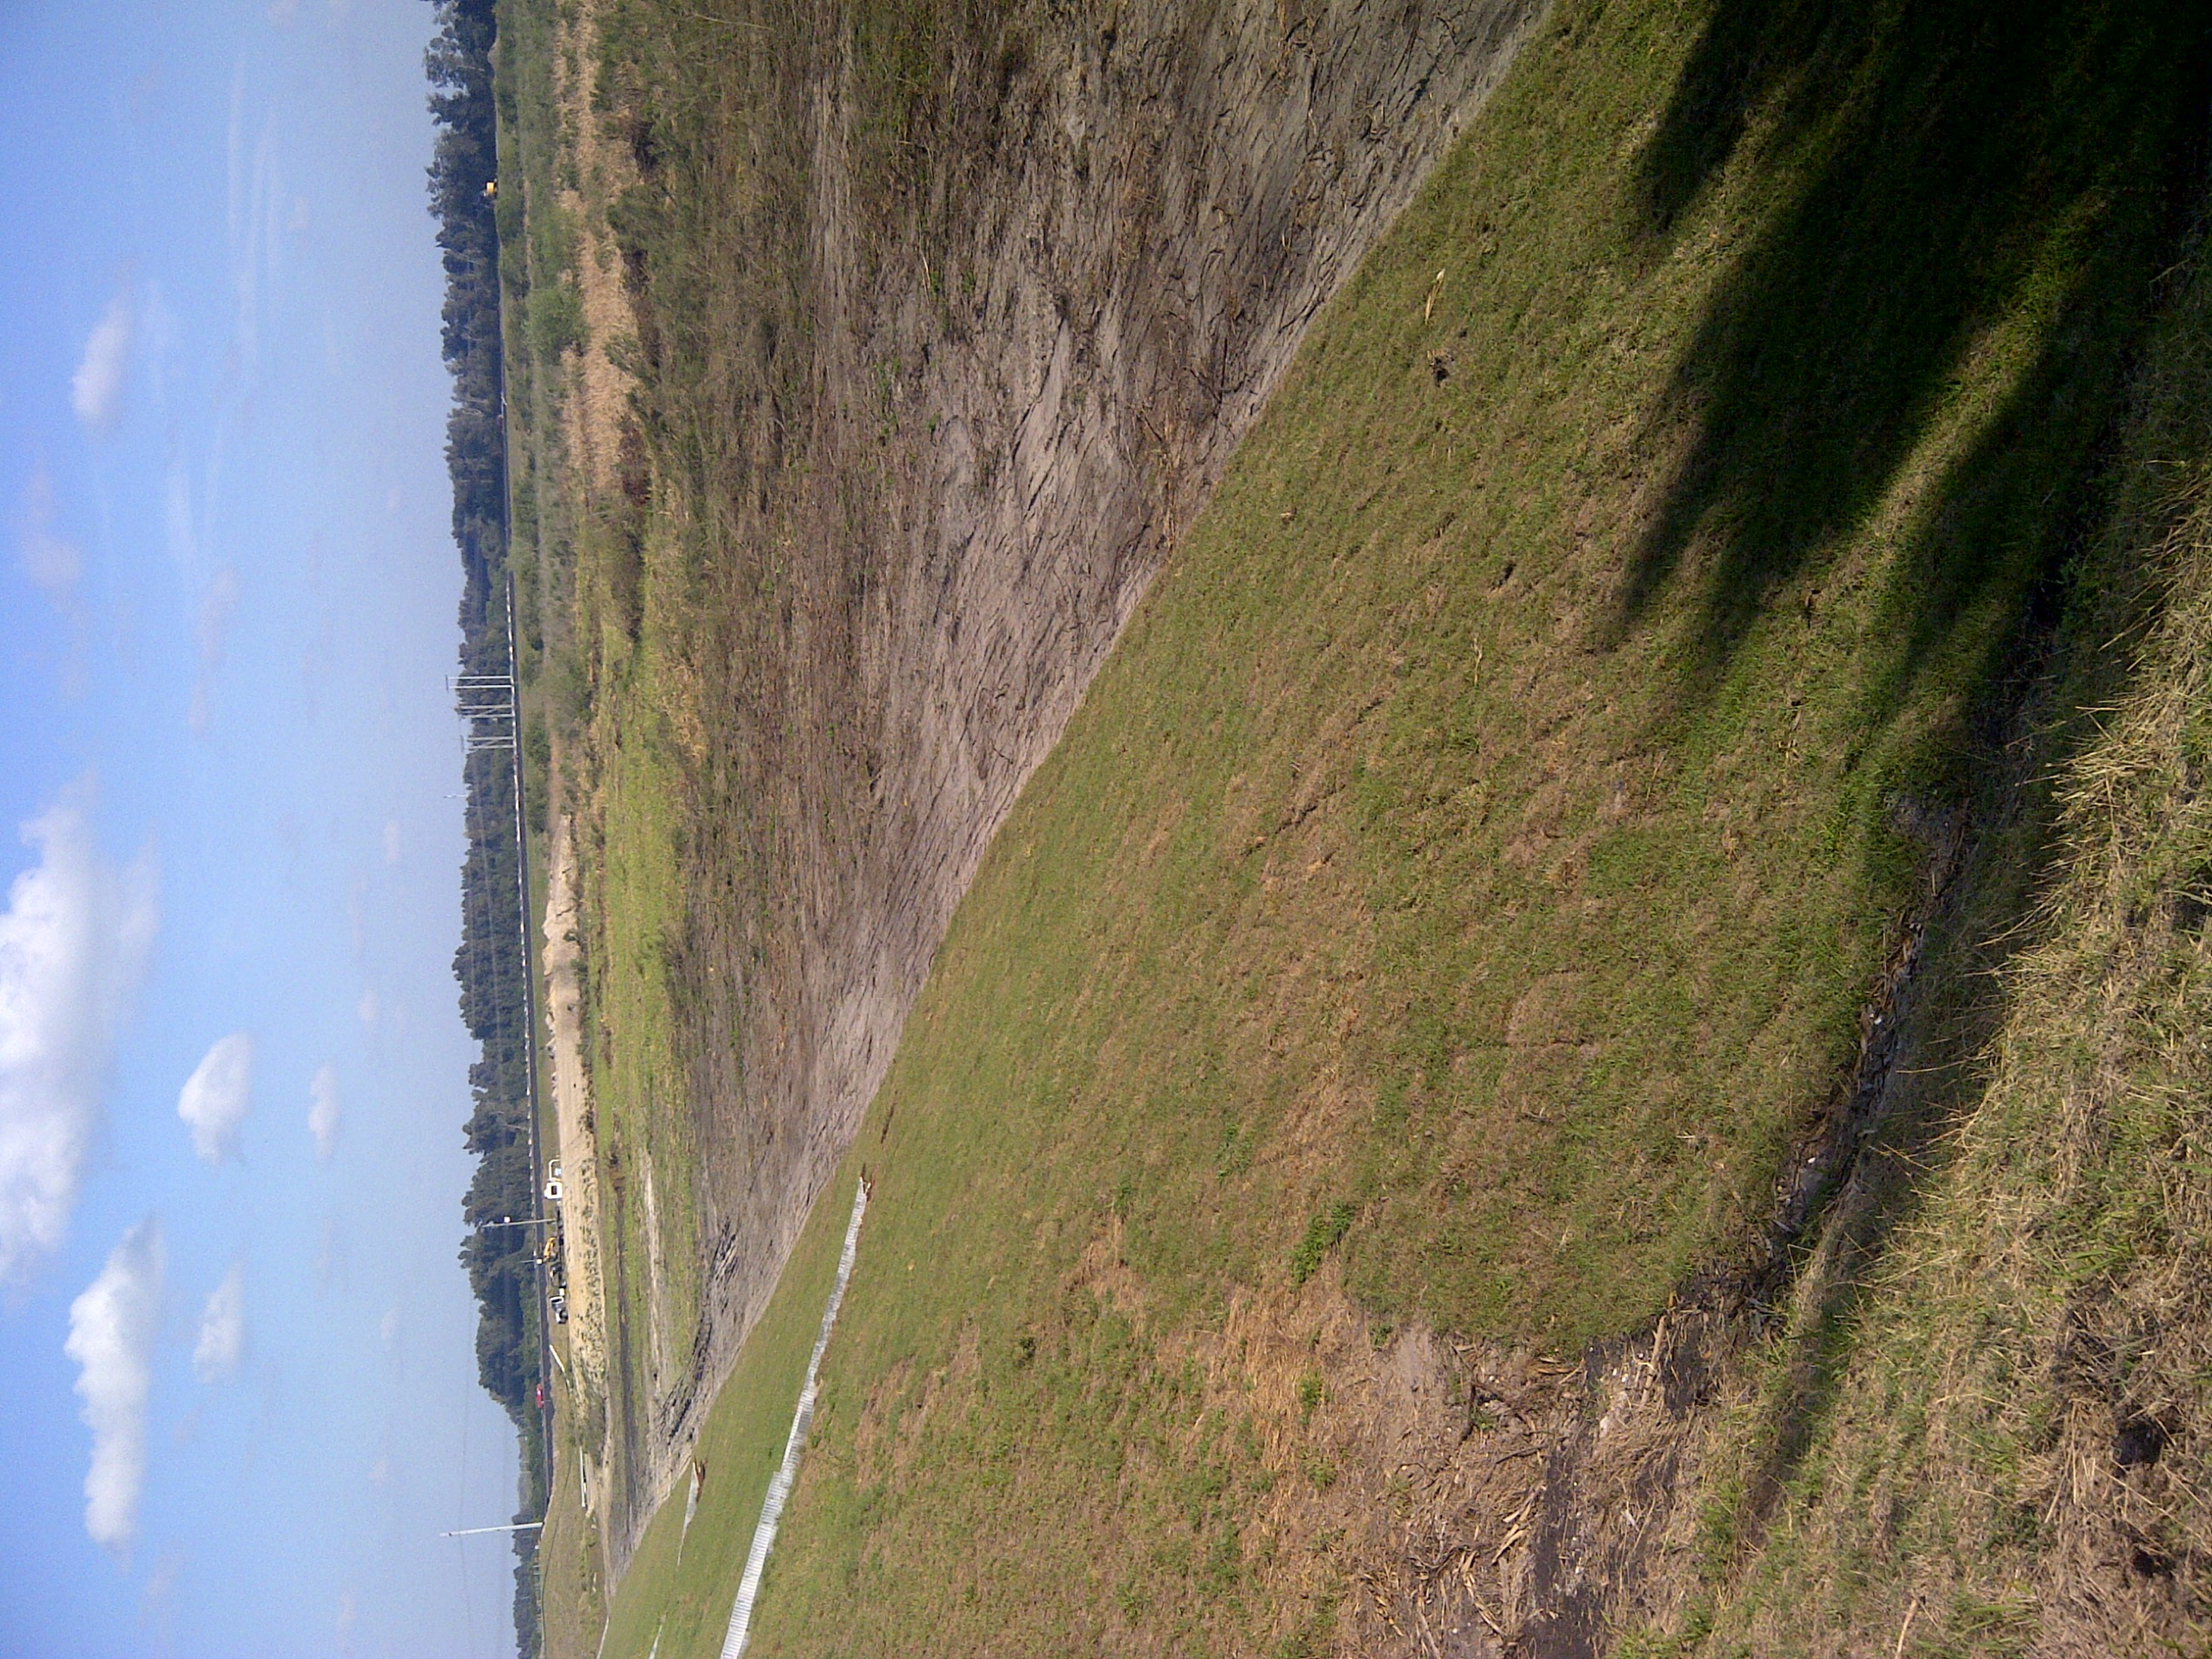
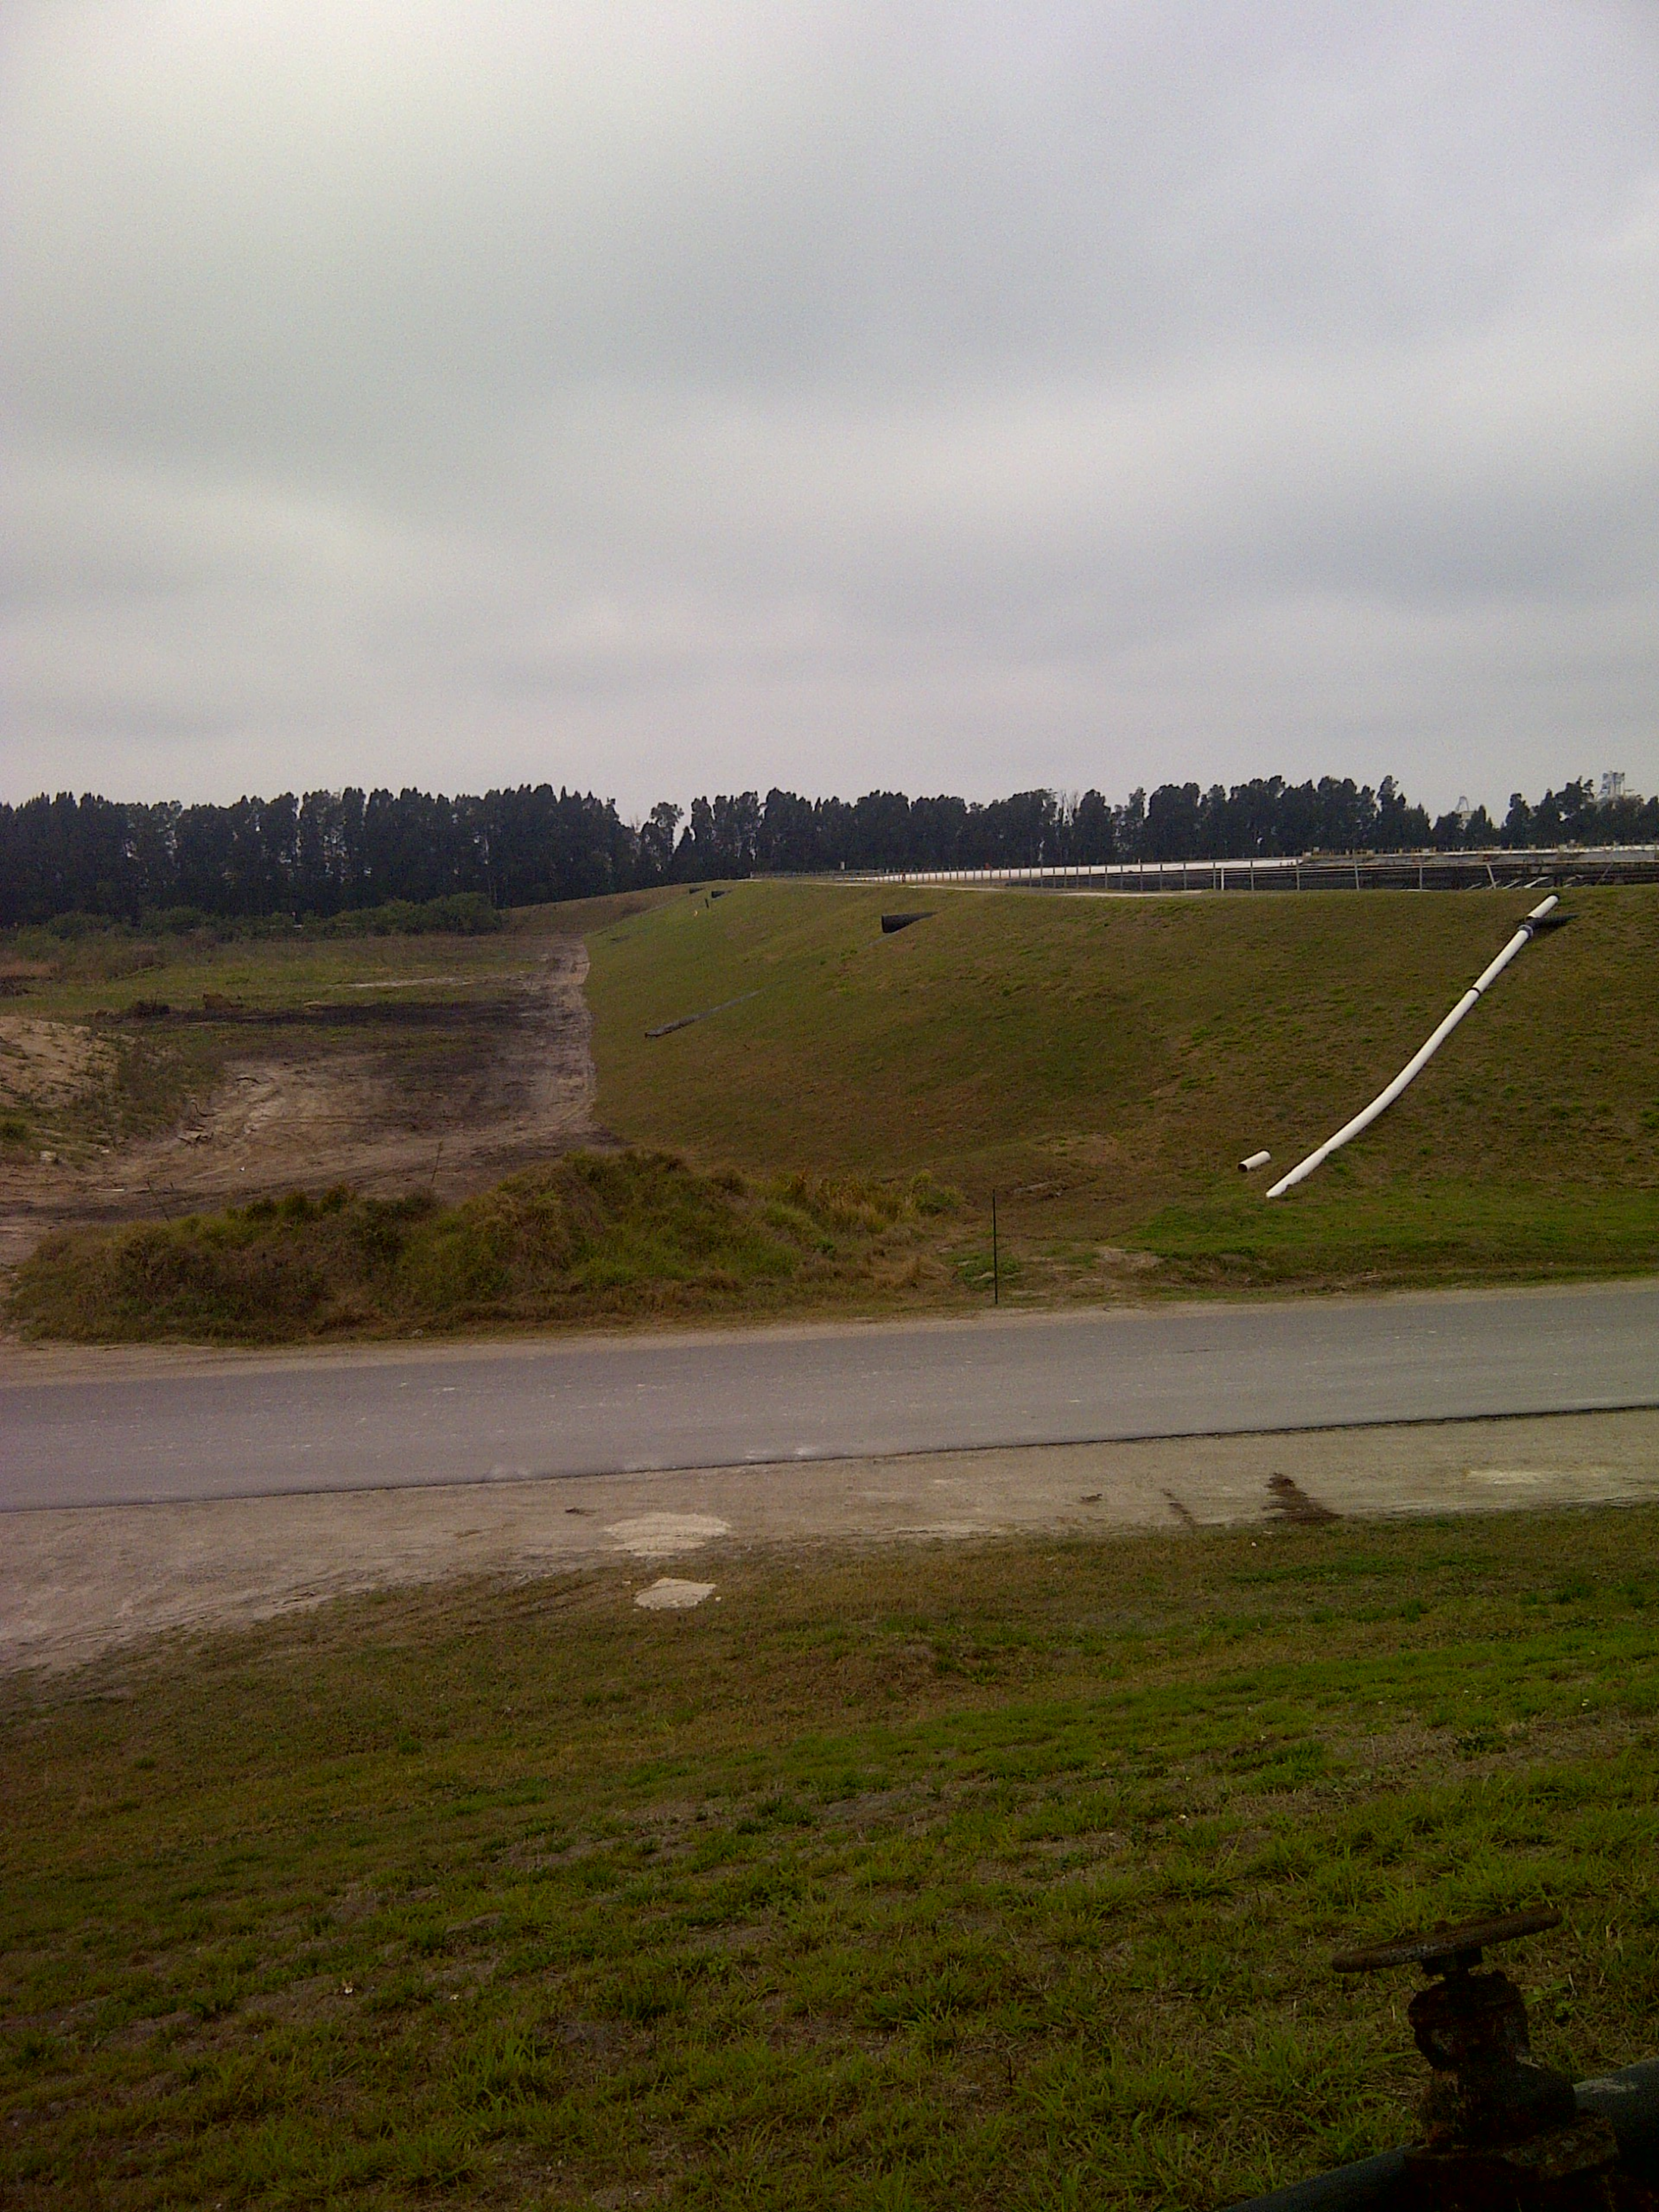
• ***Maintain and prevent further expansion of woody vegetation onto the downstream slope of South Bottom Ash Pond;***

TEC Response: As demonstrated by Photographs 5-7, vegetation at the bottom of the downstream slope has been cleared as requested and will be maintained in the future to allow for inspection of dike conditions in this area.
