Geotechnical
Environmental and
Water Resources
Engineering

FINAL
**Coal Ash Impoundment -
Specific Site Assessment Report**
**Tri-State Generation and
Transmission Association**
Escalante Generating Station

September 2009
Project 091330

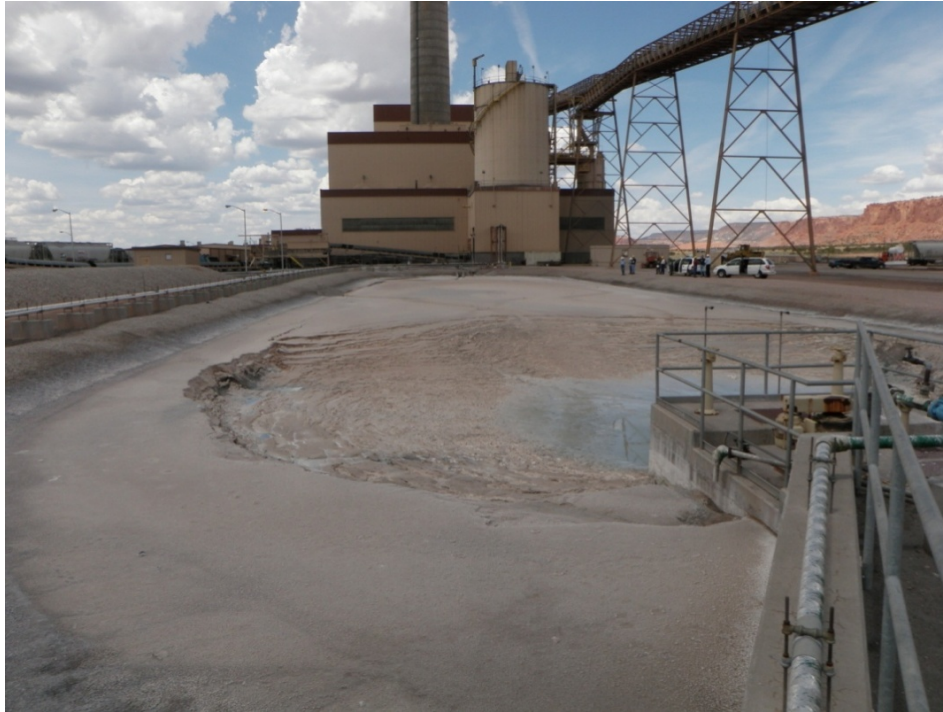
Photo 1: Emergency Scrubber Pond Looking West

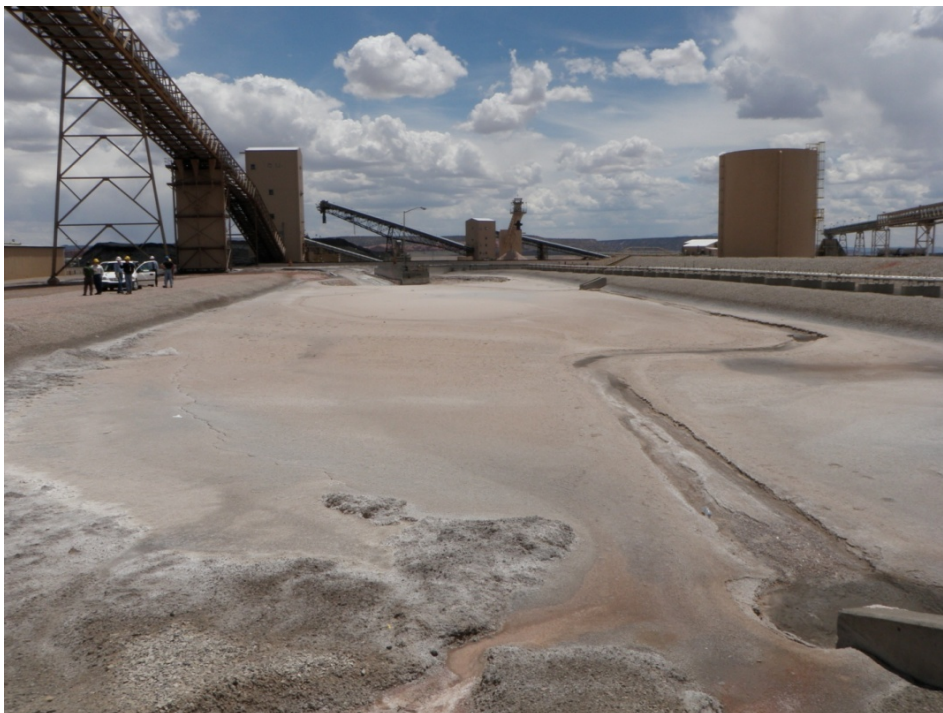
Photo 2: Emergency Scrubber Pond Looking East

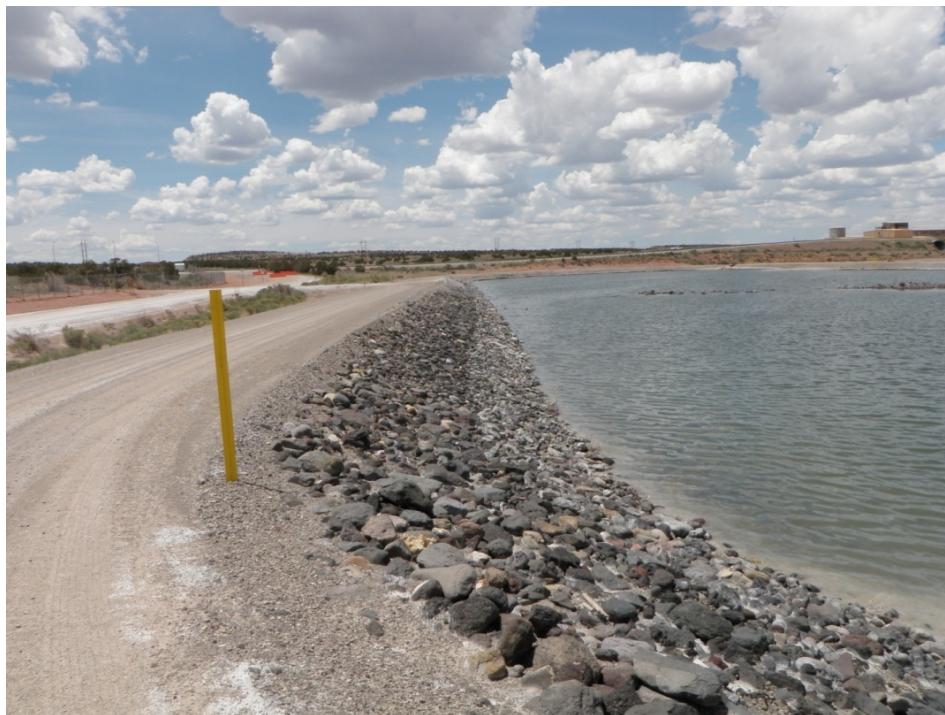
Photo 3: Bottom Ash Pond – South : Upstream Toe: Looking West along South Dike

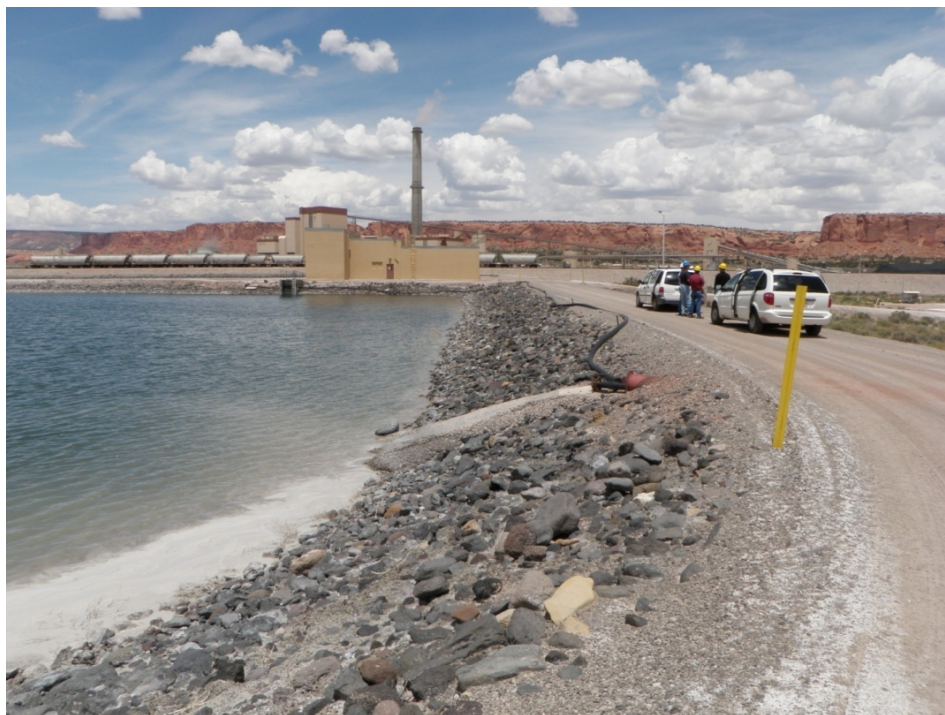
Photo 4: Bottom Ash Pond – South : Upstream Toe: Looking North along East Dike

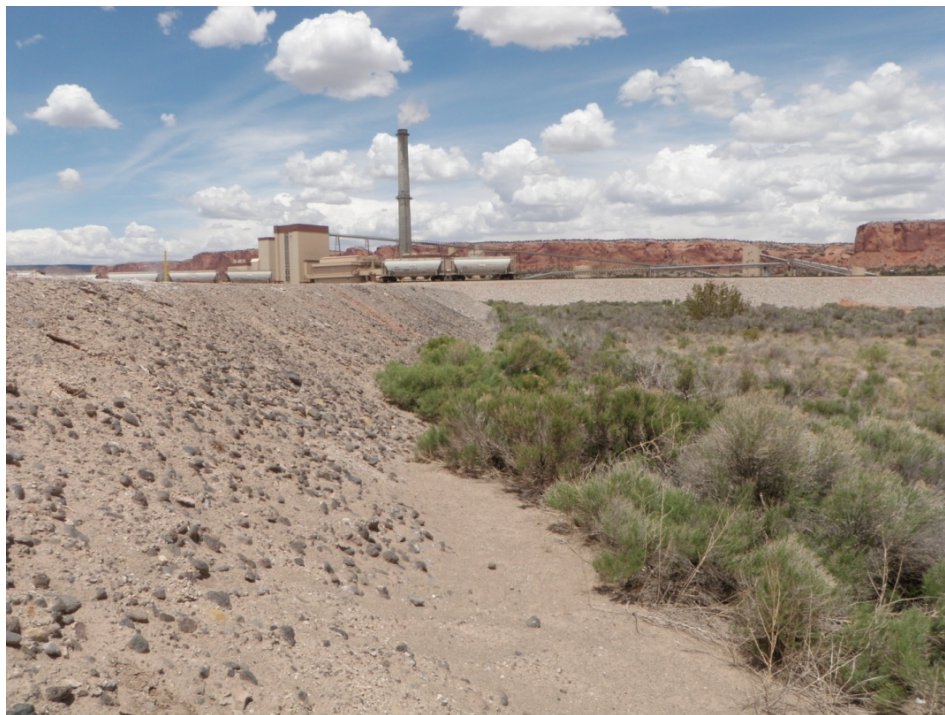
Photo 5: Bottom Ash Pond – North : Downstream Toe: Looking North along East Dike

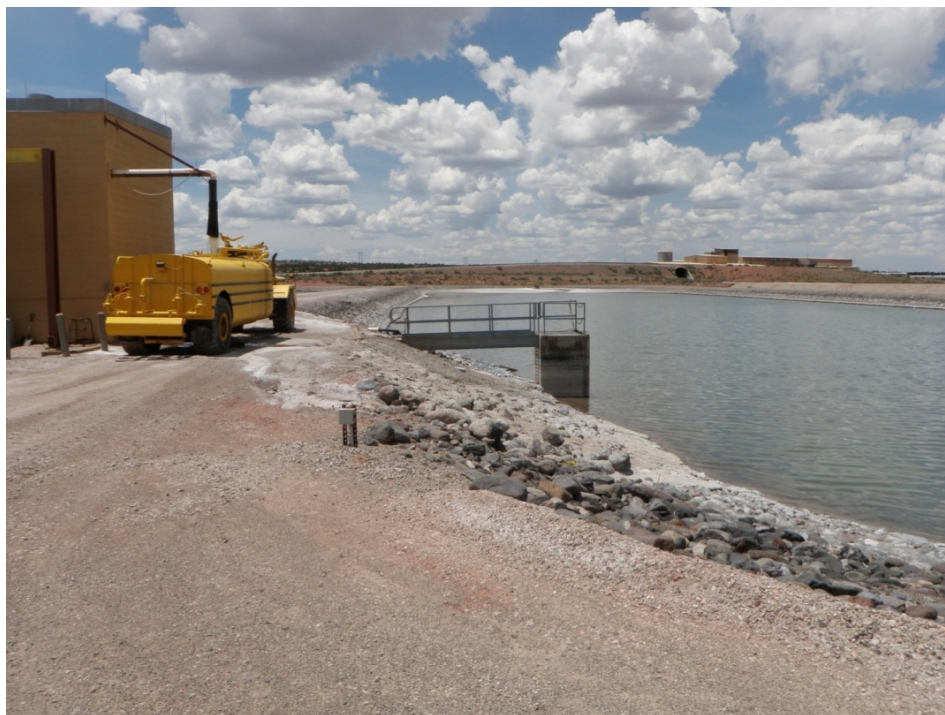
Photo 6: Bottom Ash Pond – North : Crest/Upstream Toe: Looking West along South Dike

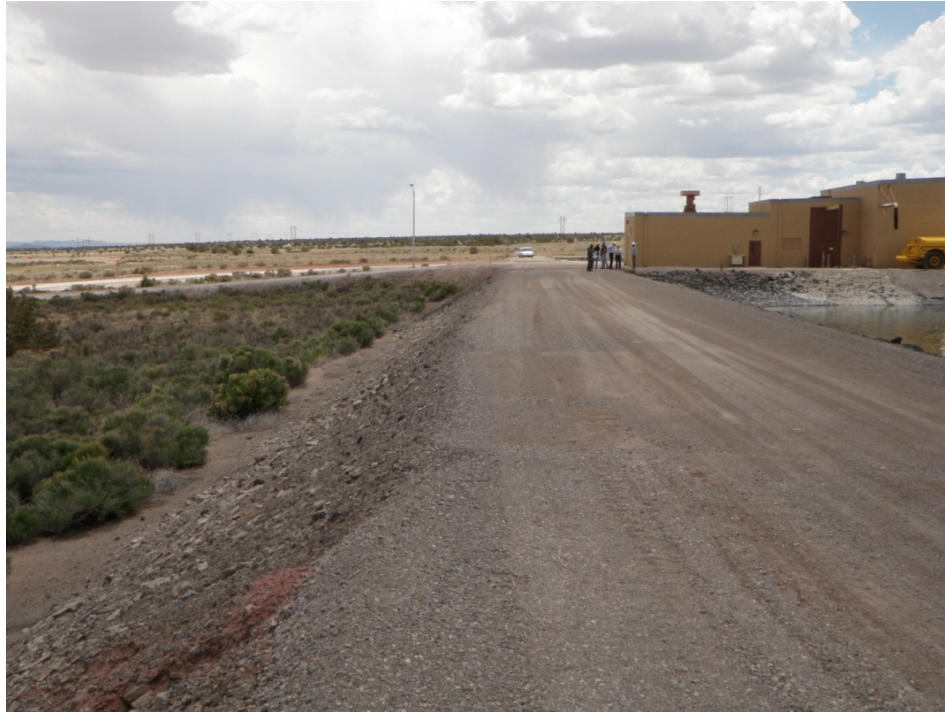
Photo 7: Bottom Ash Pond – North : Crest: Looking South along East Dike

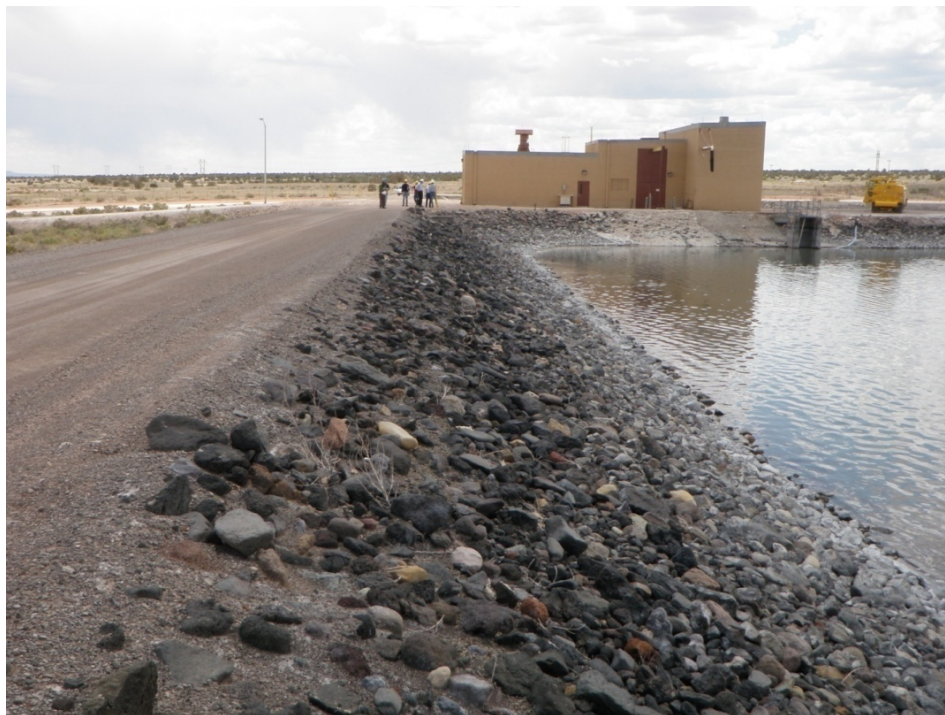
Photo 8: Bottom Ash Pond – North : Upstream Toe : Looking South along East Dike

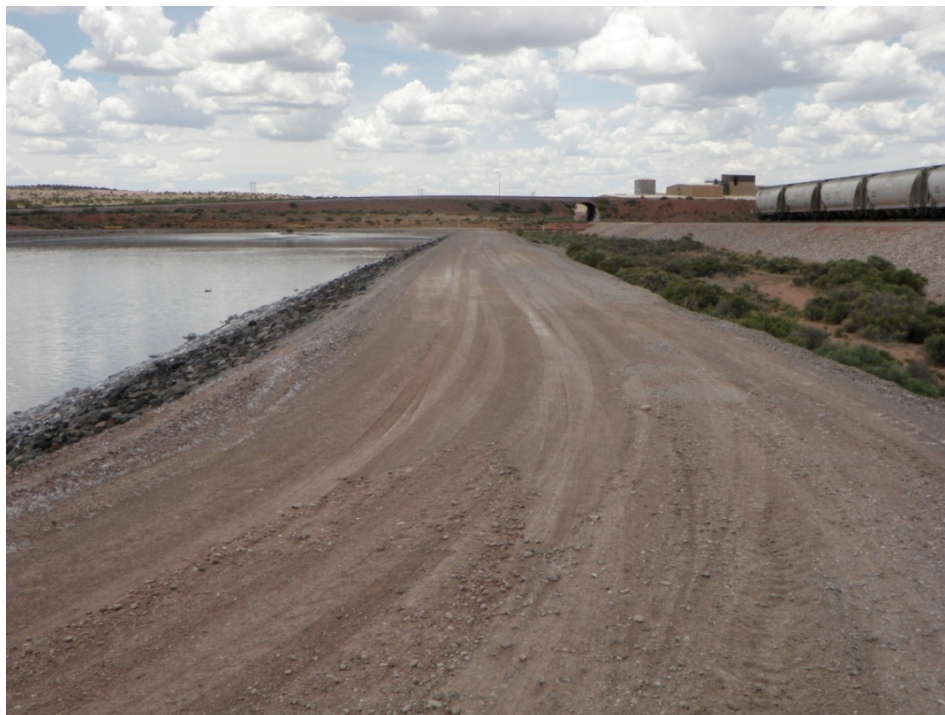
Photo 9: Bottom Ash Pond – North : Crest : Looking West along North Dike

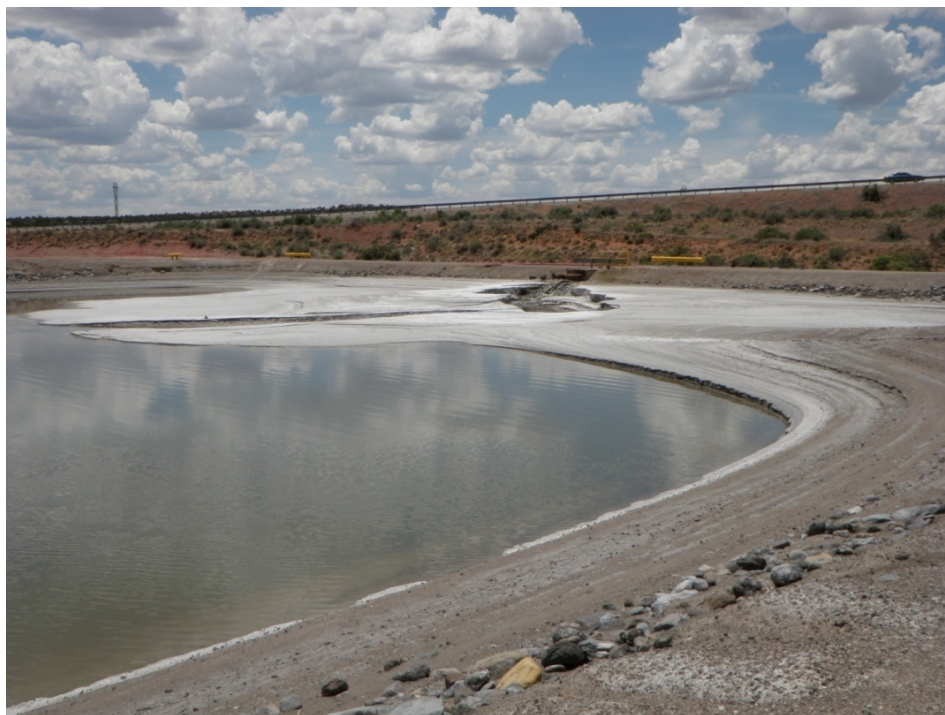
Photo 10: Bottom Ash Pond – North : Upstream Toe : Looking SW at Inlet pipes through the West Dike from the North Dike

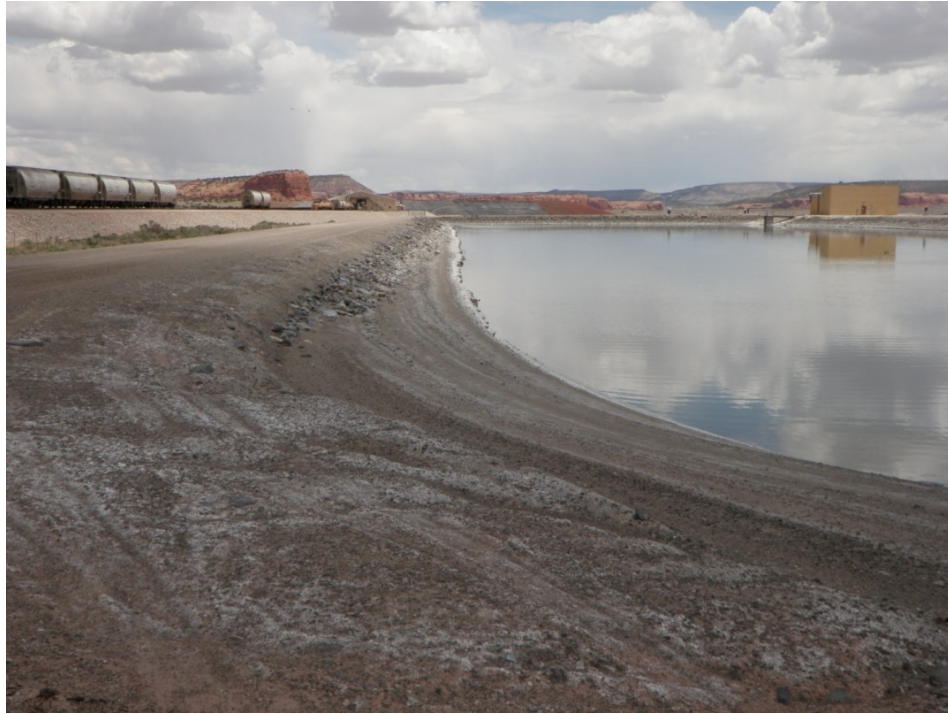
Photo 11: Bottom Ash Pond – North : Upstream Toe : Looking East along North Dike

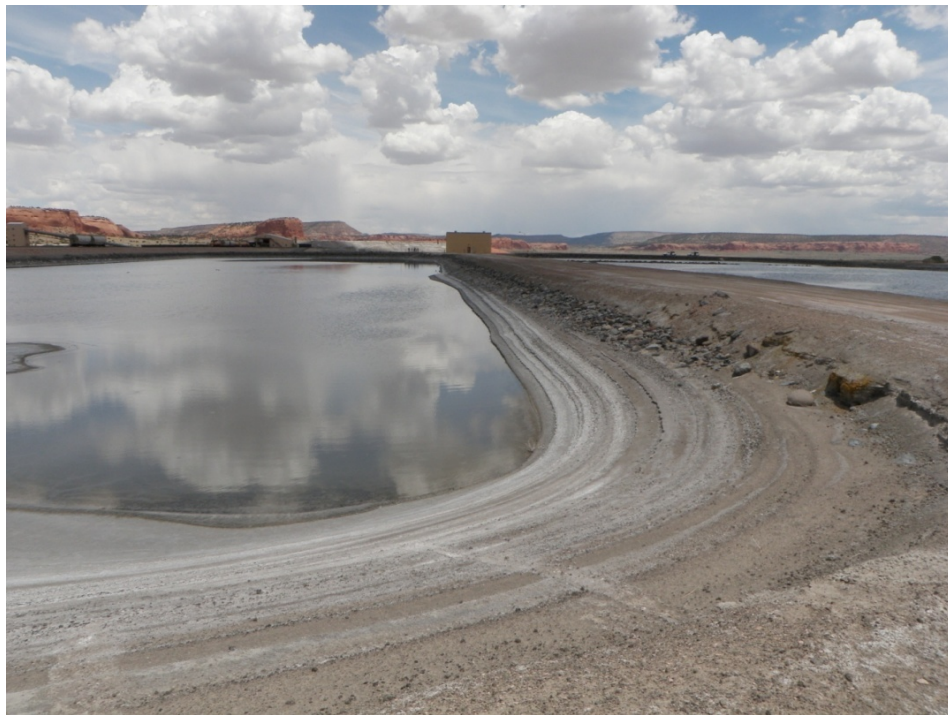
Photo 12: Bottom Ash Pond – North : Upstream Toe : Looking East along South Dike

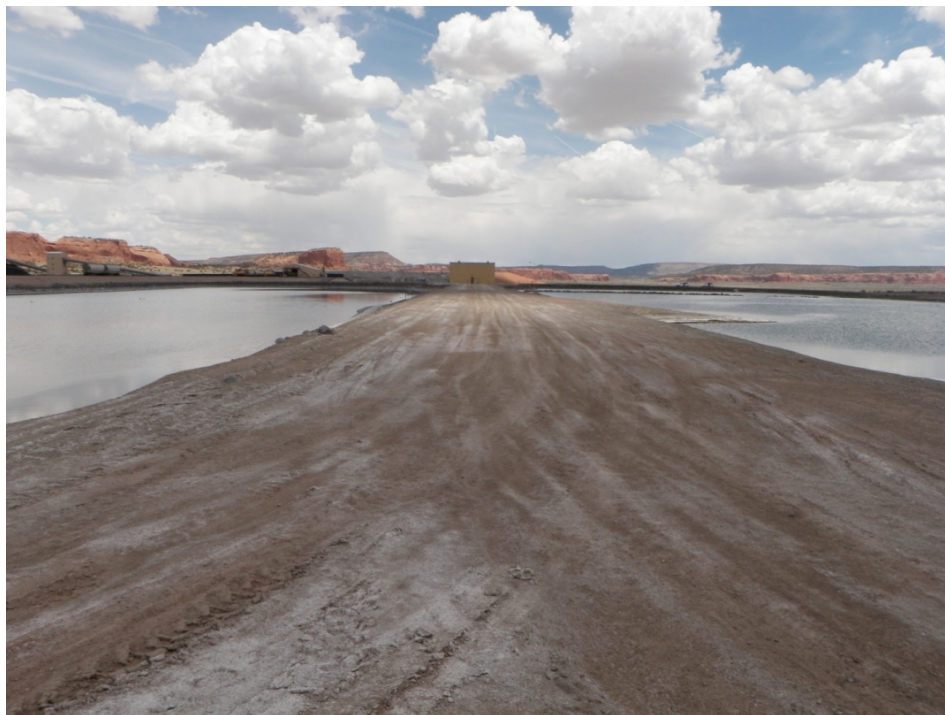
Photo 13: Bottom Ash Pond – North/South : Crest : Looking East along the Dike dividing the North and South Ponds. South Pond on the right- North Pond on the left.

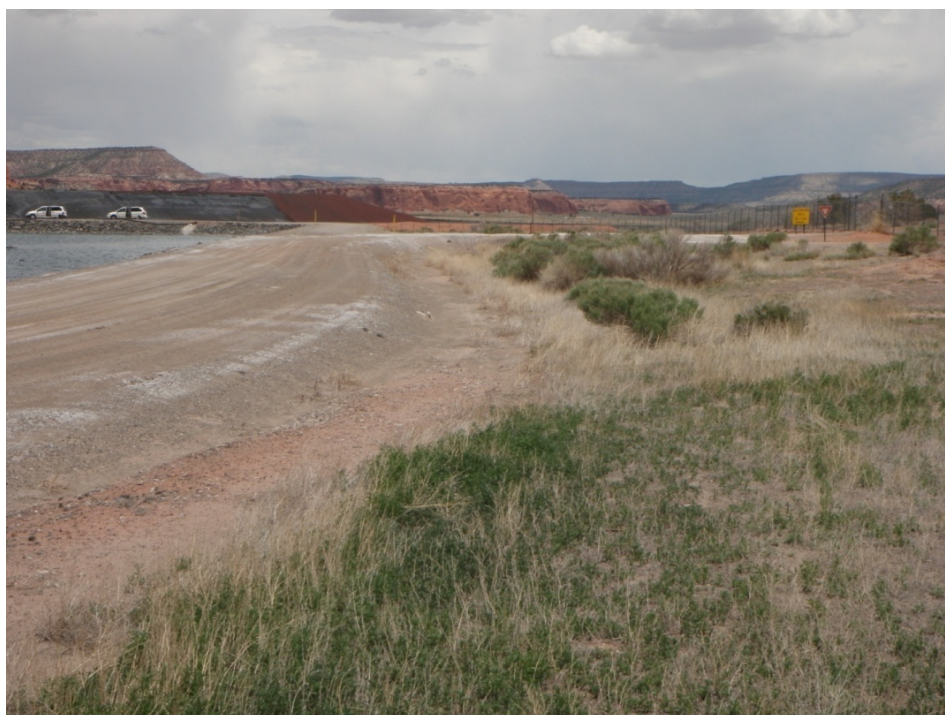
Photo 14: Bottom Ash Pond – South : Downstream Toe : Looking East along South Dike

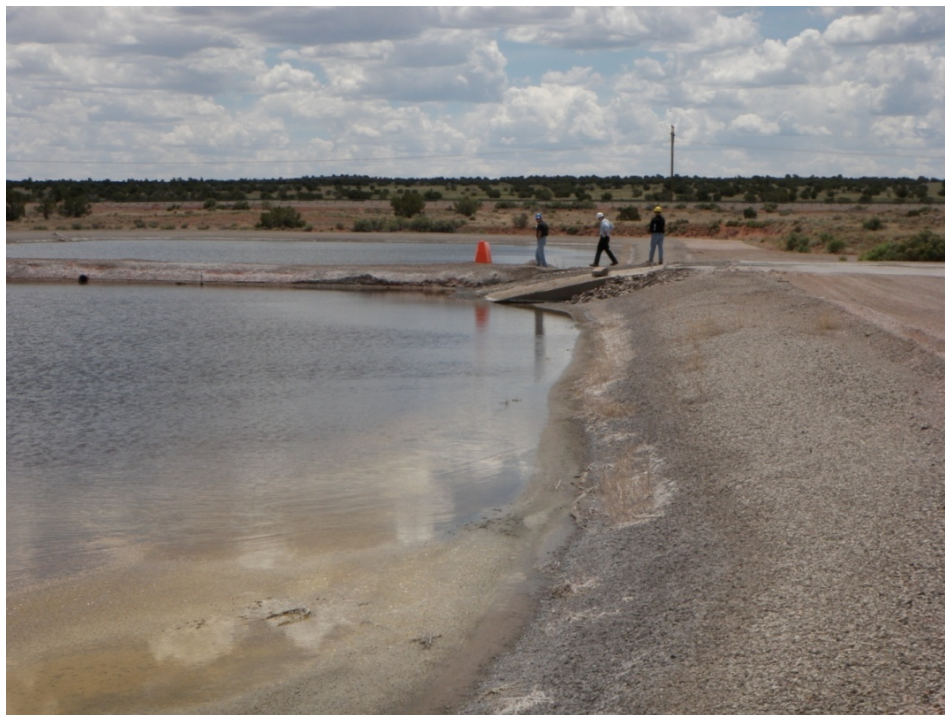
Photo 15: Evaporation Pond 1a : Upstream Toe : Looking South along West dike

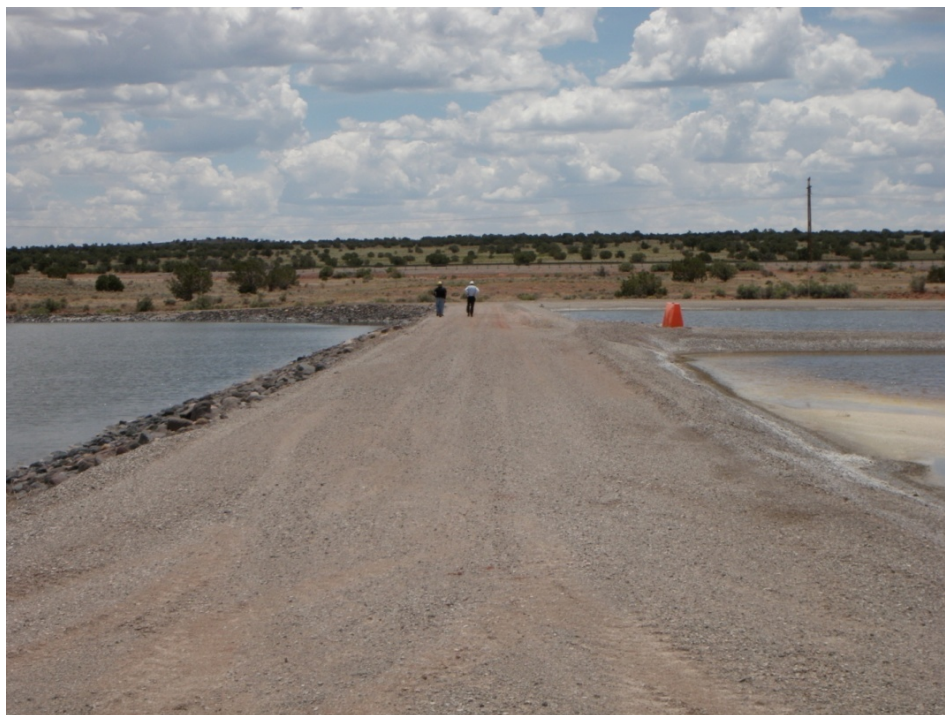
Photo 16: Evaporation Pond 2 (left) & 1a (right) & 1b (right background) : Crest : Looking South

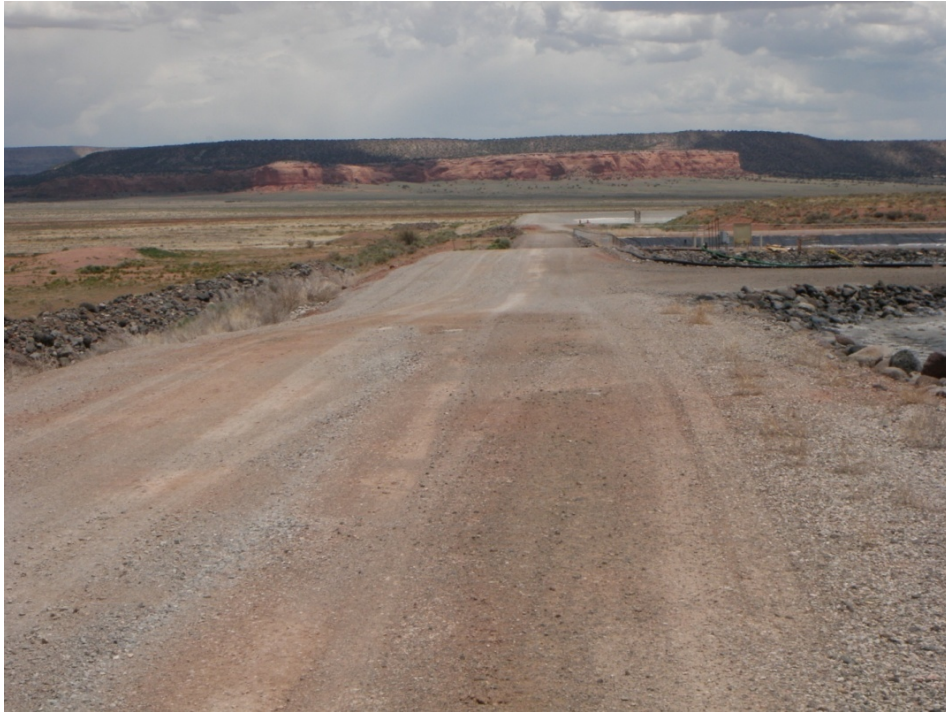
Photo 17: Evaporation Pond 2 : Crest : Looking East along North dike

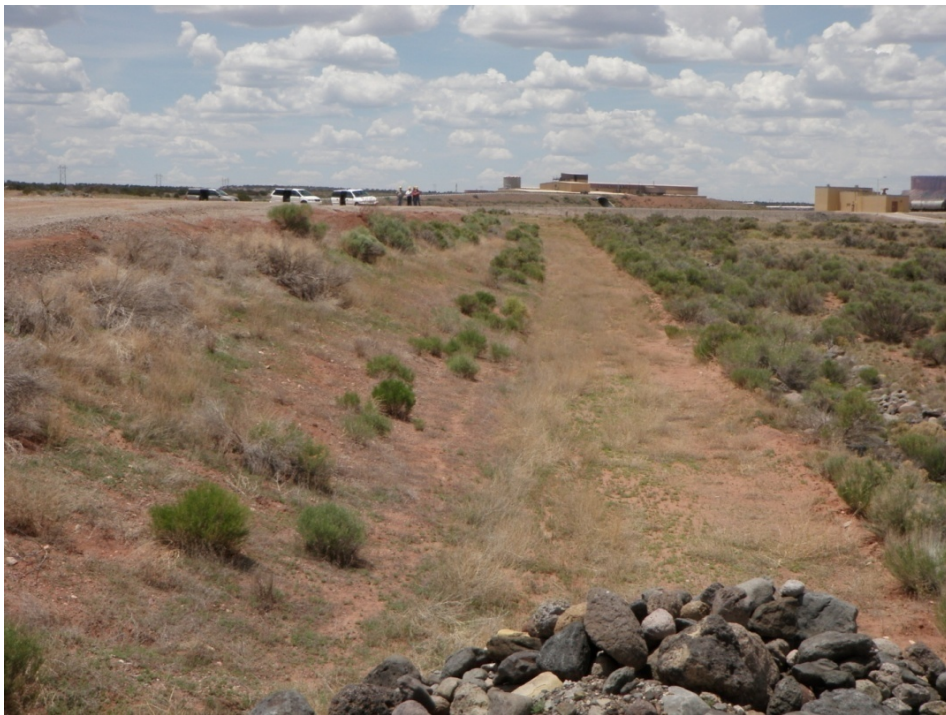
Photo 18: Evaporation Pond 2 : Downstream Toe : Looking West along north dike

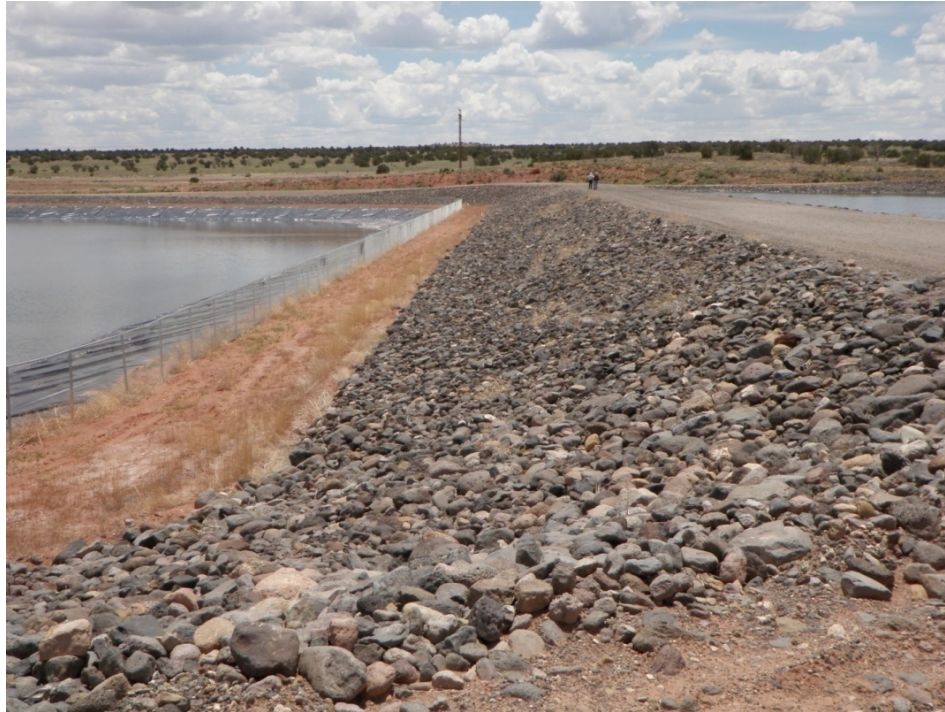
Photo 19: Evaporation Pond 4 : Upstream Toe : Looking South along West dike

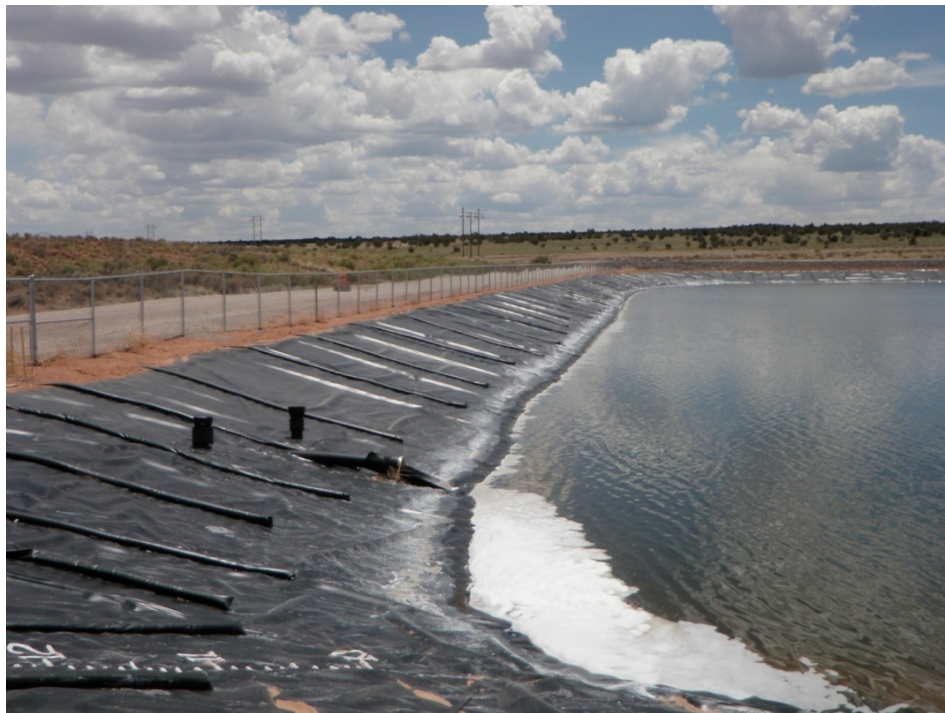
Photo 20: Evaporation Pond 4 : Upstream Toe : Looking South along east dike

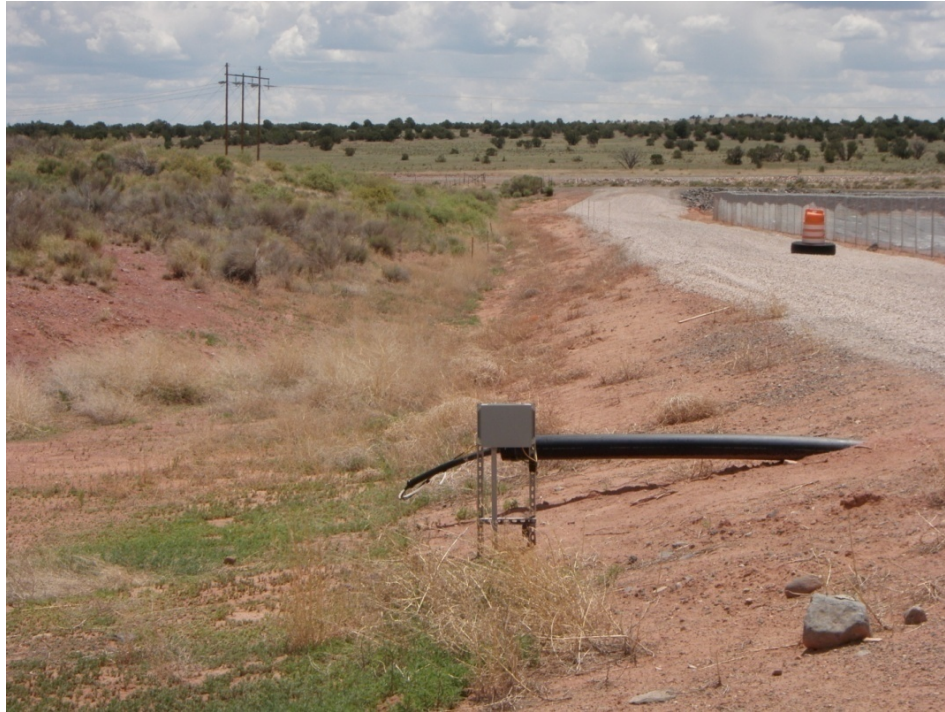
Photo 21: Evaporation Pond 4 : Downstream Toe : Looking South along east dike

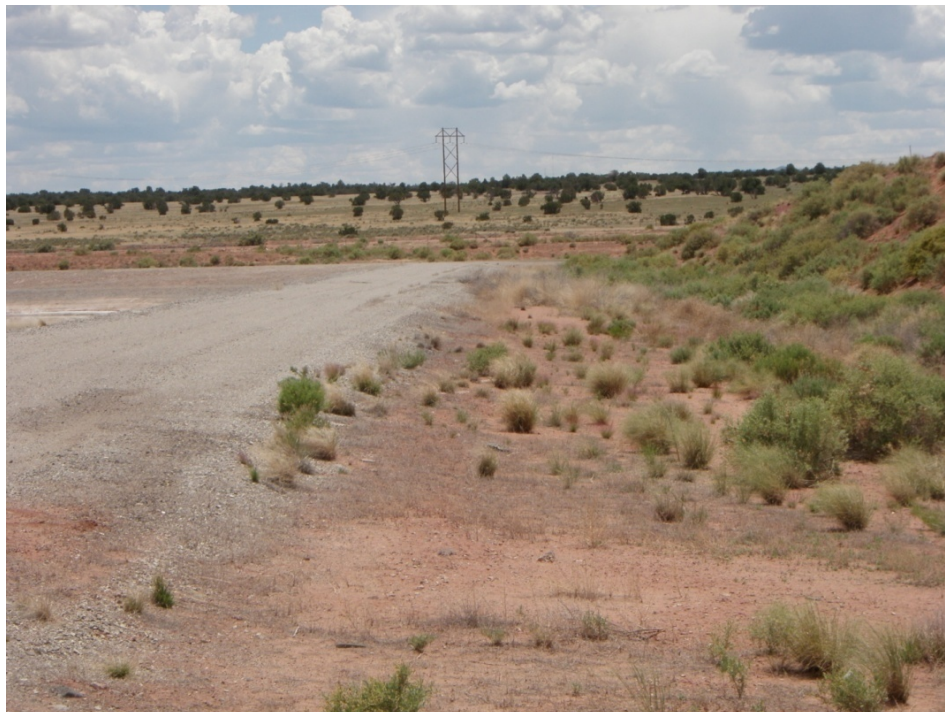
Photo 22: Evaporation Pond 5: Downstream Toe : Looking South along west dike

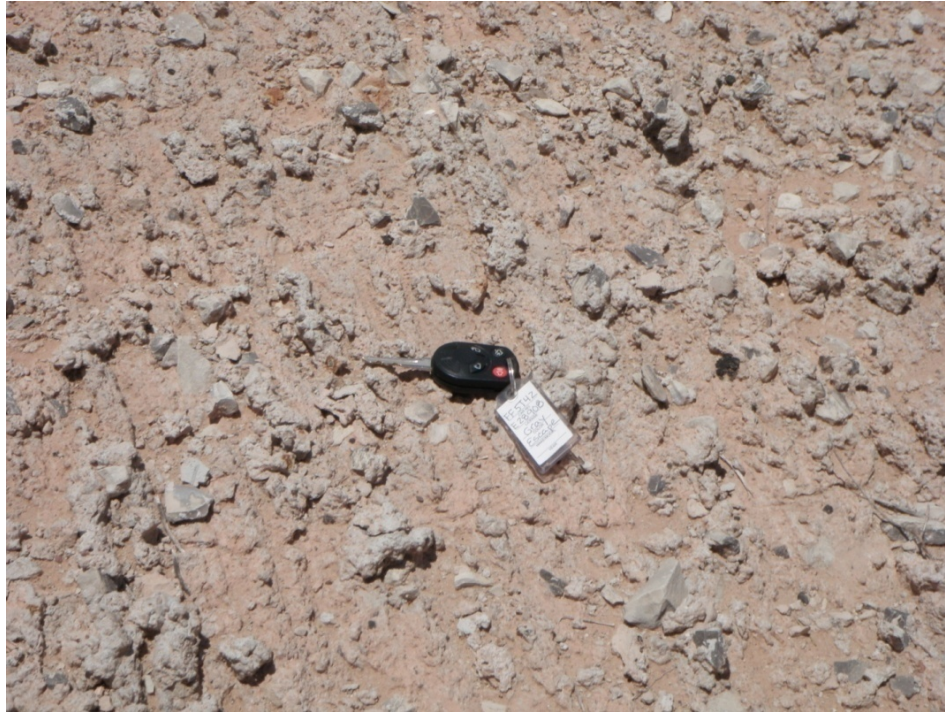
Photo 23: Evaporation Pond 5 : Raked liner finish

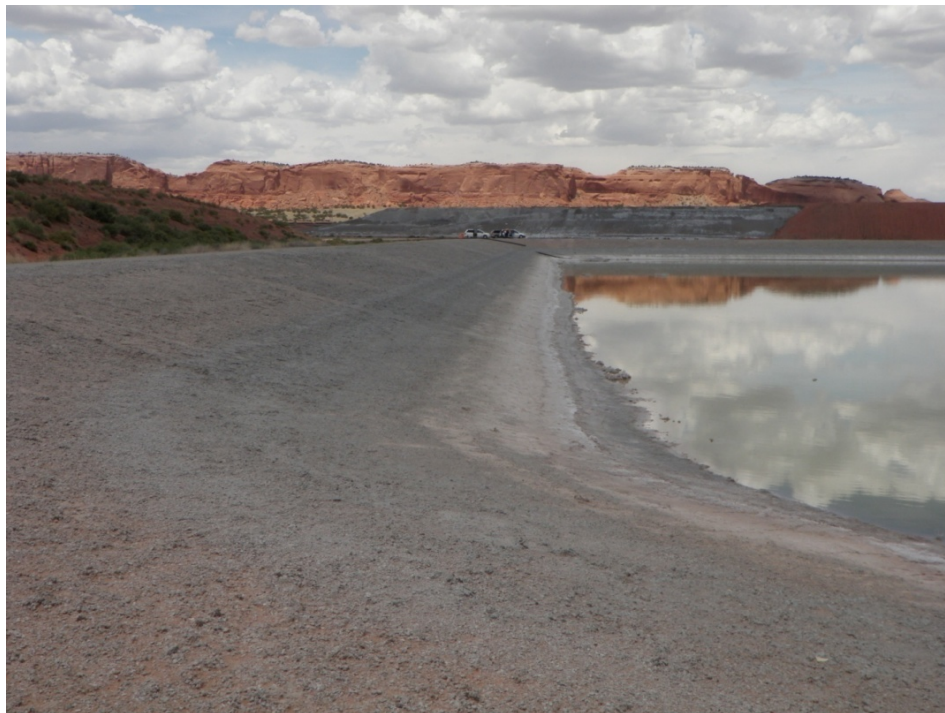
Photo 24: Evaporation Pond 5 : Upstream Toe : Looking North along west dike

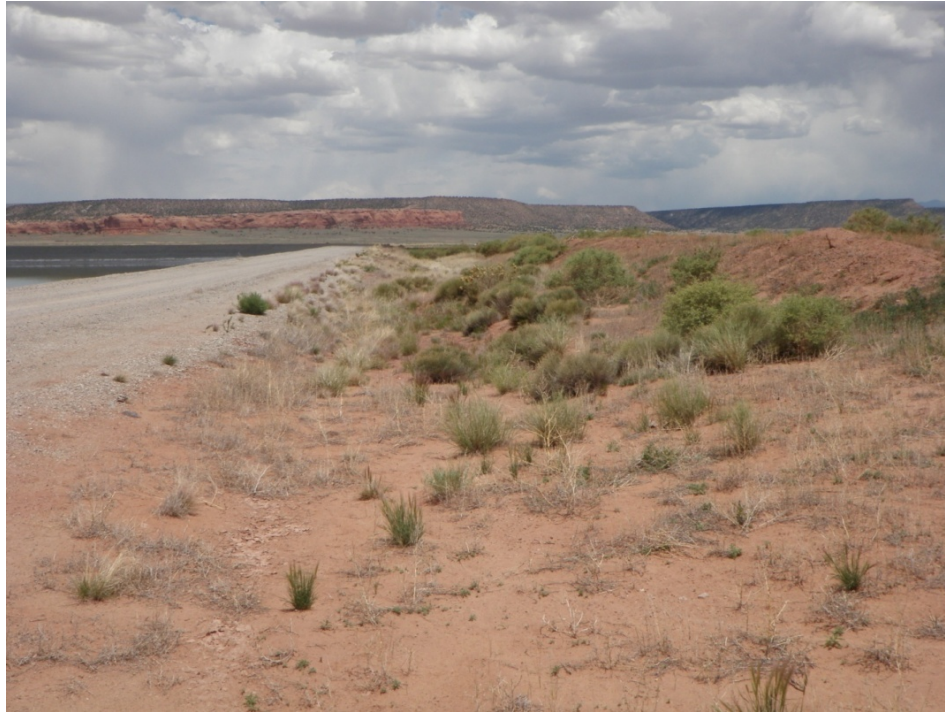
Photo 25: Evaporation Pond 5 : Downstream Toe : Looking East along south dike

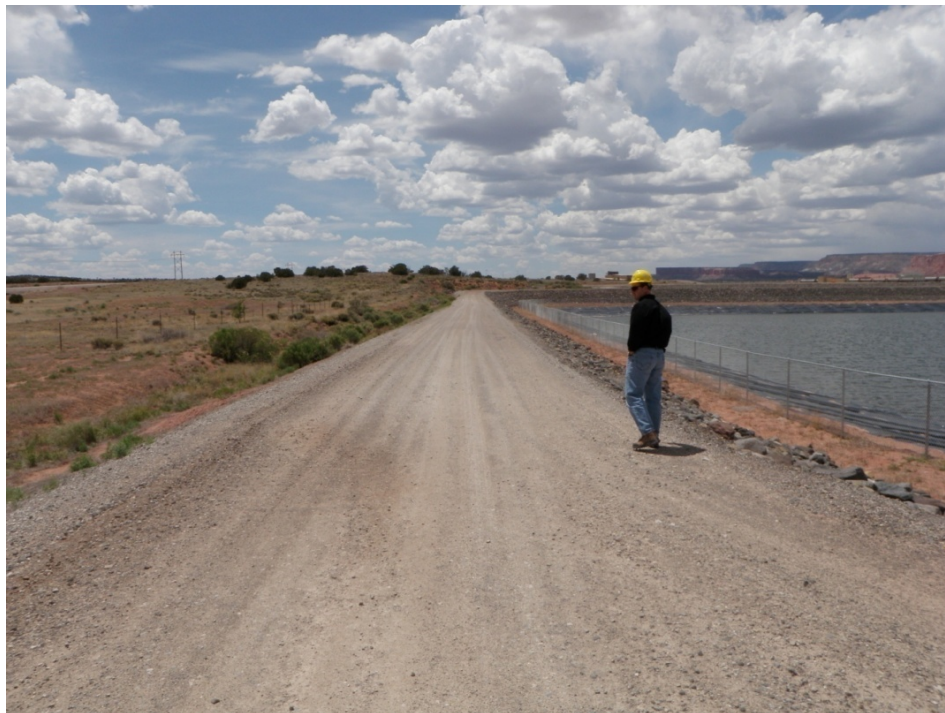
Photo 26: Evaporation Pond 4 : Crest : Looking East along south dike

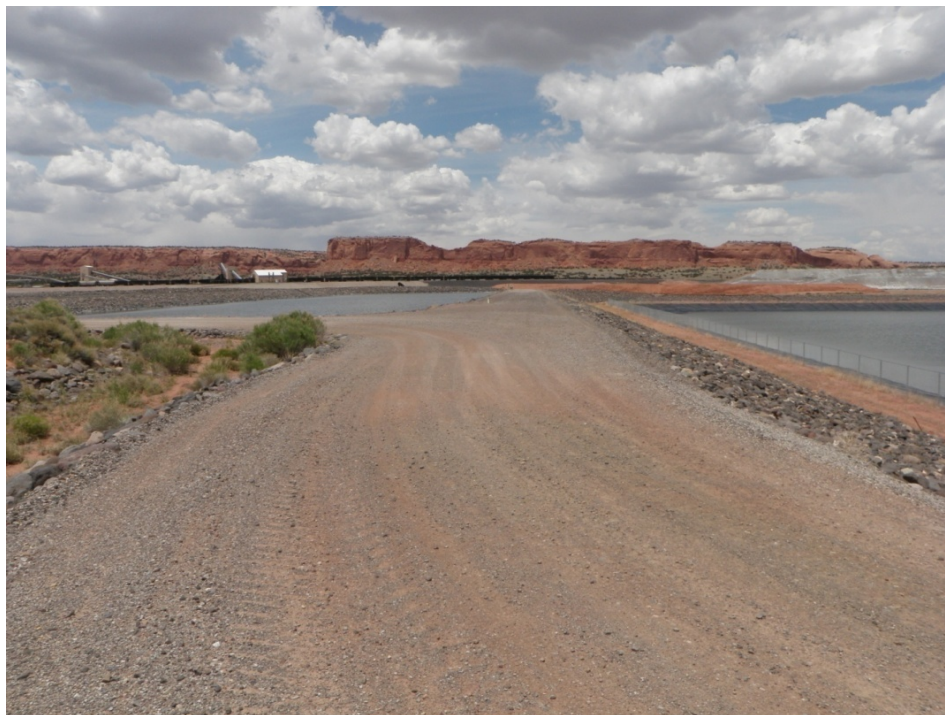
Photo 27: Evaporation Pond 4 (right) & Pond 3 (left) : Crest : Looking North along Pond 4 west dike

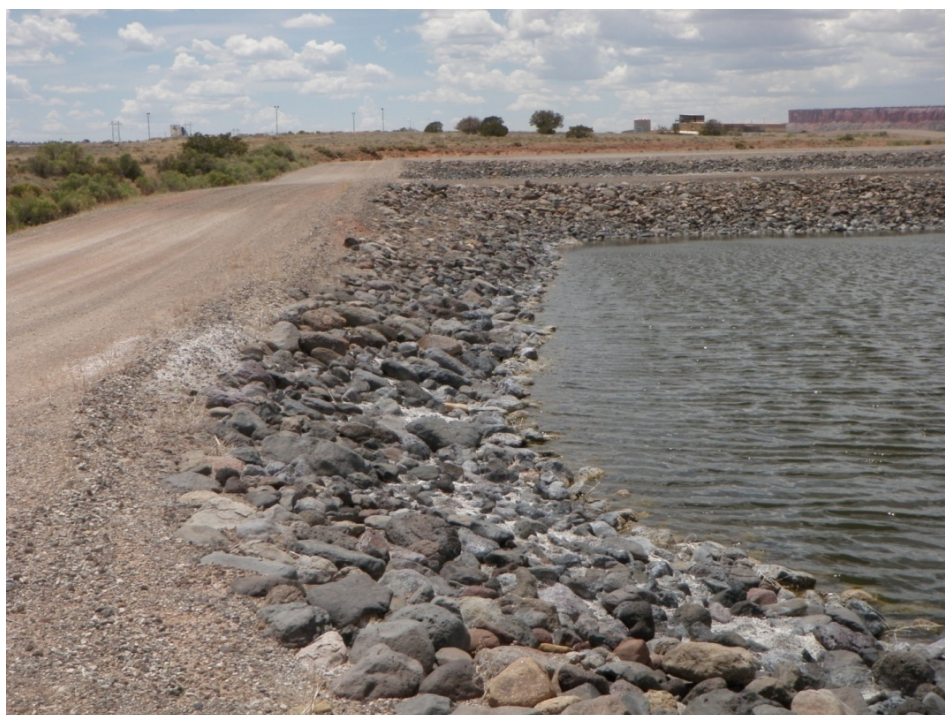
Photo 28: Evaporation Pond 3 : Upstream Toe : Looking West along south dike

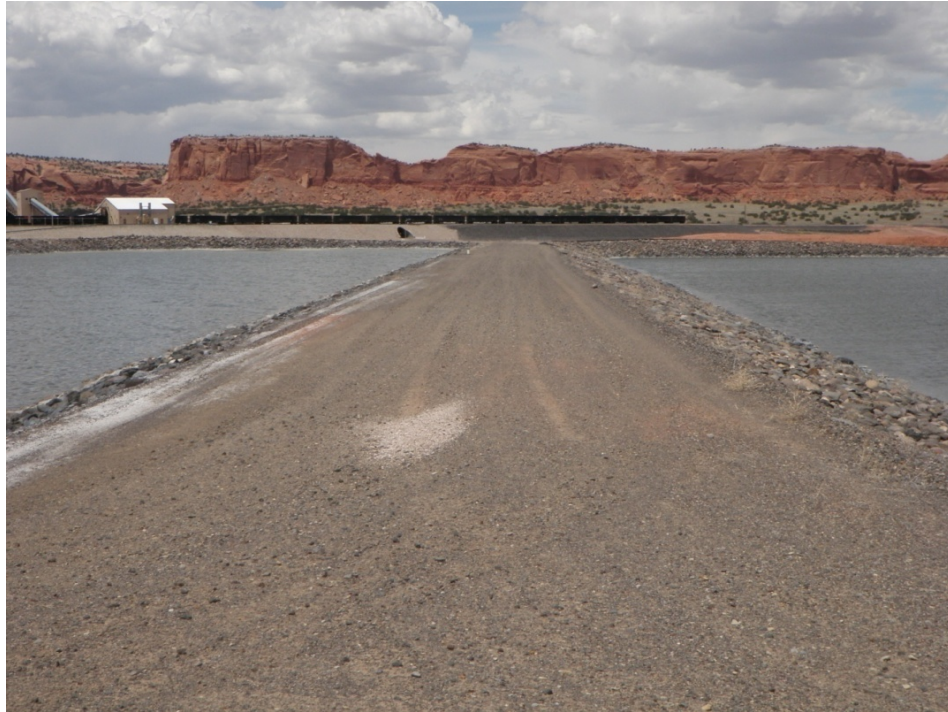
Photo 29: Evaporation Pond 2 (left) & Pond 3 (right) : Crest : Looking North

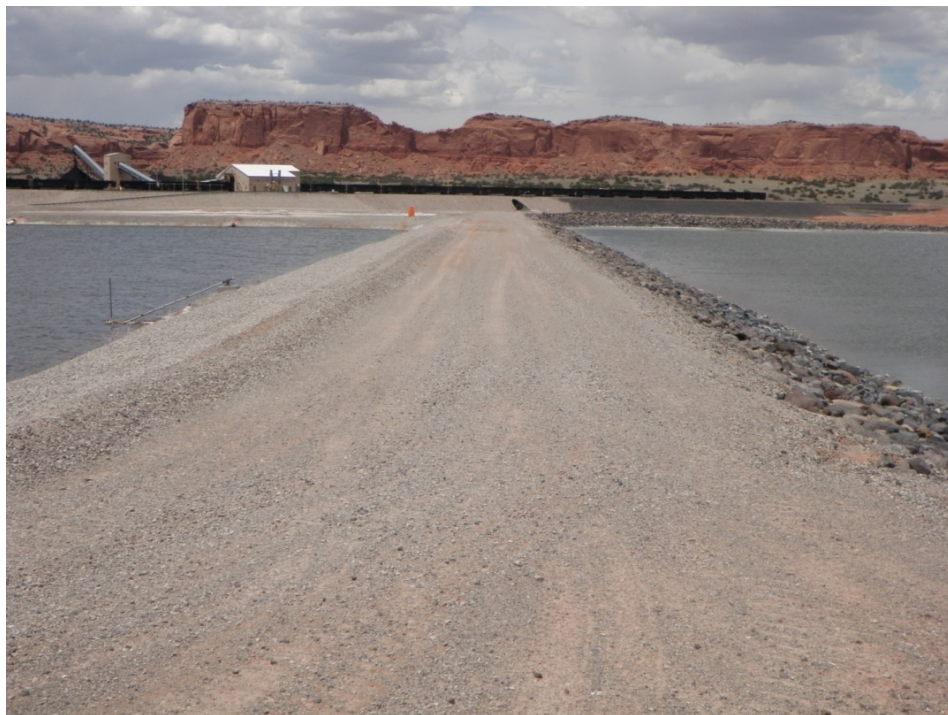
Photo 30: Evaporation Pond 2 (right) & 1b (left) : Crest : Looking North

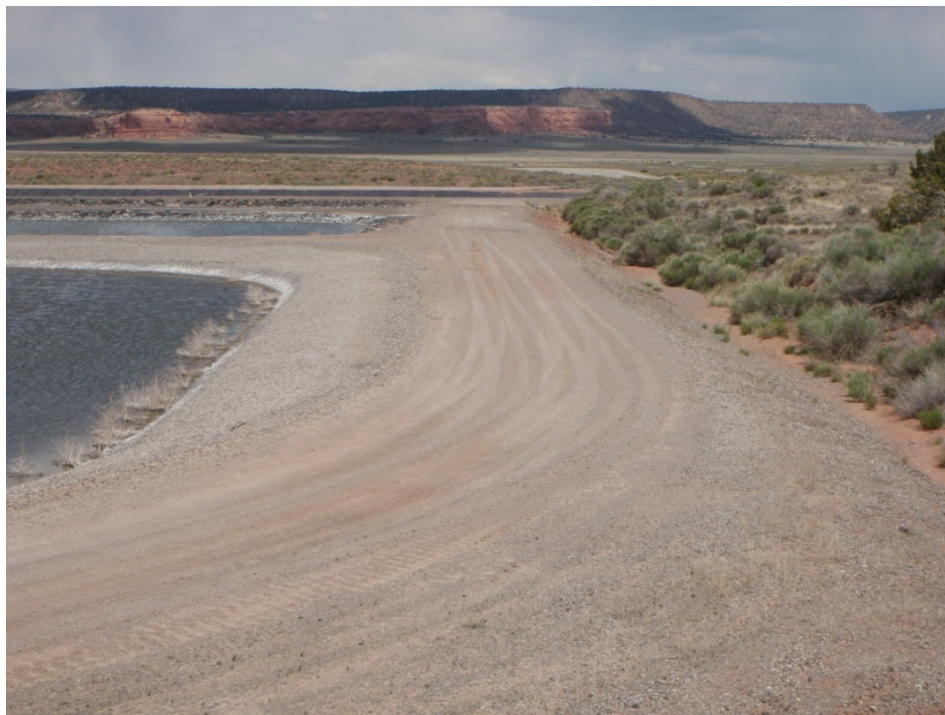
Photo 31: Evaporation Pond 1b : Crest : Looking East along south dike

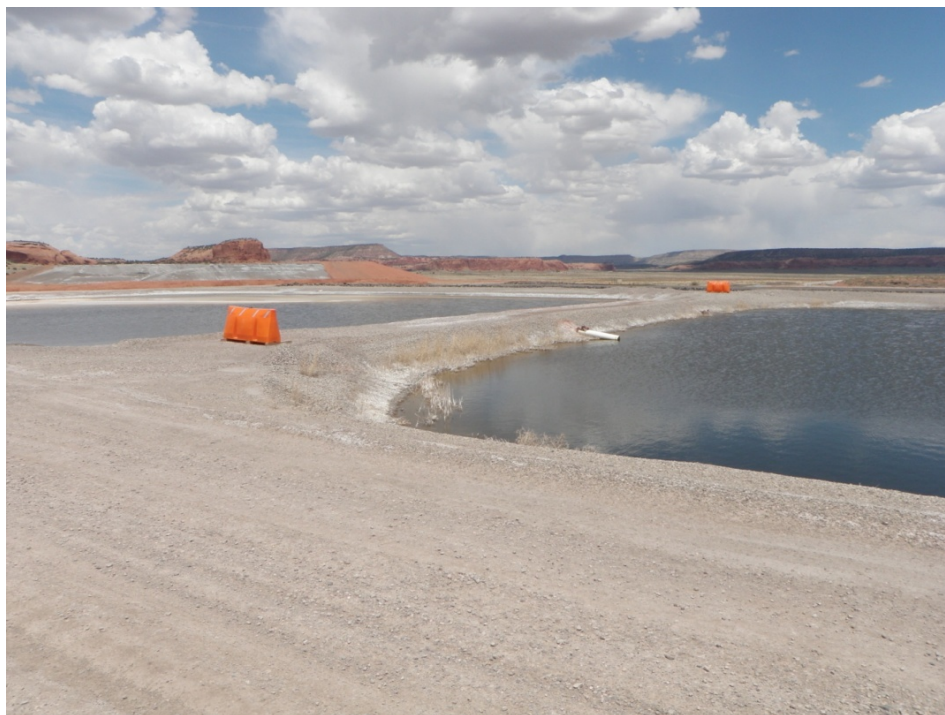
Photo 32: Evaporation Pond 1a (left) & 1b (right) : Looking Northeast from the west dike of Pond 1b at dike dividing 1b from 1a
