**Coal Combustion Residue Impoundment  
Round 11 - Dam Assessment Report**

*Allen Fossil Plant*

*Tennessee Valley Authority*  
**Memphis, Tennessee**

**August 2012**

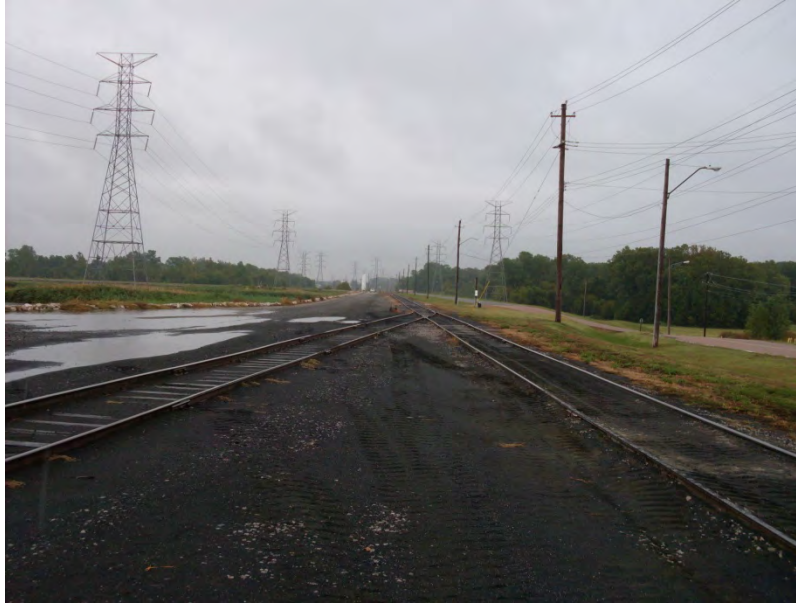
**Photo 5.1: EAP Perimeter dike crest south side, looking east. Note ponded water.**

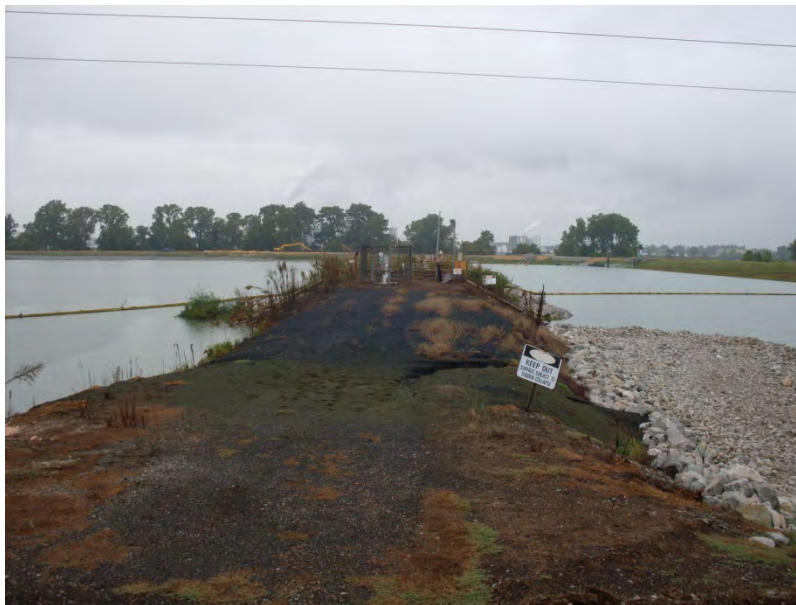
**Photo 5.3: EAP Divider dike crest south end, looking north. Note gully erosion in the bottom ash embankment.**

- 1) Repair gully erosion on the divider dike;
- 2) Add crushed stone surfacing material in worn shallow depression on the dike crest south side where haul trucks turn into the dredge cell;
- 3) Avoid mowing the slopes when the ground is still wet from rainfall to minimize mower ruts on the slopes;
- 4) Observe over time the wet area at the toe of the north side exterior slope to verify that the puddle is not due to seepage. If the water source is found to be seepage, then repair the slope with an inverted filter. If the water is not from seepage, then re-grade or fill the slight depression with crushed stone surfacing material.

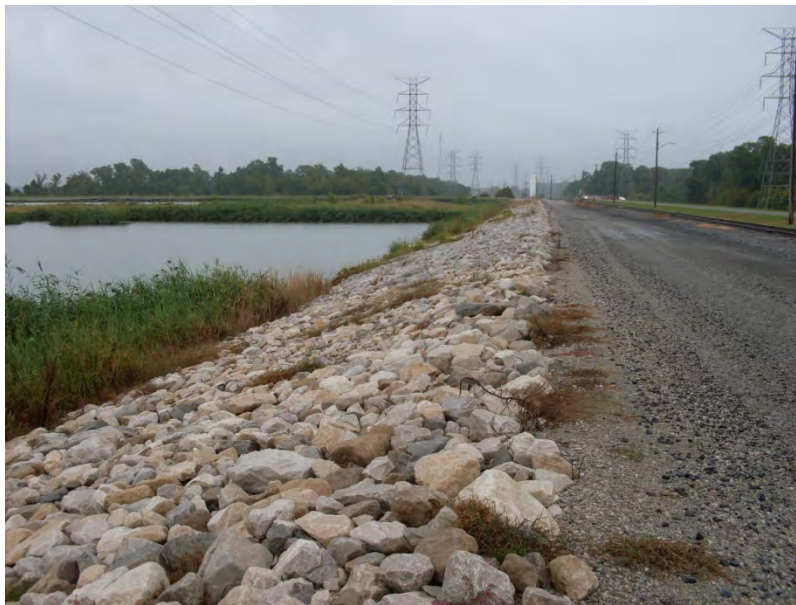
**Photo 5.4: EAP Perimeter dike inside slope south side, looking east.  
Note riprap that was placed in 2010 to protect against wave erosion.**

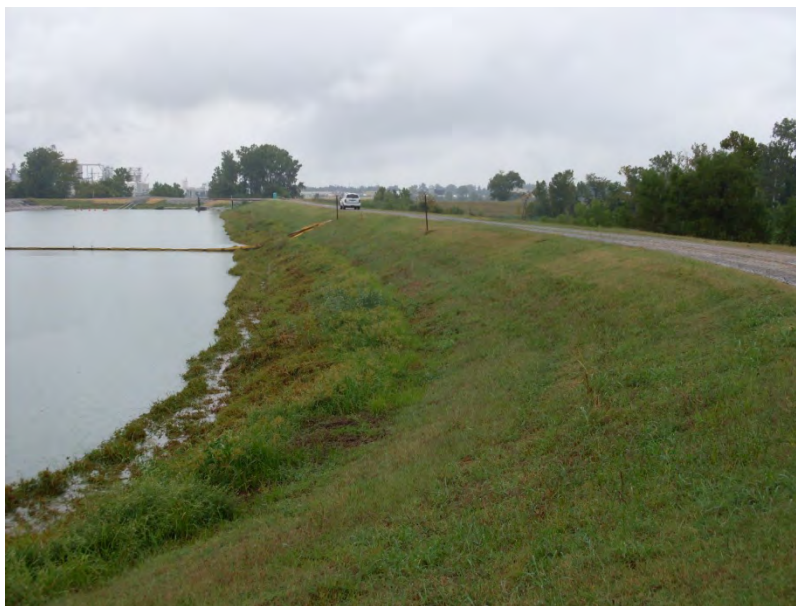
**Photo 5.5: EAP Perimeter dike inside slope east side (stilling pond),  
looking north.**

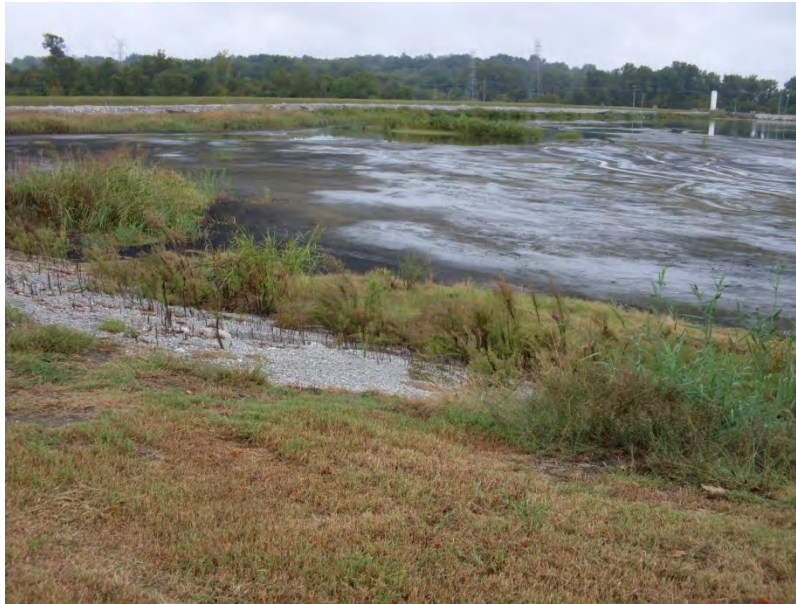
**Photo 5.6: EAP Perimeter dike inside slope north side, looking east southeast in area of recent slump repair. Note crushed stone material used in the repair.**

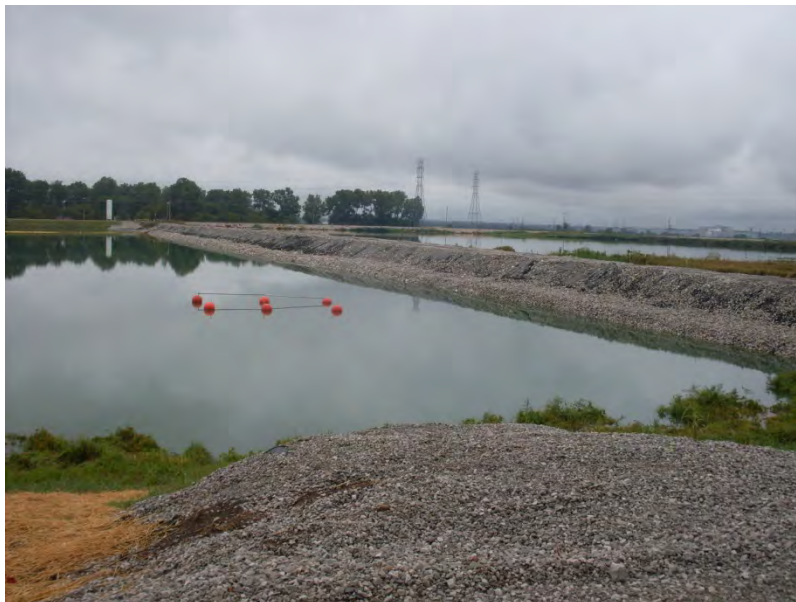
**Photo 5.7: EAP Divider dike slope east side, looking southwest. Note minor gully erosion in slope above riprap blanket.**

The slopes of the divider dike were observed to be steeper than those of the perimeter dike. The slope on the stilling basin side of the divider dike was observed to have a partial-height blanket of small riprap that was placed during recent remedial construction. The remaining surfaces of the divider dike slopes (and most of the crest) were observed to be covered with a thin layer of crushed stone. Minor gully erosion in the slope of this ash embankment above the new riprap blanket was observed, as shown in Photo 5.7. The fly ash excavation operation was observed in the dredge cell, as shown in Photo 5.8. The visible part of the sanitary sewer temporary bypass recently constructed in the dredge cell was observed where it ties into the manhole in the south part of the dredge cell, as shown in Photo 5.9. A view of the ash sluice lines to the East Ash Pond were observed, as shown in Photo 5.10.

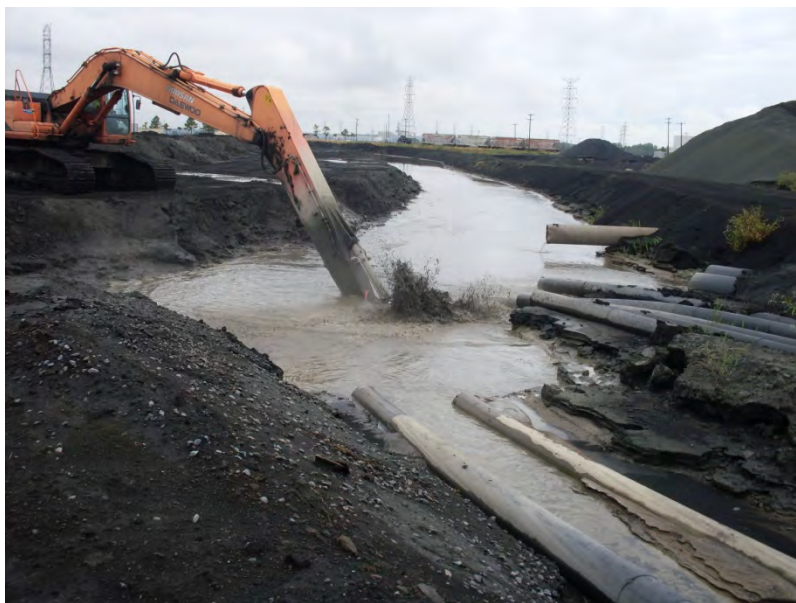
**Photo 5.8: EAP Excavation of fly ash in dredge cell, looking south. Note greenish stockpile of boiler slag/bottom ash in background.**

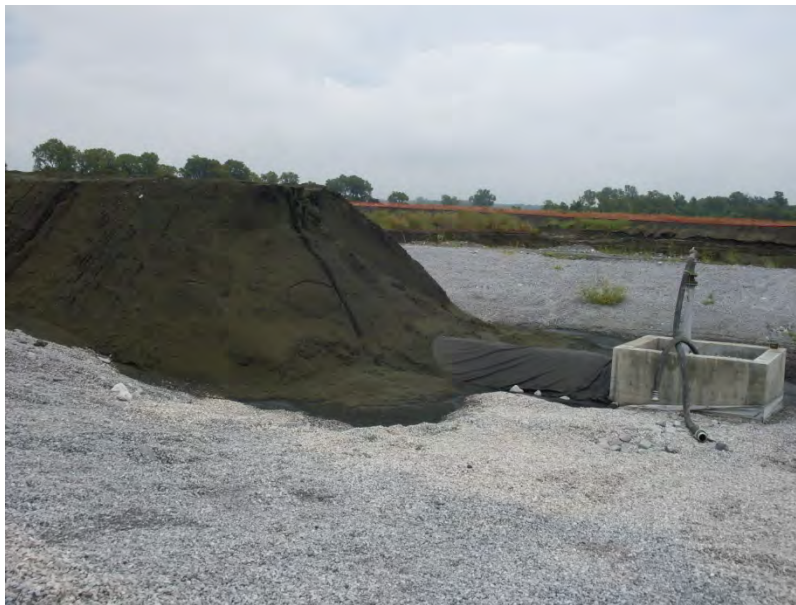
**Photo 5.9: EAP South end of temporary bypass construction for active sanitary sewer under dredge cell.**

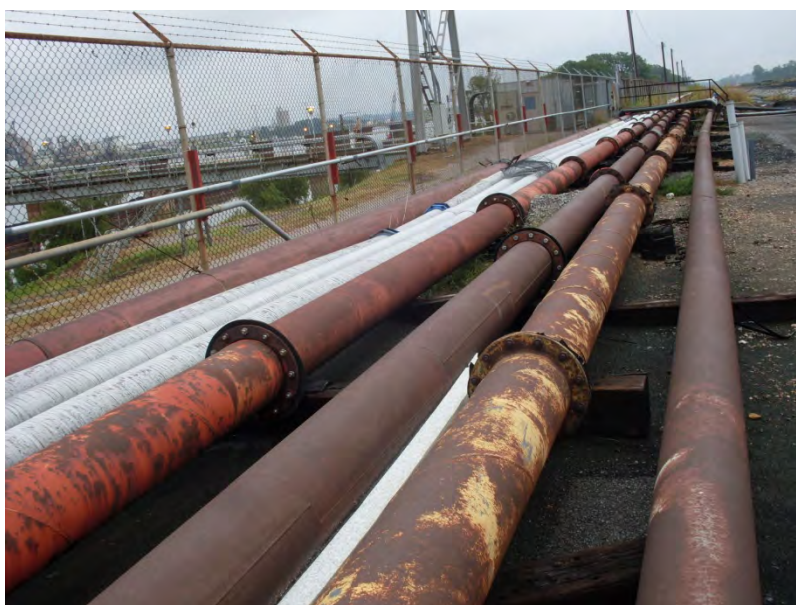
**Photo 5.10: EAP View of ash sluice lines and plant process water line (leftmost) extending from the plant to the active pond, looking east. Rightmost line is abandoned.**

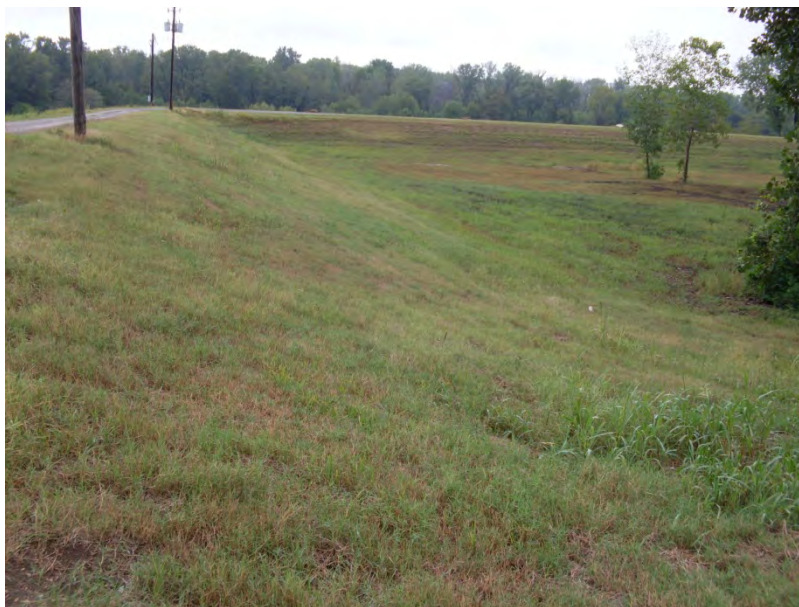
**Photo 5.11: WAP Typical view perimeter inside slope west side, viewed north.**

At the West Ash Pond (WAP) the inside slopes were observed to have a well-maintained cover of grass, as shown by the typical view in Photo 5.11. The inside slopes were in satisfactory condition. The interior of the inactive pond was observed to have some scattered trees, but the area was clear of brush and undergrowth and covered with a well-maintained grass cover, as shown in Photo 5.12. It was observed that the eastern part had been filled in with what appeared to be dry ash, as shown in Photo 5.13. The piles of stones on the barren surface had been placed to discourage nesting of the Least Tern in close proximity to the plant.

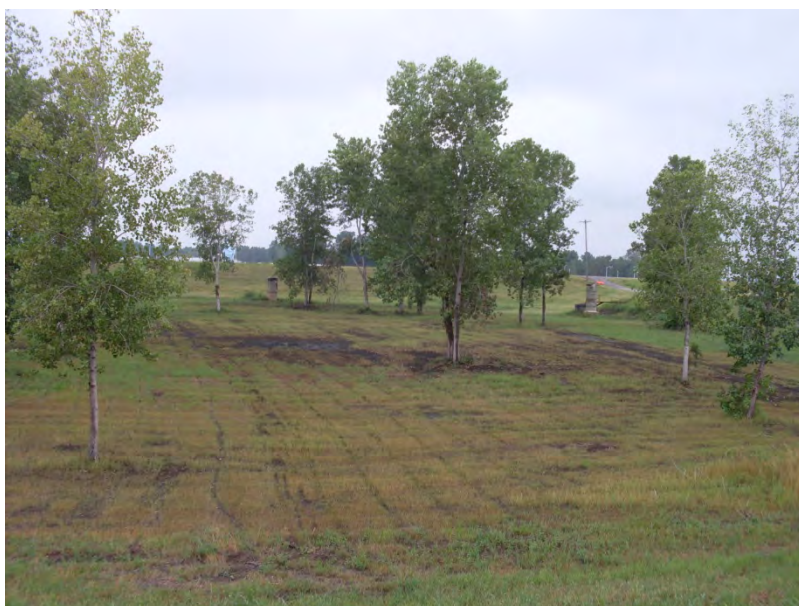
**Photo 5.12: WAP Typical view of inactive pond area, viewed south.**

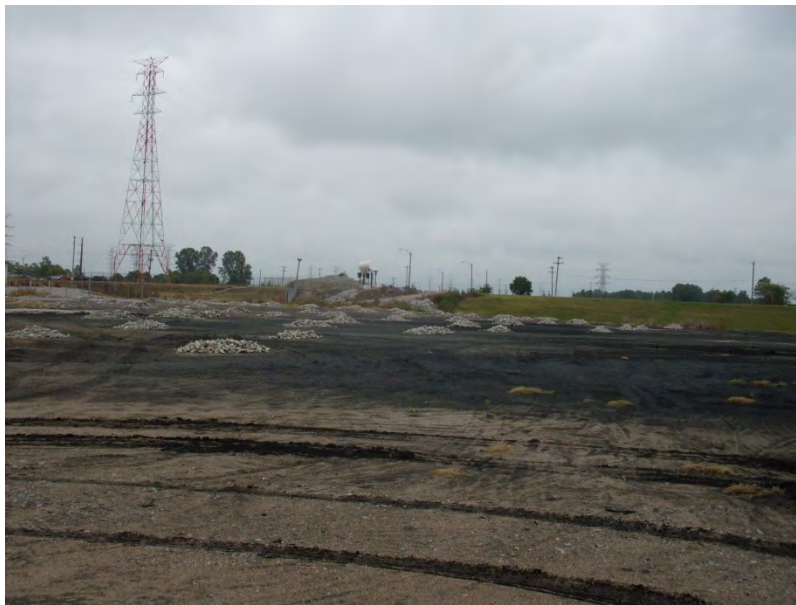
**Photo 5.13: WAP View of apparent ash fill at east end of pond, viewed southeast. Note stone piles as deterrent for Least Tern nesting.**

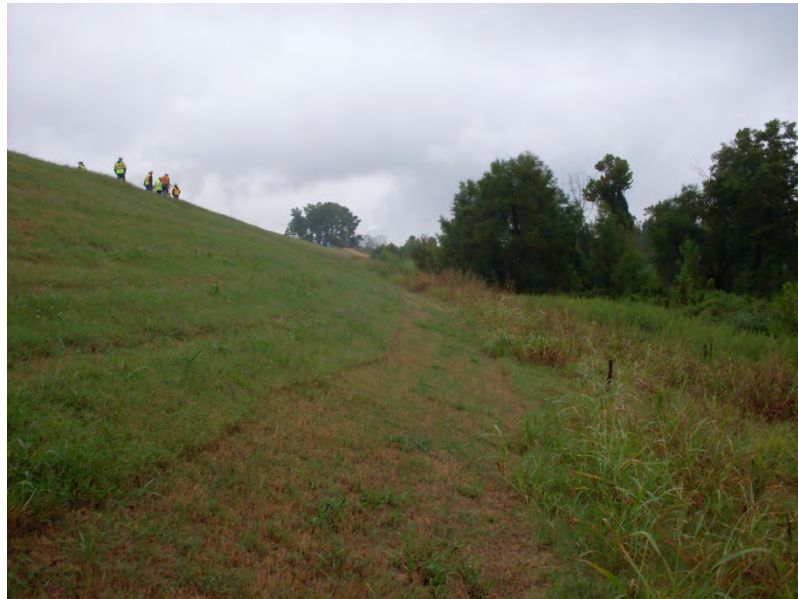
**Photo 5.14: EAP Perimeter dike outside slope east side, looking north.**

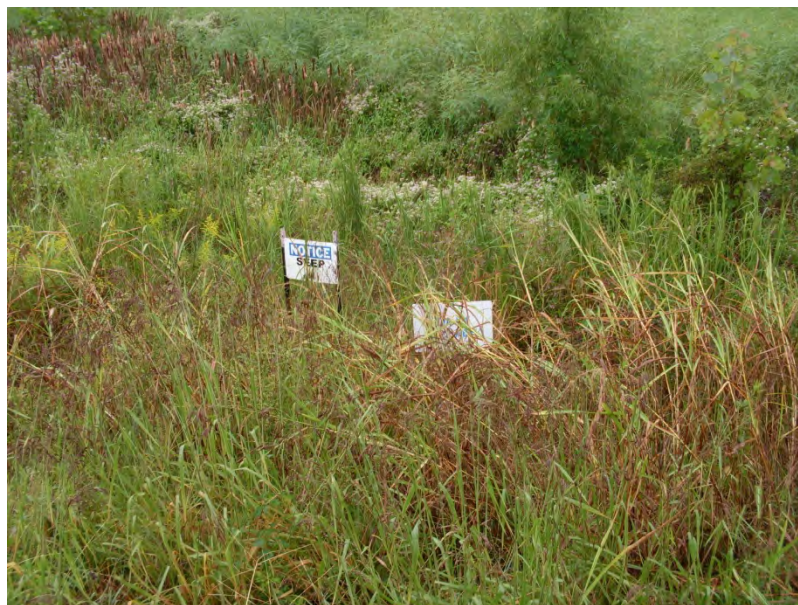
**Photo 5.15: EAP Perimeter dike outside toe east side, identified seep area.**

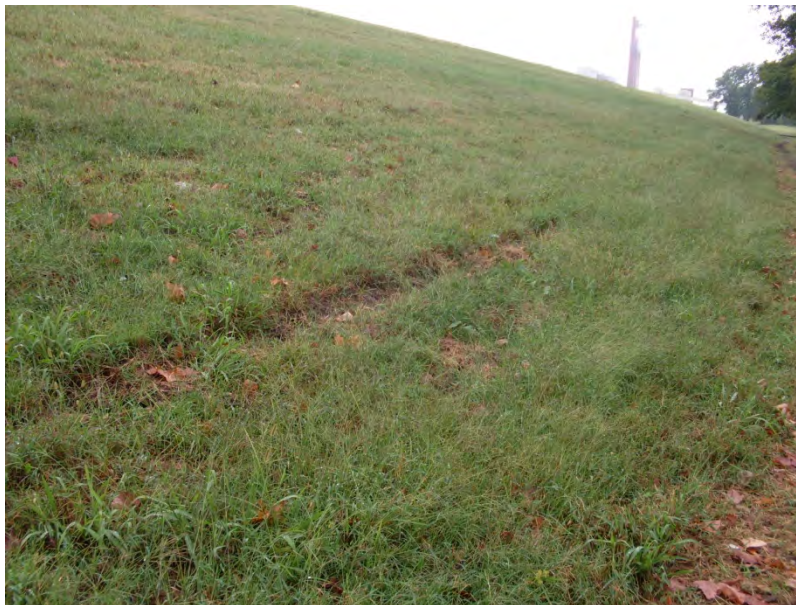
area to the east is a natural wetland that has standing water during the wet season. A minor mower rut was observed on the outside slope of the perimeter dike north side, as shown in Photo 5.16.

**Photo 5.16: EAP Perimeter dike outside slope north side, looking west. Note mower rut.**

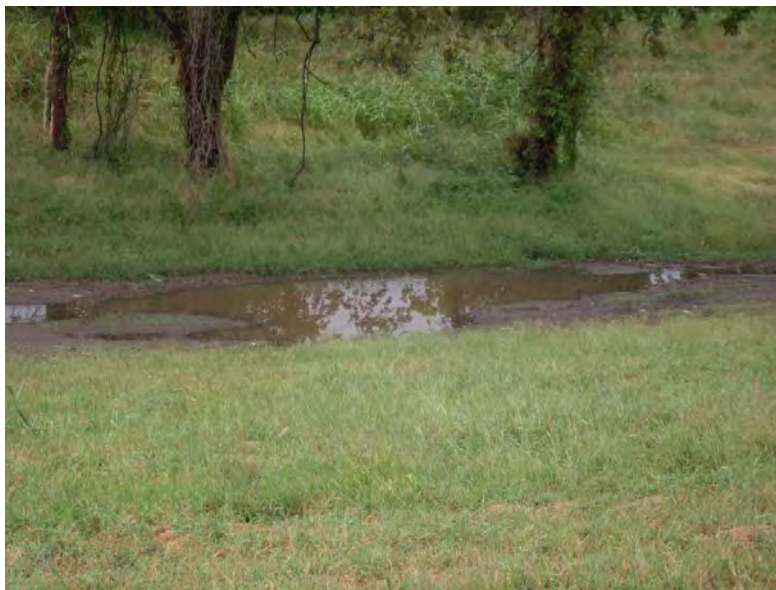
Surface water was observed in a puddle at the one location along the outside toe of the perimeter dike north side, as shown in Photo 5.17. There appeared to be no flowing seepage associated with this puddle.

**Photo 5.17: EAP Perimeter dike outside toe north side. Note ponded water.**

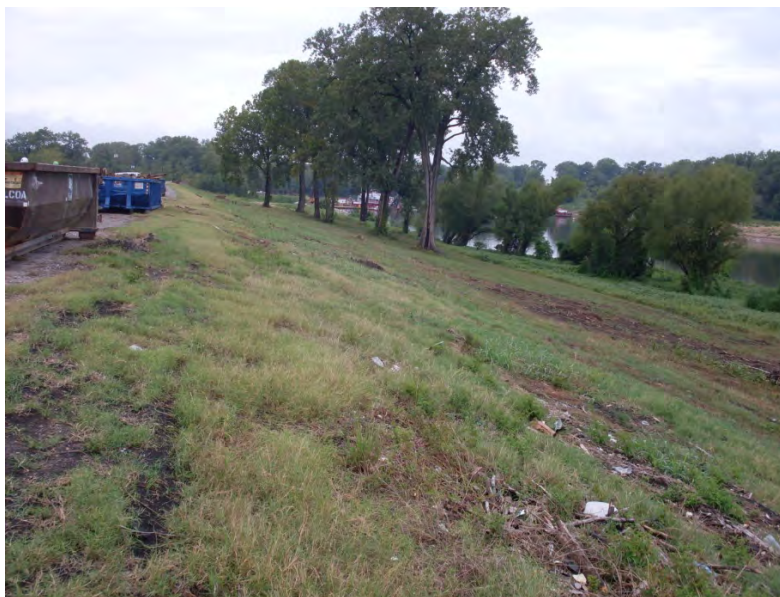
**Photo 5.18: WAP Perimeter dike outside slope north side. Note dumpsters for cleanup of debris from spring flooding.**

At the West Ash Pond the outside slopes were observed to be in satisfactory condition. The outside slope of the perimeter dike north side was observed to have a well-maintained cover of grass, as shown in Photo 5.18. At the time of the site visit debris from flooding earlier in the year was still being removed from the slope and placed in dumpsters, visible in Photo 5.18. It was observed that the outside slopes on the north and west sides of West Ash Pond are the only well-defined exterior slopes around this pond. The chemical pond and filled areas exist on the east side. The south side is a broad relatively level area that extends over to the municipal waste water treatment plant. The rim elevation on this side is higher than the dike crest on the north side. Even on the west side the outside slope does not have substantial height above the outside toe area, which appeared to be a broad fill extending to a low brushy and wooded area to the west.

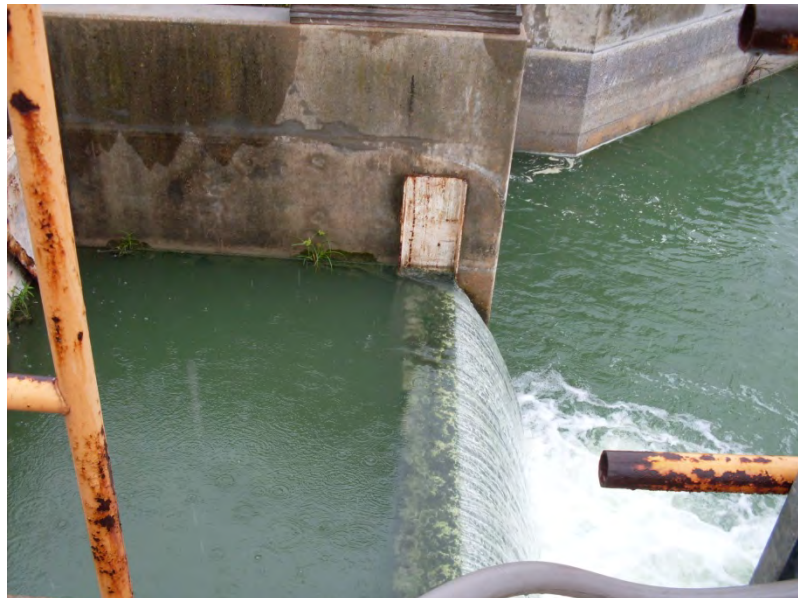
**Photo 5.19: EAP South bay of concrete spillway in divider dike, discharging into stilling pond.**

- 5) Paint corroded metal parts and hardware at the spillway in the divider dike and on the gates and gate-operators at the discharge end of the primary outlet conduits.

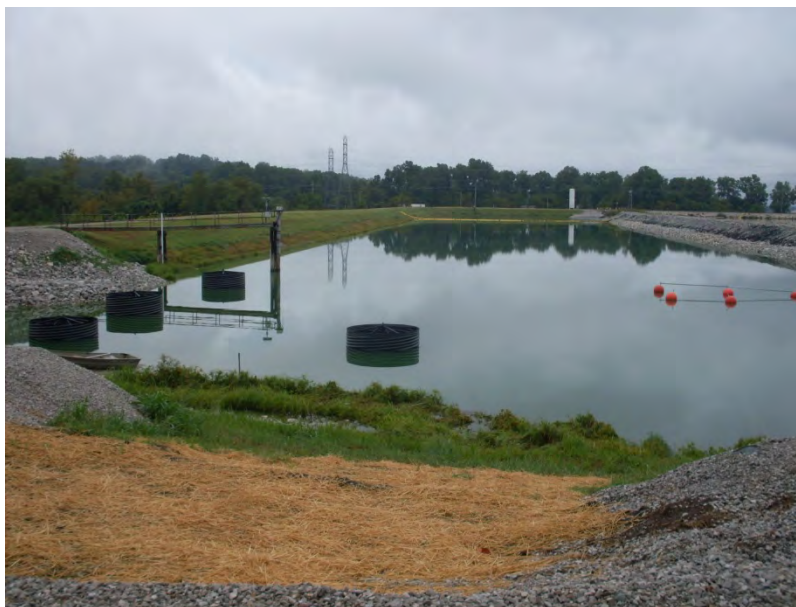
**Photo 5.20: EAP View of skimmers atop overflow risers in stilling pond, looking south.**

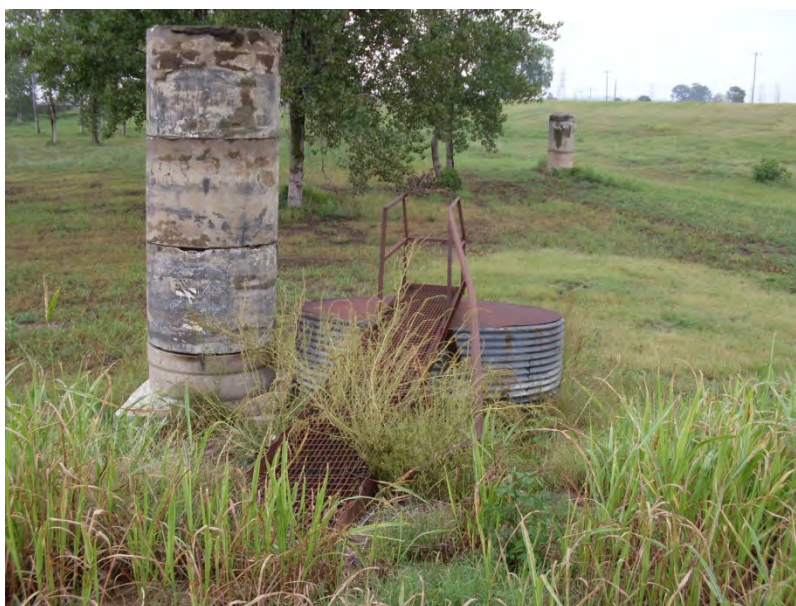
The old overflow riser at the West Ash Pond is shown in Photo 5.21. The RCP sections that form the riser were observed to be weathered, but they appeared sound. The skimmer structure had been taken off the top of the riser, along with a metal-grate walkway, to allow placement of an extra section of pipe on top of the riser to raise the overflow elevation. TVA personnel indicated that this was done to prevent reverse overflow into the pond from backflow during extreme flood events when water levels in the Mississippi River and Lake McKellar are elevated, as occurred earlier this year.

**Photo 5.21: WAP View of old overflow riser in inactive pond, looking east. Note extra RCP section on top of riser.**

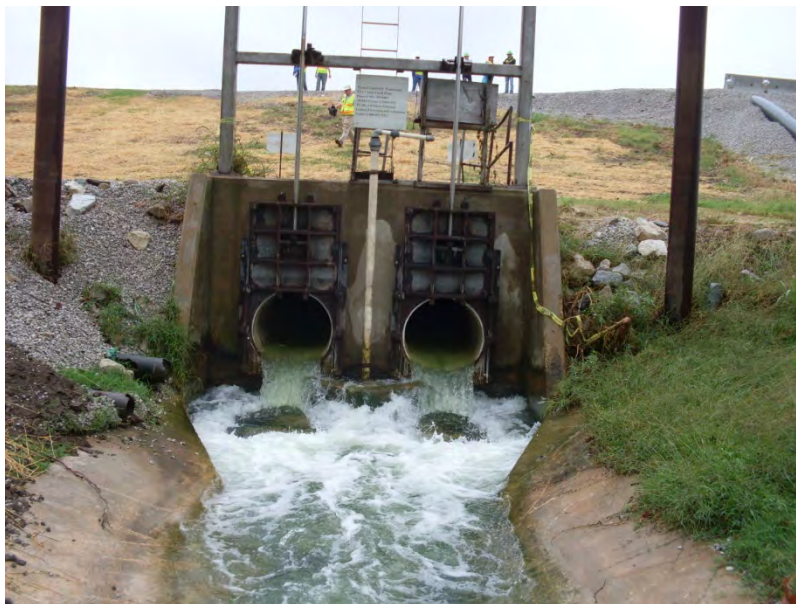
**Photo 5.22: EAP View of outlet ends of primary spillway conduits, looking south.**

At the East Ash Pond (stilling pond) water that overflows the two 48-inch diameter primary riser structures discharges through two 36-inch diameter RCP conduits that pass through the perimeter dike north side to outfall into the flume that leads to Lake McKellar. Water was discharging from these primary outlet conduits at the time of the site visit, as shown in Photo 5.22. The concrete-lined flume is shown in Photo 5.23. The primary conduits were observed to be lined with polyvinyl chloride (PVC). The conduits appeared to be sound and functional. No sinkholes or dropouts were observed along the alignment of the conduits through the dike embankment. The concrete end wall structure with mounted floodgates appeared sound, although the metal gates and hardware were observed to be rusty. One of the operator stem guide brackets (for west gate) was observed to be bent down. TVA personnel indicated that the floodgates normally remain open and are closed only to prevent backflow when Lake McKellar is elevated during extreme floods. The concrete-line flume was observed to have some cracks and surface deterioration but appeared to be functional.

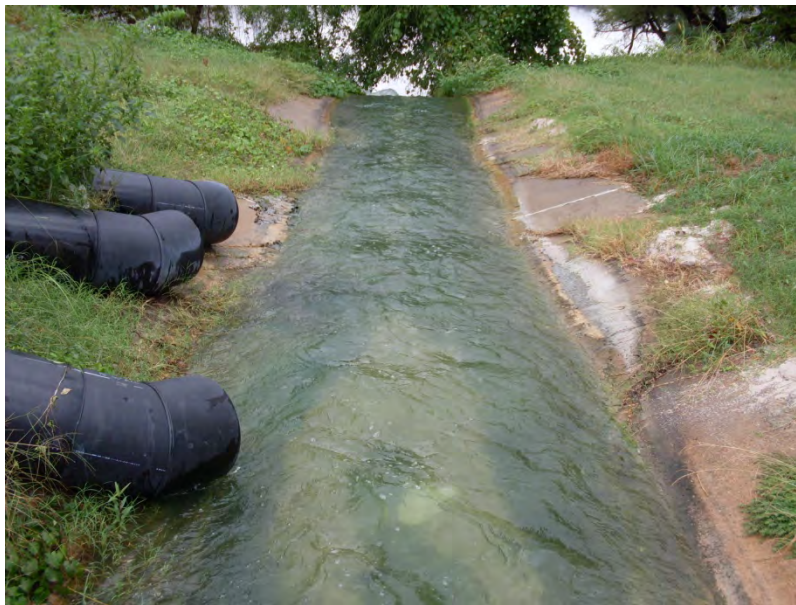
**Photo 5.23: EAP View of flume to Lake McKellar, looking north.  
Note outlet ends of siphons.**

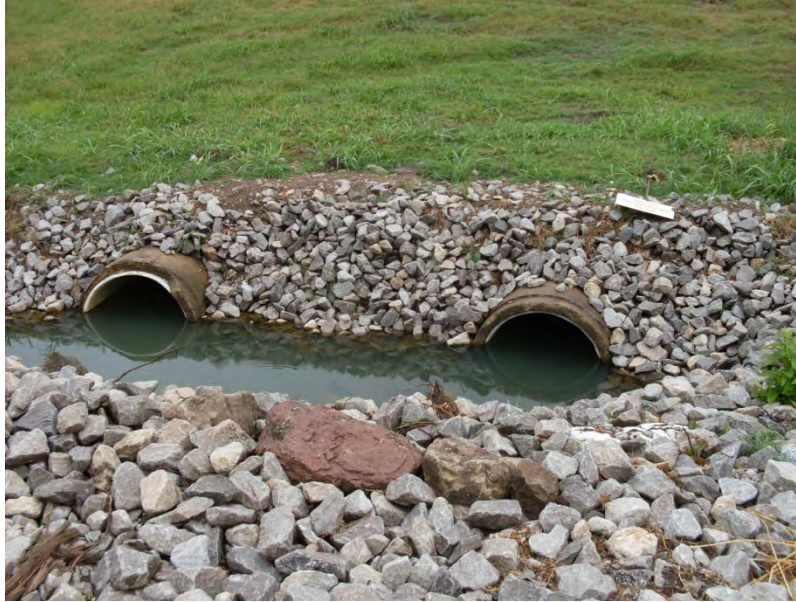
Water that overflows the two 48-inch diameter emergency riser structures discharges through two 36-inch diameter RCP conduits that pass through the perimeter dike east side to outfall into a ditch that leads to the Horn Lake Cutoff channel. The outlet ends of the two emergency outlet conduits were observed to be more than half submerged, as shown in Photo 5.24. No water was flowing through these conduits at the time of the site visit. TVA personnel indicated that preferences are to pump from the stilling pond rather than discharge through the emergency conduits, when the floodgates have to be closed at the primary outlet conduits. These emergency conduits were observed to be lined with PVC and appeared to be sound and functional. No sinkholes or dropouts were observed along the alignment of the emergency conduits through the dike embankment. The blanket of small riprap used for erosion control around the outlet ends of the emergency conduits was observed to be in satisfactory condition.

**Photo 5.24: EAP View of outlet ends of emergency spillway conduits, looking west.**

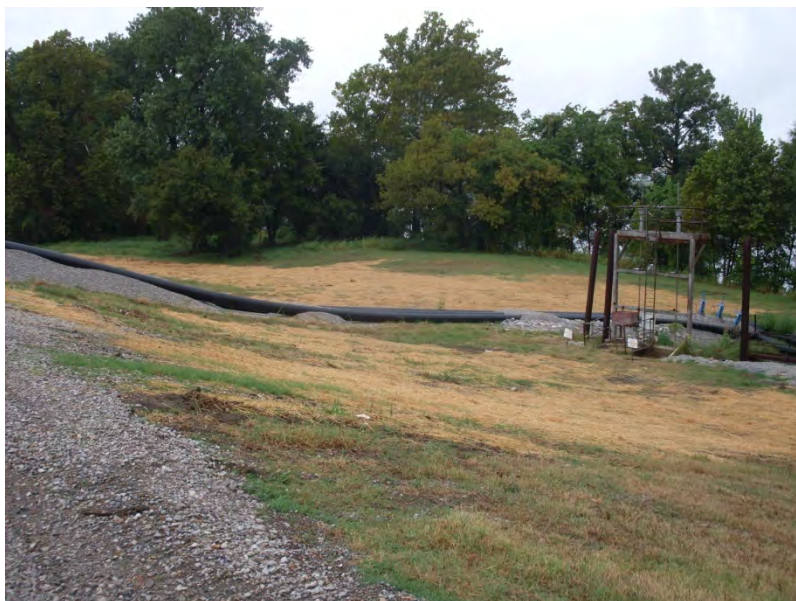
Photo 5.25: EAP Partial view of siphons, looking west.

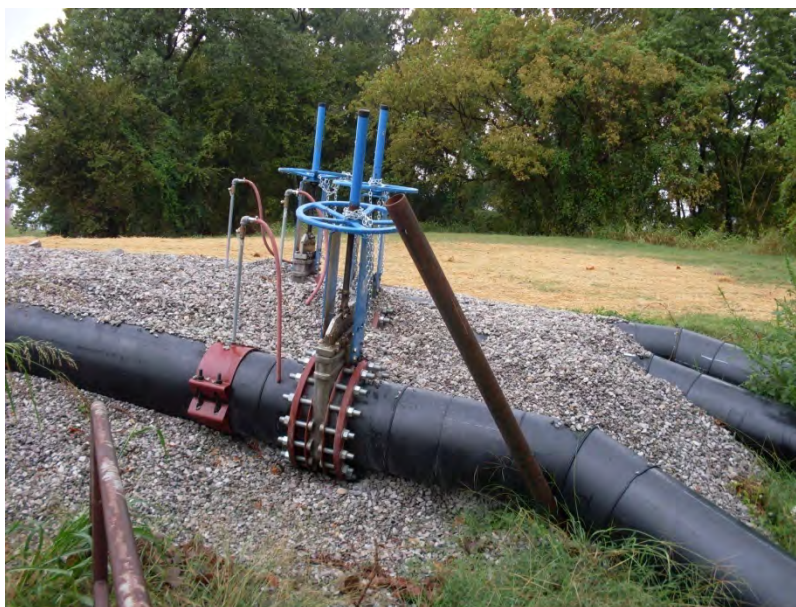
Photo 5.26: EAP Gate valves in siphons, looking west.

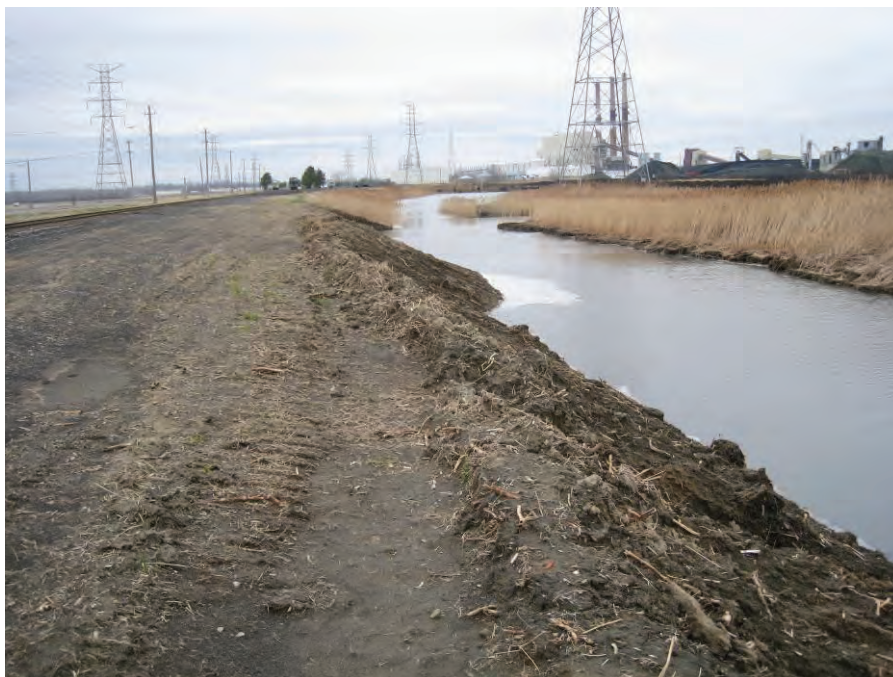
Drawing Mark EAP-1 Erosion is occurring on the interior slope along the south dike looking west.

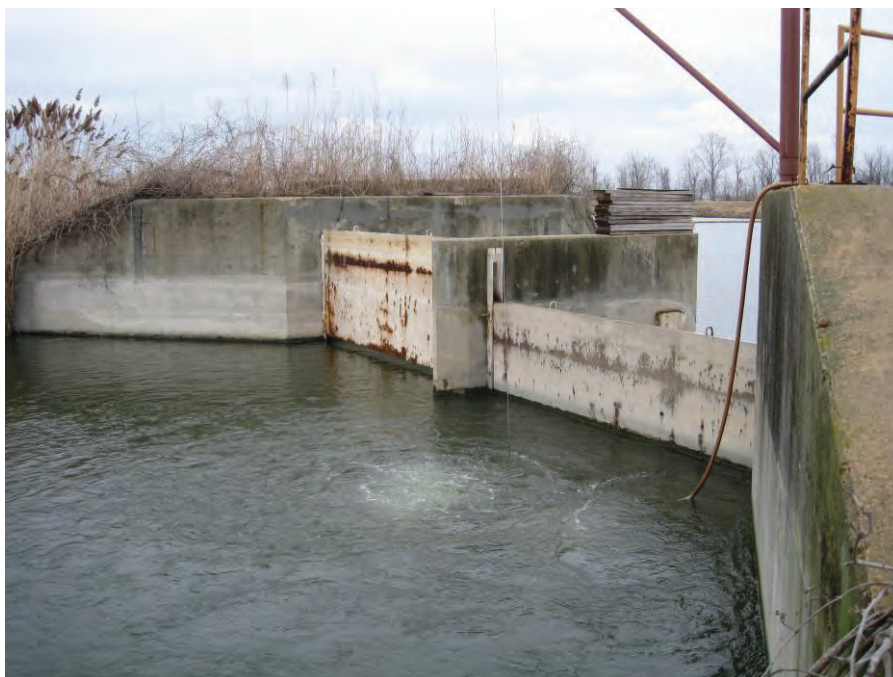
Drawing Mark EAP-2 Outlet Structure operated using stop logs.

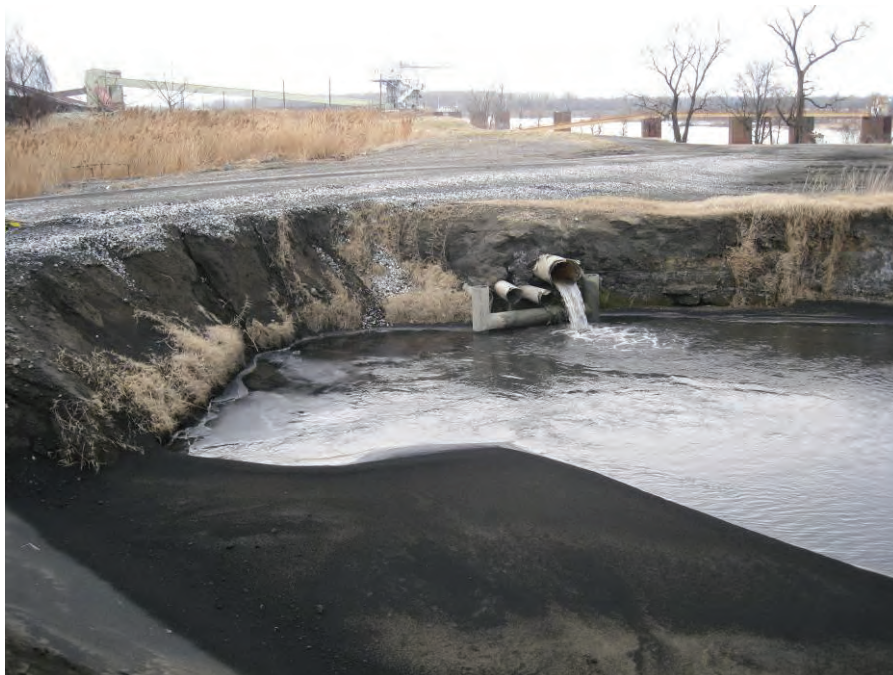
Drawing Mark EAP-3 Fly Ash influent pipes at northwest corner.

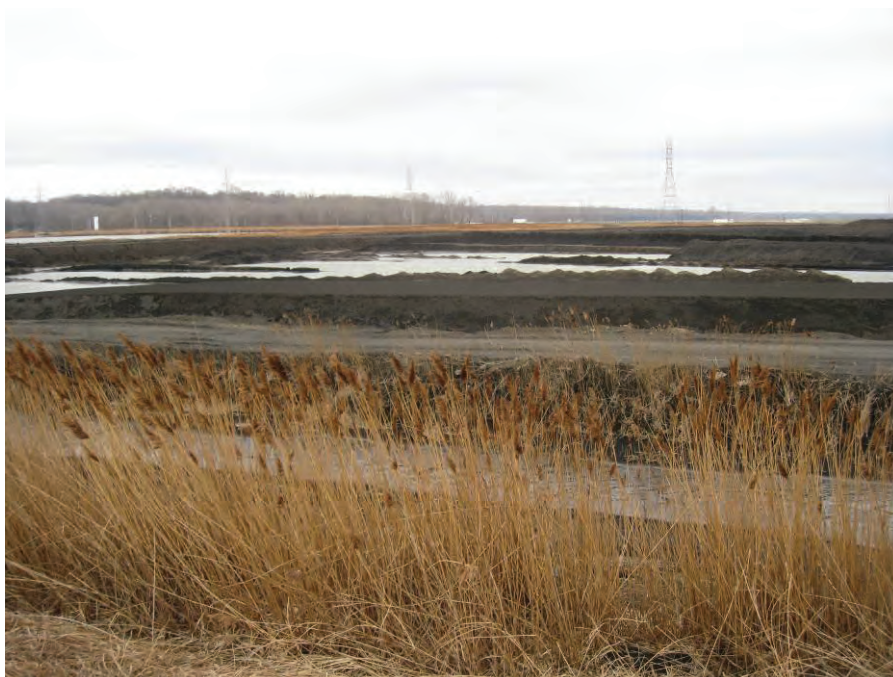
Drawing Mark EAP-4 Dredge Cell interior drainage looking south.

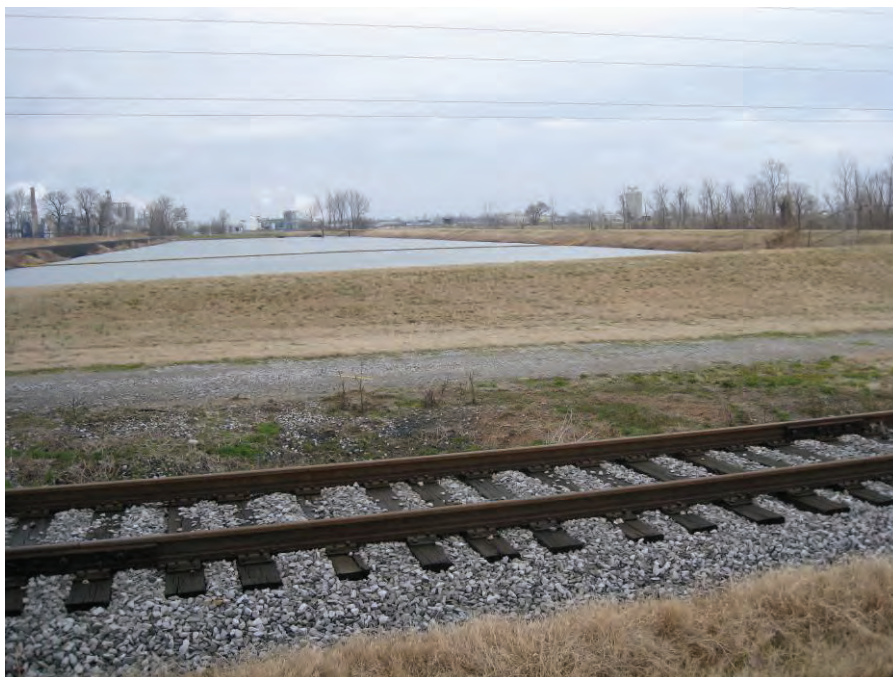
Drawing Mark EASP-1

Overview of pond showing railroad to the south.

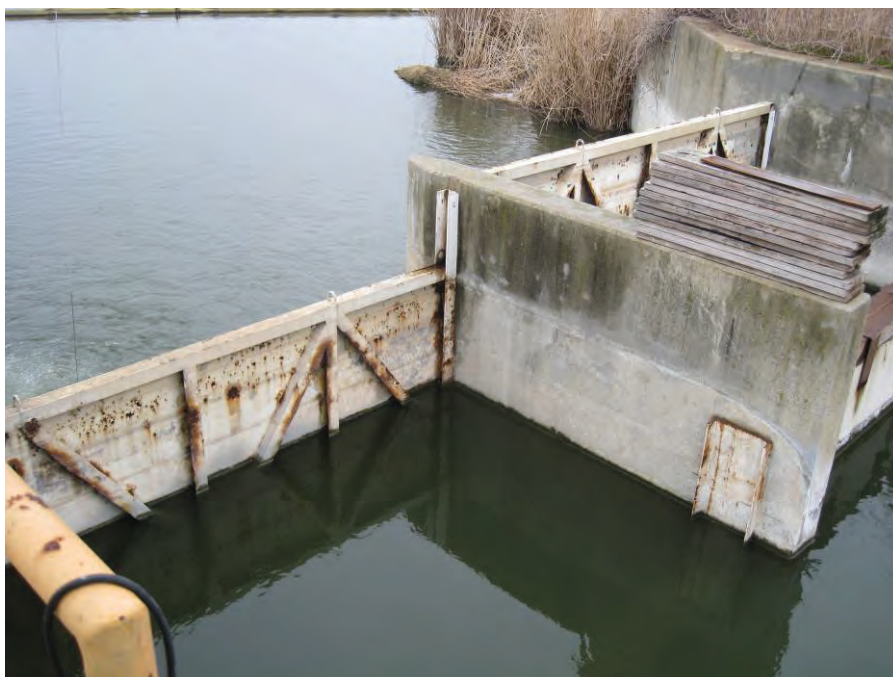
Drawing Mark EASP-2

Concrete inlet structure with stop logs.

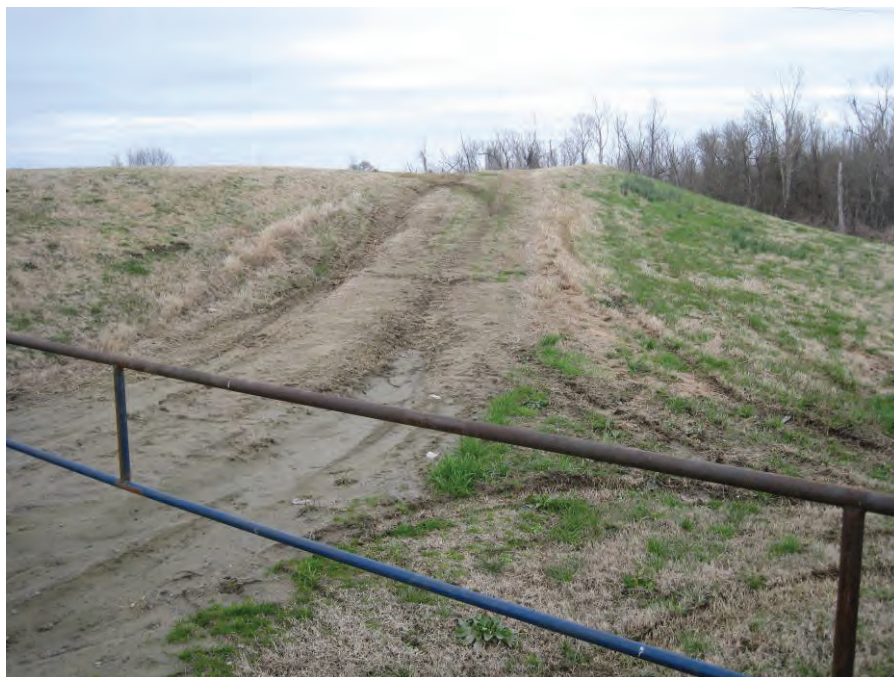
Drawing Mark EASP-3

Access ramp to crest on southeast corner of pond. Note the erosion on the ramp.

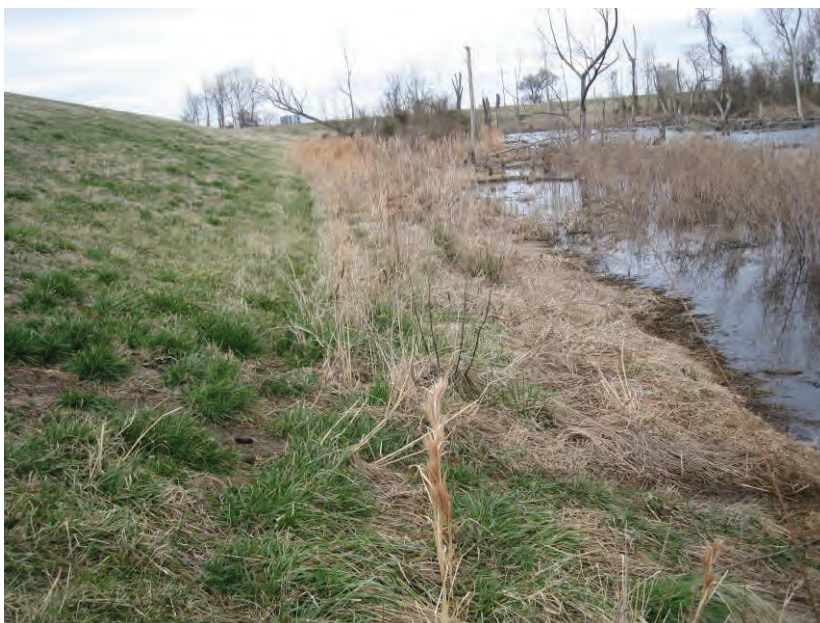
Drawing Mark EASP-5

Eastern embankment showing ponding water and thick vegetation at the toe. Portions of the slope had small (1 to 2 inch diameter) animal burrow holes.

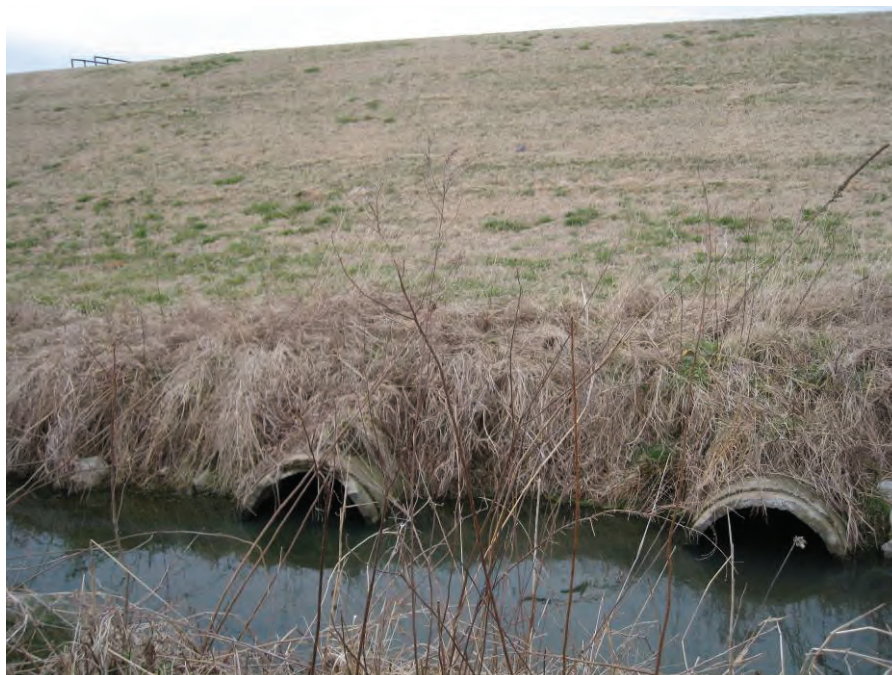
Drawing Mark EASP-6

Decant structure outlets to Horn Lake. Note partially submerged outlet pipes.

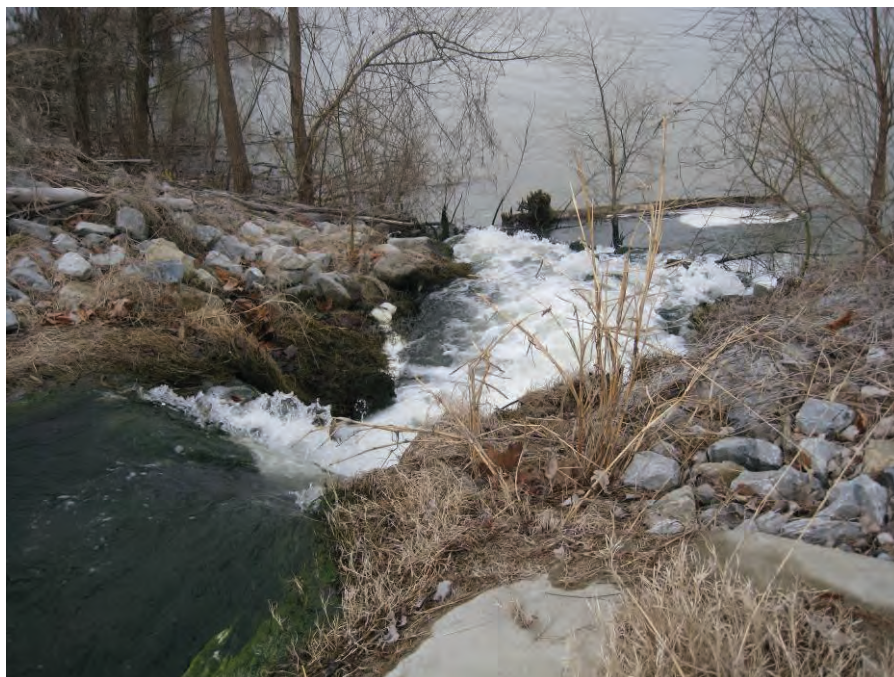
Drawing Mark EASP-7      Decant structure outlet into McKellar Lake has erosion occurring.

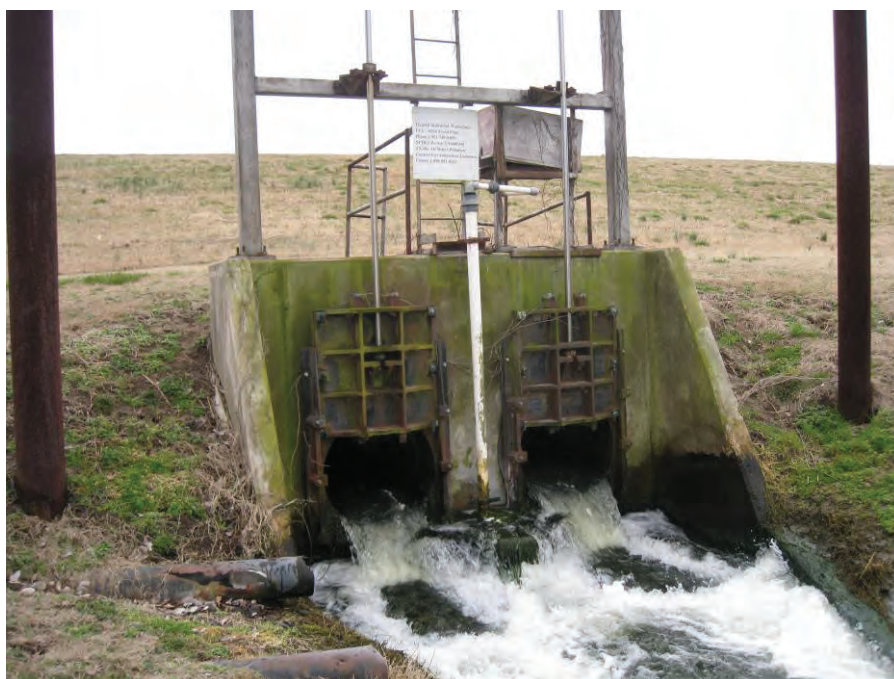
Drawing Mark EASP-8      Decant structure outlets to McKellar Lake.

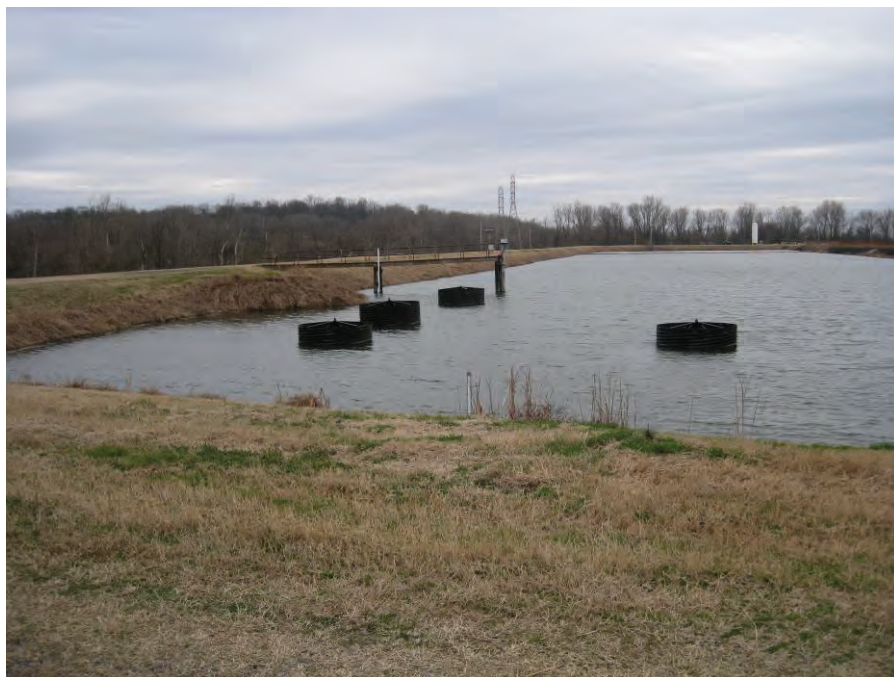
Drawing Mark EASP-9      Decant structure inlets with skimmers.

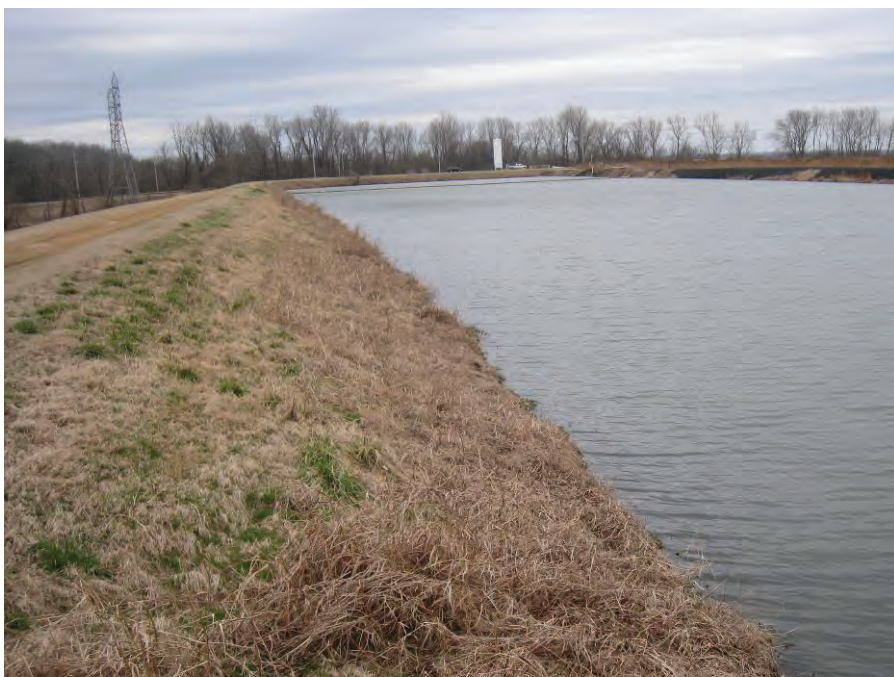
Drawing Mark EASP-10      Interior slope wave erosion.
