**Coal Combustion Residue Impoundment  
Round 11 - Dam Assessment Report**

*Allen Fossil Plant*

*Tennessee Valley Authority*  
**Memphis, Tennessee**

**August 2012**

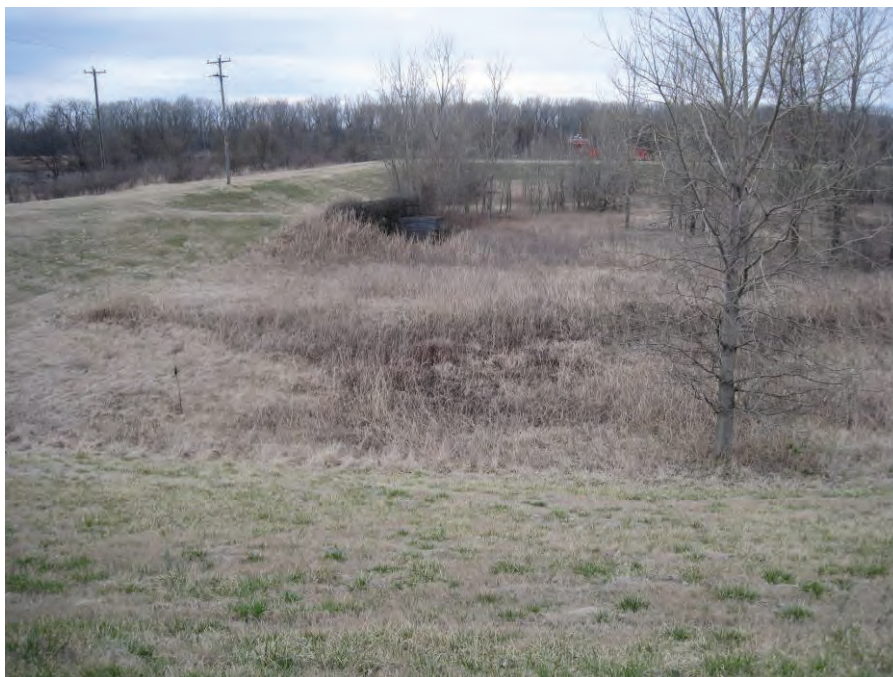
Drawing Mark WAP-1 Interior of Ash Pond mainly empty and covered with trees and dense vegetation.

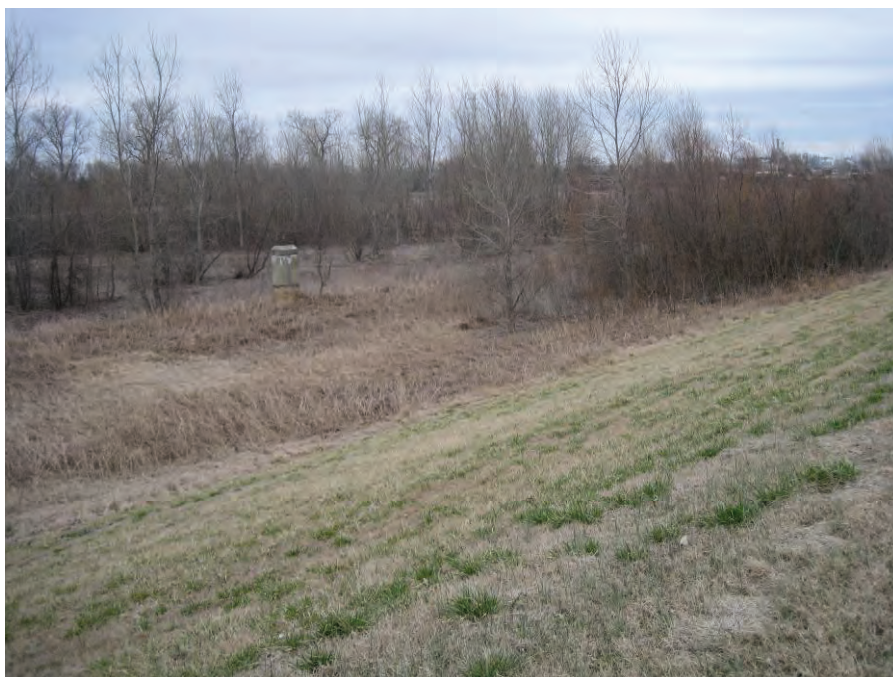
Drawing Mark WAP-2 Dense trees and vegetation are growing on the interior of the pond.

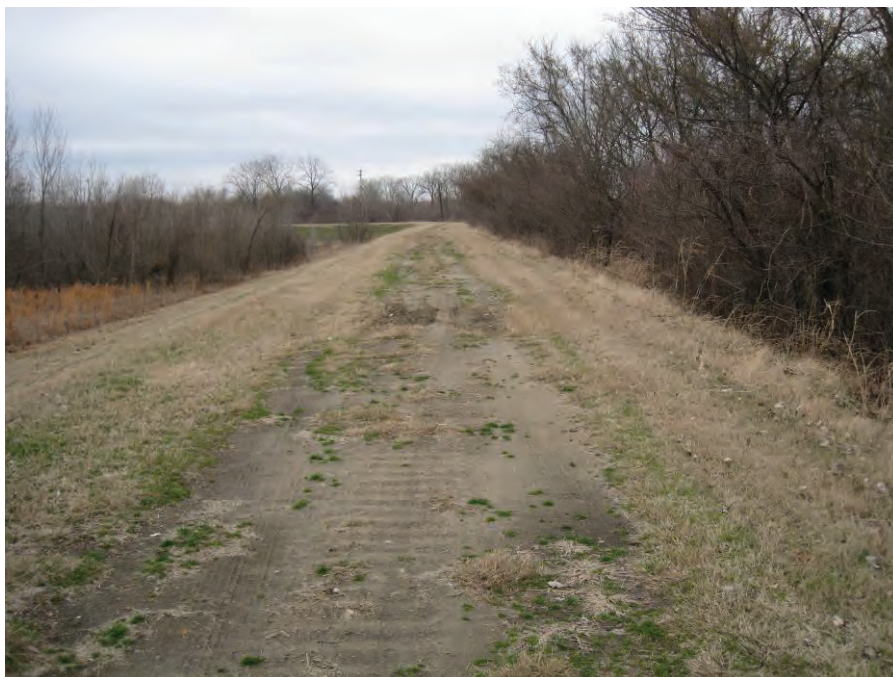
Drawing Mark WAP-3 Dense trees and vegetation are growing on the exterior slope of the north dike.

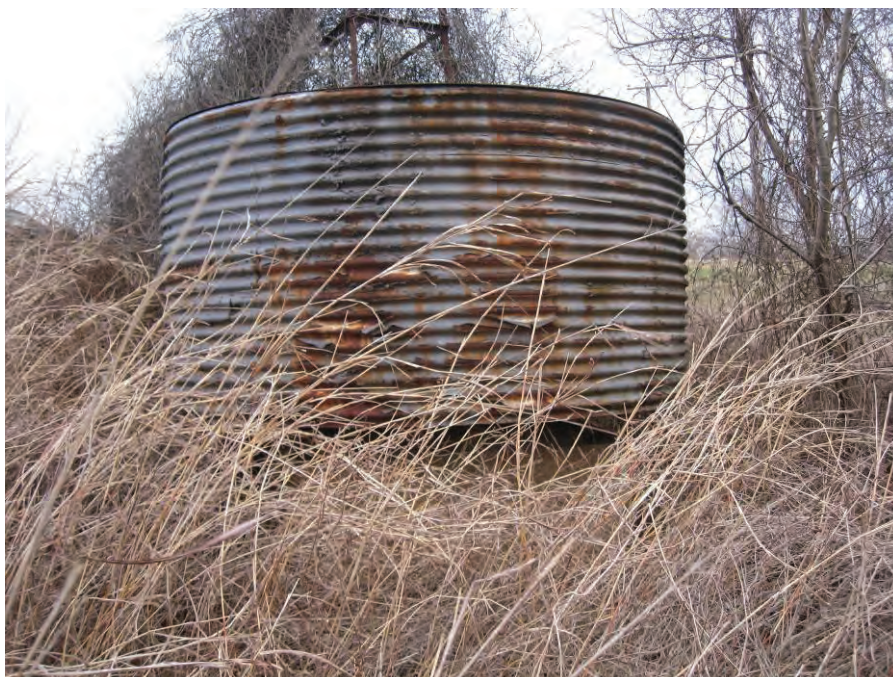
Drawing Mark WAP-4 Abandoned decant structure on west end of pond. Deteriorated and surrounded by heavy vegetation.

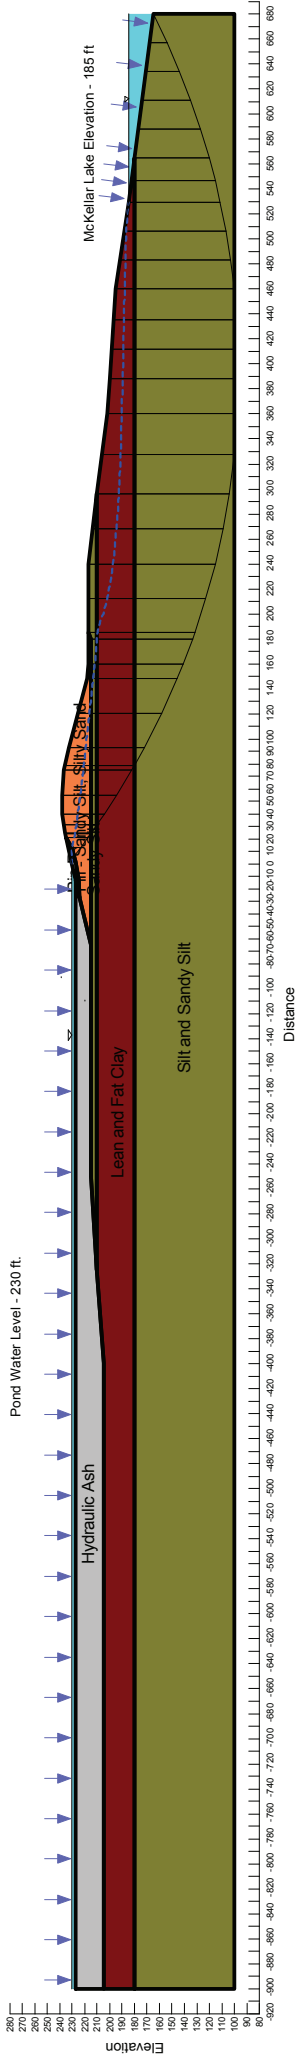
Factor of Safety: 0.73  
Horizontal Seismic Coefficient  $K_h = 0.127\text{ g}$   
500-year Return Period Event
