**Coal Combustion Residue Impoundment
Round 11 - Dam Assessment Report**

Allen Fossil Plant

Tennessee Valley Authority
Memphis, Tennessee

Dewberry Consultants LLC
Fairfax, Virginia

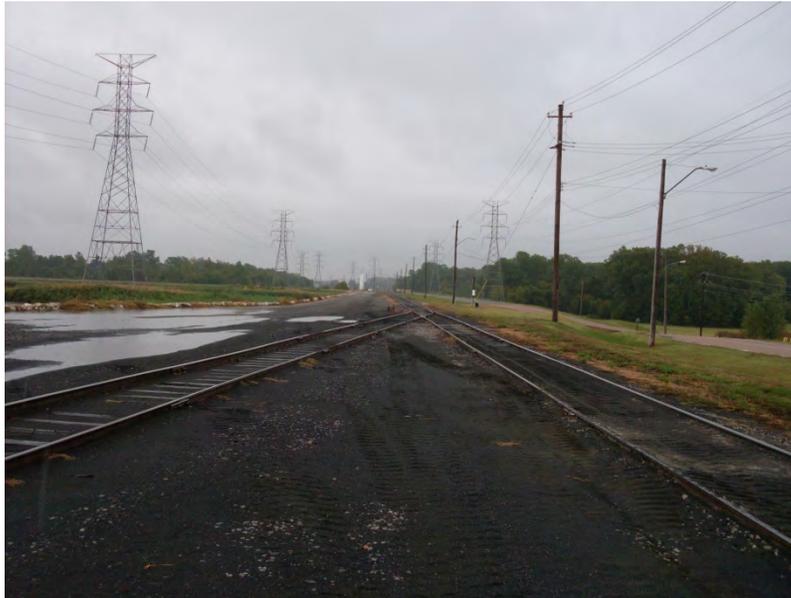
Photo 5.1: EAP Perimeter dike crest south side, looking east. Note ponded water.

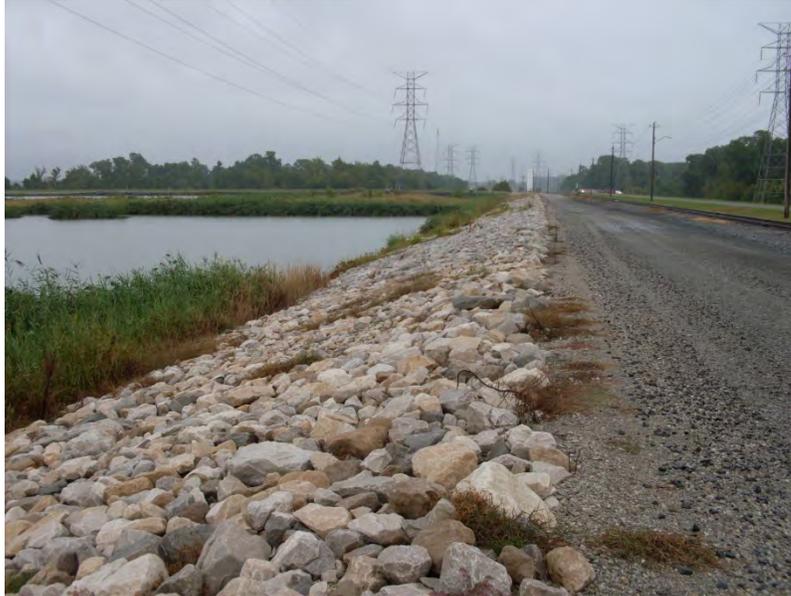
Photo 5.4: EAP Perimeter dike inside slope south side, looking east. Note riprap that was placed in 2010 to protect against wave erosion.

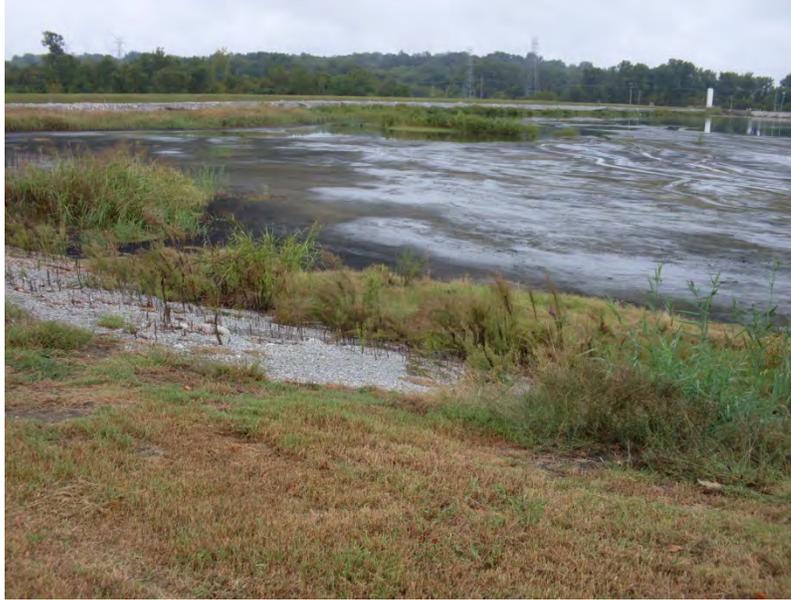
A small slump or slough occurred on the inside slope of the north side perimeter dike of the East Ash Pond in 2009; it was repaired with riprap and crushed stone. The slump had occurred during excavation of the interior rim ditch, which over-steepened the slope and caused it to locally slump down. Because there was concern that the excavation penetrated the 3-foot thick impermeable layer that had been placed on the interior slope of the dike (levee) during development of the East Ash Pond, the

Photo 5.6: EAP Perimeter dike inside slope north side, looking east southeast in area of recent slump repair. Note crushed stone material used in the repair.

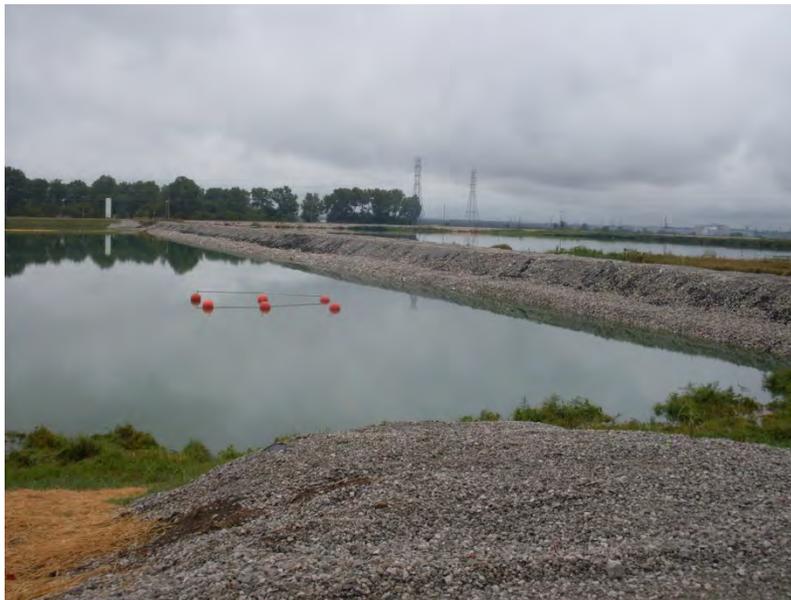
Photo 5.7: EAP Divider dike slope east side, looking southwest. Note minor gully erosion in slope above riprap blanket.

The slopes of the divider dike were observed to be steeper than those of the perimeter dike. The slope on the stilling basin side of the divider dike was observed to have a partial-height blanket of small riprap that was placed during recent remedial construction. The remaining surfaces of the divider dike slopes (and most of the crest) were observed to be covered with a thin layer of crushed stone. Minor gully erosion in the slope of this ash embankment above the new riprap blanket was observed, as shown in Photo 5.7. The fly ash excavation operation was observed in the dredge cell, as shown in Photo 5.8. The visible part of the sanitary sewer temporary bypass recently constructed in the dredge cell was observed where it ties into the manhole in the south part of the dredge cell, as shown in Photo 5.9. A view of the ash sluice lines to the East Ash Pond were observed, as shown in Photo 5.10.

- 1) Repair gully erosion on the divider dike;
- 2) Add crushed stone surfacing material in worn shallow depression on the dike crest south side where haul trucks turn into the dredge cell;
- 3) Avoid mowing the slopes when the ground is still wet from rainfall to minimize mower ruts on the slopes;
- 4) Observe over time the wet area at the toe of the north side exterior slope to verify that the puddle is not due to seepage. If the water source is found to be seepage, then repair the slope with an inverted filter. If the water is not from seepage, then re-grade or fill the slight depression with crushed stone surfacing material.
- 5) Paint corroded metal parts and hardware at the spillway in the divider dike and on the gates and gate-operators at the discharge end of the primary outlet conduits.

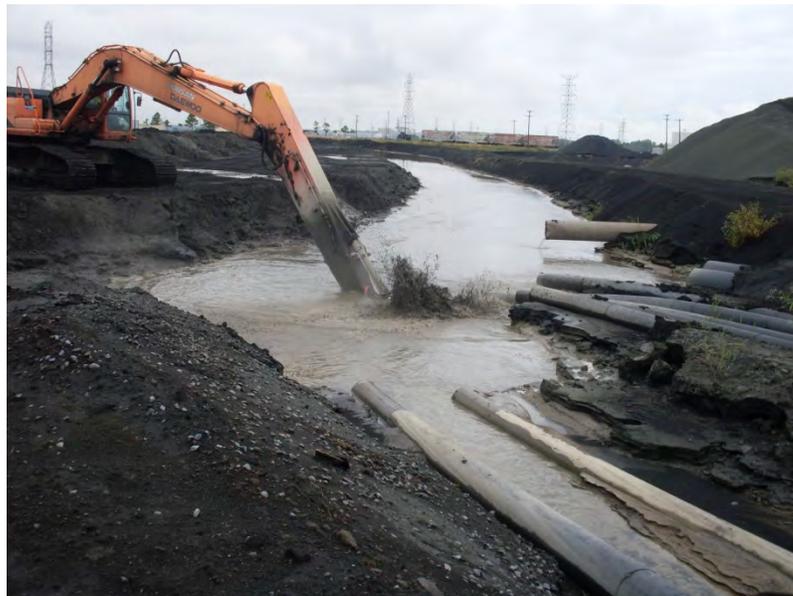
Photo 5.8: EAP Excavation of fly ash in dredge cell, looking south. Note greenish stockpile of boiler slag/bottom ash in background.

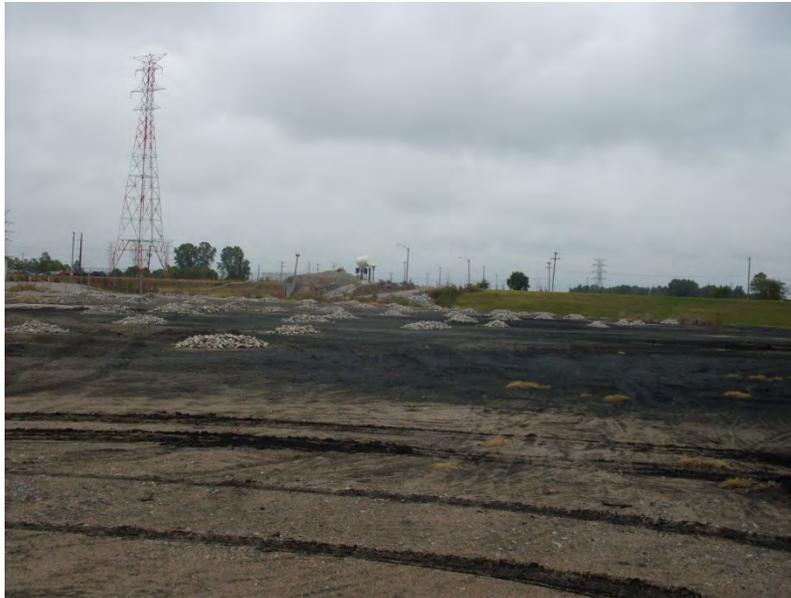
Photo 5.13: WAP View of apparent ash fill at east end of pond, viewed southeast. Note stone piles as deterrent for Least Tern nesting.

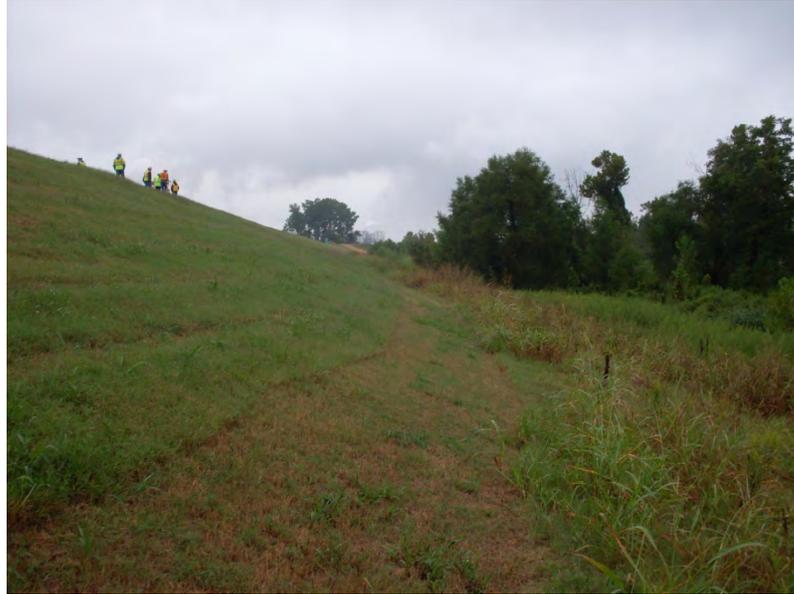
Photo 5.14: EAP Perimeter dike outside slope east side, looking north.

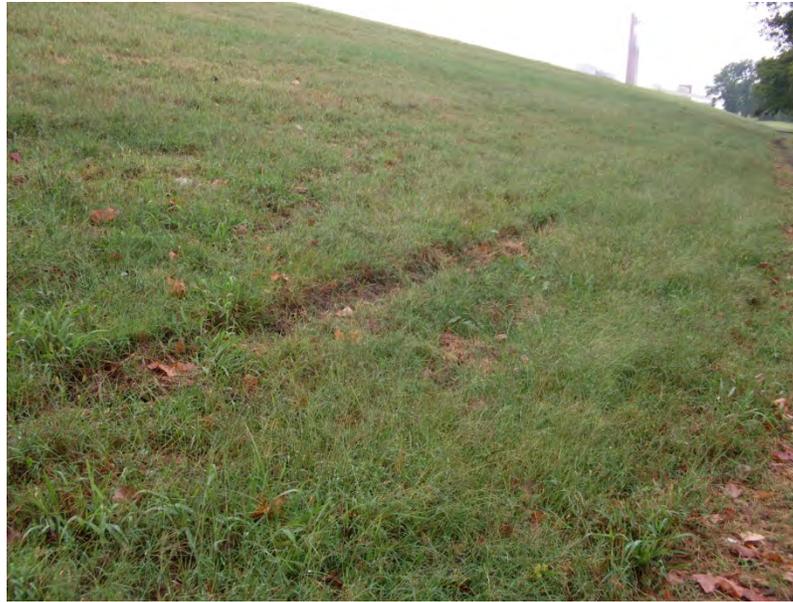
hindered clear observation. TVA personnel indicated that the adjacent area to the east is a natural wetland that has standing water during the wet season. A minor mower rut was observed on the outside slope of the perimeter dike north side, as shown in Photo 5.16.

Photo 5.16: EAP Perimeter dike outside slope north side, looking west. Note mower rut.

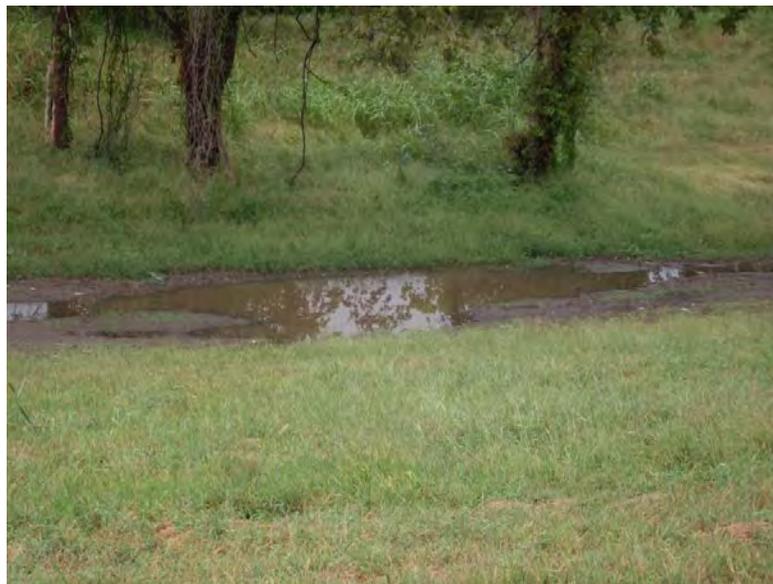
Surface water was observed in a puddle at the one location along the outside toe of the perimeter dike north side, as shown in Photo 5.17. There appeared to be no flowing seepage associated with this puddle.

Photo 5.17: EAP Perimeter dike outside toe north side. Note ponded water.

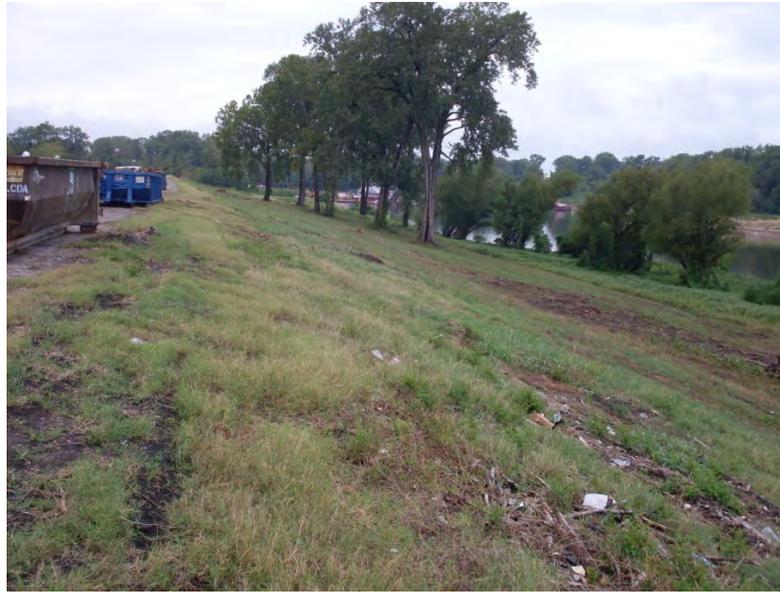
Photo 5.18: WAP Perimeter dike outside slope north side. Note dumpsters for cleanup of debris from spring flooding.

At the West Ash Pond the outside slopes were observed to be in satisfactory condition. The outside slope of the perimeter dike north side was observed to have a well-maintained cover of grass, as shown in Photo 5.18. At the time of the site visit debris from flooding earlier in the year was still being removed from the slope and placed in dumpsters, visible in Photo 5.18. It was observed that the outside slopes on the north and west sides of West Ash Pond are the only well-defined exterior slopes around this pond. The chemical pond and filled areas exist on the east side. The south side is a broad relatively level area that extends over to the municipal waste water treatment plant. The rim elevation on this side is higher than the dike crest on the north side. Even on the west side the outside slope does not have substantial height above the outside toe area, which appeared to be a broad fill extending to a low brushy and wooded area to the west.

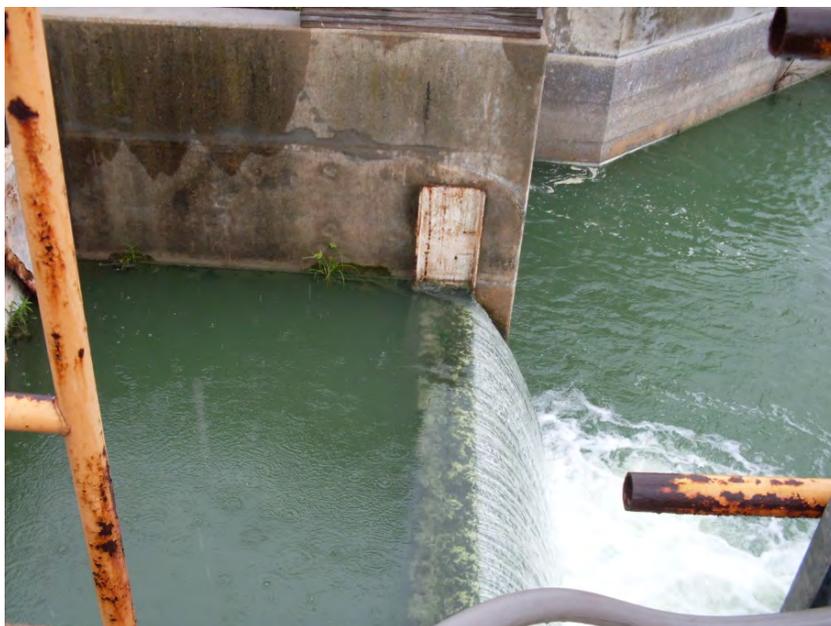
Photo 5.19: EAP South bay of concrete spillway in divider dike, discharging into stilling pond.

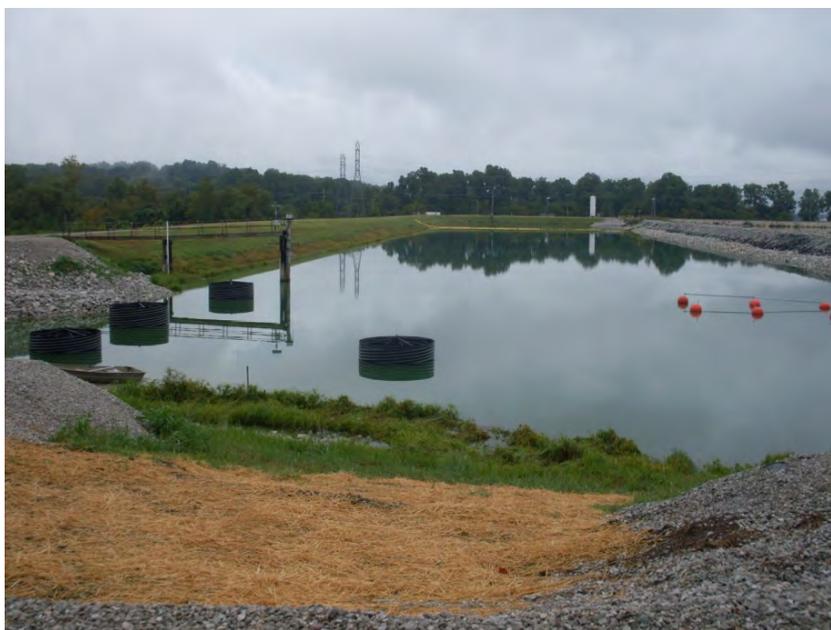
Photo 5.20: EAP View of skimmers atop overflow risers in stilling pond, looking south.

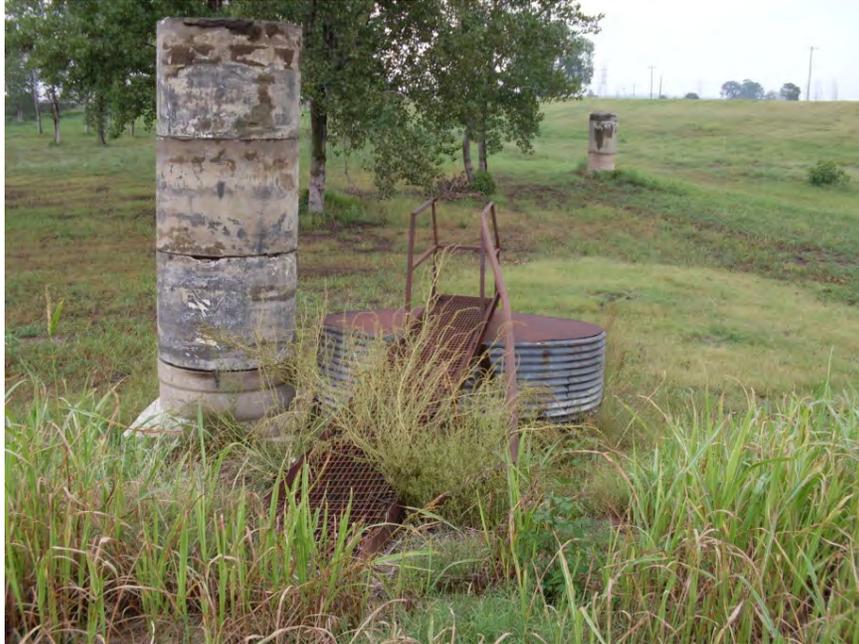
Photo 5.21: WAP View of old overflow riser in inactive pond, looking east. Note extra RCP section on top of riser.

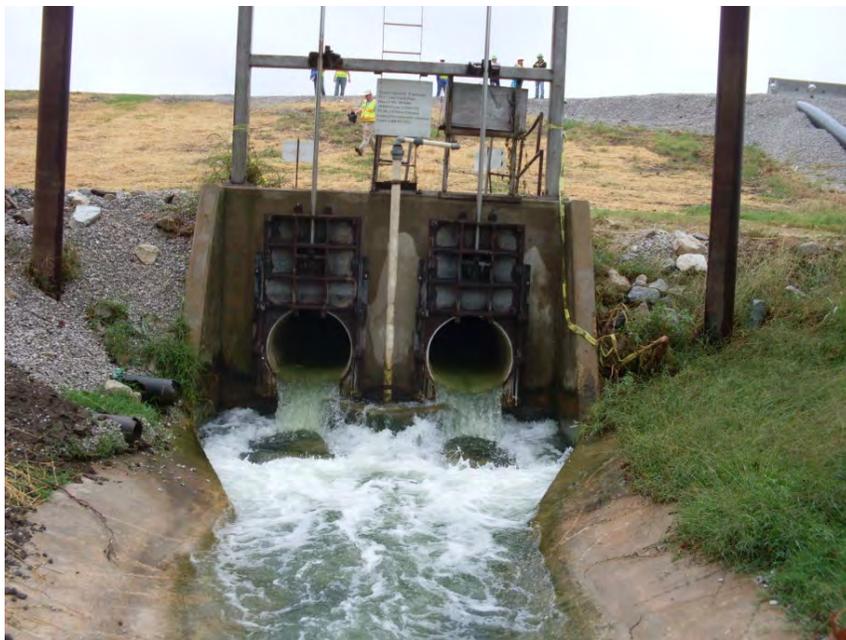
Photo 5.22: EAP View of outlet ends of primary spillway conduits, looking south.

At the East Ash Pond (stilling pond) water that overflows the two 48-inch diameter primary riser structures discharges through two 36-inch diameter RCP conduits that pass through the perimeter dike north side to outfall into the flume that leads to Lake McKellar. Water was discharging from these primary outlet conduits at the time of the site visit, as shown in Photo 5.22. The concrete-lined flume is shown in Photo 5.23. The primary conduits were observed to be lined with polyvinyl chloride (PVC). The conduits appeared to be sound and functional. No sinkholes or dropouts were observed along the alignment of the conduits through the dike embankment. The concrete end wall structure with mounted floodgates appeared sound, although the metal gates and hardware were observed to be rusty. One of the operator stem guide brackets (for west gate) was observed to be bent down. TVA personnel indicated that the floodgates normally remain open and are closed only to prevent backflow when Lake McKellar is elevated during extreme floods. The concrete-line flume was observed to have some cracks and surface deterioration but appeared to be functional.

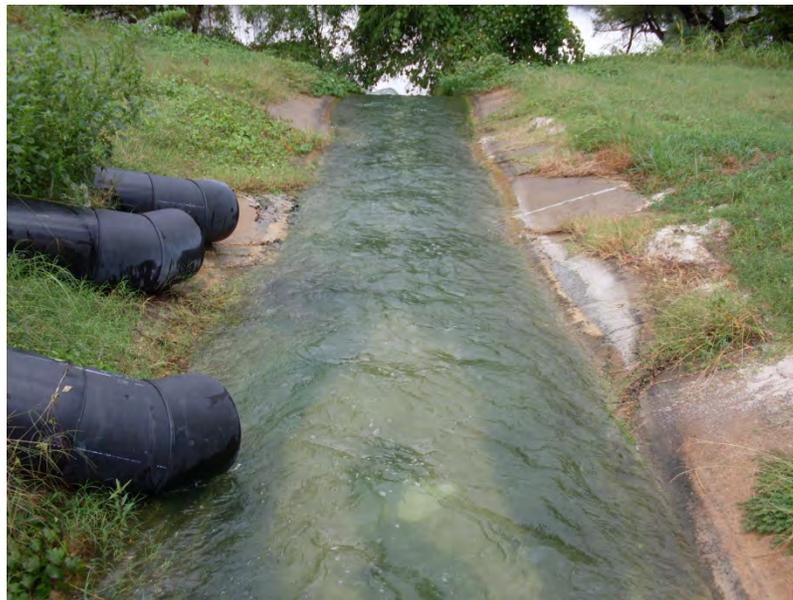
Photo 5.23: EAP View of flume to Lake McKellar, looking north. Note outlet ends of siphons.

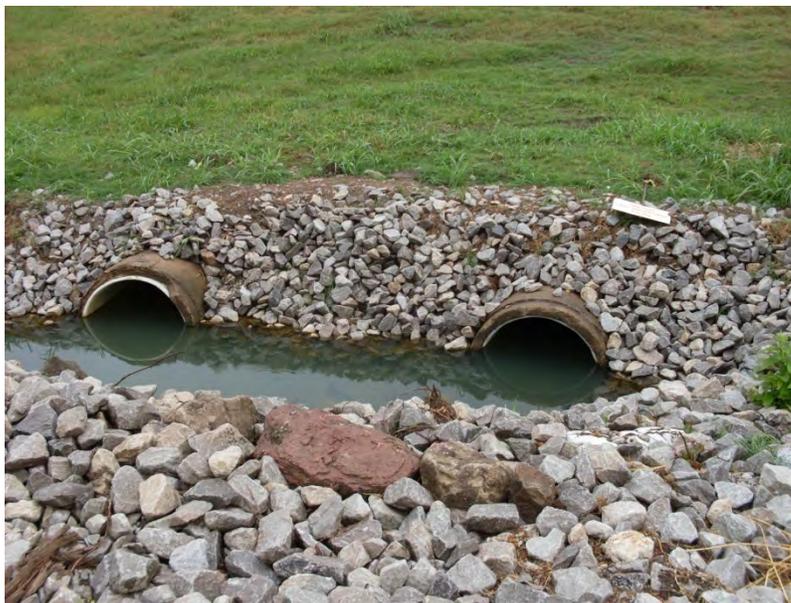
Water that overflows the two 48-inch diameter emergency riser structures discharges through two 36-inch diameter RCP conduits that pass through the perimeter dike east side to outfall into a ditch that leads to the Horn Lake Cutoff channel. The outlet ends of the two emergency outlet conduits were observed to be more than half submerged, as shown in Photo 5.24. No water was flowing through these conduits at the time of the site visit. TVA personnel indicated that preferences are to pump from the stilling pond rather than discharge through the emergency conduits, when the floodgates have to be closed at the primary outlet conduits. These emergency conduits were observed to be lined with PVC and appeared to be sound and functional. No sinkholes or dropouts were observed along the alignment of the emergency conduits through the dike embankment. The blanket of small riprap used for erosion control around the outlet ends of the emergency conduits was observed to be in satisfactory condition.

Photo 5.24: EAP View of outlet ends of emergency spillway conduits, looking west.

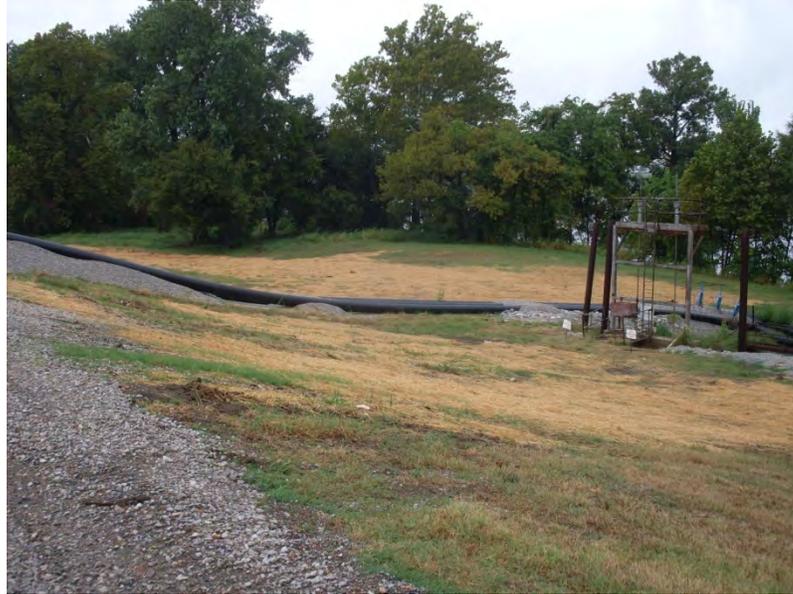
improvements at the stilling pond and will remain in place. The siphons and associated gate valves are shown in Photos 5.25 and 5.26 (see also outlet ends of siphons in Photo 5.23). The siphons and associated gates and hardware were observed to be in satisfactory condition.

Photo 5.25: EAP Partial view of siphons, looking west.

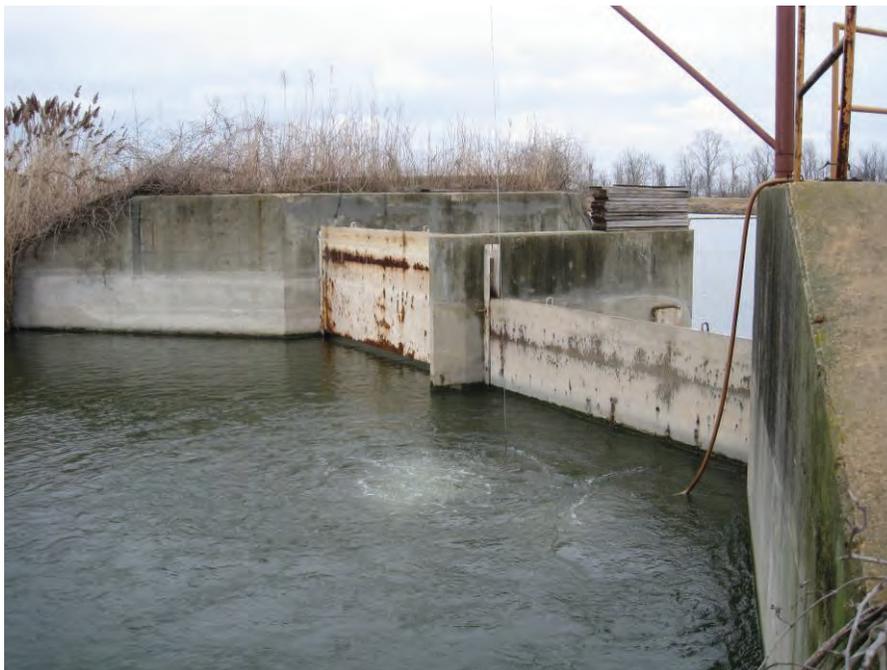
Drawing Mark EAP-2 Outlet Structure operated using stop logs.

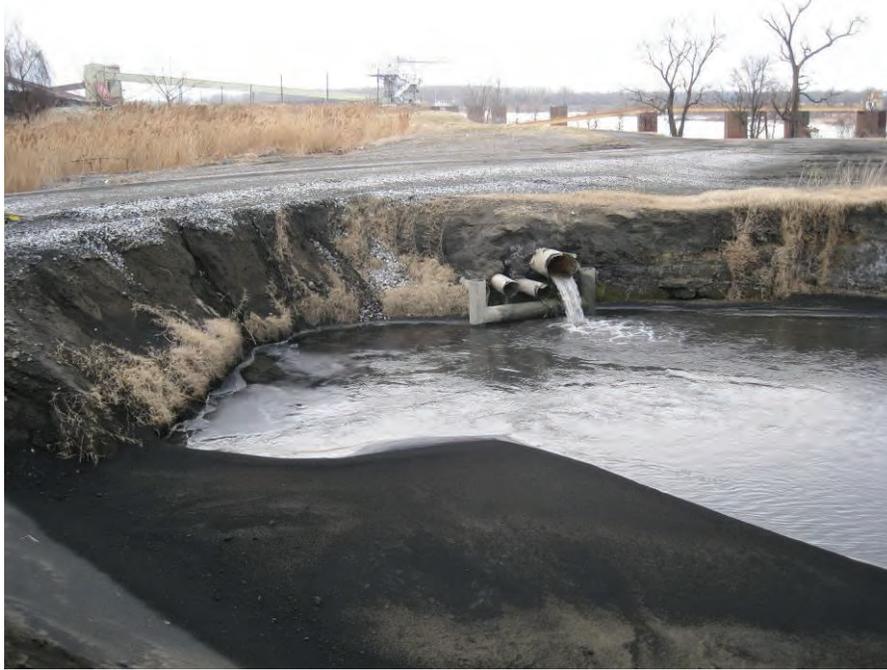
Drawing Mark EAP-3 Fly Ash influent pipes at northwest corner.

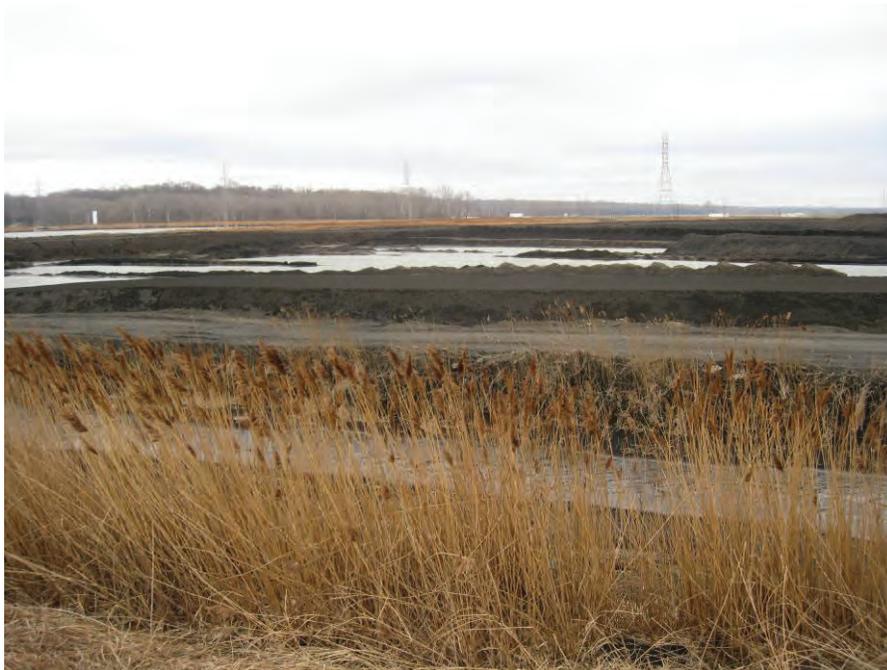
Drawing Mark EAP-4 Dredge Cell interior drainage looking south.

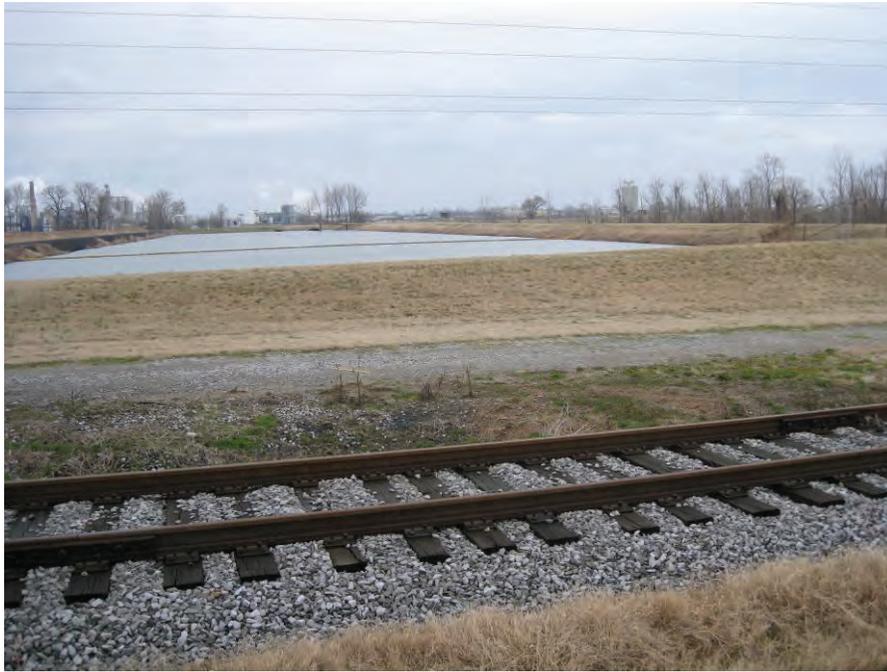
Drawing Mark EASP-1 Overview of pond showing railroad to the south.

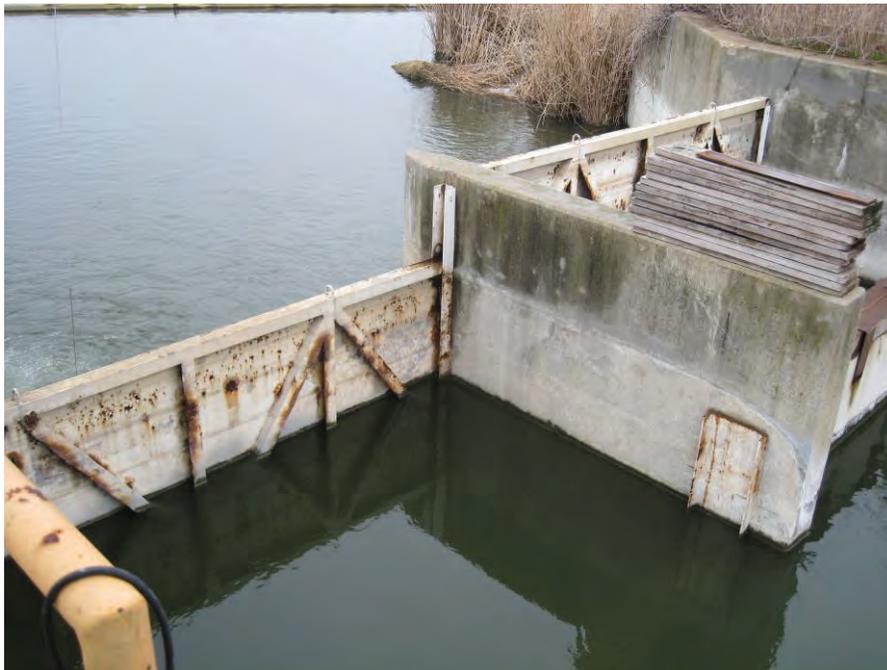
Drawing Mark EASP-2 Concrete inlet structure with stop logs.

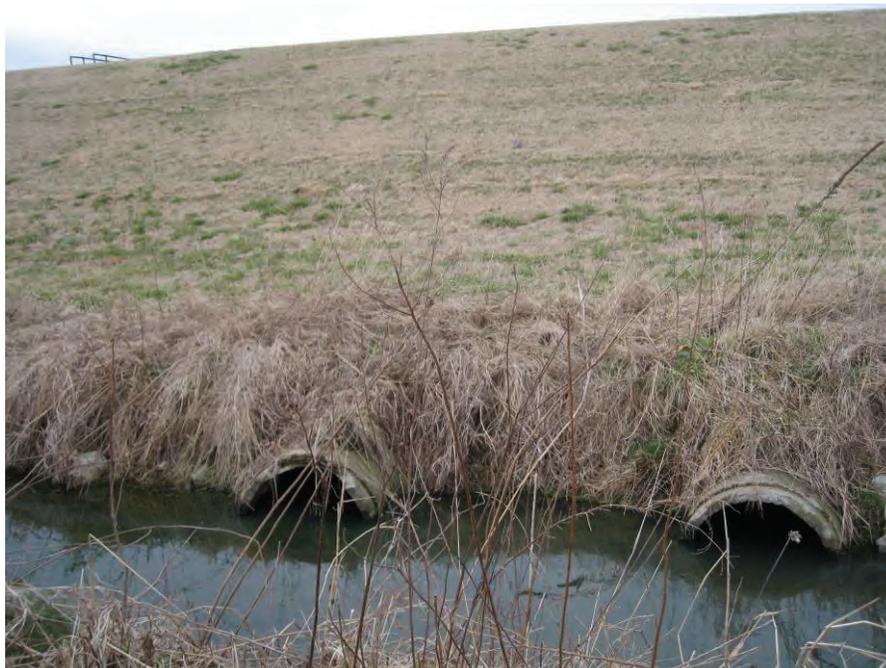
Drawing Mark EASP-6 Decant structure outlets to Horn Lake. Note partially submerged outlet pipes.

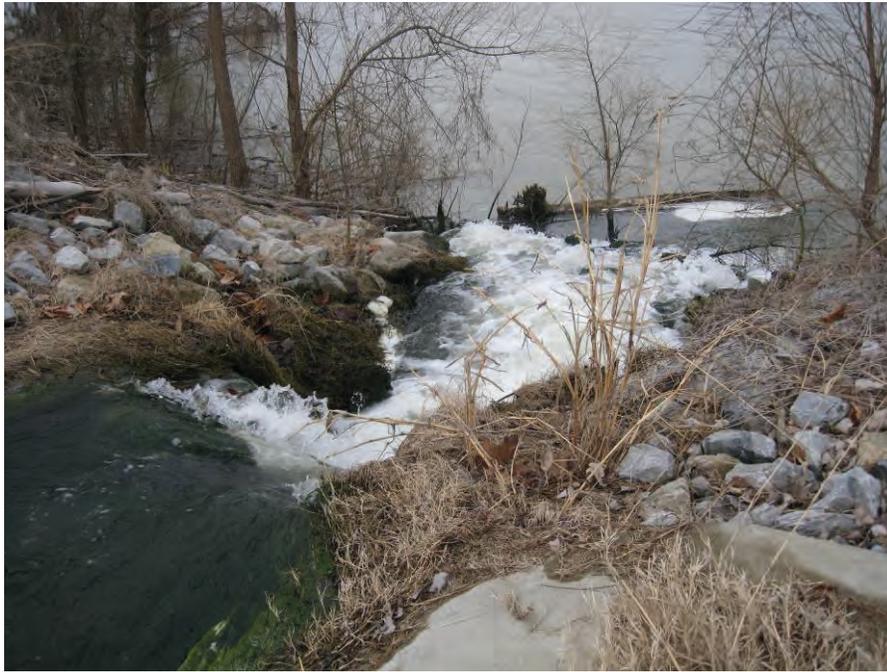
Drawing Mark EASP-7 Decant structure outlet into McKellar Lake has erosion occurring.

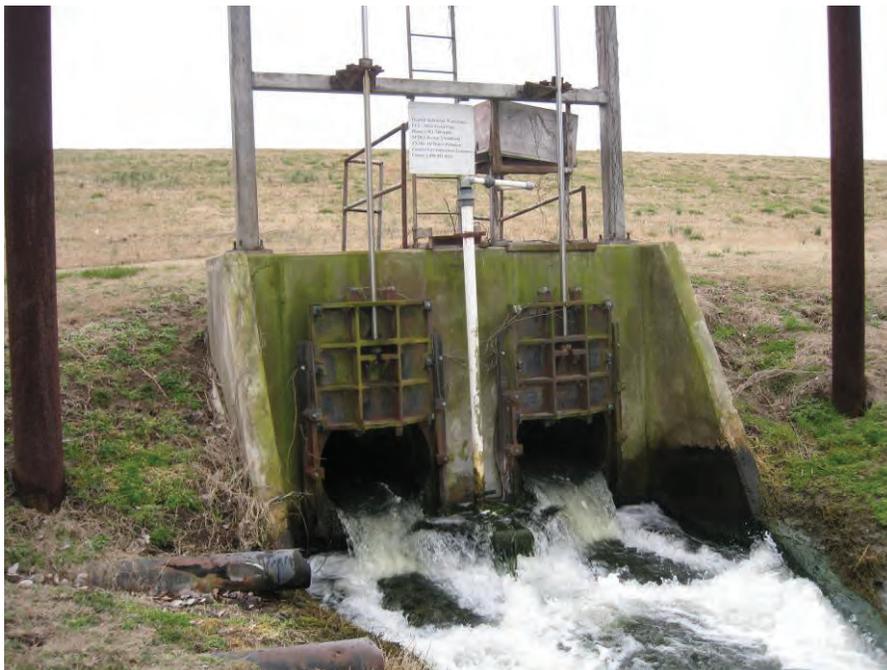
Drawing Mark EASP-8 Decant structure outlets to McKellar Lake.

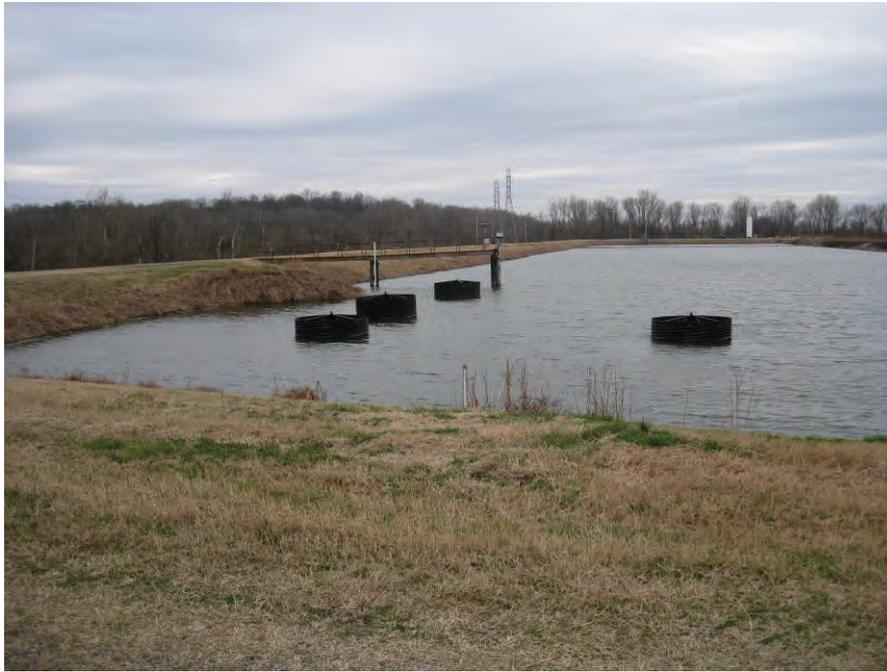
Drawing Mark EASP-9 Decant structure inlets with skimmers.

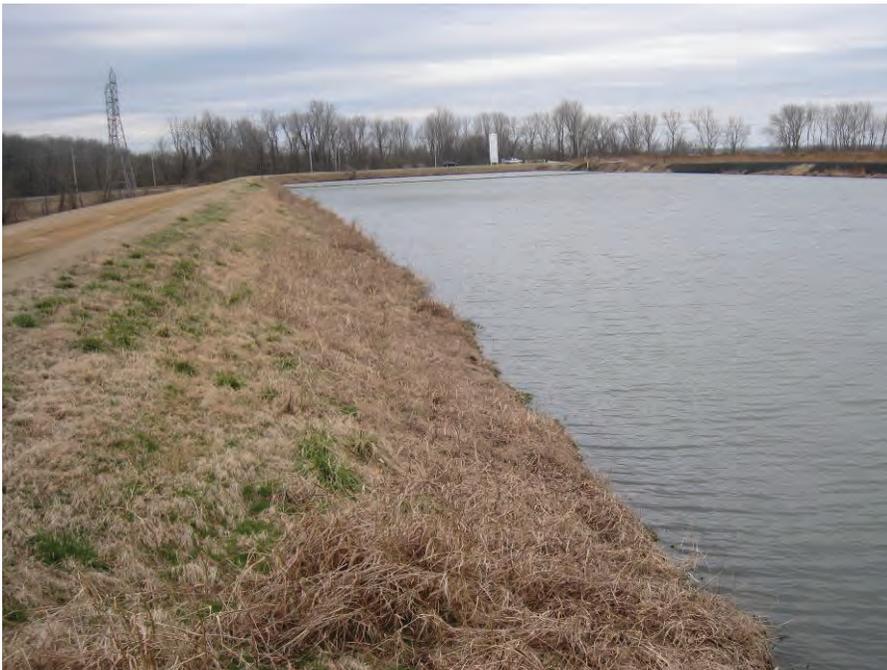
Drawing Mark EASP-10 Interior slope wave erosion.

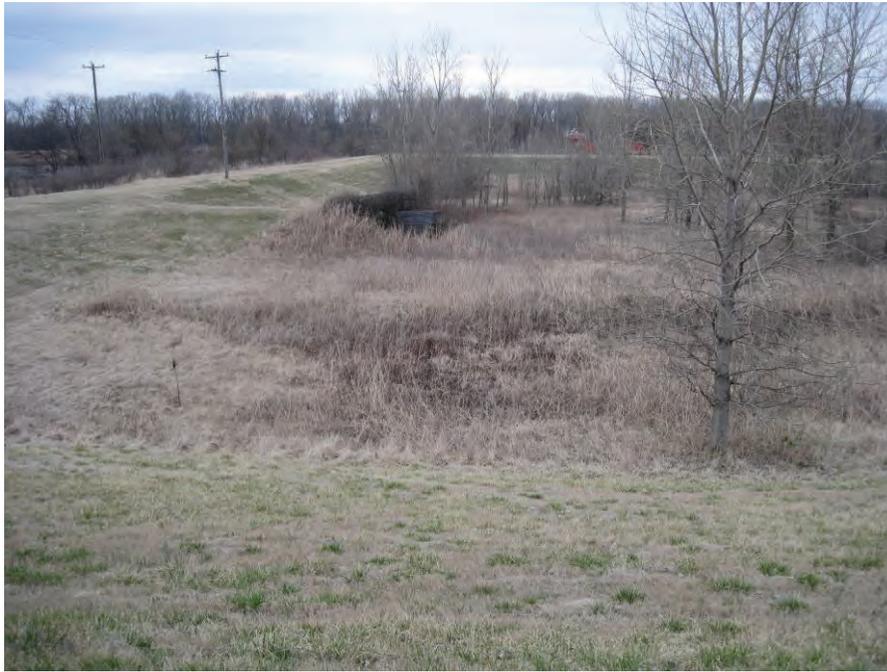
Drawing Mark WAP-1 Interior of Ash Pond mainly empty and covered with trees and dense vegetation.

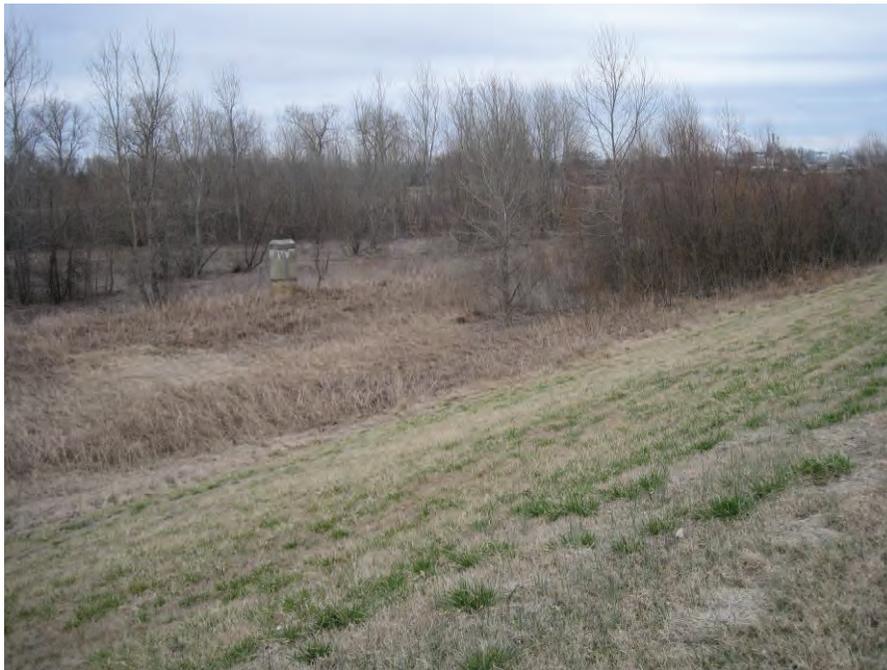
Drawing Mark WAP-2 Dense trees and vegetation are growing on the interior of the pond.

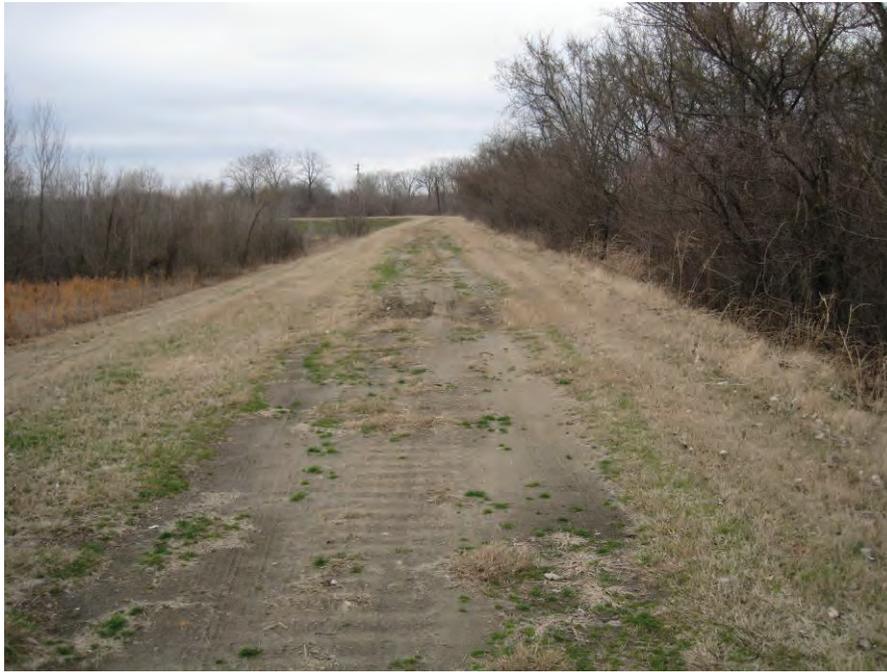
Drawing Mark WAP-3 Dense trees and vegetation are growing on the exterior slope of the north dike.

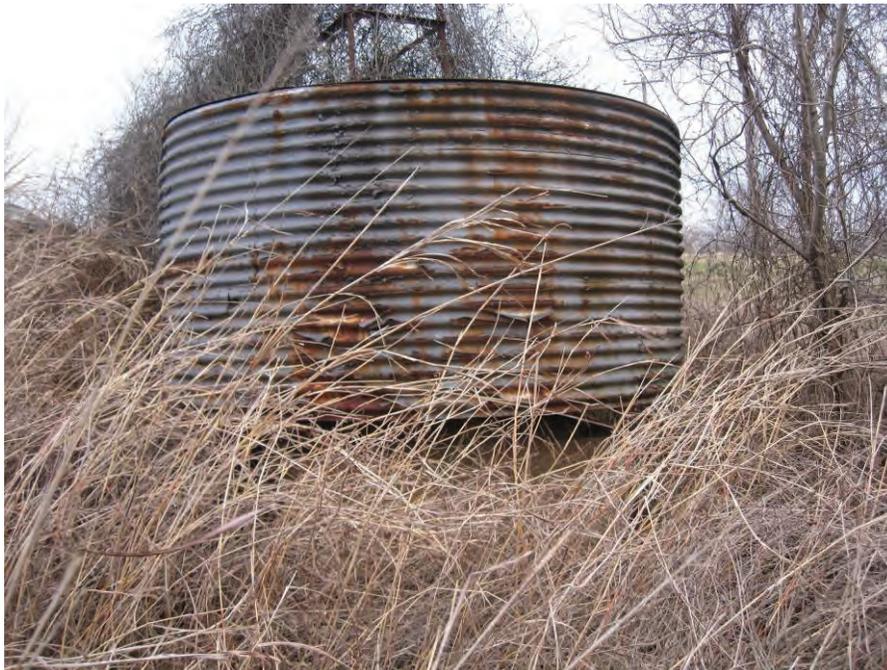
Drawing Mark WAP-4 Abandoned decant structure on west end of pond. Deteriorated and surrounded by heavy vegetation.
