**Coal Combustion Residue Impoundment  
Round 11 - Dam Assessment Report**

*Johnsonville Fossil Plant*

*Tennessee Valley Authority*  
**New Johnsonville, Tennessee**

**May 2012**

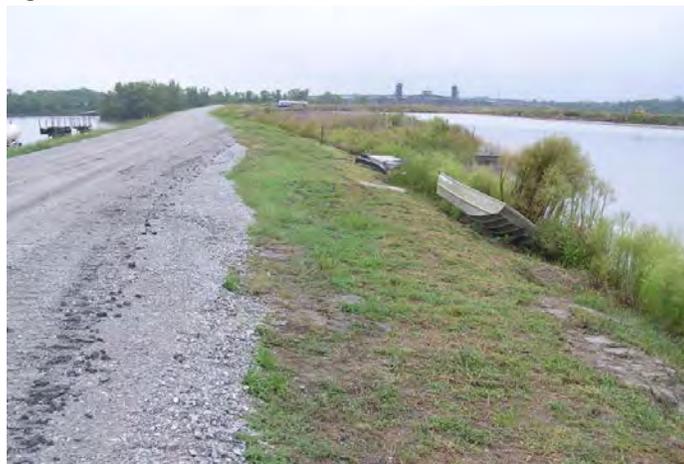
The crest of the AADA perimeter dike was observed to be surfaced with crushed stone and accessible with rubber-tired vehicles. The crest along all the major segments, including the southeast, southwest, northwest, and northeast dikes, is shown in Photos 5.1 through 5.4. The perimeter dike crest was observed to be in good condition with only minor surface indentations and some minor rill erosion along the edges. No major depressions (caused by settlement), sags, tension cracks, or other signs of significant settlement or mass soil movement were observed.

**Photo 5.1: Crest and inside slope along southeast dike, looking southwest. Note adjacent Pond B to the west (right in photo).**

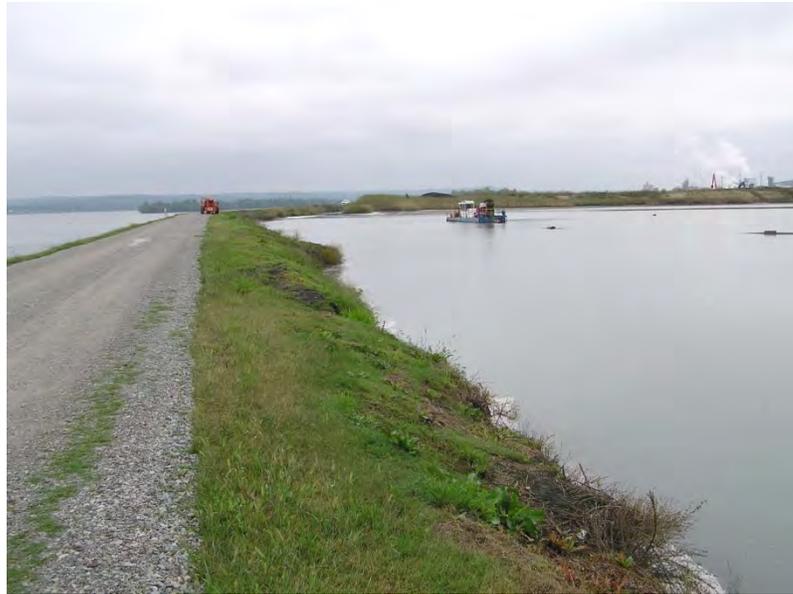
**Photo 5.2: Crest and inside slope along northern part of southwest dike, looking north. Note adjacent Pond A.**

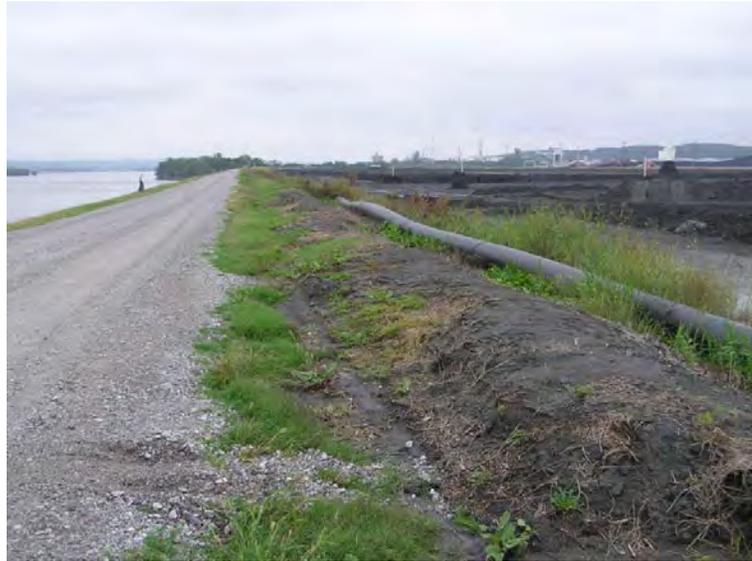
**Photo 5.3: Crest and inside slope/ interior area along northwest dike, looking northeast.**

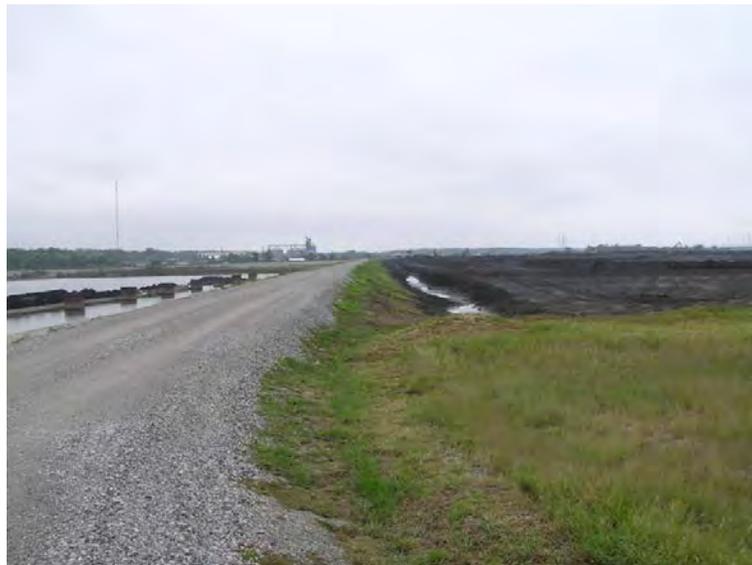
**Photo 5.4: Crest and inside slope along northeast dike, looking southeast.**

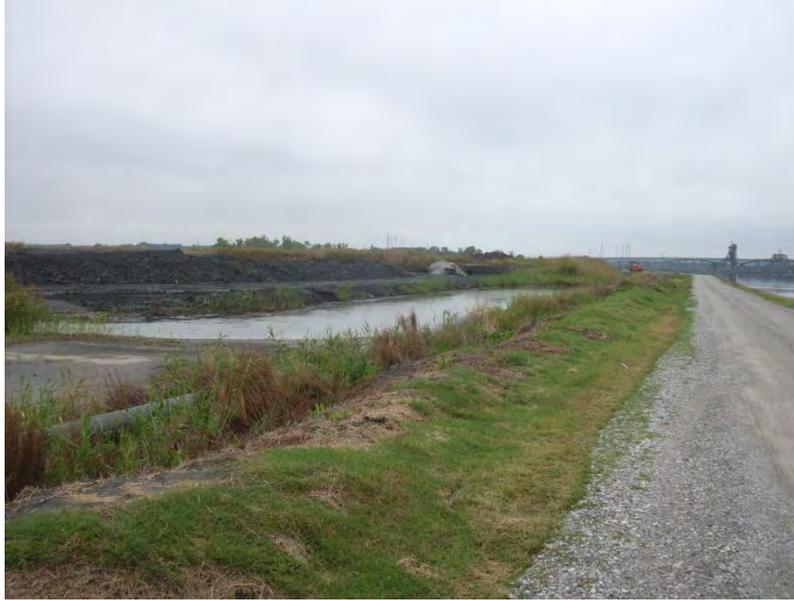
**Photo 5.5: Interior view toward south stockpile area, looking southeast.**

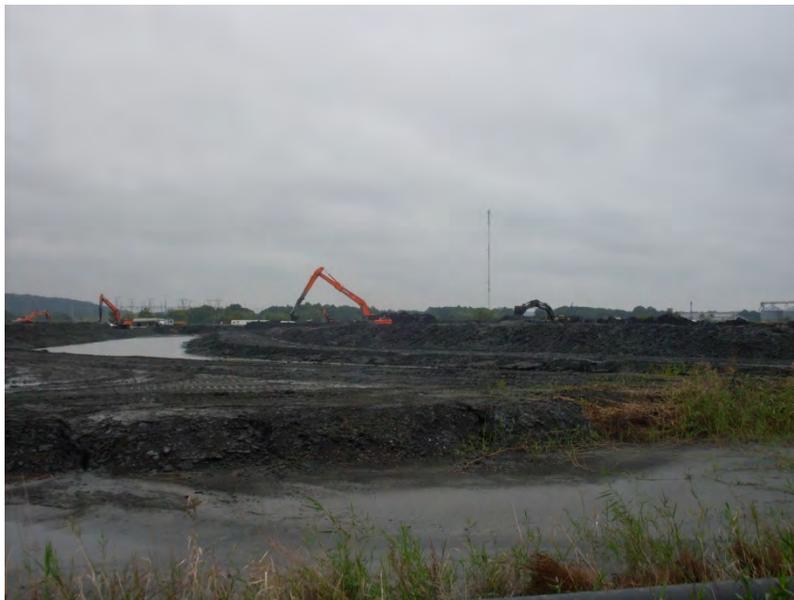
**Photo 5.6: Interior view of sluicing channel and long-reach excavators, looking east.**

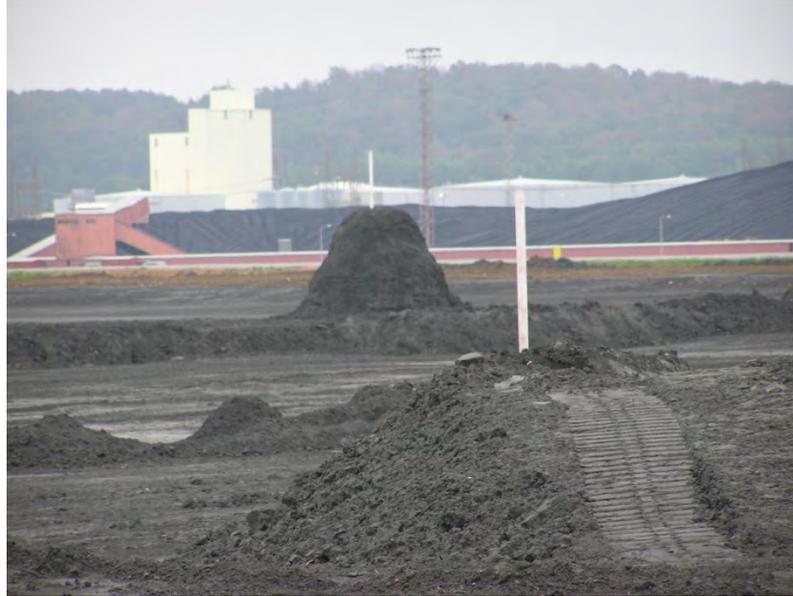
**Photo 5.7: Interior view of north stockpile area, looking northeast. Note most of stockpile has been removed by summer hauling to permitted landfill; note marker poles to gauge stockpile height.**

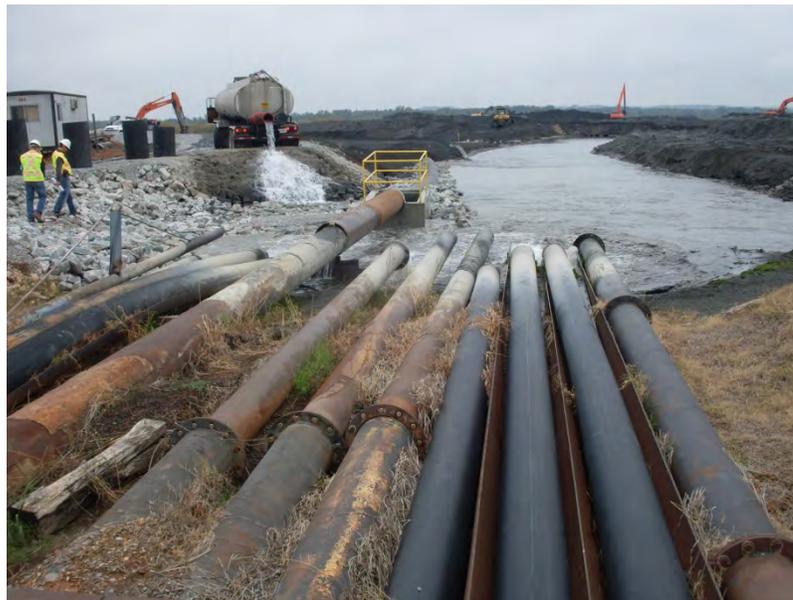
**Photo 5.8: View of ash sluice lines discharge location at sluicing channel, looking west. Note plant sump line (largest) discharges through pipe to Ash Pond Complex.**

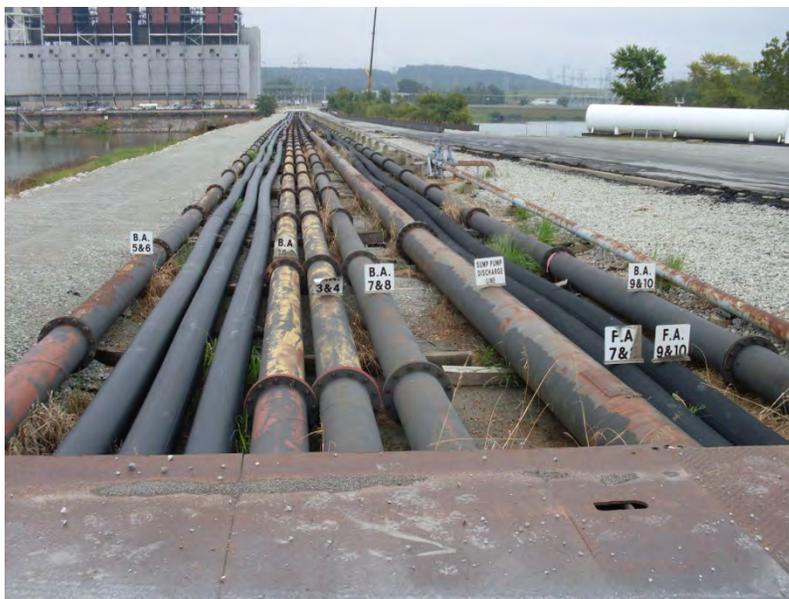
**Photo 5.9: View of identified ash sluice lines and plant sump line extending back to plant across causeway, looking east.**

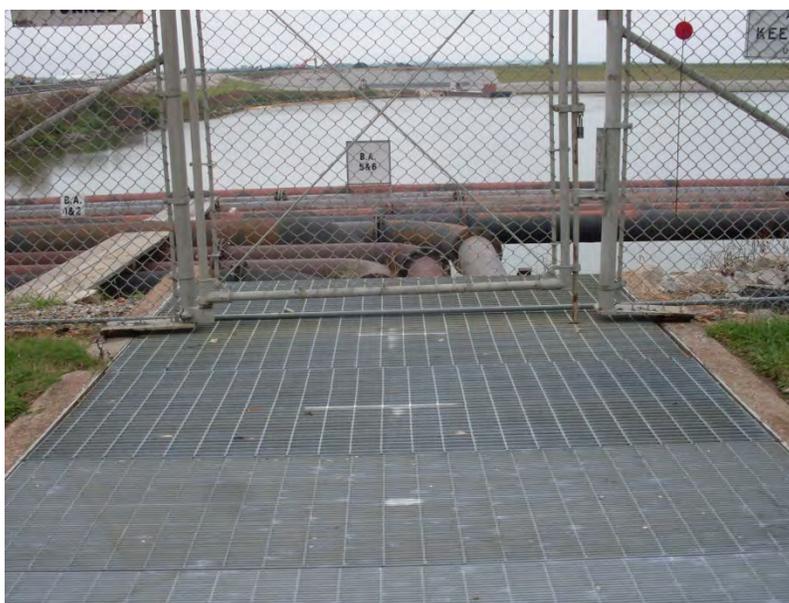
**Photo 5.10: View of ash sluice lines extending from one of plant pipe races, looking west.**

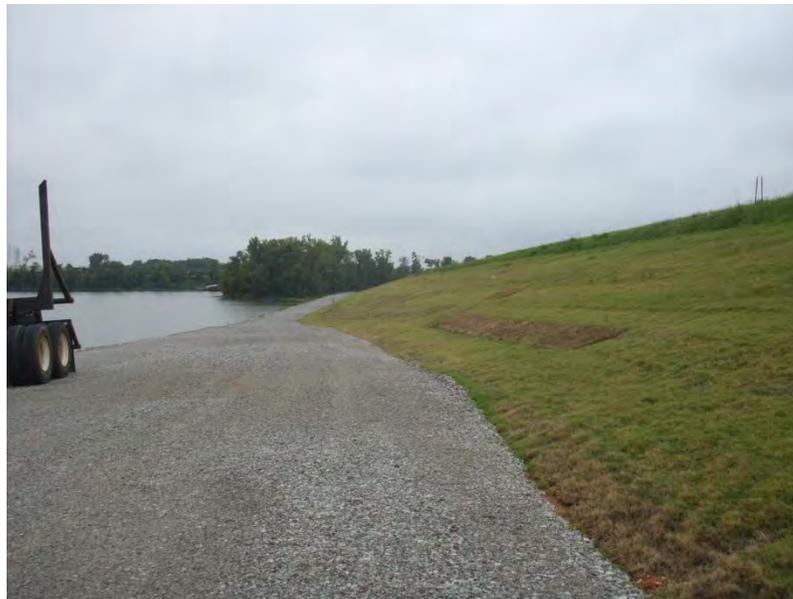
**Photo 5.11: Outside slope and toe berm along southeast dike, looking southwest. Note remnant of original steep slope at top.**

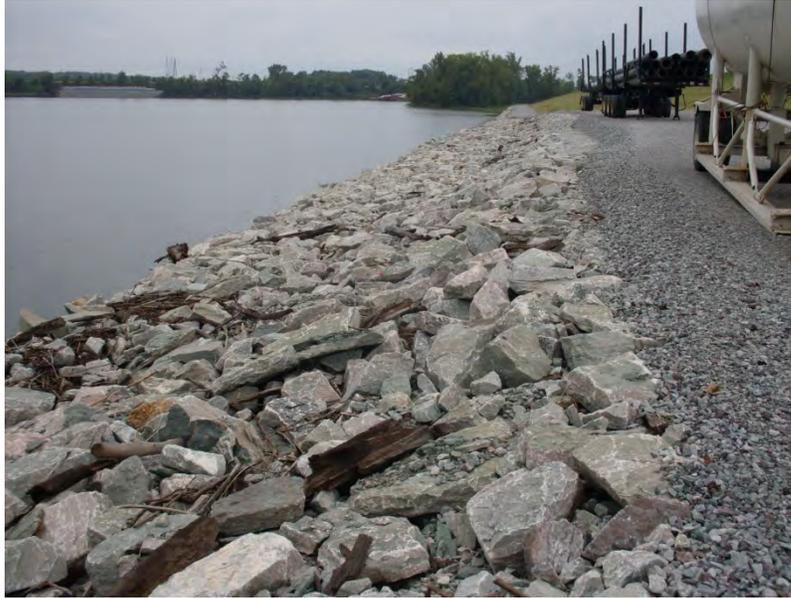
**Photo 5.12: Riprap buttress of toe berm along outside slope of southeast dike, looking southwest.**

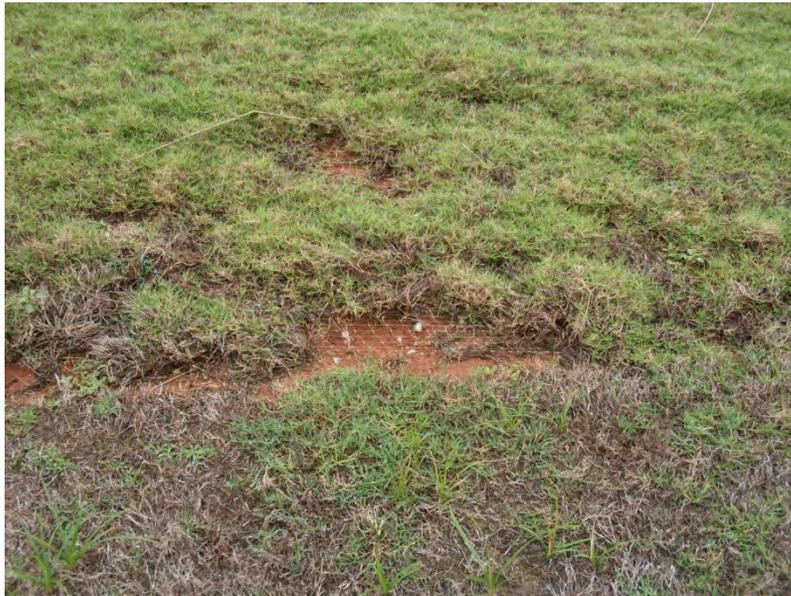
**Photo 5.13: Small eroded area on outside slope of southeast dike.**

No significant problems were observed in the field assessment that would require special attention outside of routine maintenance. The minor issues observed, mostly small eroded areas or areas of poor grass growth, should be addressed by TVA's routine maintenance activities. However, it is recommended that the areas of the two small apparent seeps at either end of the gabion wall near the south end of the northeast dike be visually monitored in future inspections, to check for flowing seepage and movement of soil particles with any flowing seepage that may develop.

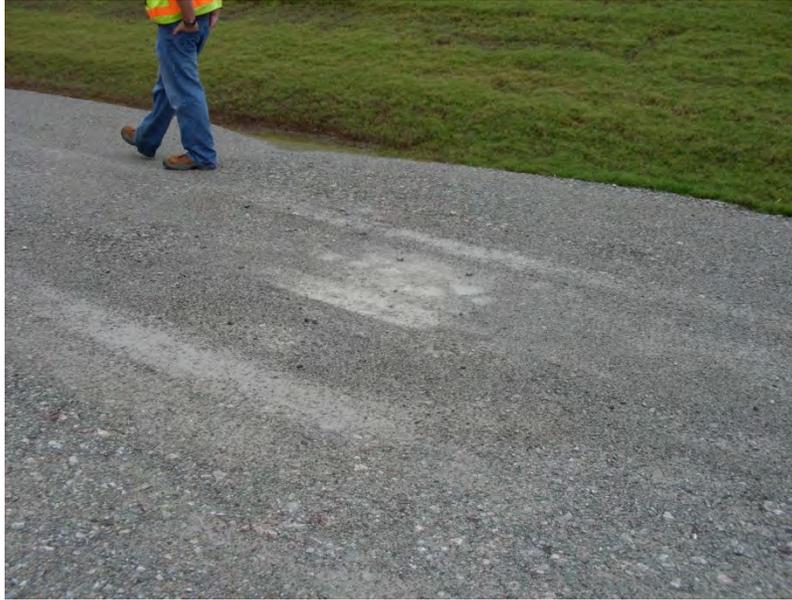
visible. It was observed that grass turf was used to establish permanent erosion protection of the new embankment slope. Some of the grass turf appeared to be “stressed.” TVA personnel indicated that the non-viable turf will be replaced. Only minor surface erosion was observed on the new slope, such as shown in Photo 5.13. Some minor rill erosion was observed on the edges of the stone surfacing of the berm, particularly on the outer edge at the southwest end. A minor depression holding apparent surface runoff was observed at the base of the new slope and in the surface of the toe berm as shown in Photo 5.14.

**Photo 5.14: Slight depression with some trapped water (apparent runoff) at base of slope and in surface of toe berm of southeast dike.**

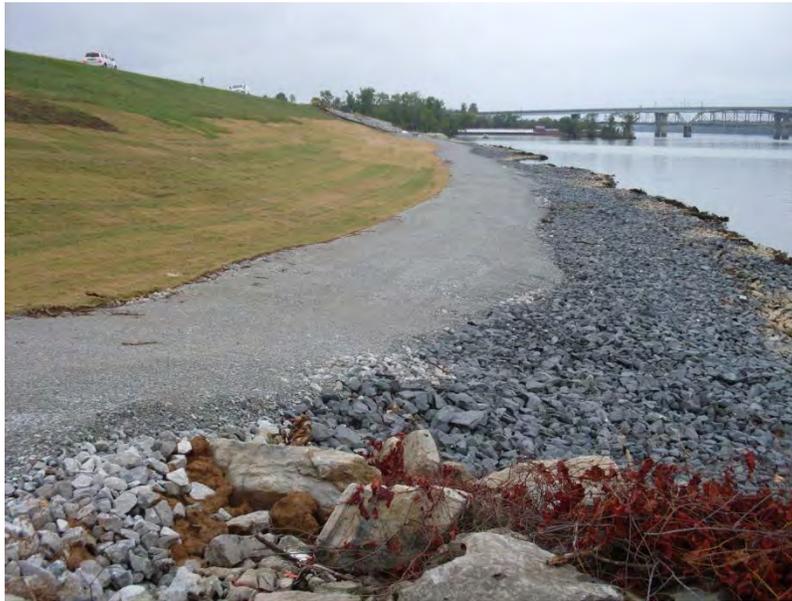
The outside slope and toe area of the north part of the southwest dike is shown in Photo 5.15. The toe area had recently been cleared of trees. The re-graded slope was covered with grass turf, which had not yet become well-established, as shown by the yellowish color of the grass in Photo 5.15. Some minor bare areas were observed on this slope; the worst one is shown in Photo 5.16.

**Photo 5.15: Outside slope and toe area along north part of southwest dike, looking south. The toe area had recently been cleared of trees. Discolored grass is recently placed sod.**

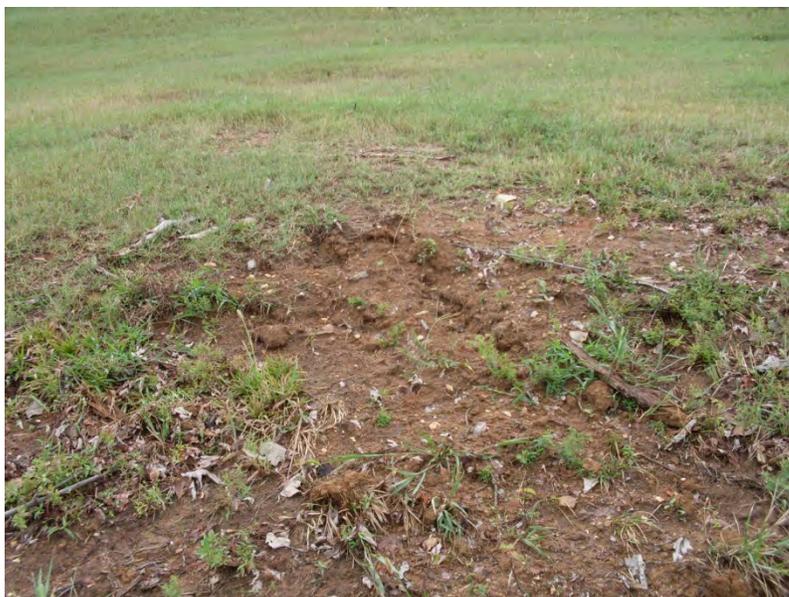
**Photo 5.16: Slightly eroded bare area on outside slope of southwest dike is above recently sodded area.**

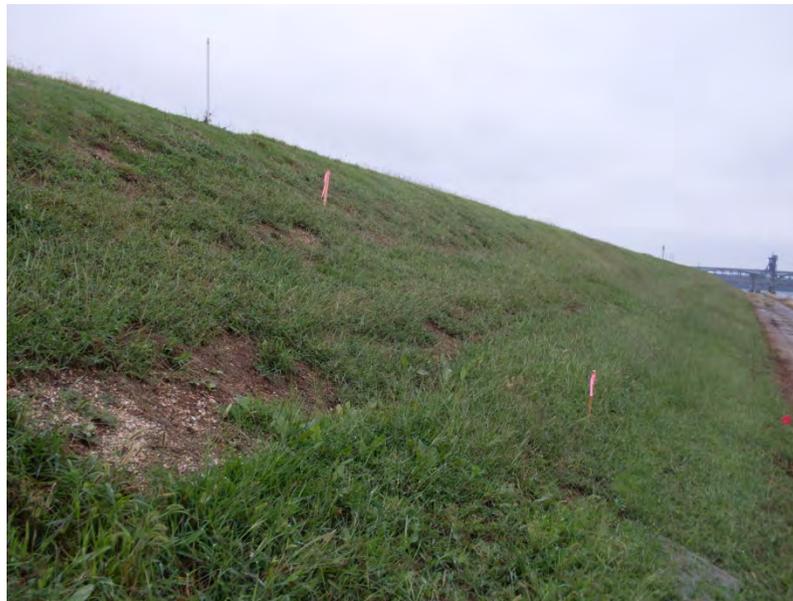
Minor bare spots were observed on the outside slope of the northwest dike; Photo 5.17 is representative. The riprap on the outside slope below the access berm along the lower part of the northwest dike was observed to have some relatively tall weeds and minor bushy vegetation, most of which appeared to have been treated with herbicide. During the flooding in May 2011, high water in Kentucky Lake rose above the riprap-protected lower part of the northwest dike outside slope and caused erosion of the embankment slope above the berm. Two separate areas were repaired with riprap. One of these is shown in Photo 5.18. The one shown is at a higher elevation than the other, and it appears that the damage at this location actually was caused by haul trucks on the narrow access berm down to the other repair site. The repairs were observed to be satisfactory. Some erosion was noted on a gravel-surfaced access ramp down the outside slope at the northern tip of the perimeter dike, as shown in Photo 5.19.

**Photo 5.17: Outside slope of northwest dike above access berm showing bare strip, looking southwest.**

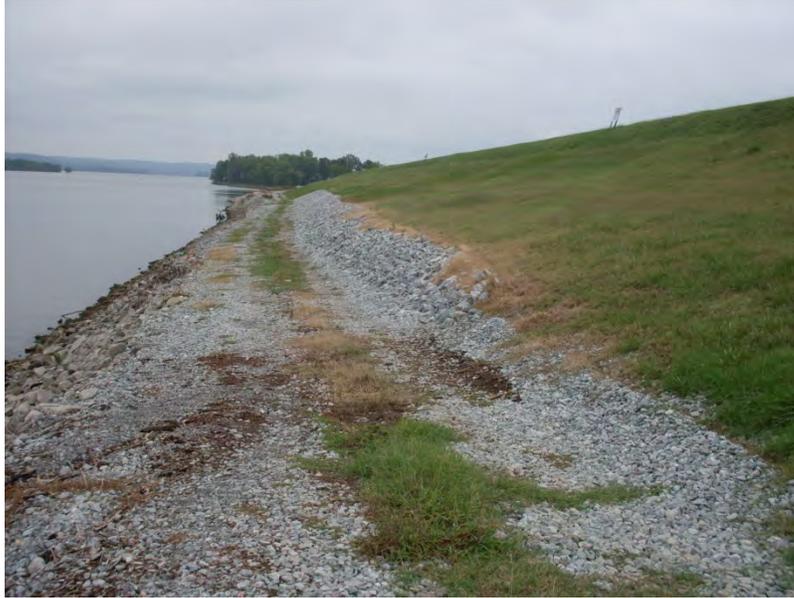
**Photo 5.18: Outside slope and toe area of northwest dike showing one of two areas repaired with riprap after being eroded by elevated Kentucky Lake level during flooding in May 2011, looking northeast.**

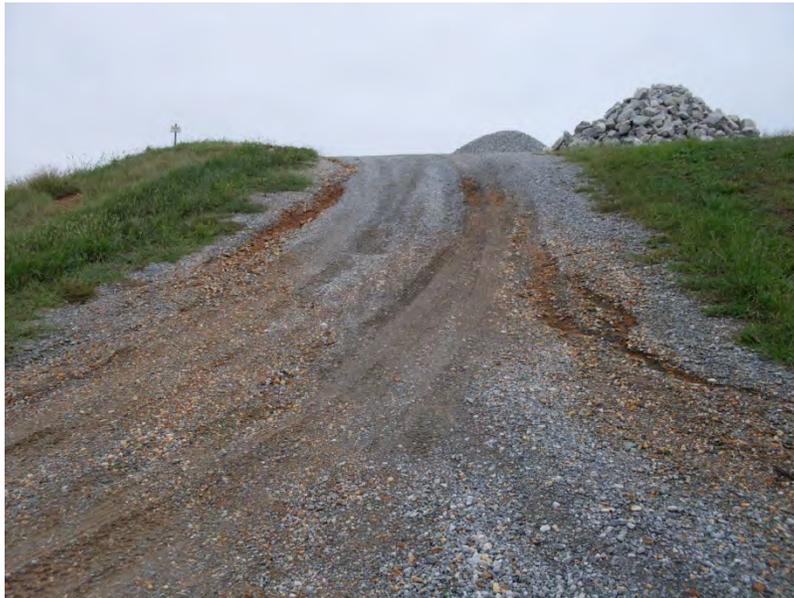
**Photo 5.19: Eroded access ramp on outside slope at northern tip of perimeter dike, looking south.**

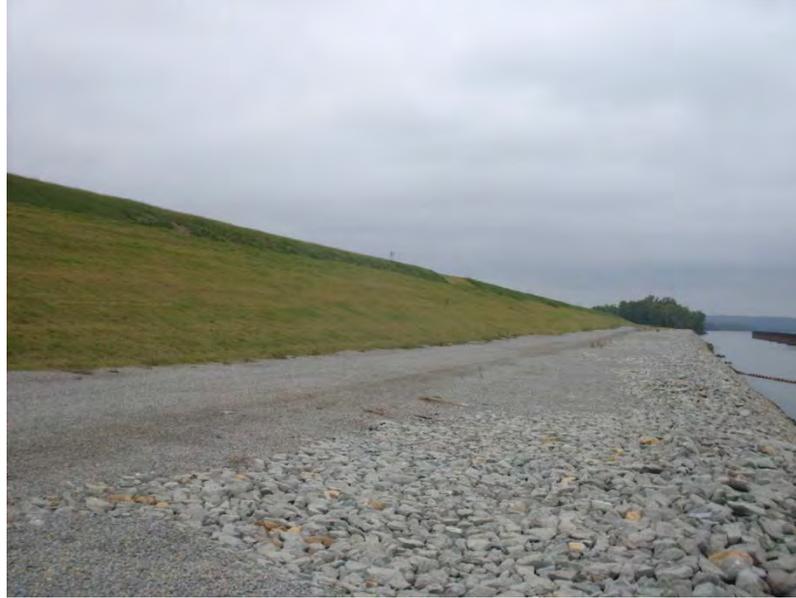
**Photo 5.20: Outside slope and toe berm along northeast dike, looking northwest. Note remnant of original steep slope at top.**

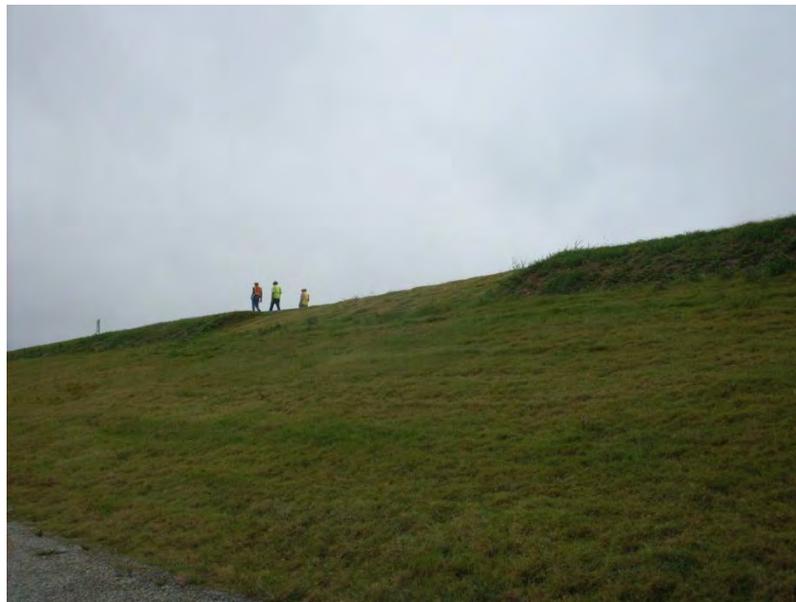
remnant of the old slope at the top where the slough occurred, which resulted in flattening the upper part to generally match the new slope below. Small apparent seeps with no discernable flow were observed along the toe of riprap at either end of a new gabion retaining wall that exists near the south end of the outside slope of the northeast dike (just north of causeway). One of these, shown in Photo 5.22, has a rust-colored growth or deposit, suggesting iron bacteria or possibly clay fines. The other seep was observed to have some green algae growth in it. Because of the presence of what appeared to be iron bacteria at one and green algae at the other, the wet areas appeared to be persistent and not just drainage of recent rainfall runoff from the riprap. Nevertheless, these apparent seeps appeared to be minor.

**Photo 5.21: Area of repair of small slough observed earlier this year in steep part at top of the northeast dike outside slope.**

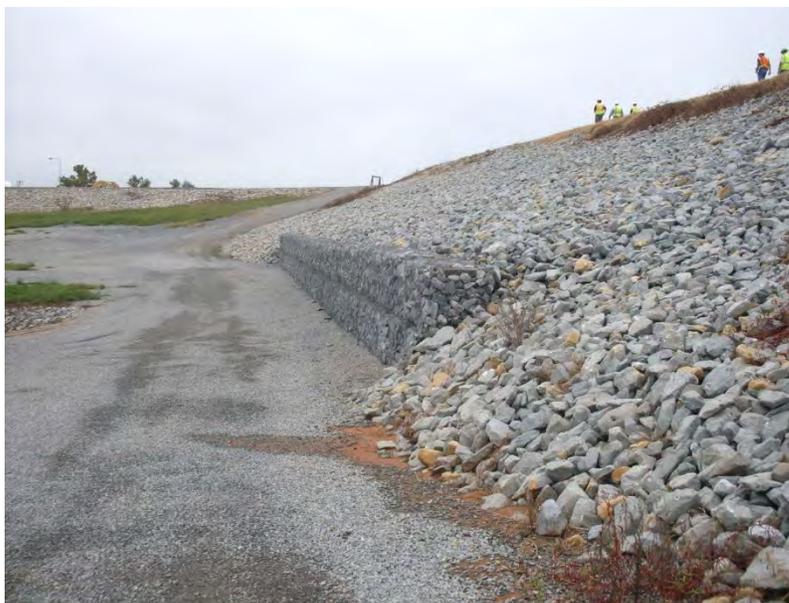
**Photo 5.22: Gabion retaining wall near south end of northeast dike outside slope. Small apparent seeps with no discernible flow observed along toe of riprap at each end of gabion wall.**

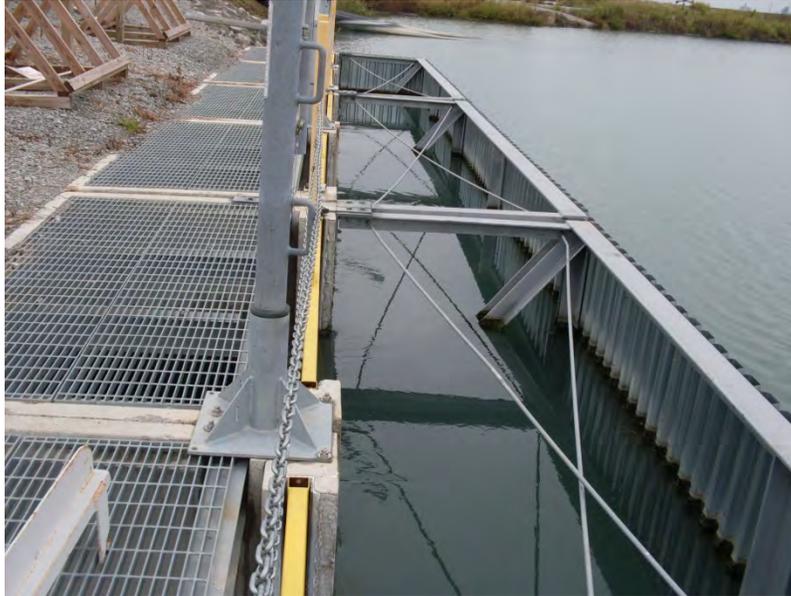
The visible part of the new spillway overflow structures located at Pond C next to the southwest dike are shown in Photo 5.23. The water level in the pond appeared to be at the new normal operating water elevation (384.6 feet). The six abutting concrete overflow structures fitted with adjustable weirs of stop logs were observed to be in good condition. The concrete structures appeared sound. No significant corrosion was observed on the metal grating, skimmer wall, or other metal parts, although a “scum line” has formed on the skimmer wall at the normal water elevation.

**Photo 5.23: View of six abutting concrete box overflow structures of new spillway fitted with stop logs, looking north. Note corrugated metal skimmer wall and adjacent Pond C.**

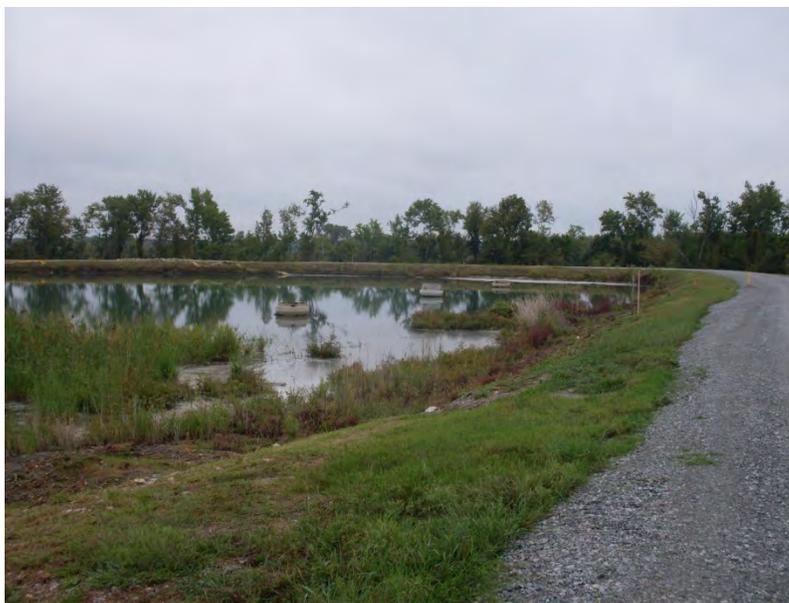
A view of the tops of the old grout-filled overflow risers in Pond C to the south of the new overflow structures is shown in Photo 5.24. As previously noted, there are six other grout- or concrete-filled risers; three are located at the southeast dike and three are located at the northwest dike. No obvious problems with any of the abandoned overflow structures were observed, and no issues with any of them have been reported since their closure.

**Photo 5.24: View of tops of old abandoned (grout-filled) overflow structures in Pond C next to southwest dike.**

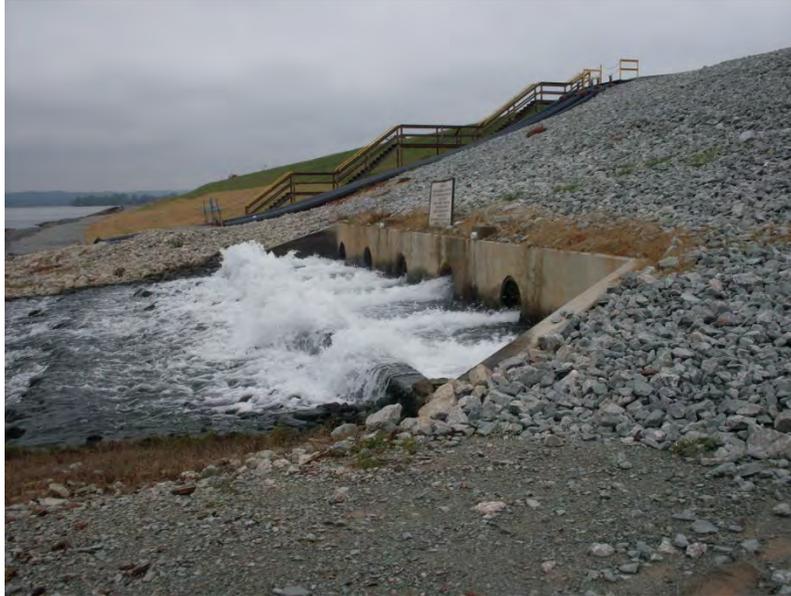
Water that overflows the six new overflow structures discharges through the six new 30-inch diameter HDPE conduits that pass through the southwest dike. These conduits serve as the primary outlet for the AADA. The water discharges into an energy dissipater before flowing down a riprap-lined apron to Kentucky Lake. Water was discharging from these primary outlet conduits at the time of the site visit, as shown in Photo 5.25. The concrete endwall and energy dissipater appeared to be in good condition with no obvious undermining. The tops of air vents installed for each conduit to prevent surging flow from entrapped air are shown near the top of the southwest dike in Photo 5.26; they appeared to be functioning properly. No sinkholes or dropouts were observed in the embankment over the conduits. The riprap-lined apron appeared to be sound with no obvious areas of eroded and displaced riprap.

**Photo 5.25: View of outlet ends of the six conduits of the new primary spillway discharging into energy dissipater, looking north. Note siphon pipes beyond.**

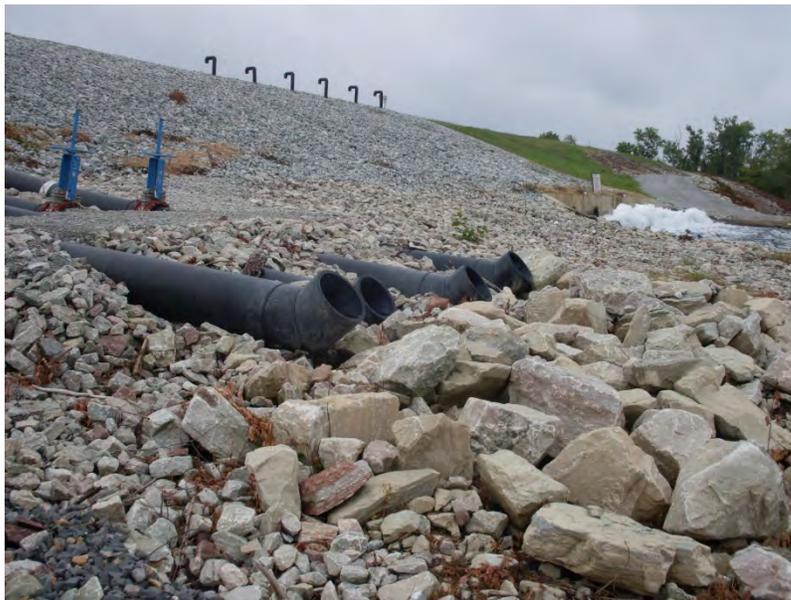
**Photo 5.26: View of outlet ends of the four new siphon pipes. Note air vents near top of southwest dike for the six new conduits of the primary spillway.**

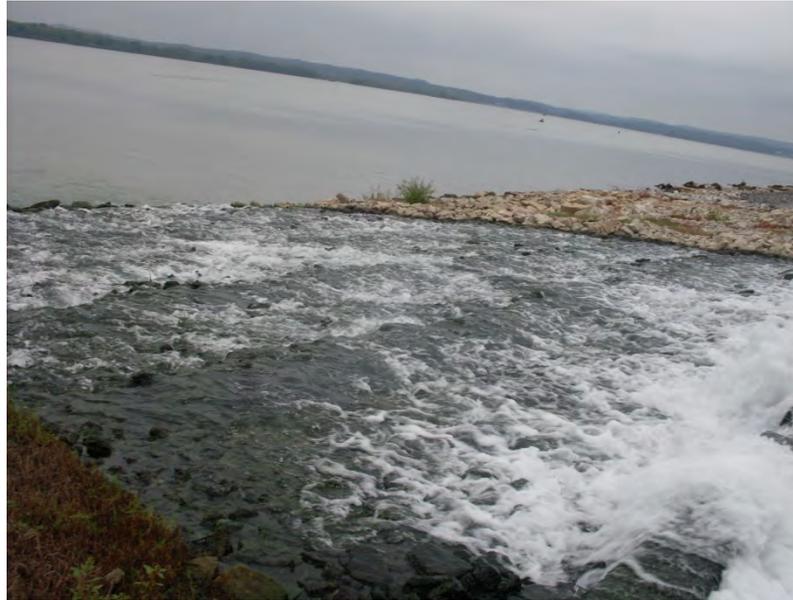
**Photo 5.27: View of flow to Kentucky Lake along riprap apron below the energy dissipater, looking northwest.**
