**Coal Combustion Residue Impoundment
Round 11 - Dam Assessment Report**

Johnsonville Fossil Plant

Tennessee Valley Authority
New Johnsonville, Tennessee

Dewberry Consultants LLC
Fairfax, Virginia

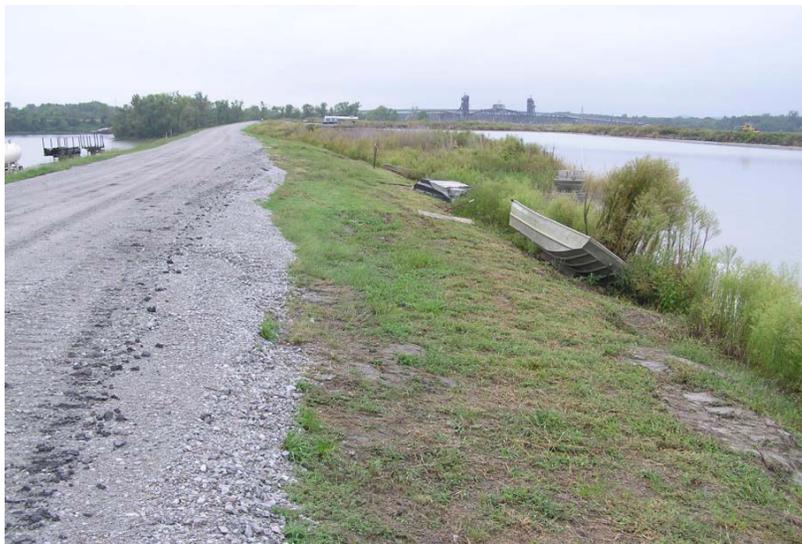
Photo 5.1: Crest and inside slope along southeast dike, looking southwest. Note adjacent Pond B to the west (right in photo).

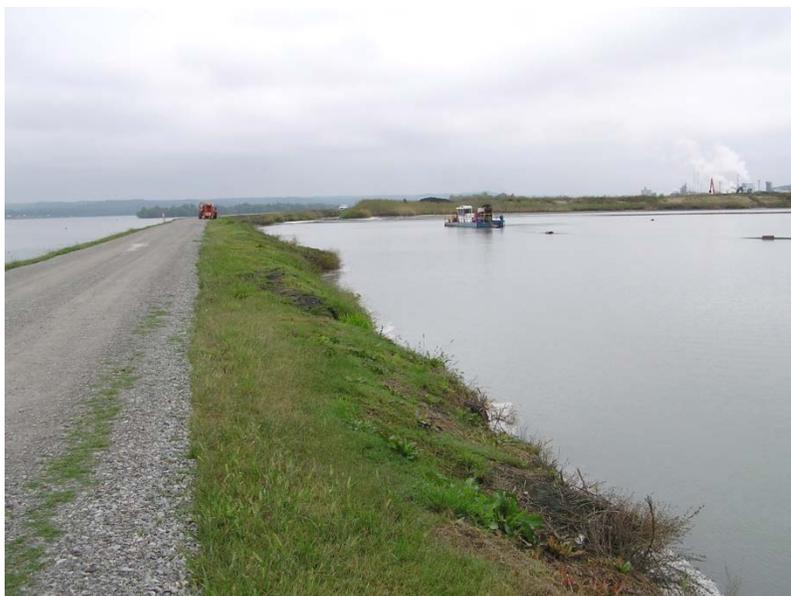
Photo 5.2: Crest and inside slope along northern part of southwest dike, looking north. Note adjacent Pond A.

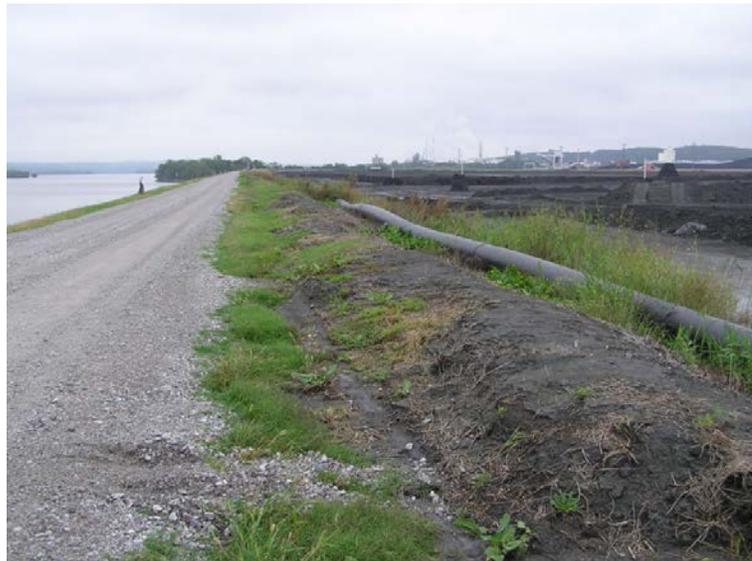
Photo 5.3: Crest and inside slope/ interior area along northwest dike, looking northeast.

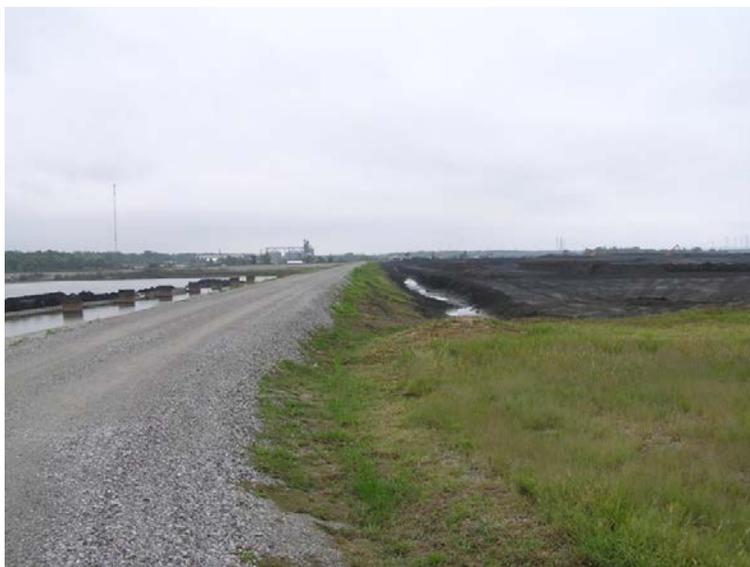
Photo 5.4: Crest and inside slope along northeast dike, looking southeast.

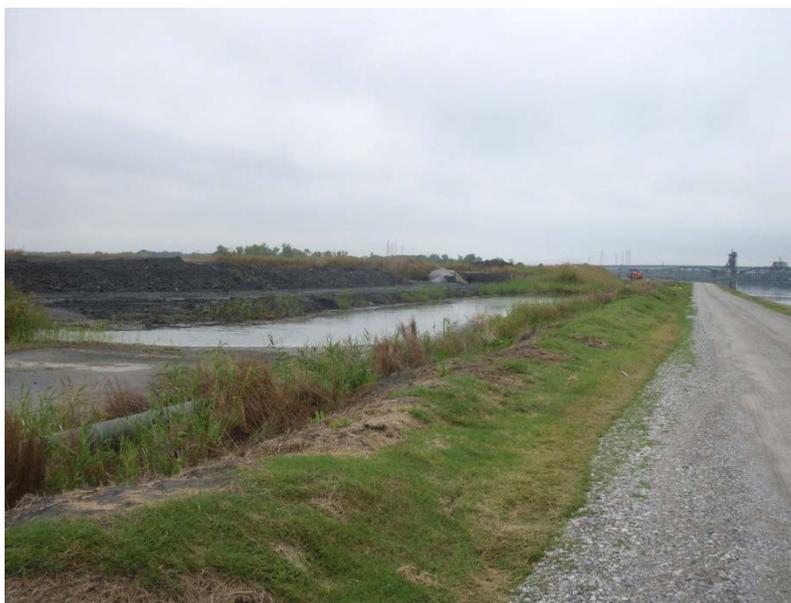
Photo 5.5: Interior view toward south stockpile area, looking southeast.

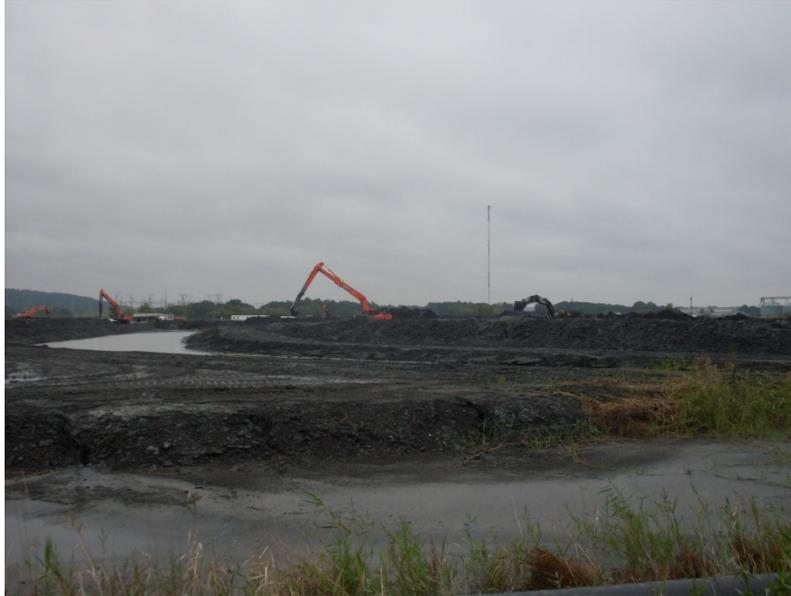
Photo 5.6: Interior view of sluicing channel and long-reach excavators, looking east.

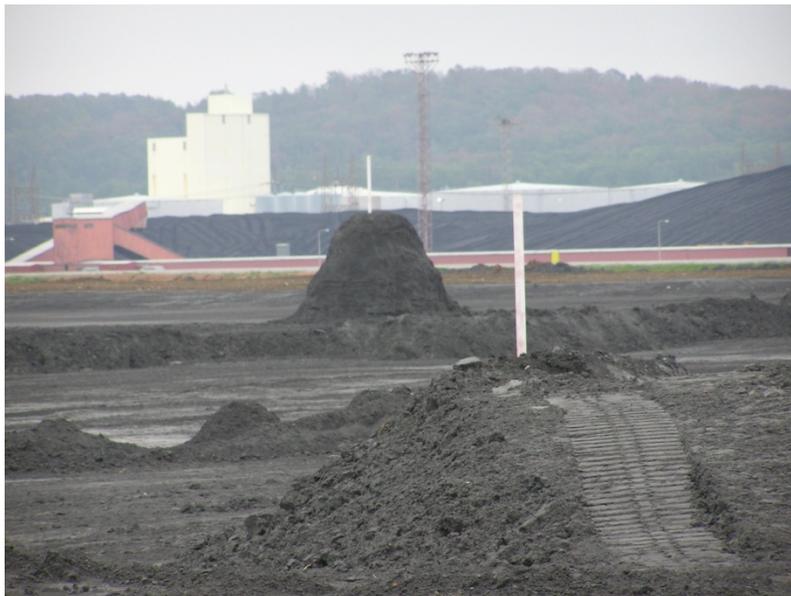
Photo 5.7: Interior view of north stockpile area, looking northeast. Note most of stockpile has been removed by summer hauling to permitted landfill; note marker poles to gauge stockpile height.

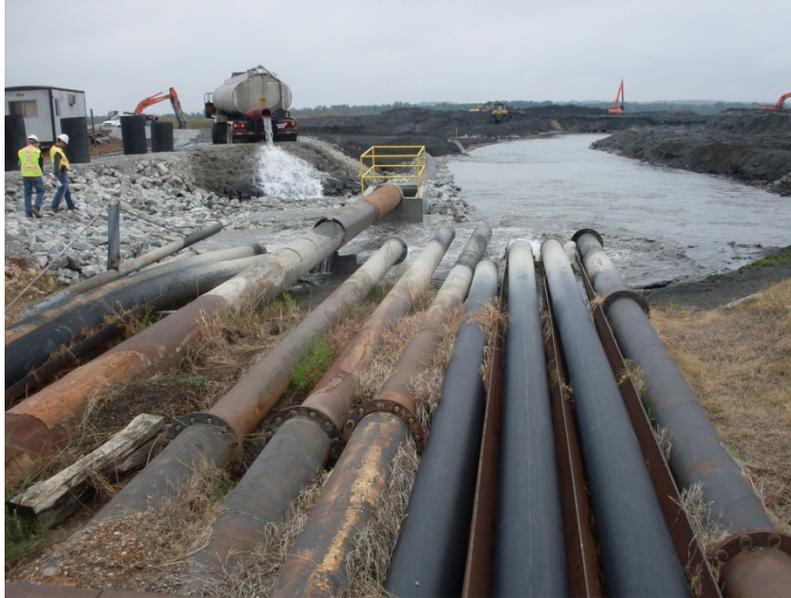
Photo 5.8: View of ash sluice lines discharge location at sluicing channel, looking west. Note plant sump line (largest) discharges through pipe to Ash Pond Complex.

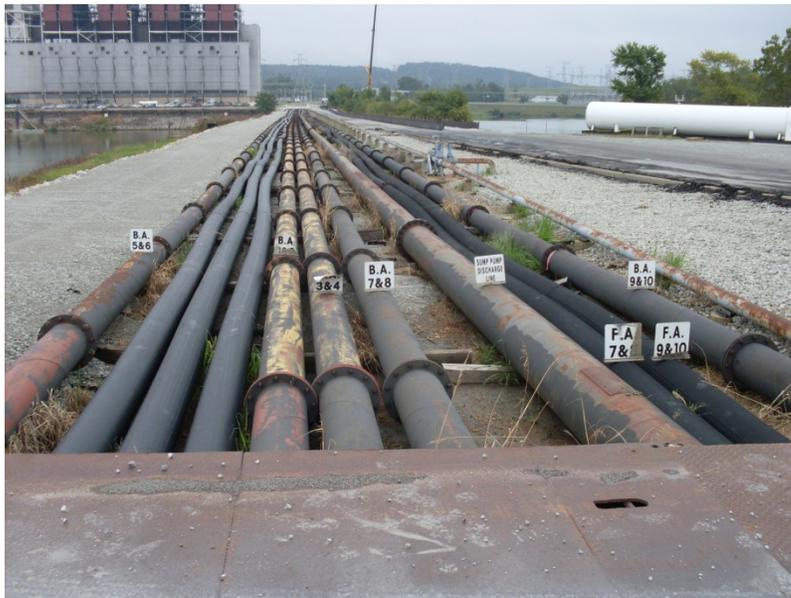
Photo 5.9: View of identified ash sluice lines and plant sump line extending back to plant across causeway, looking east.

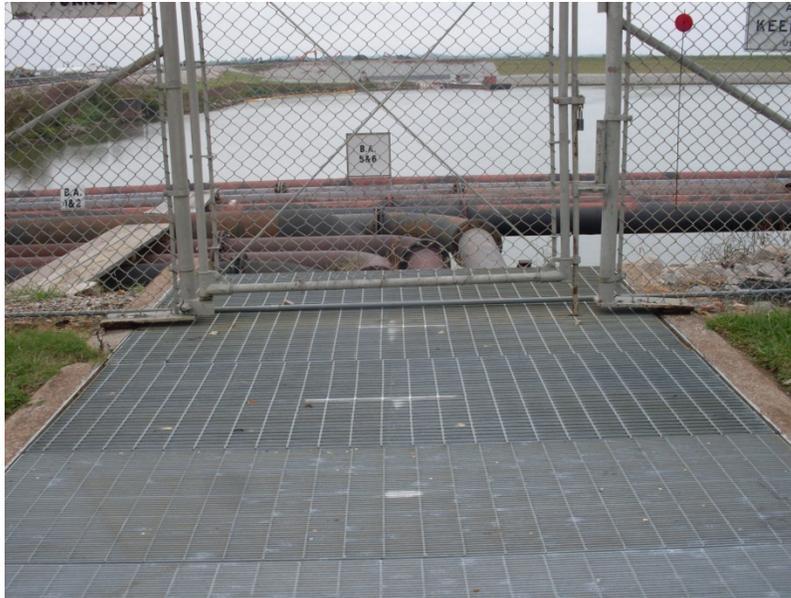
Photo 5.10: View of ash sluice lines extending from one of plant pipe races, looking west.

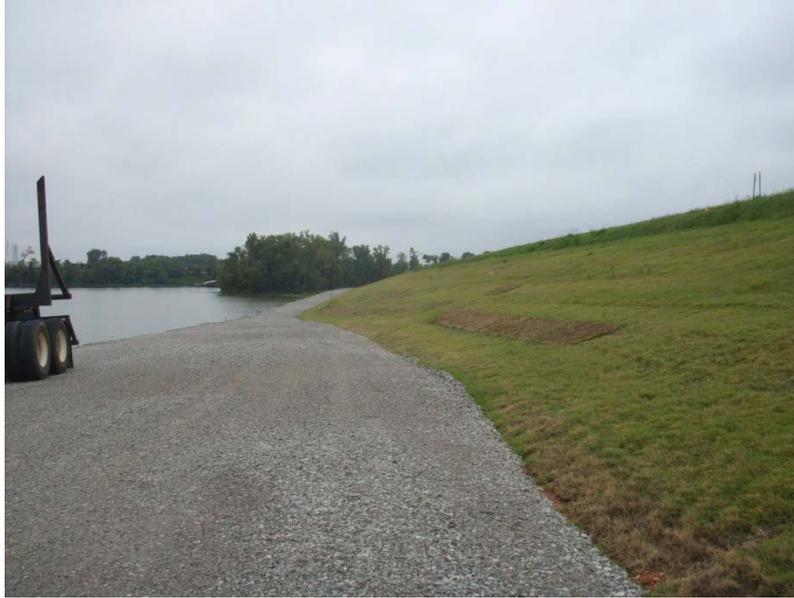
Photo 5.11: Outside slope and toe berm along southeast dike, looking southwest. Note remnant of original steep slope at top.

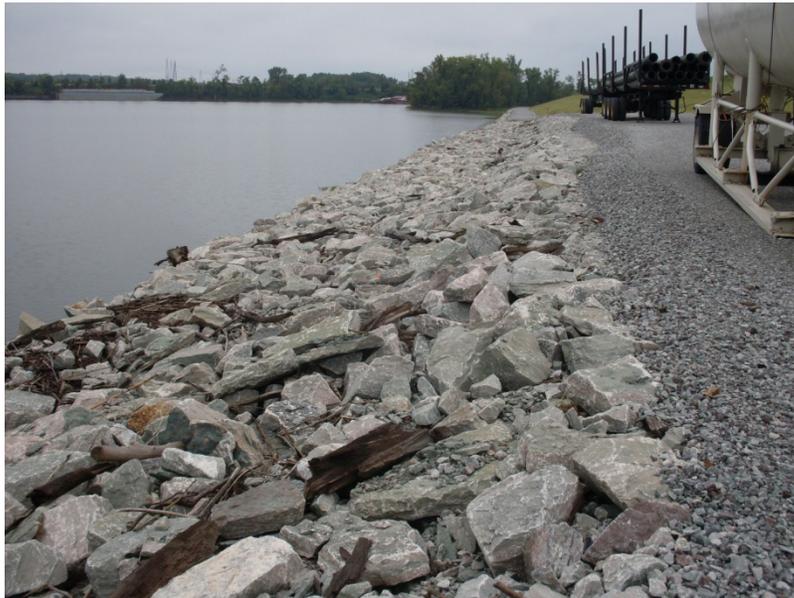
Photo 5.12: Riprap buttress of toe berm along outside slope of southeast dike, looking southwest.

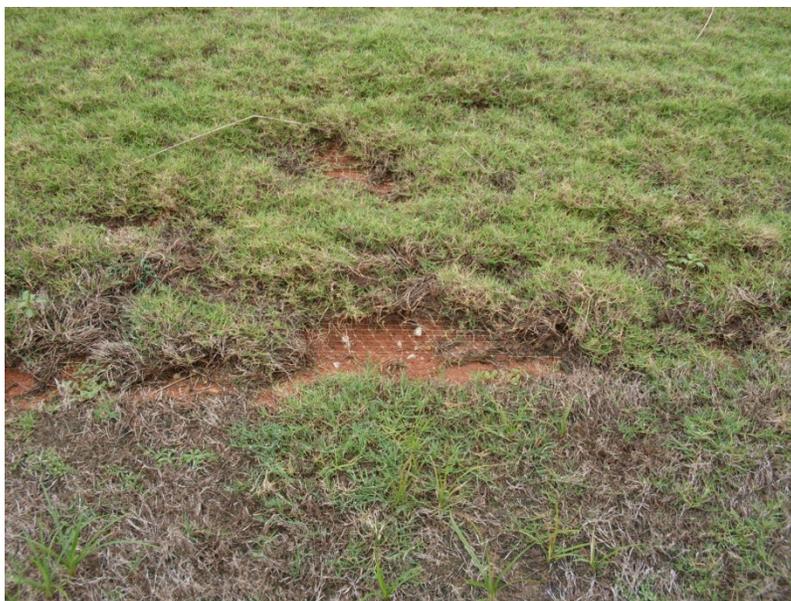
Photo 5.13: Small eroded area on outside slope of southeast dike.

No significant problems were observed in the field assessment that would require special attention outside of routine maintenance. The minor issues observed, mostly small eroded areas or areas of poor grass growth, should be addressed by TVA's routine maintenance activities. In the DRAFT Dam Assessment Report, it was recommended that the areas of the two small apparent seeps at either end of the gabion wall near the south end of the northeast dike be visually monitored in future inspections, to check for flowing seepage and movement of soil particles with any flowing seepage that may develop.

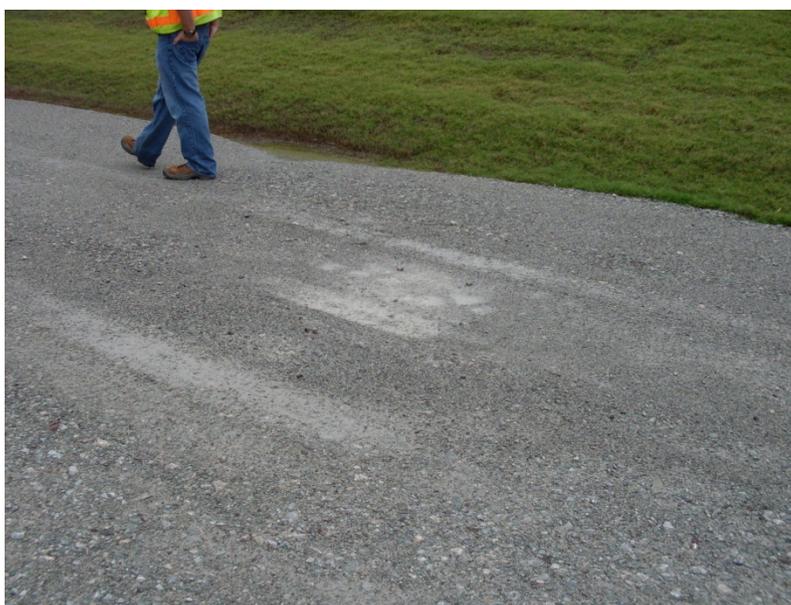
Photo 5.14: Slight depression with some trapped water (apparent runoff) at base of slope and in surface of toe berm of southeast dike.

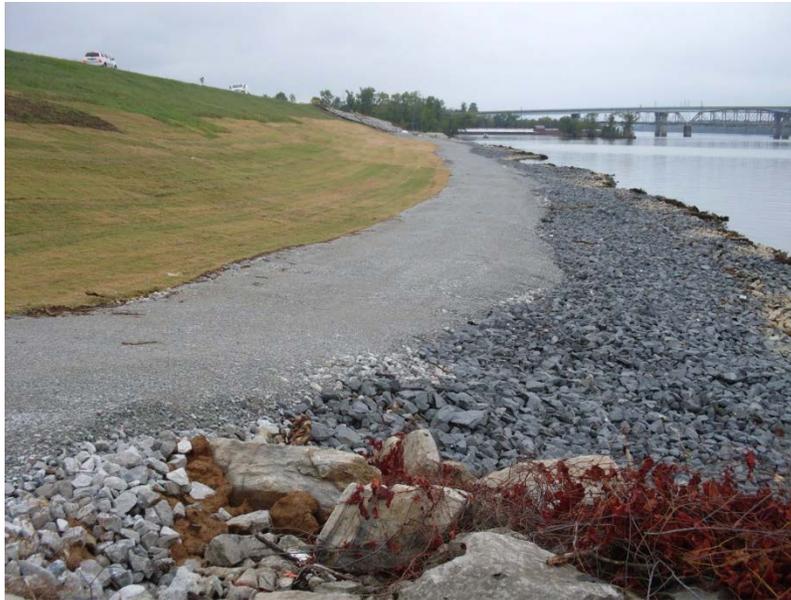
Photo 5.15: Outside slope and toe area along north part of southwest dike, looking south. The toe area had recently been cleared of trees. Discolored grass is recently placed sod.

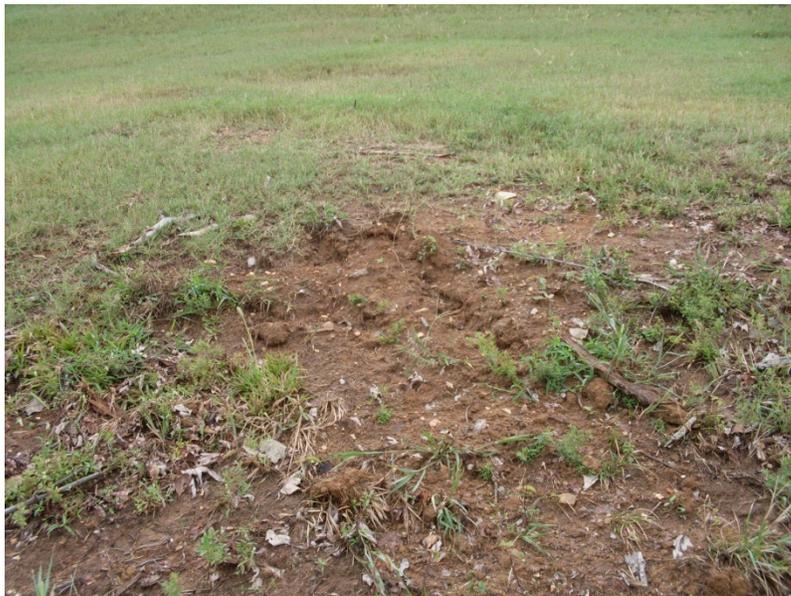
Photo 5.16: Slightly eroded bare area on outside slope of southwest dike is above recently sodded area.

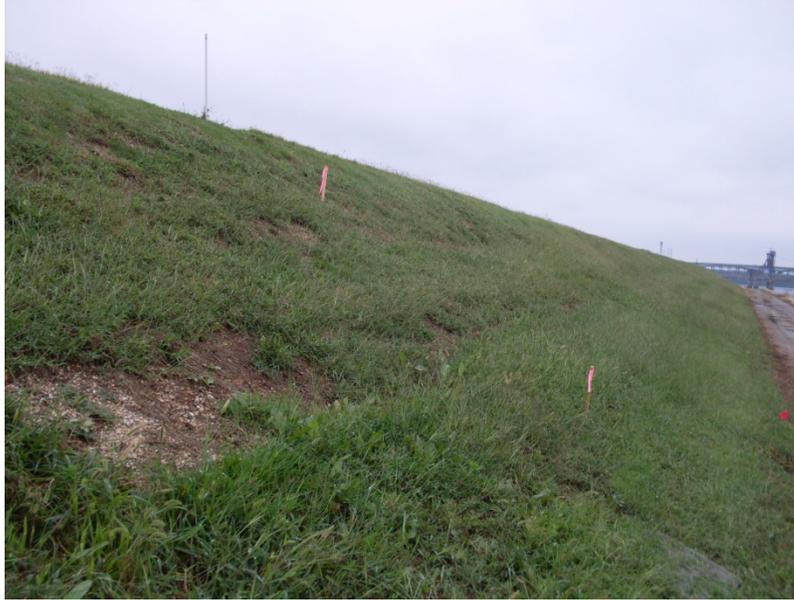
Minor bare spots were observed on the outside slope of the northwest dike; Photo 5.17 is representative. The riprap on the outside slope below the access berm along the lower part of the northwest dike was observed

Photo 5.17: Outside slope of northwest dike above access berm showing bare strip, looking southwest.

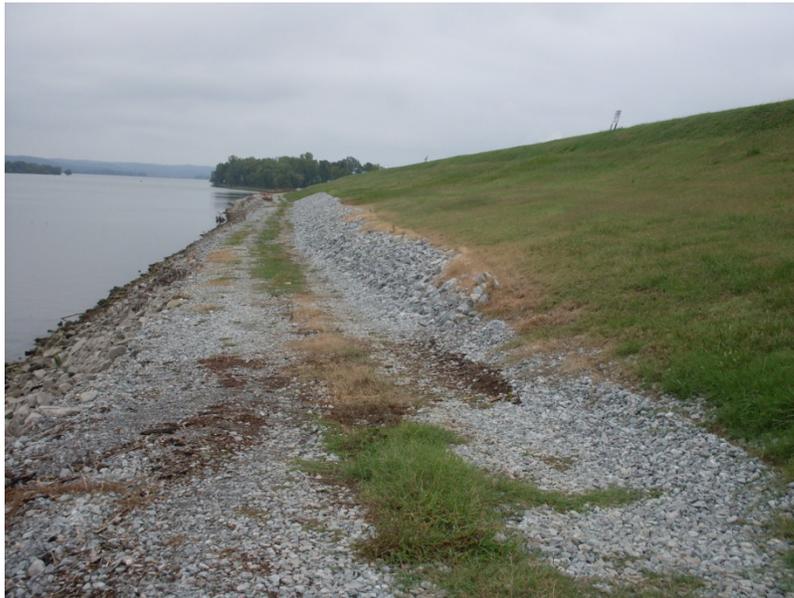
Photo 5.18: Outside slope and toe area of northwest dike showing one of two areas repaired with riprap after being eroded by elevated Kentucky Lake level during flooding in May 2011, looking northeast.

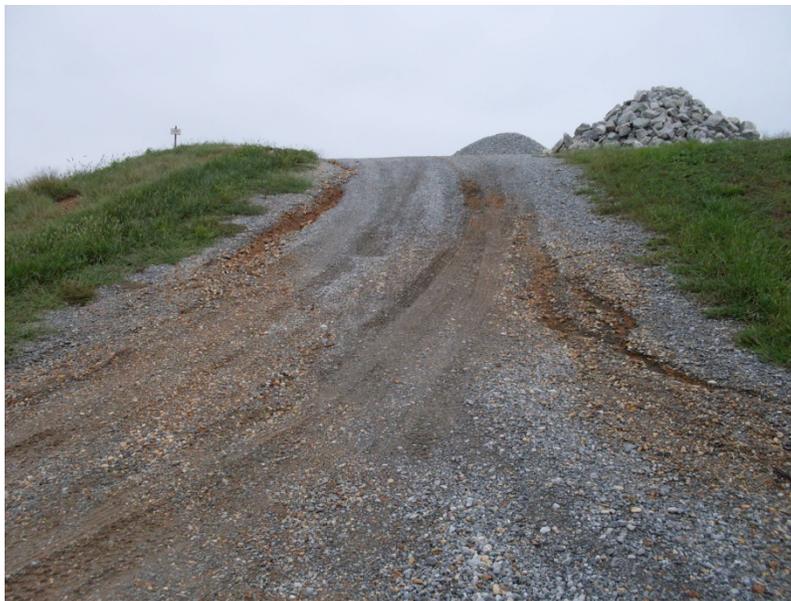
Photo 5.19: Eroded access ramp on outside slope at northern tip of perimeter dike, looking south.

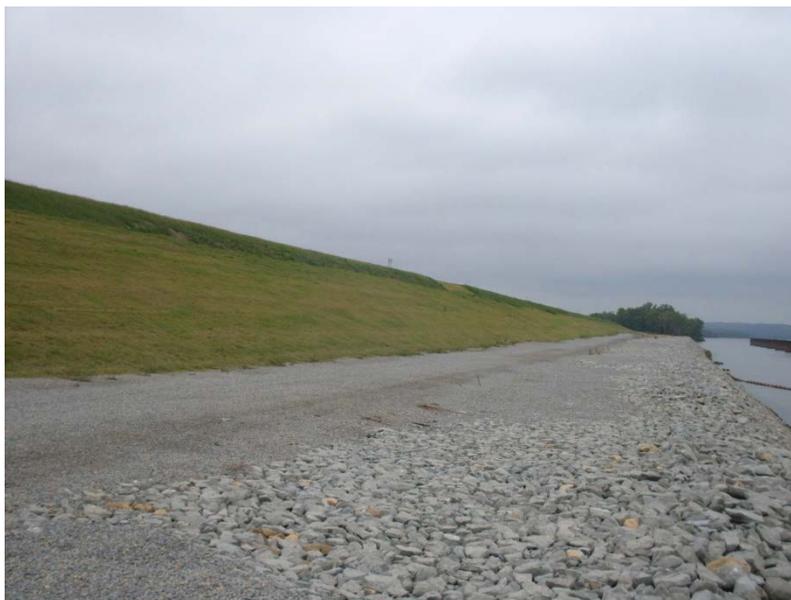
Photo 5.20: Outside slope and toe berm along northeast dike, looking northwest. Note remnant of original steep slope at top.

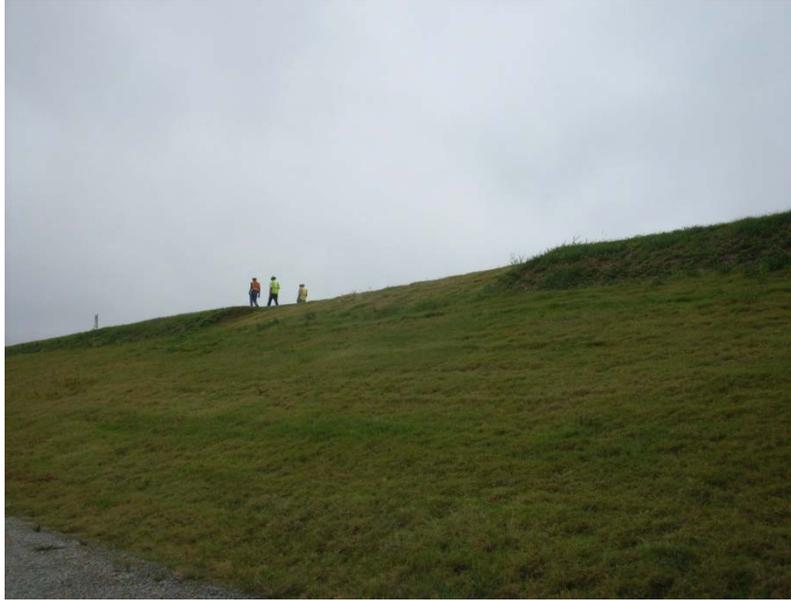
Photo 5.21: Area of repair of small slough observed earlier this year in steep part at top of the northeast dike outside slope.

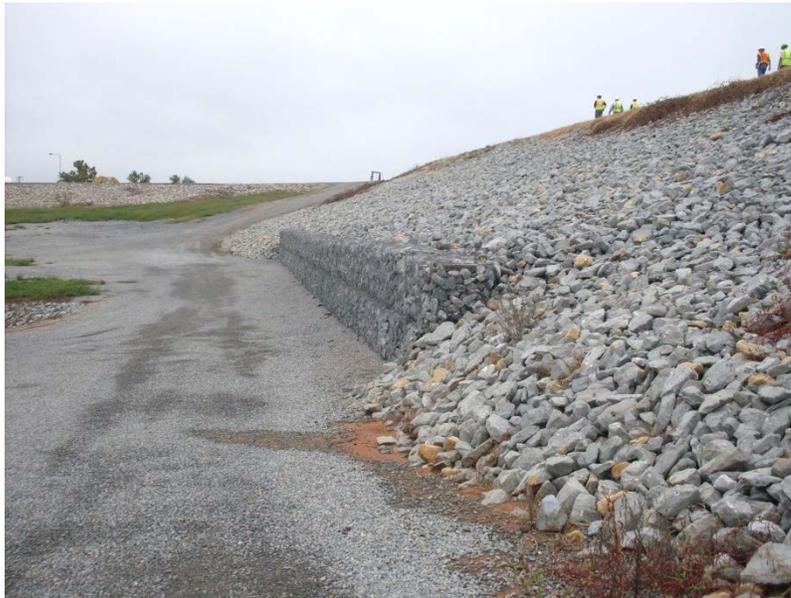
Photo 5.22: Gabion retaining wall near south end of northeast dike outside slope. Small apparent seeps with no discernible flow observed along toe of riprap at each end of gabion wall.

TVA has addressed the above comments and recommendation (see Stantec's letter dated October 3, 2012 in Appendix C, Doc 16). The two apparent seeps were determined to be wet-weather features.

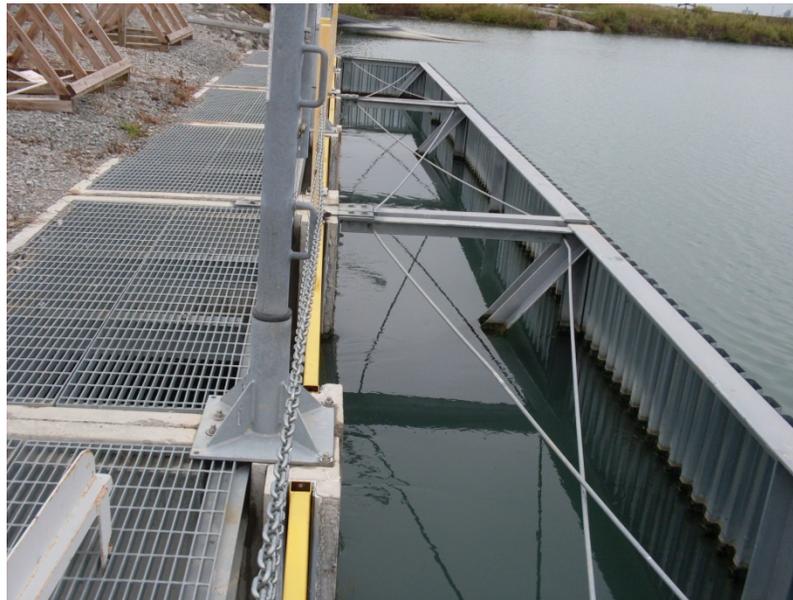
The visible part of the new spillway overflow structures located at Pond C next to the southwest dike are shown in Photo 5.23. The water level in the pond appeared to be at the new normal operating water elevation (384.6 feet). The six abutting concrete overflow structures fitted with adjustable weirs of stop logs were observed to be in good condition. The concrete structures appeared sound. No significant corrosion was observed on the metal grating, skimmer wall, or other metal parts, although a “scum line” has formed on the skimmer wall at the normal water elevation.

Photo 5.23: View of six abutting concrete box overflow structures of new spillway fitted with stop logs, looking north. Note corrugated metal skimmer wall and adjacent Pond C.

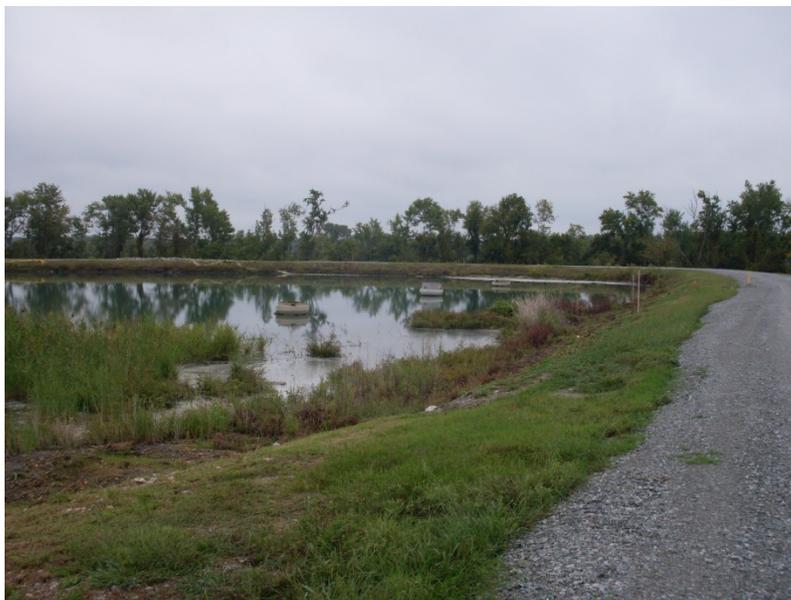
A view of the tops of the old grout-filled overflow risers in Pond C to the south of the new overflow structures is shown in Photo 5.24. As previously noted, there are six other grout- or concrete-filled risers; three are located at the southeast dike and three are located at the northwest dike. No obvious problems with any of the abandoned overflow structures were observed, and no issues with any of them have been reported since their closure.

Photo 5.24: View of tops of old abandoned (grout-filled) overflow structures in Pond C next to southwest dike.

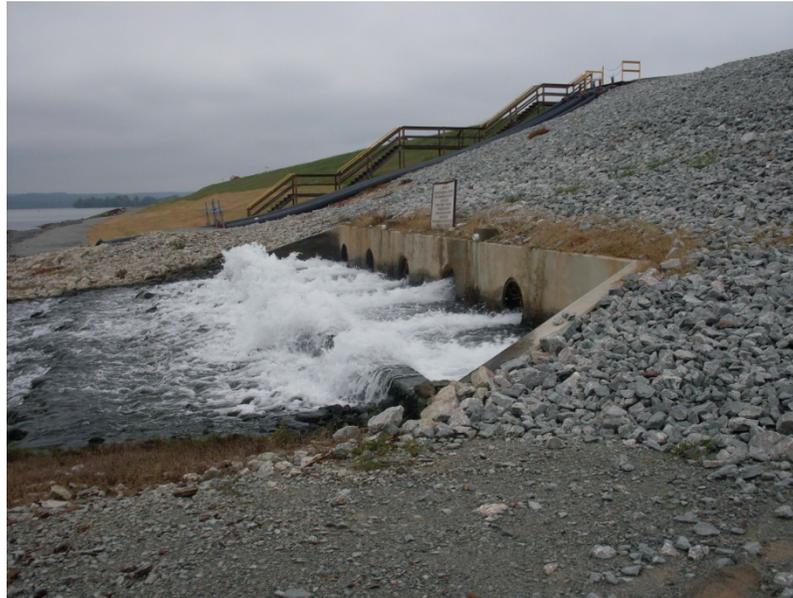
Photo 5.25: View of outlet ends of the six conduits of the new primary spillway discharging into energy dissipater, looking north. Note siphon pipes beyond.

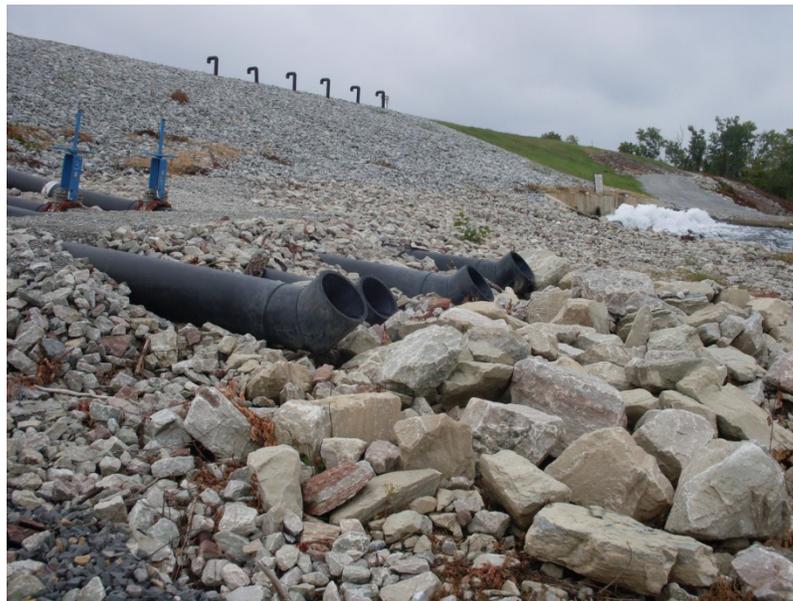
Photo 5.26: View of outlet ends of the four new siphon pipes. Note air vents near top of southwest dike for the six new conduits of the primary spillway.

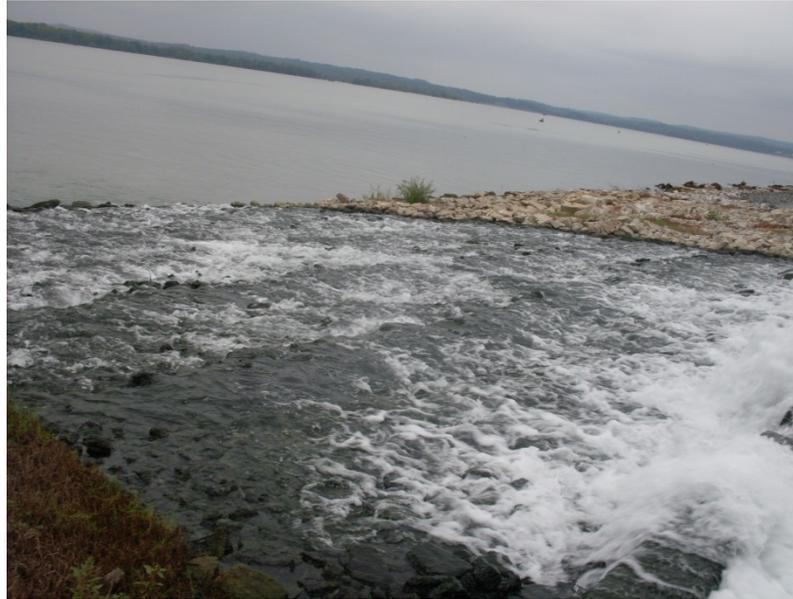
Photo 5.27: View of flow to Kentucky Lake along riprap apron below the energy dissipater, looking northwest.
