**Coal Combustion Residue Impoundment  
Round 11 - Dam Assessment Report**

*John Sevier Fossil Plant*

*Ash Basin Dikes*

*Tennessee Valley Authority  
Rogersville, Tennessee*

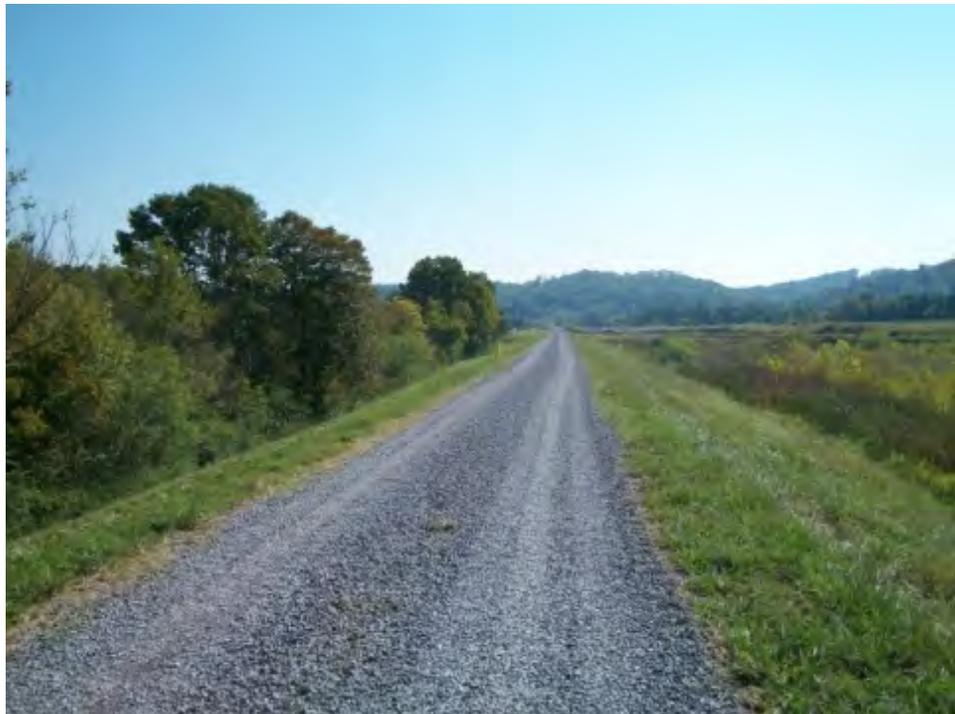
Figure 5.2.1-1 Crest around Bottom Ash Disposal Area 2

Overall, there were no signs of rutting, depressions, tension cracking, or other indications of settlement or shear failure and the crest appeared to be in satisfactory condition (see Figure 5.2.1-1).

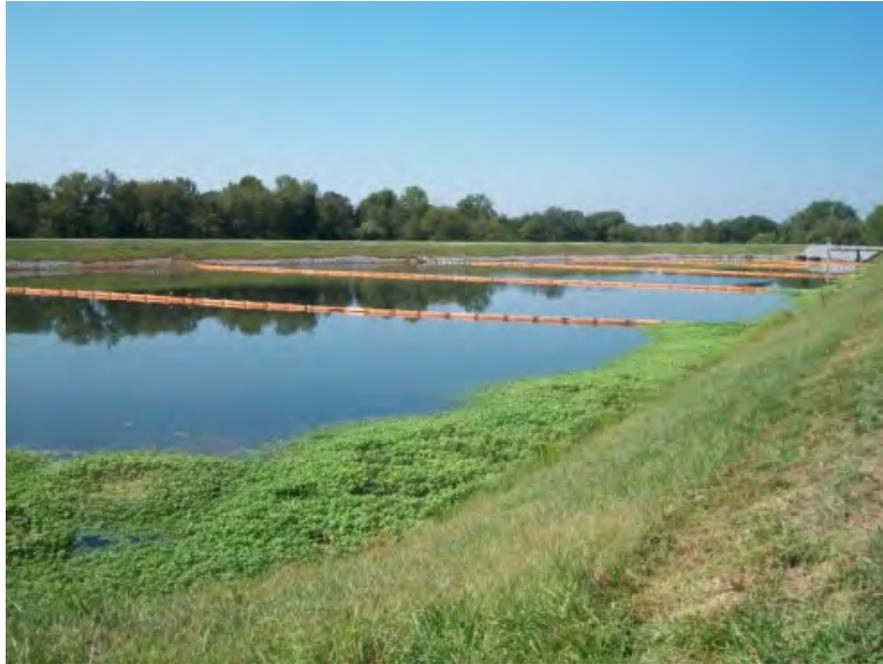
**Figure 5.2.2-1 Inside Slope**

No scarps, sloughs, depressions, bulging or other indications of slope instability or signs of erosion were observed (see Figure 5.2.2-1).

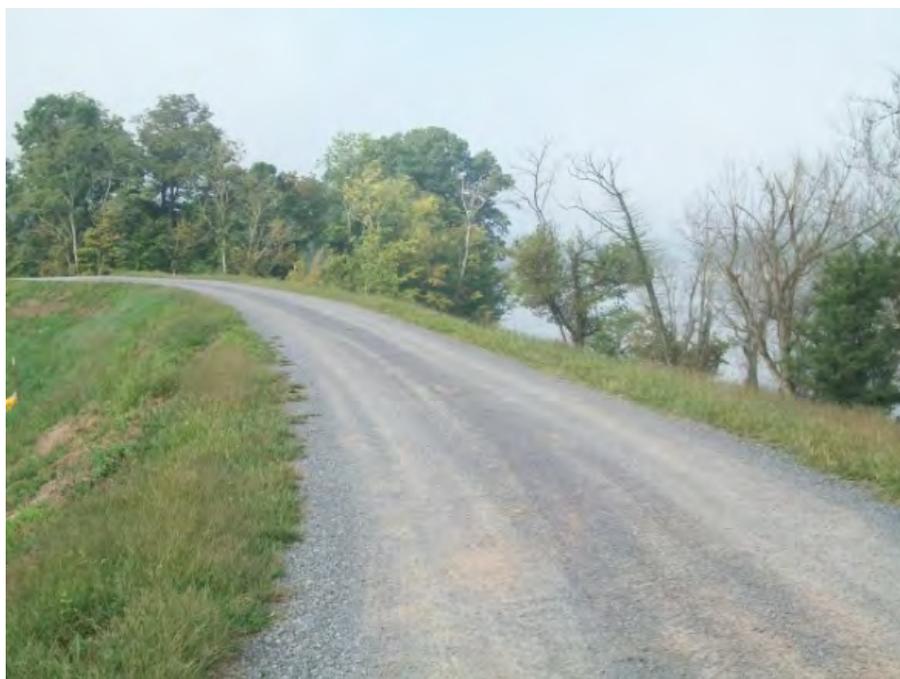
**Figure 5.3.1-1 Crest Around Dry Fly Ash Stack**

The impoundment crest is gravel covered and used to access the Dry Fly Ash Stack. The crest is designated the Upper Perimeter Road, Overall, there were no signs of rutting, depressions, tension cracking, or other indications of settlement or shear failure and the crest appeared to be in satisfactory condition (see Figure 5.3.1-1).

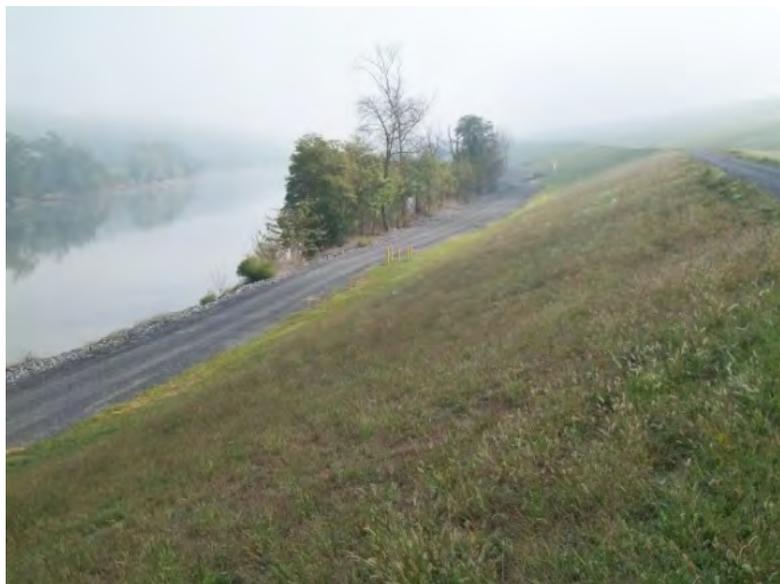
**Figure 5.3.3-1 Outside Slope, Dry Fly Ash Stack**

No scarps, sloughs, depressions, bulging or other indications of slope instability or signs of erosion were observed (see Figure 5.3.3-1).

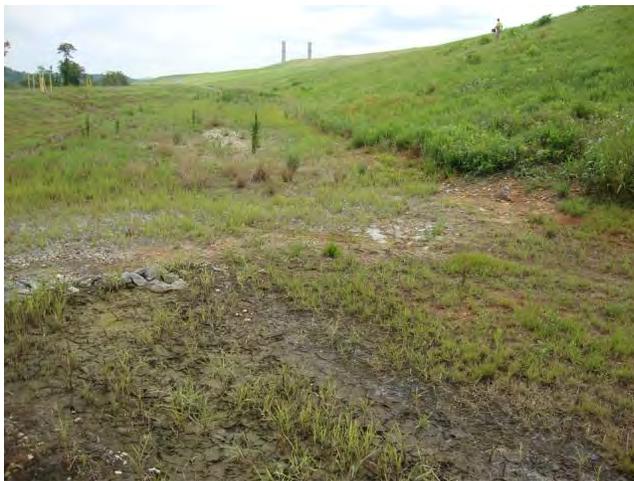
**Photo 2 (TVA Item No. 66)**

Standing water observed at the west end of the exterior upper slope of the area.

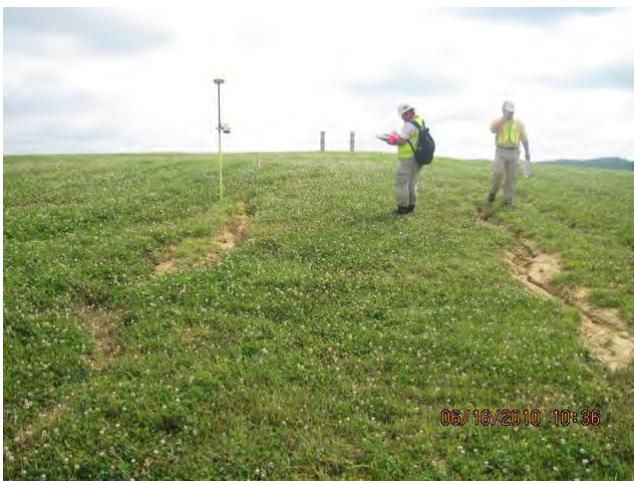
**Photo 3 (TVA Item No. 34)**

Moisture observed in ditch on the northwest corner of the area.

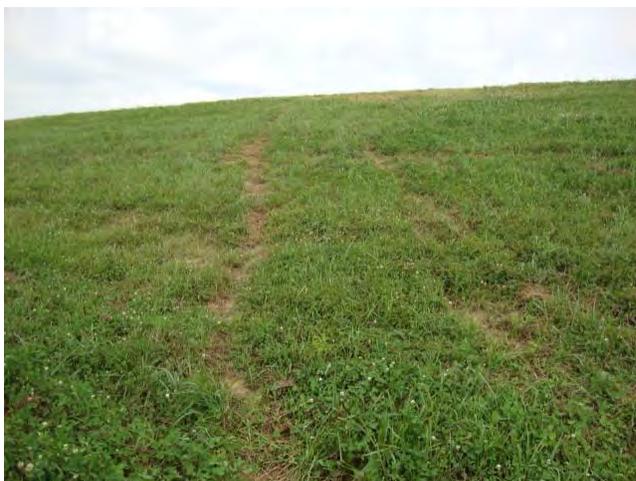
**Photo 6 (TVA Item No. 63)**

Sparse vegetation located on the upper exterior slope on the south side of the area.

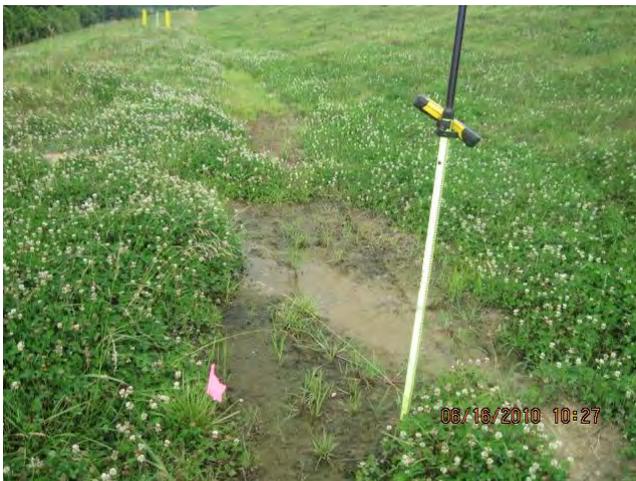
**Photo 11 (TVA Item No. 33)**

Animal burrow located on the upper exterior slope on the north side of the area.

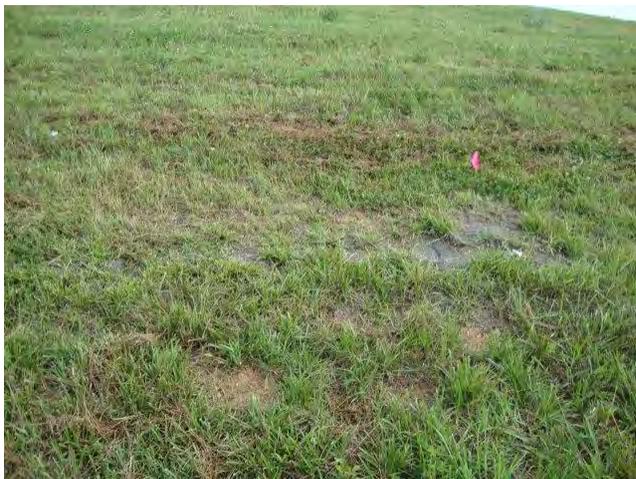
**Photo 12 (TVA Item No. 57)**

Standing water observed on the upper exterior slope on the south side of the area.

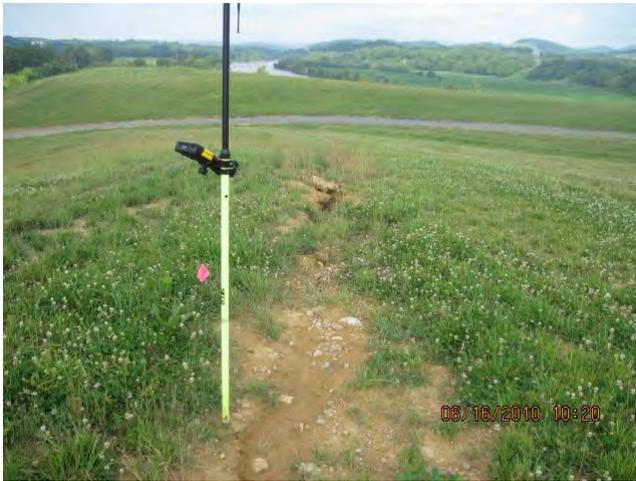
**Photo 16 (TVA Item No. 31)**

Exposed ash observed on the lower exterior slope on the south side of the area.

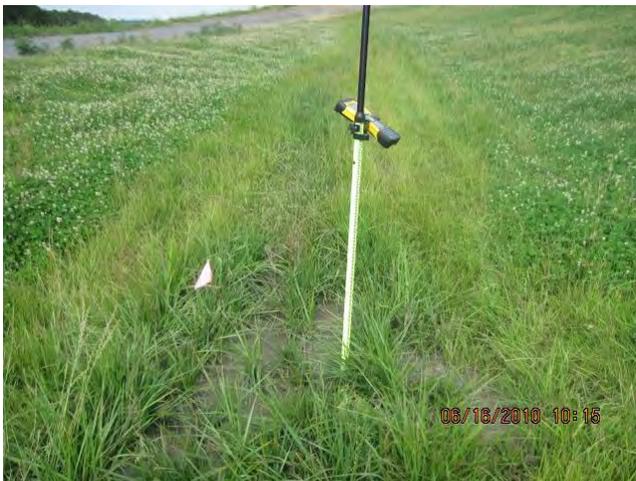
**Photo 17 (TVA Item No. 30)**

Erosion observed on the interior of the area, approximately 200 feet long.

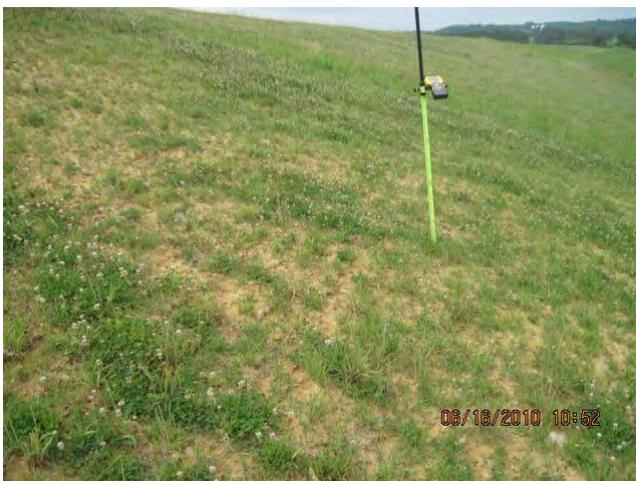
**Photo 18 (TVA Item No. 37)**

Exposed ash in drainage ditch observed on the interior of the area.

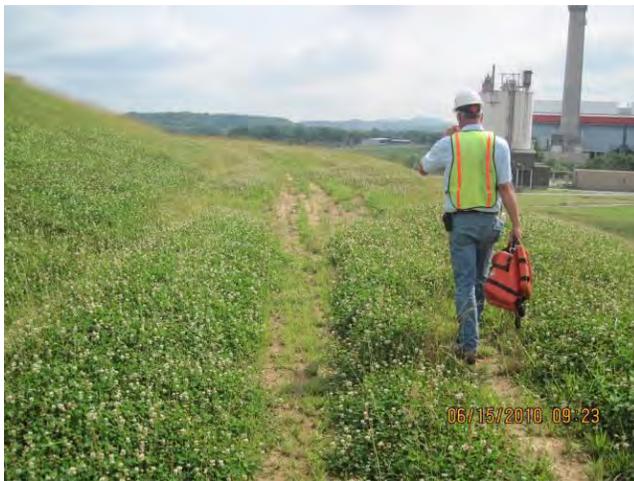
**Photo 26 (TVA Item No. 3)**

Sparse vegetation observed on the upper exterior slope on the east side of the area.

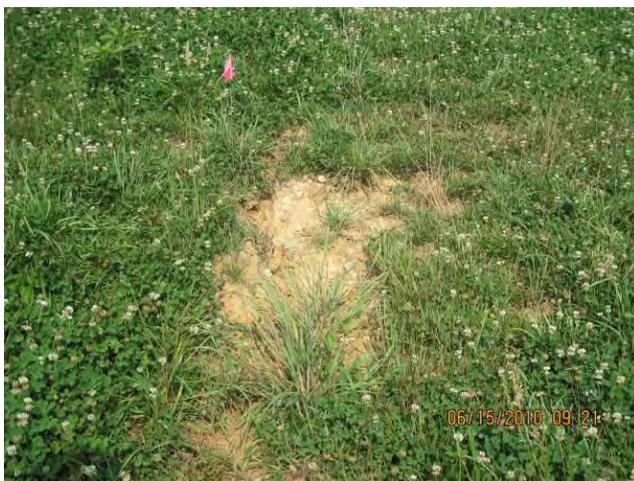
**Photo 27 (TVA Item No. 2)**

Low spot observed on the bench on the east side of the area.

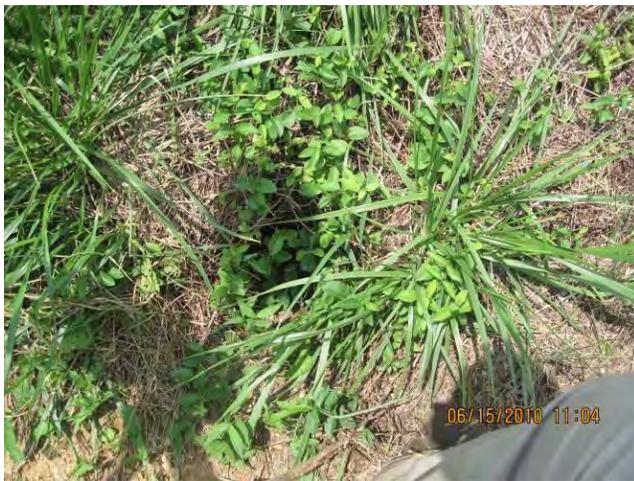
**Photo 14 (TVA Item No. 21)**

Tree and stump observed near the toe on the exterior slope on the northeast side of the pond.

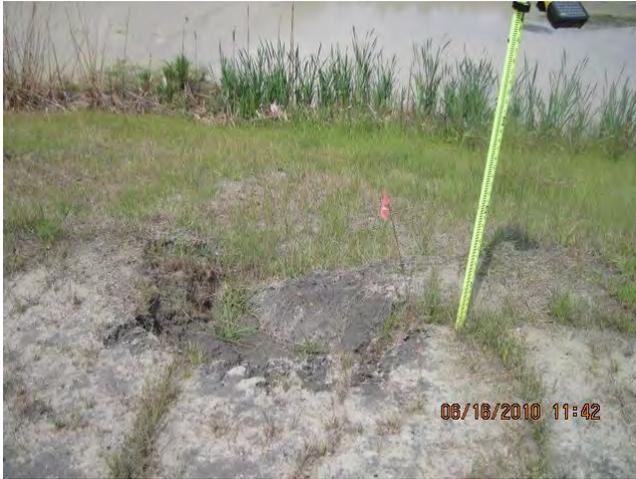
**Photo 22 (TVA Item No. 38)**

Exposed ash observed on the exterior slope on the south side of the pond.

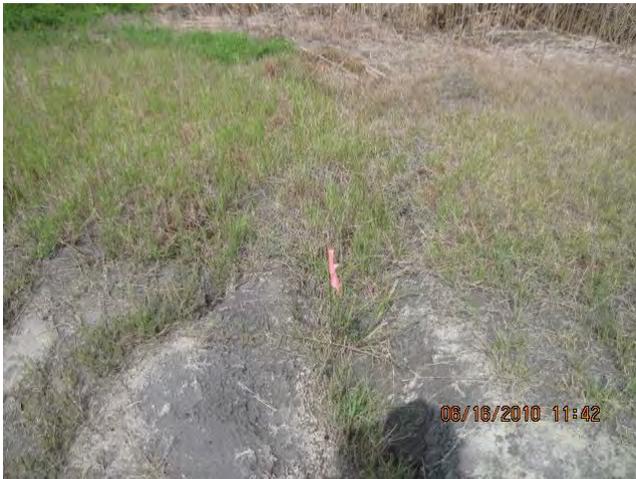
**Photo 23 (TVA Item No. 39)**

Erosion observed on the slope of the interior embankment (divider dike) of the pond.

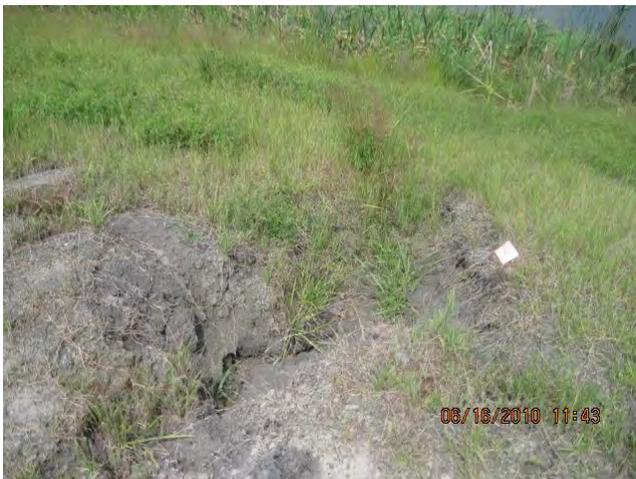
**Photo 24 (TVA Item No. 40)**

Erosion observed on the slope of the interior embankment (divider dike) of the pond.

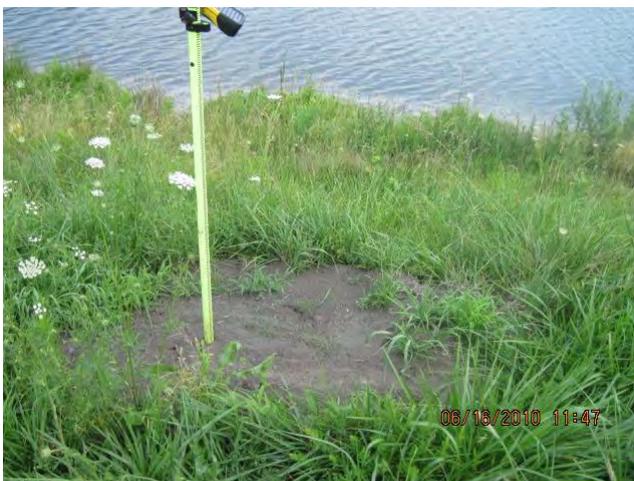
**Photo 27 (TVA Item No. 43)**

Erosion observed on the slope of the interior embankment (divider dike) of the pond.

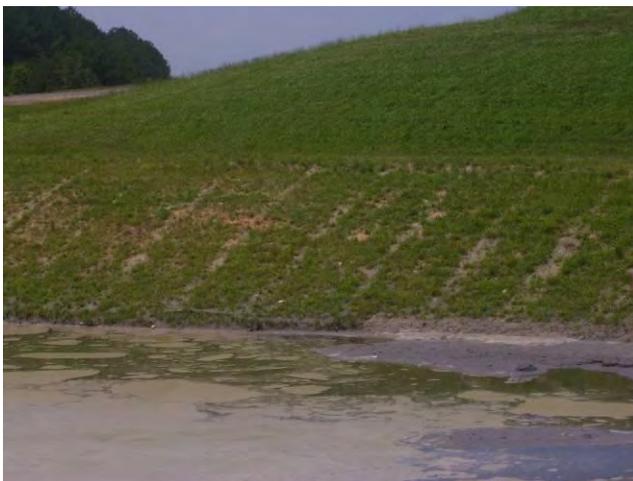
**Photo 3**

Sparse vegetation observed on the interior slope at the southeast corner of the pond.

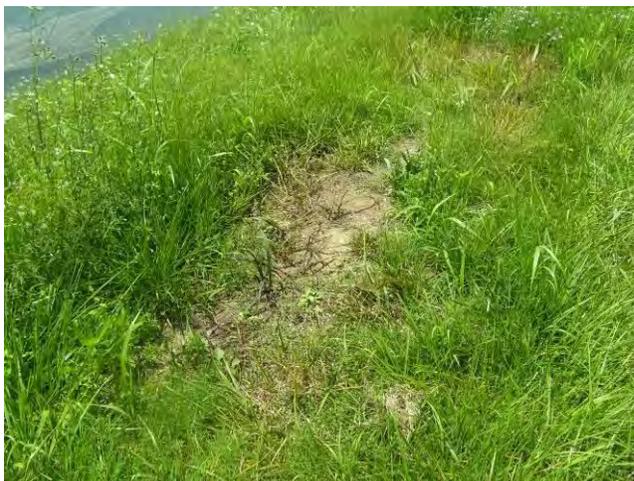
**Photo 3**

Tree stump observed on the east interior slope of the pond.

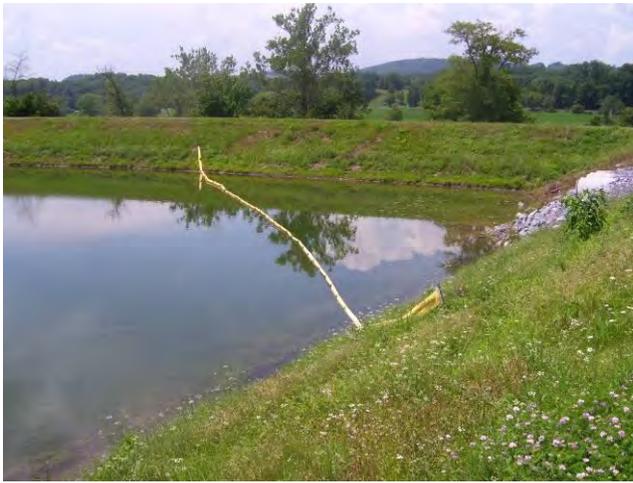
**Photo 4**

Sparse vegetation observed along the east interior slope of the pond.

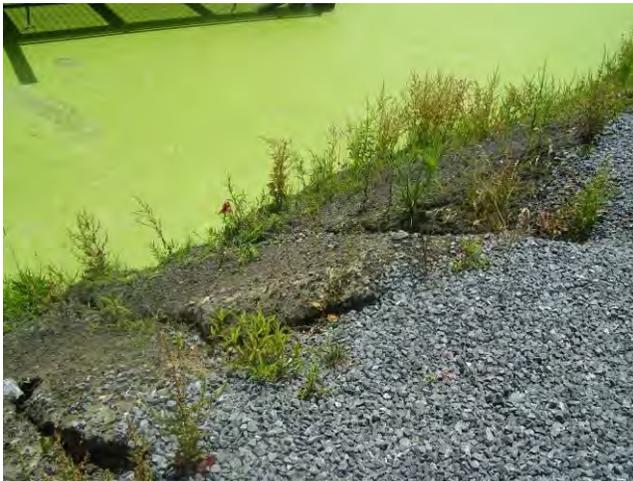
**Photo 2**

Erosion observed at the east end of the interior dike access road that crosses the pond.

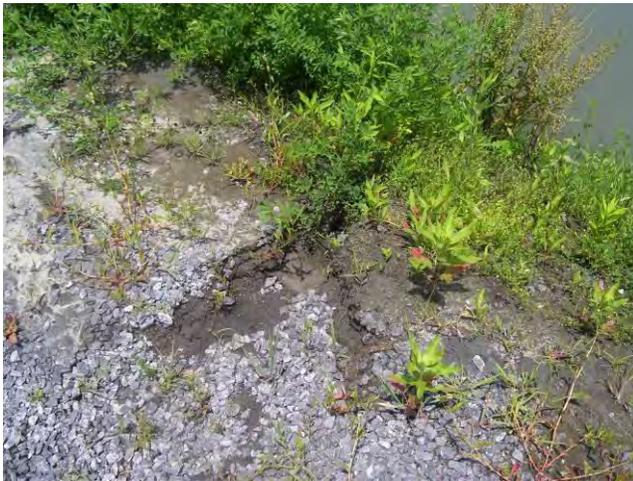
**Photo 5**

Erosion observed along the interior dike access road that crosses the pond.

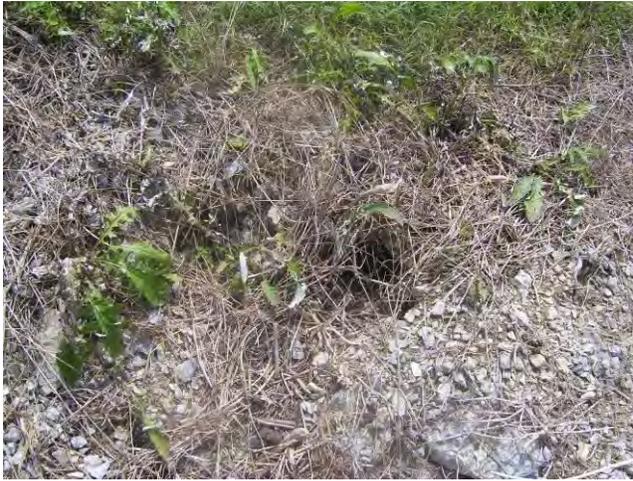
**Photo 4**

Animal burrow observed at the northeast corner of the pond.

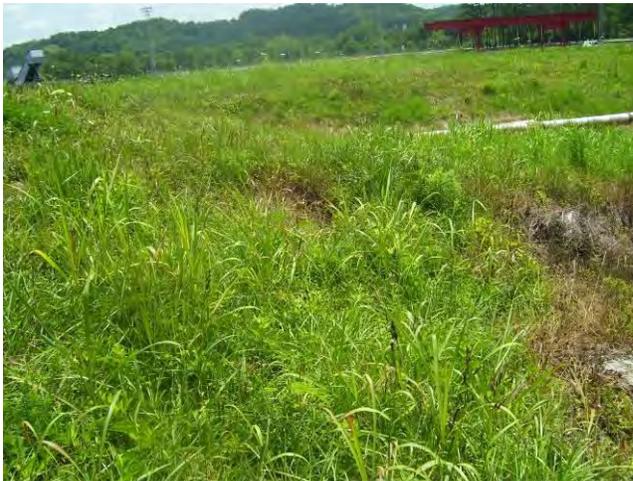
**Photo 5**

Animal burrow observed at the northeast corner of the pond.

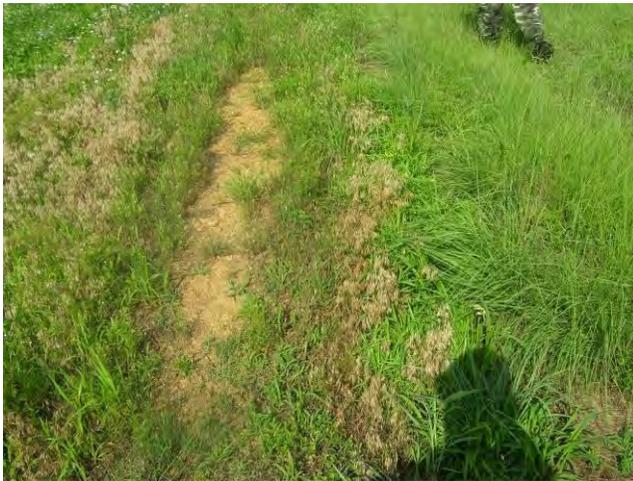
**Photo 14**

Damp area and rutting observed near drainage outlet at the toe of the exterior slope on the south side of the area.

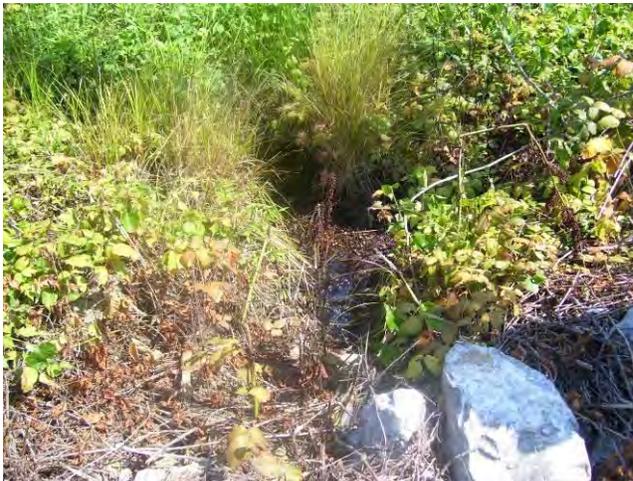
**Photo 20**

Tree stump observed on the north exterior slope of the area.
