**Coal Combustion Residue Impoundment
Round 11 - Dam Assessment Report**

John Sevier Fossil Plant

Ash Basin Dikes

*Tennessee Valley Authority
Rogersville, Tennessee*

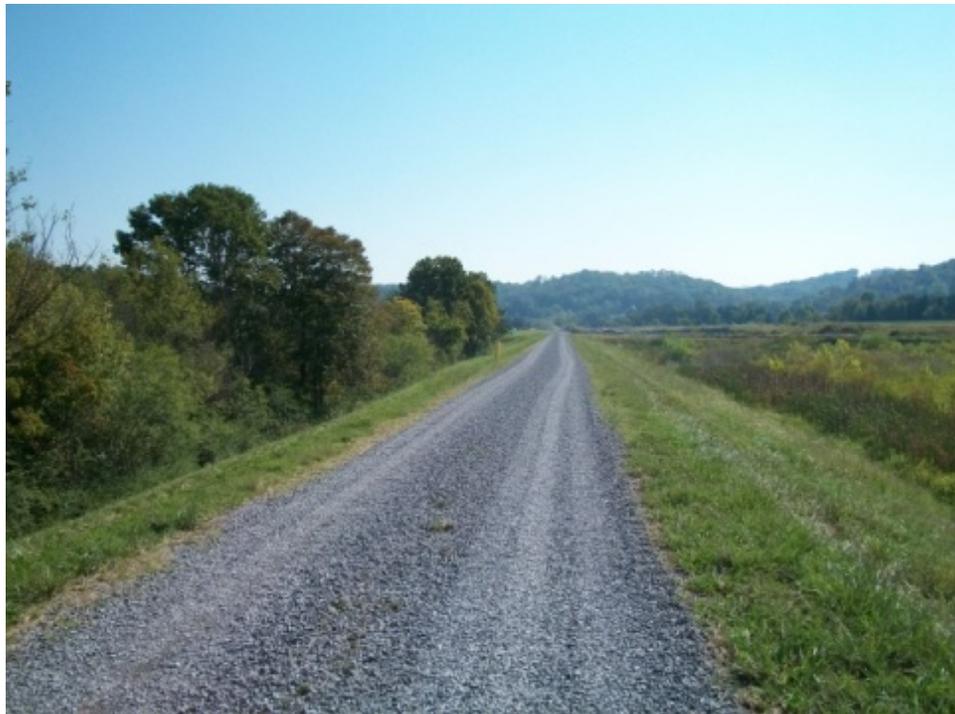
Figure 5.2.1-1 Crest around Bottom Ash Disposal Area 2

Overall, there were no signs of rutting, depressions, tension cracking, or other indications of settlement or shear failure and the crest appeared to be in satisfactory condition (see Figure 5.2.1-1).

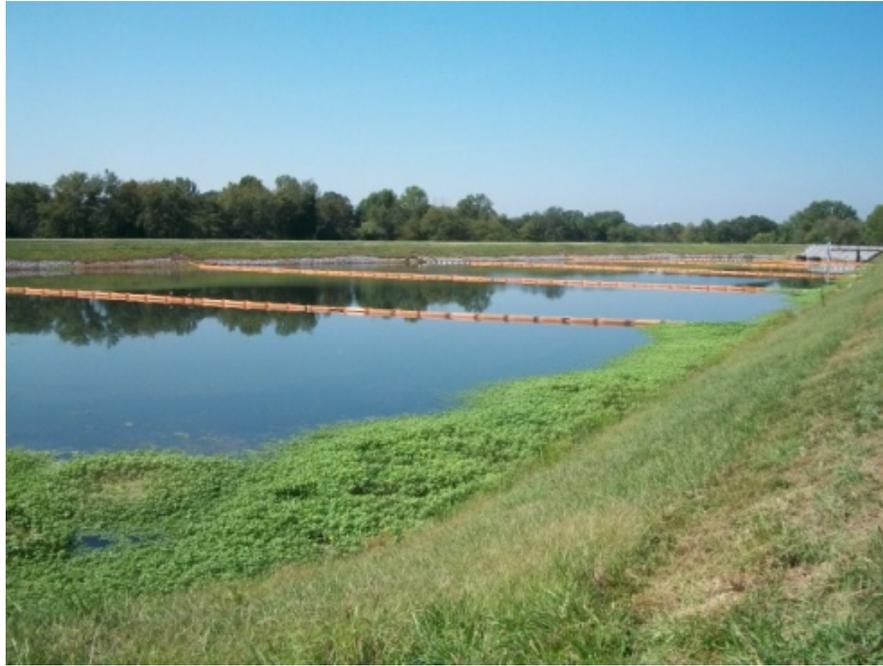
Figure 5.2.2-1 Inside Slope

No scarps, sloughs, depressions, bulging or other indications of slope instability or signs of erosion were observed (see Figure 5.2.2-1).

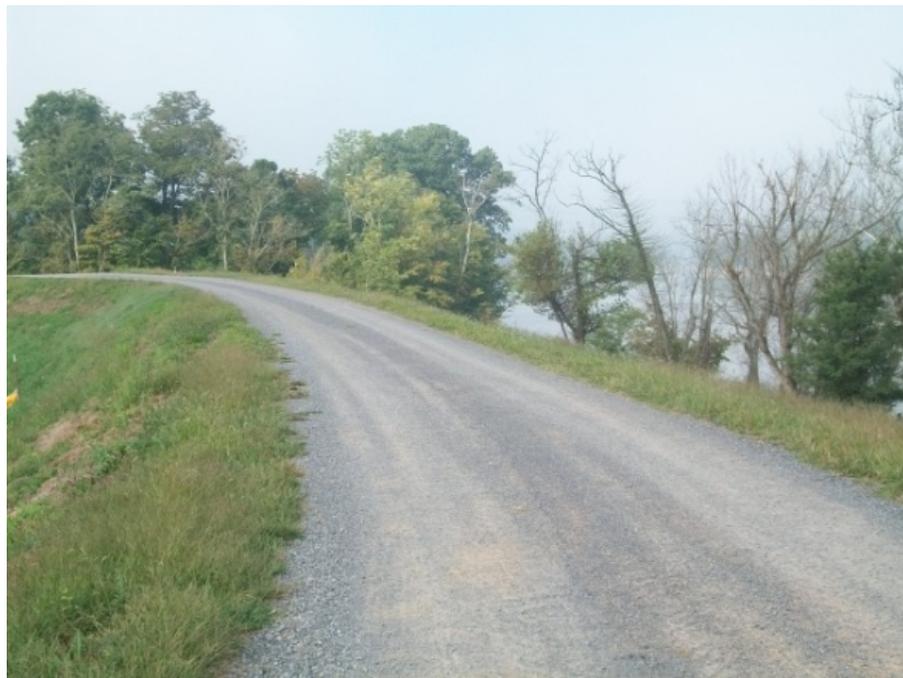
Figure 5.3.1-1 Crest Around Dry Fly Ash Stack

The impoundment crest is gravel covered and used to access the Dry Fly Ash Stack. The crest is designated the Upper Perimeter Road, Overall, there were no signs of rutting, depressions, tension cracking, or other indications of settlement or shear failure and the crest appeared to be in satisfactory condition (see Figure 5.3.1-1).

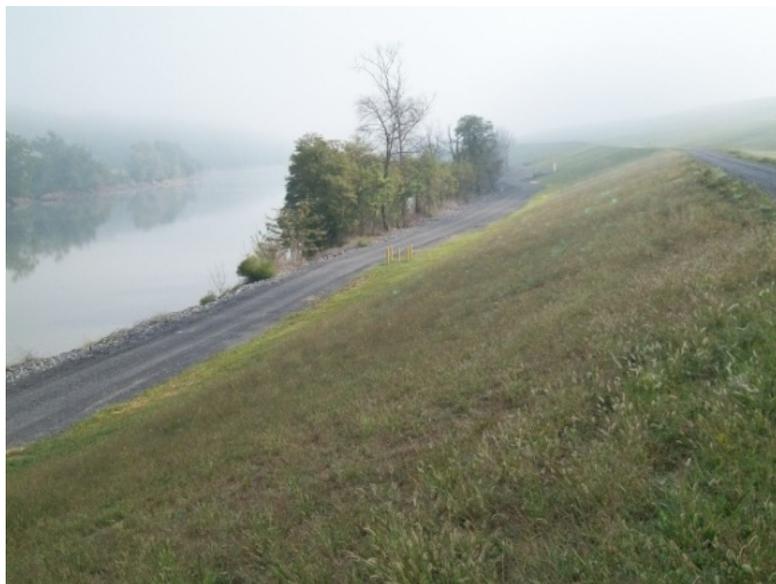
Figure 5.3.3-1 Outside Slope, Dry Fly Ash Stack

No scarps, sloughs, depressions, bulging or other indications of slope instability or signs of erosion were observed (see Figure 5.3.3-1).

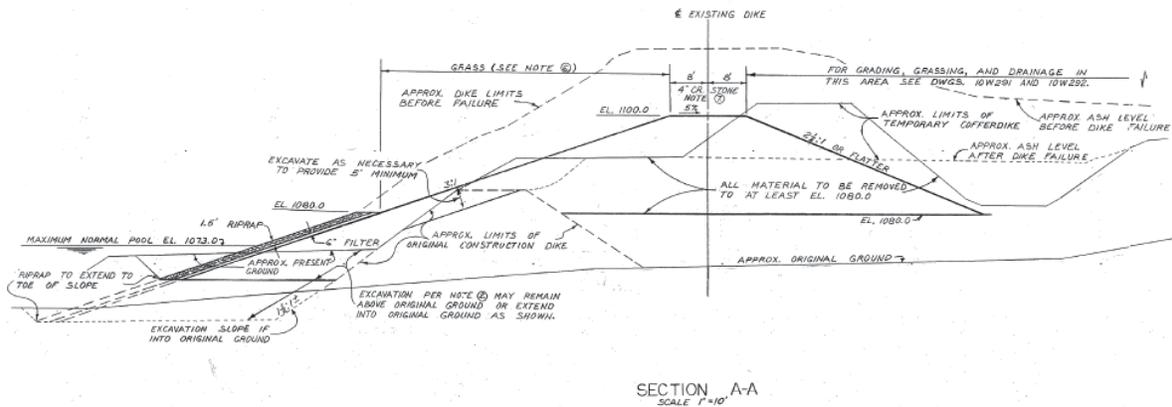
Figure 5. Ash Disposal Area “E” – Dike Repair 1973 (As Built 1975)

Reference No. 2 (listed in Table 1) is a drawing titled “Ash Disposal Area “E” - Dike Repair,” originally dated July, 1973 and signed, “Record Drawing As Constructed” in March, 1975. This drawing, shown in Figure 5, illustrates conditions prior to the May, 1973 dike failure. The break in the northern dike occurred near the divider dike between Areas E and F and was approximately 300 feet long.

The drawing depicts several features not shown in the 1958 typical section (Figure 4). It appears that at least in Area E the original dike was not expanded following the original intended design. The following items provide some insight to the conditions of this area in 1973 and repair work proposed at that time.

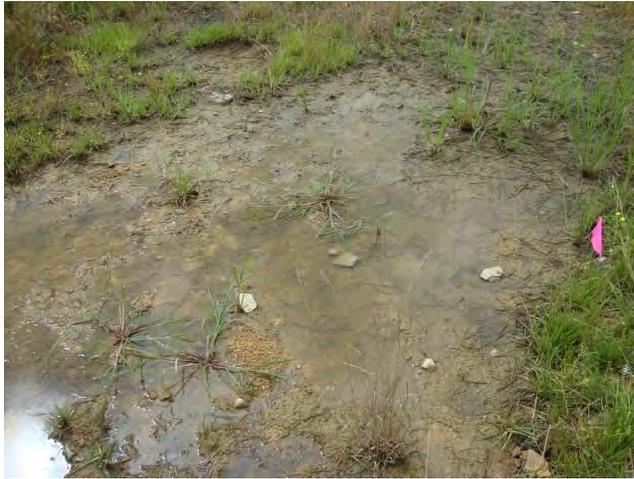
Photo 1 (TVA Item No. 65)

Standing water observed at the west end of the exterior upper slope of the area.

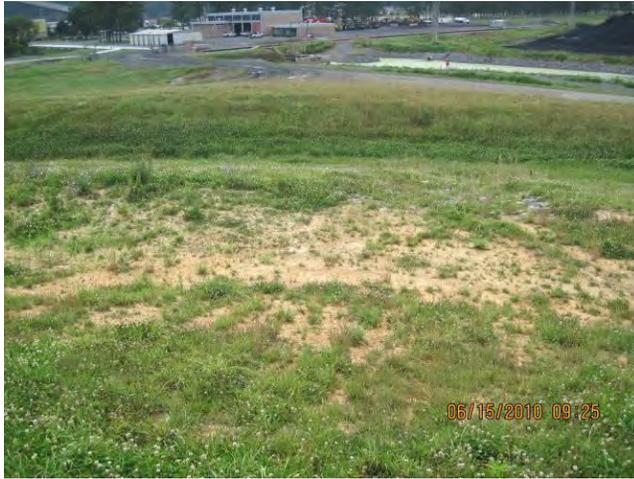
Photo 25 (TVA Item No. 4)

Sparse vegetation observed on the upper exterior slope on the east side of the area.

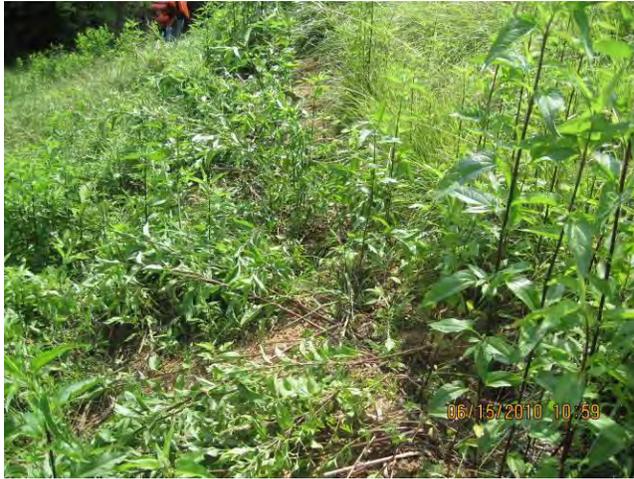
Photo 10 (TVA Item No. 18)

Rutting observed (beginning) near the toe of the exterior slope on the north side of the pond.

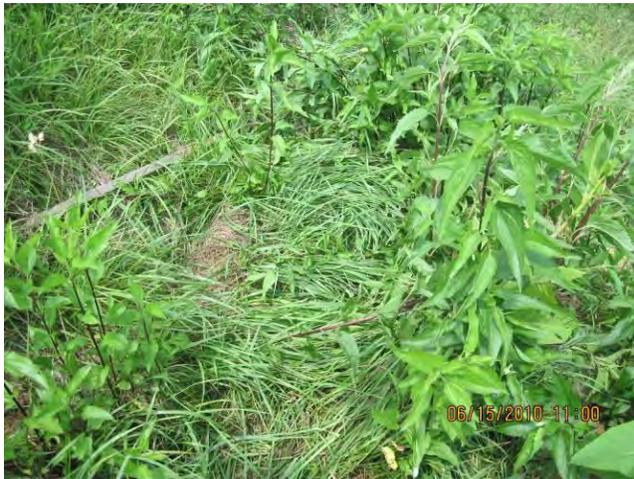
Photo 11 (TVA Item No. 19)

Rutting observed (end) near the toe of the exterior slope on the north side of the pond.

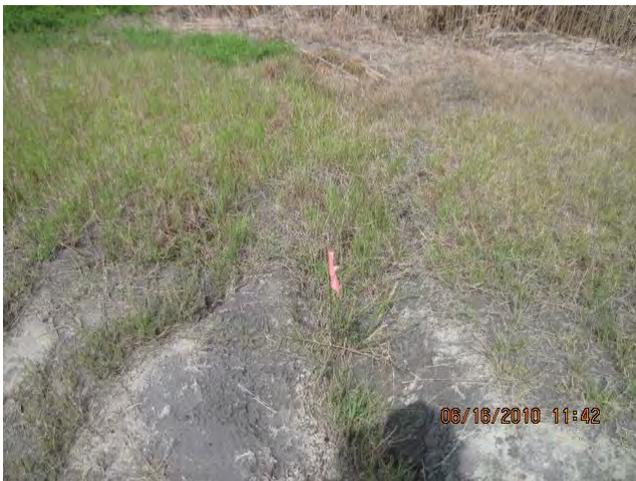
Photo 23 (TVA Item No. 39)

Erosion observed on the slope of the interior embankment (divider dike) of the pond.

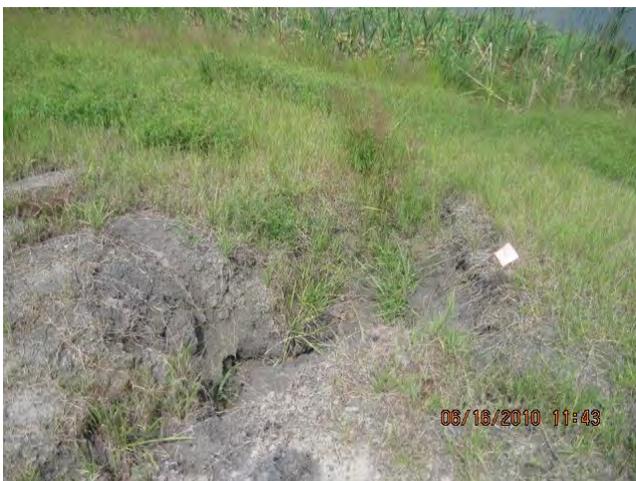
Photo 24 (TVA Item No. 40)

Erosion observed on the slope of the interior embankment (divider dike) of the pond.

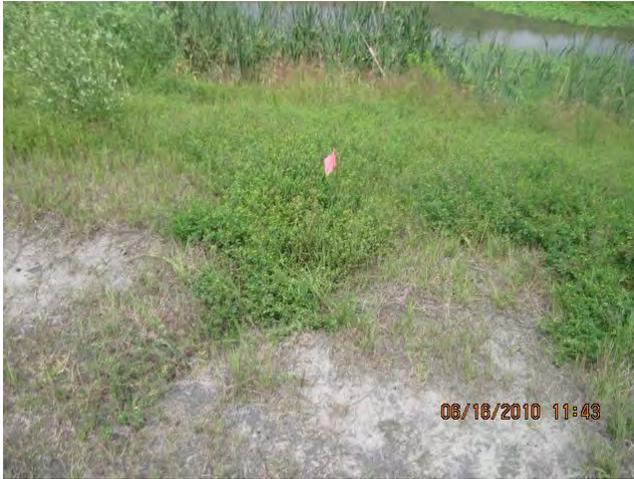
Photo 25 (TVA Item No. 41)

Erosion observed on the slope of the interior embankment (divider dike) of the pond.

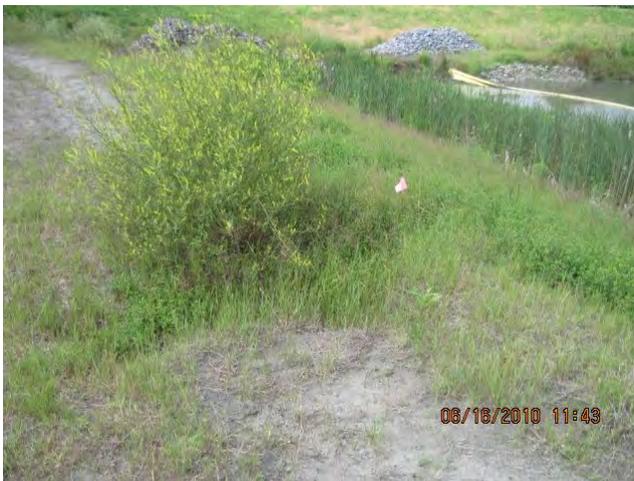
Photo 26 (TVA Item No. 42)

Erosion observed on the slope of the interior embankment (divider dike) of the pond.

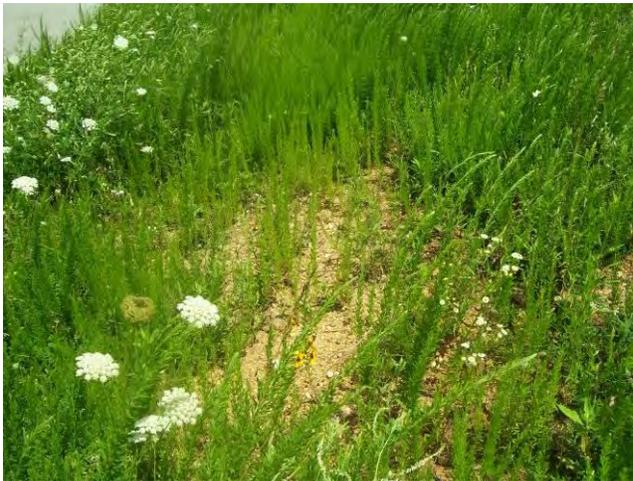
Photo 2

Sparse vegetation observed on the interior slope at the southeast corner of the pond.

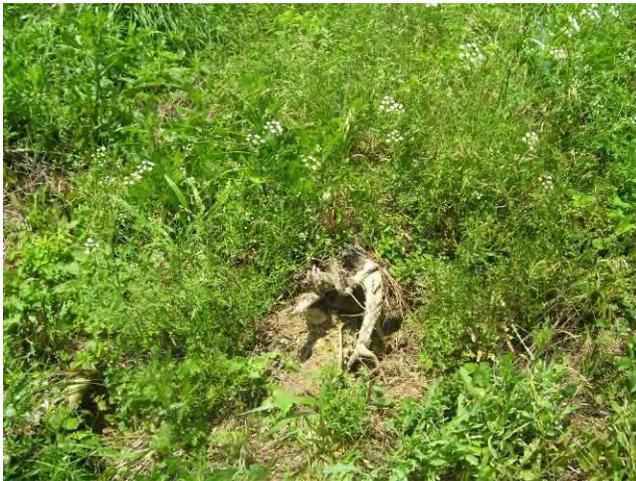
Photo 2

Tree stump observed on the east interior slope of the pond.

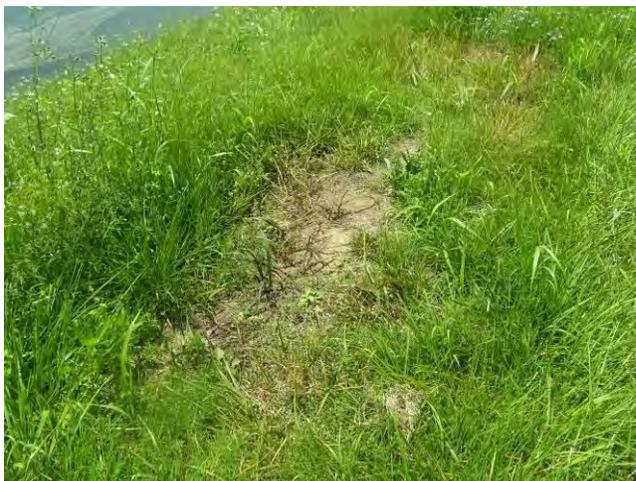
Photo 3

Sparse vegetation observed along the east interior slope of the pond.
