**DRAFT REPORT
ROUND 10 DAM ASSESSMENT – MAY 19, 2011
UGI DEVELOPMENT COMPANY
HUNLOCK CREEK POWER STATION
ASH BASIN 003 (EAST BASIN) & ASH BASIN 005 (WEST BASIN)
HUNLOCK CREEK, PENNSYLVANIA**

**GZA GeoEnvironmental, Inc.
One Edgewater Drive
Norwood, Ma 02062
GZA File No. 01.0170142.30**

March 9, 2012
GZA File No. 170142.30

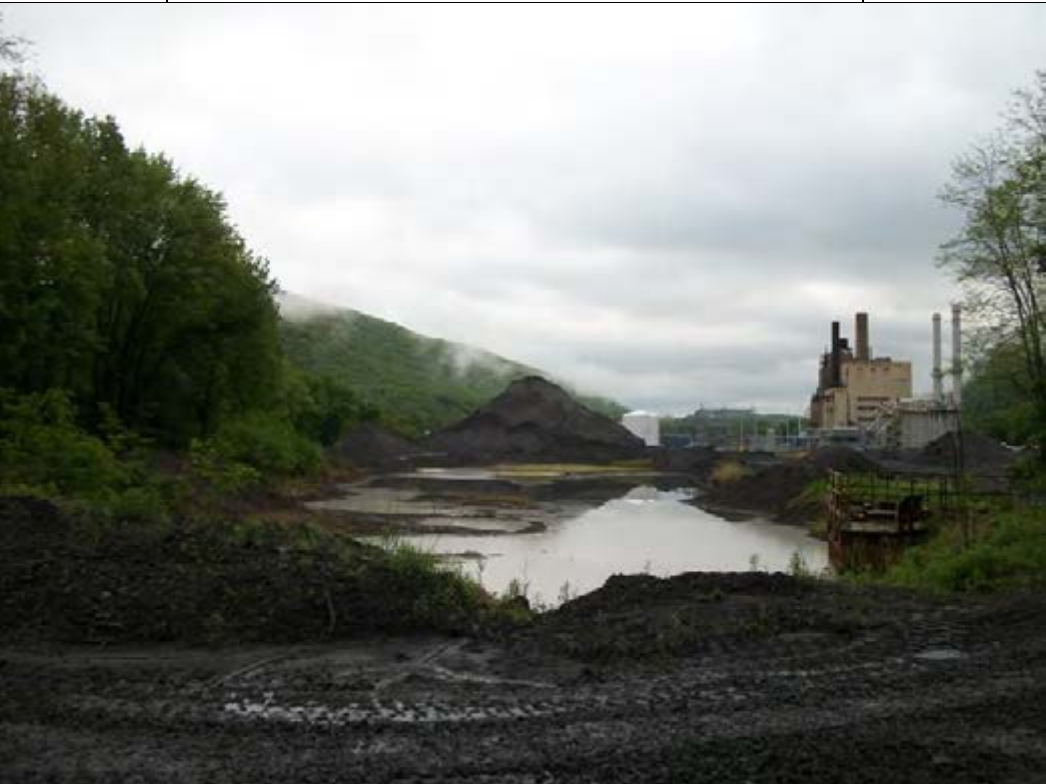
Client Name: U.S. Environmental Protection Agency		Site Location: Hunlock Creek Station, Hunlock Creek, PA	Project No. 170142.30
Photo No. 1	Date: 5/19/2011

Direction Photo Taken: Northeasterly			
Description: Overview of the West Basin from south end near the downstream outlet. Note outlet structure at right side of picture (foreground).

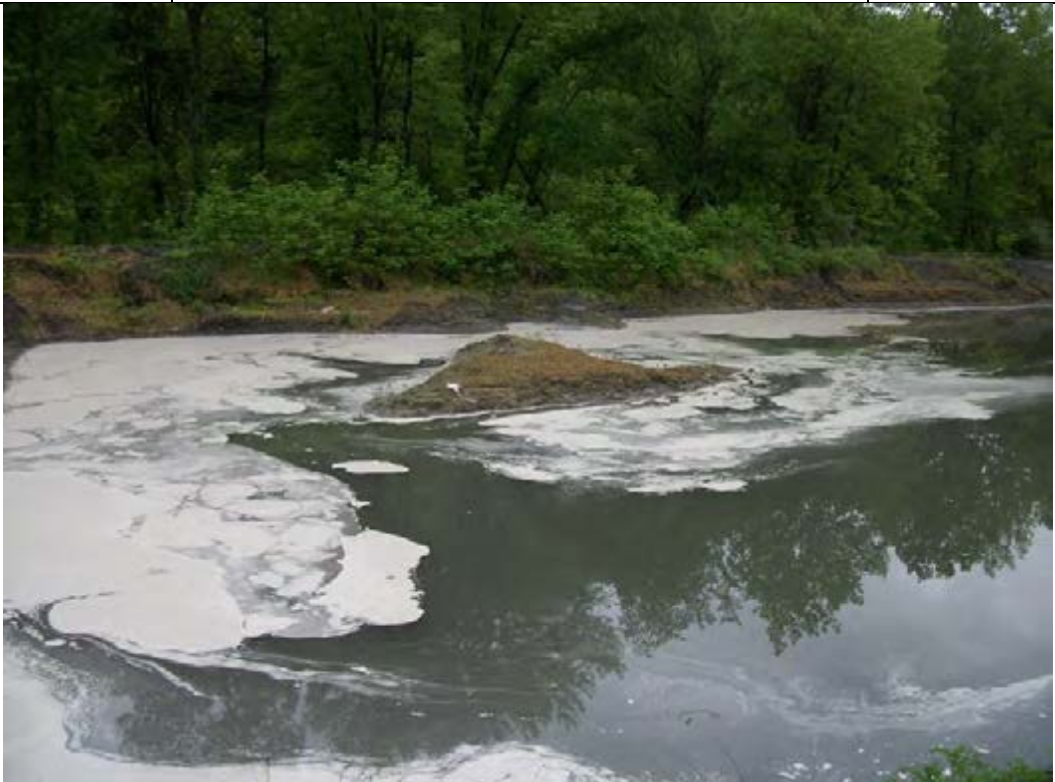
Client Name: U.S. Environmental Protection Agency		Site Location: Hunlock Creek Station, Hunlock Creek, PA	Project No. 170142.30
Photo No. 3	Date: 5/19/2011

Direction Photo Taken: Northerly			
Description: View of West Basin impoundment. Note heavily vegetated, uneven, partially eroded upstream slope.

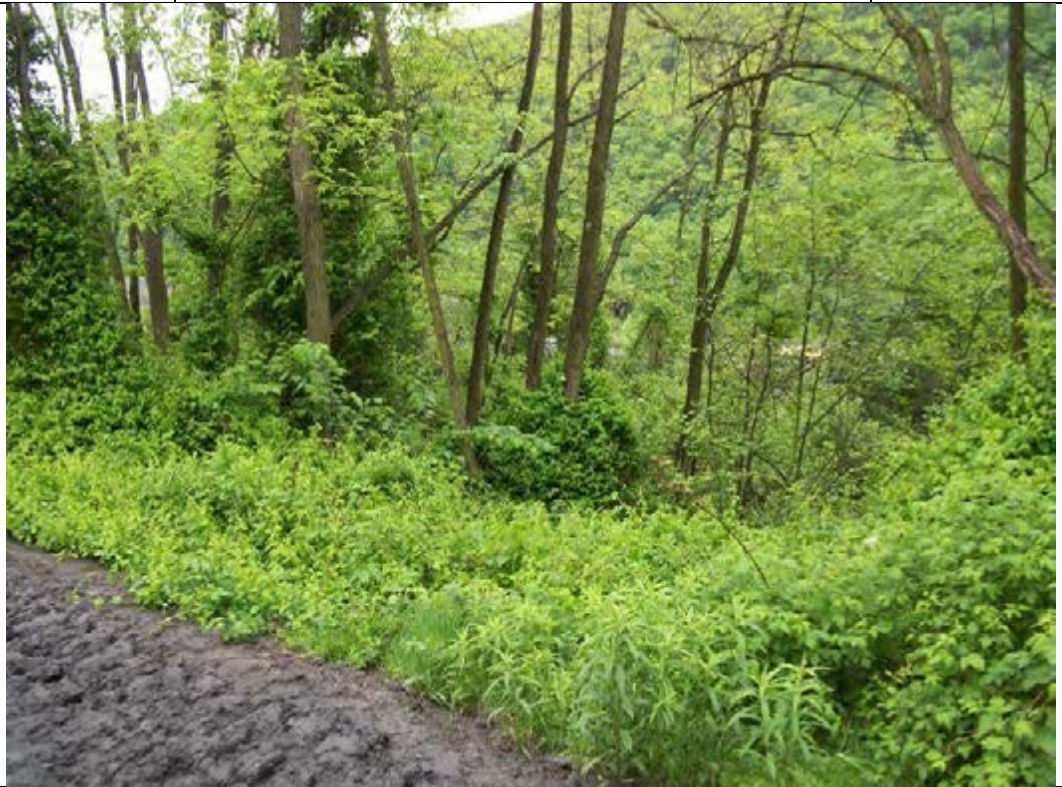
Downstream slope opposite outlet structure at the West Basin. Note dense trees and heavily overgrown vegetation on slope.

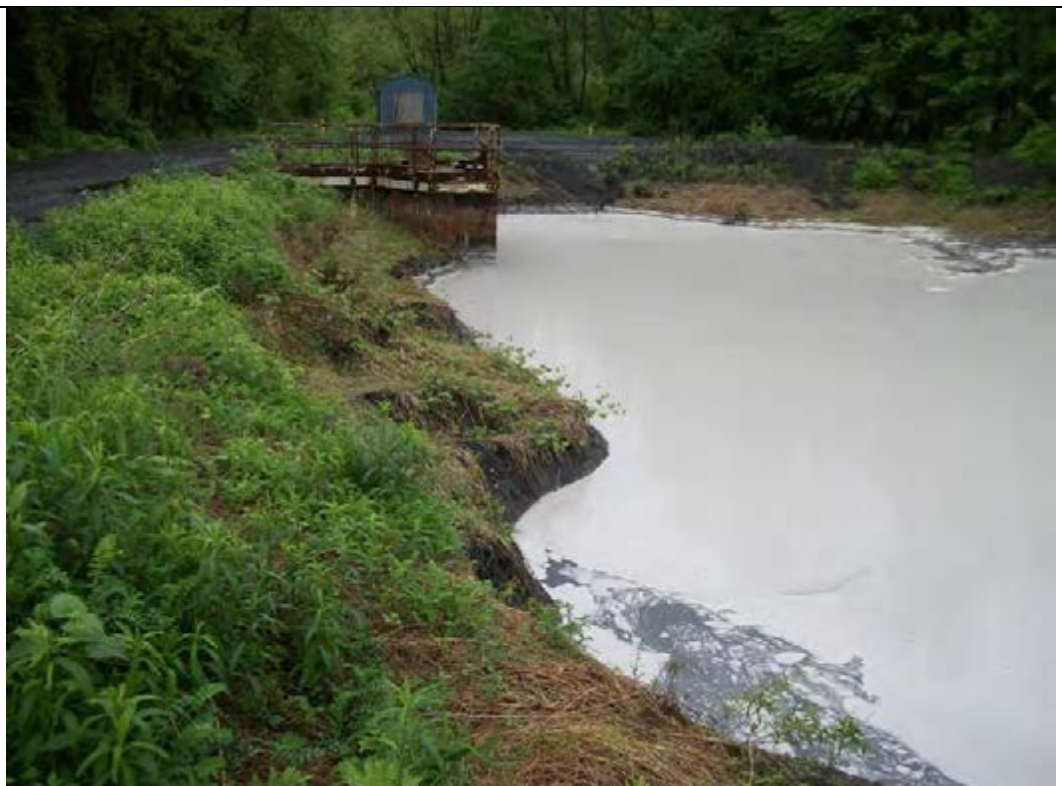
The West basin decant outflow structure was generally in poor condition. Heavy corrosion was observed along the sheeting and hand rails. Operation of the stoplogs was not performed during the inspection.

West Basin decant outlet structure from crest of embankment. Note water in pond is surface/storm water runoff accumulated from prior week's heavy rainfall.

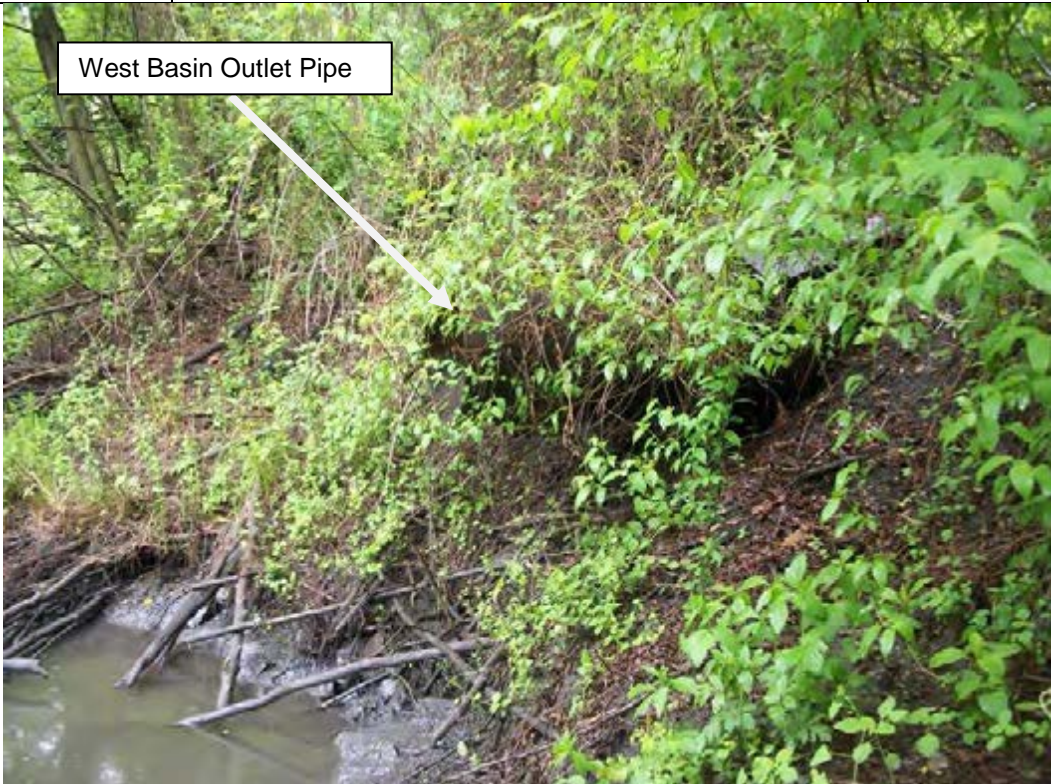
Client Name: U.S. Environmental Protection Agency		Site Location: Hunlock Creek Station, Hunlock Creek, PA	Project No. 170142.30
Photo No. 7	Date: 5/19/2011

Direction Photo Taken: Westerly			
Description: View of approximately 18-inch diameter outlet pipe from the West Basin decant outlet structure. Arrow points to pipe outfall.

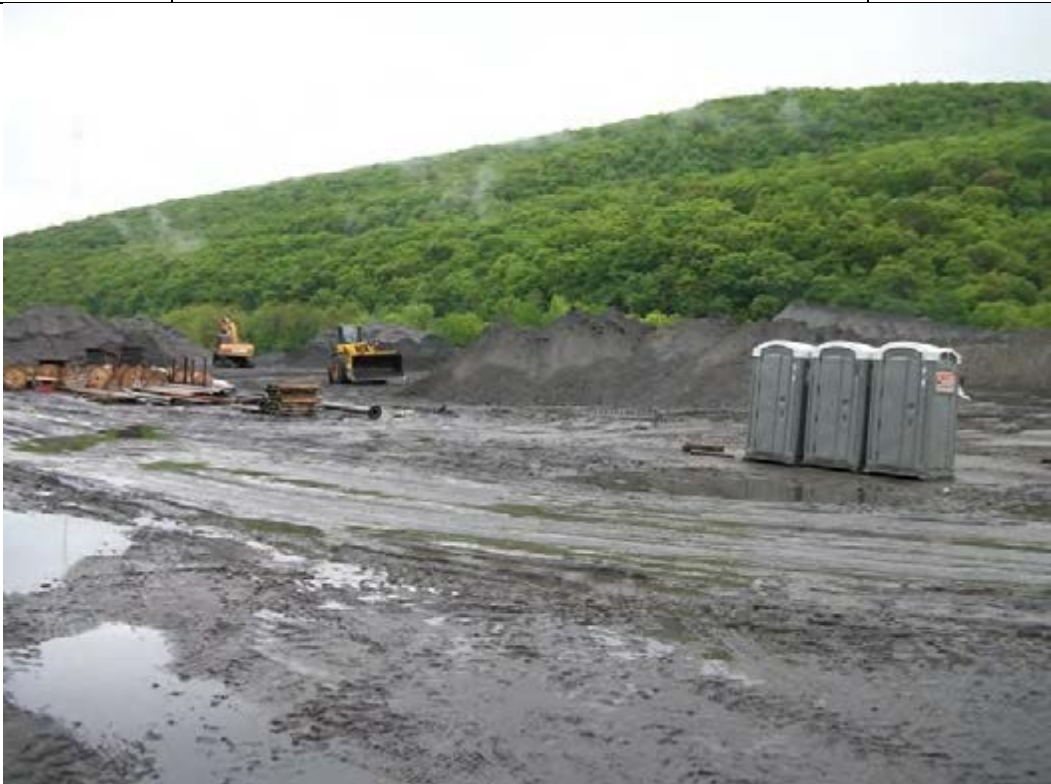
Client Name: U.S. Environmental Protection Agency		Site Location: Hunlock Creek Station, Hunlock Creek, PA	Project No. 170142.30
Photo No. 9	Date: 5/19/2011

Direction Photo Taken: Northwesterly			
Description: Overview of filled in portions of the East and West Basins. Note ash waste (previously sluiced/deposited when plant was active) is currently in the process of being excavated and disposed off-site as part of the decommissioning process.

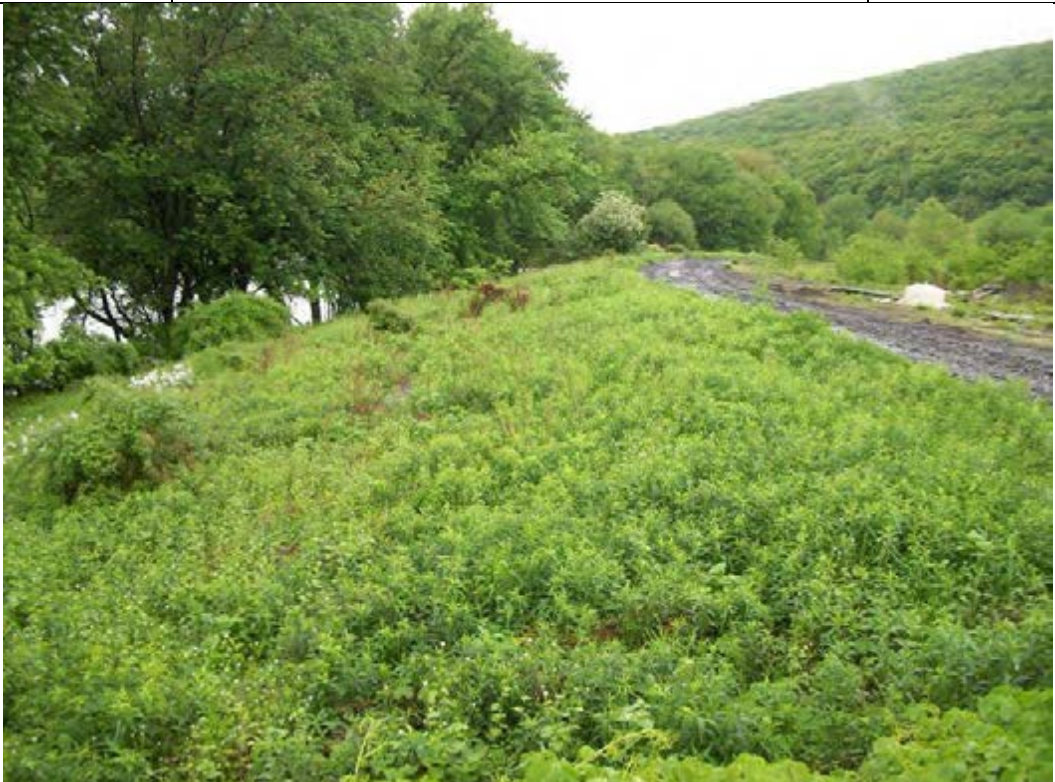
Client Name: U.S. Environmental Protection Agency		Site Location: Hunlock Creek Station, Hunlock Creek, PA	Project No. 170142.30
Photo No. 11	Date: 5/19/2011

Direction Photo Taken: Westerly			
Description: Downstream embankment along east slope at the East Basin. Note the Susquehanna River just beyond the tree line near the toe of dam. Portions of embankment along this side appear to tie into natural grades prior to meeting river.

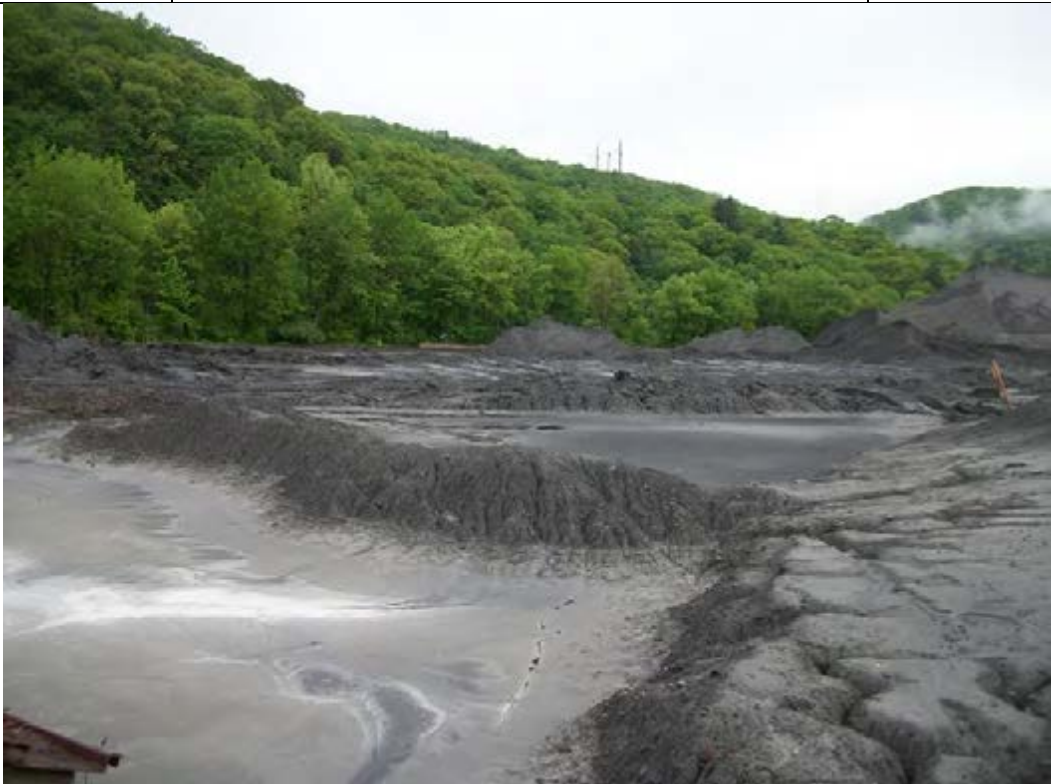
Client Name: U.S. Environmental Protection Agency		Site Location: Hunlock Creek Station, Hunlock Creek, PA	Project No. 170142.30
Photo No. 13	Date: 5/19/2011

Direction Photo Taken: Northeasterly			
Description: View of East Basin just northeast of the East Basin outlet structure. Ash waste in this area will be excavated and disposed offsite as part of the decommissioning process.

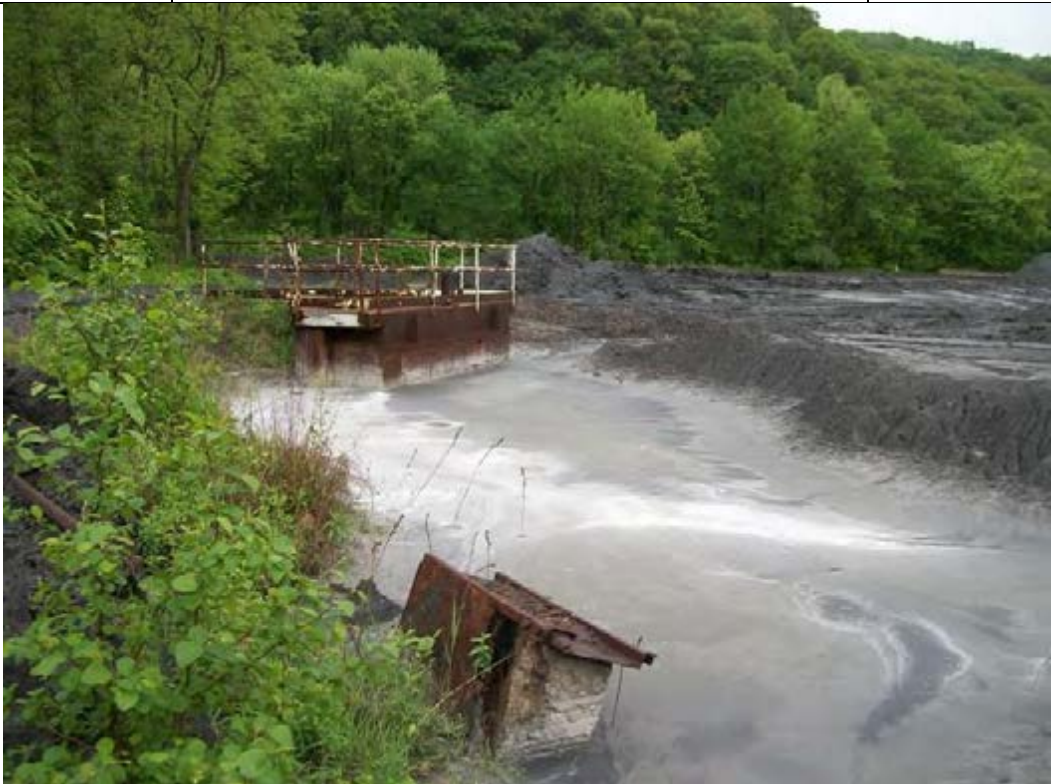
Client Name: U.S. Environmental Protection Agency		Site Location: Hunlock Creek Station, Hunlock Creek, PA	Project No. 170142.30
Photo No. 15	Date: 5/19/2011

The East Basin Decant outflow structure was generally in poor condition. The weir intake structure was almost completely silted in. Heavy corrosion was observed along the sheeting and hand rails. Rails were separated from the stanchions at some places. Operation of the stoplogs was not performed during the inspection.

Direction Photo Taken: Northwesterly			
Description: View of East Basin Decant Outlet Structure from crest of East Basin embankment. Note water in pond is surface/storm water runoff accumulated from prior week's heavy rainfall.

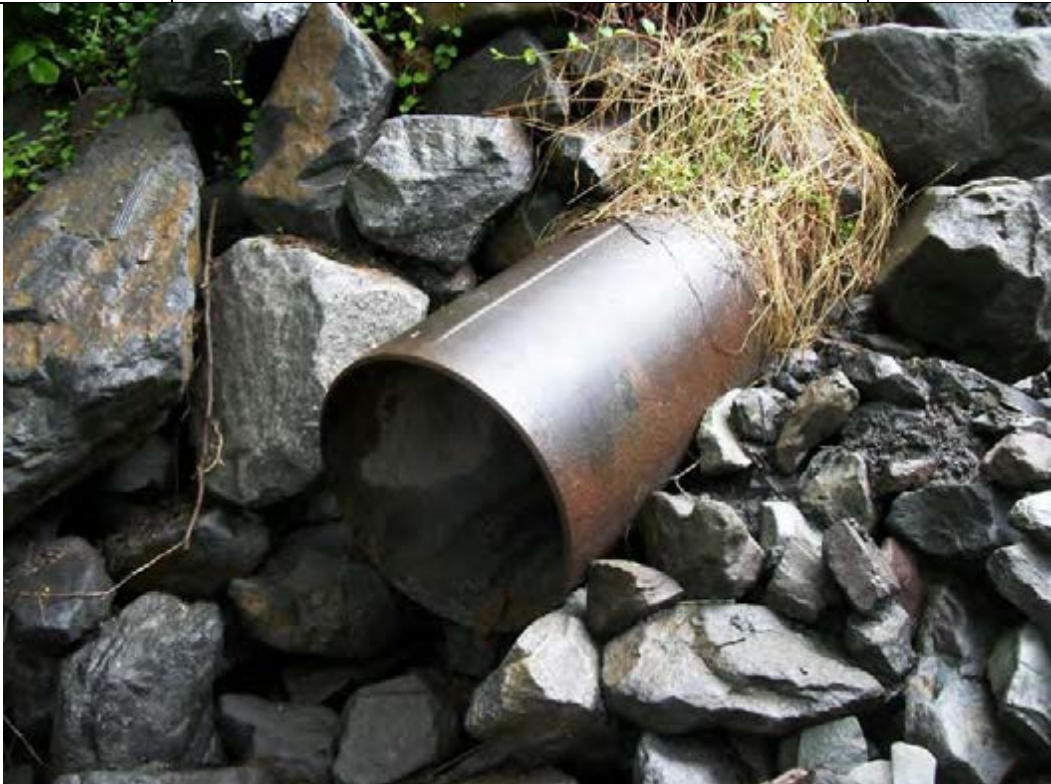
Client Name: U.S. Environmental Protection Agency		Site Location: Hunlock Creek Station, Hunlock Creek, PA	Project No. 170142.30
Photo No. 17	Date: 5/19/2011

Direction Photo Taken: Northeasterly			
Description: Approximately 18 to 20-inch diameter decant structure steel outlet pipe from the East Basin.

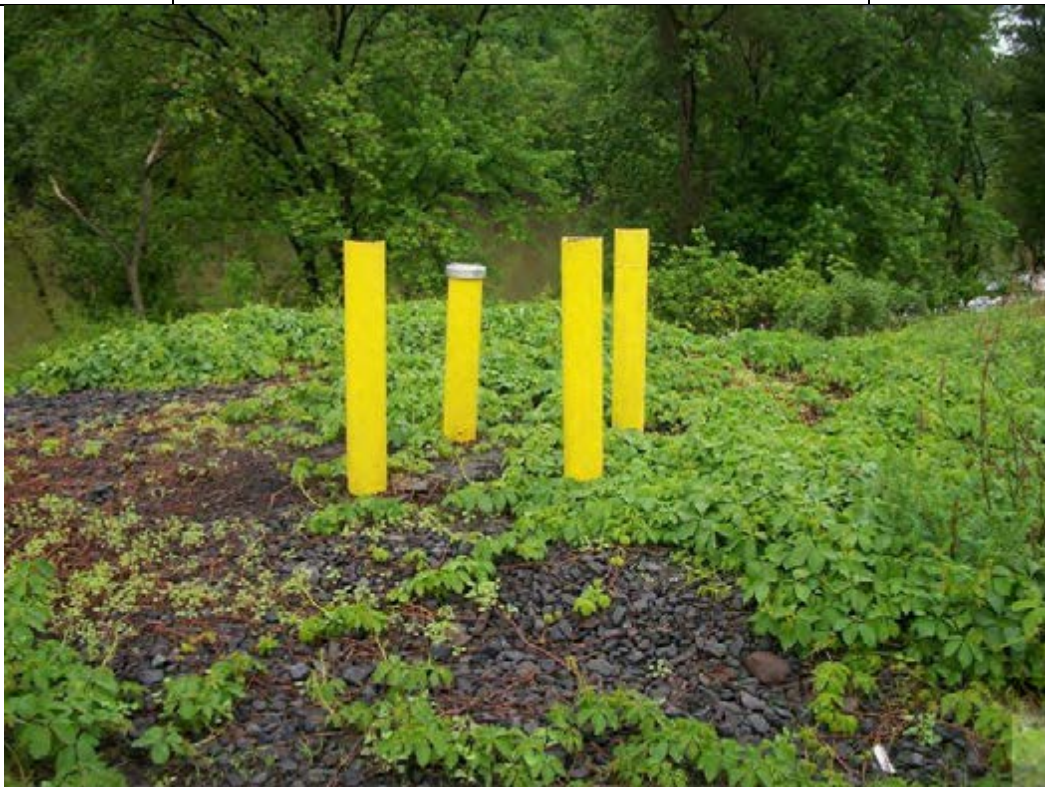
View of water quality monitoring well on the crest of the East Basin embankment. Note the Susquehanna River in the background.

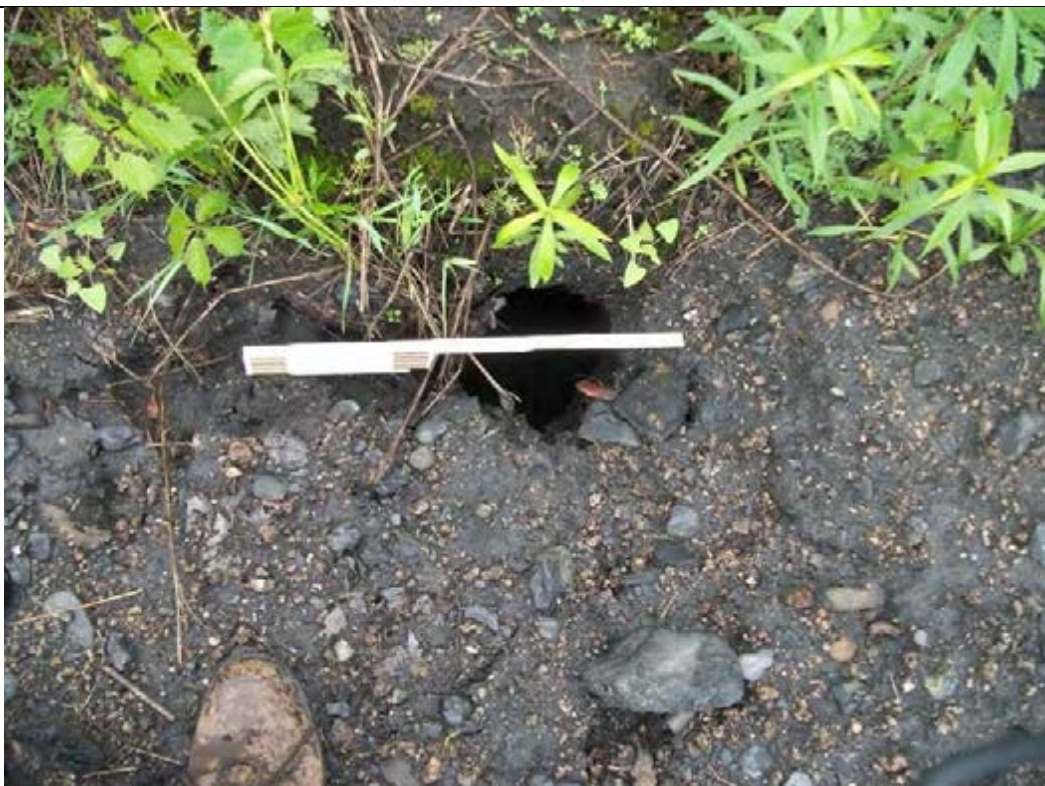
observed at the embankment crest and downstream slope above (former) normal pool elevation.

Animal burrow observed on the downstream slope of the East Basin embankment.

1. Fill ruts and animal burrows.
2. Record and maintain monthly measurements of the pond water surface elevation and observation wells and establish response action protocols for various elevation levels as appropriate.
3. Monitor and repair sloughing at the upstream slope at the West Basin and at the East Basin decant structure outlet pipe.
4. Clear inappropriate woody vegetation, including trees and brush and maintain grass cover on the downstream slope and toe area approximately 15 feet beyond. The USACE recommends vegetation be kept less than 12 inches in height on embankments.
5. Monitor decant outflow structures and clear silt or debris which may block or impede outflow.
6. Remove stoplogs from the weir intake at each decant outlet structure so that the normal water level in the impoundment cannot rise above elevation 531.8 feet.
