**FINAL REPORT  
ROUND 10 DAM ASSESSMENT  
UGI DEVELOPMENT COMPANY  
HUNLOCK CREEK POWER STATION  
ASH BASIN 003 (EAST BASIN) & ASH BASIN 005 (WEST BASIN)  
HUNLOCK CREEK, PENNSYLVANIA**

**AUGUST 17, 2012**

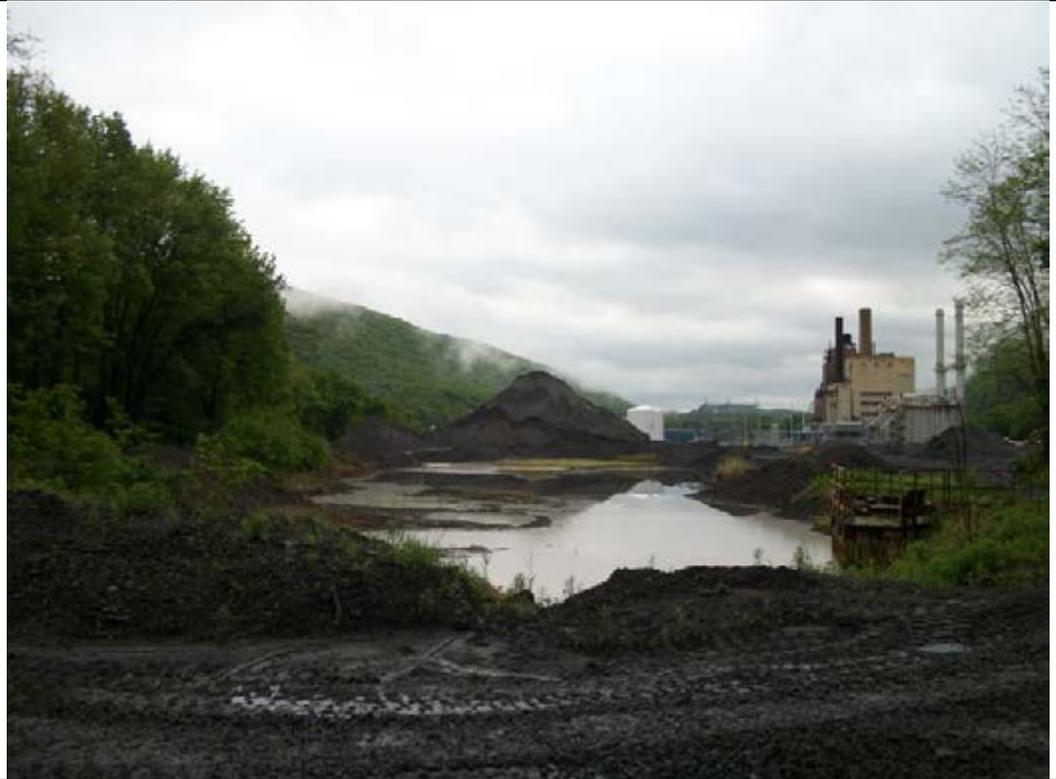
**Description:**  
Overview of the West Basin from south end near the downstream outlet. Note outlet structure at right side of picture (foreground).

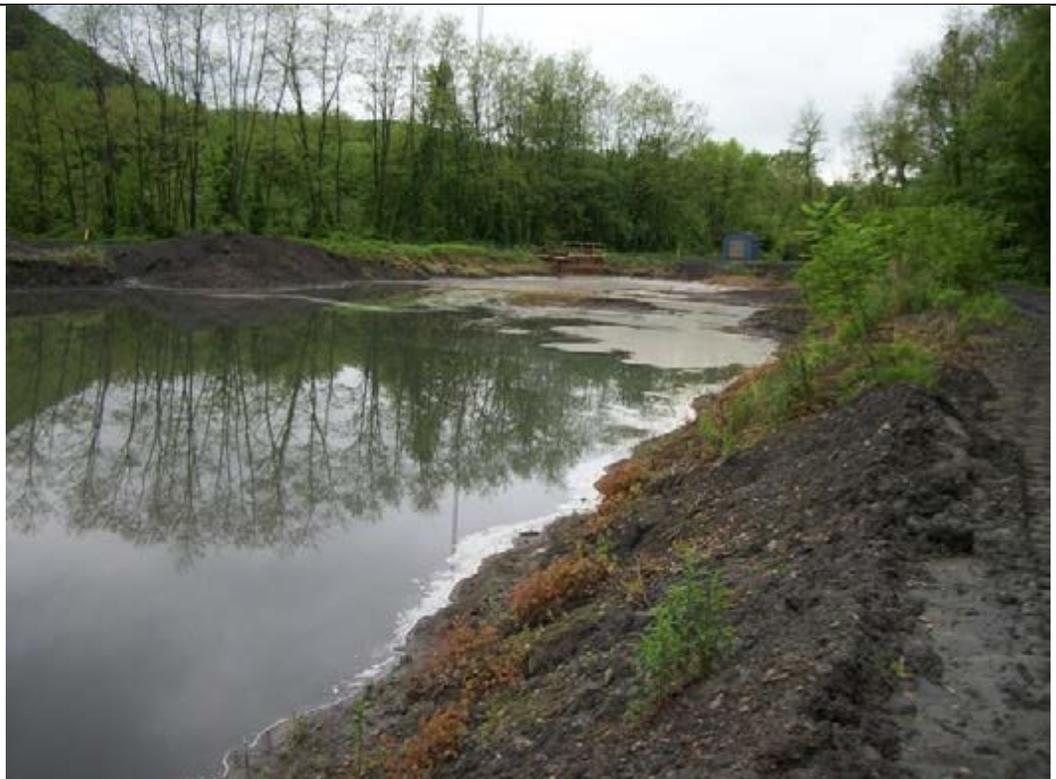
**Photo No.**  
2      **Date:**  
5/19/2011

**Description:**  
View of West Basin pond and outlet structure from embankment crest on northern side.

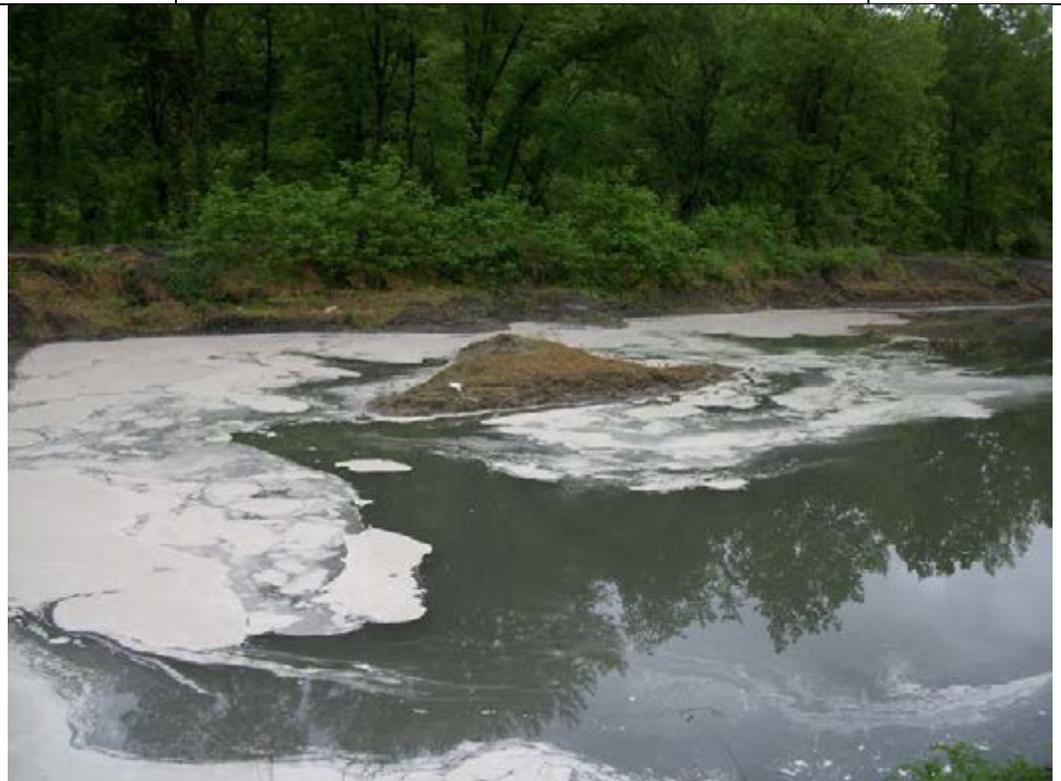
Scarps were observed on the inside slopes near the water line, causing vertical benching along much of the inside slope.

**Description:**  
View of West Basin impoundment. Note heavily vegetated, uneven, partially eroded upstream slope.

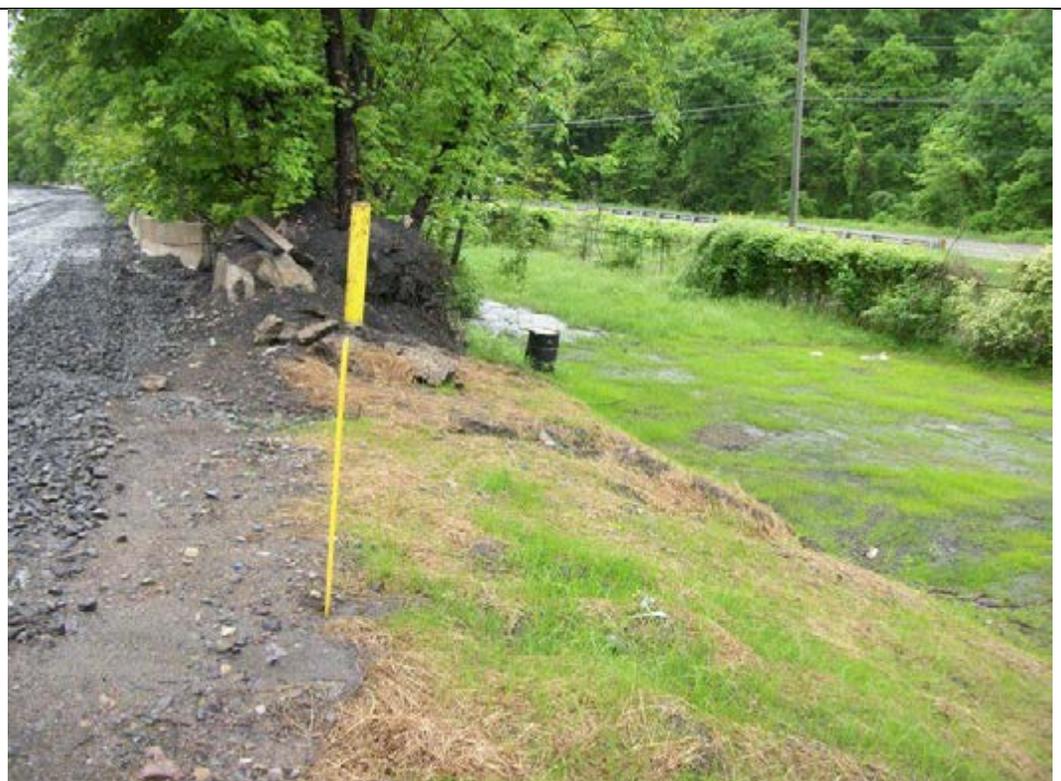
<b>Photo No.</b> 4	<b>Date:</b> 5/19/2011
-----------------------	---------------------------

The downstream embankment at the north side of the West Basin had heavy tree cover (including trees greater than 18 inches diameter). Slopes were observed to be oversteep, on average approximately 1.5H:1V (which apparently is steeper than called for on the original design drawings) and mostly exposed earth with no grass cover.

**Description:**  
View of downstream side of embankment from crest at the northeastern end of the West Basin impoundment. Note channel between embankment and roadway was reportedly a former canal.

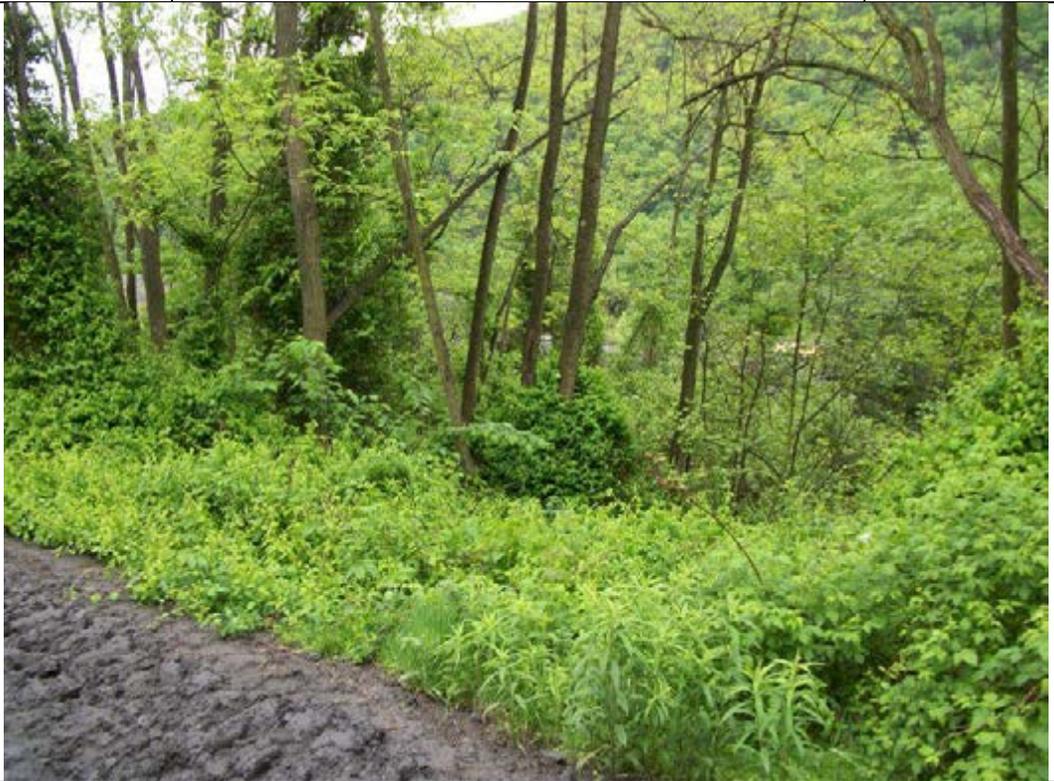
**Description:**  
Downstream slope opposite outlet structure at the West Basin. Note dense trees and heavily overgrown vegetation on slope.

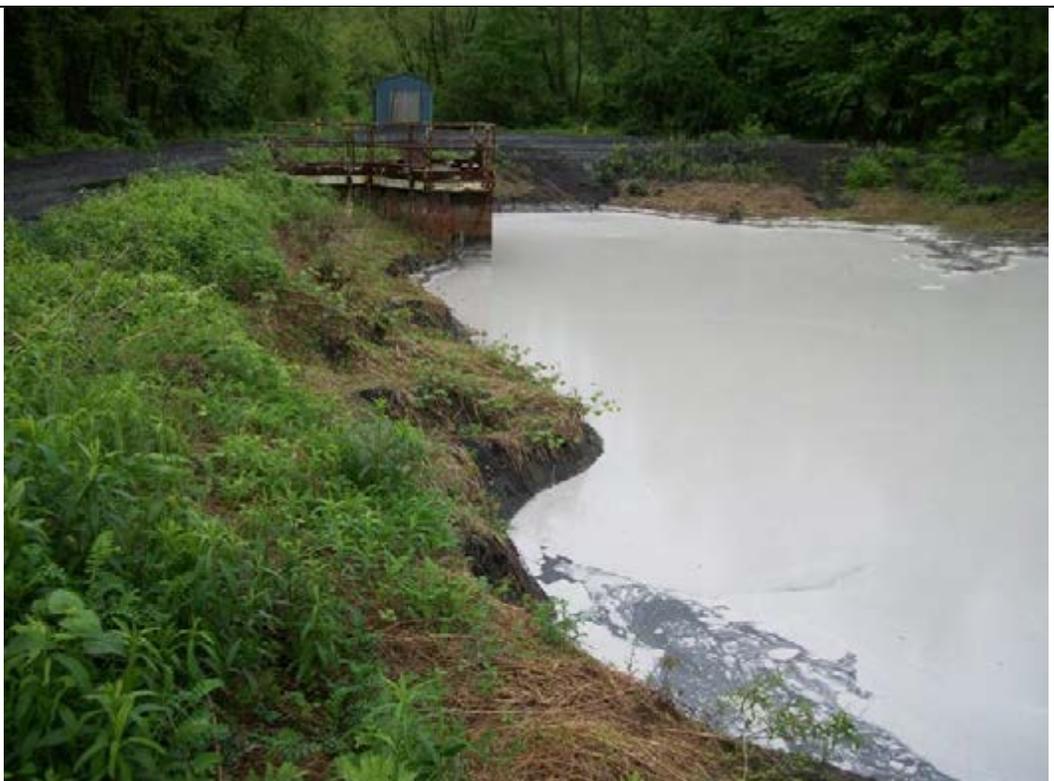
<b>Photo No.</b> 6	<b>Date:</b> 5/19/2011
<b>Direction Photo Taken:</b> Westerly

The West basin decant outflow structure was generally in poor condition. Heavy corrosion was observed along the sheeting and hand rails. Operation of the stoplogs was not performed during the assessment.

**Description:**  
West Basin decant outlet structure from crest of embankment. Note water in pond is surface/storm water runoff accumulated from prior week's heavy rainfall.

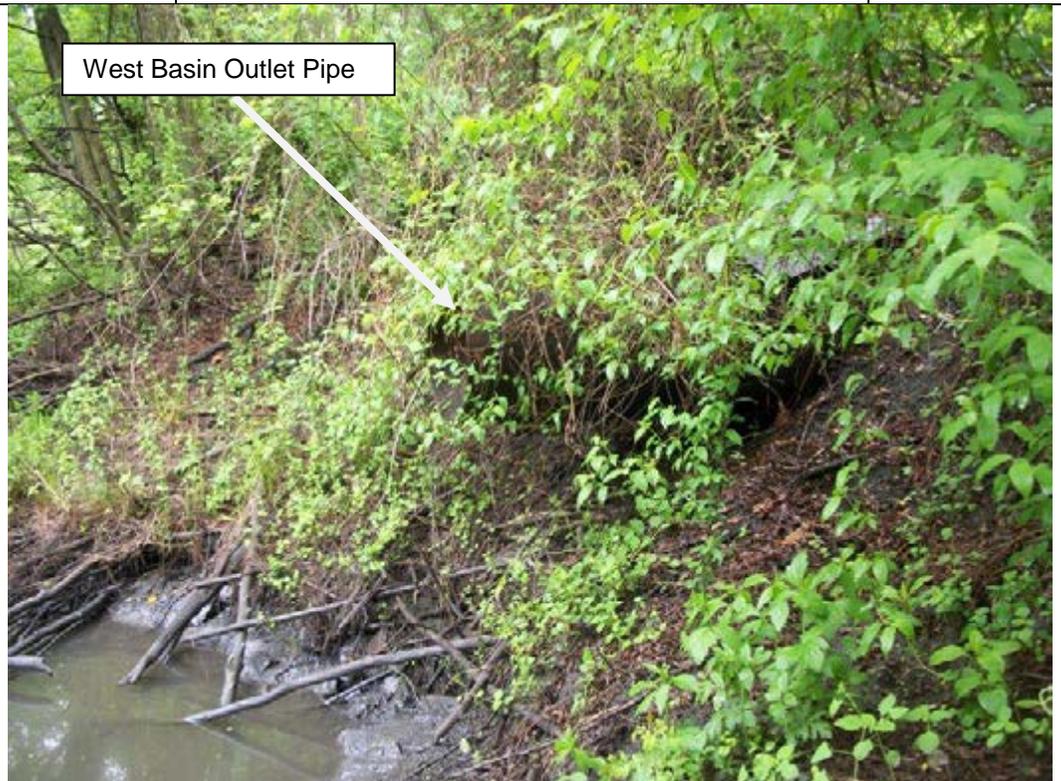
**Description:**  
View of approximately 18-inch diameter outlet pipe from the West Basin decant outlet structure. Arrow points to pipe outfall.

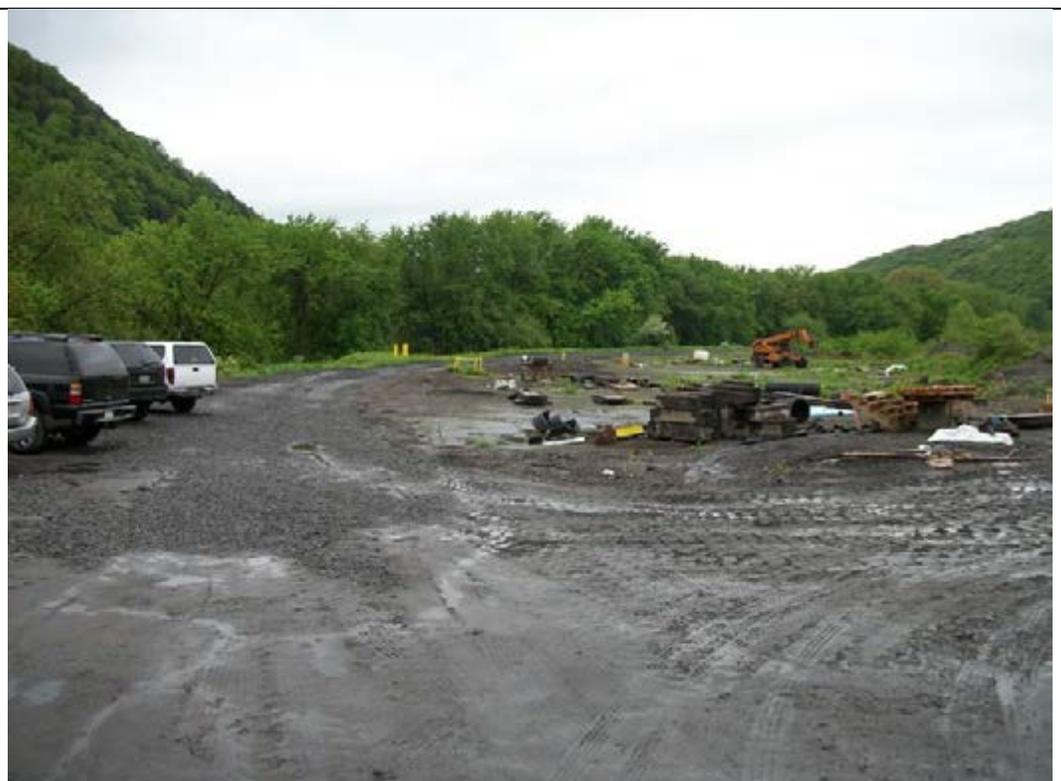
<b>Photo No.</b> 8	<b>Date:</b> 5/19/2011
-----------------------	---------------------------

**Description:**  
Overview of crest of East Basin from north end. Roadway along left traverses embankment crest. Ash waste within the interior of the impoundment (a large portion of which is shown from the construction debris pile to beyond the large fork lift truck) will be excavated and disposed of off-site as part of the decommissioning process.

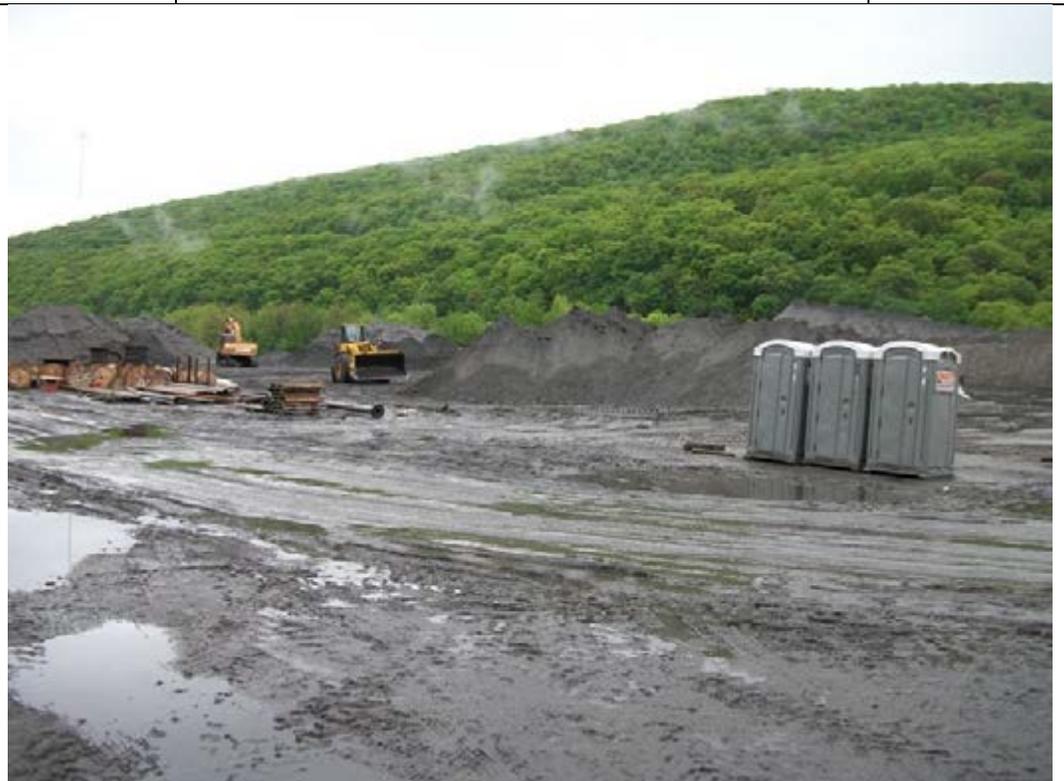
**Description:**  
Overview of filled in portions of the East and West Basins. Note ash waste (previously sluiced/deposited when plant was active) is currently in the process of being excavated and disposed off-site as part of the decommissioning process.

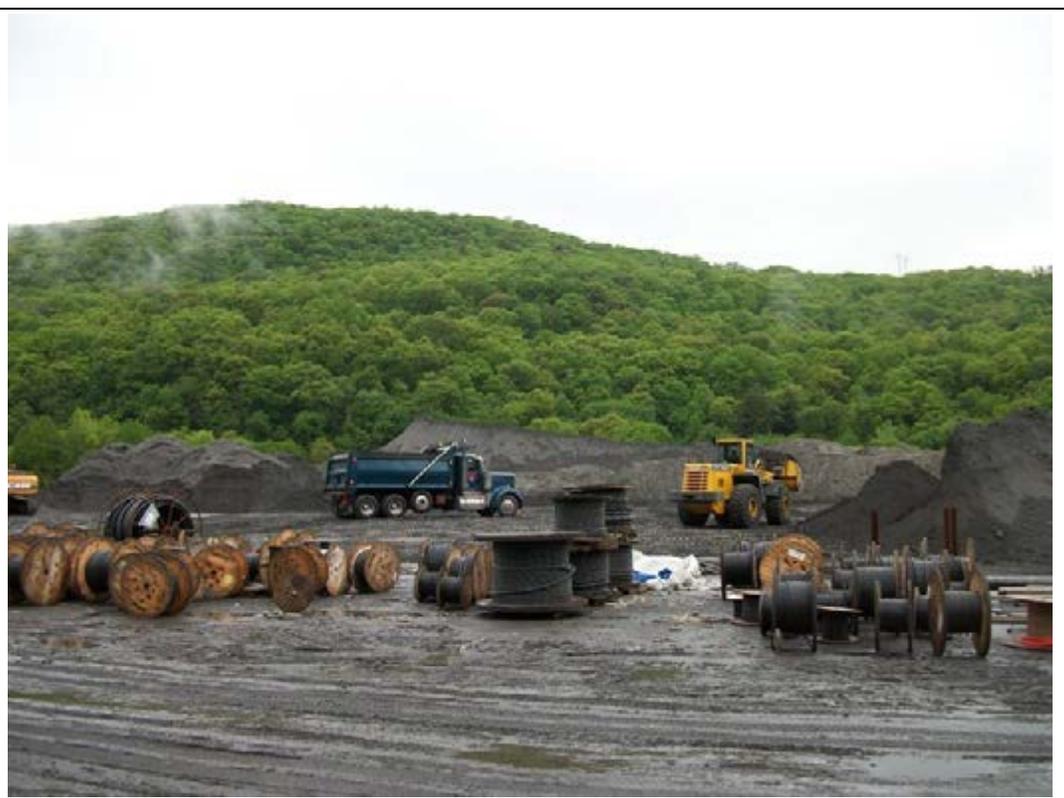
<b>Photo No.</b> 10	<b>Date:</b> 5/19/2011
------------------------	---------------------------

**Description:**  
Similar to previous photo, additional overview of filled in portions of the East and West Basins. Piles are from excavation of ash waste from other portions of the impoundment. Front loader in process of loading piles for off-site disposal.

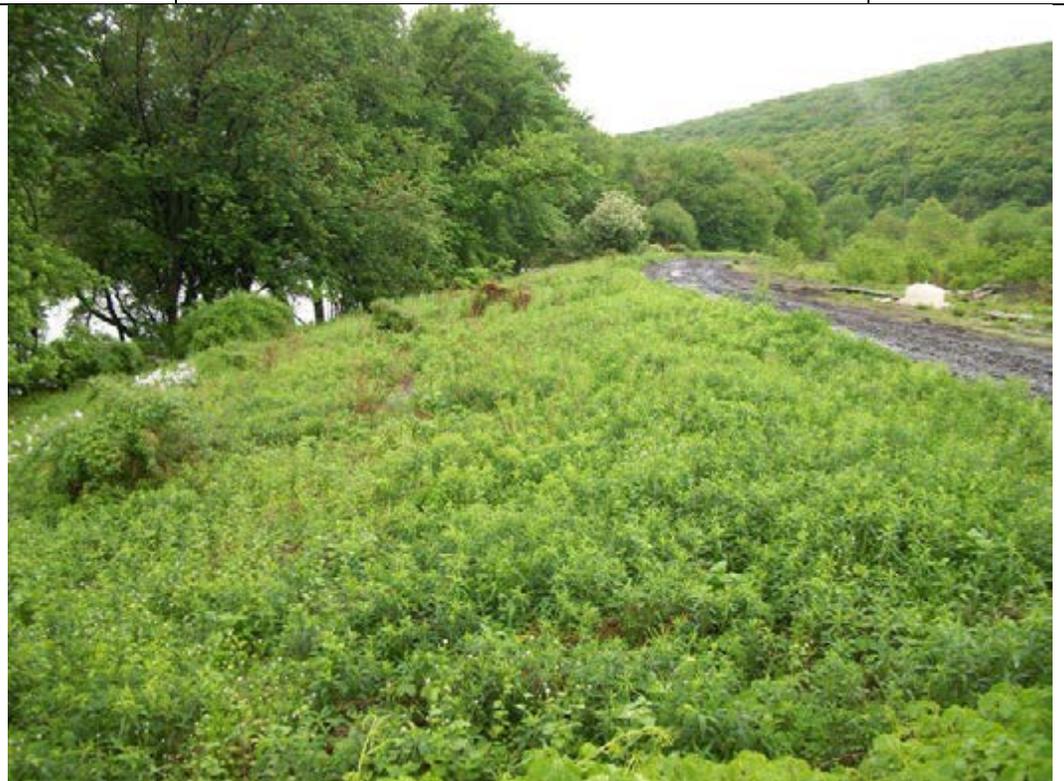
**Description:**  
Downstream embankment along east slope at the East Basin. Note the Susquehanna River just beyond the tree line near the toe of dam. Portions of embankment along this side appear to tie into natural grades prior to meeting river.

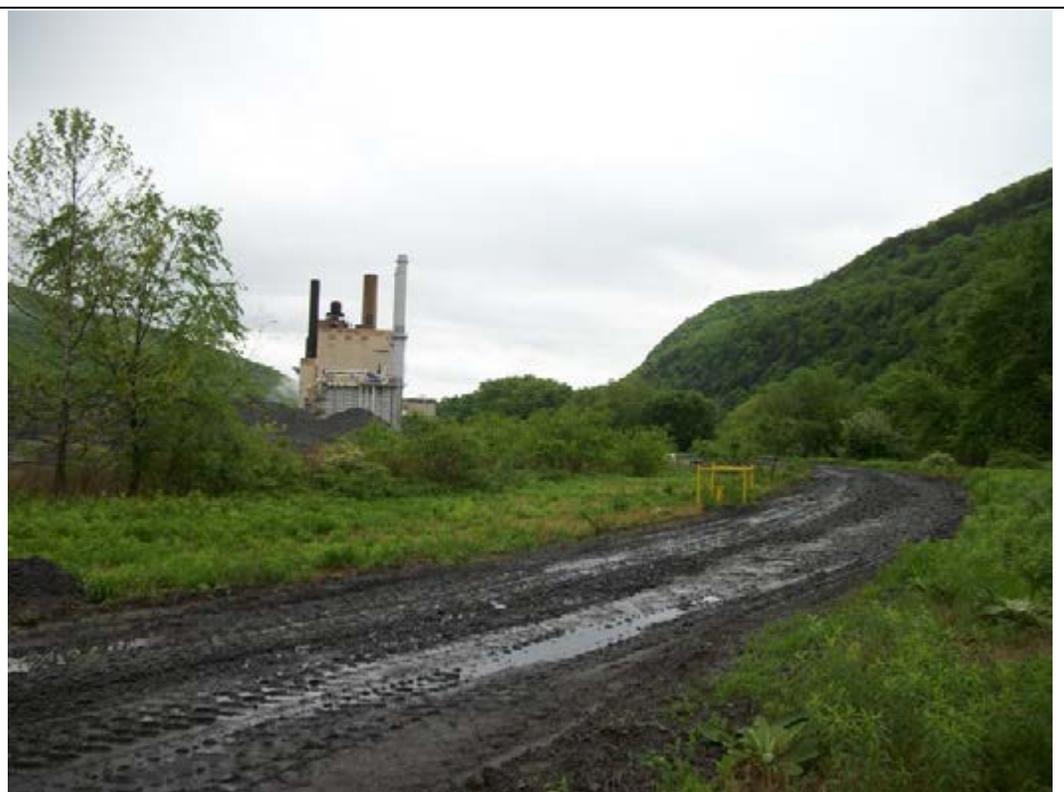
<b>Photo No.</b> 12	<b>Date:</b> 5/19/2011
<b>Direction Photo Taken:</b> Easterly

**Description:**  
Crest of East Basin from just northeast of the outlet structure. Note impoundment (beyond roadway) has been filled with sluiced fly ash during the time the facility was active. As with all other areas of the basin, the material will be removed, disposed of off-site, and the area regarded as part of the decommissioning process.

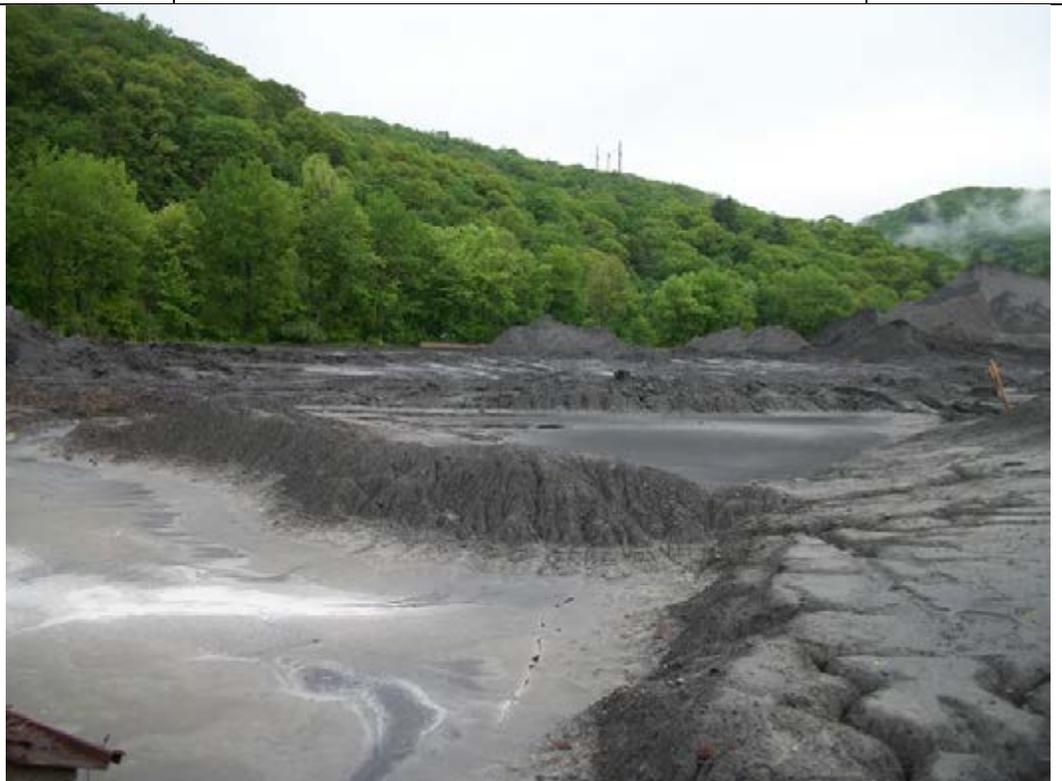
**Description:**  
View of East Basin just northeast of the East Basin outlet structure. Ash waste in this area will be excavated and disposed offsite as part of the decommissioning process.

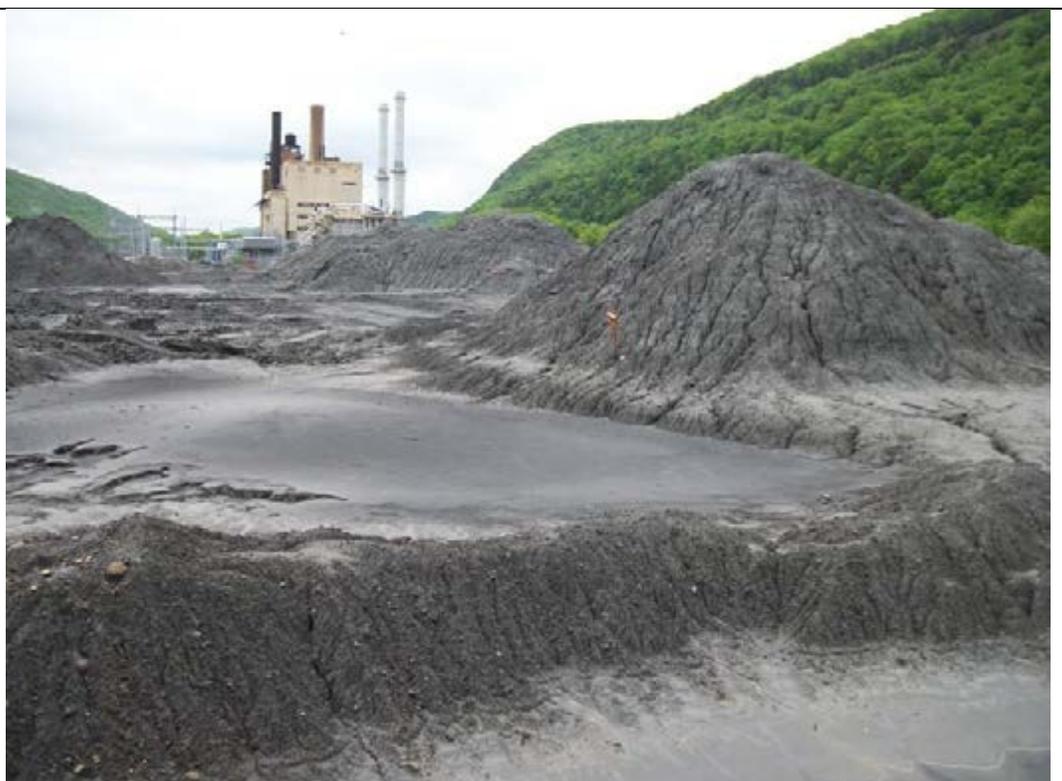
<b>Photo No.</b> 14	<b>Date:</b> 5/19/2011
------------------------	---------------------------

**Description:**  
Overview of East Basin taken from on top of its outlet structure. Note stockpiles of waste ash. Decommissioning process includes excavation and temporary stockpiling of waste ash which is tested prior to off-site disposal.

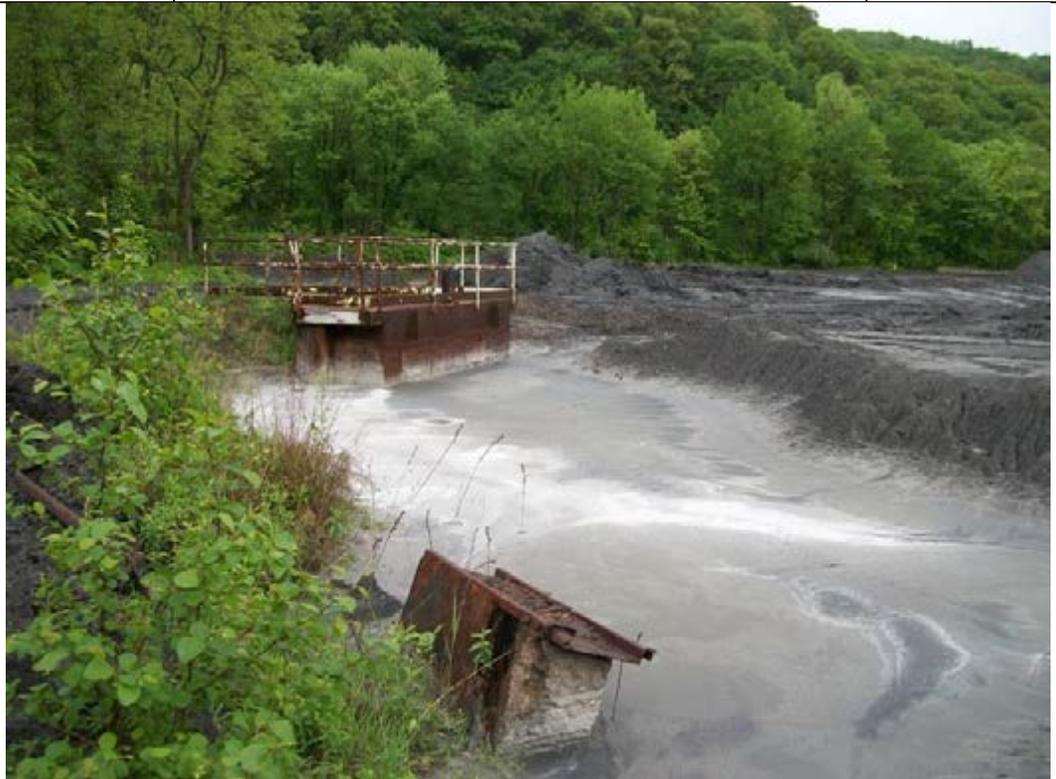
The East Basin Decant outflow structure was generally in poor condition. The weir intake structure was almost completely silted in. Heavy corrosion was observed along the sheeting and hand rails. Rails were separated from the stanchions at some places. Operation of the stoplogs was not performed during the assessment.

Description:  
View of East Basin Decant  
Outlet Structure from crest  
of East Basin embankment.  
Note water in pond is  
surface/storm water runoff  
accumulated from prior  
week's heavy rainfall.

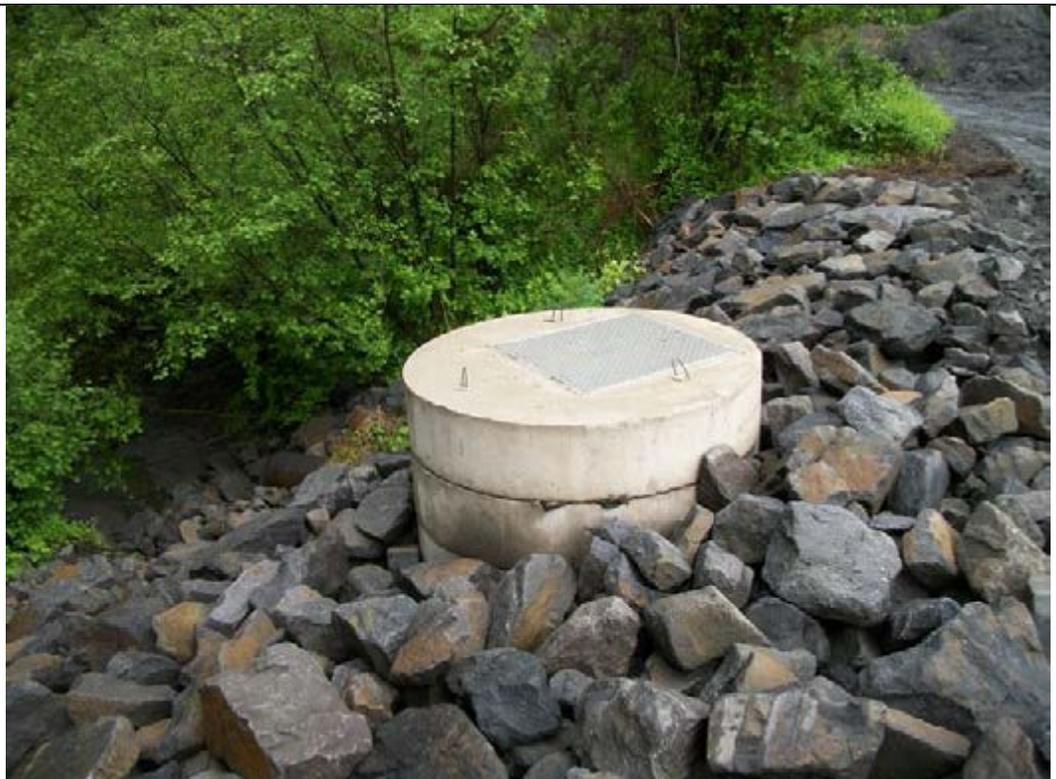
Photo No.  
16      Date:  
5/19/2011

Description:  
Downstream slope near East  
Basin outlet pipe. Note  
manhole in foreground  
recently constructed as part  
of the storm water drainage  
system associated with the  
site's new natural gas fired  
facility.

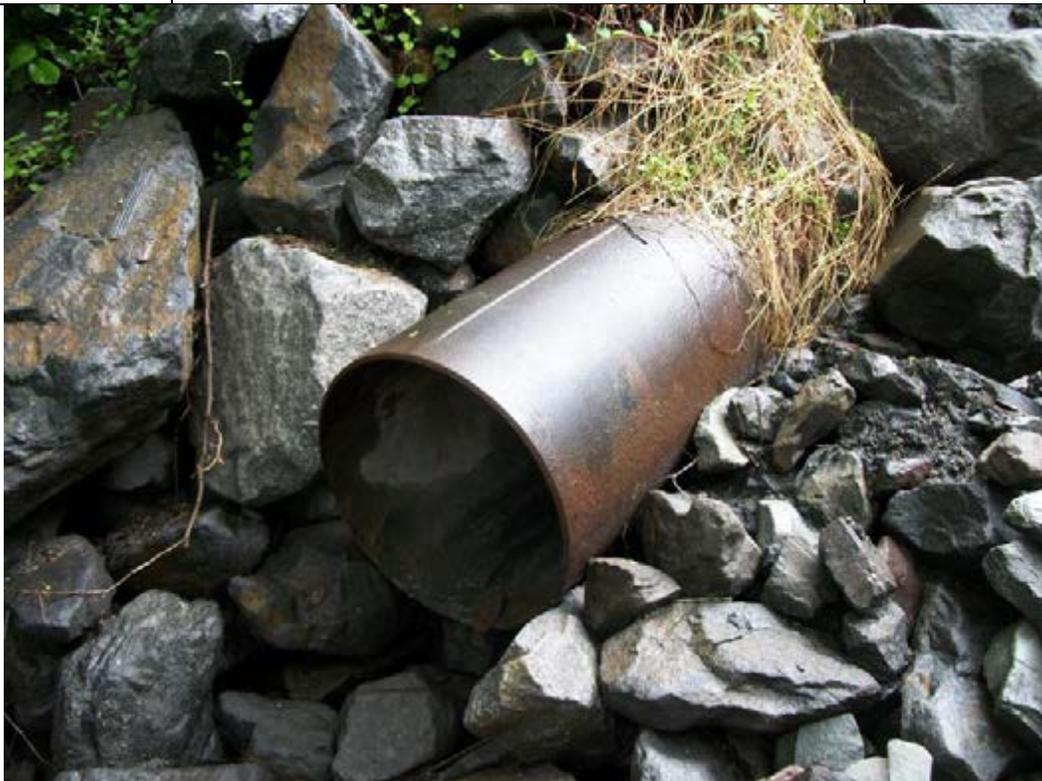
**Description:**  
Approximately 18 to 20-inch diameter decant structure steel outlet pipe from the East Basin.

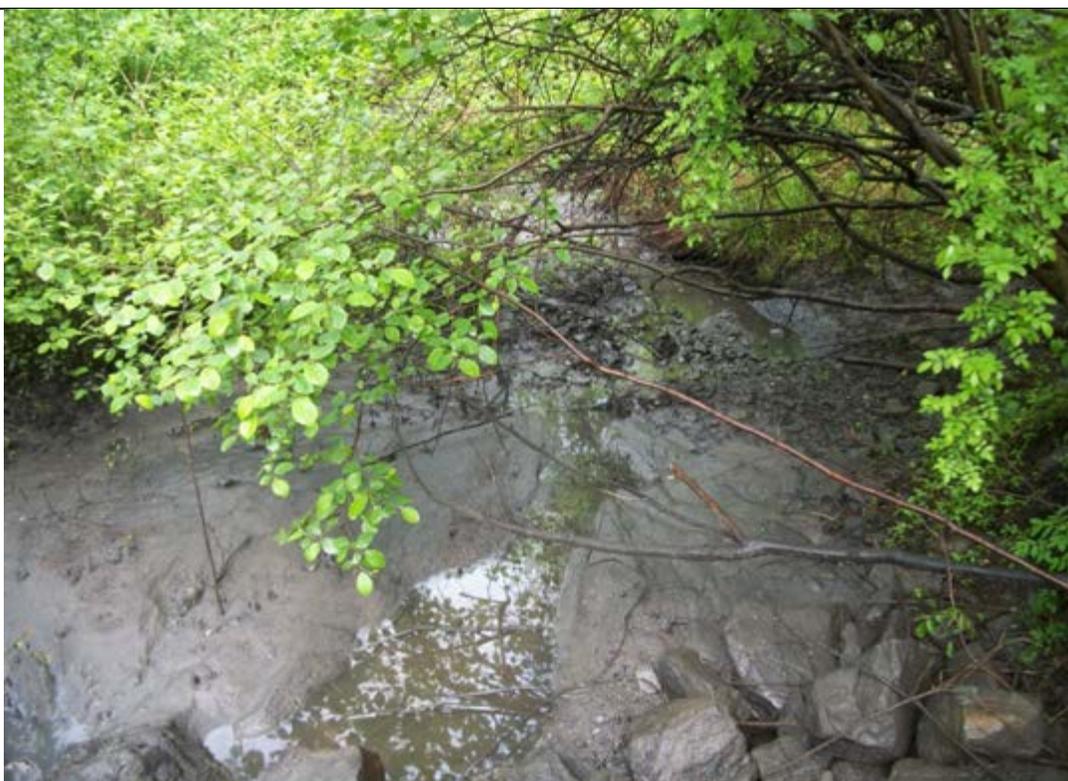
<b>Photo No.</b> 18	<b>Date:</b> 5/19/2011
<b>Direction Photo Taken:</b> Southerly

**Description:**  
View of East and West Basin discharge channel. Surficial sediment present is free of coal ash/residue.

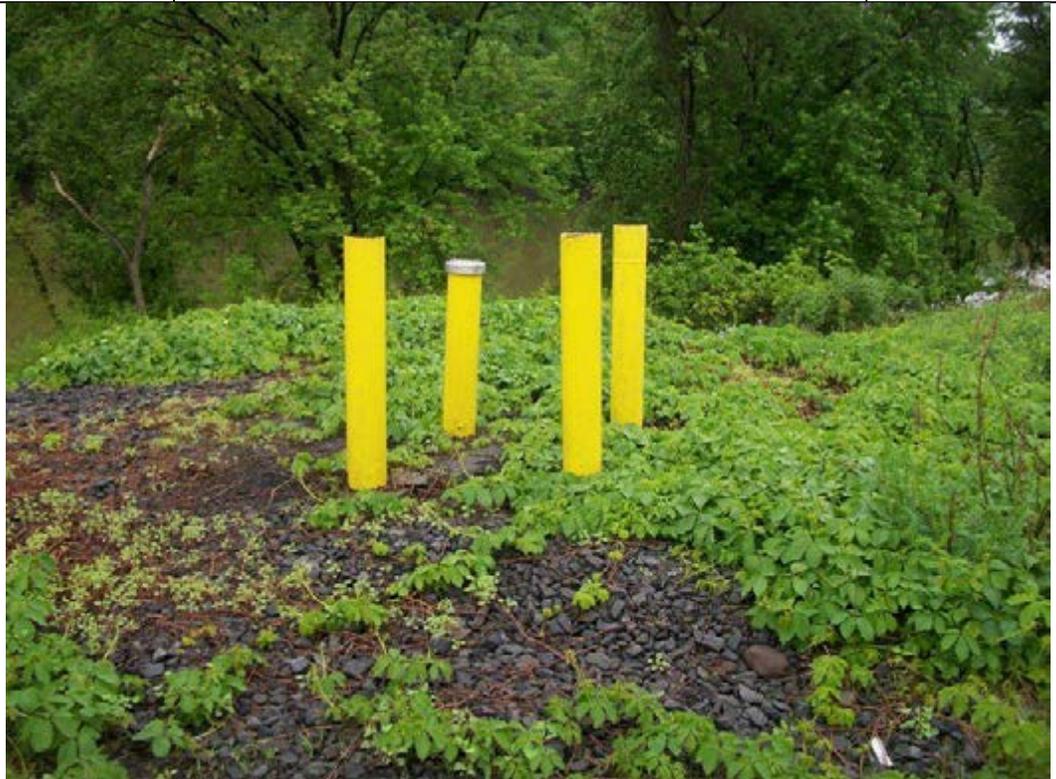
**Description:**  
View of water quality monitoring well on the crest of the East Basin embankment. Note the Susquehanna River in the background.

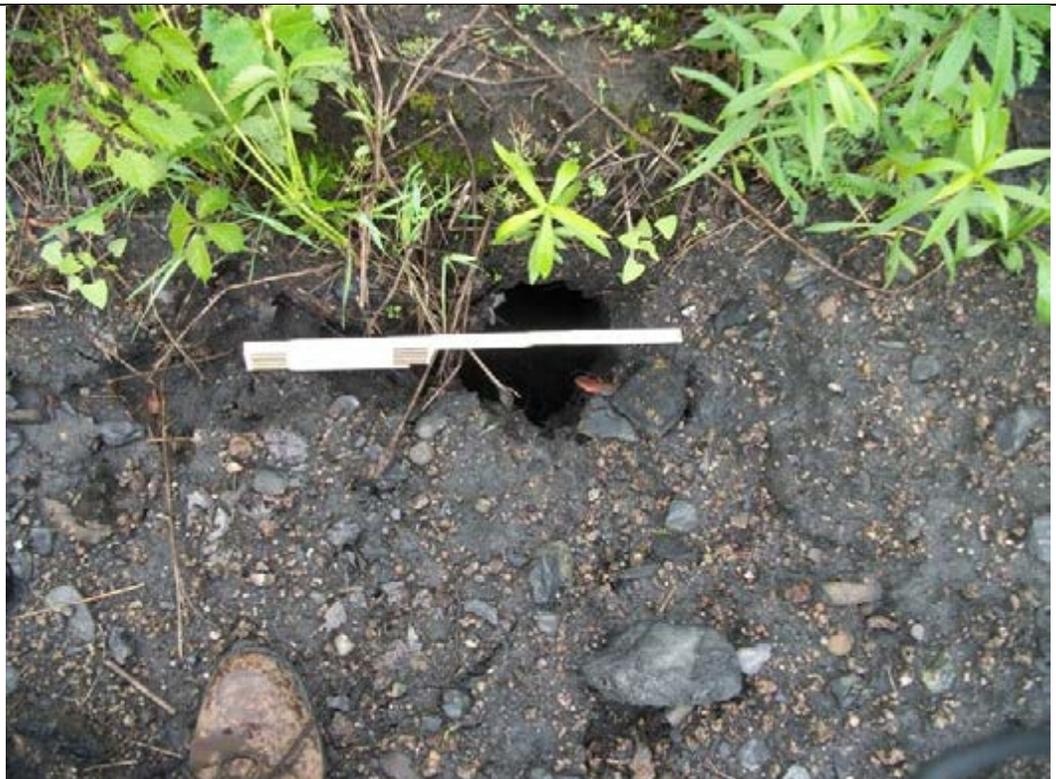
**Photo No.**  
20

3. Animal burrows observed at downstream slope of south embankment.
4. Portion of exposed earth observed at the south east end of the downstream slope.
5. Large diameter trees (greater than 18 inches) at toe of downstream slope.

**Description:**  
Animal burrow observed on the downstream slope of the East Basin embankment.

1. Fill ruts and animal burrows.
2. Record and maintain monthly measurements of the pond water surface elevation and observation wells and establish response action protocols for various elevation levels as appropriate.
3. Monitor and repair sloughing at the upstream slope at the West Basin and at the East Basin decant structure outlet pipe.
4. Clear inappropriate woody vegetation, including trees and brush and maintain grass cover on the downstream slope and toe area approximately 15 feet beyond. The USACE recommends vegetation be kept less than 12 inches in height on embankments.
5. Monitor decant outflow structures and clear silt or debris which may block or impede outflow.
6. Remove stoplogs from the weir intake at each decant outlet structure so that the normal water level in the impoundment cannot rise above elevation 531.8 feet.
