## COAL ASH IMPOUNDMENT SITE ASSESSMENT REPORT

**F. B. Culley Power Generating Station  
Vectren Corporation  
Newburgh, Indiana**

KLEINFELDER PROJECT NUMBER 112618-1

**April 2011**

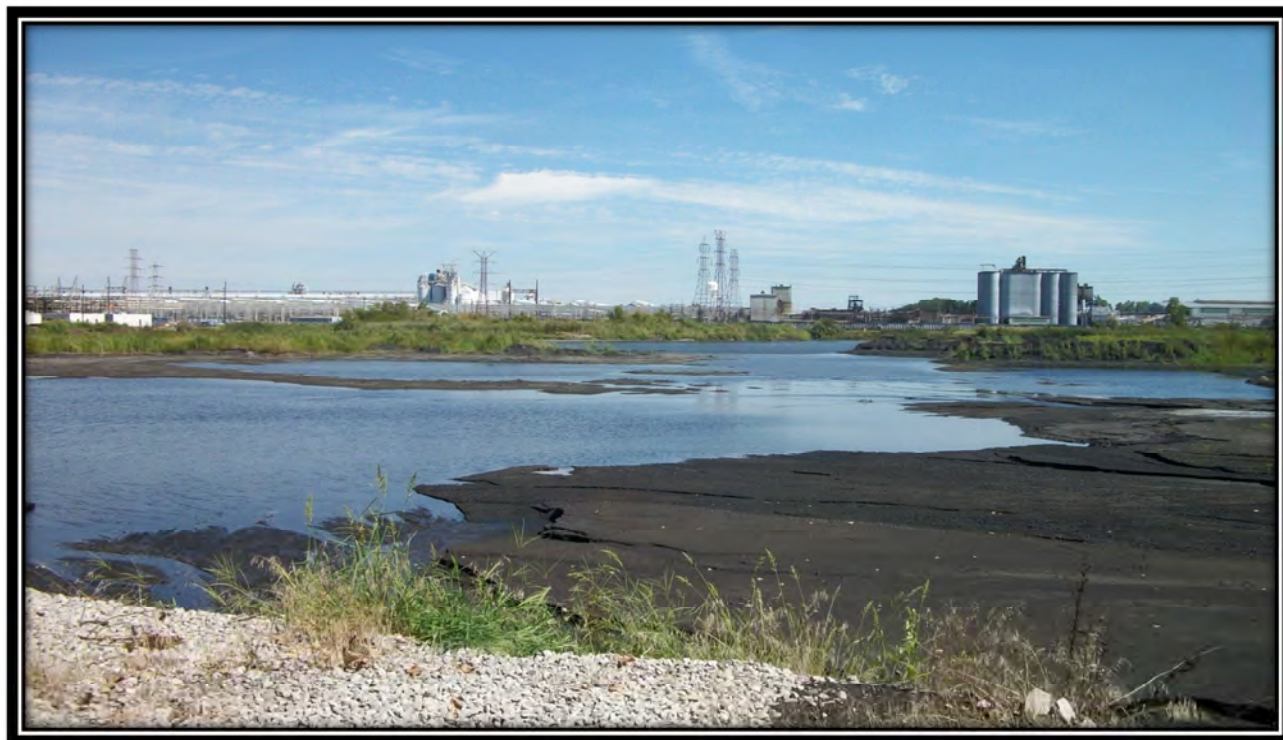
Photo 1 – West pond looking north from southeast corner

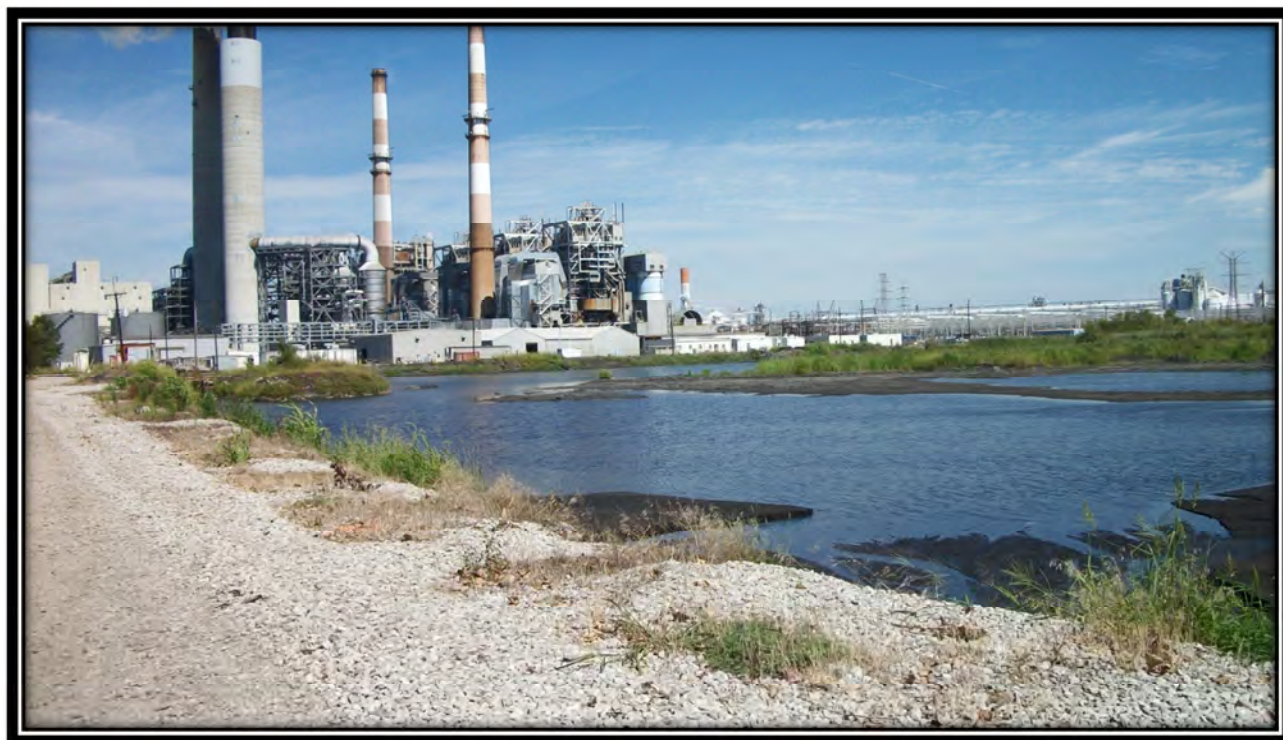
Photo 2 - West pond looking west along upstream south bank

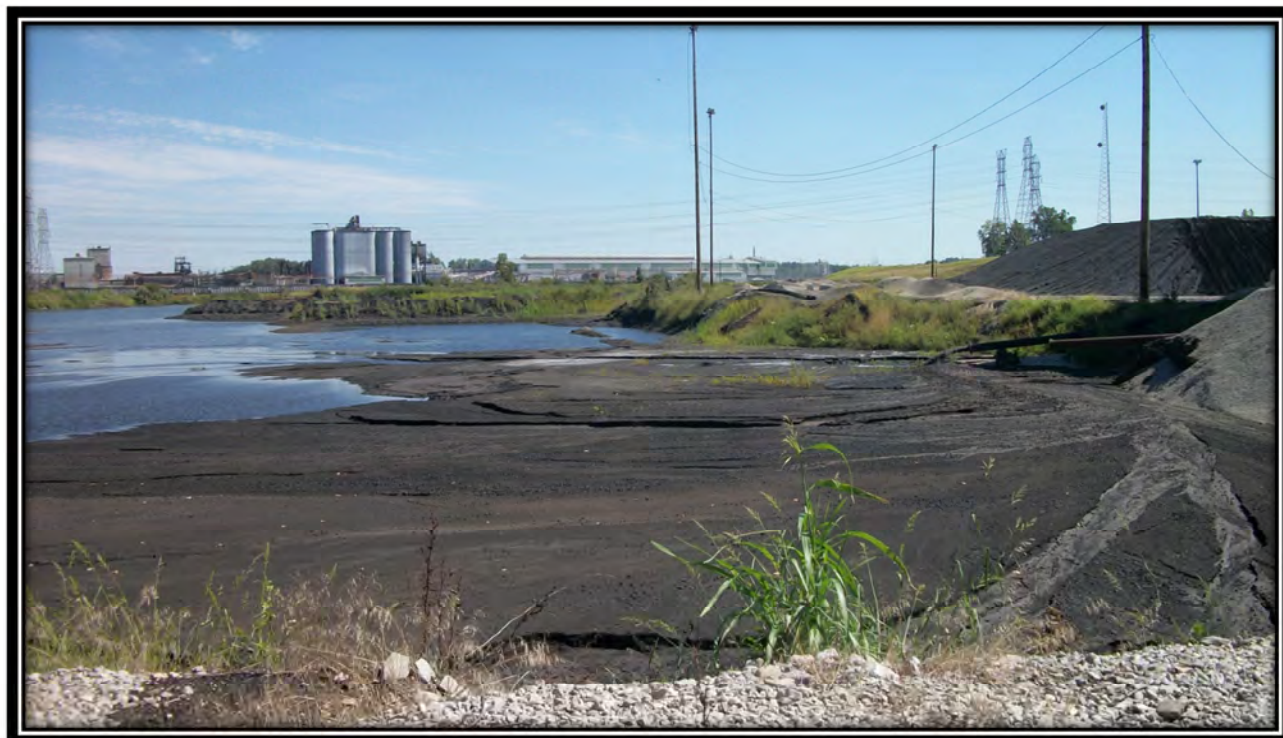
Photo 3 - West pond looking north along east bank

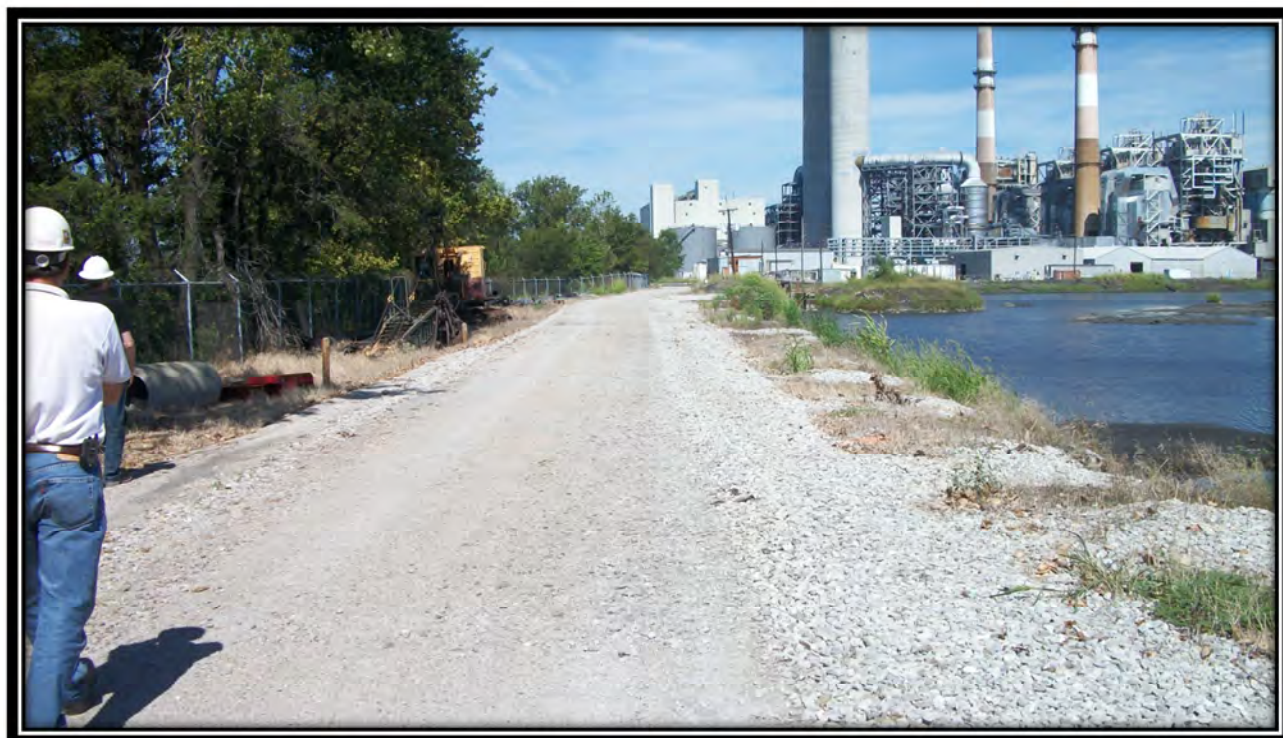
Photo 4 - West pond looking west along south bank

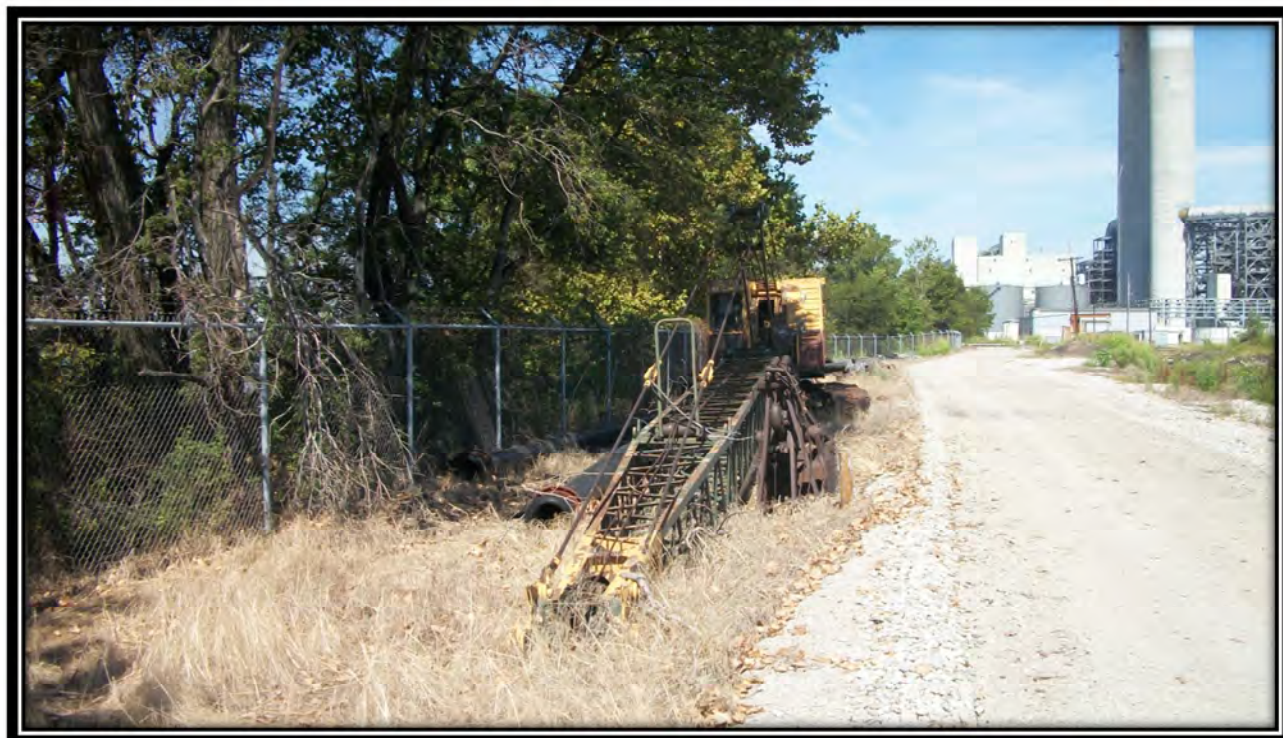
Photo 5 - West pond looking west along south bank

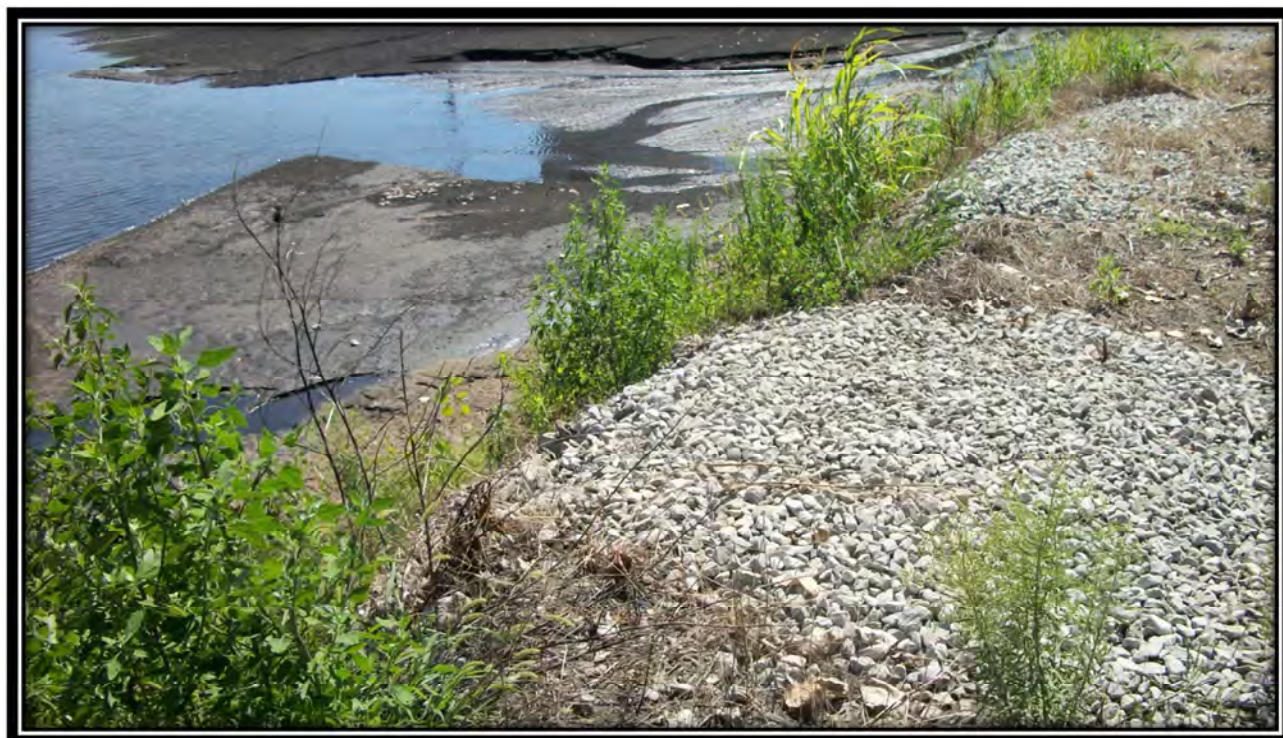
Photo 6 – Road gravel on upstream south bank near southwest corner

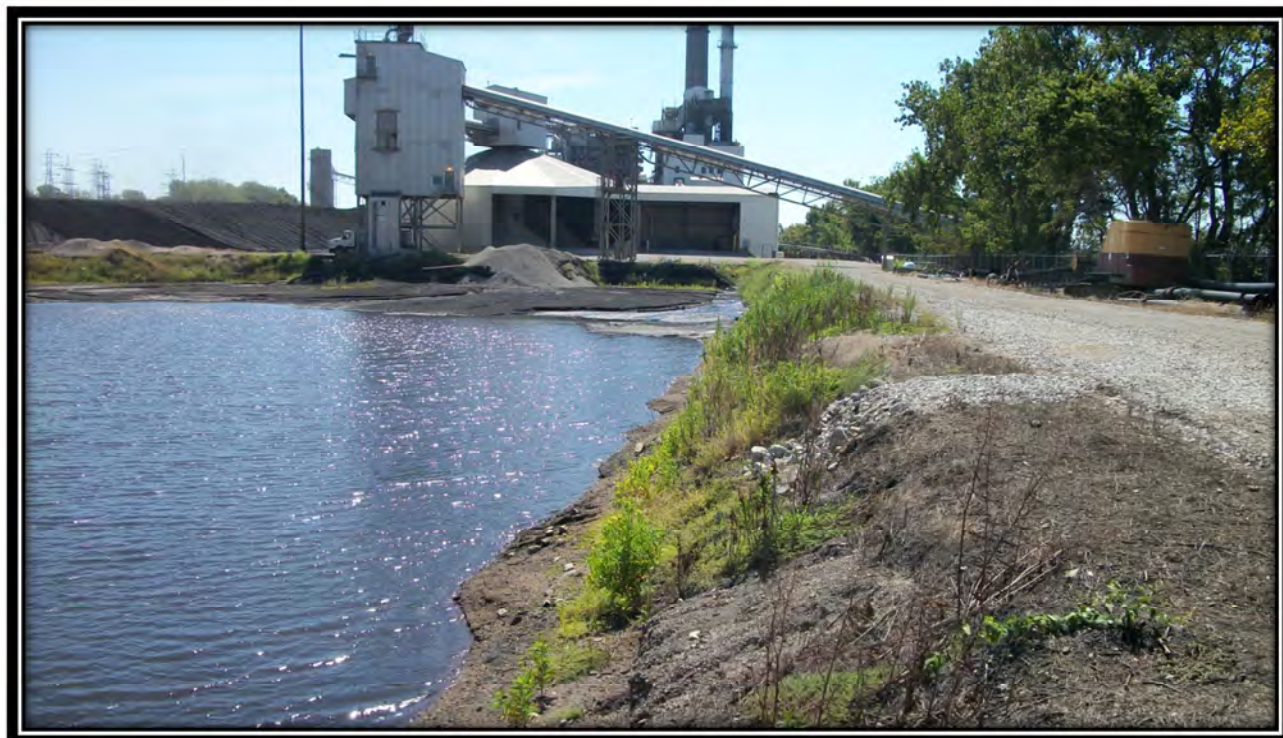
Photo 7 – West pond upstream south bank looking east at plant

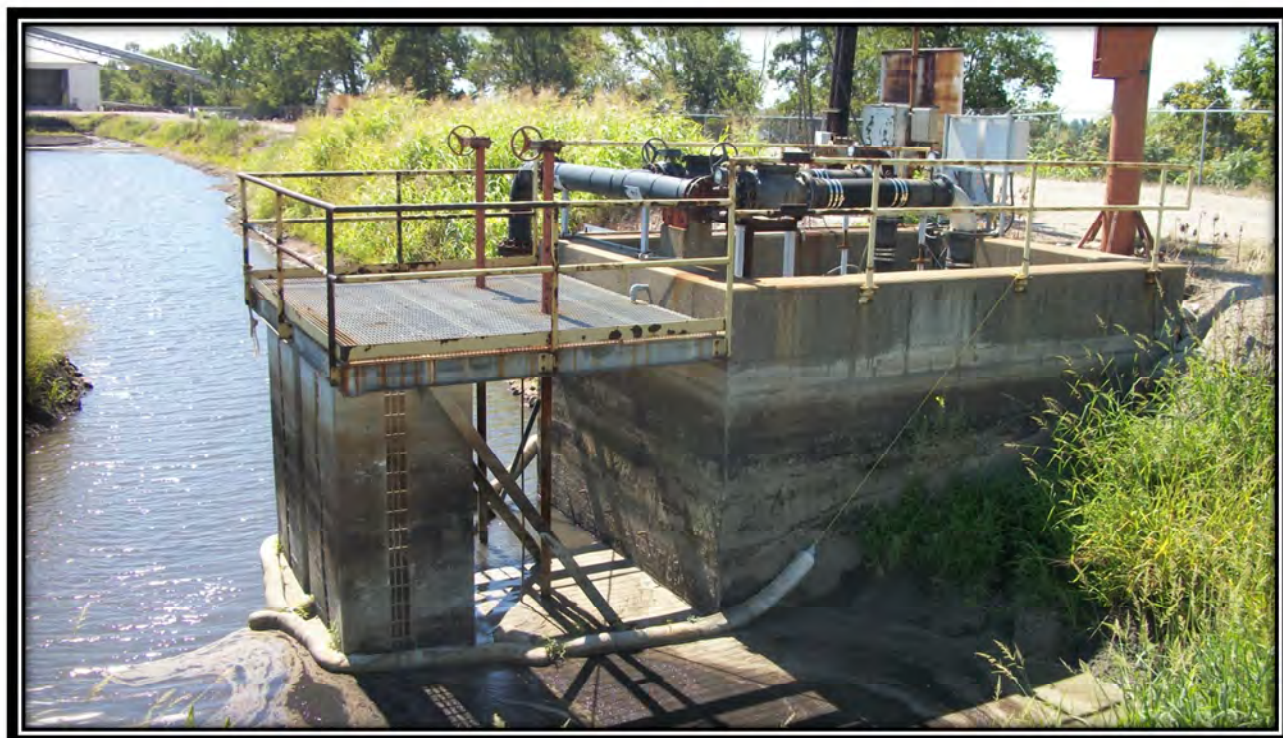
Photo 8 – West pond pump near southwest corner

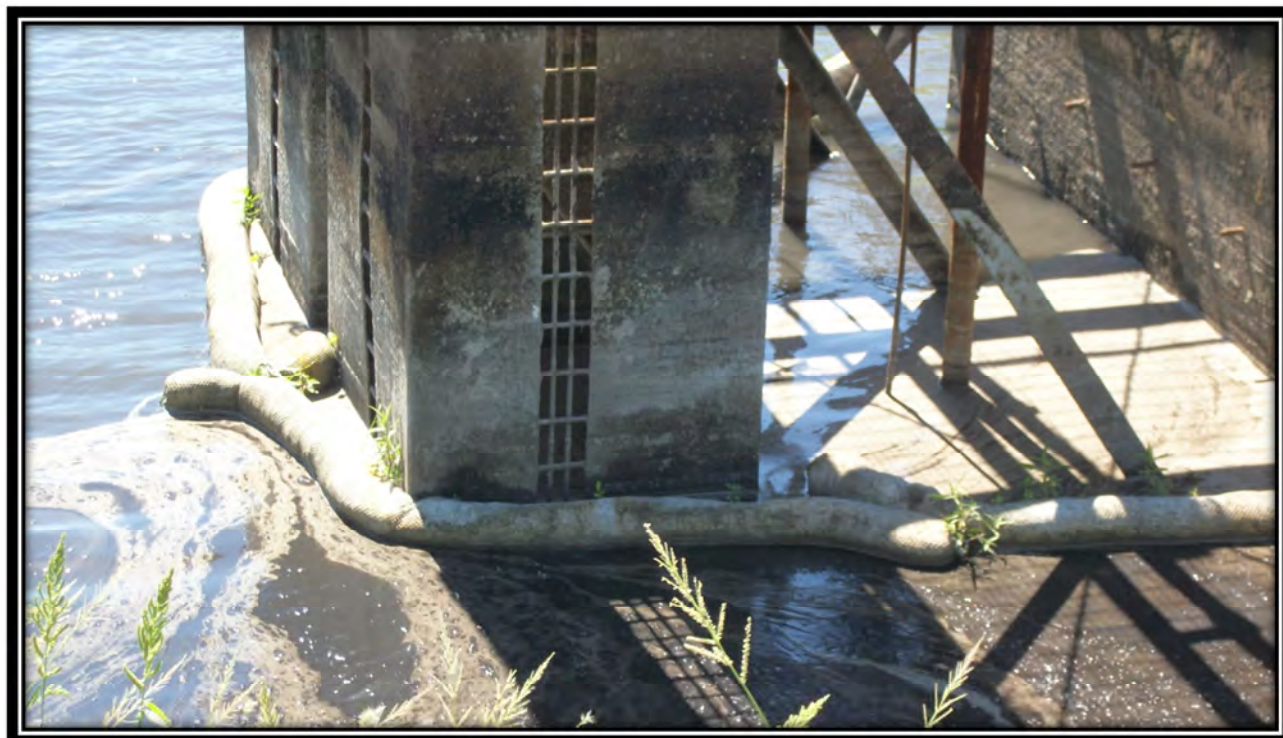
Photo 9 – West pond pump near southwest corner

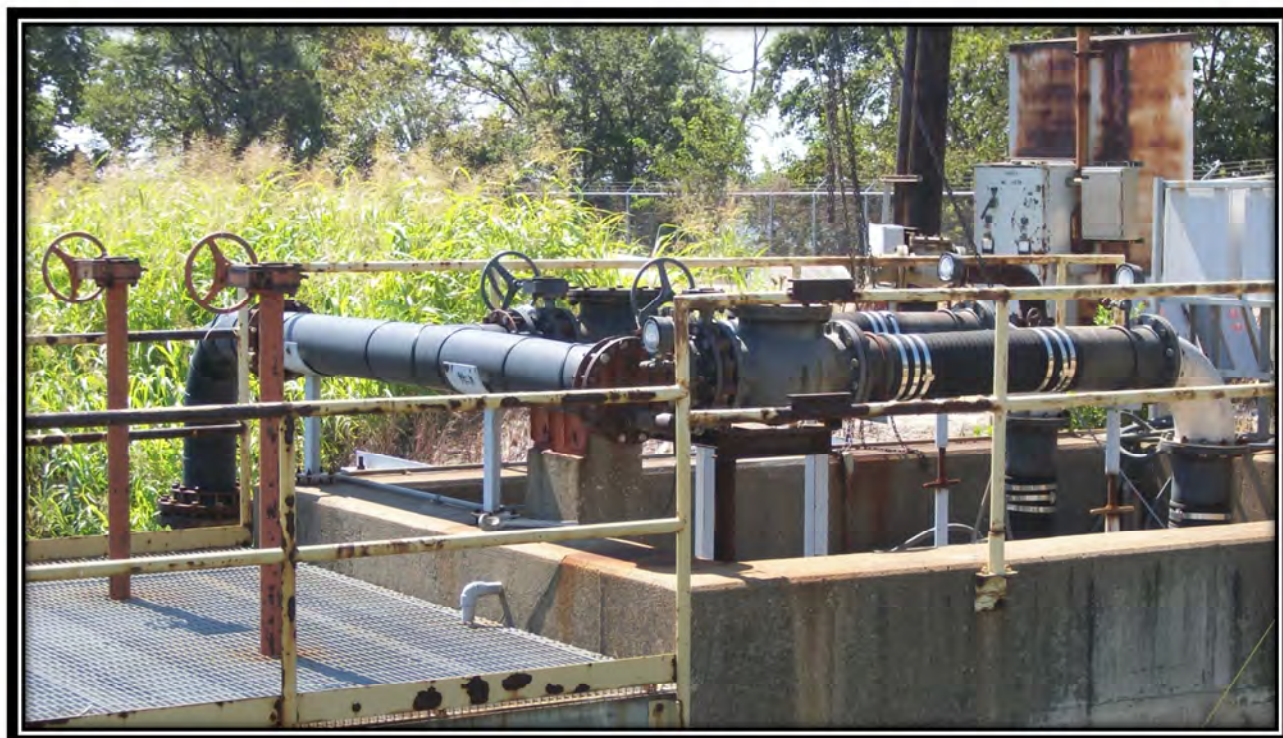
Photo 10 – West pond pump

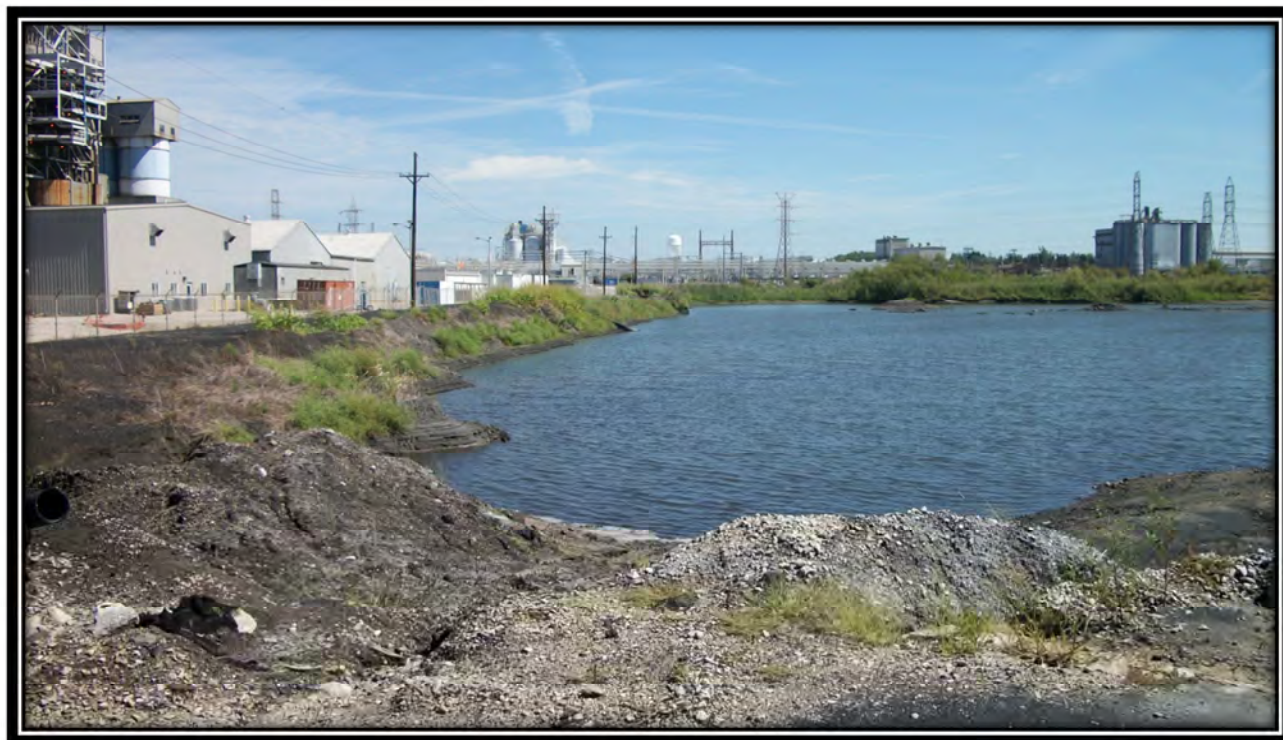
Photo 11 – West pond looking north along upstream west bank

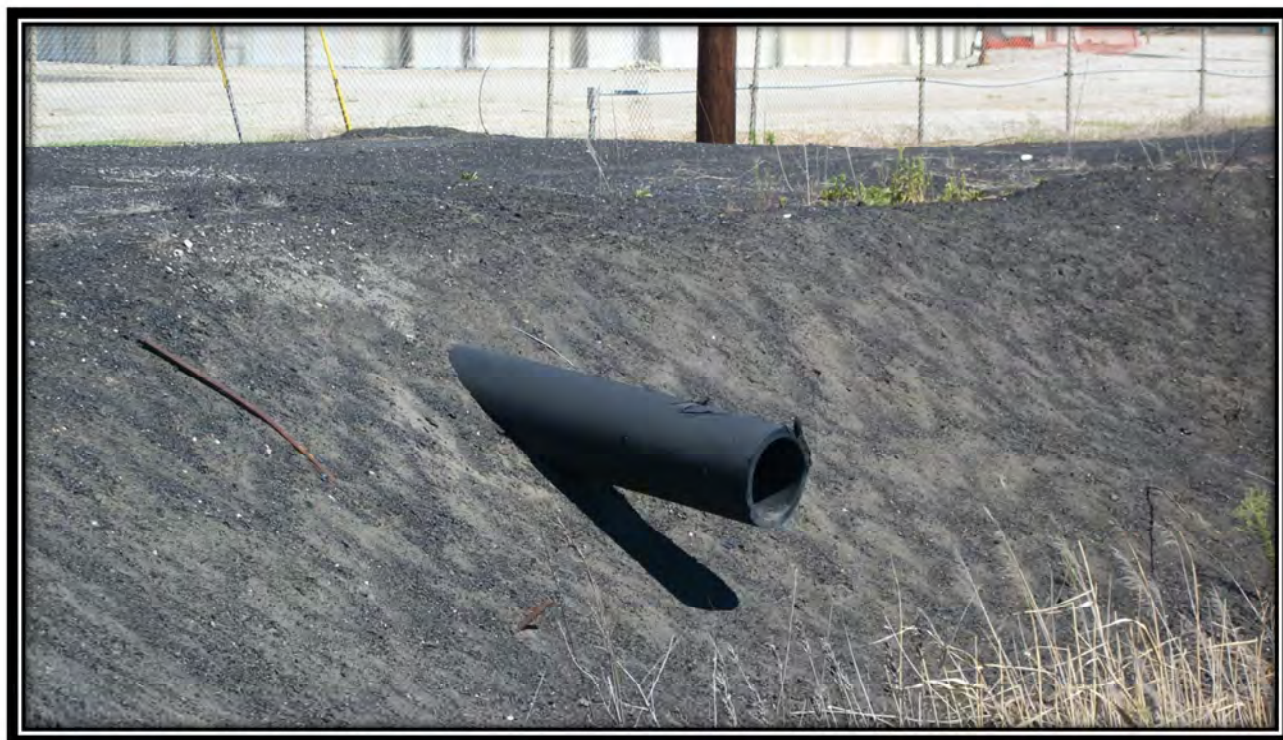
Photo 12 – Old ash line from neighboring site through west bank

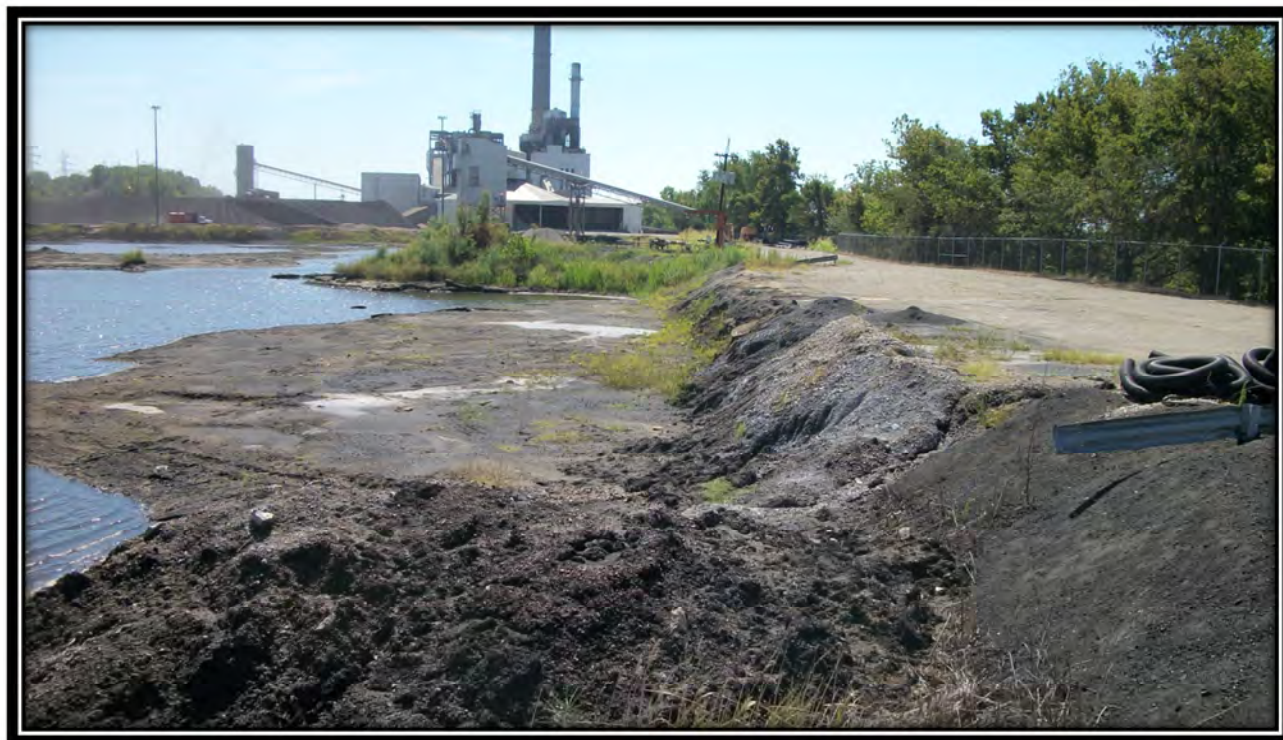
Photo 13 – West pond looking east along upstream south bank

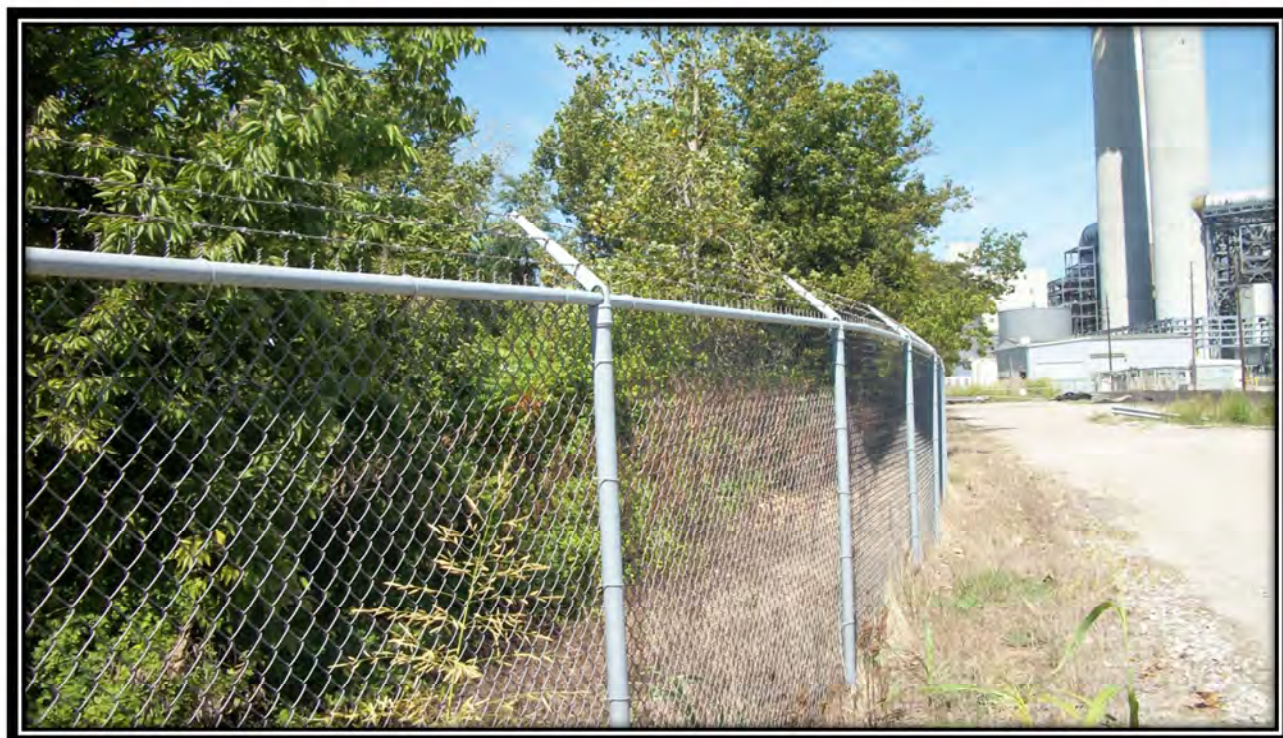
Photo 14 – West pond looking west along downstream top of south bank

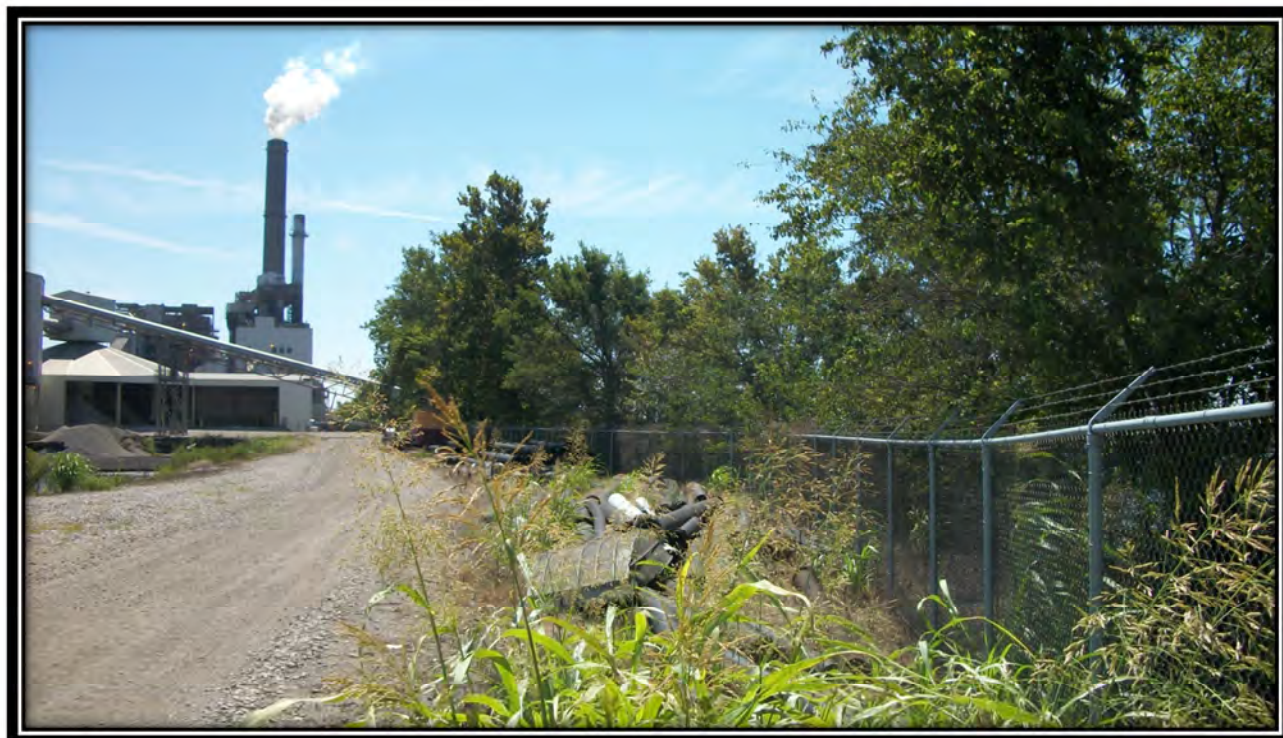
Photo 15 – West pond looking east along downstream top of south bank

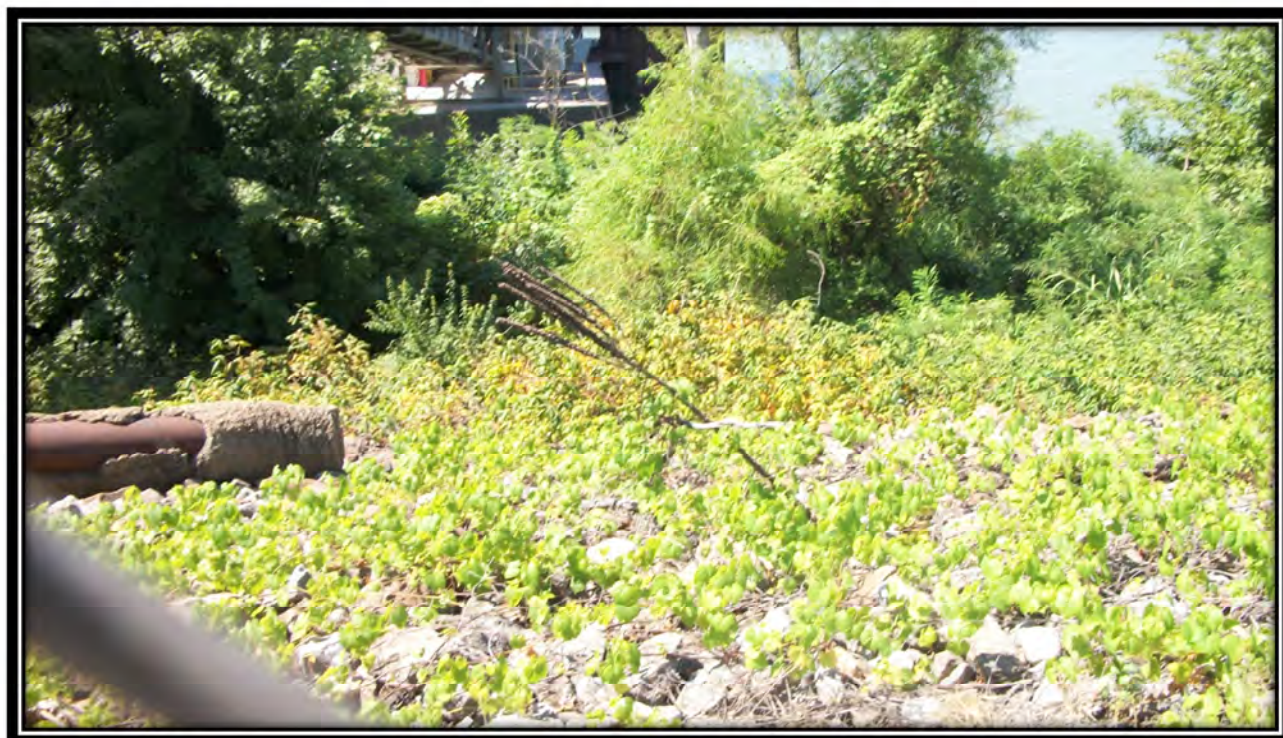
- The south bank downstream slope was at approximately 2H:1V to 3H:1V. Some areas of the south bank downstream slope appear to have riprap slope protection. Limitations to access and thickness of vegetation did not permit any further evaluation of the downstream slope protection.
- Brush and large mature trees were observed on the downstream slope and at the toe of the embankment for the majority of the south bank.

Photo 16 – Riprap and debris on downstream south slope of west pond near southeast corner

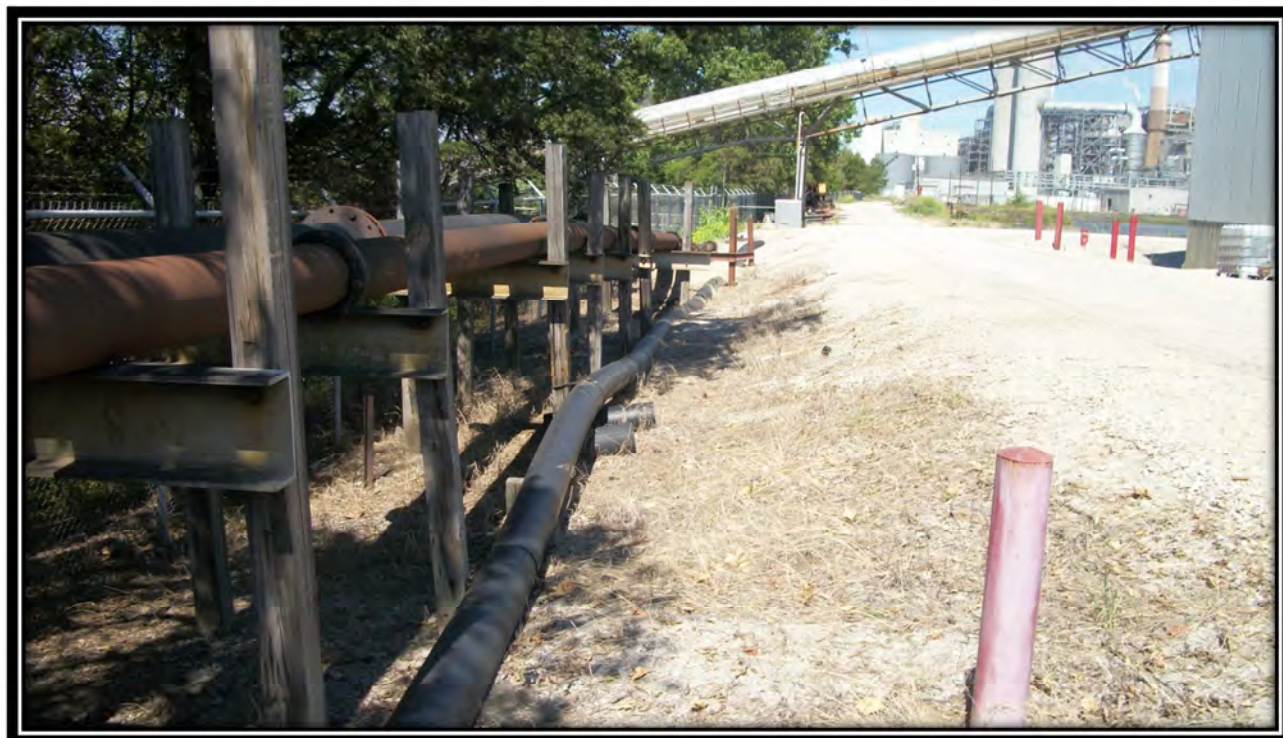
Photo 17 – Pump lines along plant between west and east ponds (looking west)

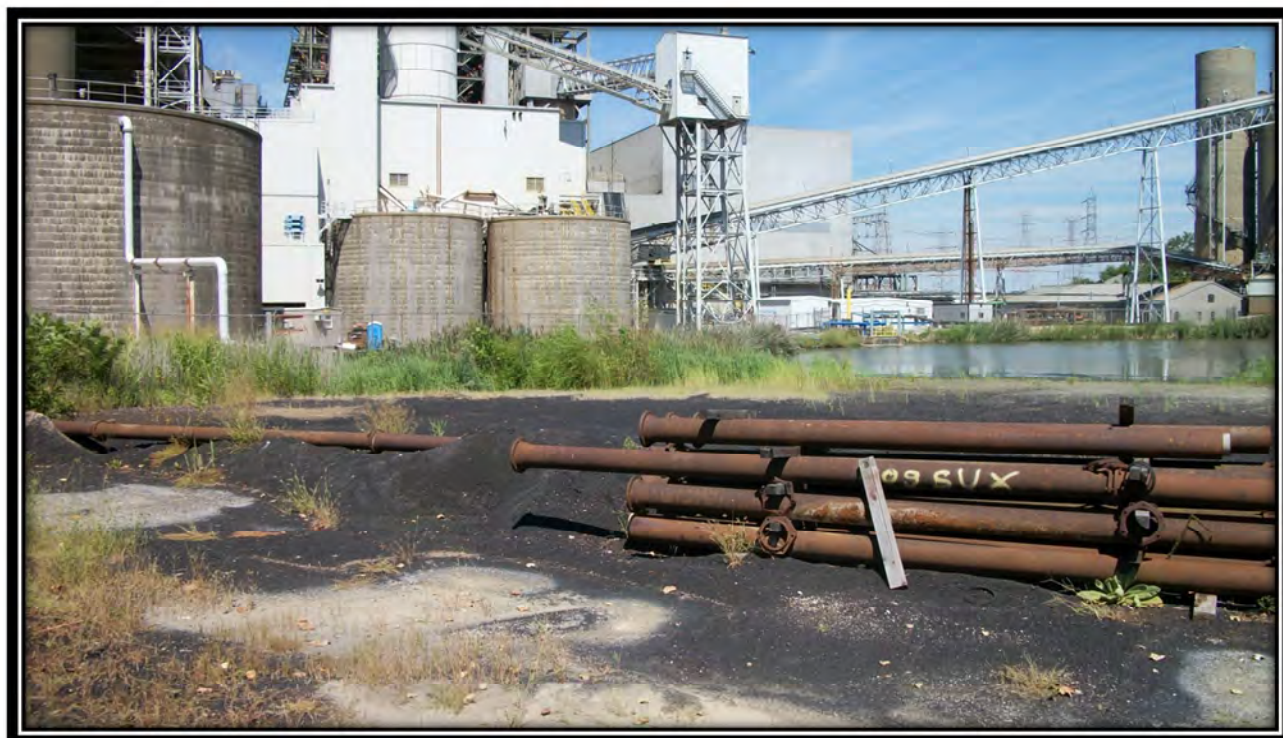
Photo 18 – East pond looking northwest from southwest corner

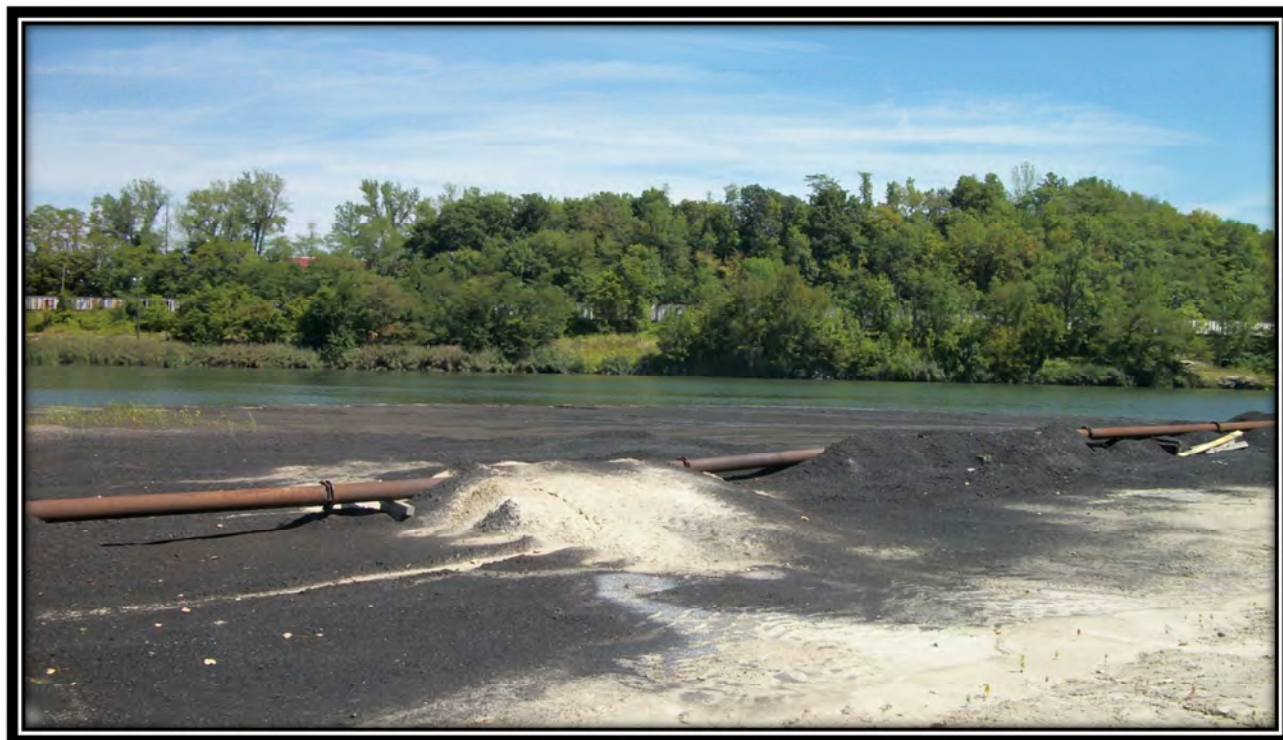
Photo 19 – East pond looking north from south bank

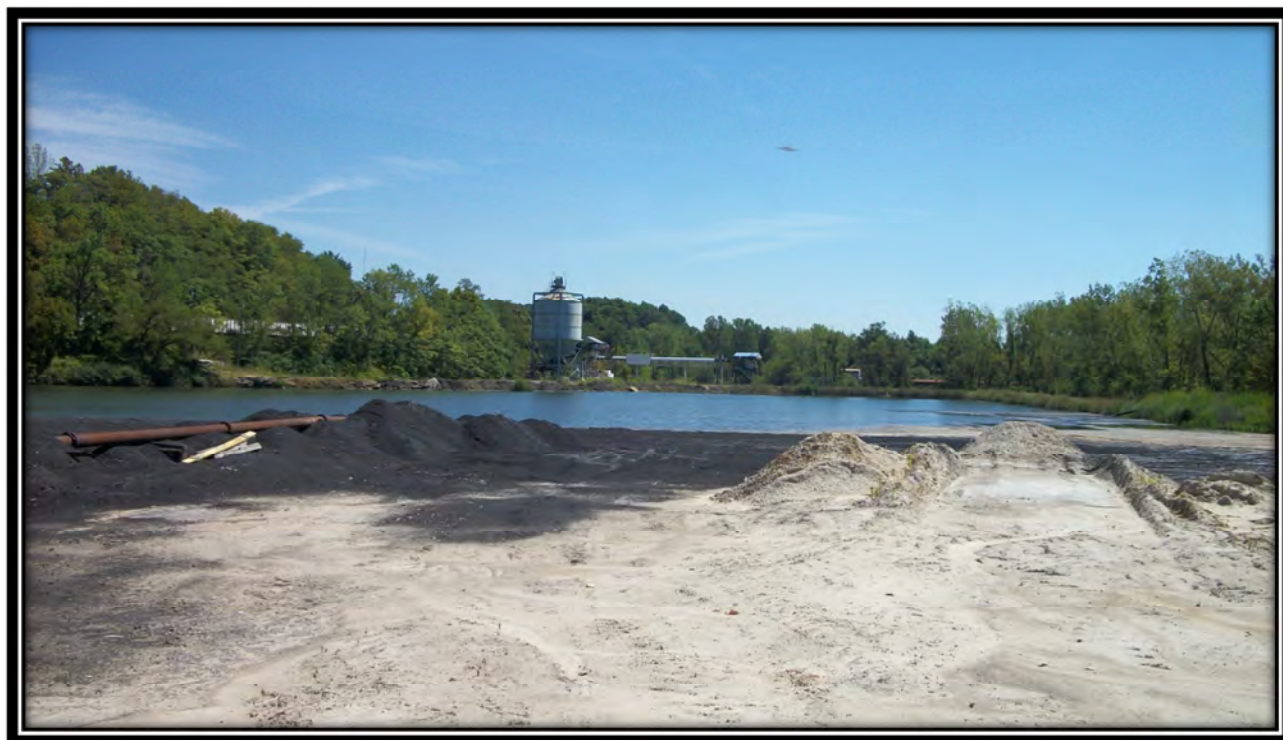
Photo 20 – East pond looking east from southwest corner

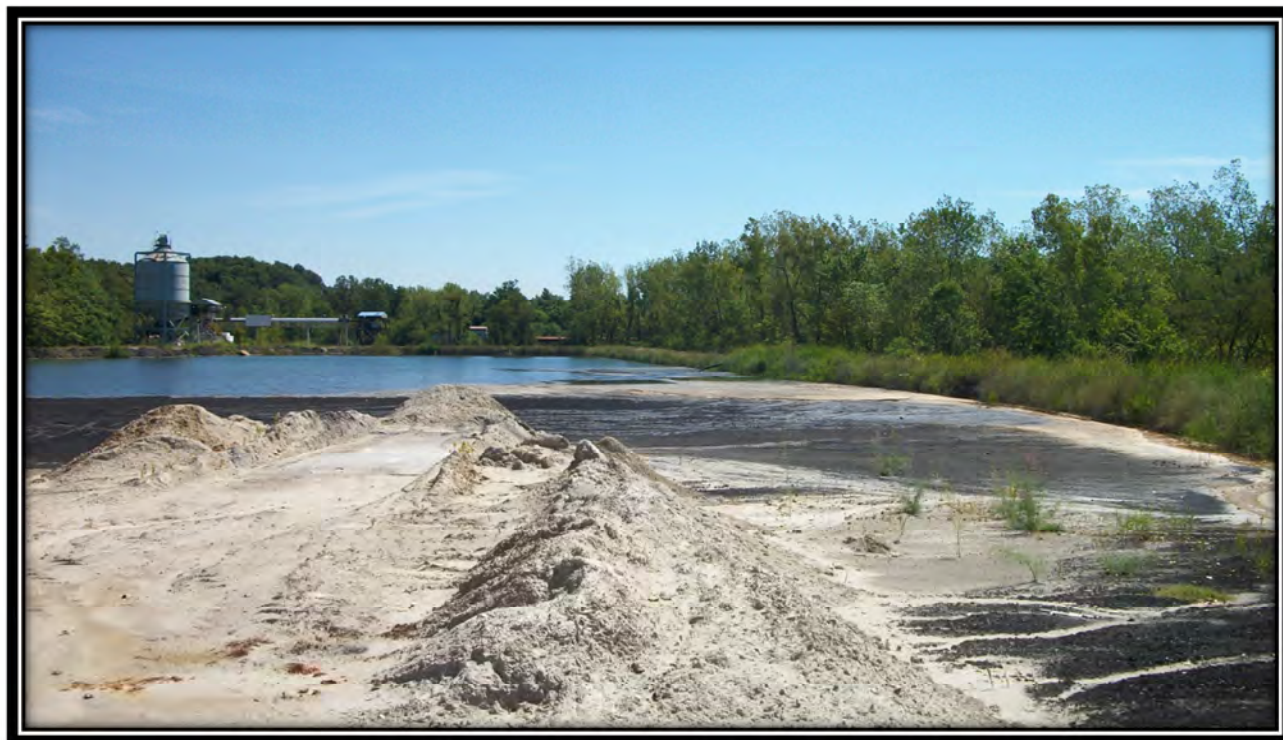
Photo 21 – East pond looking east

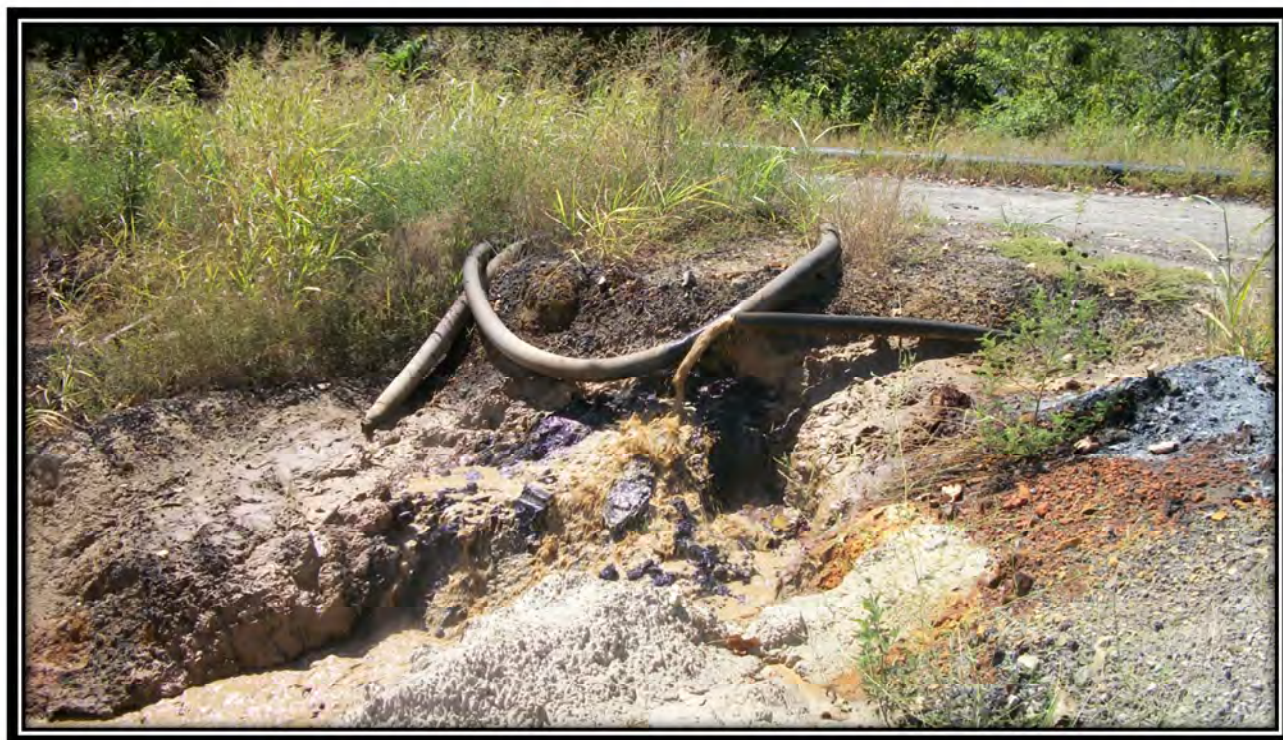
Photo 22 – Discharge pipe into east pond near southwest corner

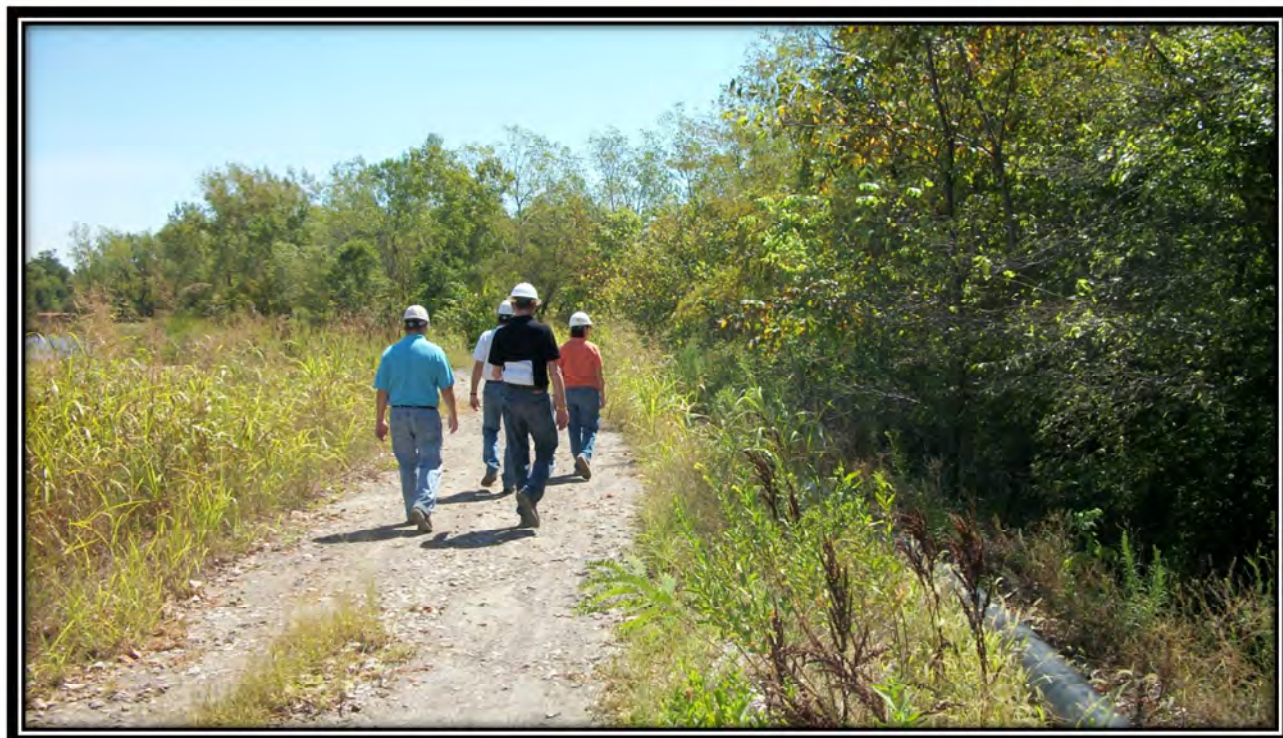
Photo 23 – East pond looking east along south bank

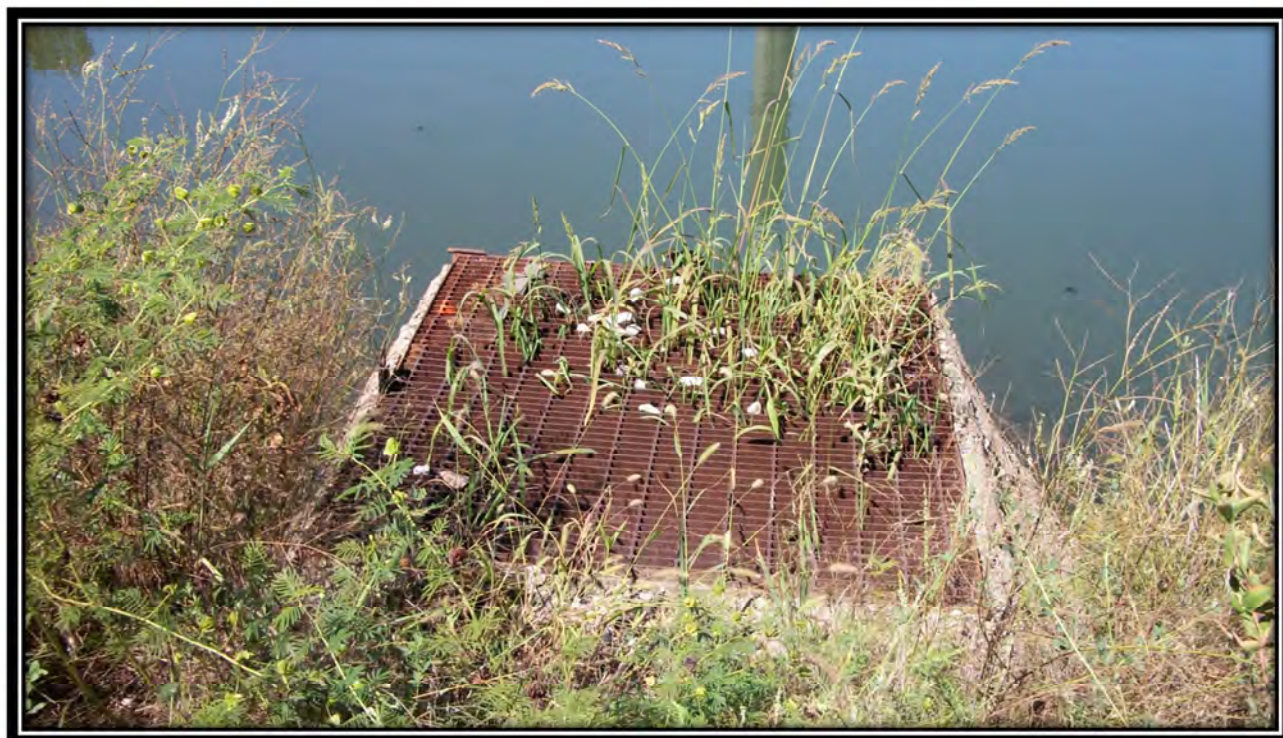
Photo 24 – Old overflow capped and plugged with concrete on east upstream bank
