## COAL ASH IMPOUNDMENT SITE ASSESSMENT REPORT

**F. B. Culley Power Generating Station  
Vectren Corporation  
Newburgh, Indiana**

KLEINFELDER PROJECT NUMBER 112618-1

**April 2011**

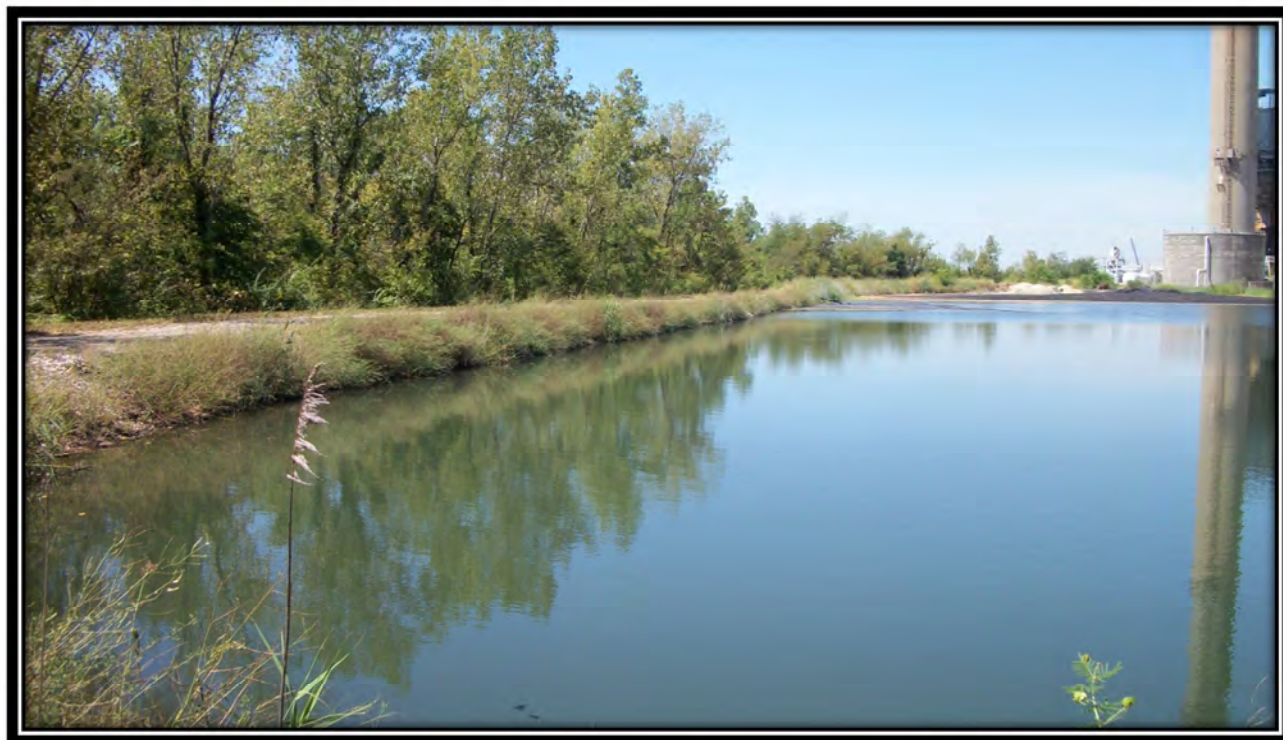
Photo 25 – East pond looking west along upstream south bank

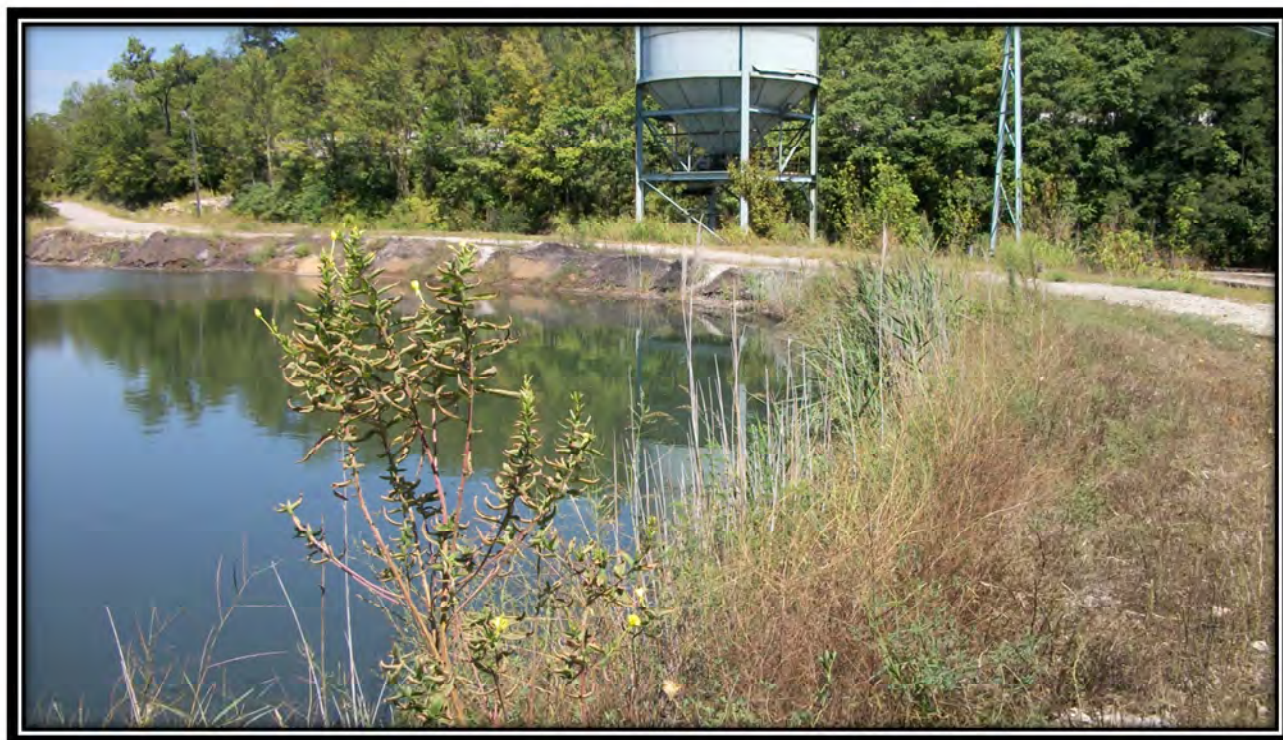
Photo 26 – East pond looking north along upstream east bank

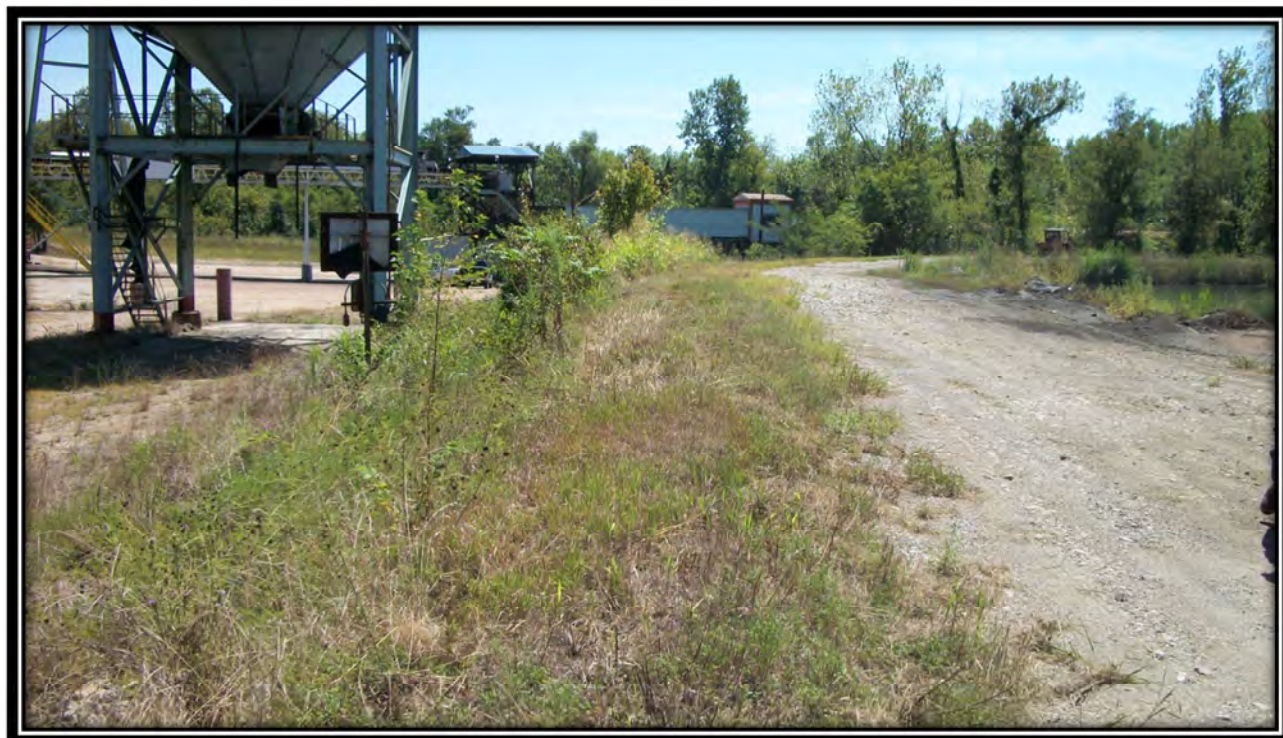
Photo 27 – East pond looking east along downstream north bank near northeast corner

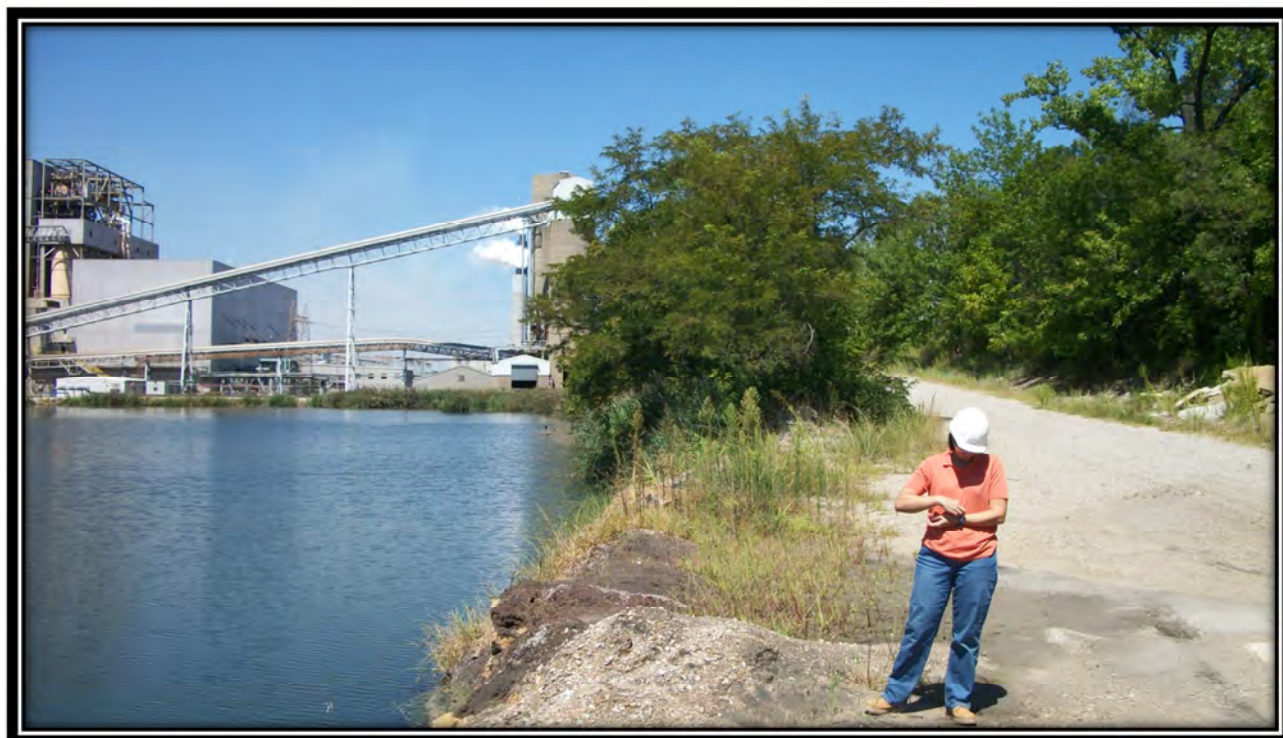
Photo 28 – East pond looking west along upstream north bank

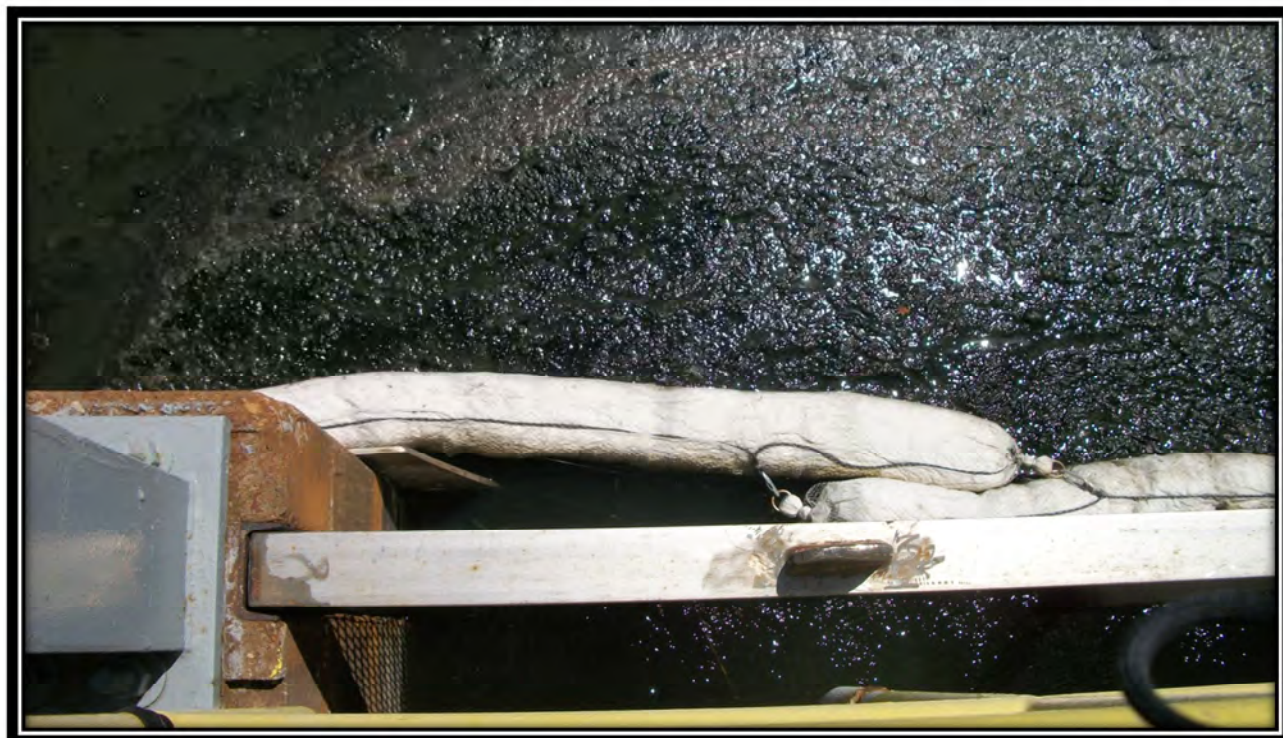
Photo 29 – East pond pump on upstream west bank

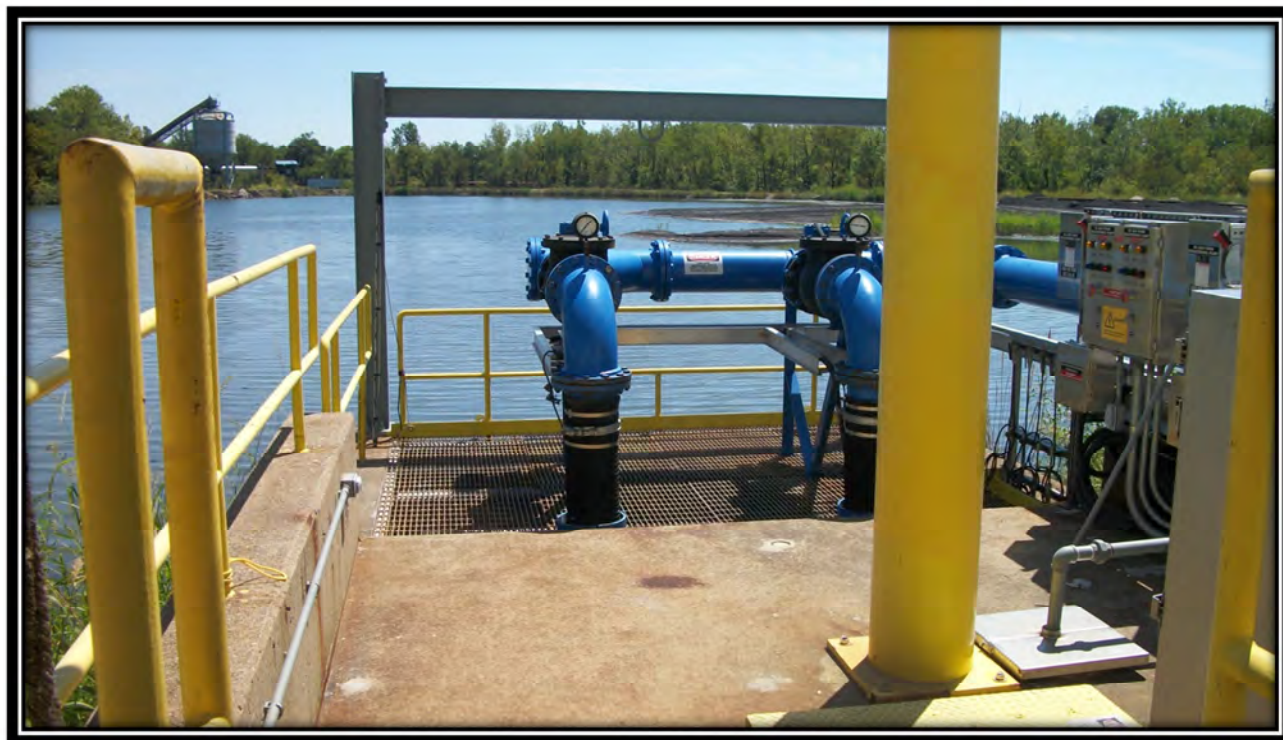
Photo 30 – East pond pump on upstream west bank

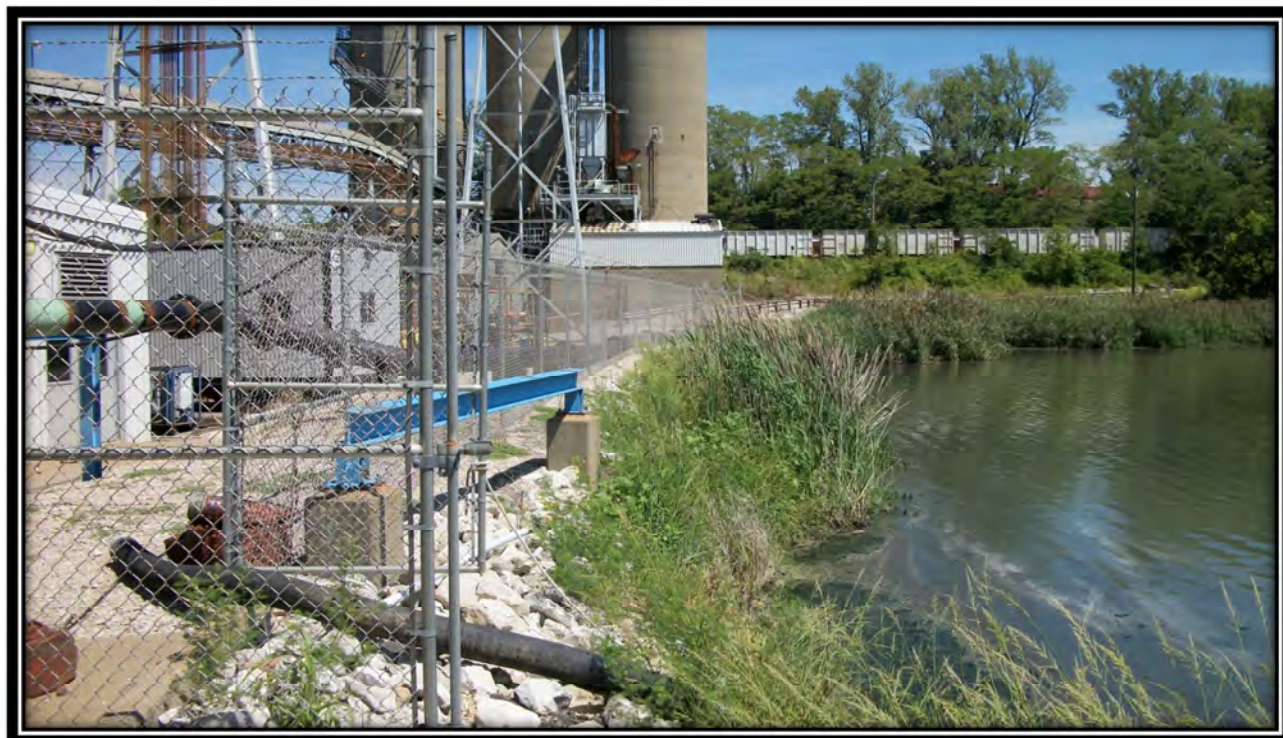
Photo 31 – East pond looking north from pump station along upstream west bank
