**Lower Ash Pond Dam
– A.B. Brown Station Assessment
Report**

**Lockheed Martin
Contractor for the USEPA**

September 2009

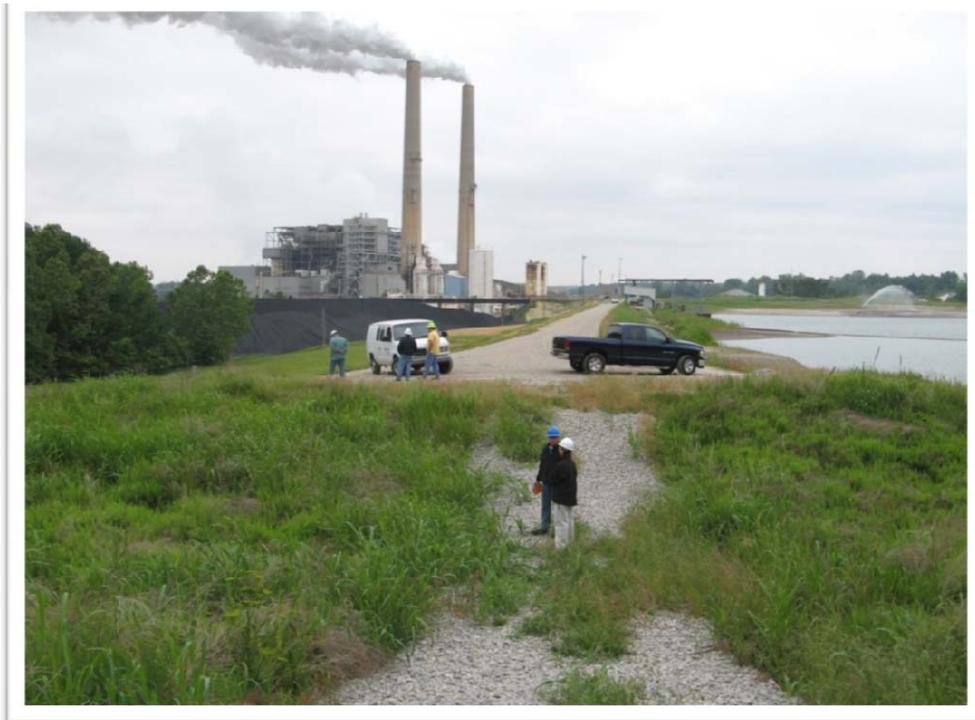
Photo 1- Lower Ash Pond Dam Crest Looking North

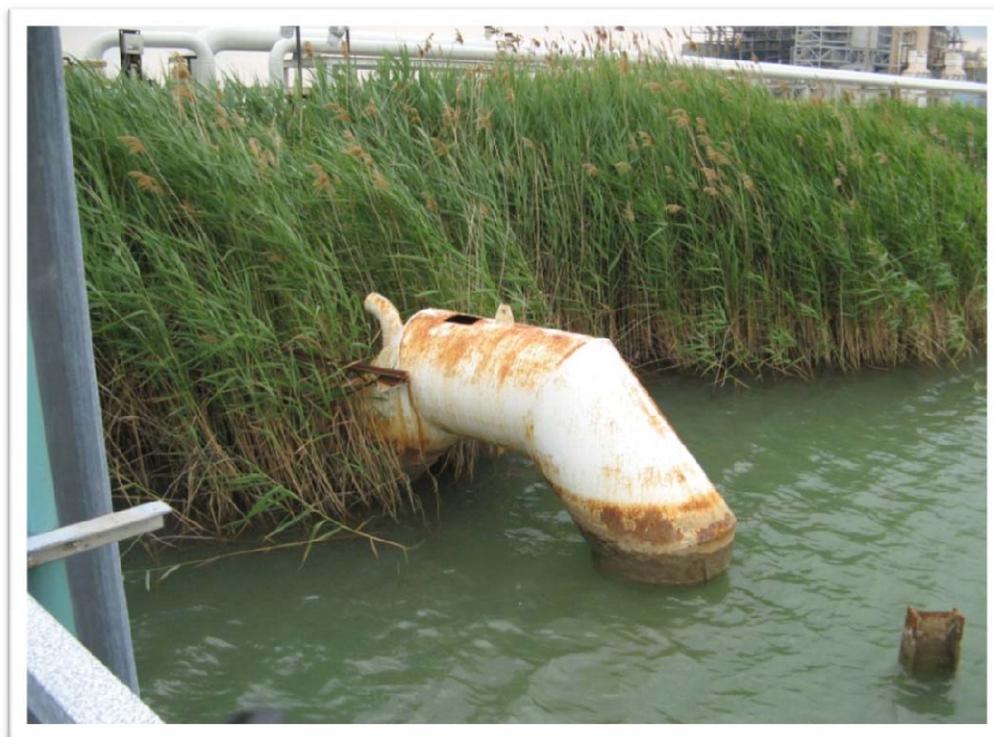
- The phragmites vegetation growing from the upstream slope in the vicinity of the normal pool elevation obscures the slope and inhibits thorough inspection of the embankment in this area.

Photo 2- Principal Spillway Goose Neck Inlet. Note Vegetation on Embankment

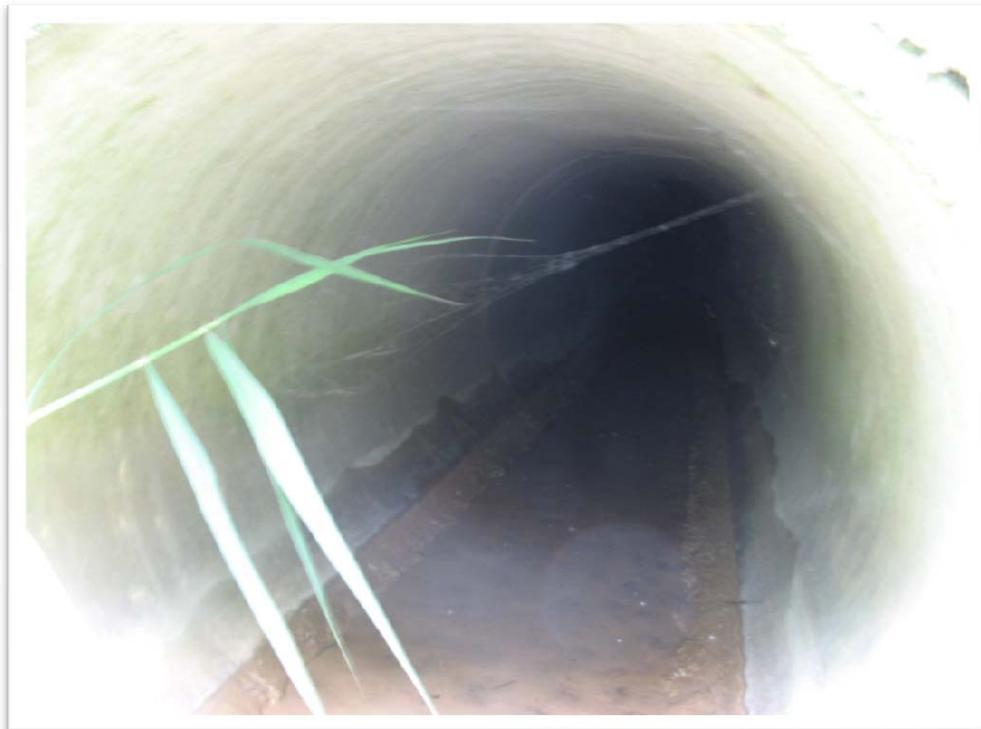
Photo 3- Principal Spillway Outlet

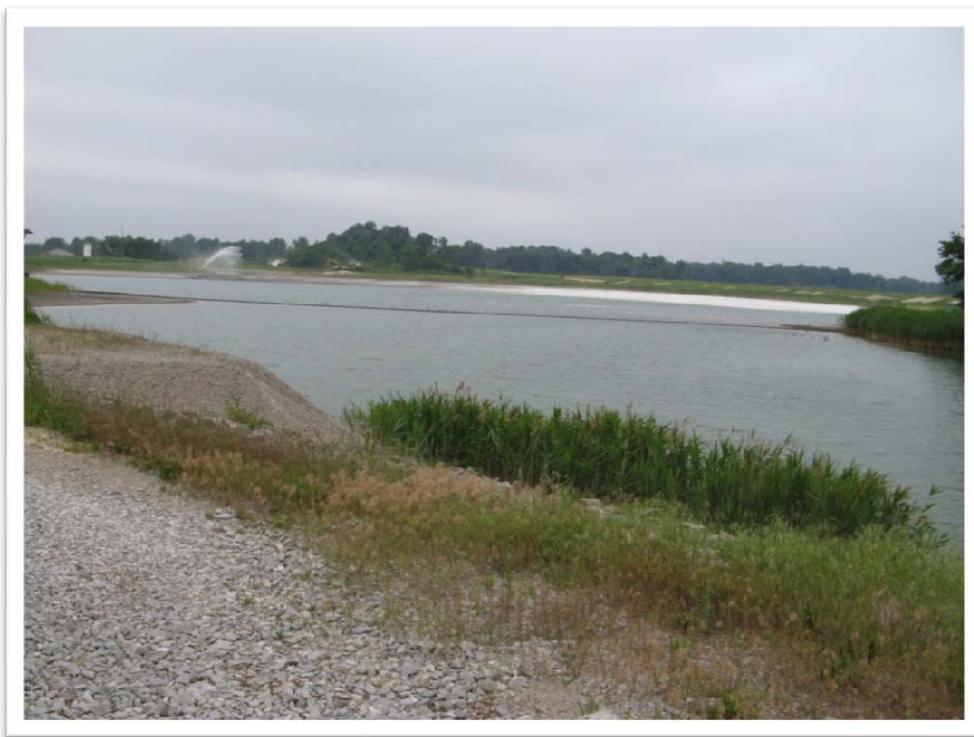
Photo 4- Lower Ash Pond Looking Northeast. Note White Residue from Scrubber Blowdown

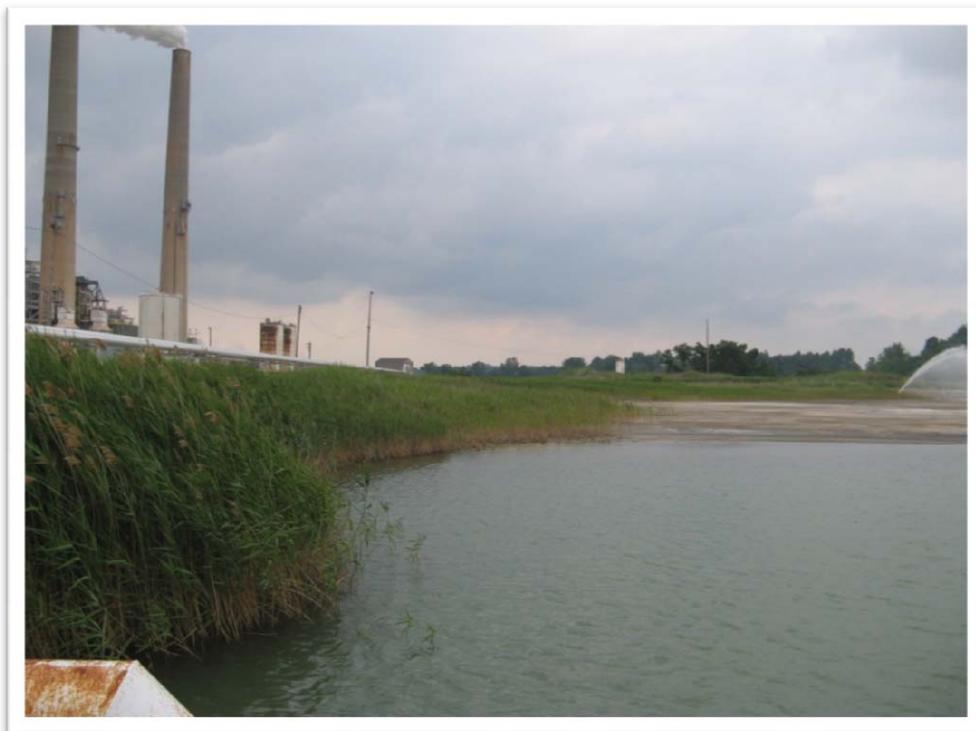
Photo 5- Upstream Embankment Looking North. Note Vegetation on Embankment

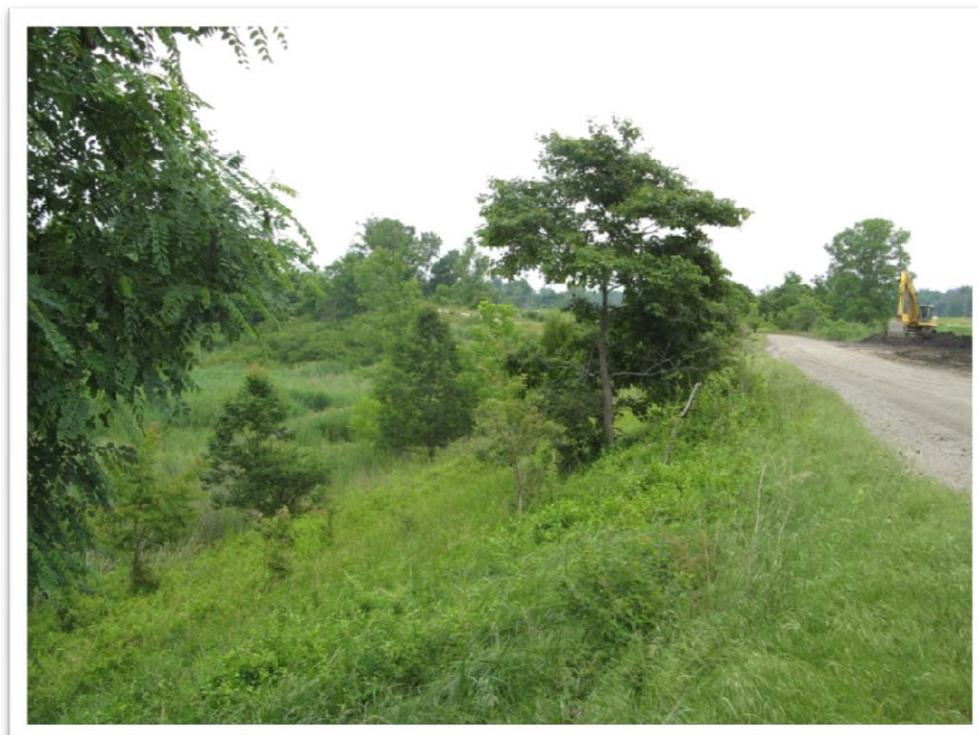
Photo 6- Northwest Area of Downstream Embankment

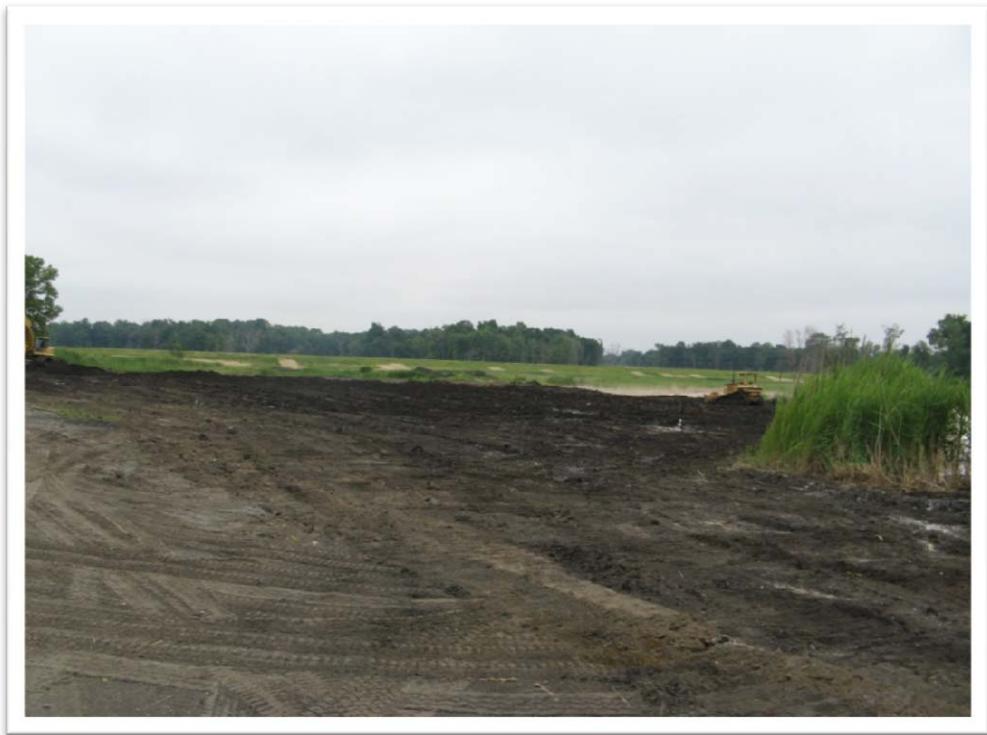
Photo 7- Northern Area of Ash Pond with Solidified Material

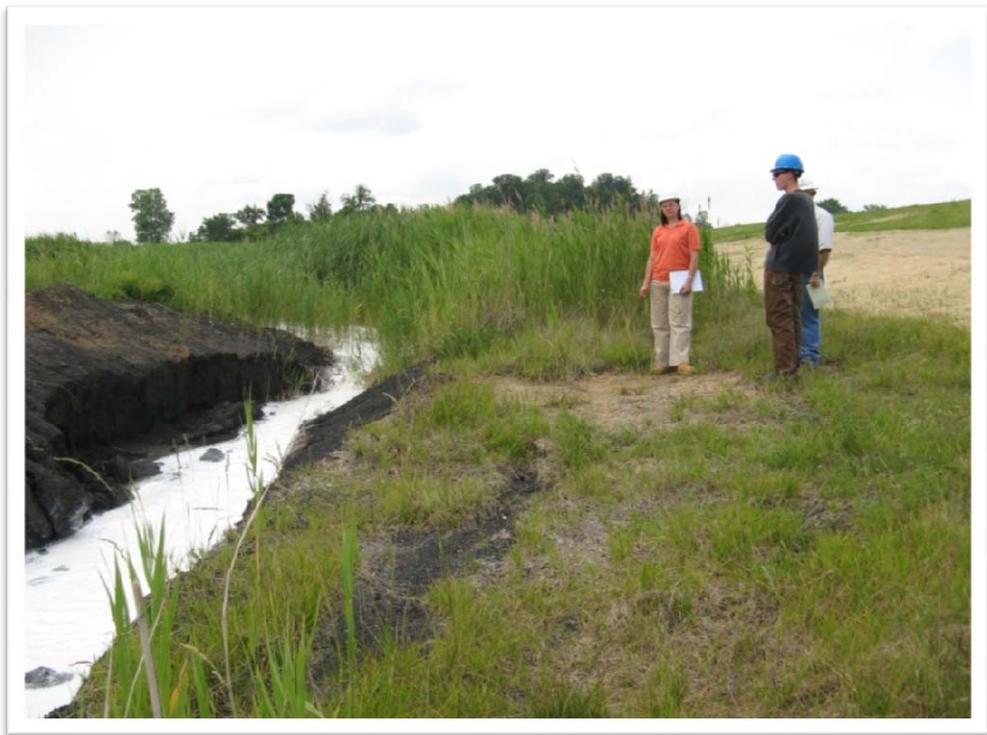
Photo 8- Northern Area of Ash Pond with Channel for White-ish Scrubber Blowdown

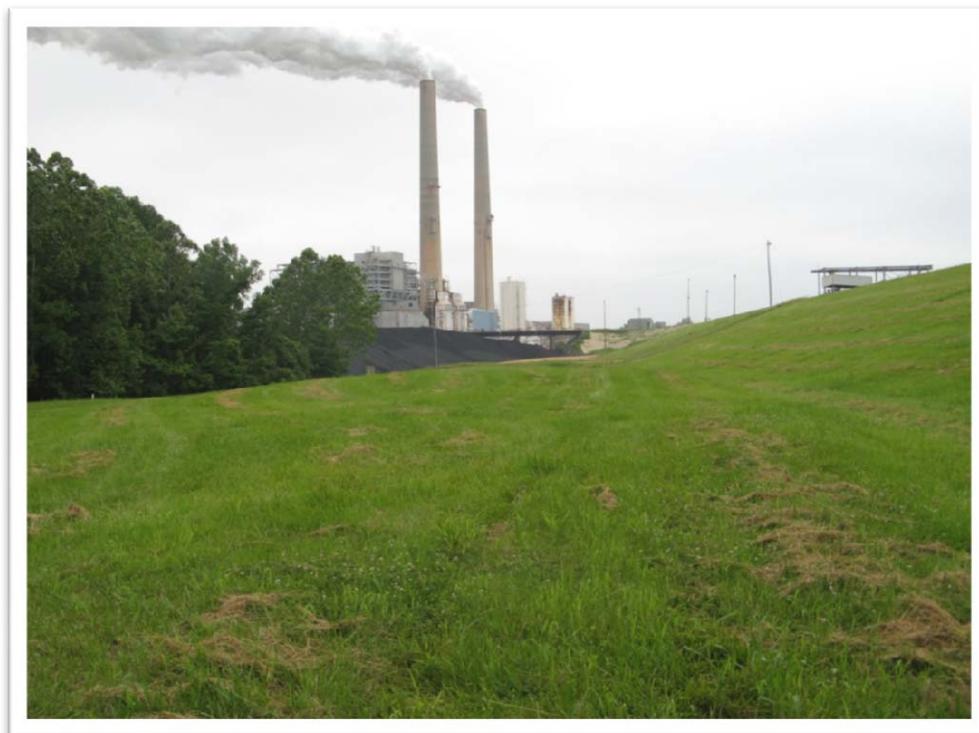
Photo 9- Lower Embankment Berm Area Looking North

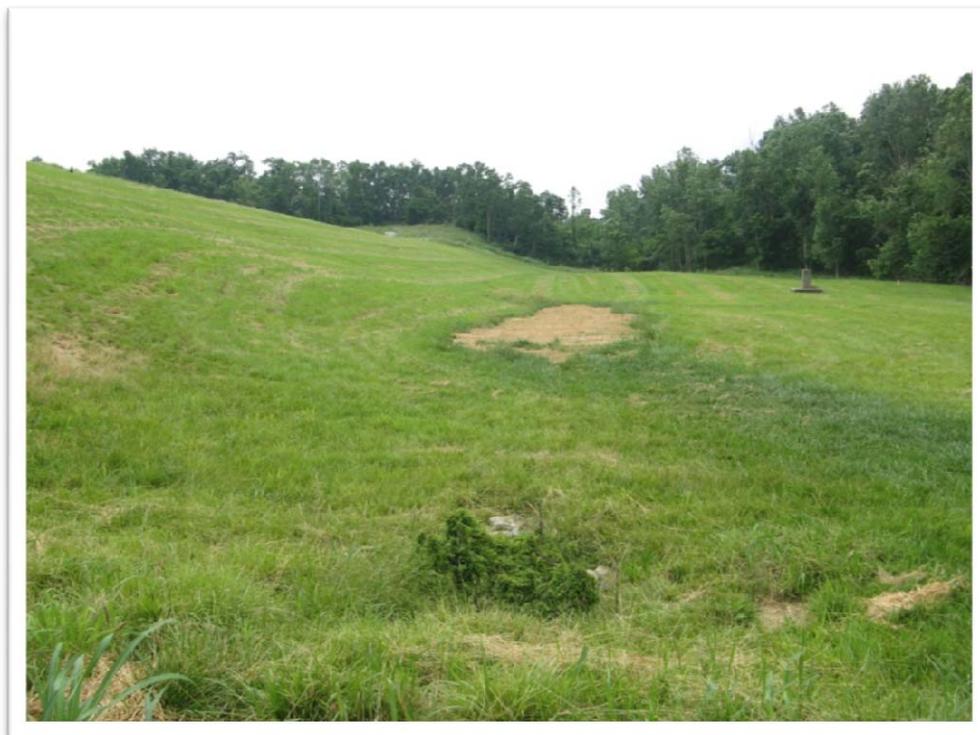
Photo 10- Lower Embankment Berm Area Looking South. Note Repaired Area

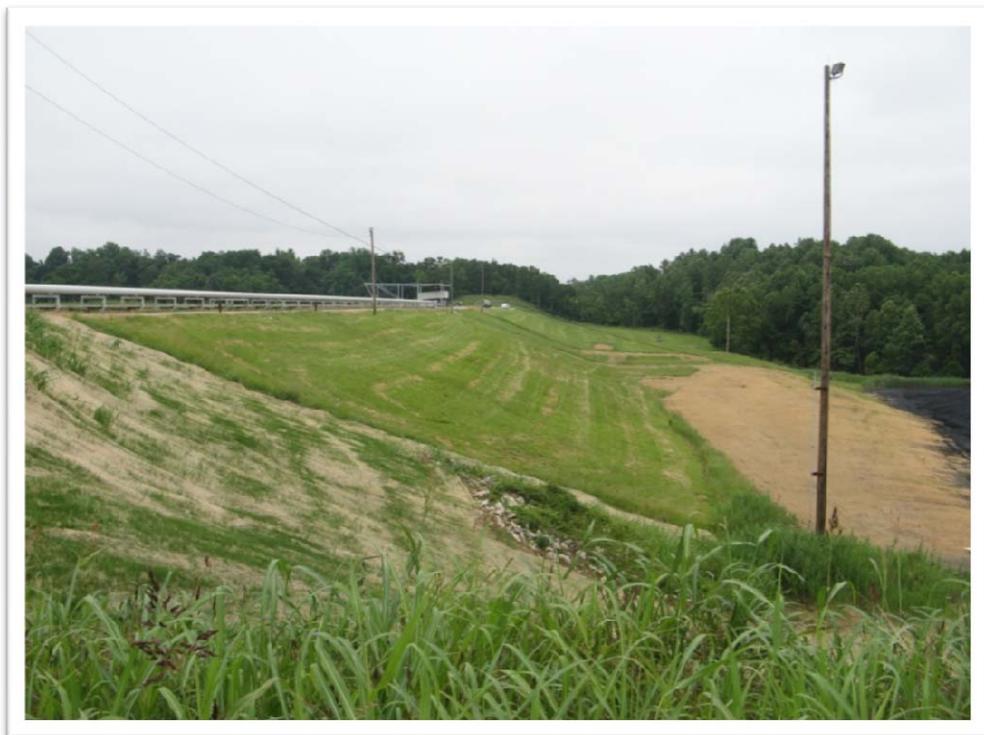
Photo 11- Upper Area of Downstream Embankment Looking South. Note Repaired Area Adjacent to Coal Pile and Random Rip Rap and Vegetation near Utility Pole

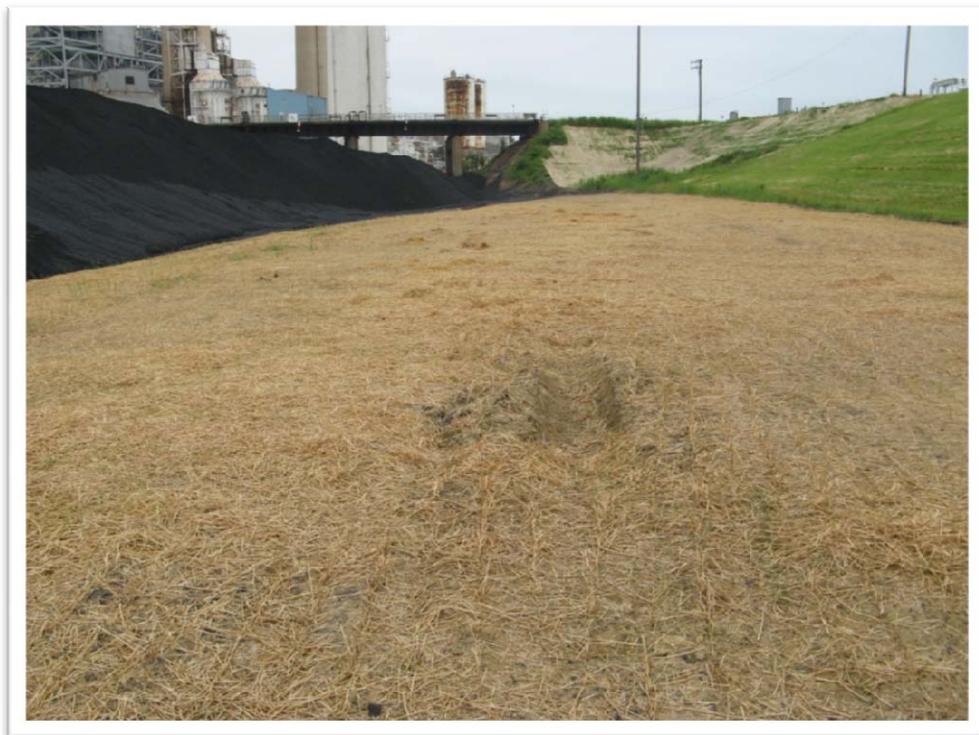
Photo 12- Repaired Area on Berm Looking North. Note Tire Rut in Repaired Area

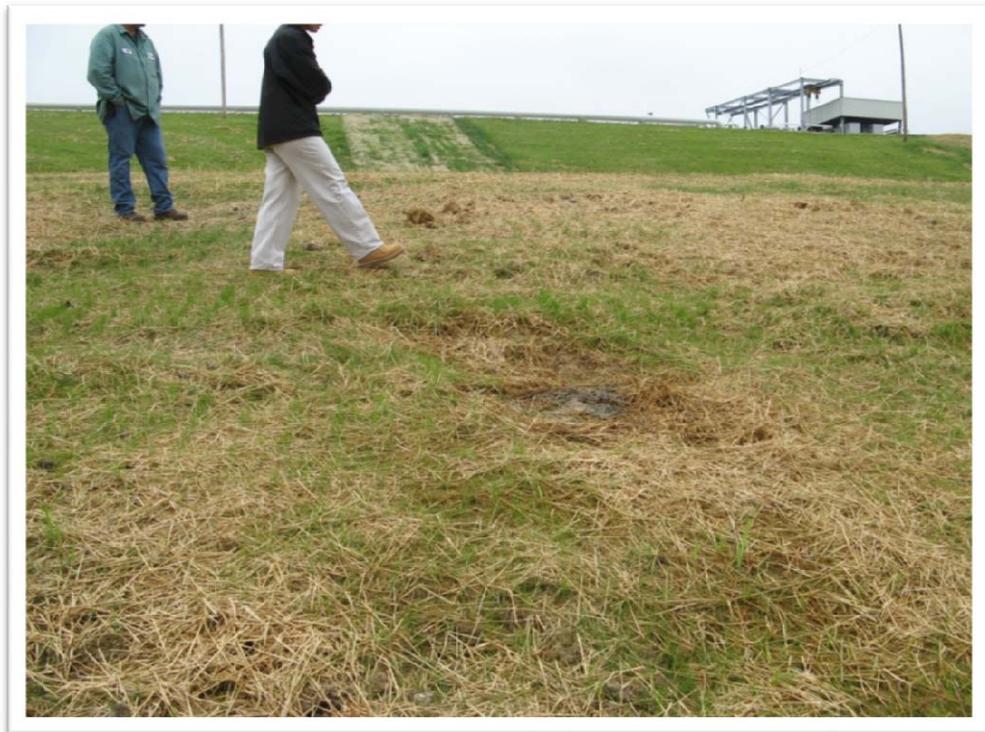
- Ponding of water on the berm surface indicates that the berm does not have sufficient slope for adequate drainage.
 - Trees growing from the lower portion of the downstream slope (to the south of the outlet channel) could threaten the integrity of the embankment, since they could be uprooted during storm conditions with significant displacement of the earth around the roots.

Photo 13- Wet Area on Berm Looking North

2. Depending on the results of the seepage investigation described above, a drain outlet system should be designed to allow free drainage from the Seepage Collection Zone and collection/conveyance of the seepage flow. The berm surface should also be regraded as necessary to promote drainage of rainfall runoff and to minimize infiltration of surface water into the Seepage Collection Zone.

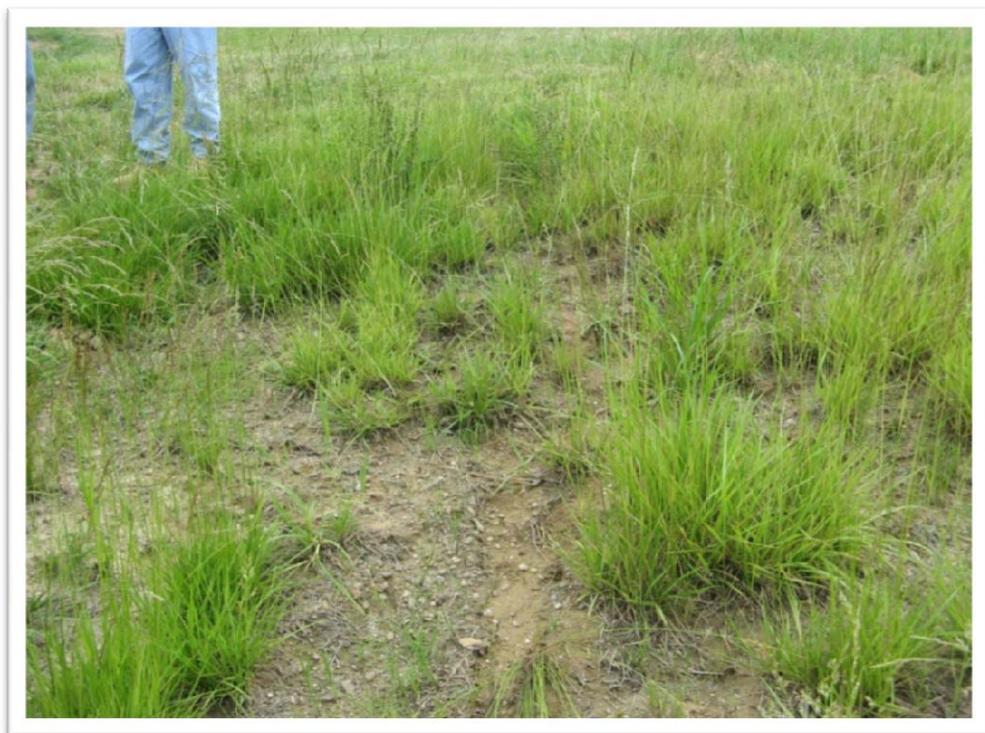
Photo 14- Wet and Eroded Area on Lower Slope Below Berm Looking East

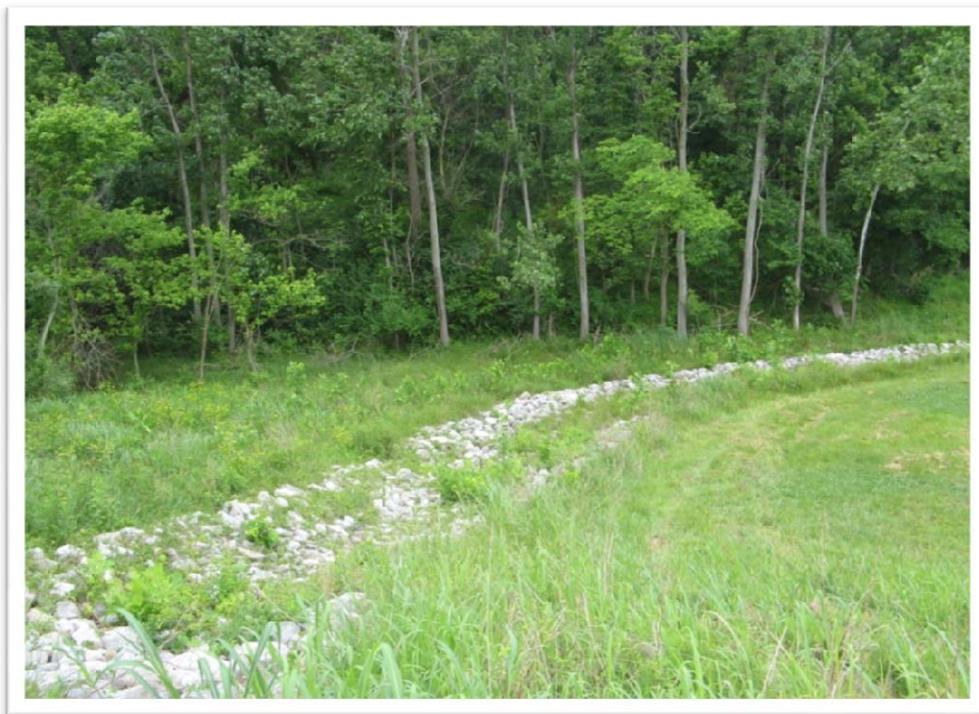
3. Emergency Spillway – The emergency spillway appears to be in satisfactory condition; however, reed-like vegetation growing in the outlet channel could impede flow in the event of a major storm. According to Vectren representatives, the emergency spillway has not been activated since its construction in 2003, which is consistent with the hydrologic/hydraulic analyses that indicate that the peak SDF (50% of 6-hour PMF) pond elevation would be below the emergency spillway crest.

Photo 15- Emergency Spillway Looking West. Note Vegetation Growth in Spillway Outlet Channel

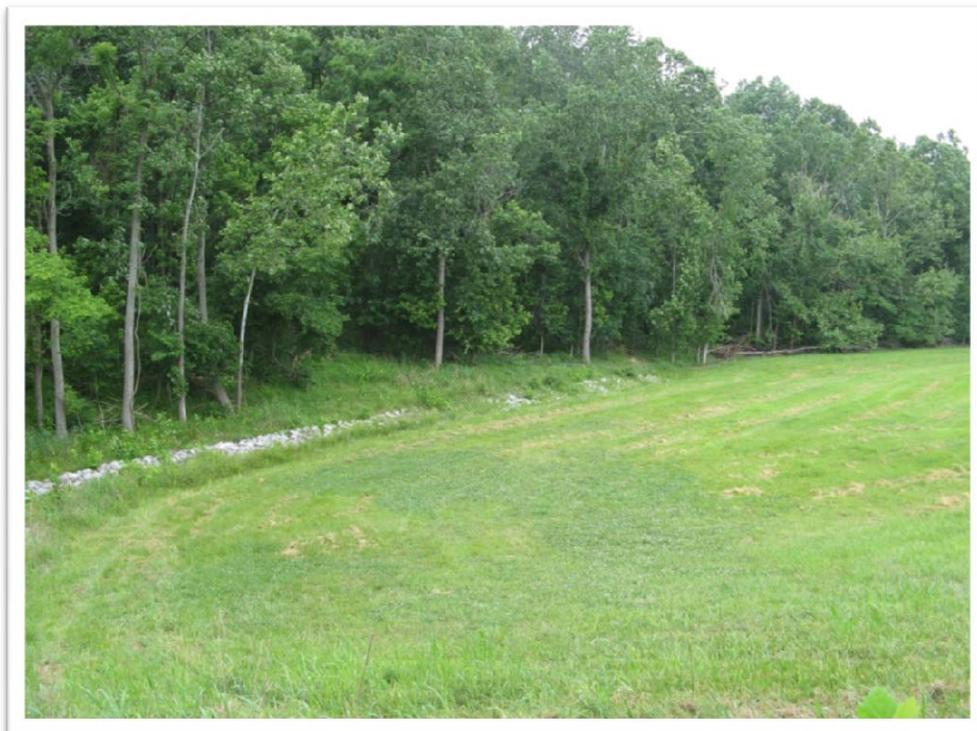
Photo 16- Emergency Spillway Looking West. Note Tree Growth on Lower Embankment Area Adjacent to Spillway Outlet Channel
