**Coal Combustion Waste Impoundment
Round 7- Dike Assessment Report**

Lawrence Energy Center

Ash Impoundment Dike

Westar Energy

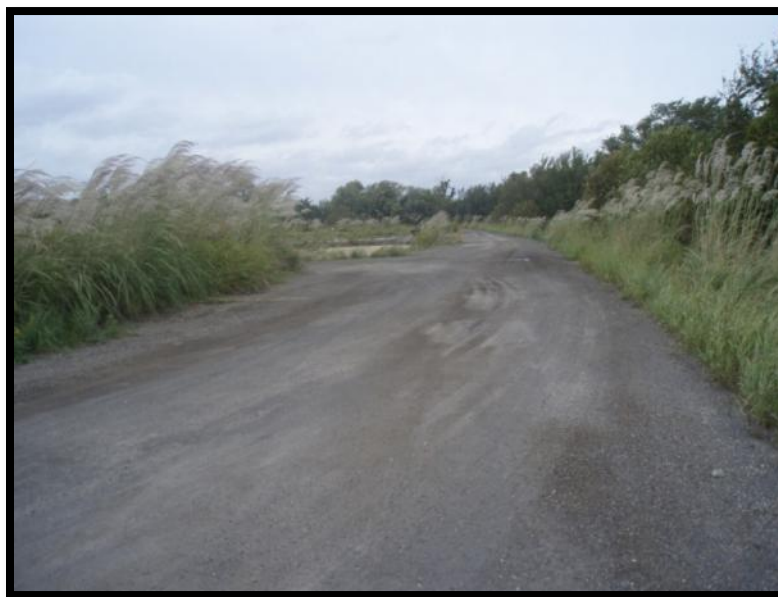
The crest of the northeastern portion of the perimeter dike had no signs of depressions, tension cracks, or other indications of settlement or shear failure, and appeared to be in satisfactory condition. Figure 5.2.1-1 shows the condition of the crest of the northeastern portion of the perimeter dike.

Figure 5.2.1-1: Crest of Northeastern Portion of the Perimeter Dike.

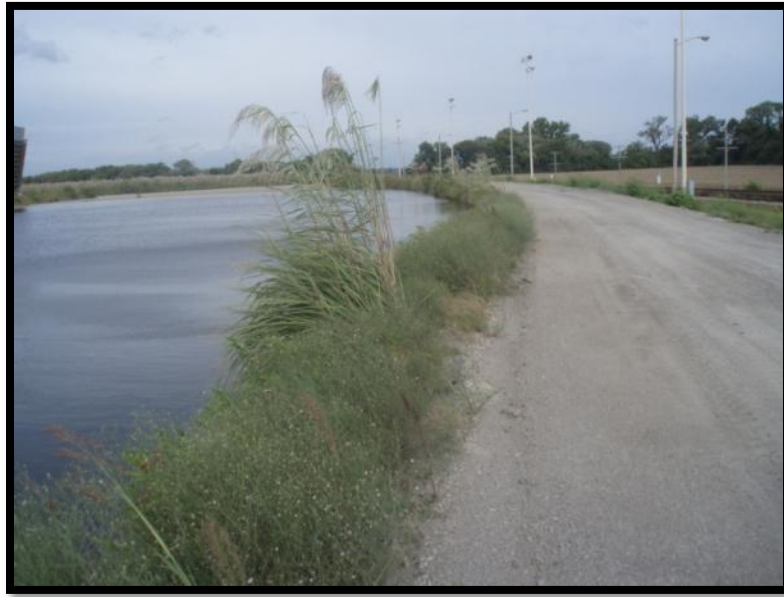
The inside dike embankments are mostly unprotected. Much of the interior embankment was substantially vegetated. Figure 5.2.2-1 shows the general condition of the inside slope of the northeastern portion of the perimeter dike (Area 1).

Figure 5.2.2-1: Inside Slope of the Northeastern Portion of the Perimeter Dike.

There were no observed scarps, sloughs or other indications of slope instability.

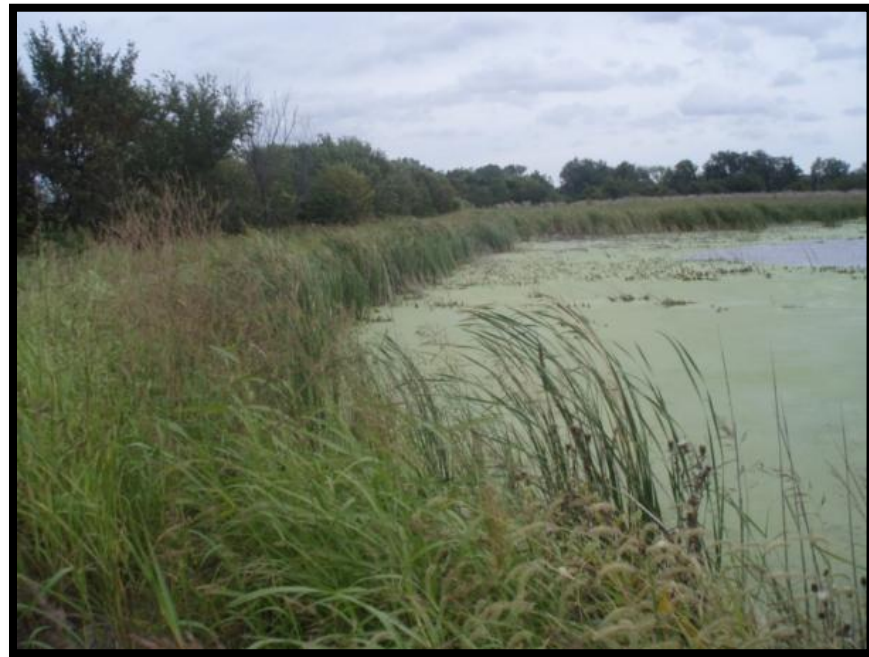
The inside slope of the western portion of the perimeter dike revealed varying amounts of exposed earth embankment depending on the amount of sediment or plant wash contained in them. Similar to most areas, substantial vegetation was observed on the interior of the perimeter dike in Area 4, see Figure 5.3.2-1.

Figure 5.3.2-1: Inside Slope of Northwest Portion of Perimeter Dike (Area 4).

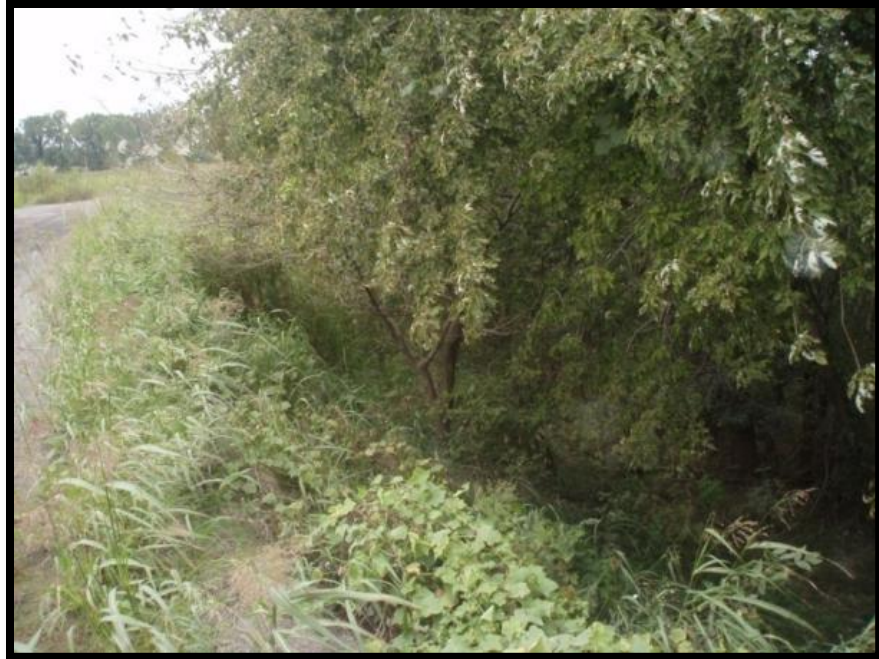
Figure 5.3.3-1 shows the general condition of the outside slope. The outside slope of the northwestern and western portions of the perimeter dike is heavily vegetated, including some large trees in the lower portion and toe areas, see Figure 5.3.3-2. The northwestern portion of the perimeter dike is bordered by Baldwin Creek and a dirt road, which appeared to be seldom-used based upon the vegetation growing in the roadway, see Figure 5.3.3-3. There were no observed scarps, sloughs, bulging, cracks, or depressions or other indications of slope instability or signs of erosion.

Figure 5.3.3-1: Typical Condition of Outside Slope of Western Portion of Perimeter Dike.

The large trees along the lower section of the western embankment should be removed. A vegetation control program should be instituted to control the type, amount, and height of vegetation on the outer embankment slopes. Implementation of this recommendation will prevent the creation of potential seepage paths in the embankment and allow for easier inspection of the outer slopes and toes of the embankment.

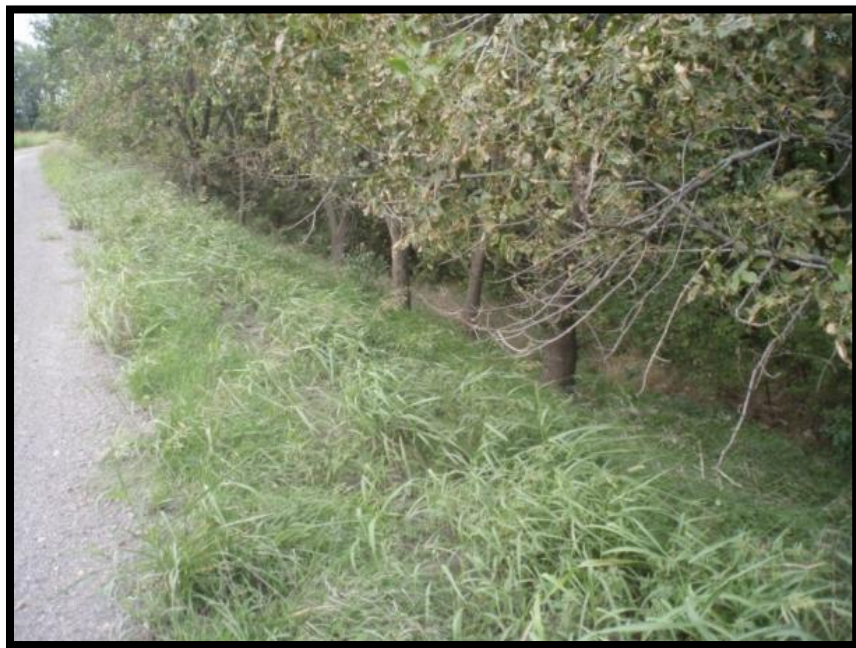
Figure 5.3.3-2: Trees on Outside of Western Portion of Perimeter Dike.

- Immediately implementing a program to remove the large trees along the outside slope of the northwestern portion of the perimeter dike
- Develop and implement a vegetation control program for all the dikes
- Develop a written periodic inspection program of the dike condition
- Check the serviceability of the overflow structure

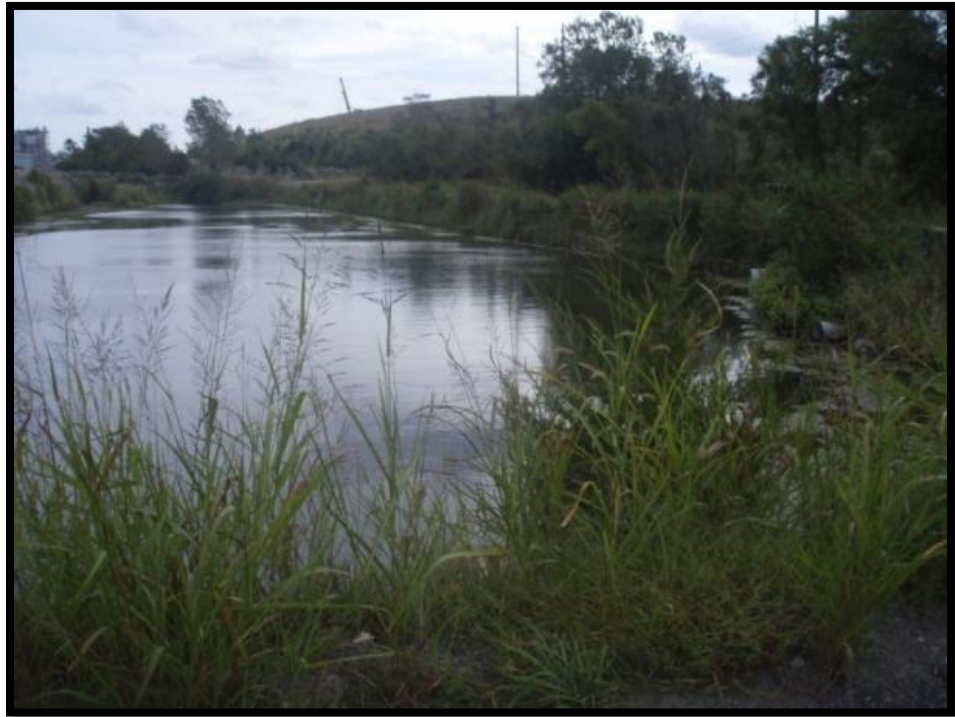
There were no observed scarps, sloughs, bulging, cracks, or depressions or other indications of slope instability or signs of erosion. Figure 5.4.1-1 above shows the general condition of the inside slope of the southern portion of the perimeter dike.

Figure 5.4.1-1: Looking East Across Storm Water Pond on South Side of Ash Pond Area (Southern Edge of Area 3). Closed landfill is seen in background.

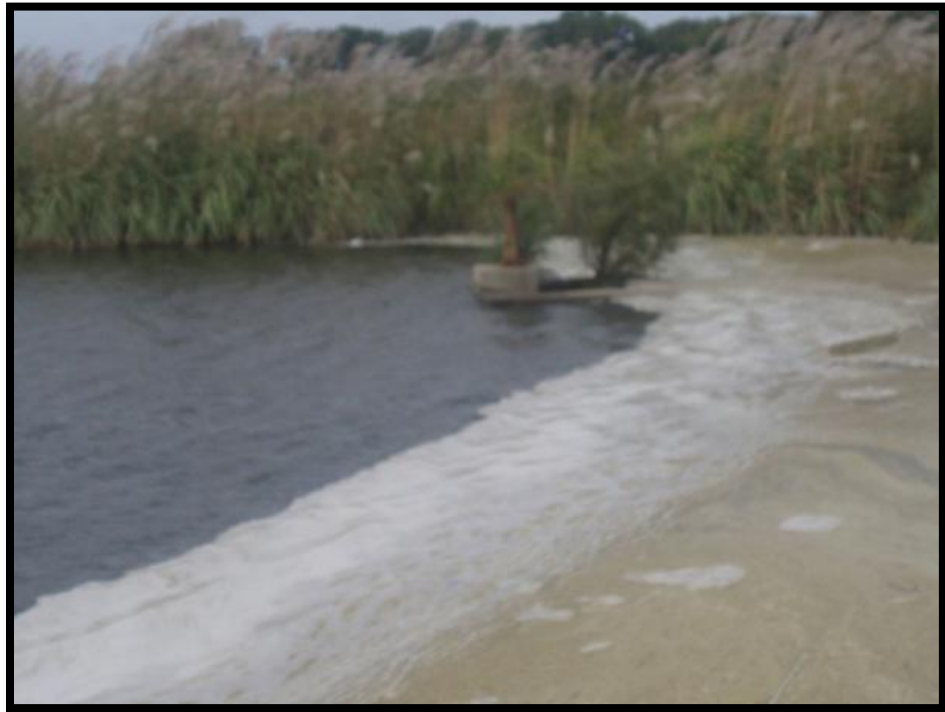
The plant personnel believe the overflow structure in Area 1 has never been used. It visibly appears to be in working condition; however, we were not able to access the discharge outlet, see Figure 5.5.1-1.

Figure 5.5.1-1: Overflow Outlet Structure (Area 1).

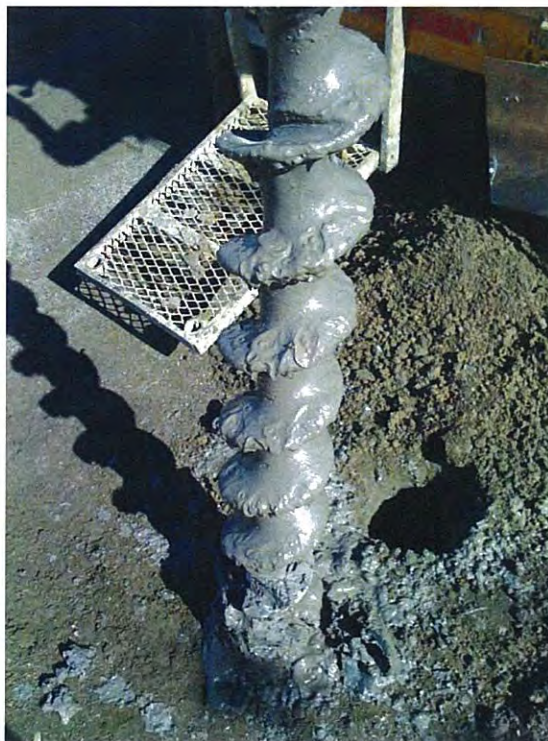
Photograph 6 – Soft saturated clay found in Borehole LEC-7 (looking northeast)

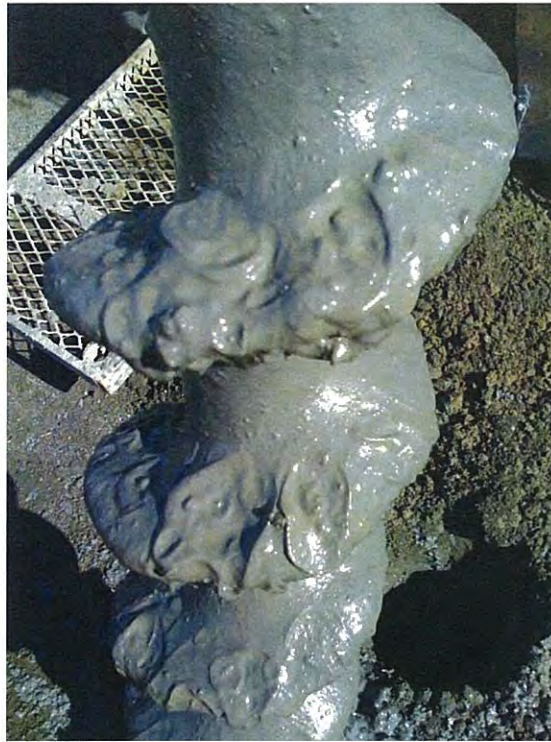
Photograph 7 – Soft saturated clay found in Borehole LEC-7 (looking northeast)

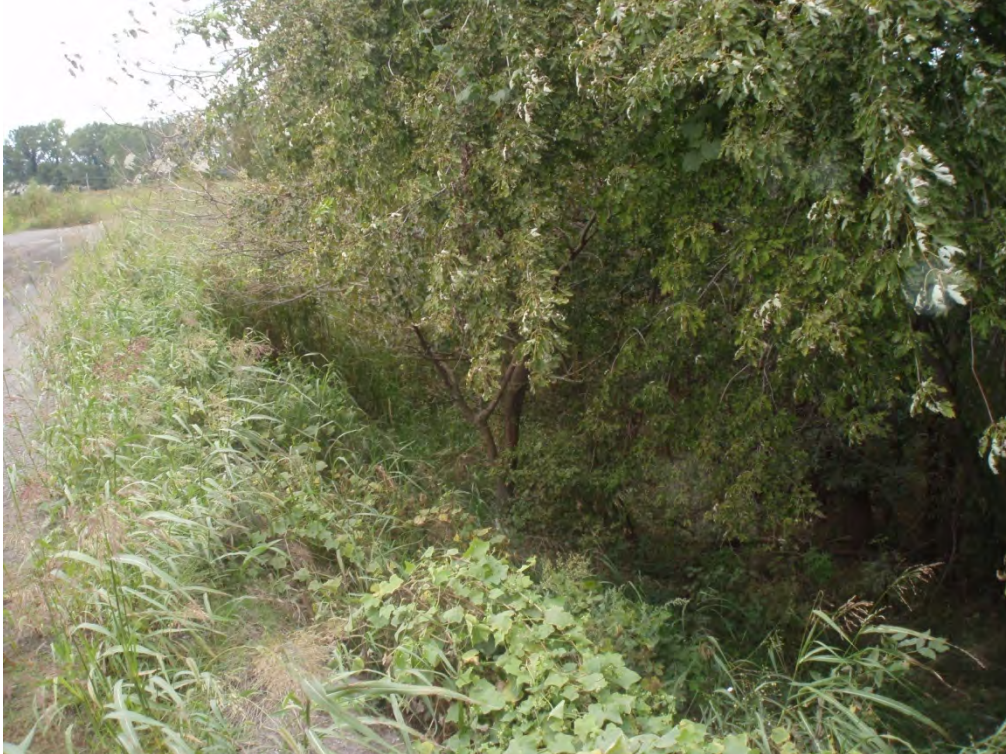
13. EXTERIOR OF NORTHWESTERN PORTION OF PERIMETER DIKE (AREA 4) – HEAVY VEGETATION AND TREES OBSERVED.

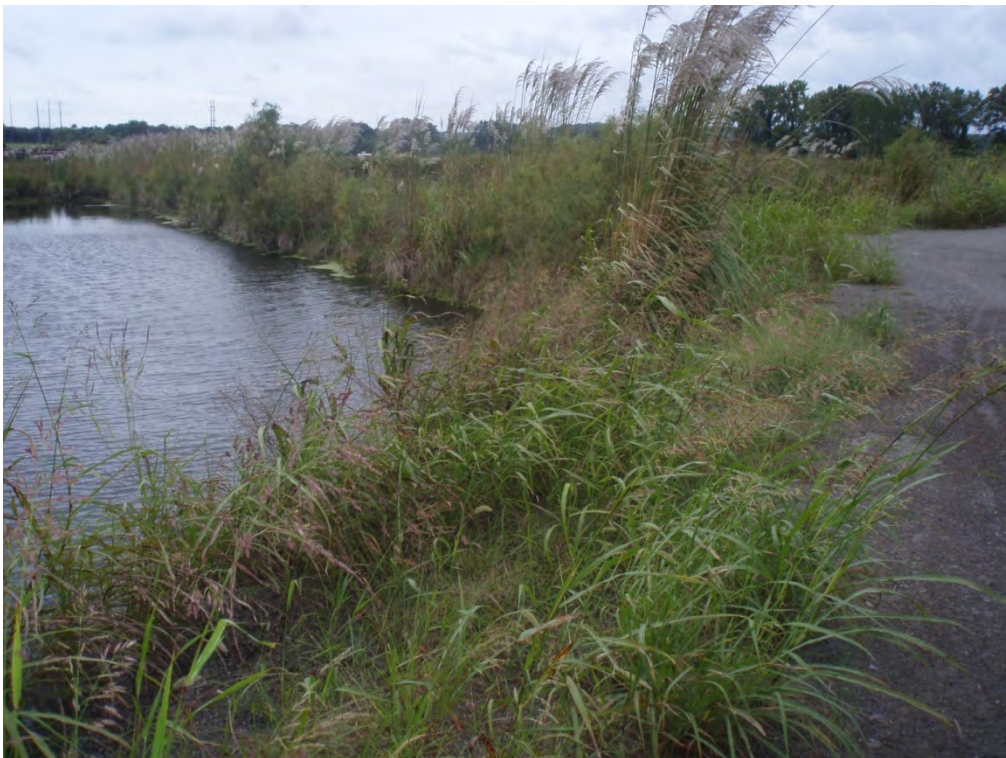
14. INTERIOR OF NORTHWESTERN PORTION OF PERIMETER DIKE (AREA 4)

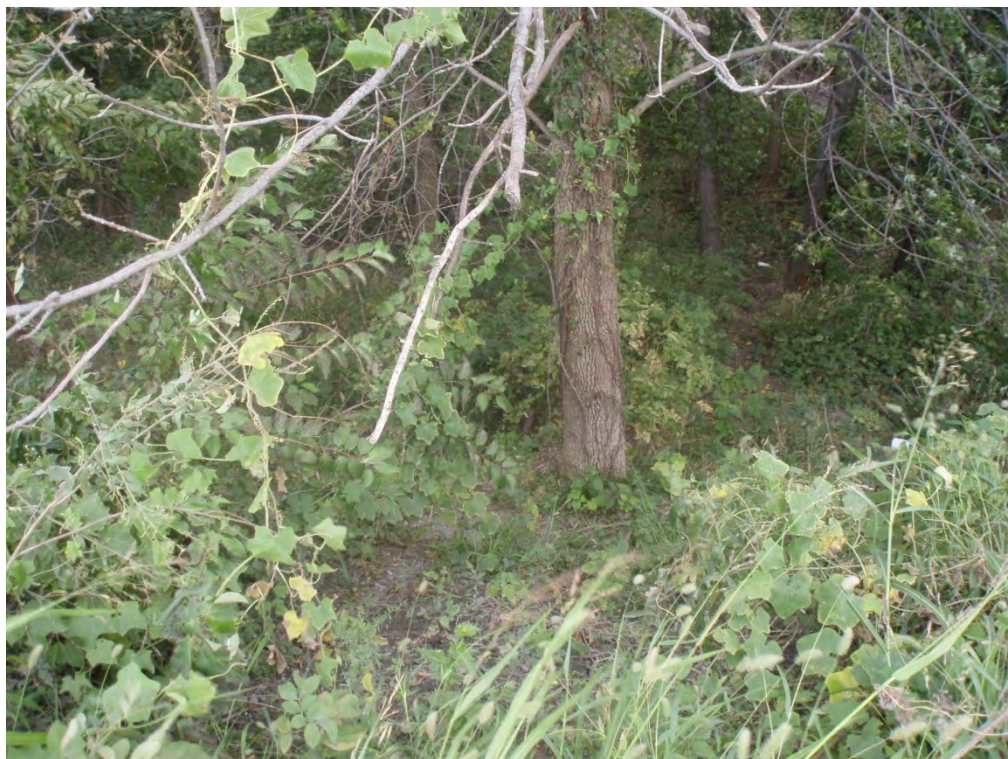
15. EXTERIOR OF NORTHWESTERN PORTION OF PERMETER DIKE (AREA 4) - 10" TREE OBSERVED AT TOE OF EMBANKMENT

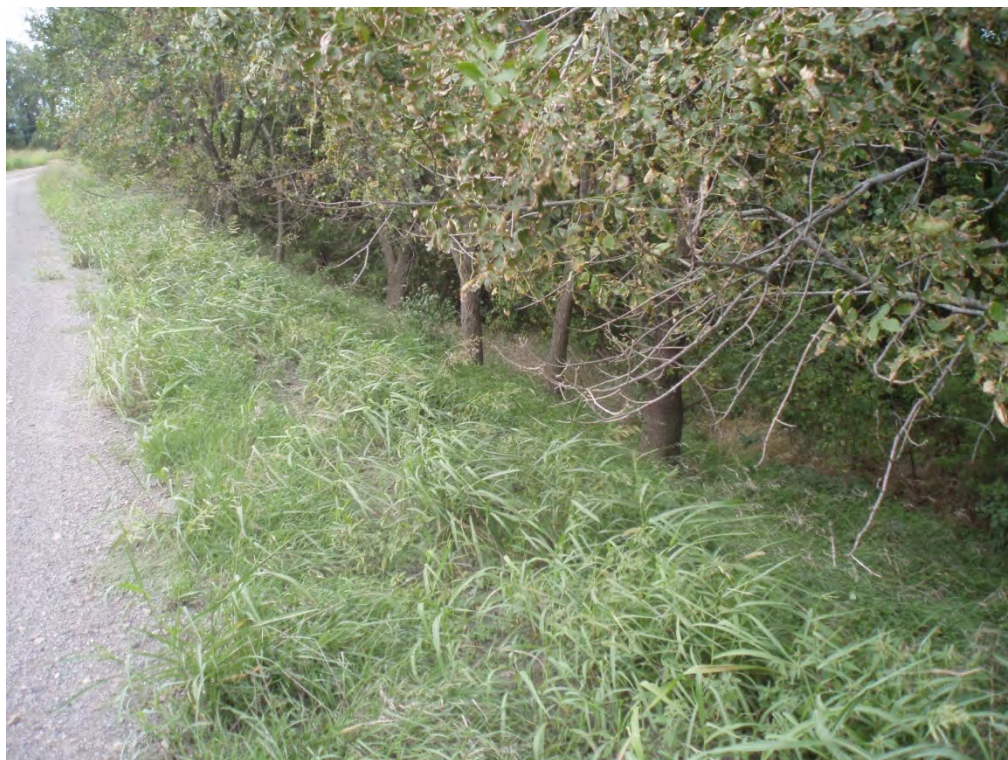
16. EXTERIOR OF NORTHWESTERN PORTION OF PERMETER DIKE (AREA 4) - MULTIPLE TREES OBSERVED ON EMBANKMENT

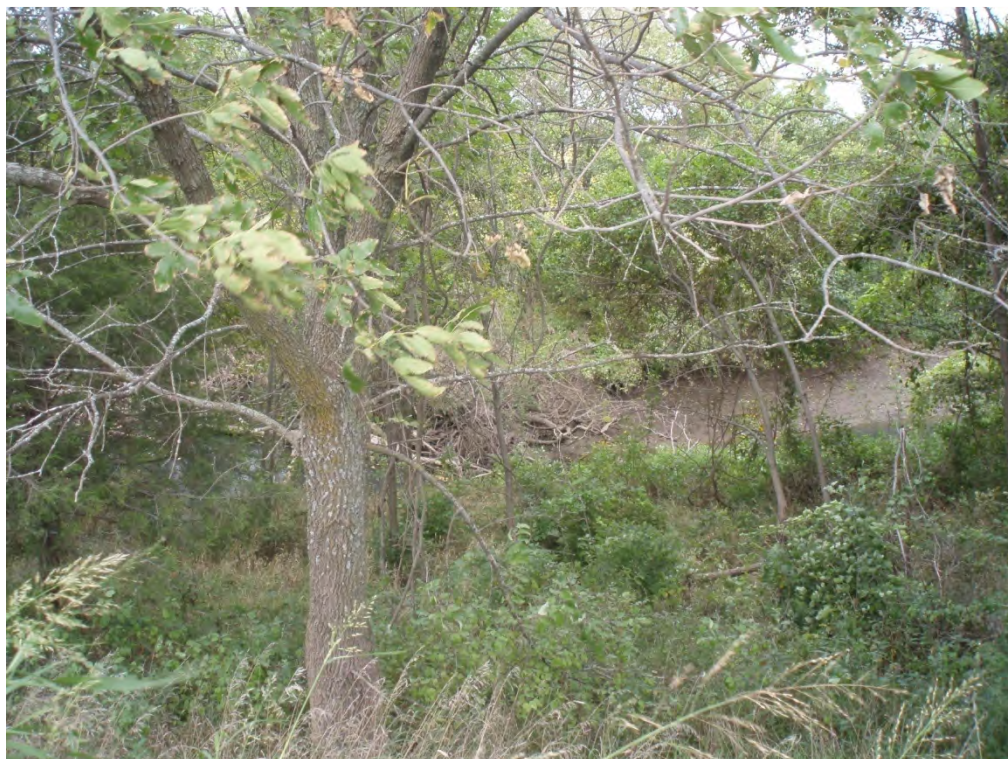
17. BALDWIN CREEK FLOWING NEAR TOE OF NORTHWESTERN PORTION OF PERIMETER DIKE (AREA 4)

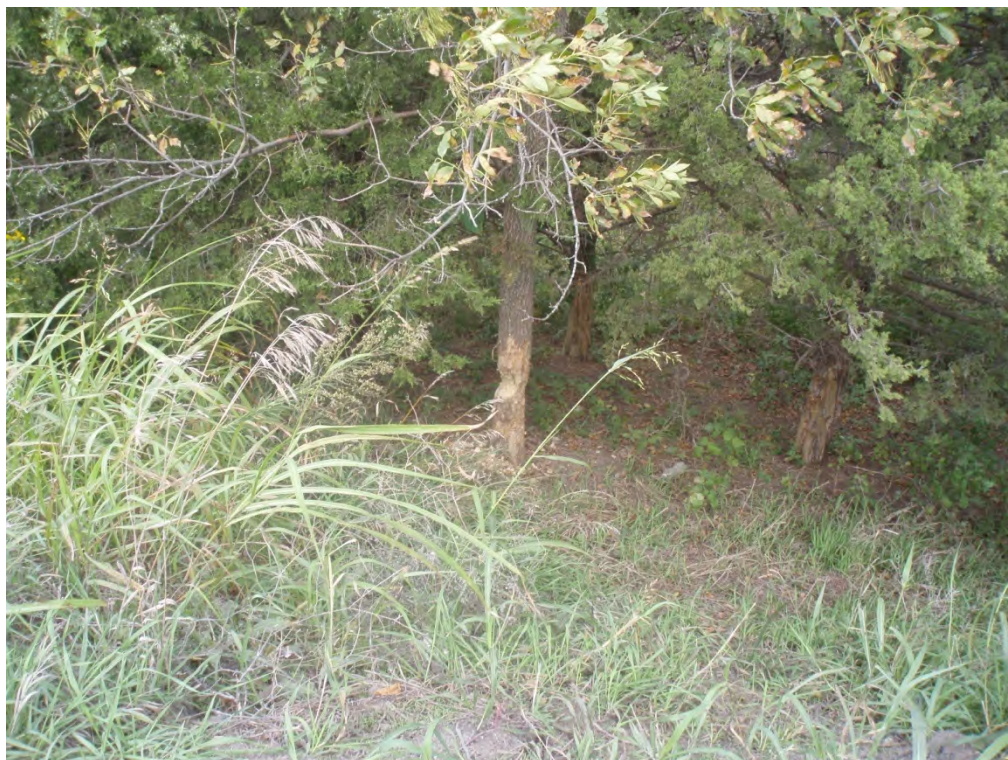
18. EXTERIOR OF NORTHWESTERN PORTION OF PERIMETER DIKE (AREA 4) - 10" TREE OBSERVED AT TOE OF EMBANKMENT

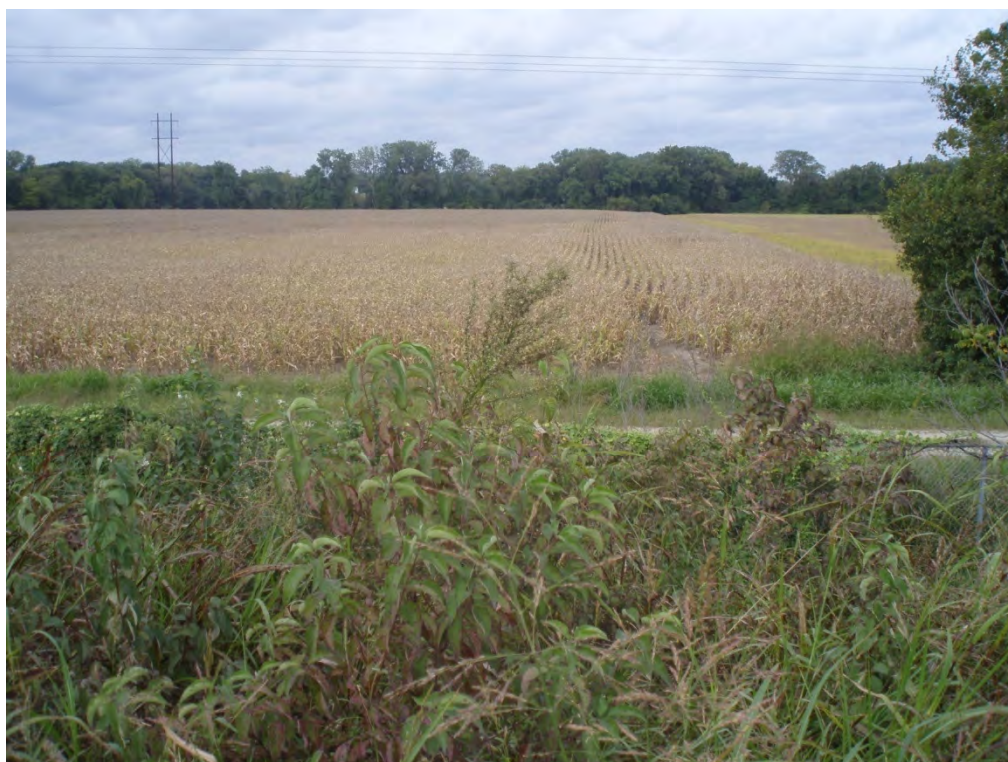
22. LOOKING WEST TOWARDS AGRICULTURAL HELDS - TAKEN FROM TOP OF WESTERN PORTION OF PERMETER DIKE (AREA 3)

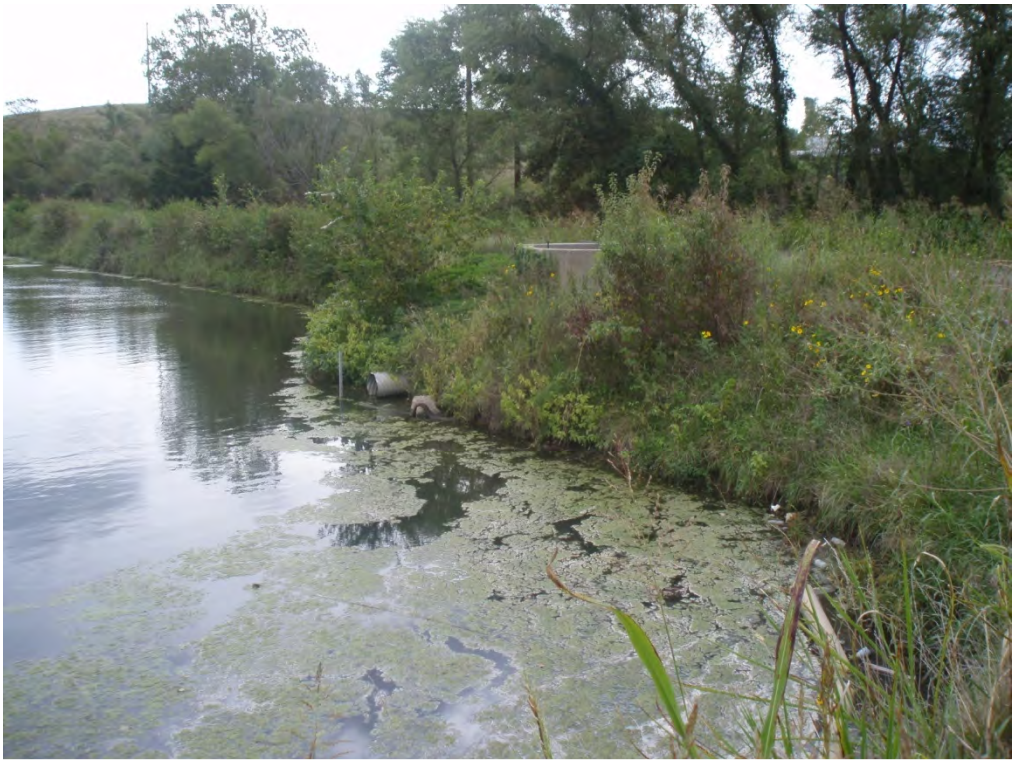
24. STORM WATERPOND DISCHARGE PIPE ON INTERIOR OF SOUTH SIDE OF AREA 3.

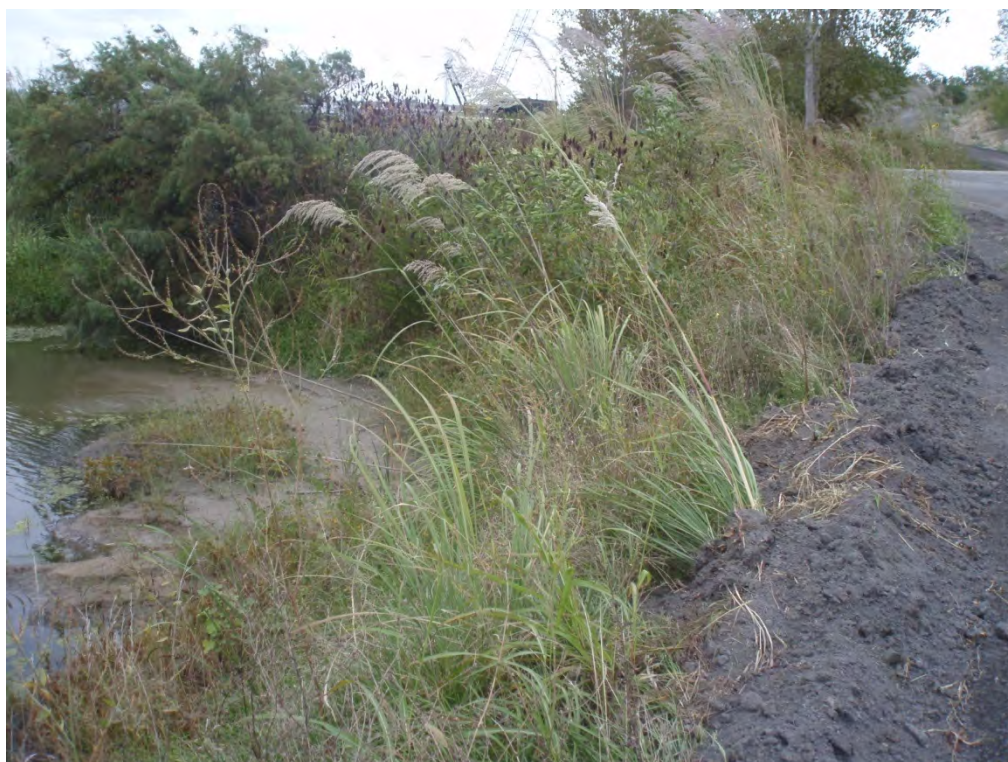
28. INTERIOR VIEW OF PERIMETER DIKE TO EXISTING GRADE/ROAD EMBANKMENT ALONG SOUTH SIDE OF AREA 3.
