Report of Dam Safety Assessment of Coal Combustion  
Surface Impoundments  
Westar Energy  
Tecumseh Energy Center, Tecumseh, KS

AMEC Project No. 3-2106-0183.0001

May 2011

Westar Energy's Tecumseh Energy Center's Area 1 and Area 2 (ash ponds) were assessed on October 26, 2010.

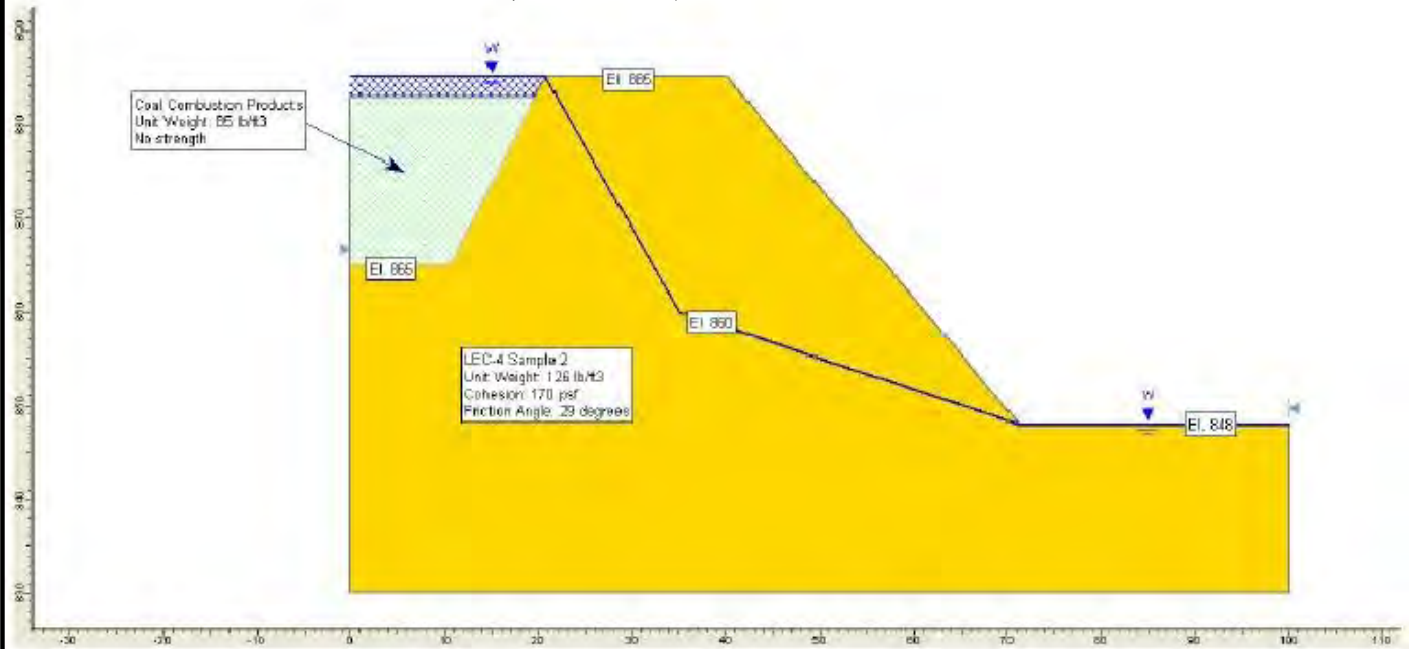
## SECTION 1 (AREA 1 POND)

Golder noted that, “Based on the factors of safety computed using SLIDE, some portions of the CCP storage facilities at TEC [1] may be only stable under static conditions and may become

unstable during a seismic event or if loaded beyond the assumed conditions.” Computed static and seismic factors of safety for Section 1 do not meet minimum acceptable factor of safety criteria. The stability of Section 2 was found to be acceptable, with factors of safety exceeding accepted minimums.

Following the initial stability calculations, Golder performed additional analysis and determined that acceptable factors of safety would be obtained for Section 1 if the existing slope was decreased (flattened), specifically to 1.7:1 (H:V). Calculated factor of safety values for the flattened slope section were determined to be 1.5 and 1.3 for static and seismic conditions, respectively. Figure 11 illustrates the boundaries of the over steep slope area of the Area 1 Pond’s north embankment that would require repair.

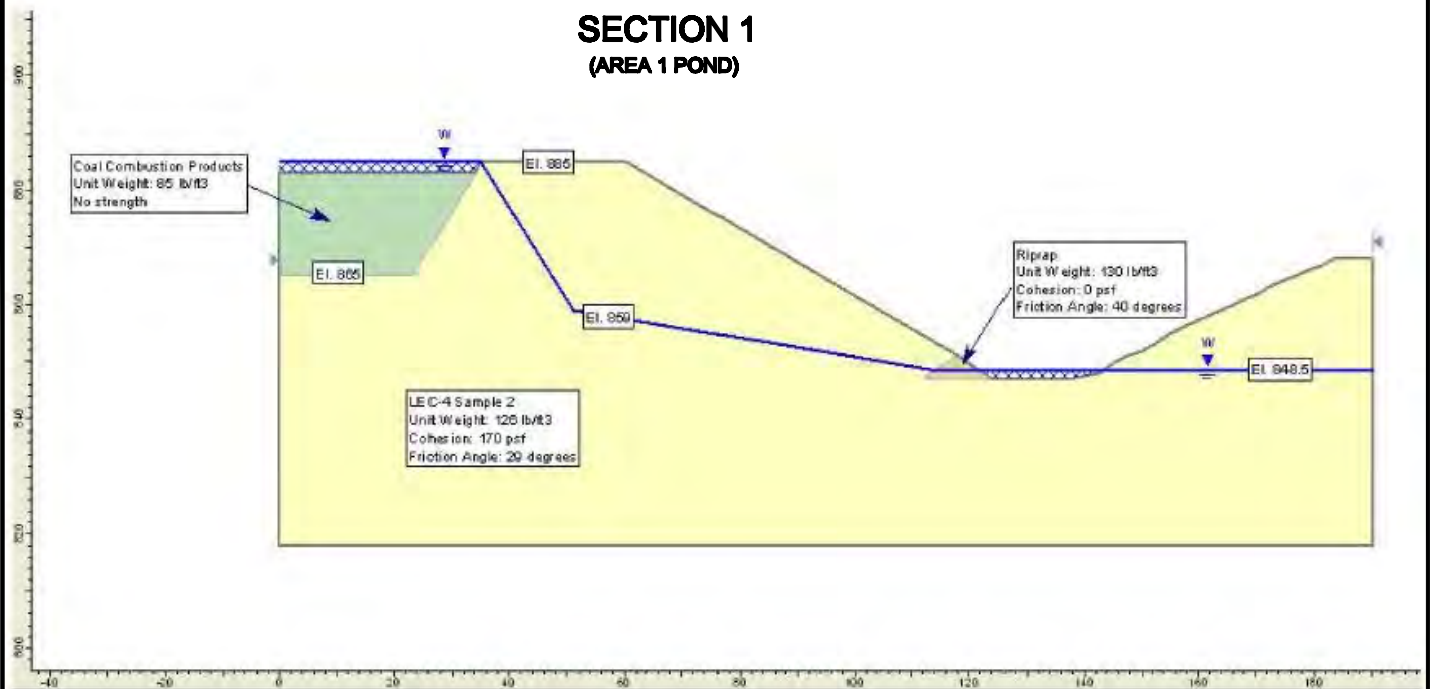
## SECTION 1 (AREA 1 POND)

<b>Cross Section and Analysis Condition</b>	<b>Computed Factor of Safety</b>	<b>Minimum Factor of Safety*</b>
Section 1 - Static	1.5	1.5
Section 1 - Seismic	1.3	1.1
Section 2 - Static**	1.5	1.5
Section 2 - Seismic**	1.4	1.1

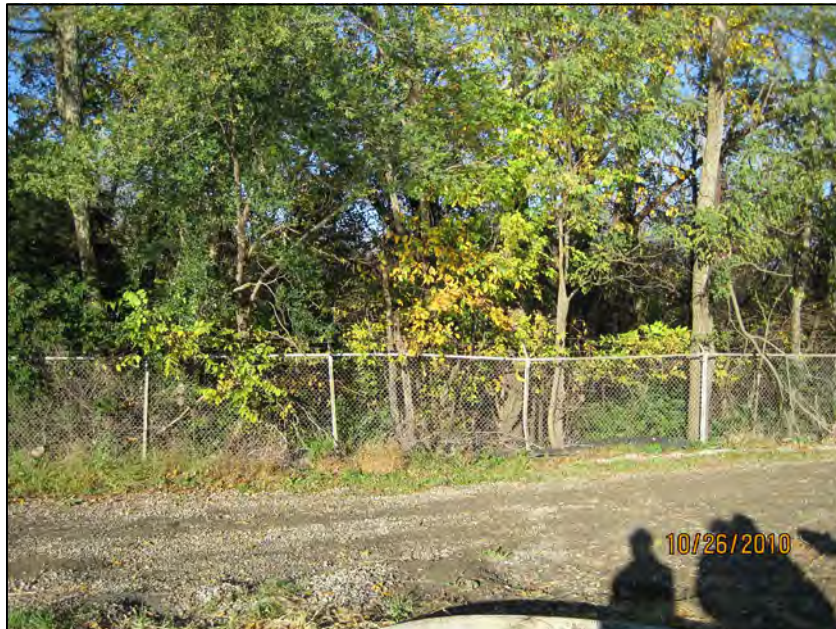
**1-12**  
**CENTRAL WEST SIDE LOOKING WEST AT  
TREES ON UPSTREAM SLOPE OUTSIDE FENCE**

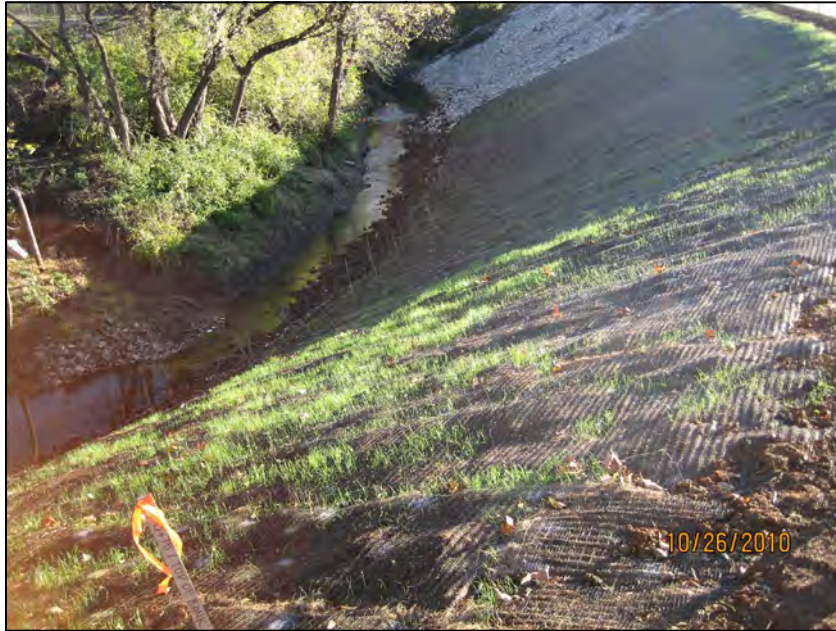
1-13

LOOKING NORTHEAST FROM NORTH CREST AT TECUMSEH CREEK AND  
AREA OF TREE/VEGETATION REMOVAL AND REPAIR ON DOWNSTREAM SLOPE

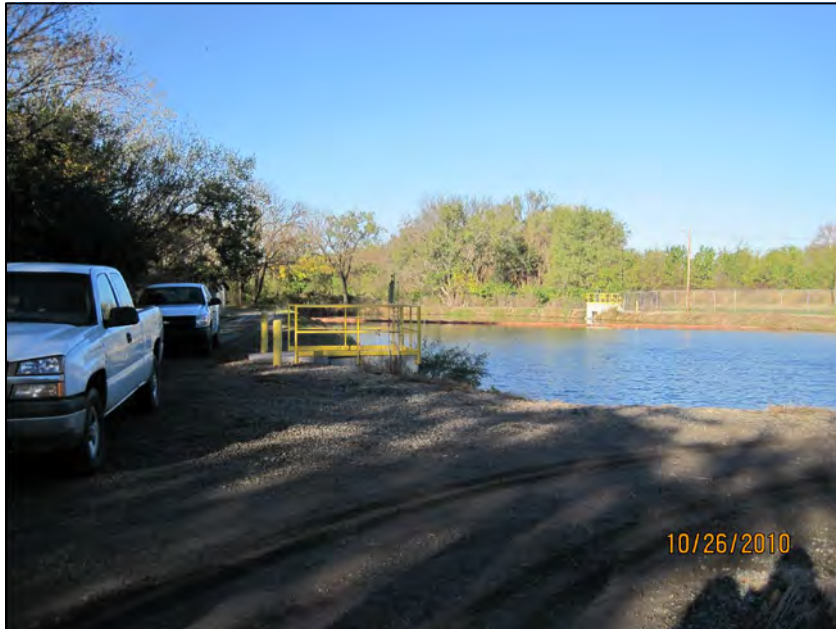
1-14

LOOKING SOUTH AT AREA 1 NORTH EMBANKMENT DOWNSTREAM REPAIR

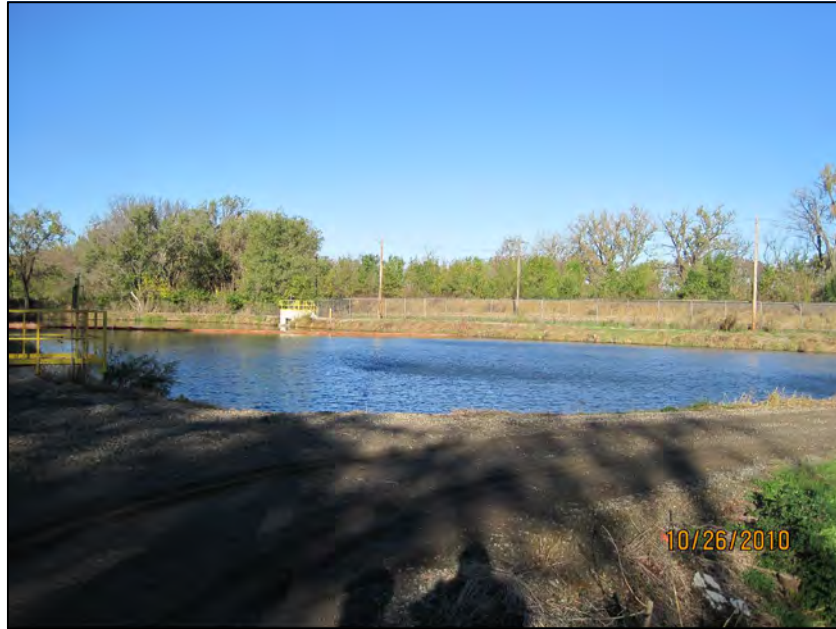
1-15

**TREES AND VEGETATION ADJACENT TO KPDES  
OUTFALL IN UPPER AREA OF SOUTH AREA 2 EMBANKMENT**

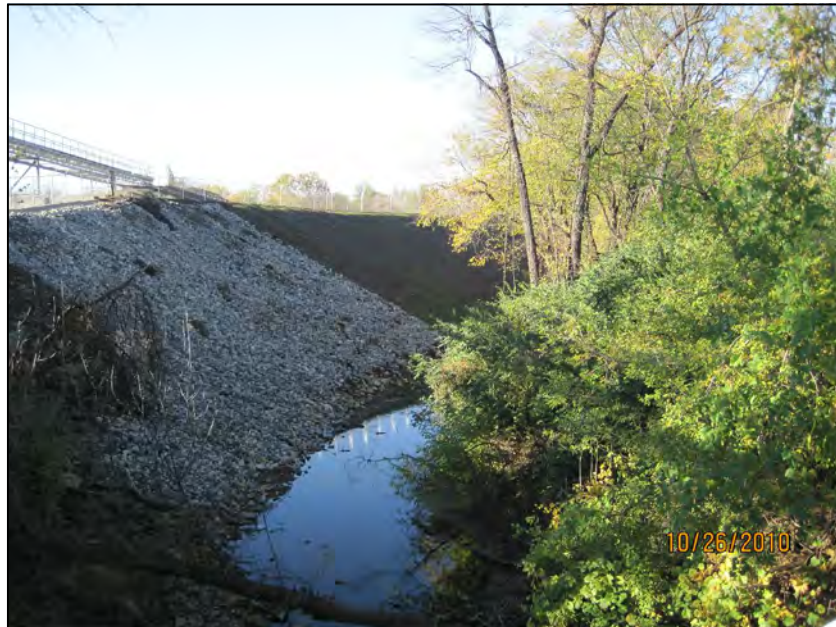
1-16

**LOOKING SOUTHWEST AT AREA 1 NORTH EMBANKMENT  
DOWNSTREAM SLOPE REPAIR AREA**

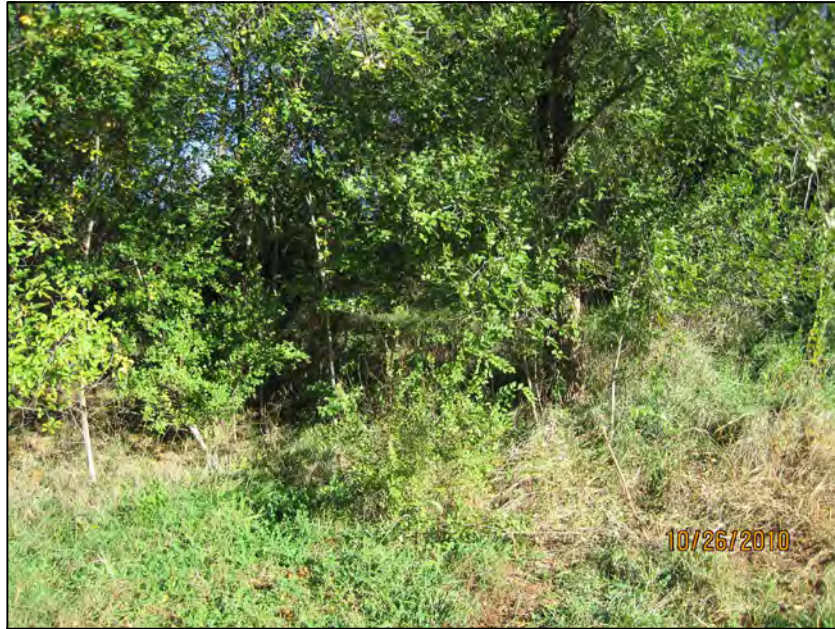
1-17

LOOKING NORTH AT TREES/VEGETATION ON DOWNSTREAM  
TOE OF SOUTHWEST EMBANKMENT

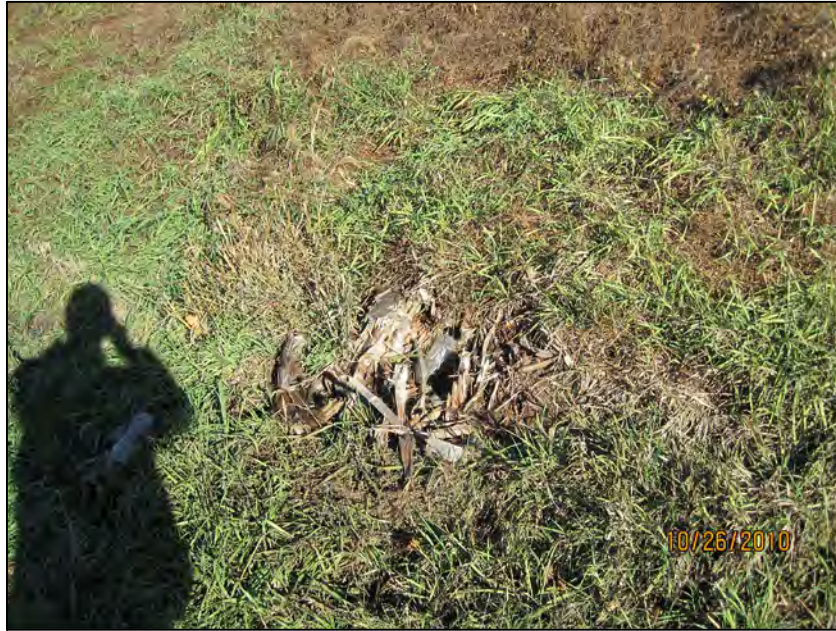
**1-19**  
**STUMP ON DOWNSTREAM EMBANKMENT FACE**

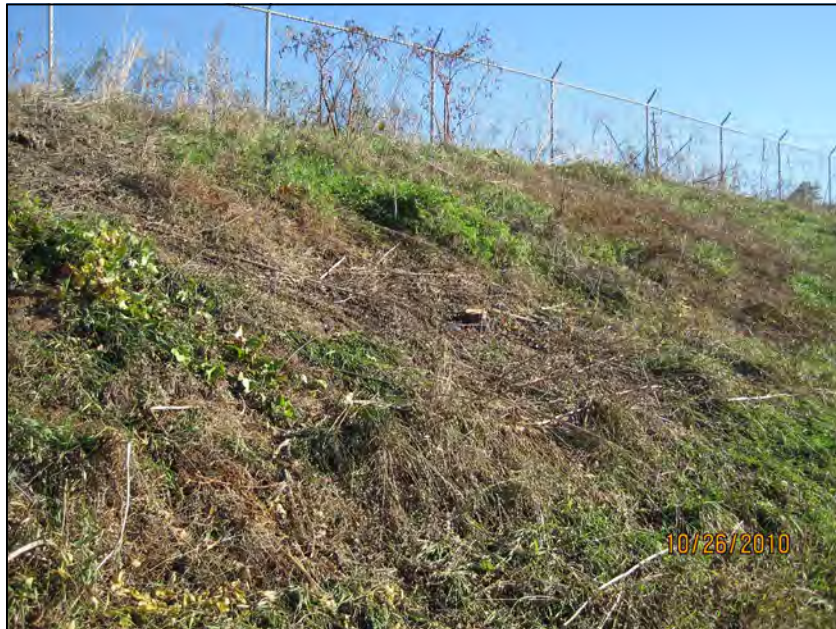
**1-20**  
**STUMP ON DOWNSTREAM EMBANKMENT FACE**

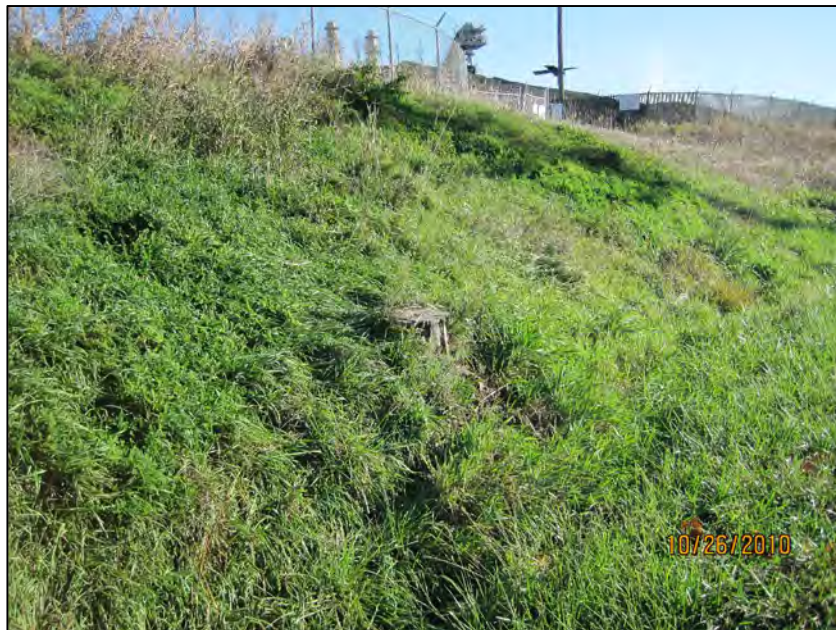
**2-22**  
**STUMP ON DOWNSTREAM EMBANKMENT FACE**

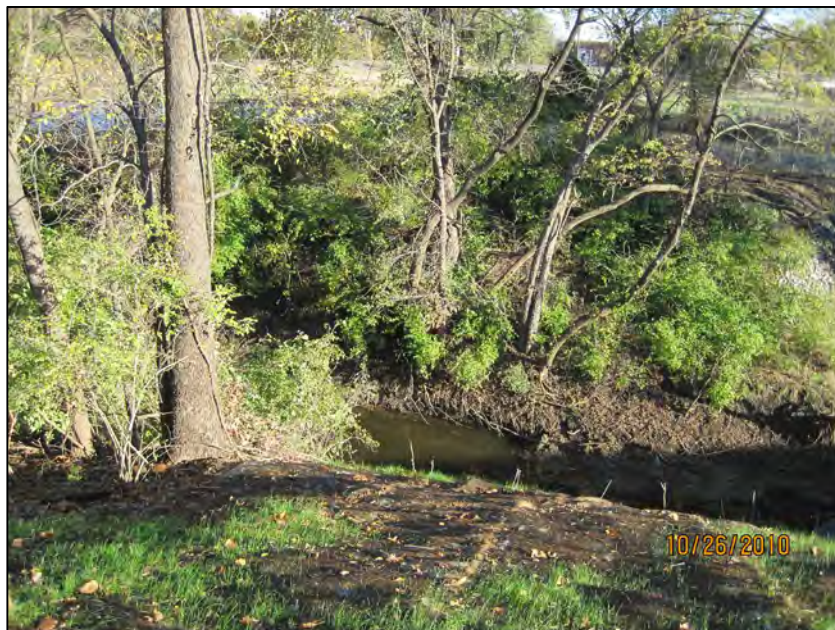
2-2

LOOKING NORTH FROM NORTH CREST AT AREA 2 SOUTH  
EMBANKMENT AND EXISTING VEGETATION AND TREE COVER

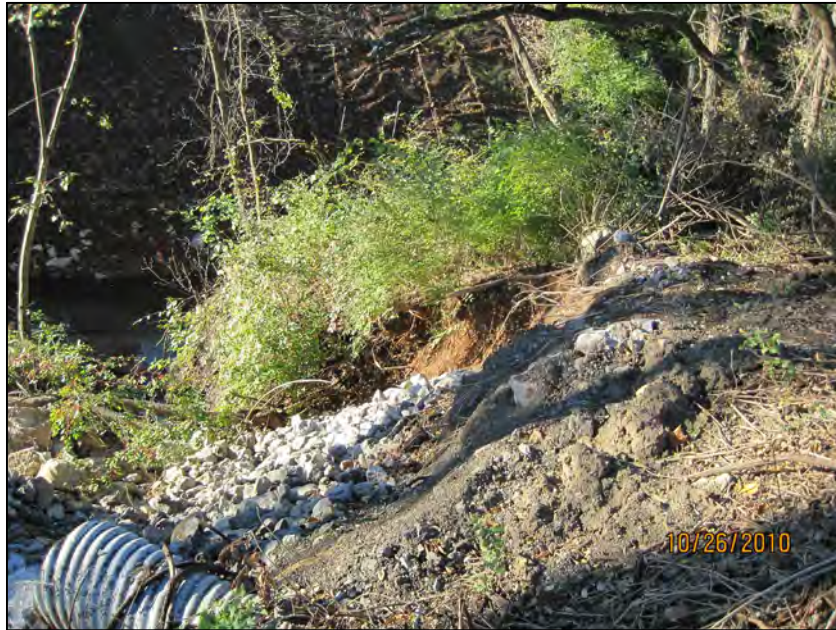
**2-5**  
**VEGETATION AND TREES ADJACENT TO KPDES OUTFALL**

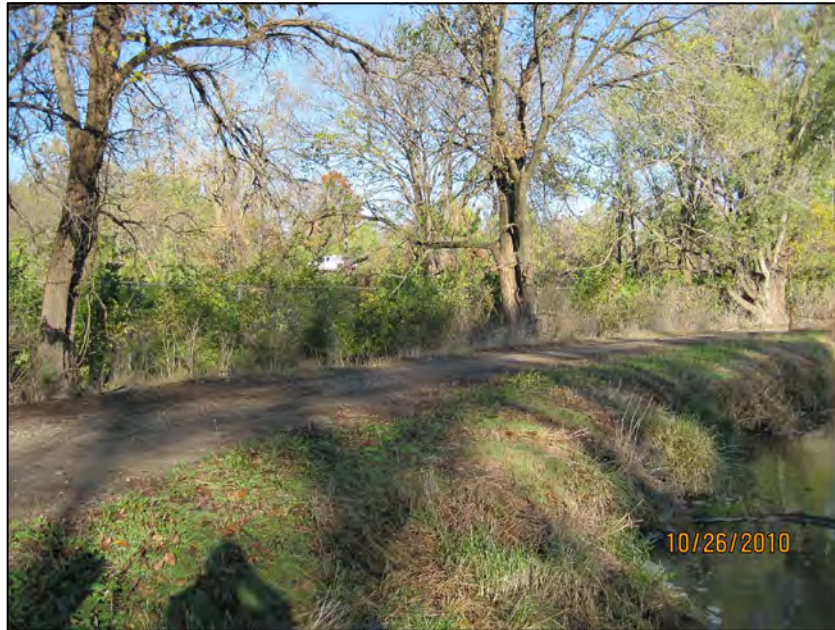
**2-11**

**LOOKING WEST AT WESTERN EMBANKMENT,  
CREST, AND EXISTING TREES/VEGETATION**

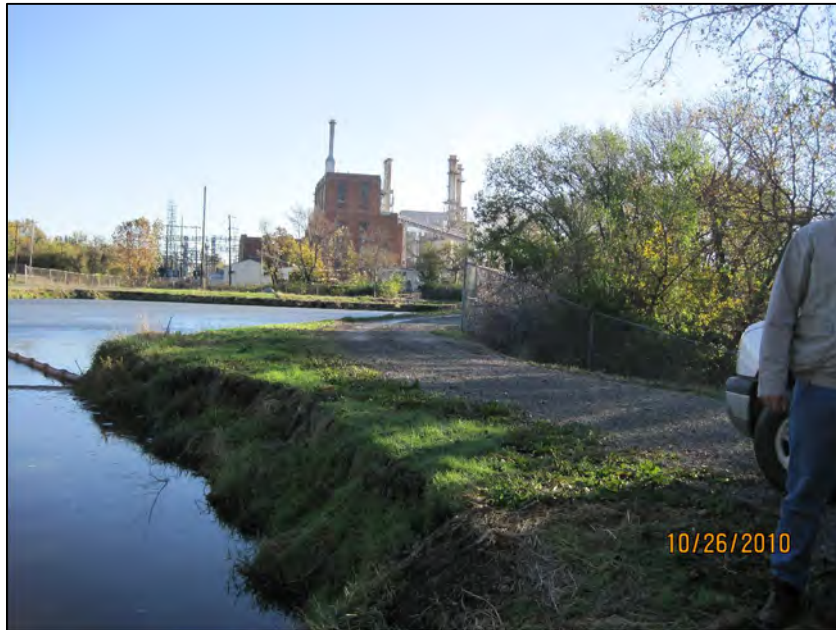
2-13

LOOKING EAST ACROSS POND AND SOUTHERN EMBANKMENT  
CREST-TREES AND VEGETATION VISIBLE ON DOWNSTREAM EMBANKMENT

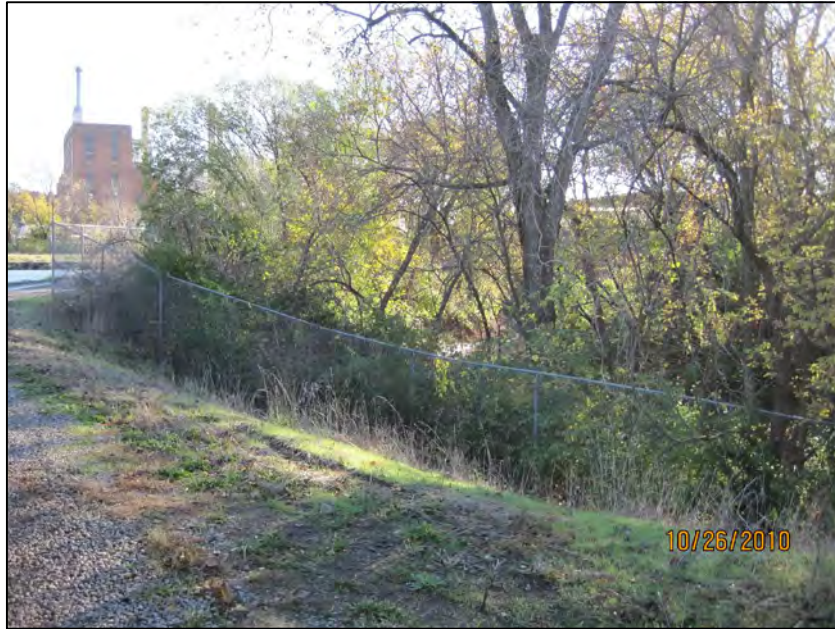
**2-15**  
**LOOKING EAST AT TREES/VEGETATION ON**  
**SOUTHERN DOWNSTREAM EMBANKMENT**

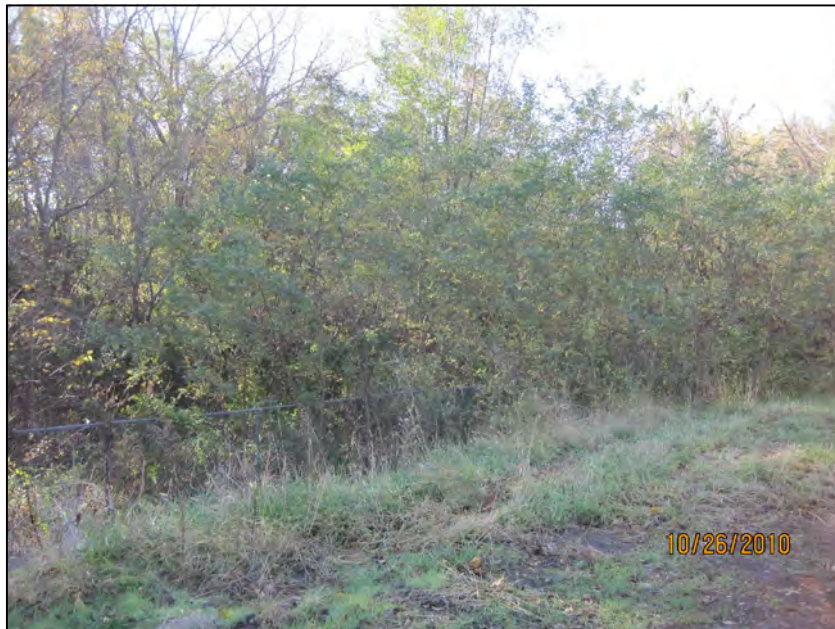
**2-16**  
**LOOKING SOUTHWEST AT TREES/VEGETATION**  
**OUTSIDE DOWNSTREAM EMBANKMENT**
