**Draft Coal Combustion Waste Impoundment Dam Assessment Report  
Dynegy Midwest Generation, Inc. Wood River Power Station; Alton, IL  
By Dewberry & Davis, LLC  
Project # 0-381  
June 2009**

**Coal Combustion Waste Impoundment  
Dam Assessment Report**

***Wood River Power Station  
Dynegy Midwest Generation, Inc.  
Alton, Illinois***

**Project # D-381  
Assessment of Dam Safety  
Coal Combustion Surface Impoundments  
for the REAC Program**

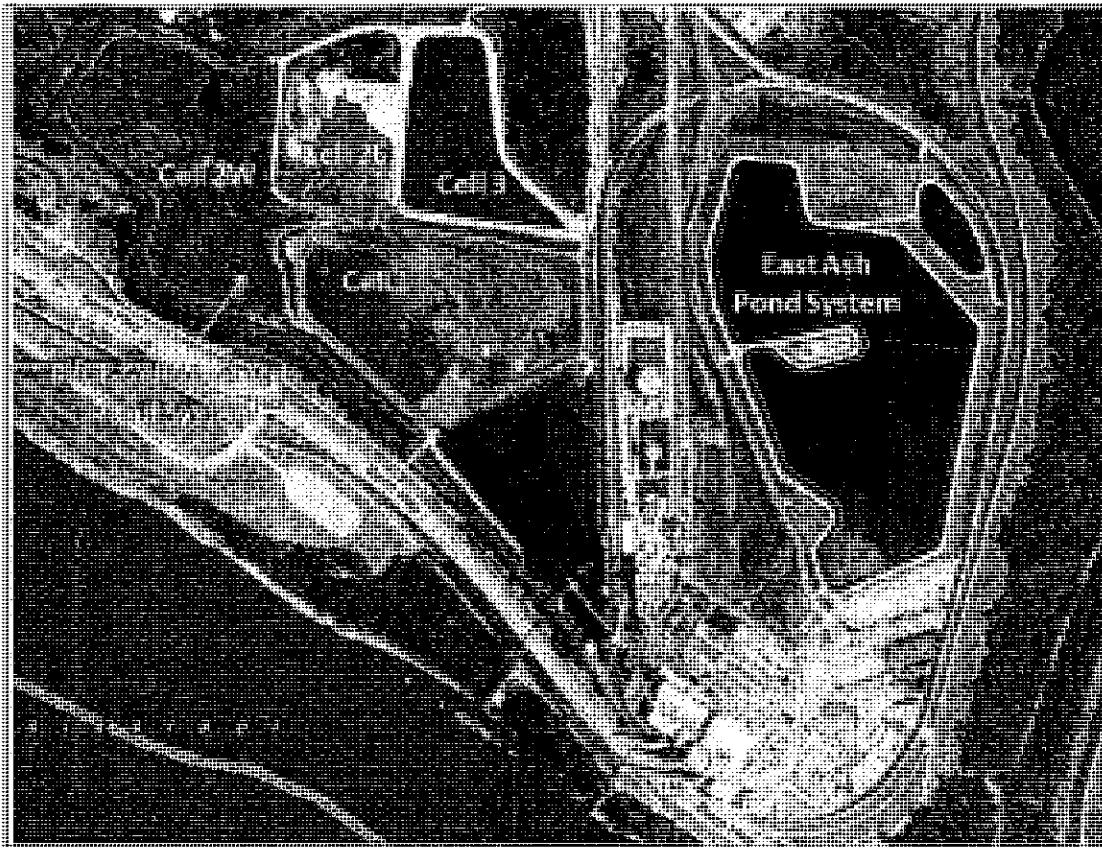
Figure 1: Wood River Power Station Aerial Map

As shown on Figure 1, the two-cell EAPS is located on the eastern side of Chessen Lane, just north of the Mississippi River. The Wood River Creek runs along the eastern edge of this system, just beyond an earthen dike. This system consists of a primary and a secondary cell. The primary cell is referred to in the site visit photos found in Appendix B as EAPSP, or East Ash Pond System, Primary cell. Similarly, the secondary cell in this system is referenced as EAPSS, or East Ash Pond System, Secondary cell, in Appendix B. The primary cell is closest to the actual plant. The secondary cell is essentially in the northeast corner of the primary cell.

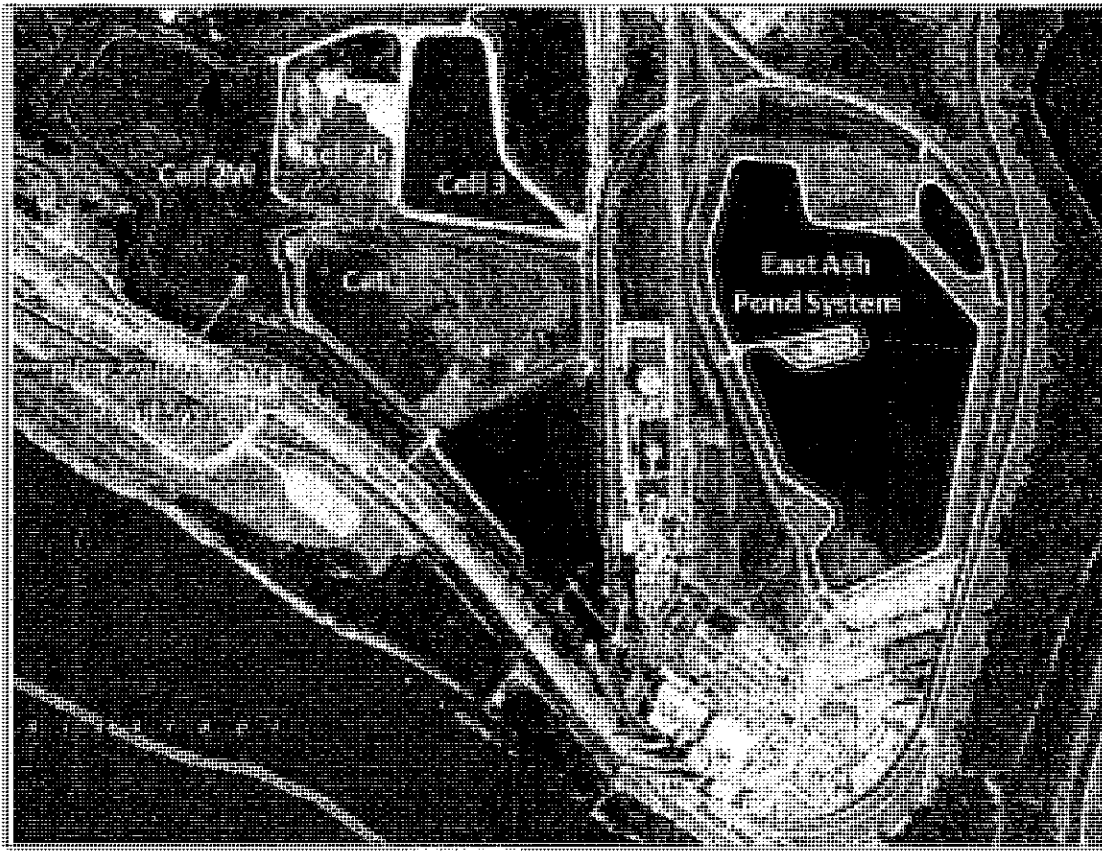
Figure 1: Wood River Power Station Aerial Map

As shown on Figure 1, the two-cell EAPS is located on the eastern side of Chessen Lane, just north of the Mississippi River. The Wood River Creek runs along the eastern edge of this system, just beyond an earthen dike. This system consists of a primary and a secondary cell. The primary cell is referred to in the site visit photos found in Appendix B as EAPSP, or East Ash Pond System, Primary cell. Similarly, the secondary cell in this system is referenced as EAPSS, or East Ash Pond System, Secondary cell, in Appendix B. The primary cell is closest to the actual plant. The secondary cell is essentially in the northeast corner of the primary cell.
