**Coal Combustion Waste Impoundment
Round 7 - Dam Assessment Report**

Black Dog Power Station

Surface Impoundments

April 2011

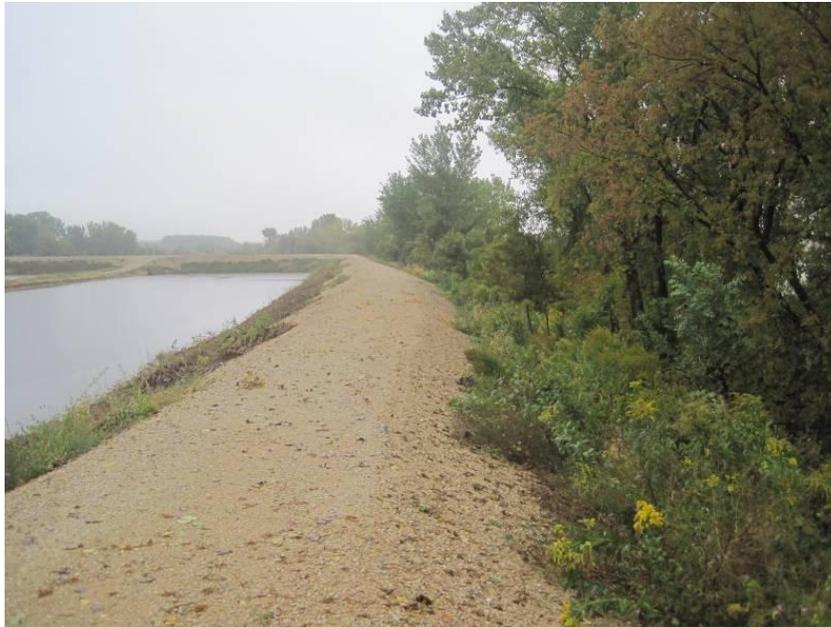
The crest of the embankment had no signs of significant depressions, tension cracks or other indications of settlement or shear failure. Figure 5.2.1-1 and Figure 5.2.1-2 show the typical crest condition of the embankment along Pond 3 and Pond 4, respectively.

Figure 5.2.1-1: Crest of embankment looking east; Pond 3 is to the left and Black Dog Lake is to the right; Crest also serves as the flood control berm; Note flood control berm wrapping to the left in the distance around Ponds 3, 2, and 1

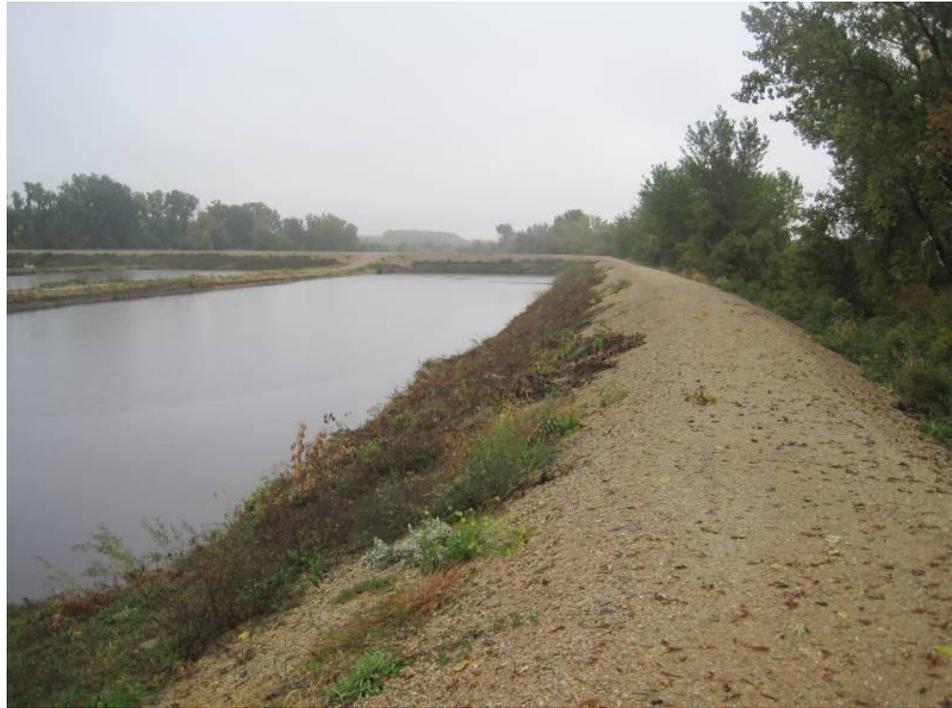
The inside slope of the embankment, including all groins, had a coverage of mixed grasses/weeds and gravel adjacent to Pond 3, and mixed grasses/weeds adjacent to Pond 4. There were no observed scarps, sloughs, bulging, cracks, depressions or other indications of slope instability. Figures 5.2.2-1 and 5.2.2-2 show a representative section of the embankment looking east and west from Pond 3 and Pond 4, respectively.

Figure 5.2.2-1: Inside slope of embankment looking east; Pond 3 is located to the immediate left

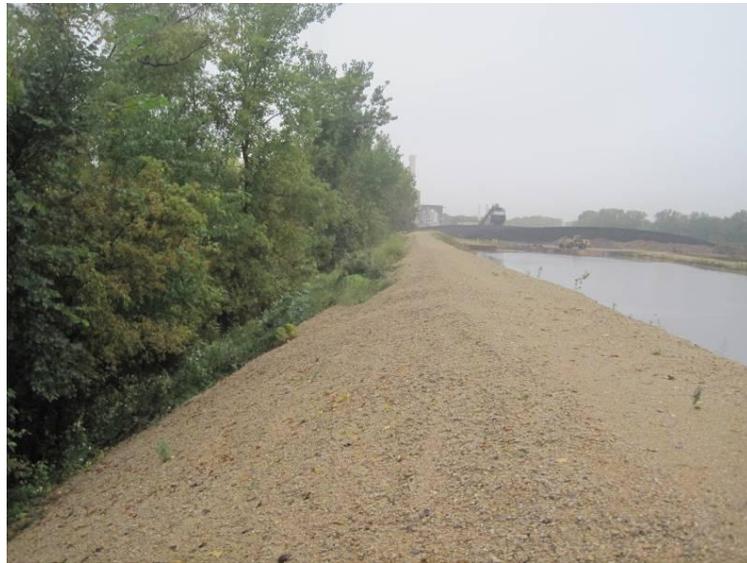
The outside slope of the embankment is vegetated with various species of tall grasses and weeds. The toe of the embankment follows the shoreline of Black Dog Lake where there are trees also growing. Heavy overgrowth along the outside slope of the embankment and toe made close observation of the embankment difficult. Based on what could be observed there were no scarps, sloughs, bulging, cracks, depressions or other indications of slope instability. Figures 5.2.3-1 and 5.2.3-2 show a representative section of the embankment looking west from Pond 3 and Pond 4.

Figure 5.2.3-1: Outside slope of embankment to the left looking west; Pond 3 is located to the immediate right

It was noted during the field assessment that there was significant vegetation and tree growth along the outside slope of the earthen embankment between Black Dog Lake and Ponds 3 and 4 that made it difficult to observe its condition. It is recommended that the outside slope of this embankment be maintained in such a way that adequate inspections of the slope can be made in the future. In response to recommendations made in the draft version of this report, NSP-M proposes to remove all understory brush (vegetation with a trunk diameter less than 2 inches) to help facilitate the inspection of the embankment. NSP-M believes that removal of trees larger than 2 inches in diameter would compromise the existing embankment and should be retained unless conditions change to the point where they pose a potential risk. This condition will be monitored by the additional biannual structural integrity inspection proposed by NSP-M under Section 1.2.1 above.

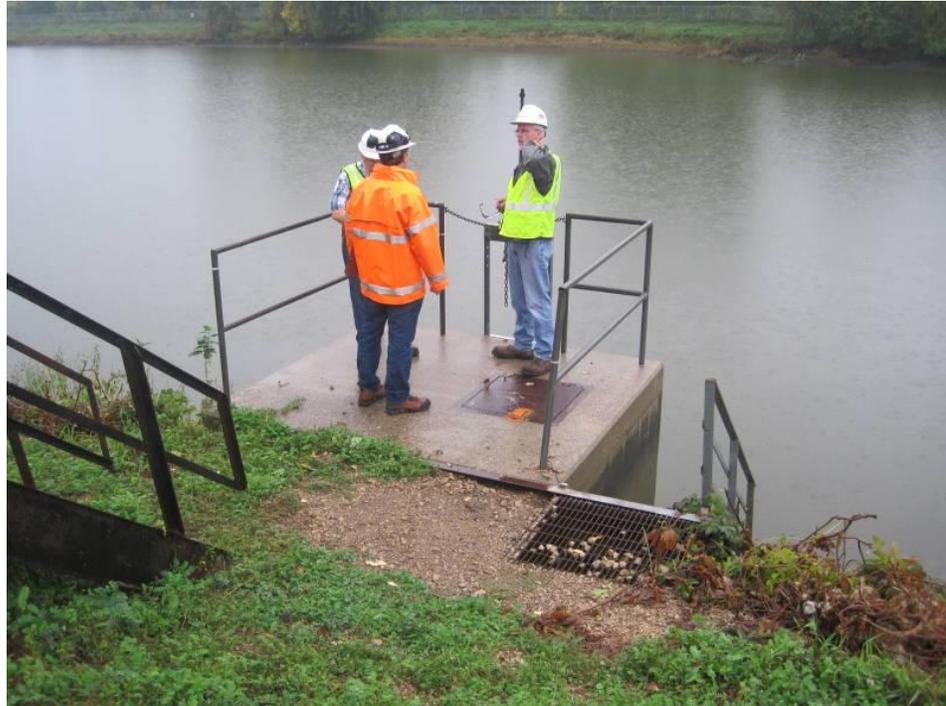
The system of four CCW ponds discharges into Black Dog Lake through a spillway structure located in the south-east corner of Pond 4. The spillway was observed to be working properly, discharging flow from the pond, and visually appeared to be in satisfactory condition. There were no signs of clogging of the spillway and the water exiting the structure was flowing clear. Figure 5.3.1- 1 shows the spillway overflow structure.

Figure 5.3.1-1: Overflow spillway structure looking north across Pond 4 from top of embankment
