**DRAFT REPORT
ROUND 10 DAM ASSESSMENT – JUNE 14, 2011
XCEL ENERGY – BAY FRONT GENERATING STATION
SURGE BASIN, POLISHING BASIN
ASHLAND, WISCONSIN**

RE: DRAFT Assessment of Dam Safety of Coal Combustion Surface Impoundments at the
Bay Front Generating Station

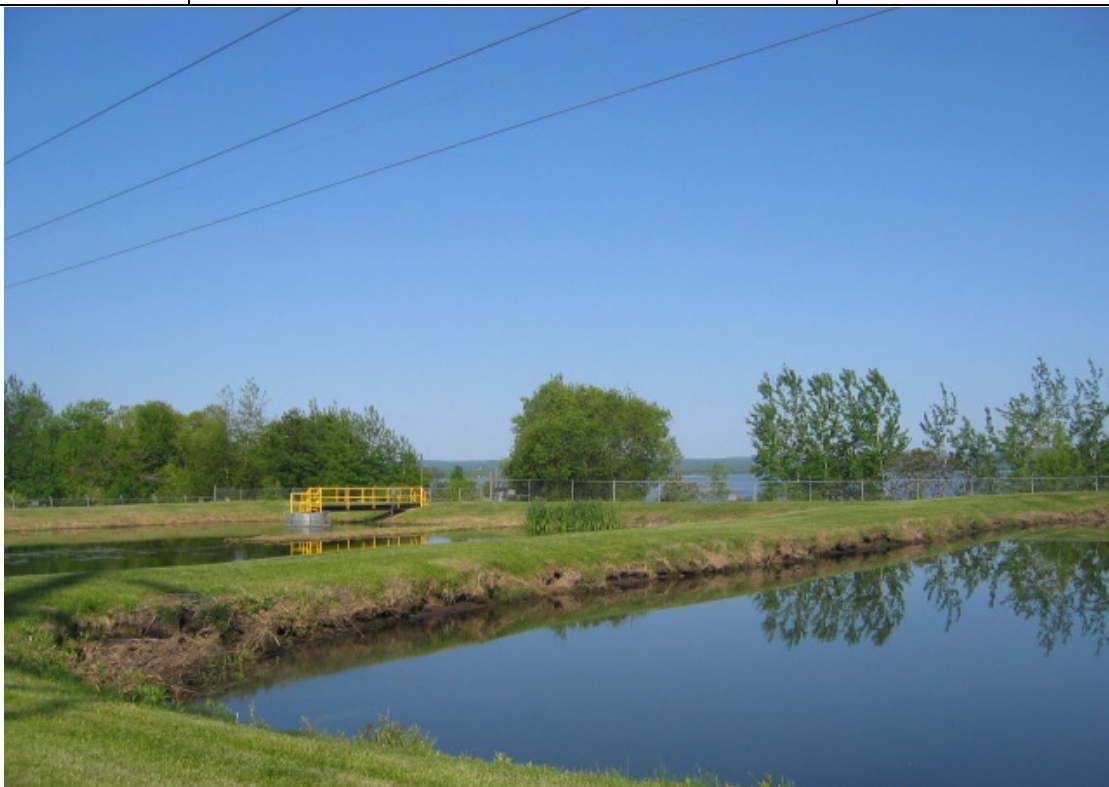
Photo No.
4

Upstream slope,
Downstream slope and Crest
of the Surge Basin.

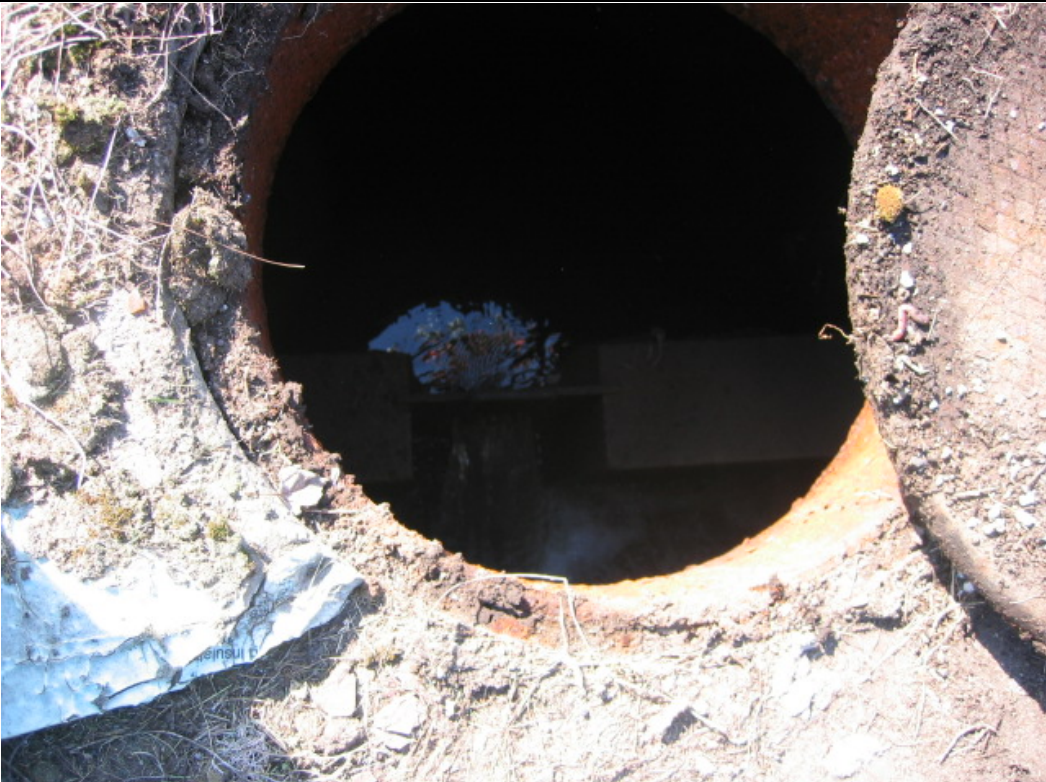
Direction Photo Taken: Southeast			
Description: Surge Basin flow control structure.

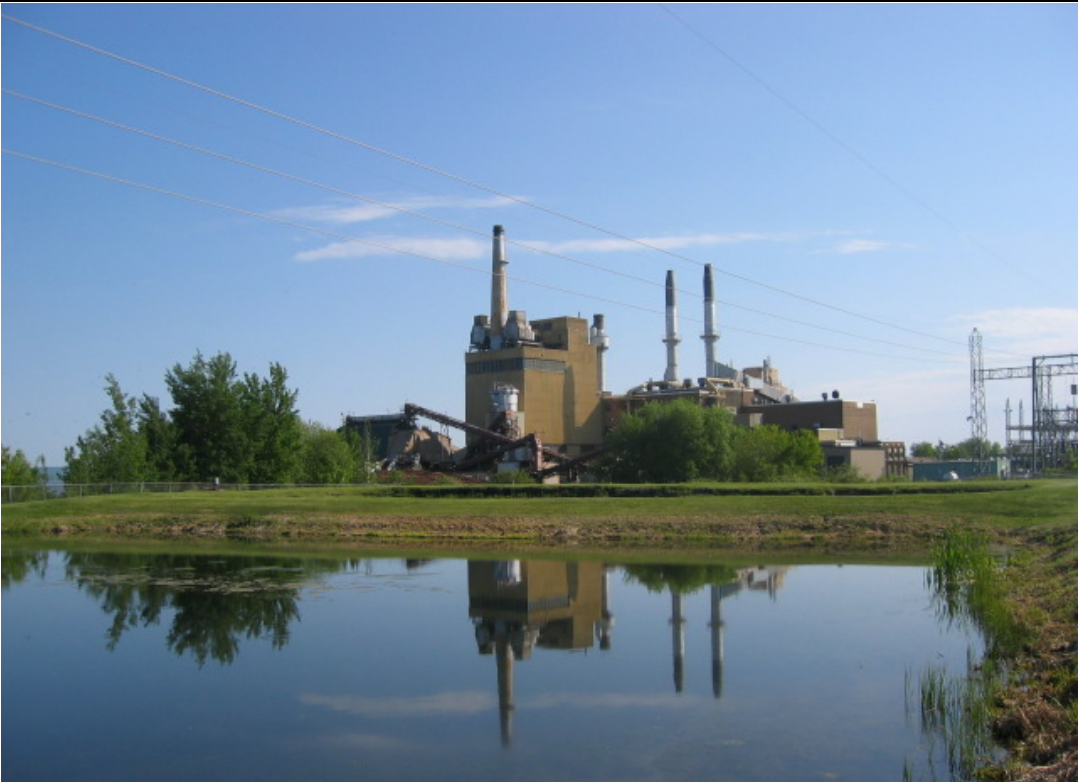
Direction Photo Taken: North			
Description: Upstream slope of the Polishing Basin.

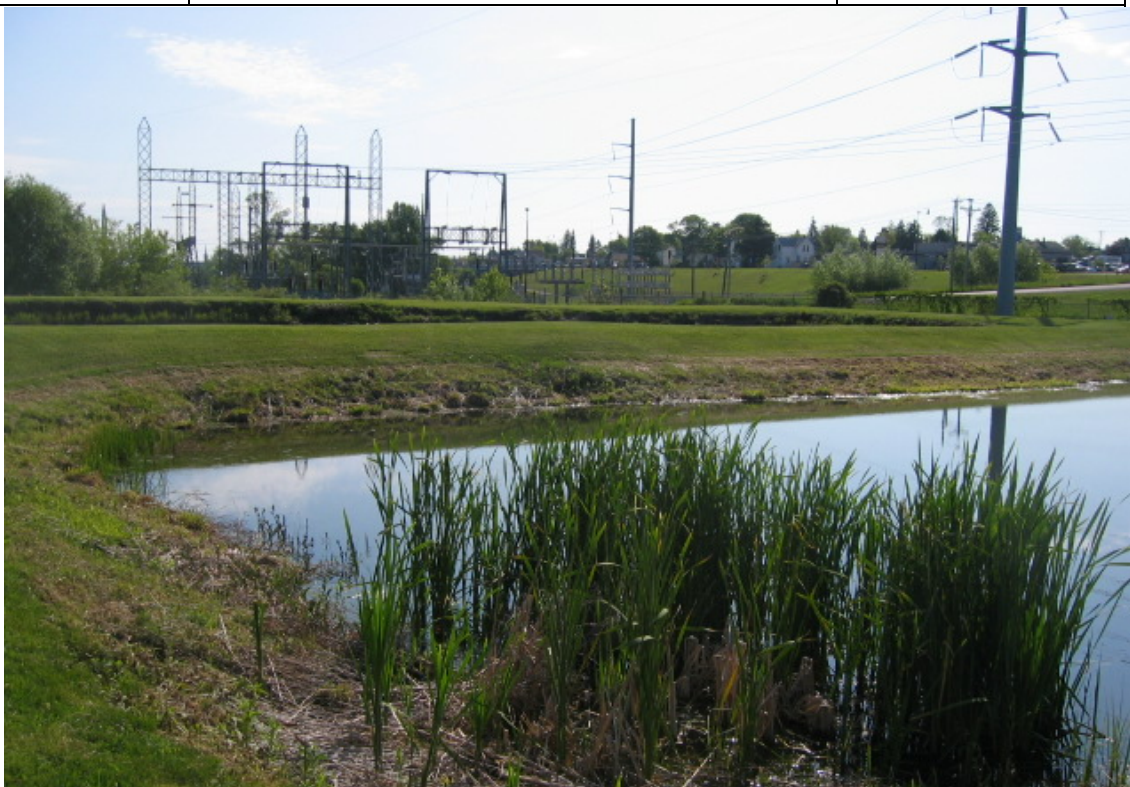
Photo No.
14

Upstream slopes and Crest of
the Polishing Basin.

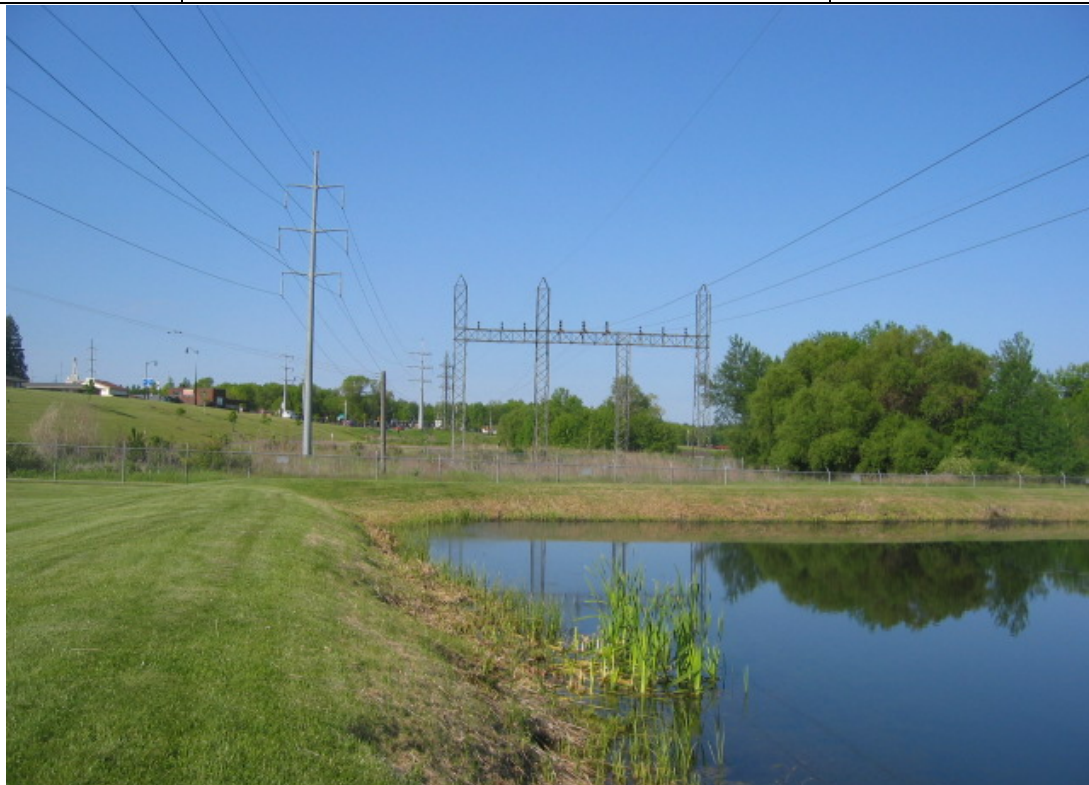
Photo No.
16

Upstream slope of the
Polishing Basin.

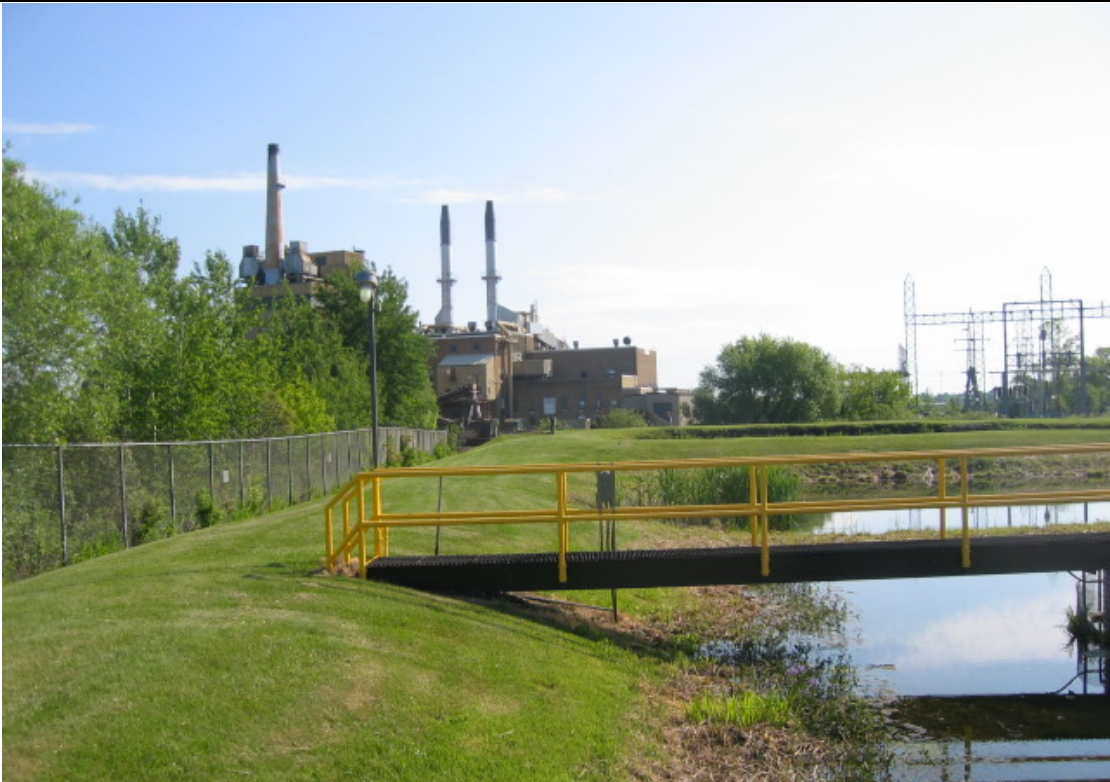
Direction Photo Taken: Northeast			
Description: Upstream slope and Crest of the Polishing Basin.

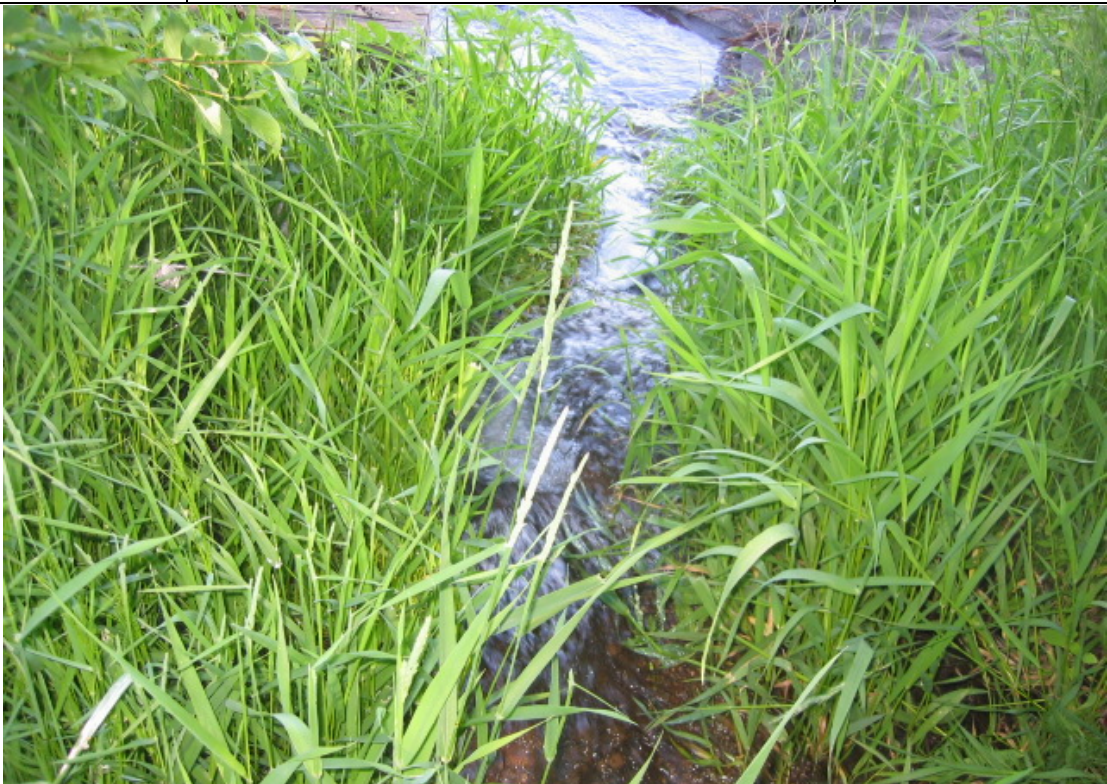
Direction Photo Taken: Northwest			
Description: Flow from Polishing Basin Outflow Discharge pipe toward Lake Superior

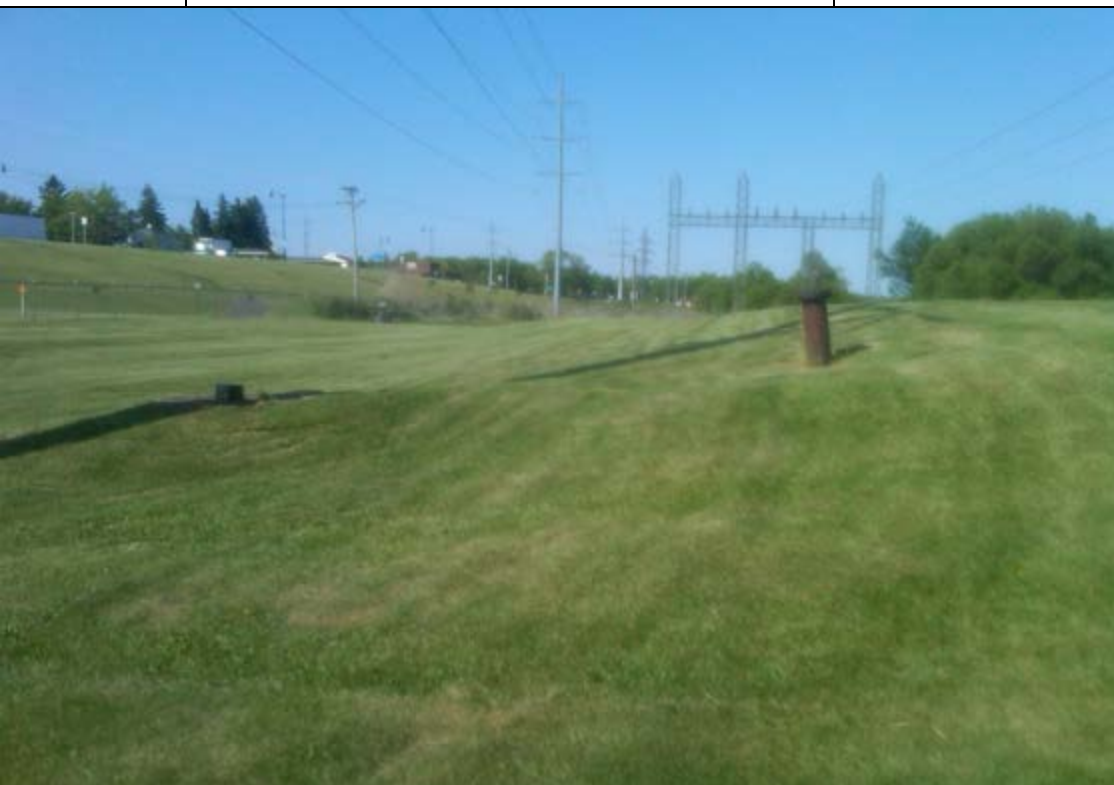
Photo No. 27	Date: 6/14/11

Direction Photo Taken: Southwest		
Description: Downstream slope of the Surge and Polishing Basin.
