**FINAL REPORT
ROUND 10 DAM ASSESSMENT
XCEL ENERGY – BAY FRONT GENERATING STATION
SURGE BASIN, POLISHING BASIN
ASHLAND, WISCONSIN
DECEMBER 31, 2012**

RE: FINAL Assessment of Dam Safety of Coal Combustion Surface Impoundments at the
Bay Front Generating Station

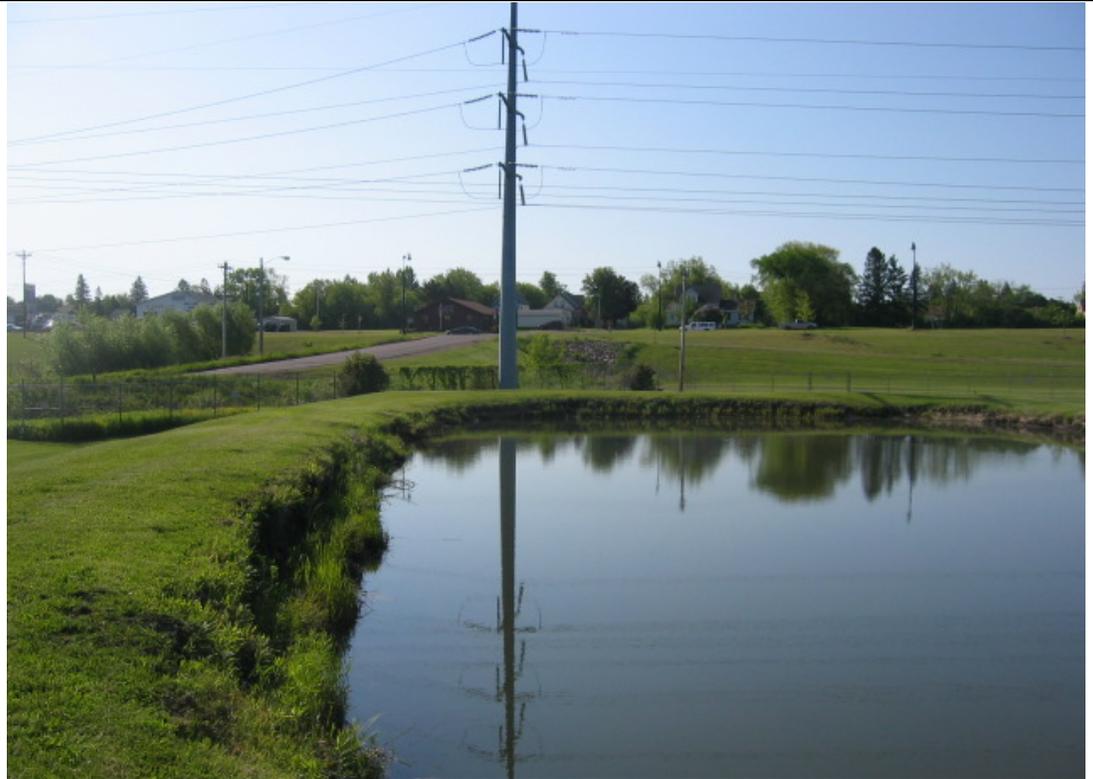
Description:
Upstream slopes and Crest of
the Surge Basin.

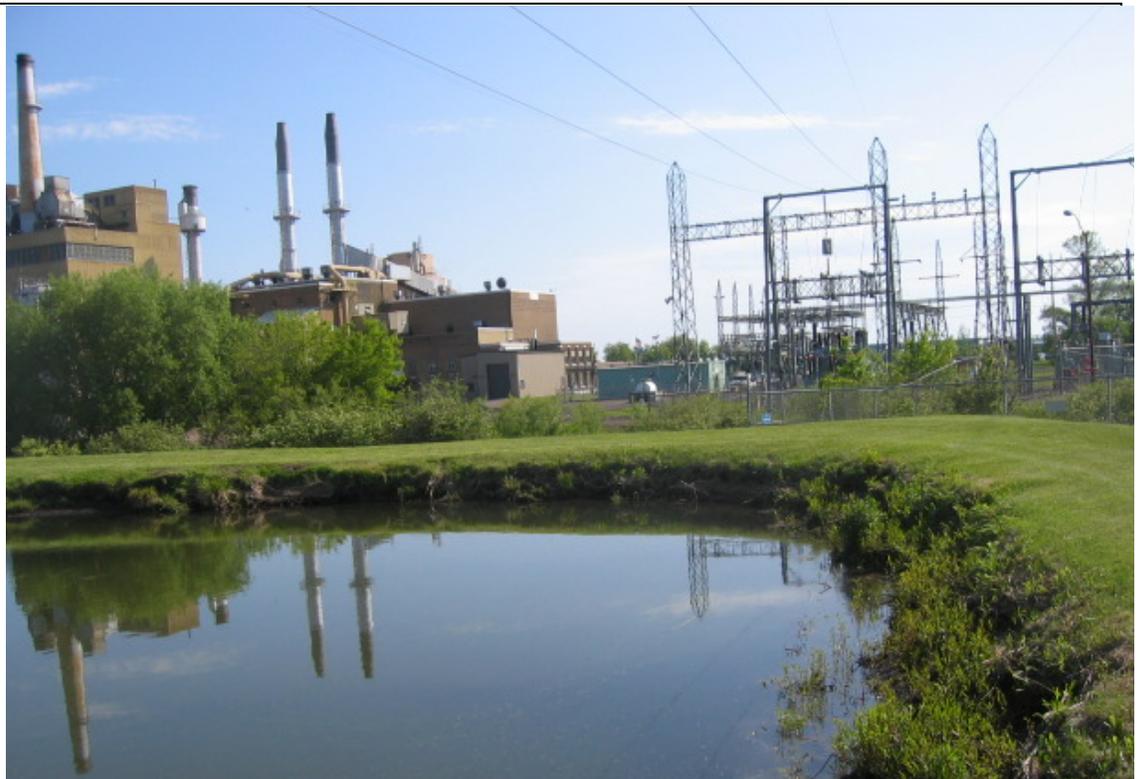
Photo No.
2

Description:
Upstream Slopes and Crest
of the Surge Basin.

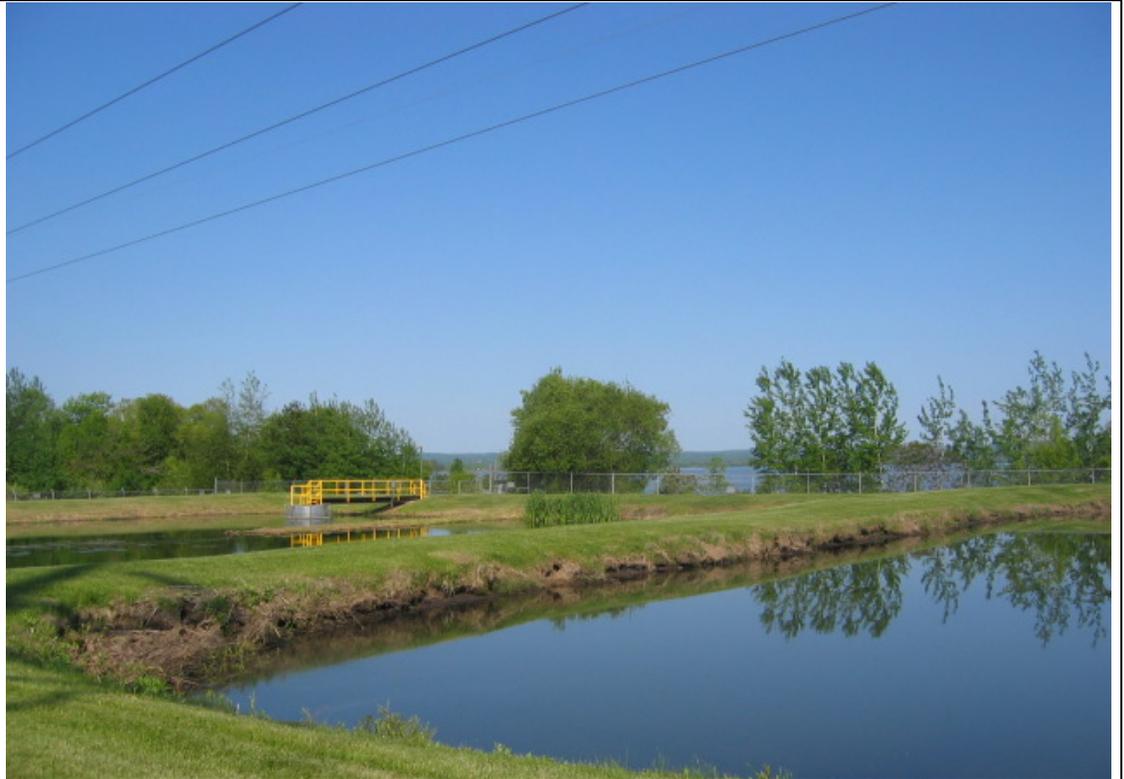
Description:
Upstream slope of the Surge
Basin and overview of
Polishing Basin.

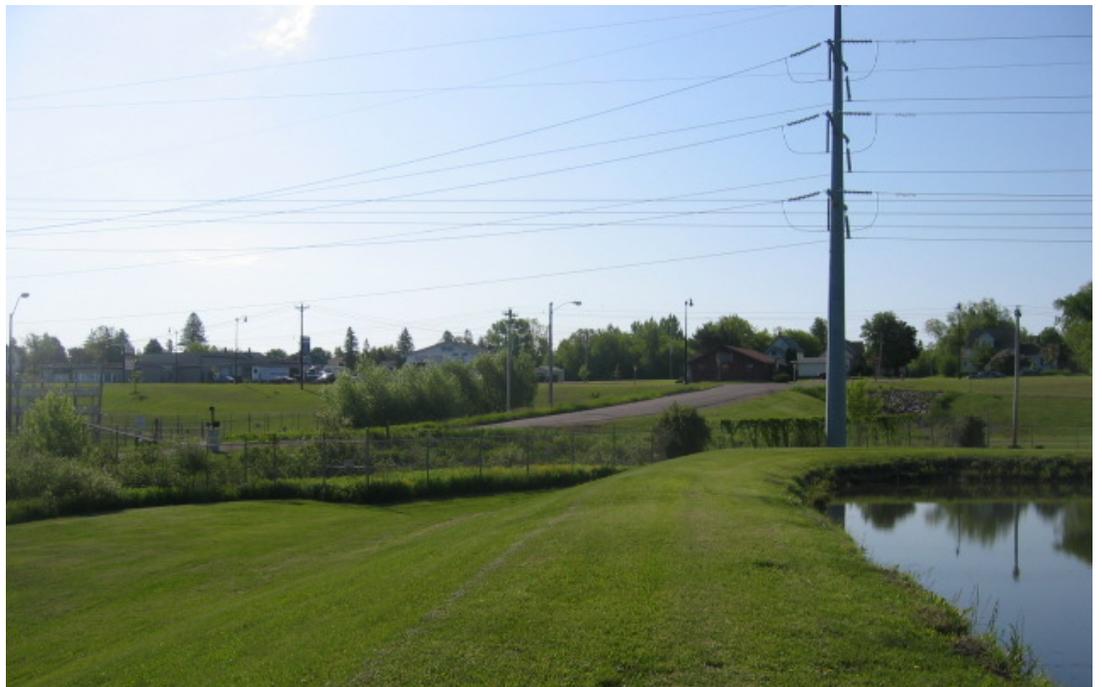
Photo No.
4

Description:
Upstream slope,
Downstream slope and Crest
of the Surge Basin.

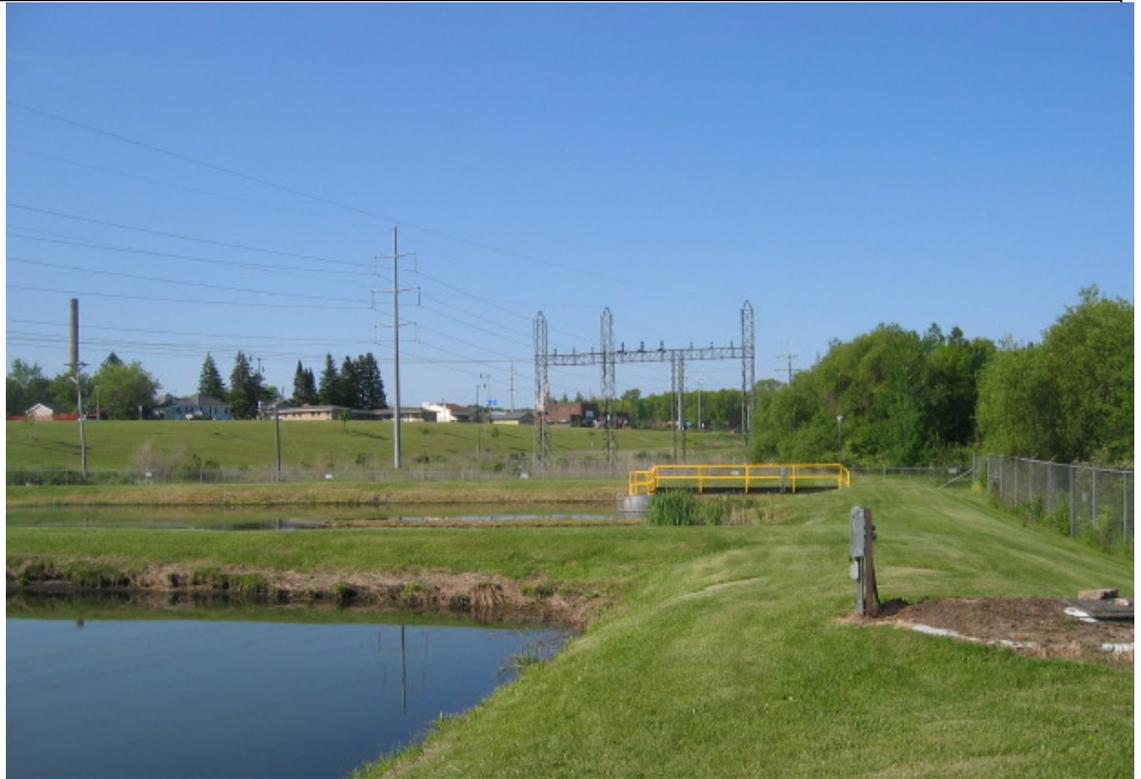
Description:
Upstream slopes and Crest of
the Surge Basin.

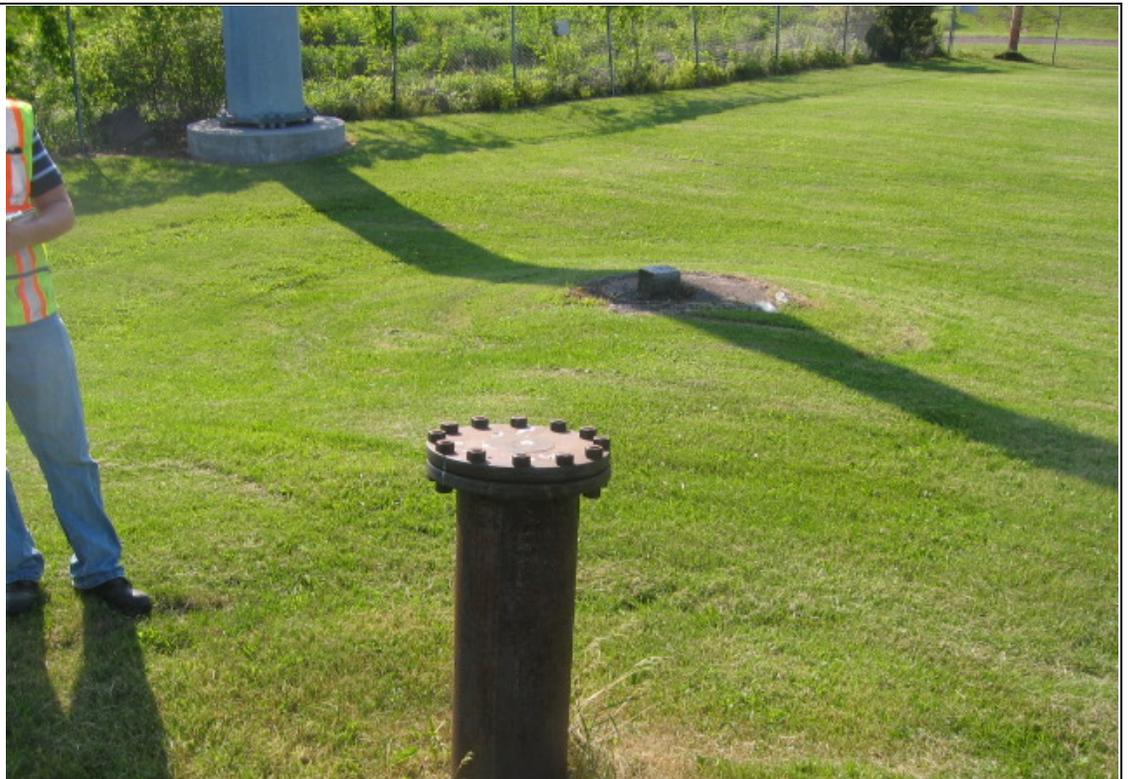
Photo No.
6

Description:
Surge Basin intake pipe
clean-out.

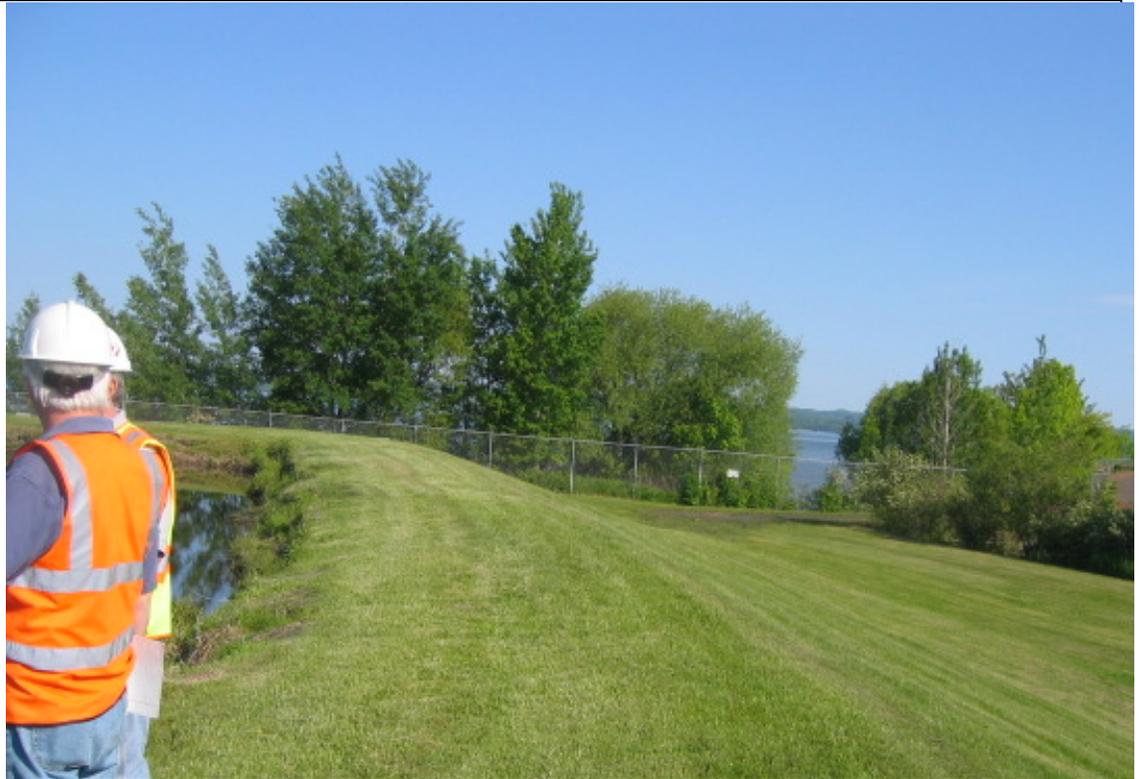
Upstream slope, downstream slope, and crest of the Surge Basin.

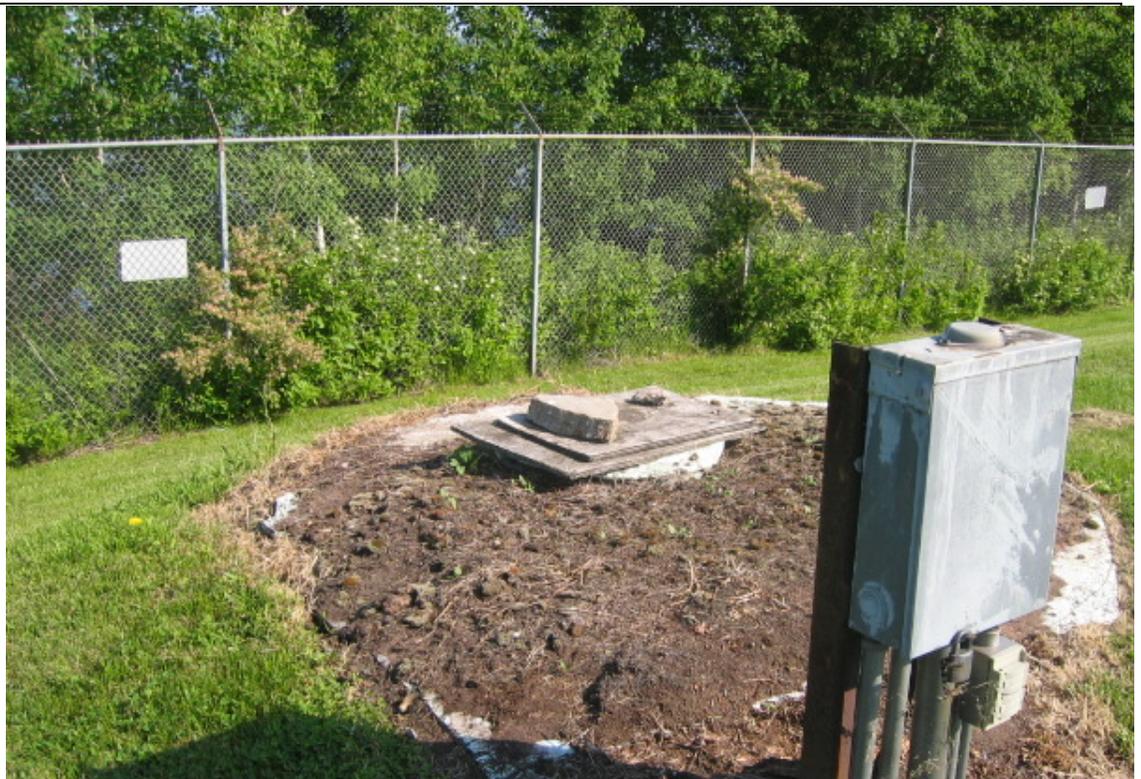
Photo No.
8

Surge Basin Flow Control structure.

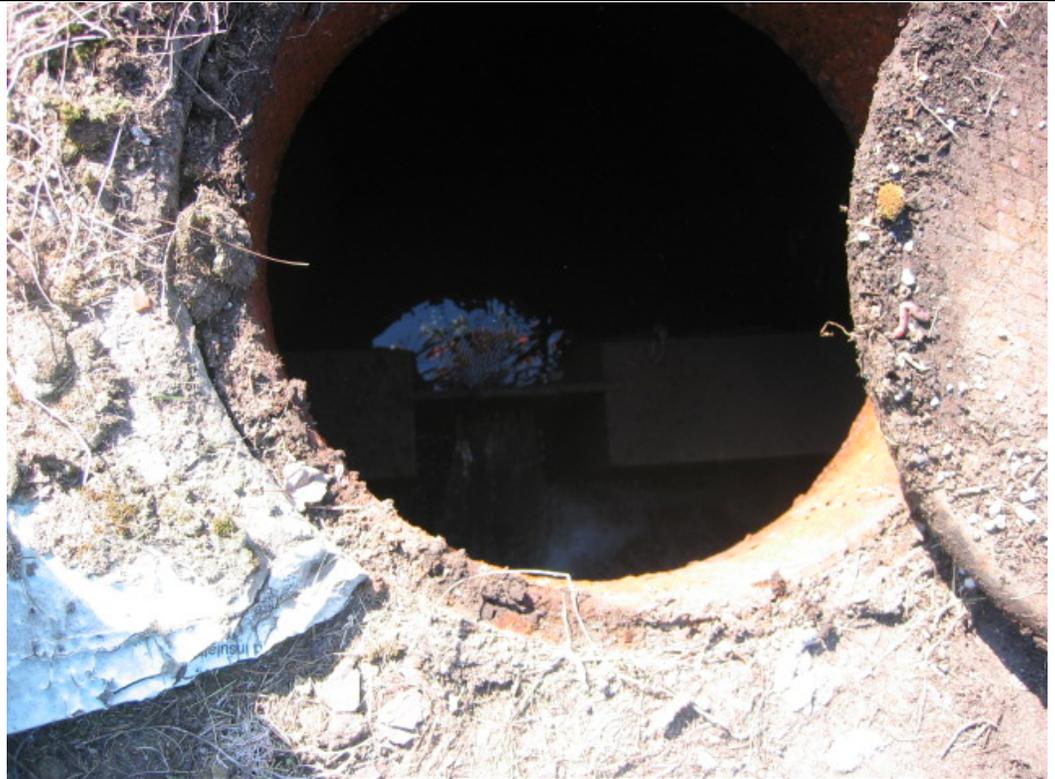
Description:
Surge Basin flow control
structure.

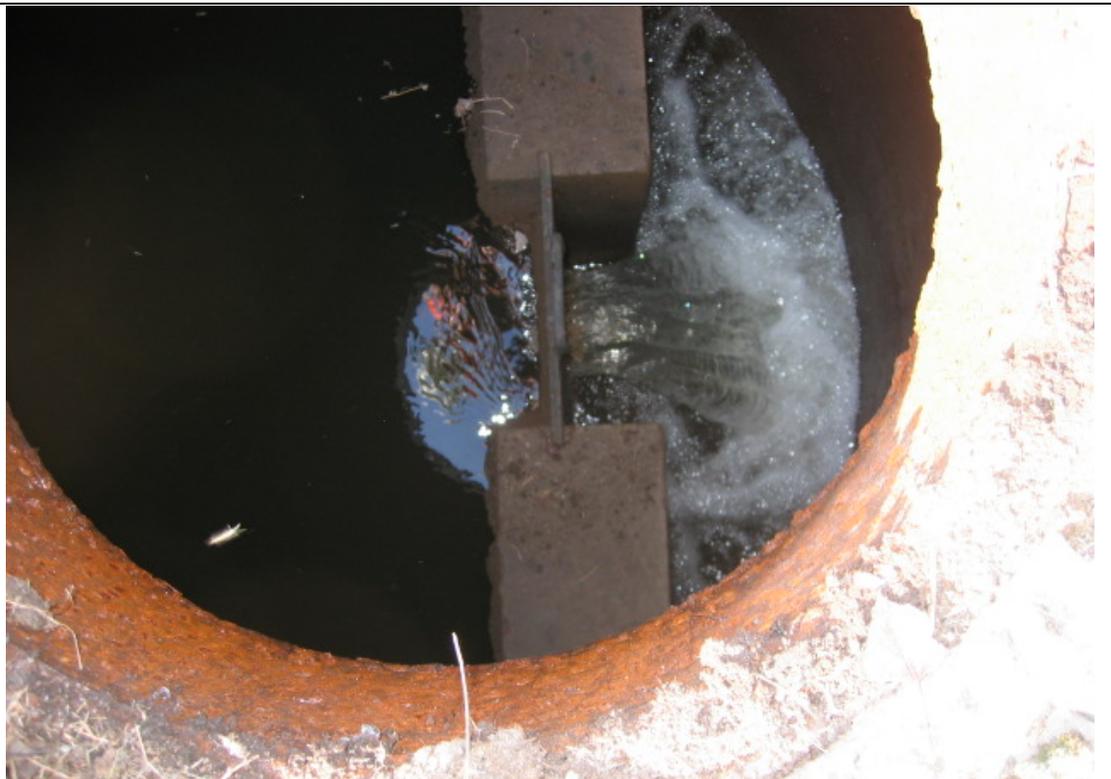
Photo No.
10

Description:
Surge Basin flow control
structure.

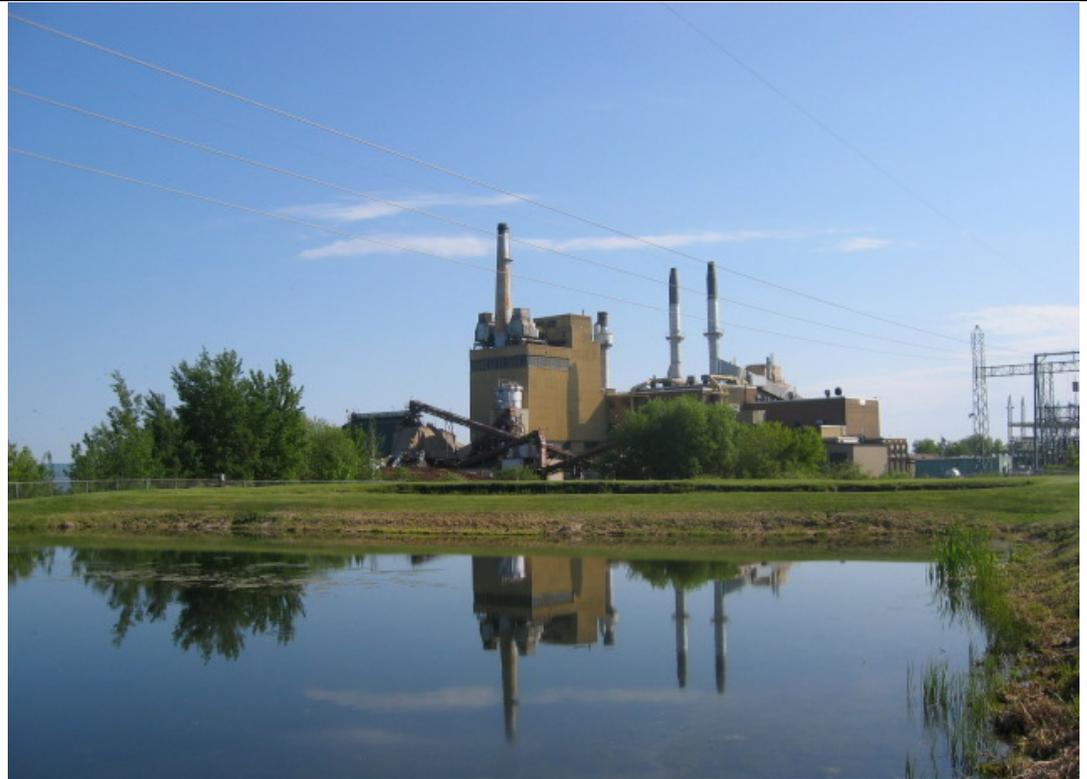
Description:
Upstream slope of the Polishing Basin.

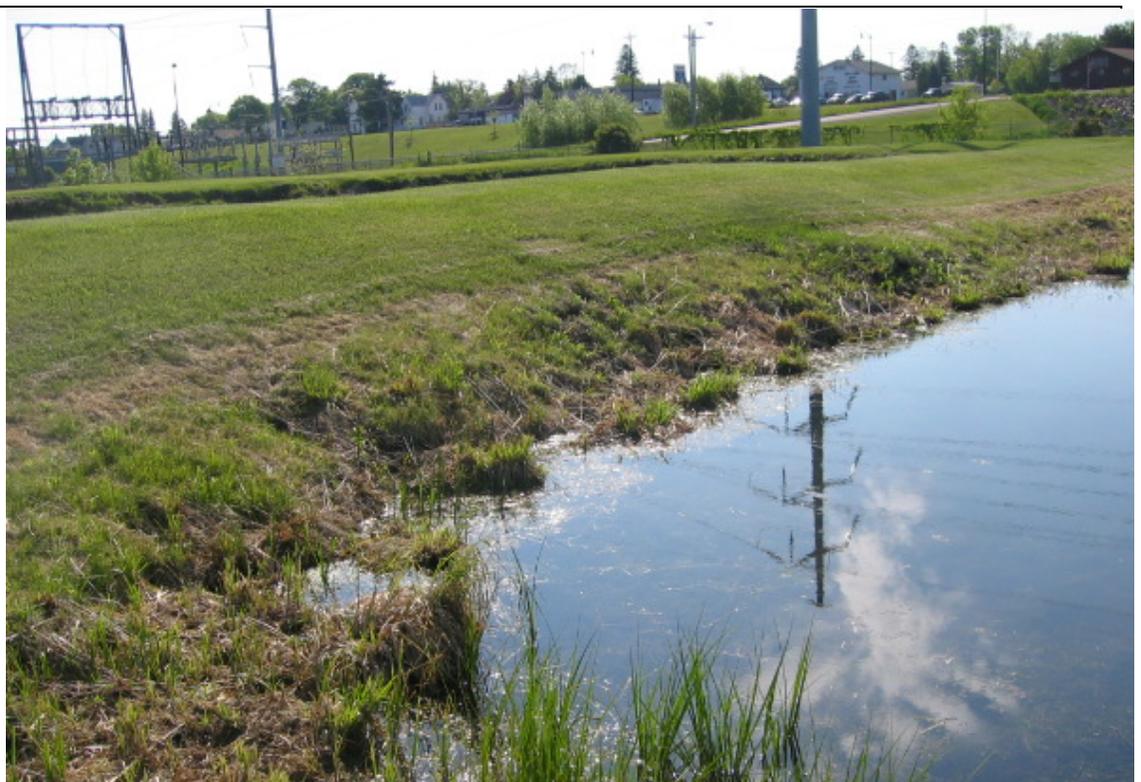
Photo No.
12

Description:
Upstream slope and Crest of the Polishing Basin.

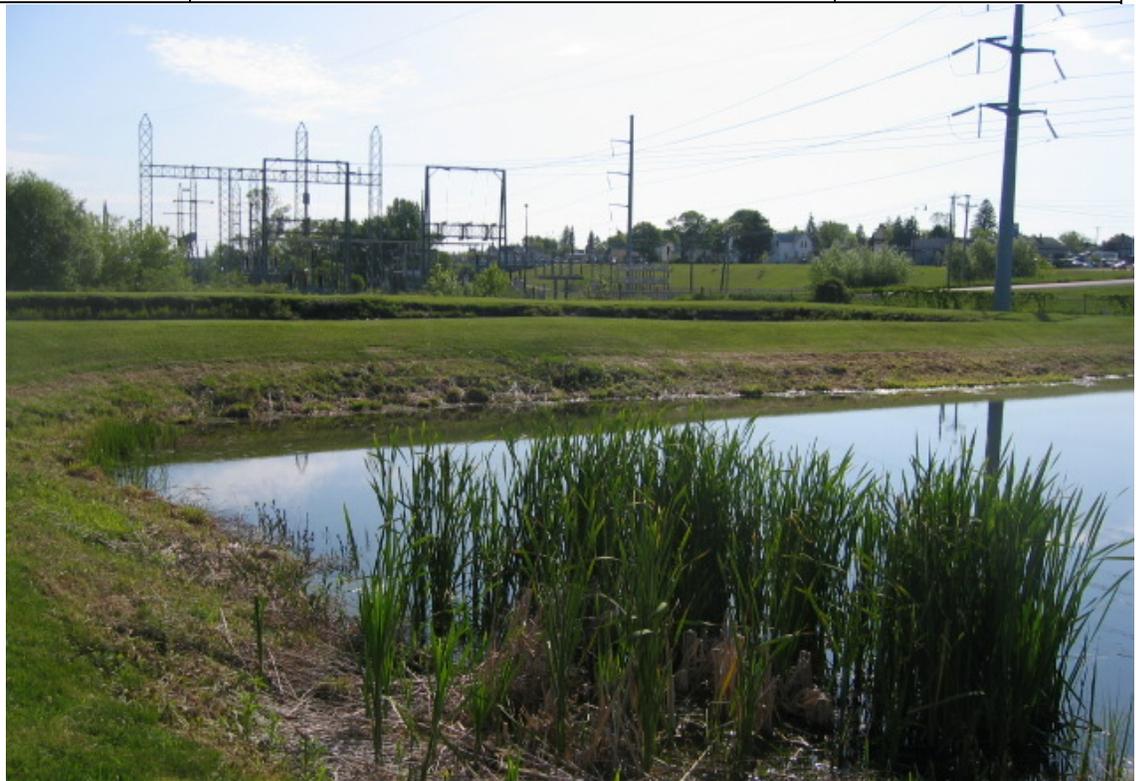
Photo No. 13	Date: 6/14/11
Direction Photo Taken: East

Description:
Upstream slopes and Crest of the Polishing Basin.

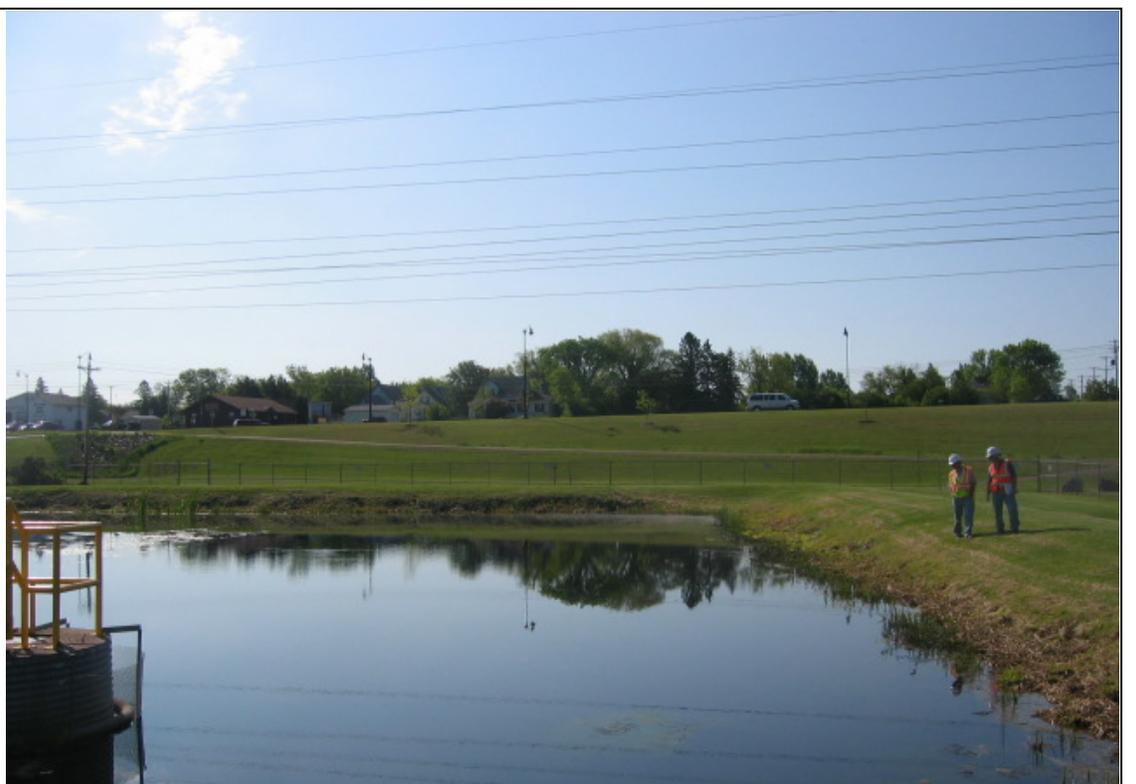
Photo No. 14	Date: 6/14/11
Direction Photo Taken: Southeast

Description:
Upstream slopes and Crest of the Polishing Basin.

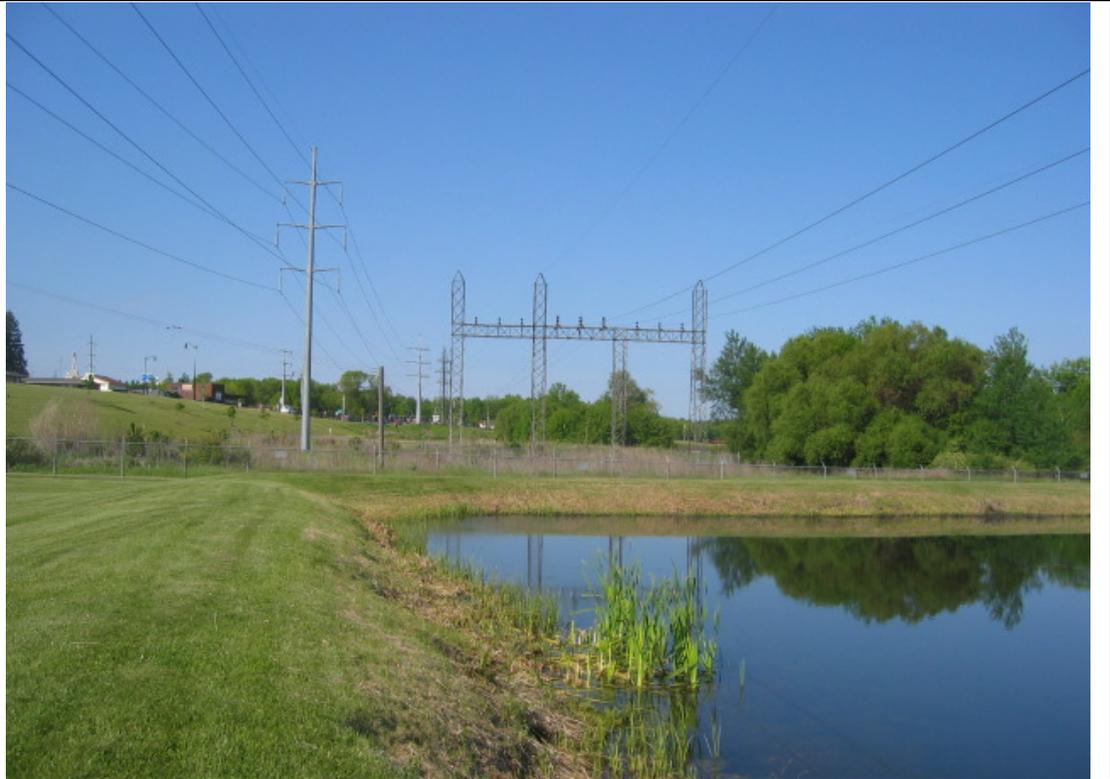
Photo No. 15	Date: 6/14/11
Direction Photo Taken: West

Description:
Upstream slopes and Crest of the Polishing Basin.

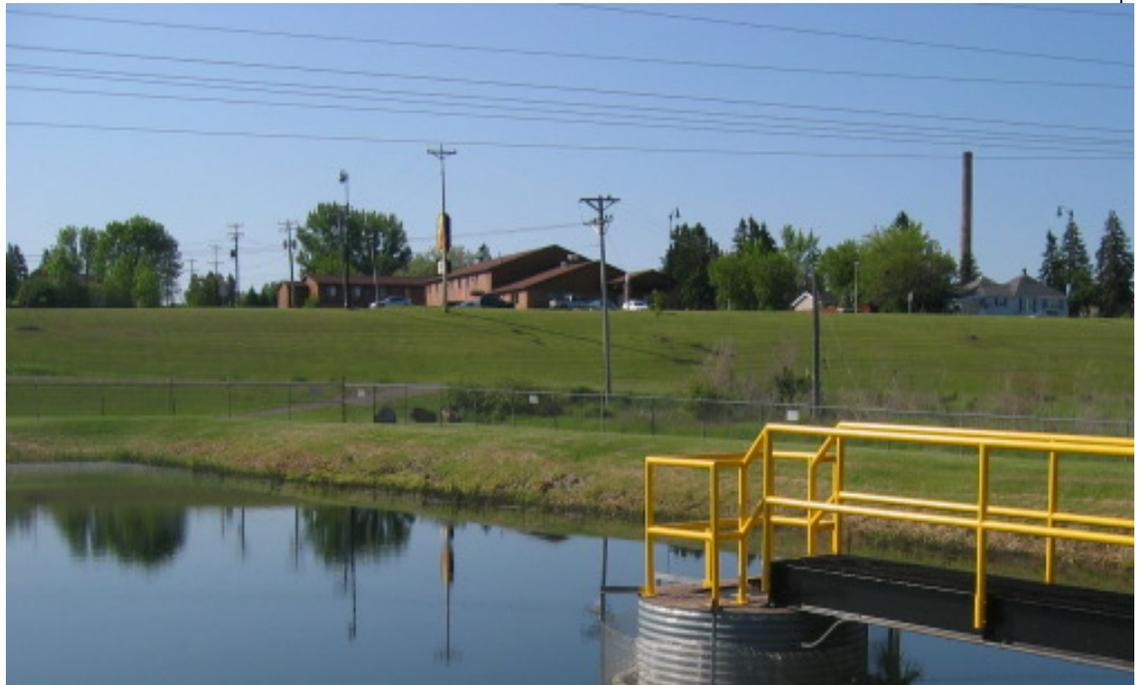
Photo No. 16	Date: 6/14/11
Direction Photo Taken: South

Description:
Upstream slope of the Polishing Basin.

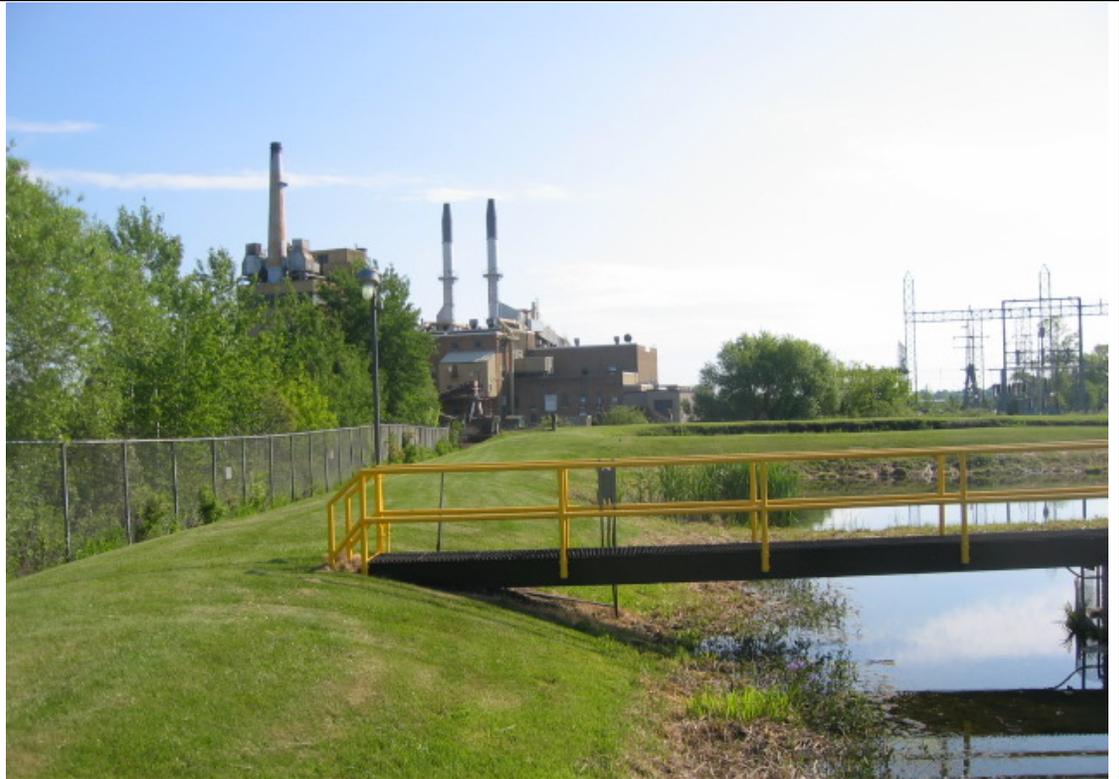
Description:
Upstream slope and Crest of
the Polishing Basin.

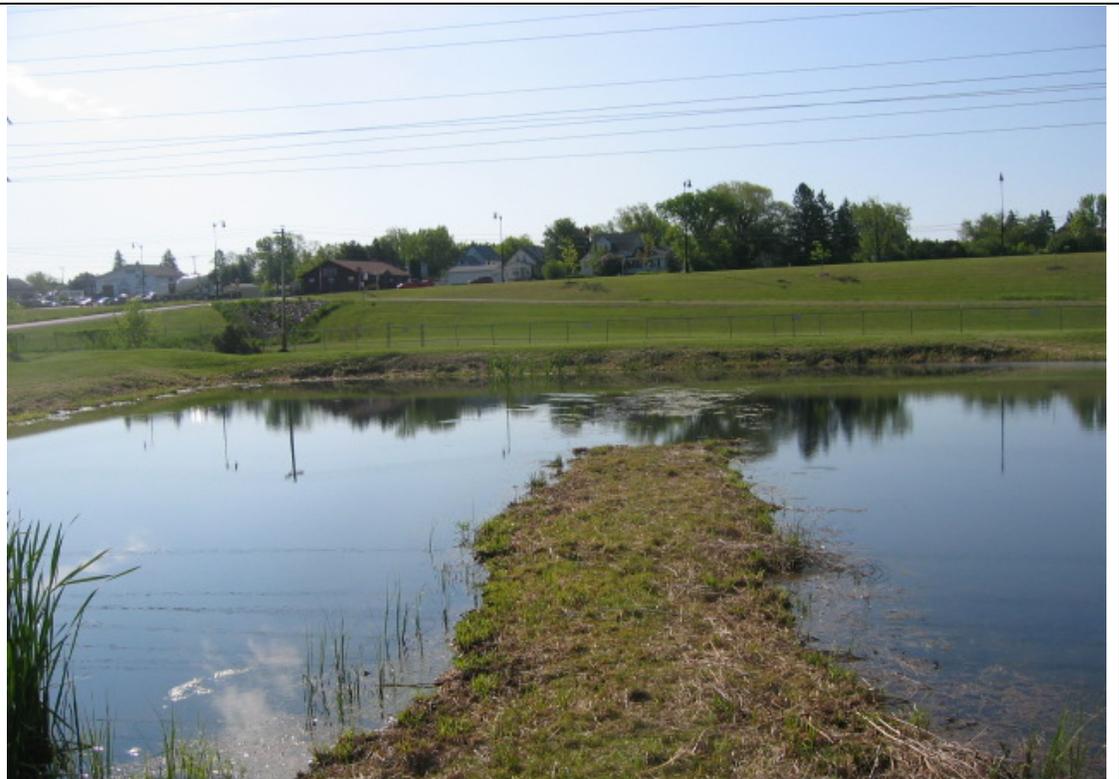
Photo No.
18

Description:
Polishing Basin training
dike.

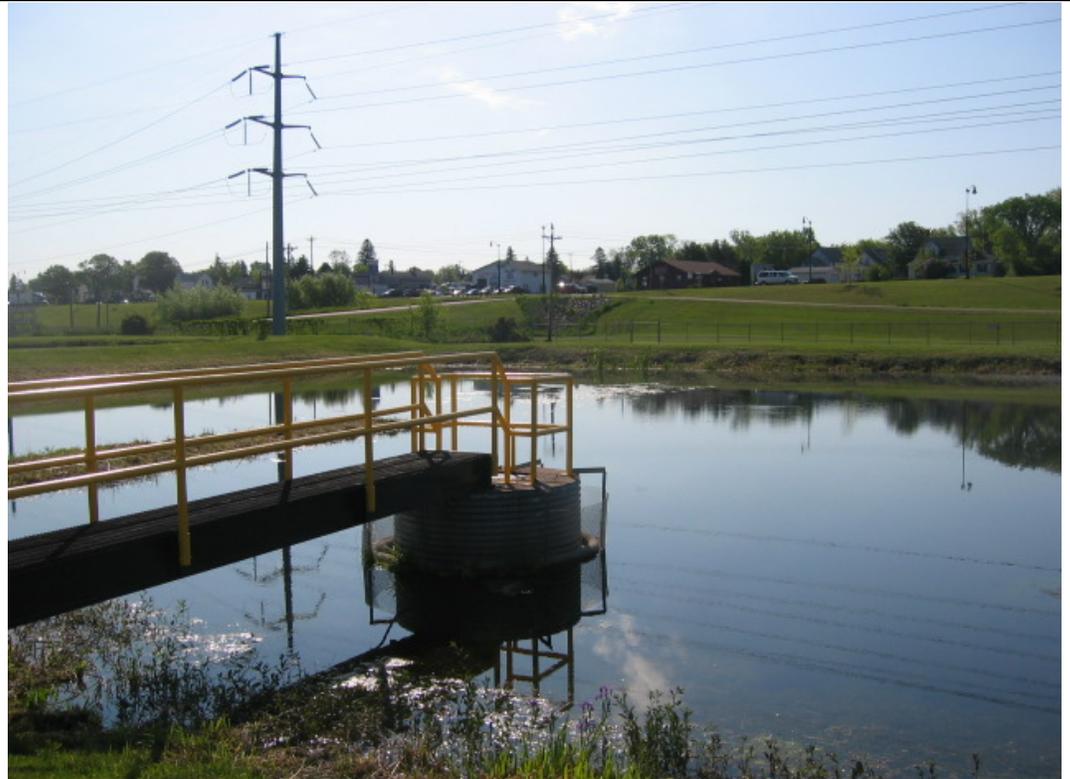
Description:
Polishing Basin Outfall
structure.

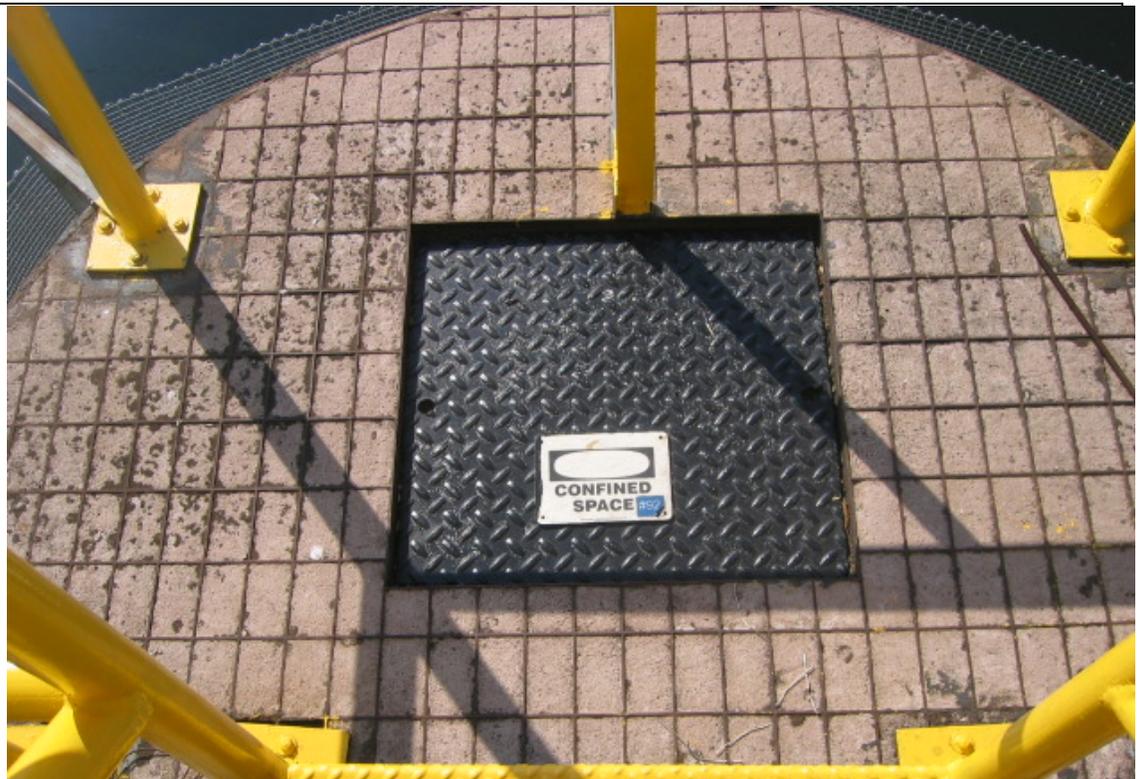
Photo No.
20

Description:
Polishing Basin Outfall
structure.

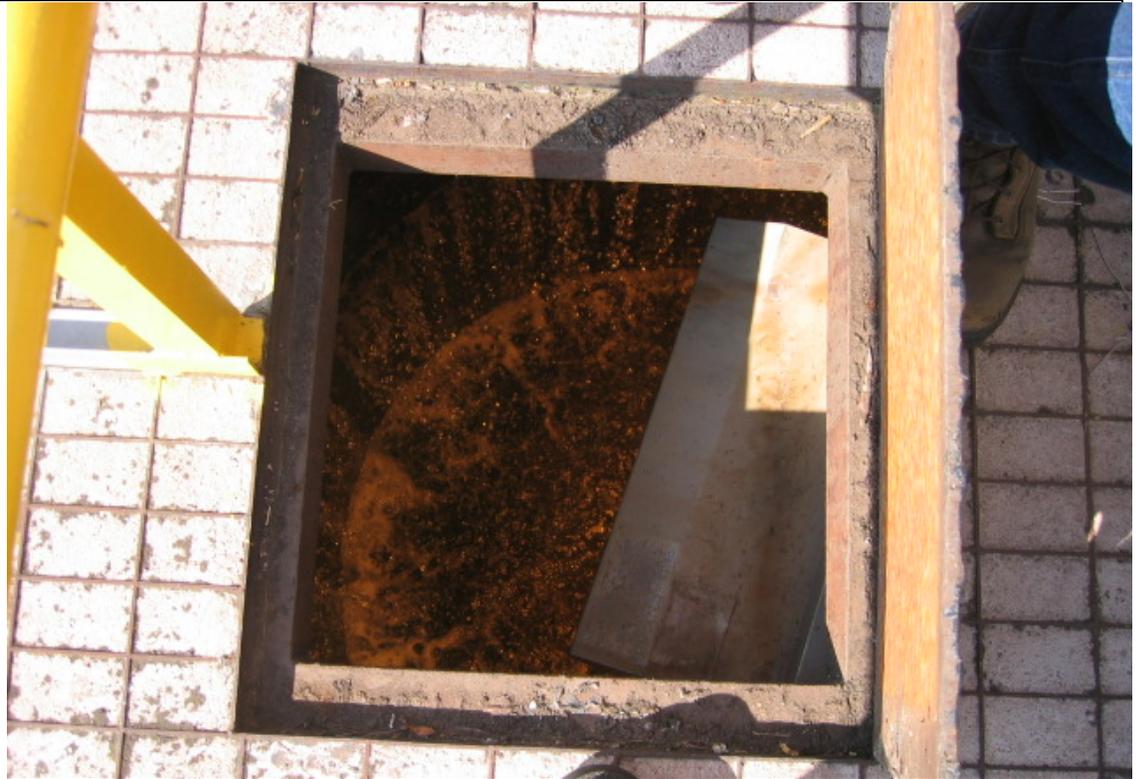
Description:
Flow into the Polishing
Basin Outfall structure.

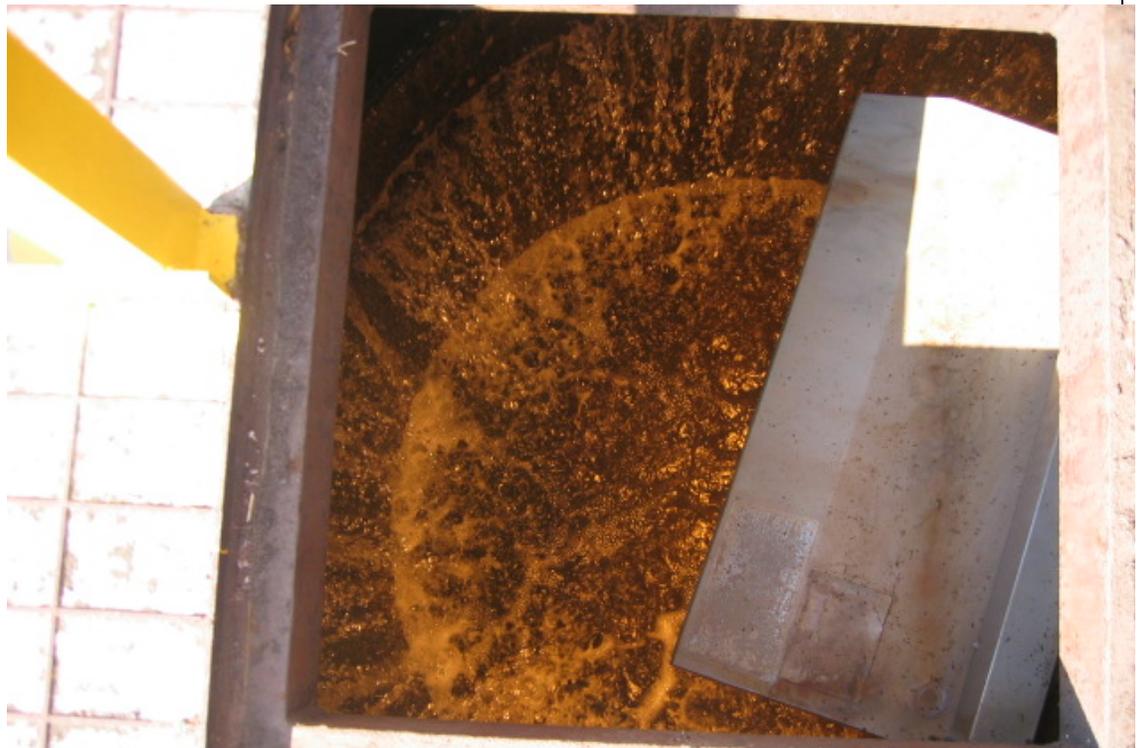
Photo No.
22

Description:
Flow into the Polishing
Basin Outfall structure.

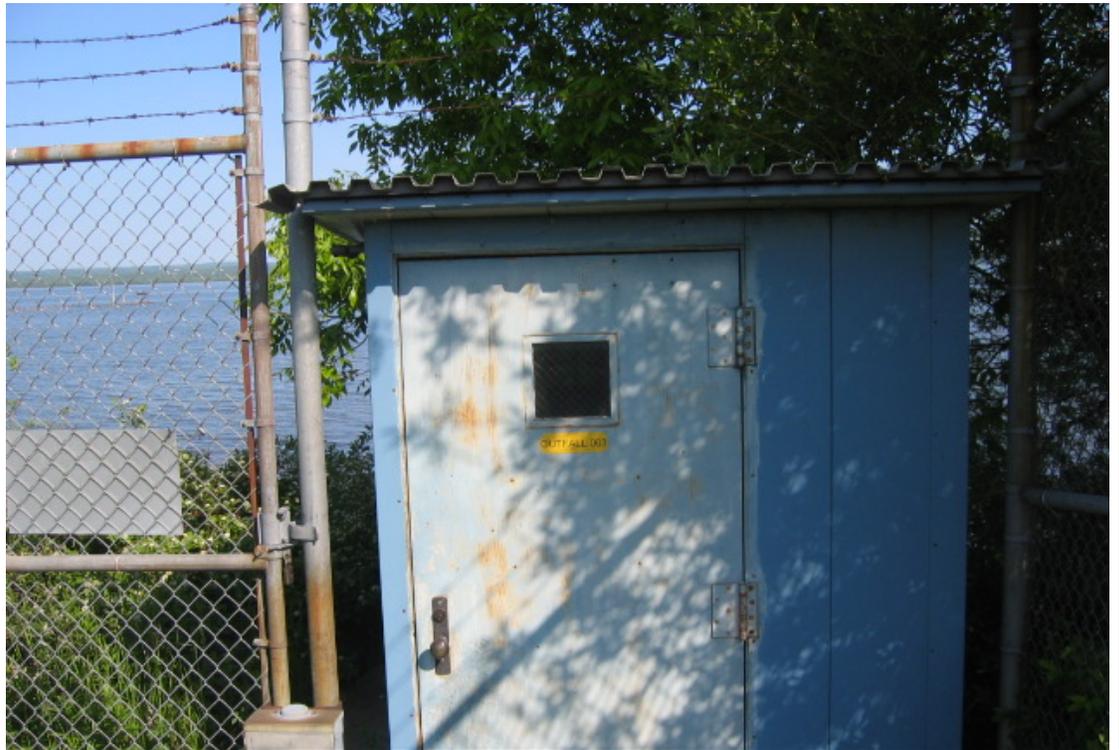
Photo No. 23	Date: 6/14/11
Direction Photo Taken: Northwest

Description:
Polishing Basin Water Quality structure

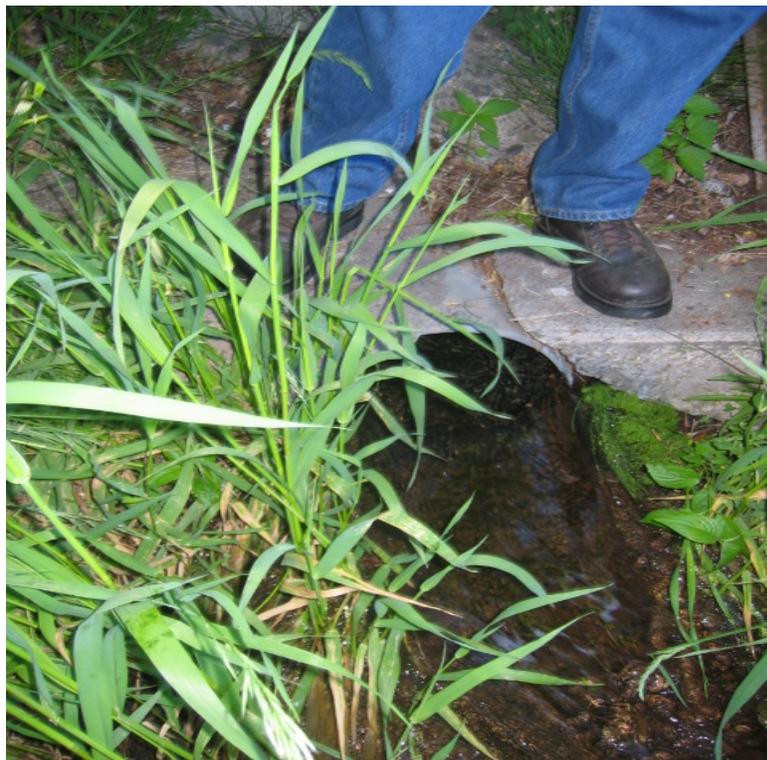
Photo No. 24	Date: 6/14/11
Direction Photo Taken: Southeast

Description:
Polishing Basin Outflow Discharge pipe

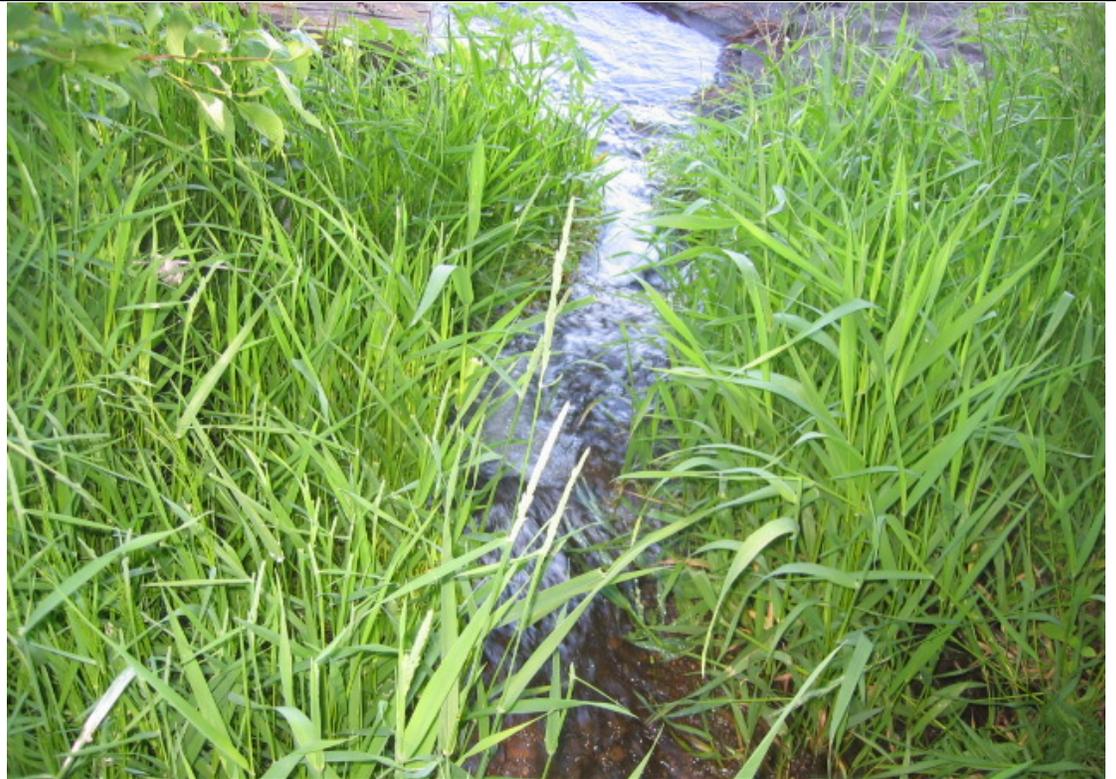
Description:
Flow from Polishing Basin
Outflow Discharge pipe
toward Lake Superior

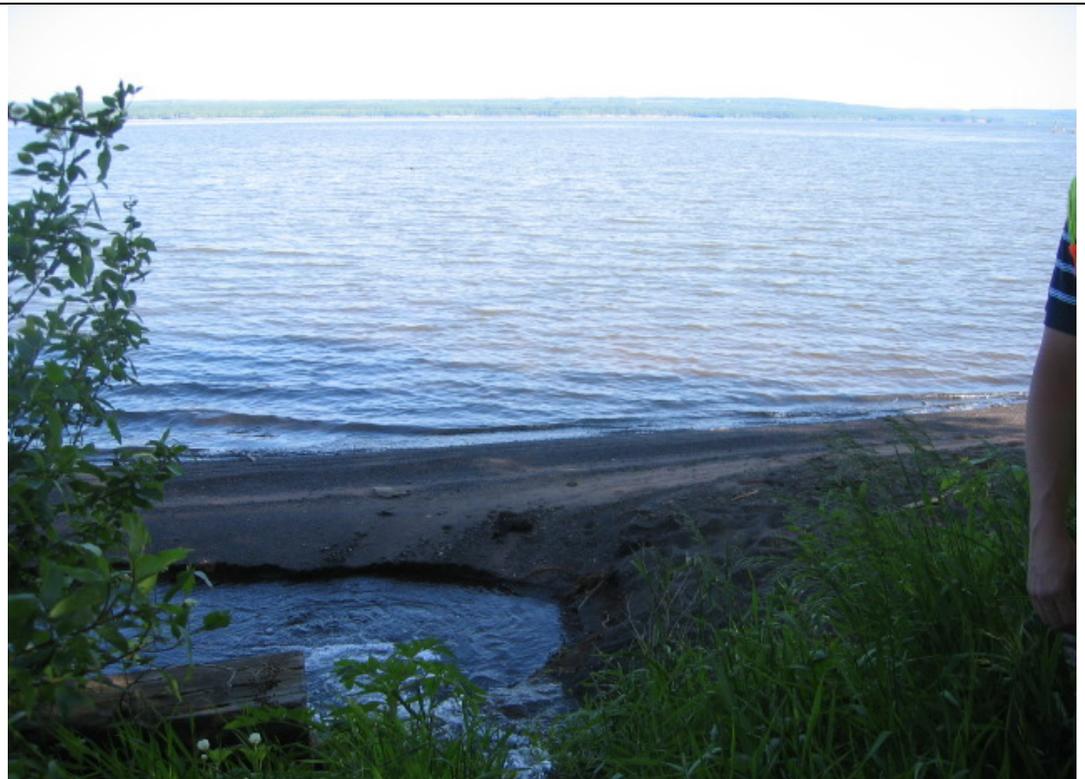
Photo No.
26

Description:
Flow from Polishing Basin
Outflow Discharge pipe into
Lake Superior
