**FINAL REPORT
ROUND 10 DAM ASSESSMENT
XCEL ENERGY – BAY FRONT GENERATING STATION
SURGE BASIN, POLISHING BASIN
ASHLAND, WISCONSIN
DECEMBER 31, 2012**

RE: FINAL Assessment of Dam Safety of Coal Combustion Surface Impoundments at the
Bay Front Generating Station

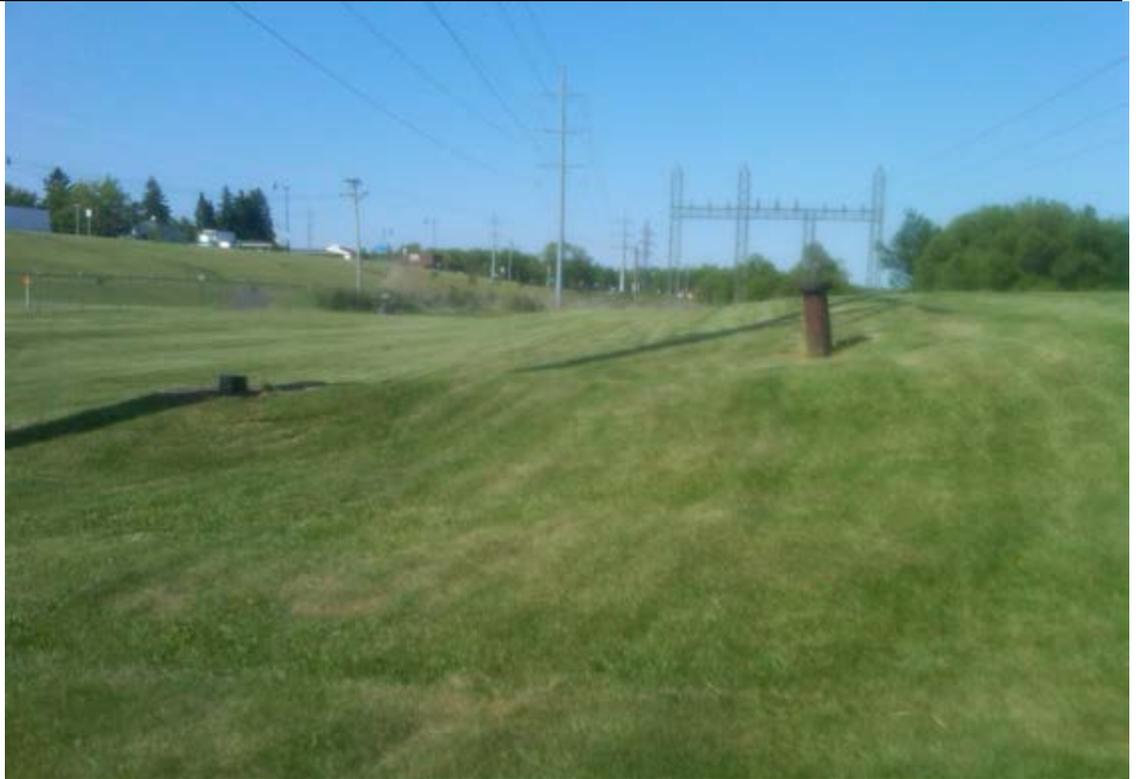
Downstream slope of the
Surge and Polishing Basin.

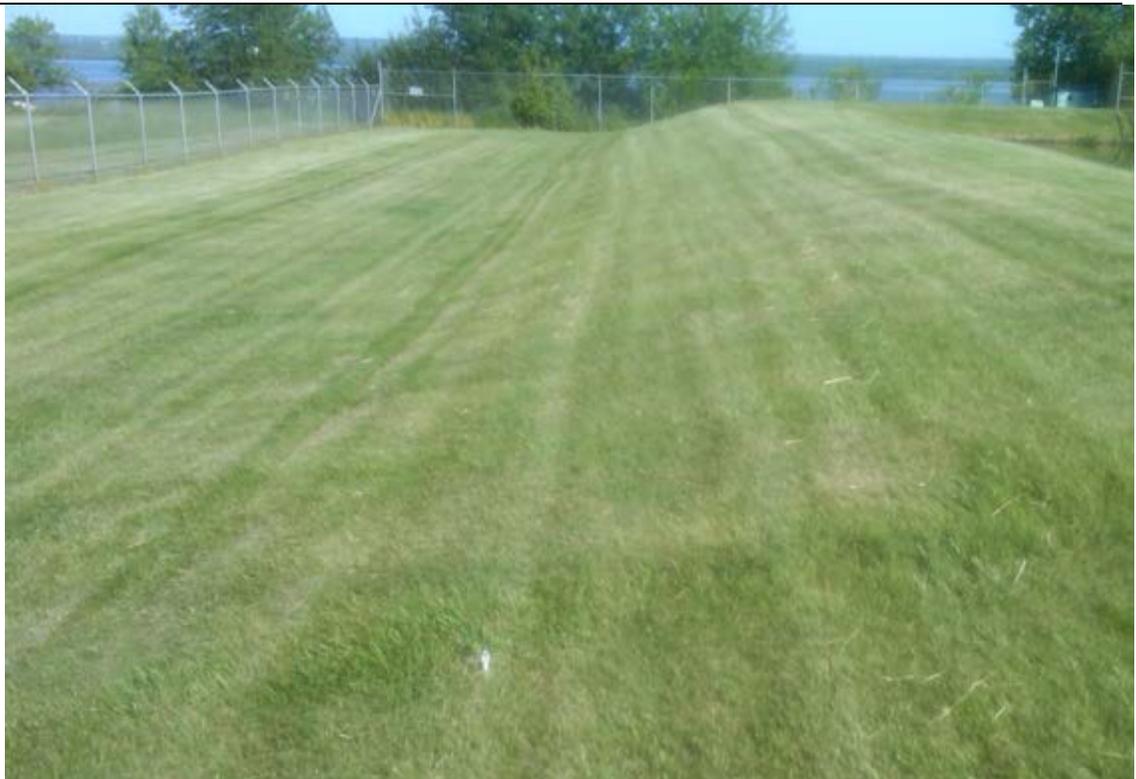
Photo No.
28

Downstream slope of the
Polishing Basin.
