# **WILLIAMSON COUNTY AERATED BIOREACTOR LANDFILL: OPERATIONS AND PERFORMANCE**

**Presented by  
Civil & Environmental Consultants  
for the  
U.S. Environmental Protection Agency  
Workshop On Bioreactor Landfills  
February 27-28, 2003**

# WILLIAMSON COUNTY LANDFILL

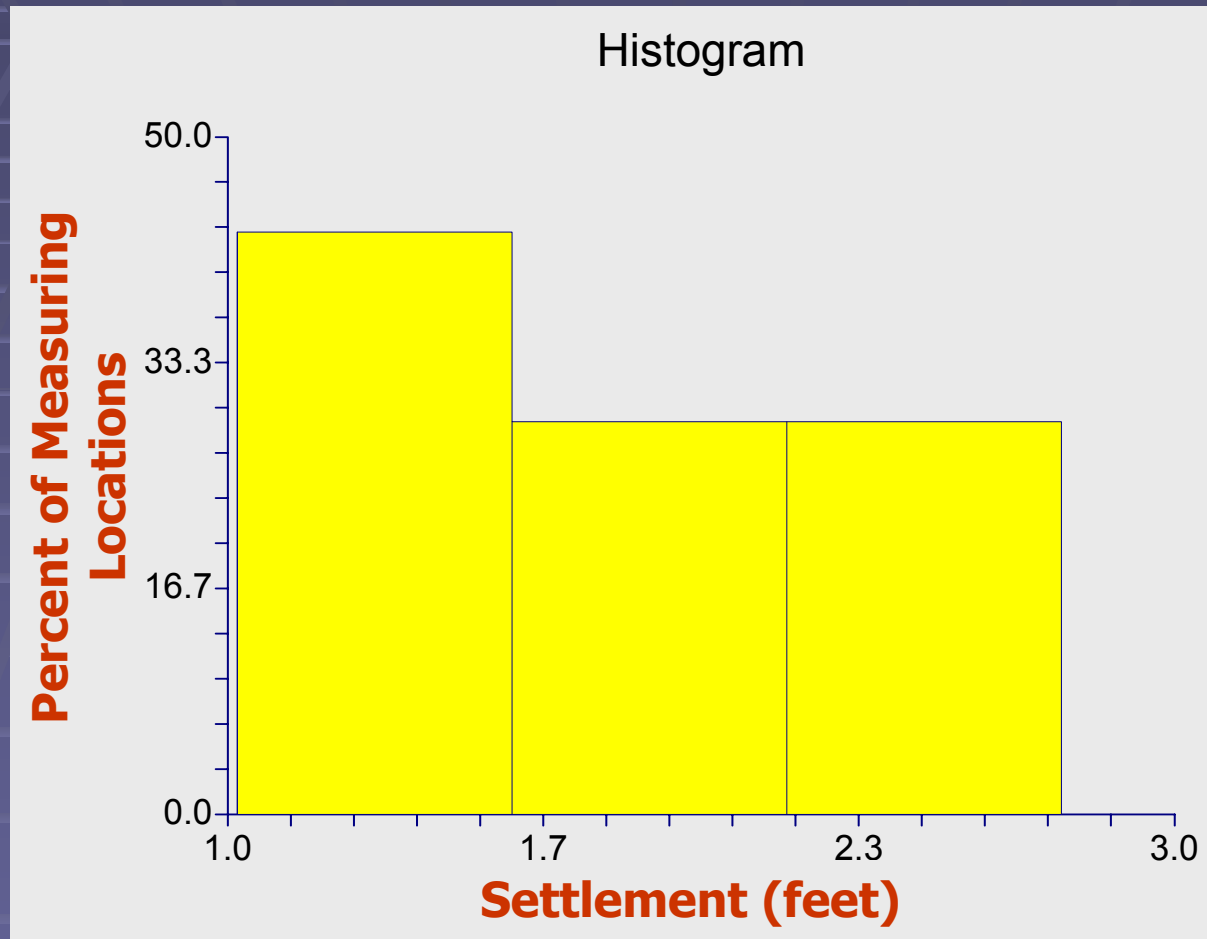
# SETTLEMENT (AS OF 1/28/03)

➤ **Average Settlement Across Site = 22 inches or 4.9% of original avg. depth**

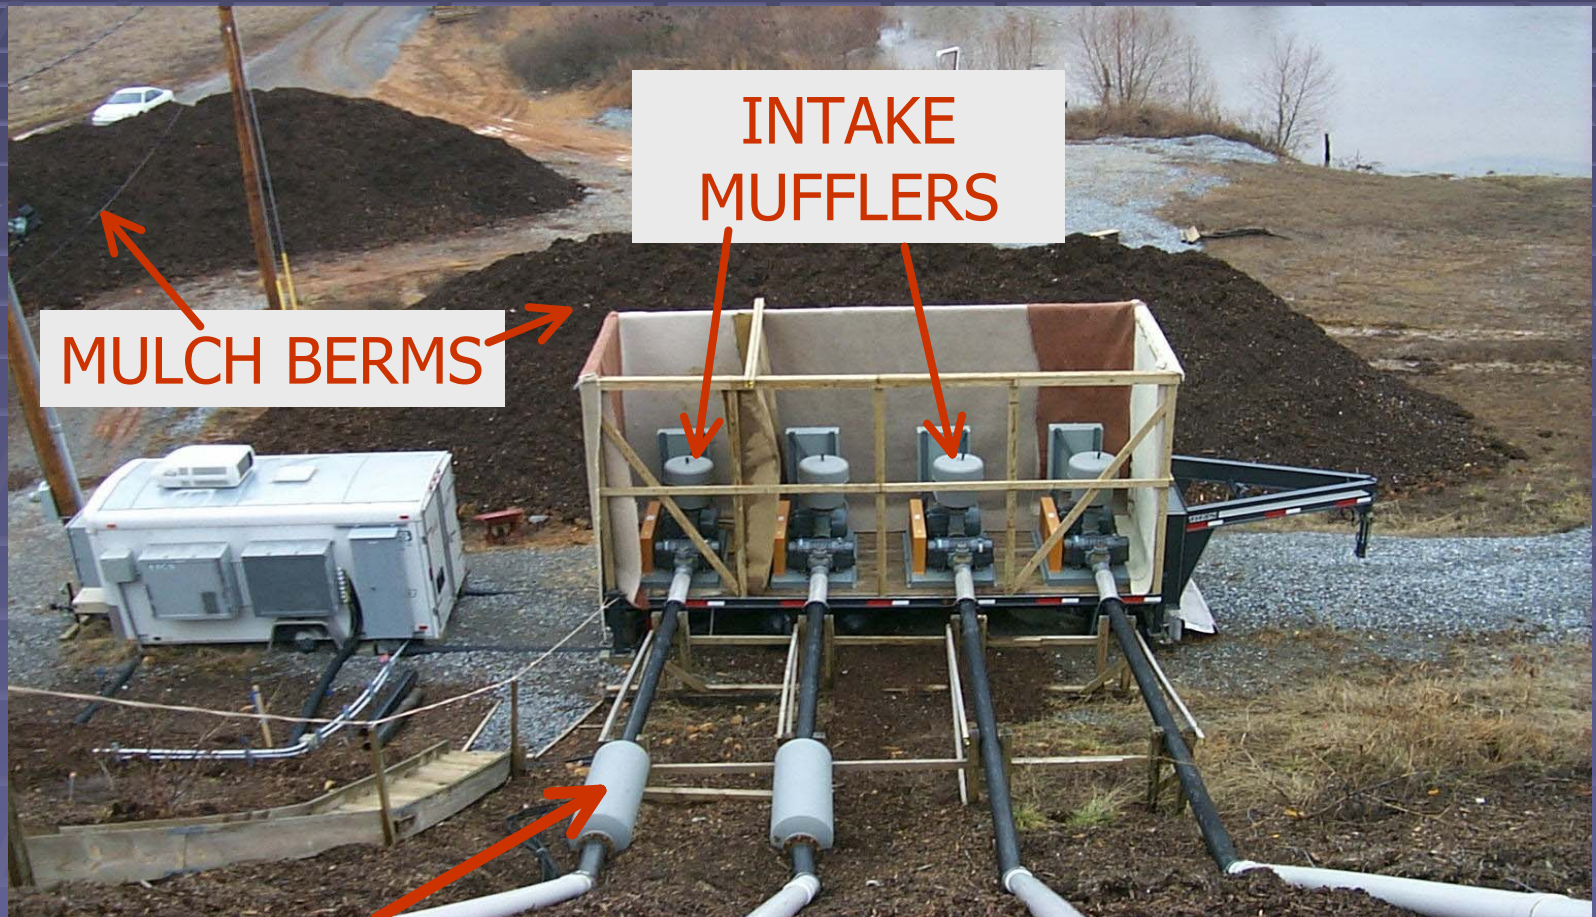
- **PROBLEM:** Noise from blowers (neighbor complaints)
- **SOLUTION:** Vibration dampeners on outlet air header pipes; mufflers on blower intakes; carpeted structure around blowers

# POSITIVE DISPLACEMENT BLOWERS WITH NOISE ABATEMENT MEASURES

DISCHARGE NOISE  
DAMPENERS

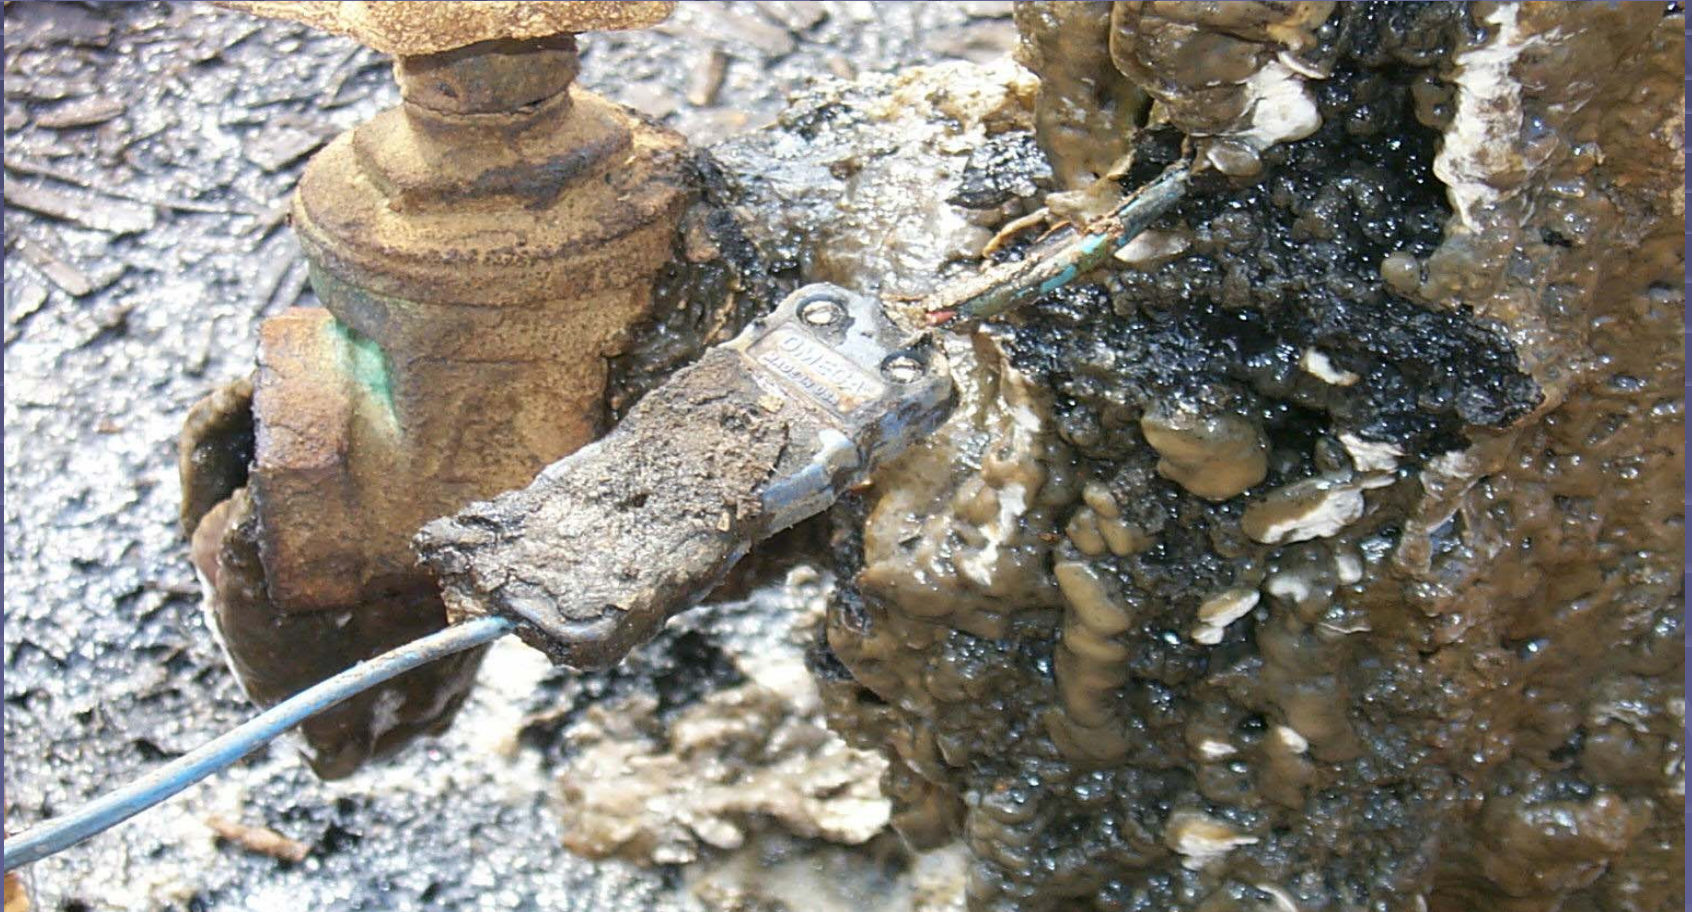
- Sealing Connections
- Shielded wire was not used
- Accidental severing of Lines
- Wires wrapped around piping

# PRECIPITATE AND CORROSION AT THERMOCOUPLE CONNECTOR

- Replacement of wire; use of shielded wire
- Shrink-Wrap Connections or replace with outdoor connectors (watertight)
- Remove wires from around piping

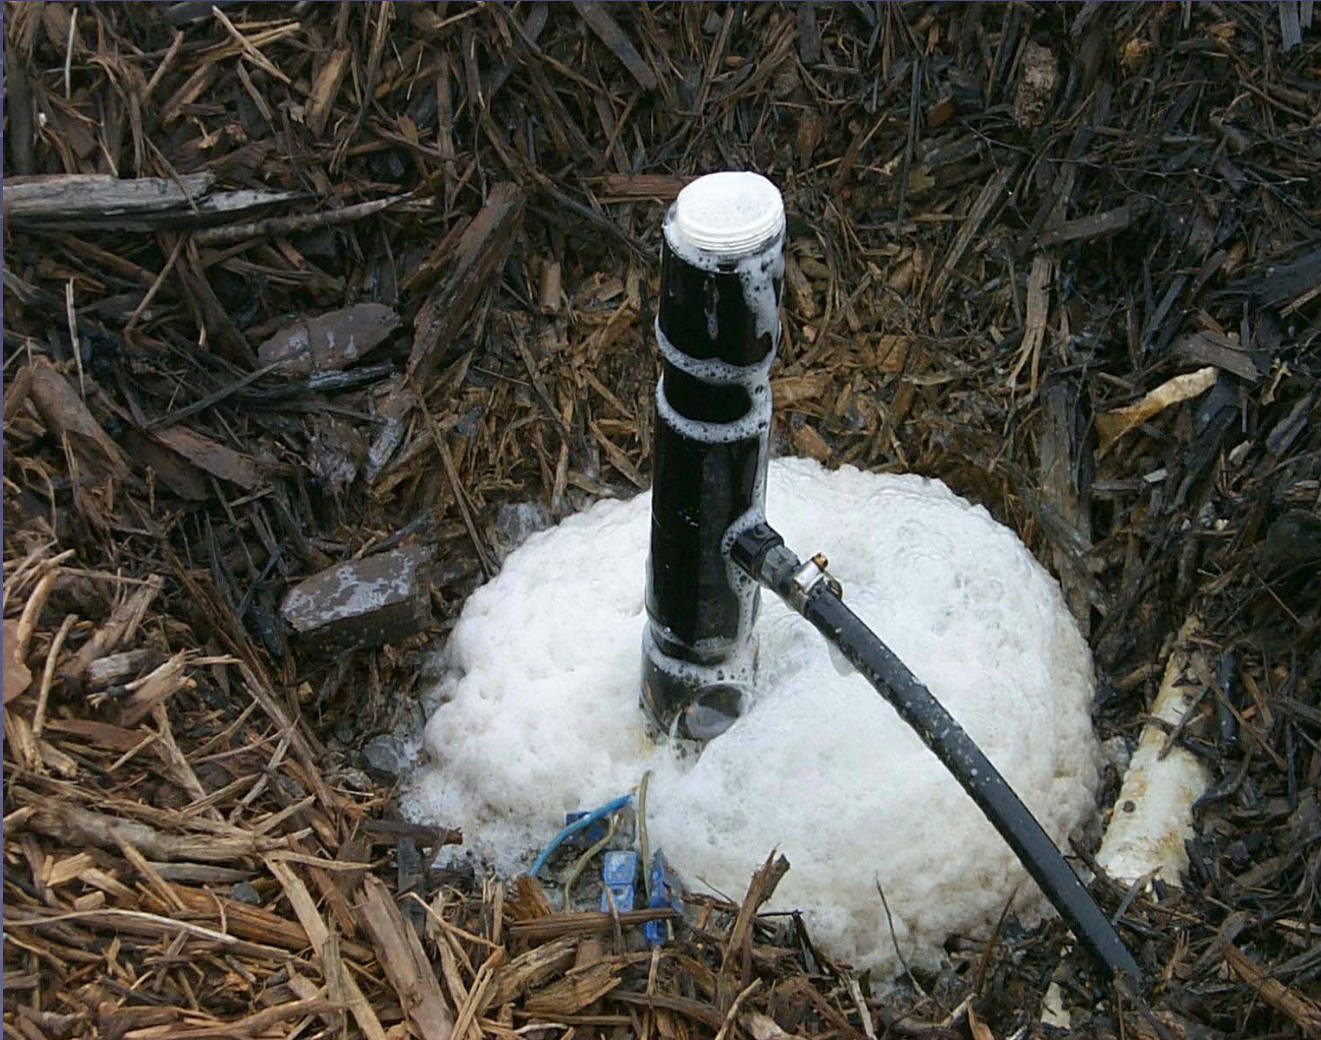
- **PROBLEM: Backflow/Surge of leachate from injection wells**
  - Leachate ejection onto base of wells
  - Backflow into air pipes when blowers are off)
  - Probable cause:
    - excessive internal gas production and associated pressures along with increasing heat

# LEACHATE BACKFLOW/SURGE

- **Throttle valves at well heads;**
- **Construct mulch berms to contain surcharge and prevent it from leaving site as stormwater;**
- **Periodic leachate dosing;**
- **Check valves on air lines to prevent leachate backflow**

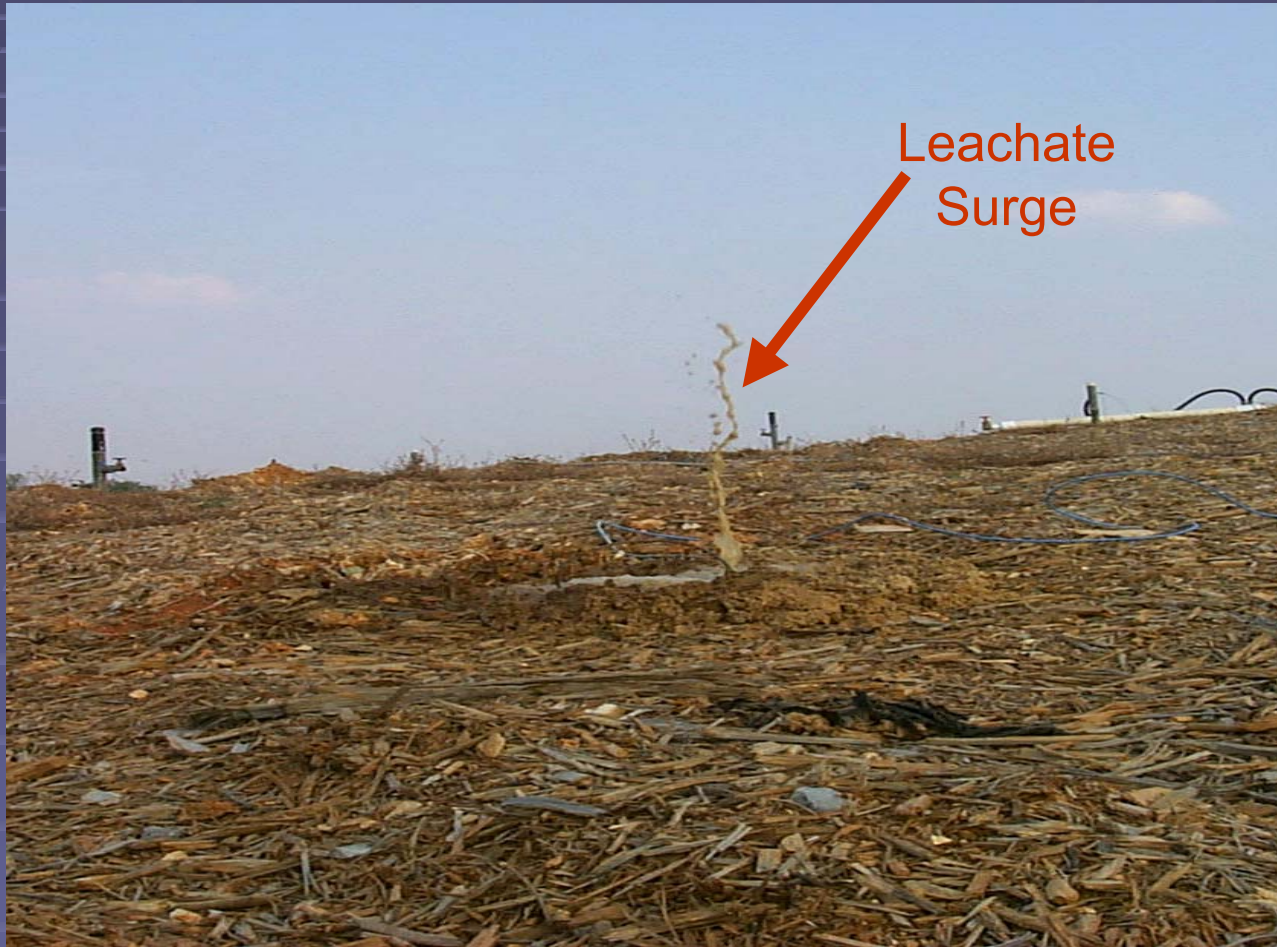
# LEACHATE BACKFLOW/SURGE

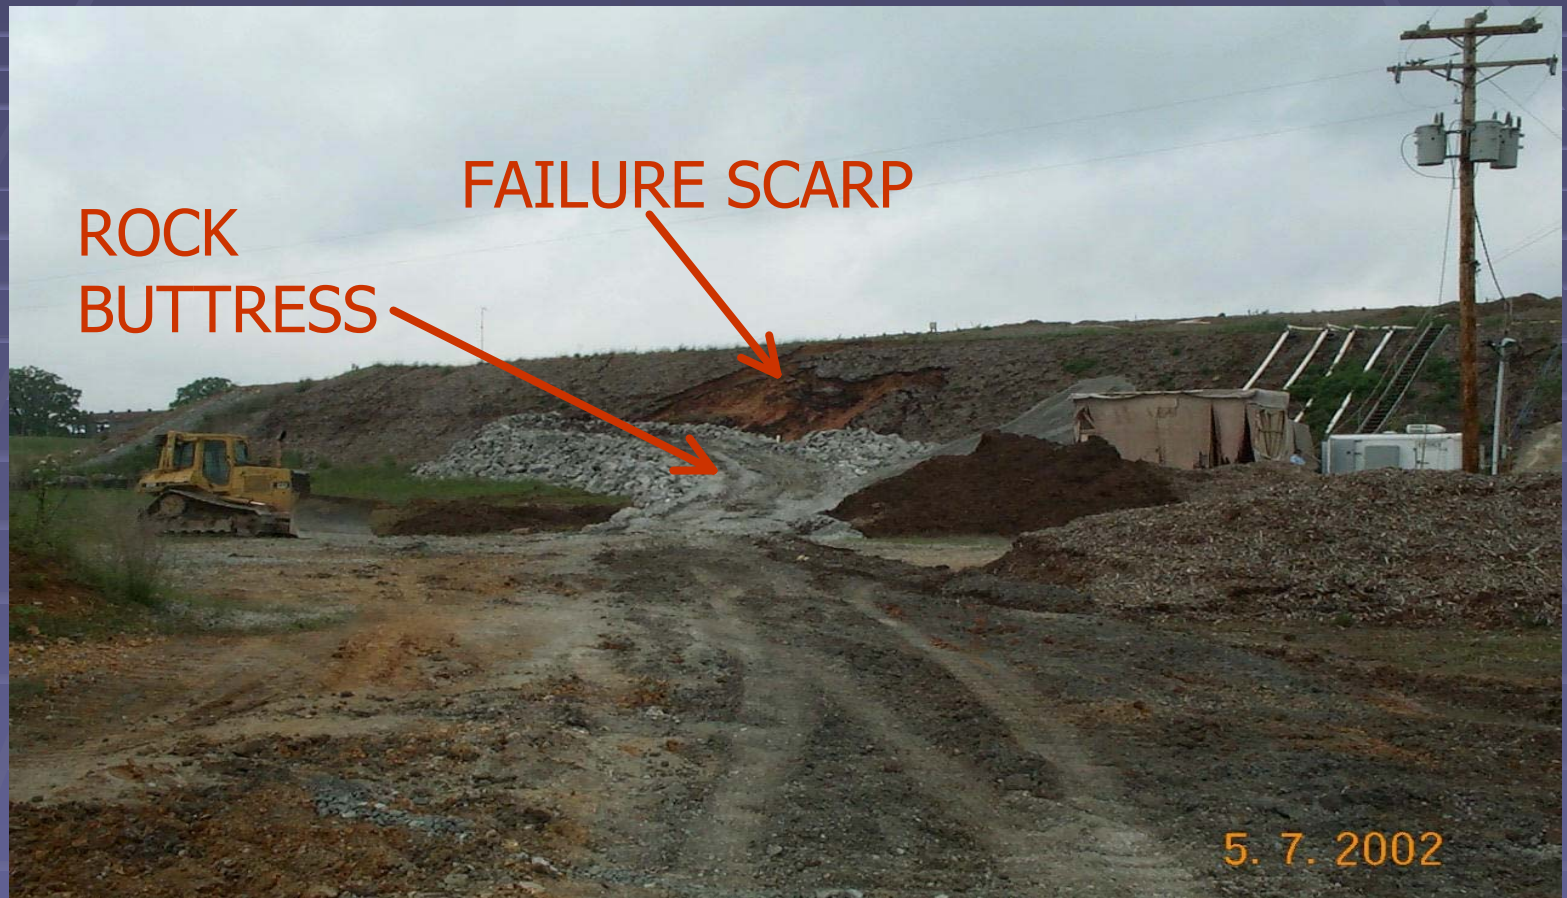
**SOUTH SLOPE – MAY 7, 2002**

# GEOTECHNICAL STABILITY

- **Continued monitoring of slope movement via sideslope risers**
- **All injection wells (air and leachate) located near top edge of slope have been shut off**
- **Rock buttresses built along south sideslope**

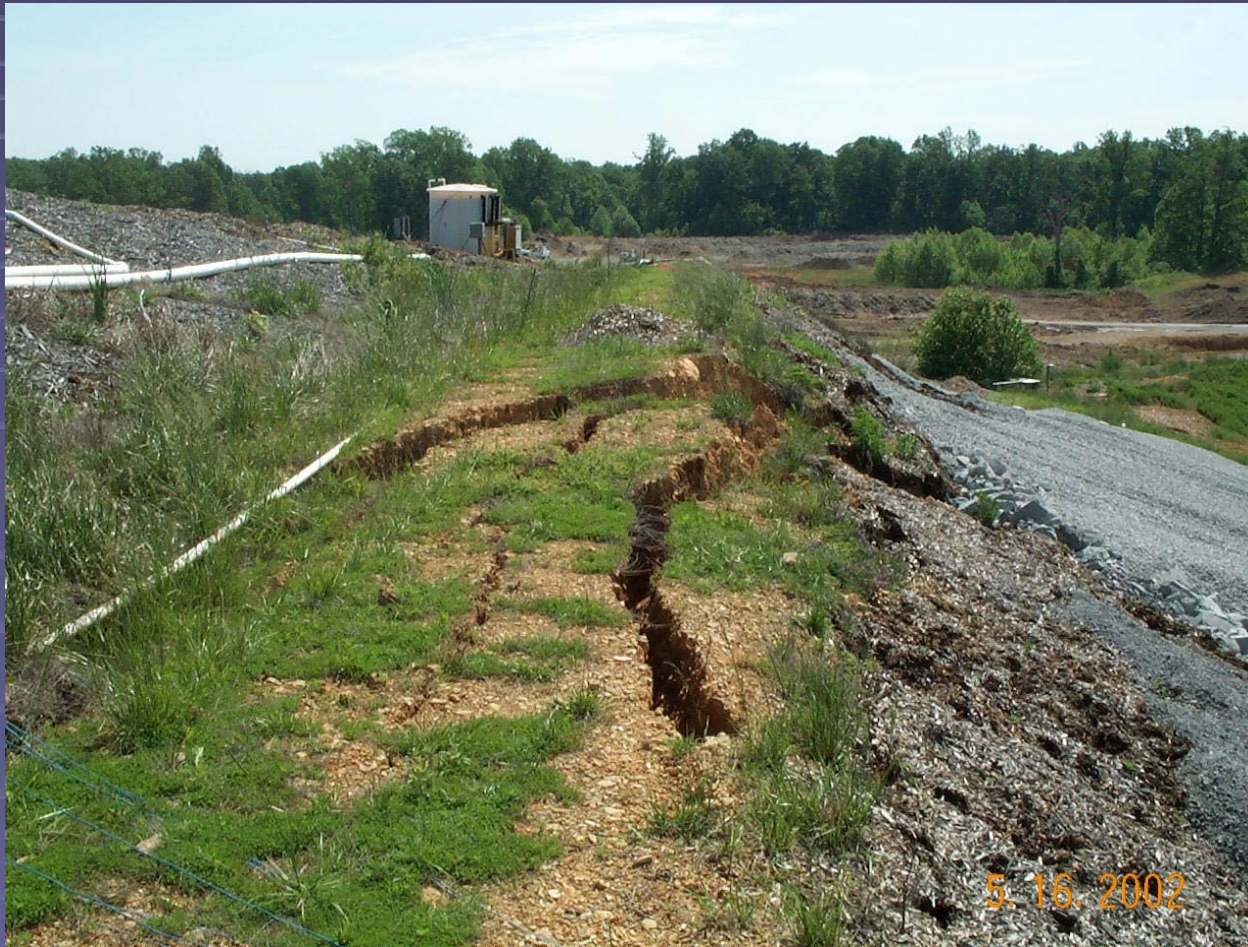
**South Slope- May 2002**

# GEOTECHNICAL STABILITY
