Facility Name & Location:
ALLENCO ENERGY LOS ANGELES CA

**Dates Photographs
Were Taken:**
11/6/2013

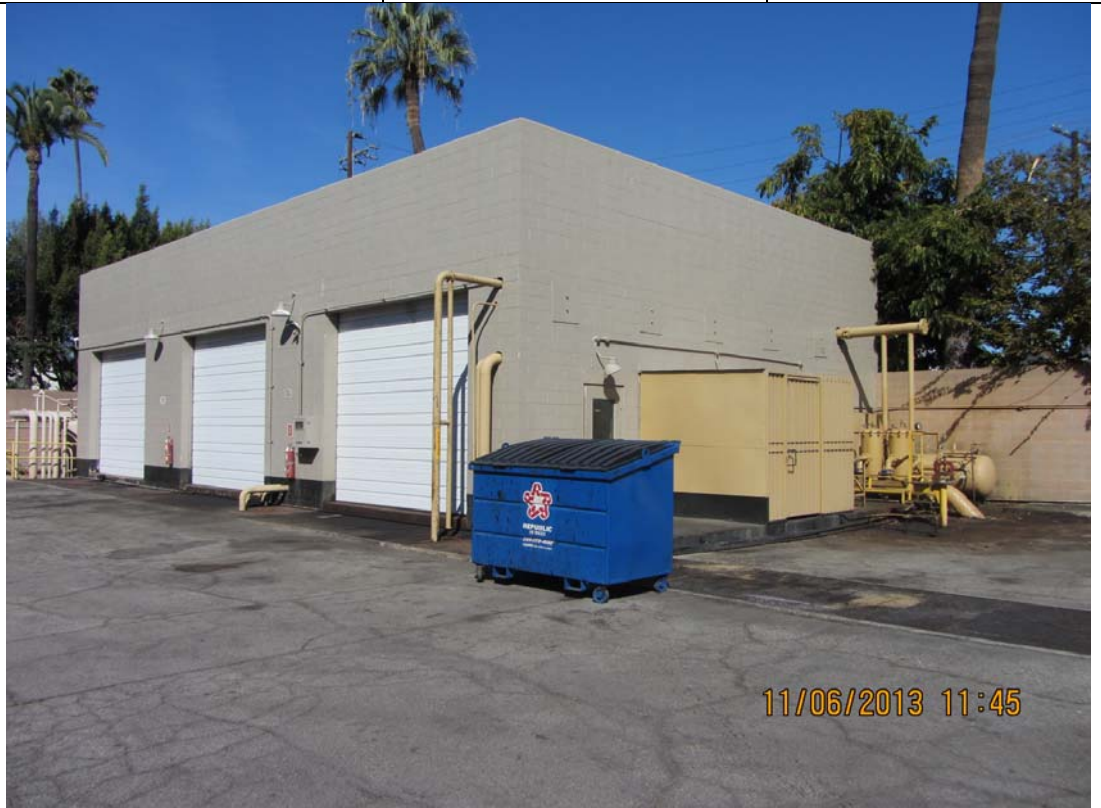
Photo No.	Time:
1	1045*

EXTERIOR OF WATER
INJECTION PUMP
HOUSE. TRENCH SUMP
UNDER GRATING.

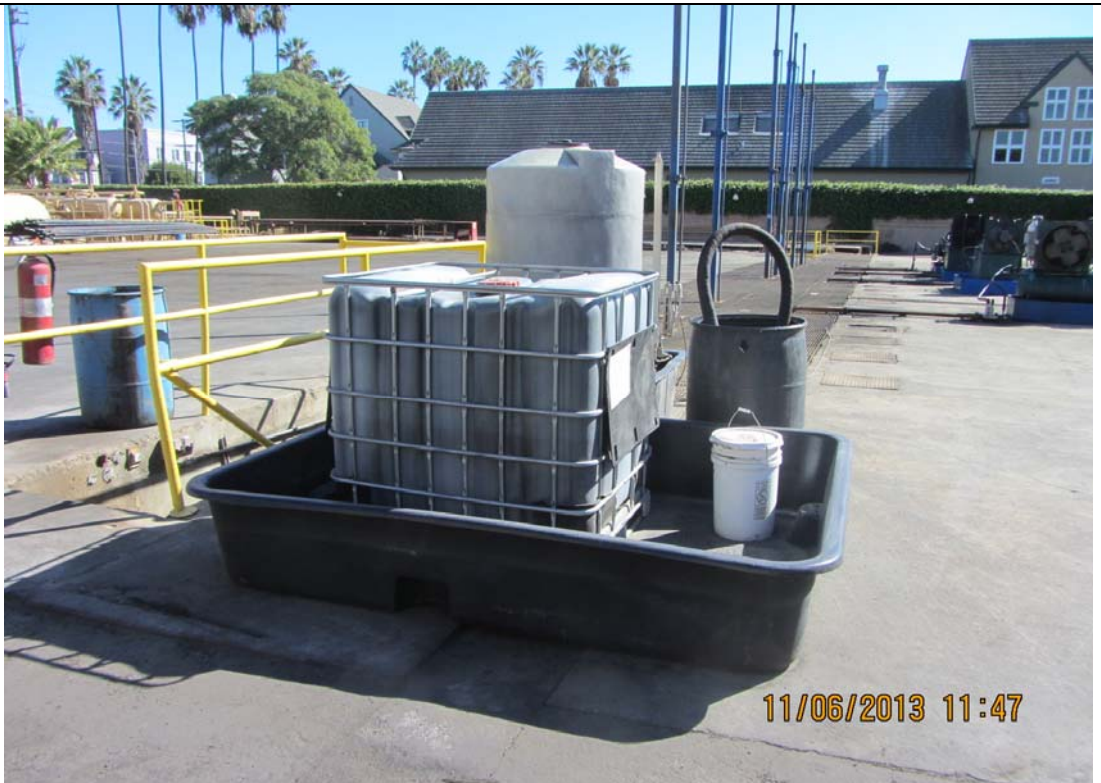
Photo No.	Time:
2	1047

PORTABLE
CONTAINERS OF
INHIBITORS (e.g.
CORROSION) IN
SECONDARY
CONTAINMENT

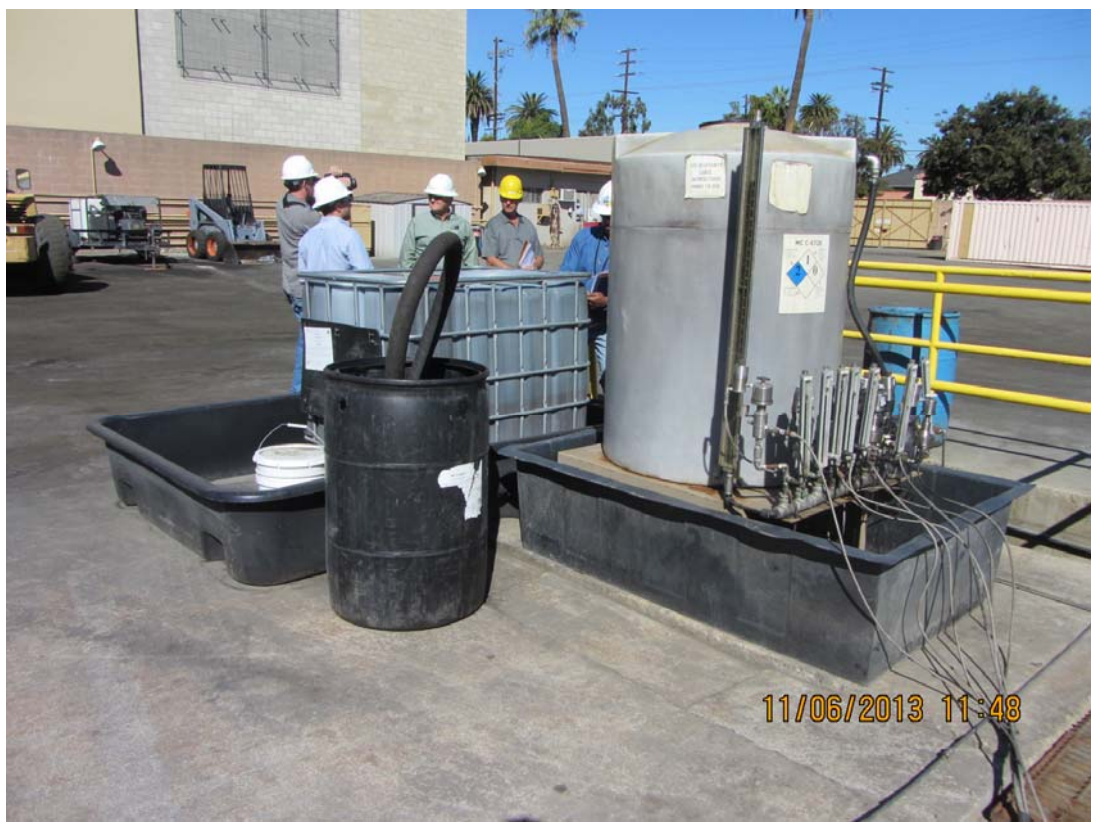
Photo No. 3	Time: 1048
-----------------------	----------------------

Photo Description:
ADDITIONAL VIEW OF INHIBITOR CONTAINERS IN SECONDARY CONTAINMENT

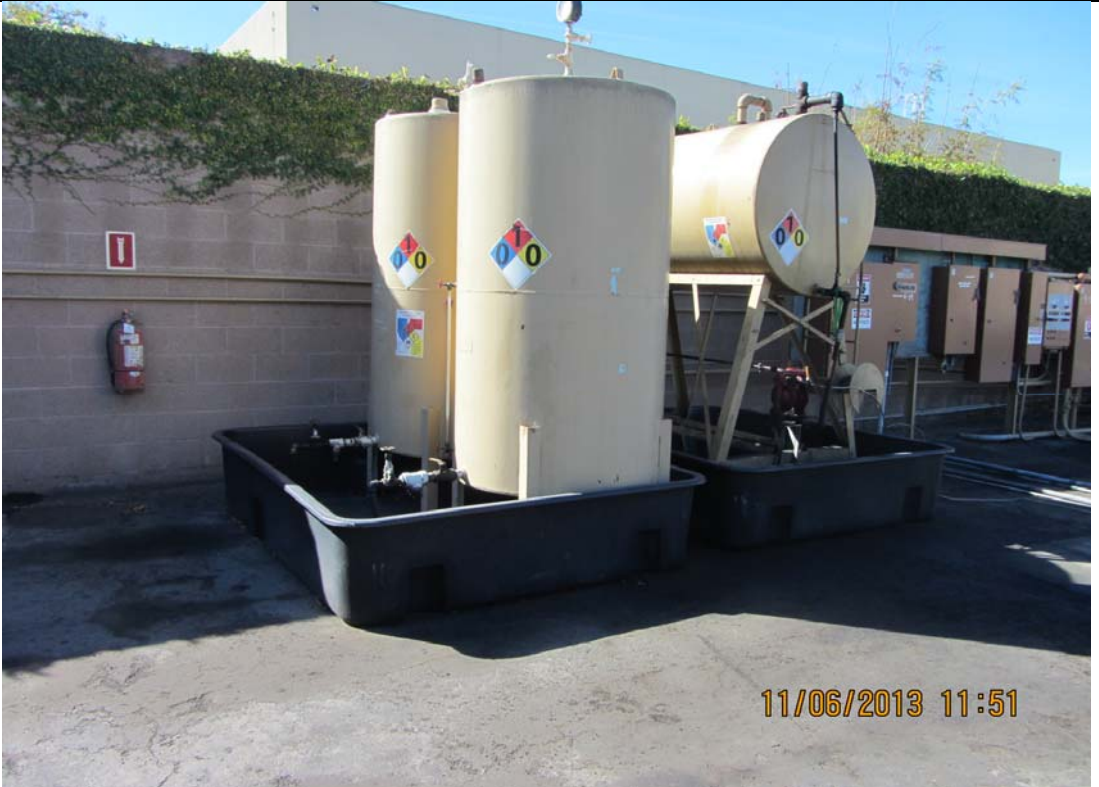
Photo No. 6	Time: 1051
Direction Photo Taken: S	
Photo Description: HYDRAULIC OIL TANKS IN SECONDRY CONTAINMENT – TANK AT RIGHT IN USE

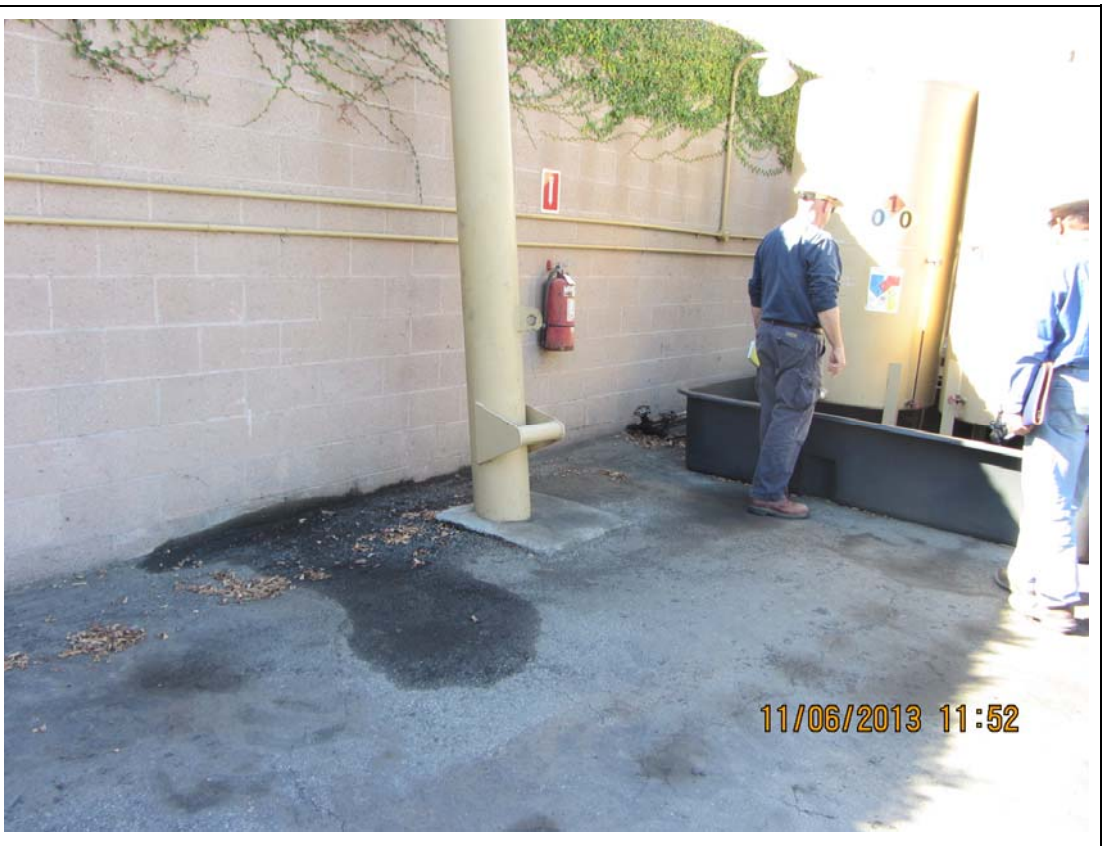
Photographer: WITUL	
Photo No. 7	Time: 1052
Direction Photo Taken: W	
Photo Description: AREAS OF DISCOLORATION, POSSIBLY WEEPING FROM HISTORICAL EVENT, OR SEEPAGE FROM BEYOND WALL. HYDRAULIC OIL TANKS AT RIGHT OF IMAGE.

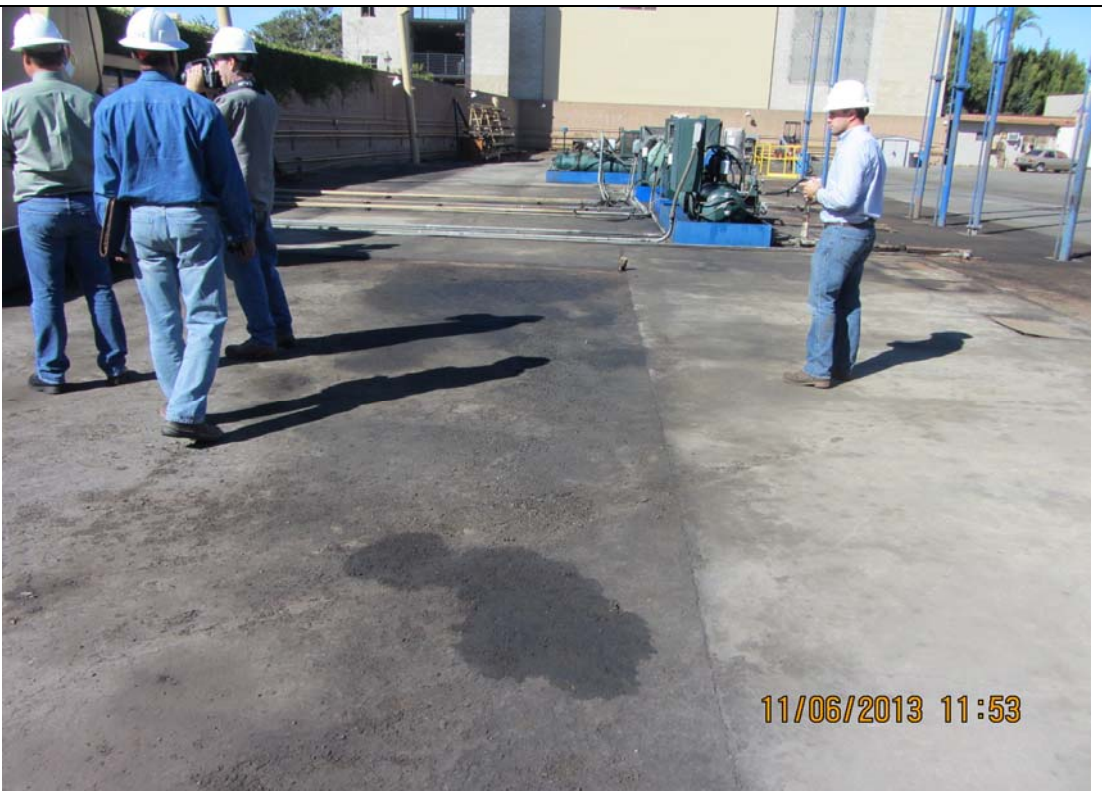
Photo No. 8	Time: 1053
Direction Photo Taken: WNW	
Photo Description: SOME AREAS OF DISCOLORATION ON PAVED AREA.

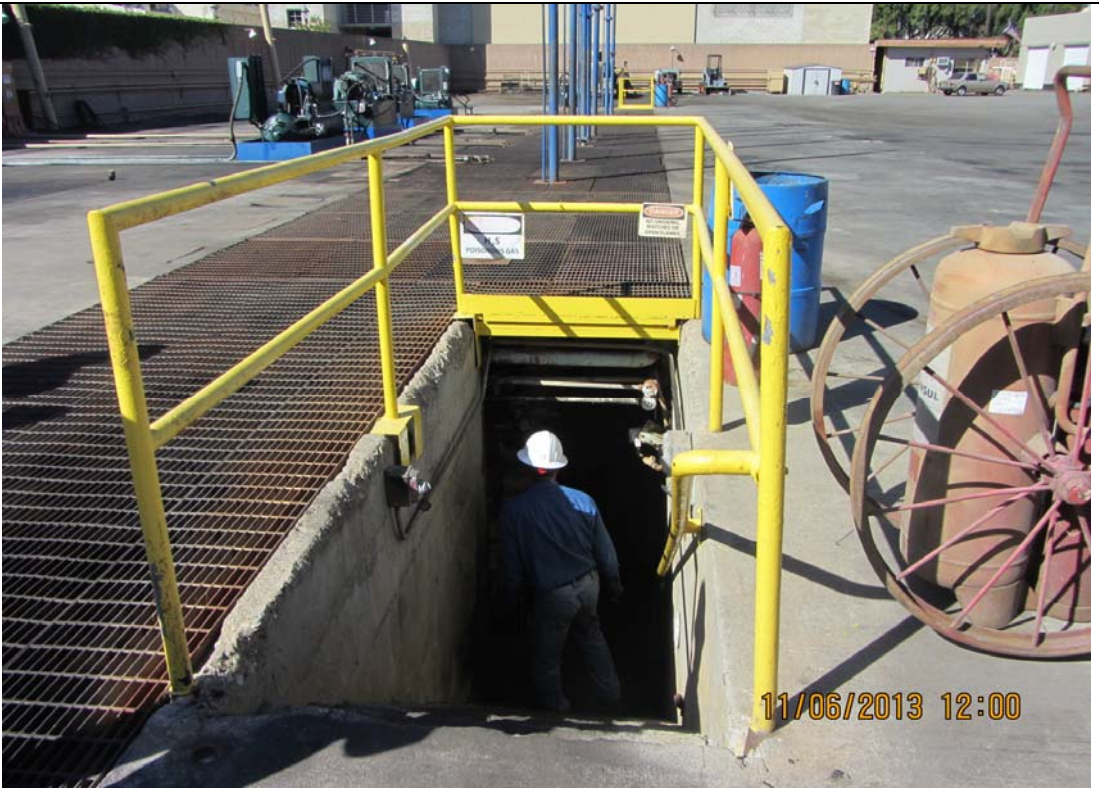
Photo No. 10	Time: 1100
------------------------	----------------------

WELL GALLERY EAST ENTRANCE WITH H2S WARNING SIGN IN PLACE ON RAIL.

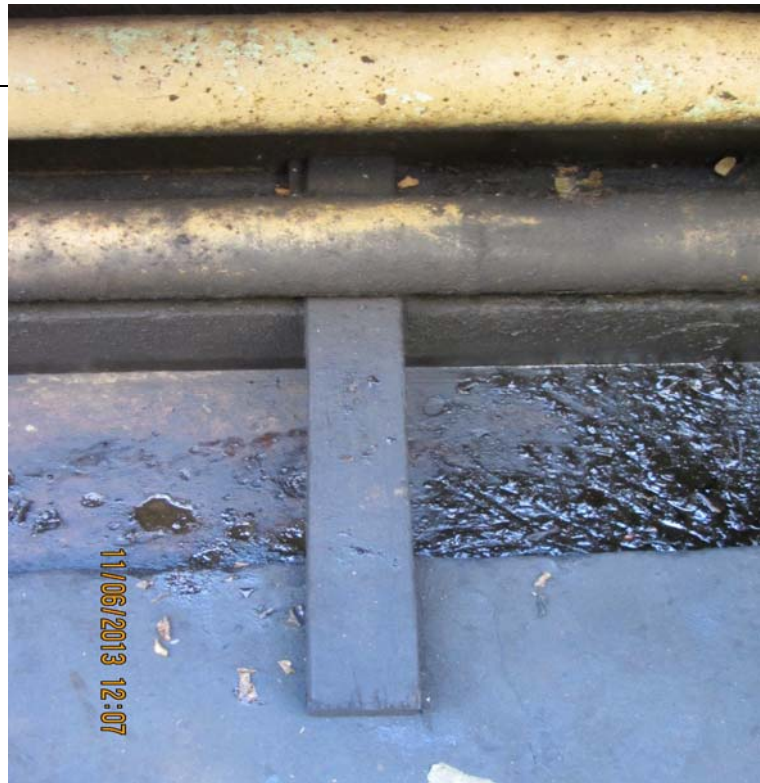
Photo No. 16	Time: 1107
Direction Photo Taken: S	
Photo Description: LUMBER USED AS PIPING SUPPORT IN WELL GALLERY

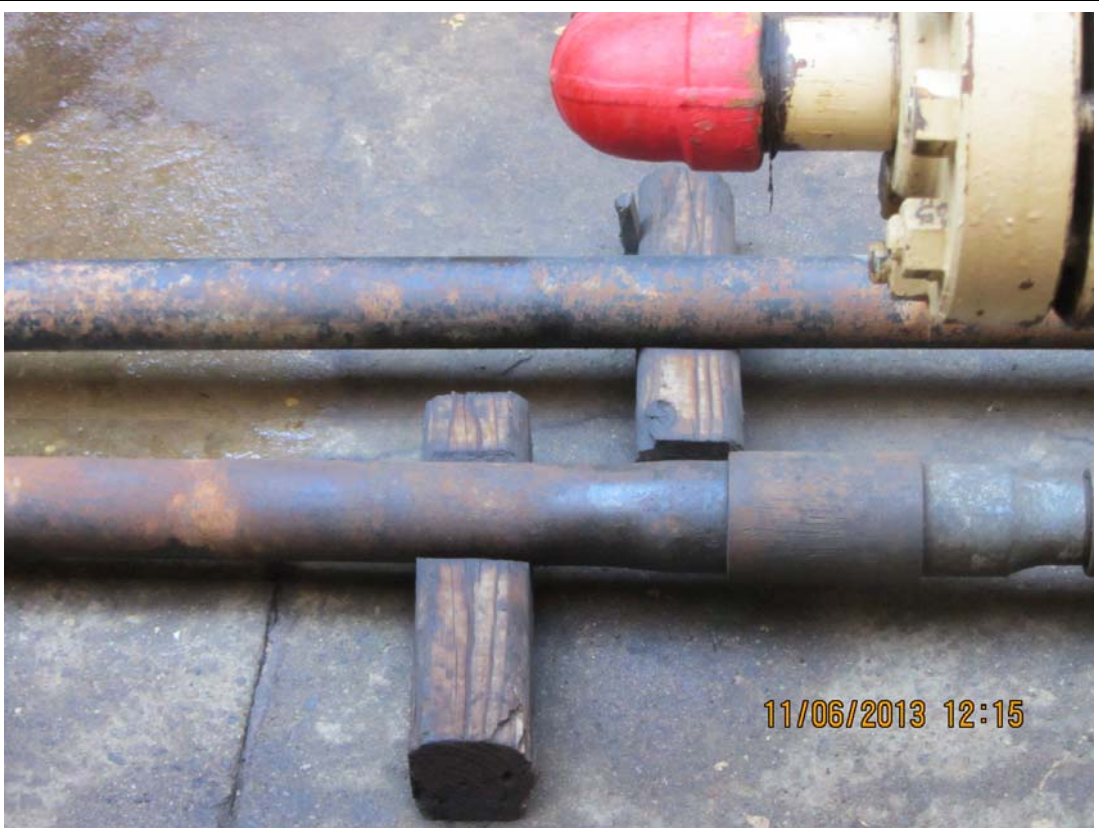
Photo No. 17	Time: 1115
------------------------	----------------------

LUMBER USED AS PIPING SUPPORTS FOR WELL #19 TEST LINES (CURRENTLY IDLE)

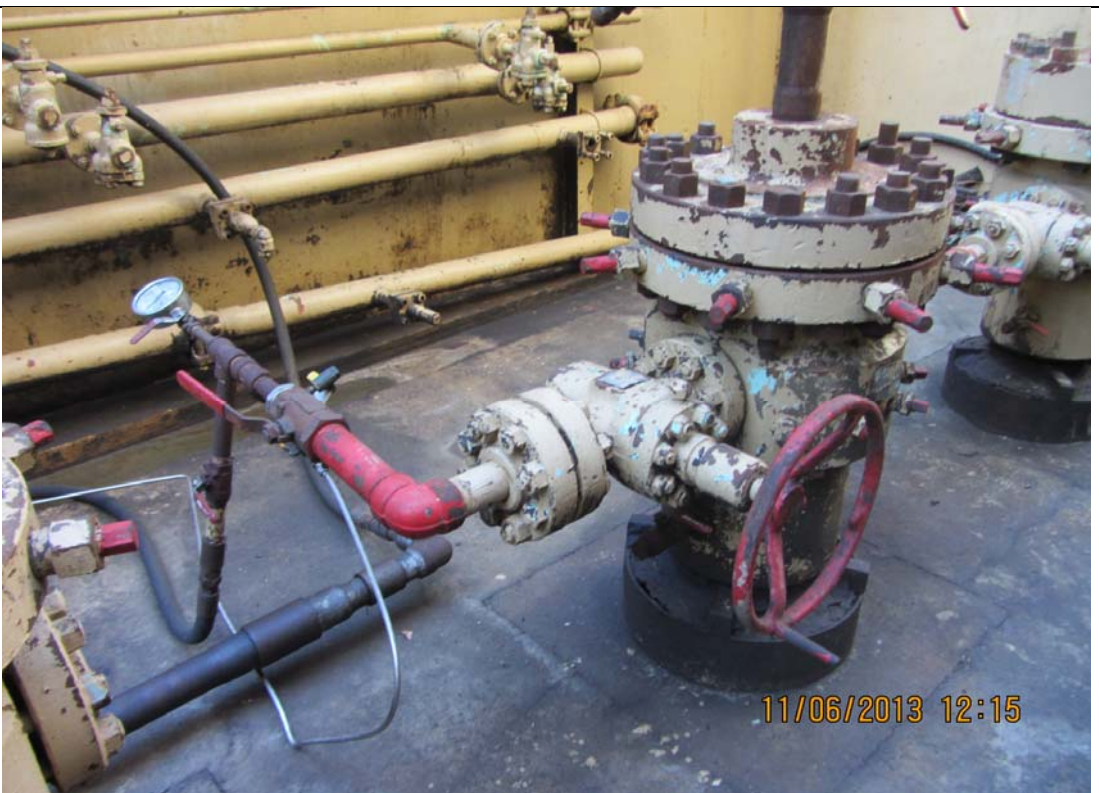
Photo No. 18	Time: 1115
------------------------	----------------------

TEST LINES (AT LEFT) TO WELL #19 (IDLE) AND #19 WELL HEAD AT RIGHT

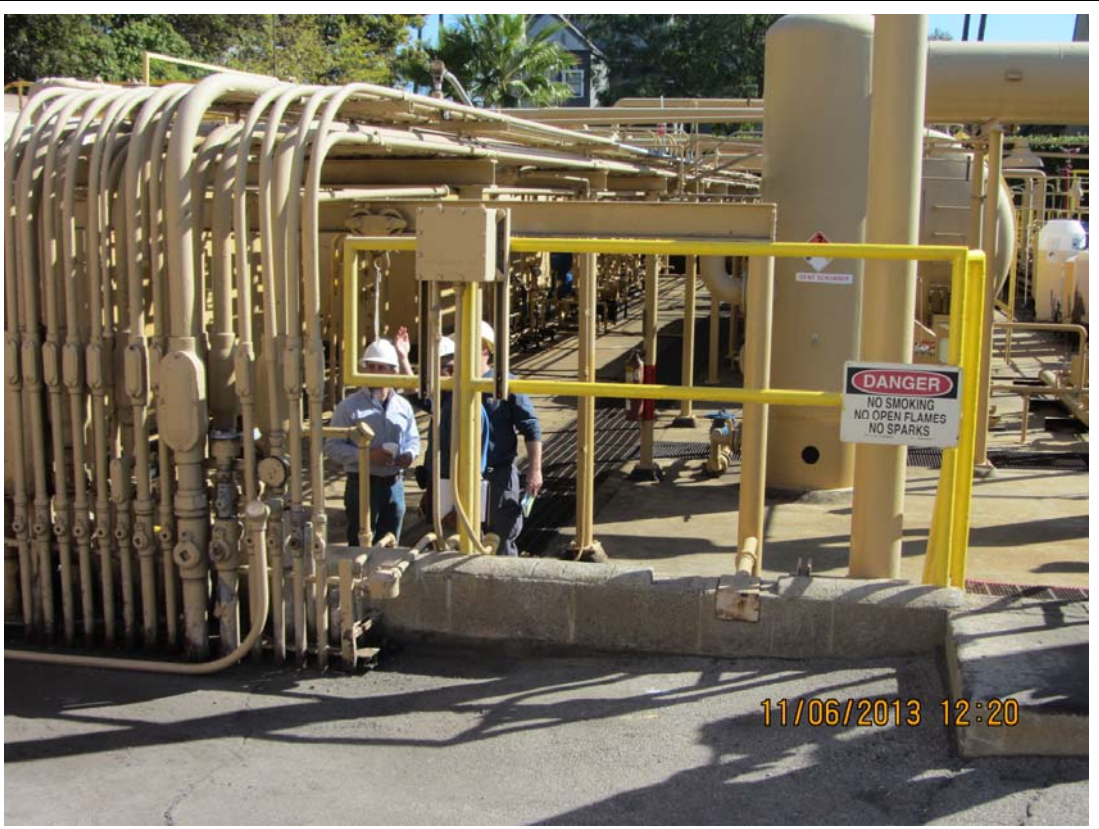
Photo No. 19	Time: 1120
------------------------	----------------------

PHOTO OF TANK FARM CONTAINMENT AREA; VIEW INCLUDES LOCATION WHERE H2S DANGER SIGN HAD PREVIOUSLY BEEN ON RAILING

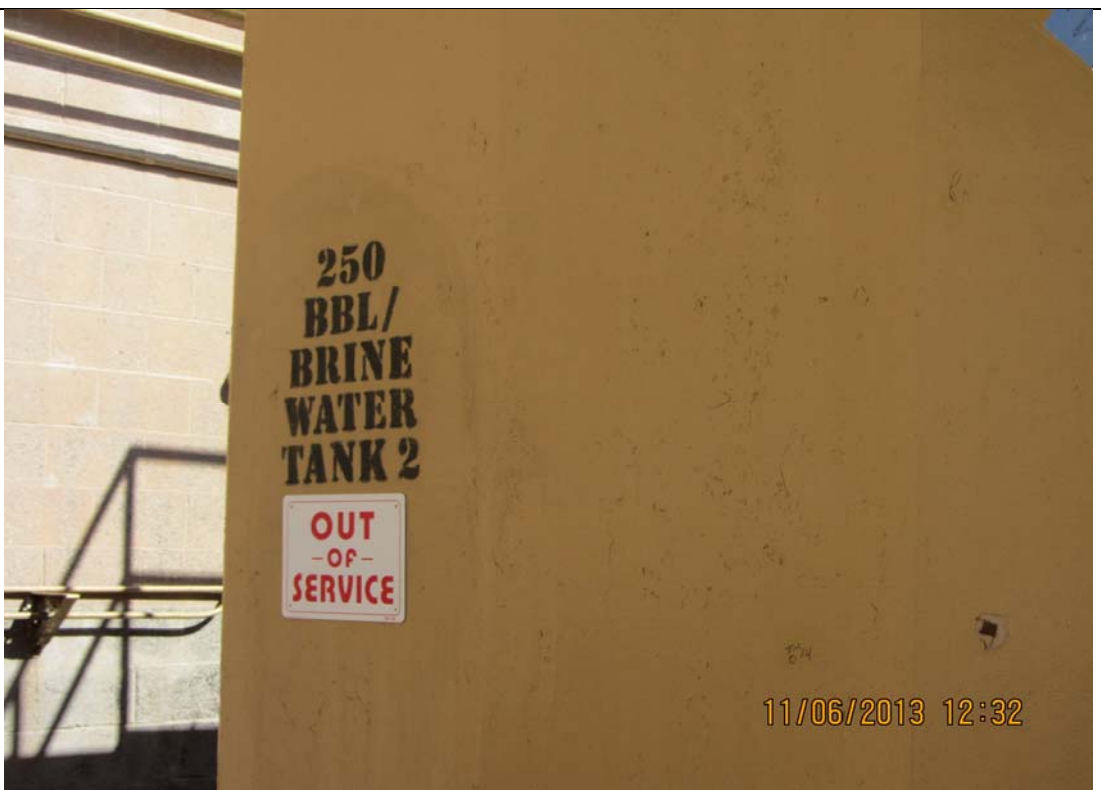
Photo No. 26	Time: 1132
Direction Photo Taken: NNE	
Photo Description: BRINE WATER TANK #2, MARKED OUT OF SERVICE (NO OOS DATE FOUND ON TANK)

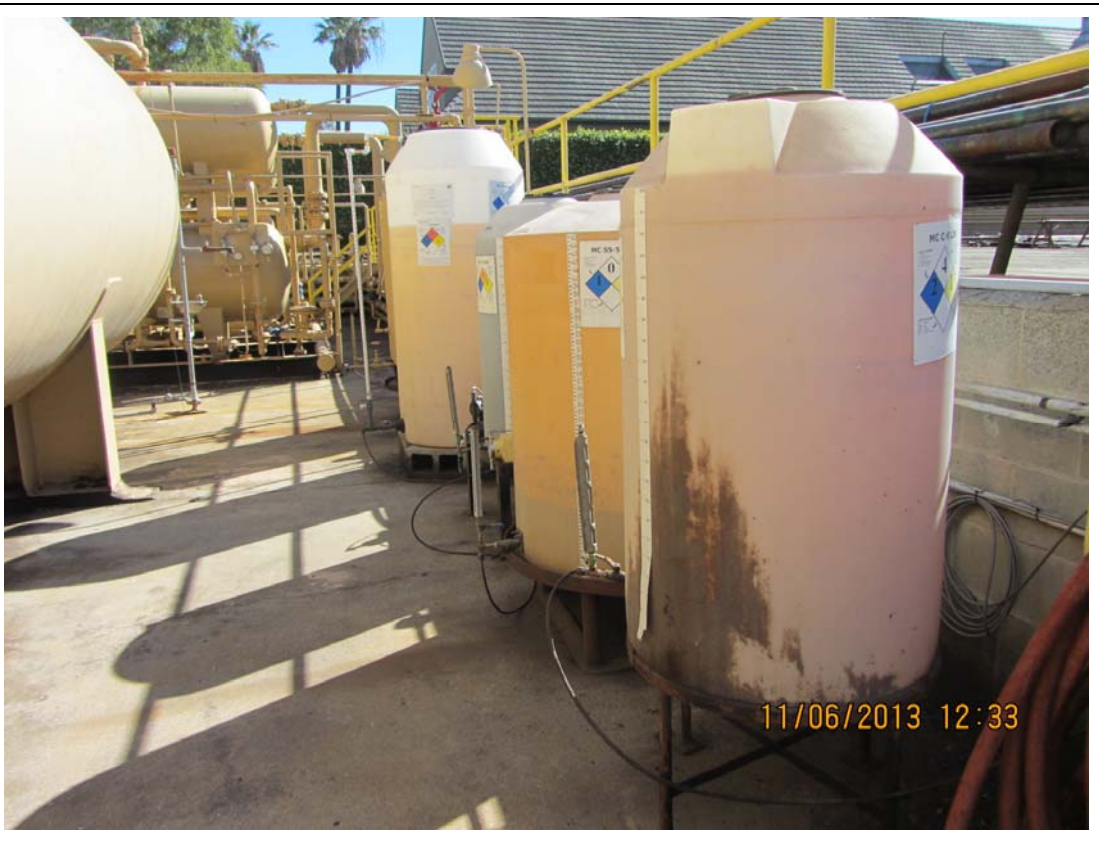
Photographer: WITUL	
Photo No. 27	Time: 1133
Direction Photo Taken: E	
Photo Description: CHEMICAL TREATMENT AREA, INSIDE TANK FARM CONTAINMENT AREA. STANDS/SUPPORTS FOR TANKS NOT ALL PROPERLY ENGINEERED.

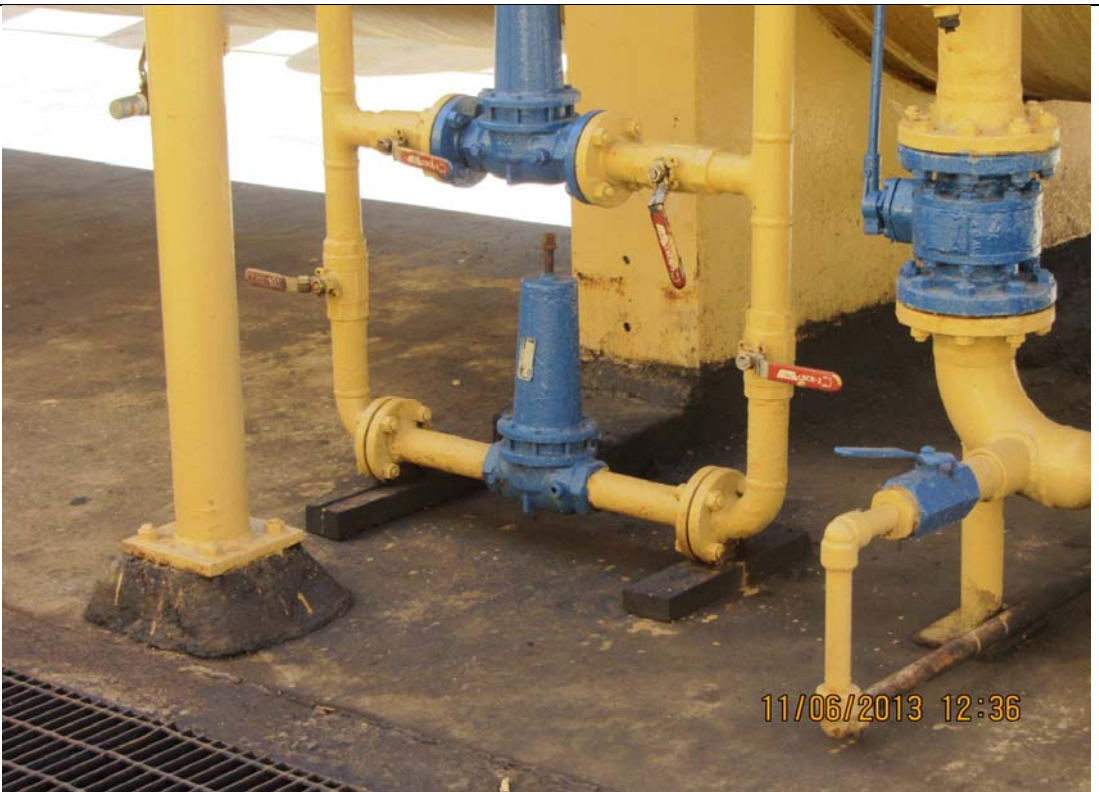
Photo No. 28	Time: 1136
Direction Photo Taken: SSE	
Photo Description: LUMBER USED FOR PIPING SUPPORTS AT FWKO TANK

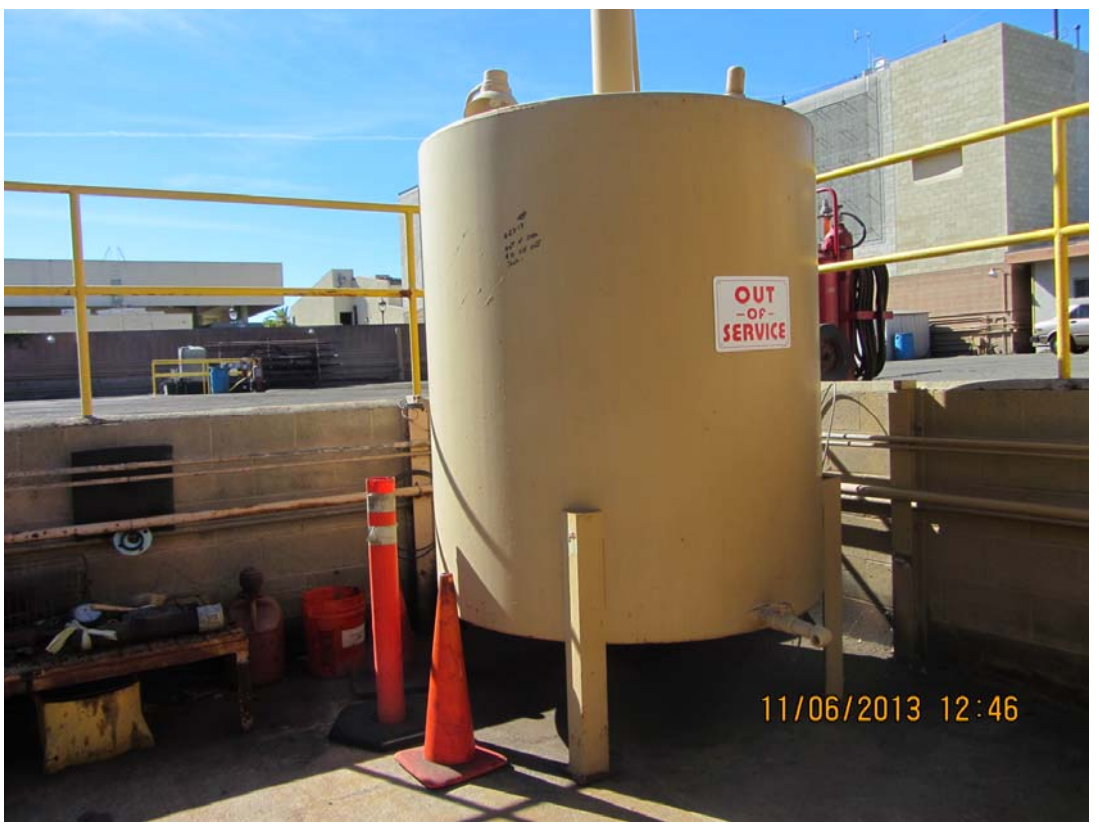
Photo No. 29	Time: 1146
------------------------	----------------------

#10 OLD VENT TANK
LABELED OUT OF
SERVICE, MARKED
WITH OOS DATE OF
4/25/13

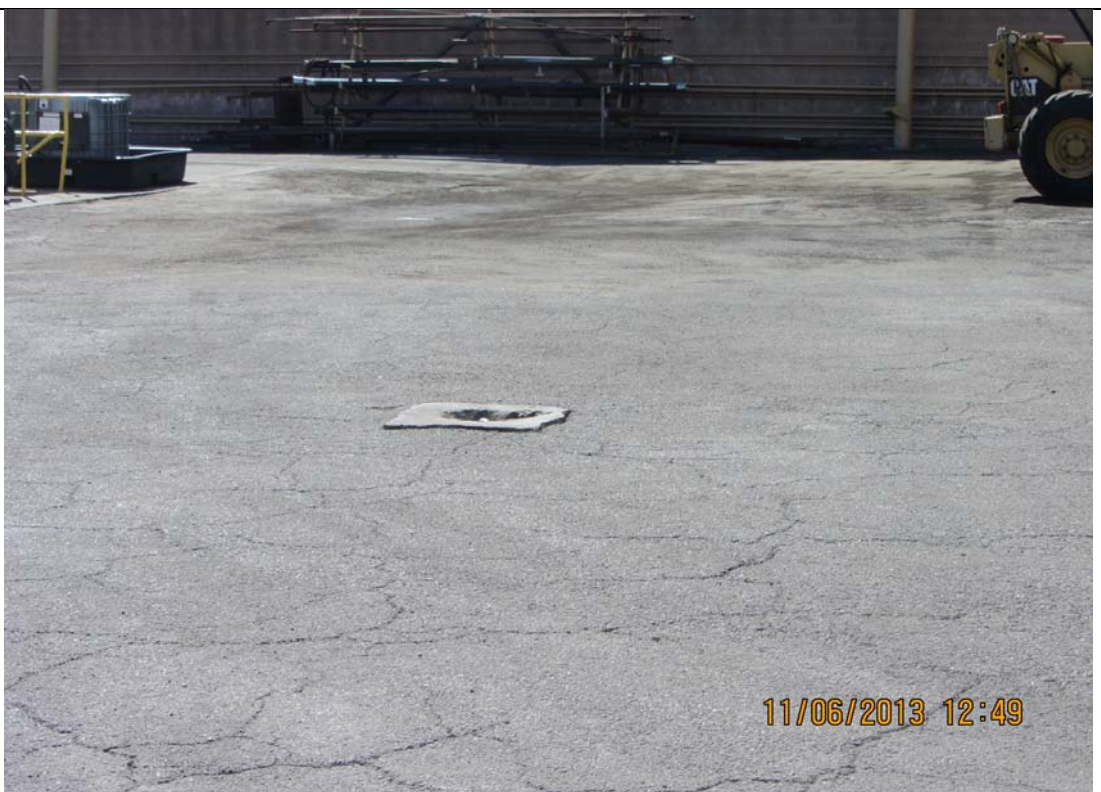
Photo No. 32	Time: 1149
Direction Photo Taken: S	
Photo Description: VIEW OF PAVEMENT IN AREA SHOWING EXCESSIVELY DARK IN GOOGLE MAP IMAGE – SEE END OF PHOTOLOG

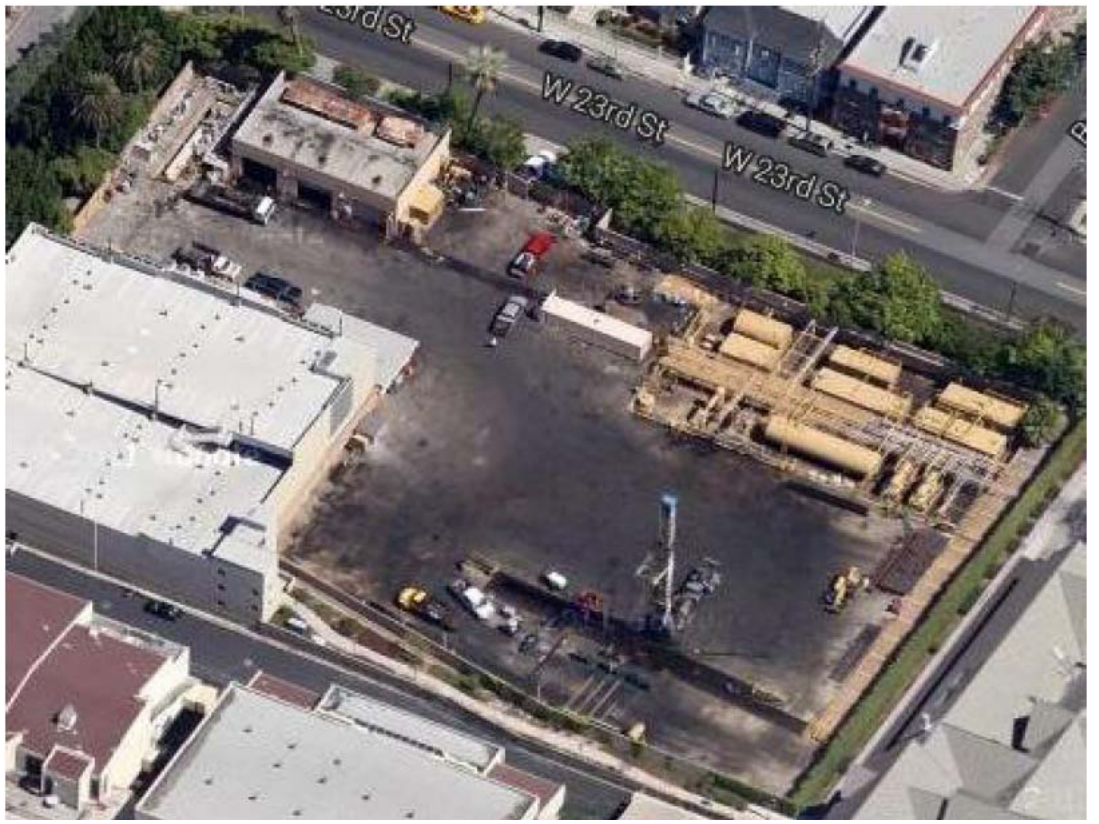
Photographer: UNKNOWN	
Photo No. N/A	Time: UNKWN
Direction Photo Taken: 45 DEGREE IMAGE, FROM ABOVE	
Photo Description: GOOGLE MAP IMAGE OF FACILITY (AND PARKING STRUCTURE AT LEFT) FROM UNKNOWN YEAR
