Purpose: RCRA Compliance Evaluation Inspection

Facility: Clean Harbors Buttonwillow, LLC.

Dates of Investigation: October 18 through 22, 2010

June 2, 2011

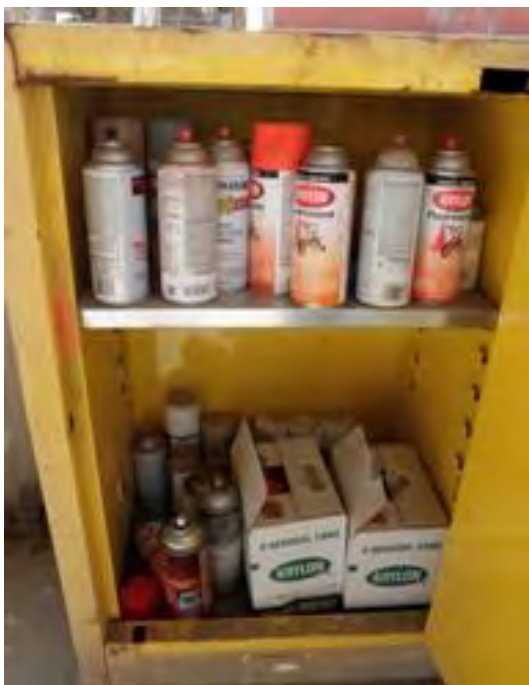
The Drum Unloading Area is located directly north of and adjacent to the Drum Unloading Bay. The Drum Unloading Area is constructed of concrete, and an overhead roof is present. During the CEI, inspectors identified a flammable materials storage cabinet with various aerosol canisters. Inspectors further noted that a nozzle on one of the aerosol cans was broken.

Olympus Stylus 8000, Photo #47; View of a flammable storage cabinet at the STU, holding aerosol products.

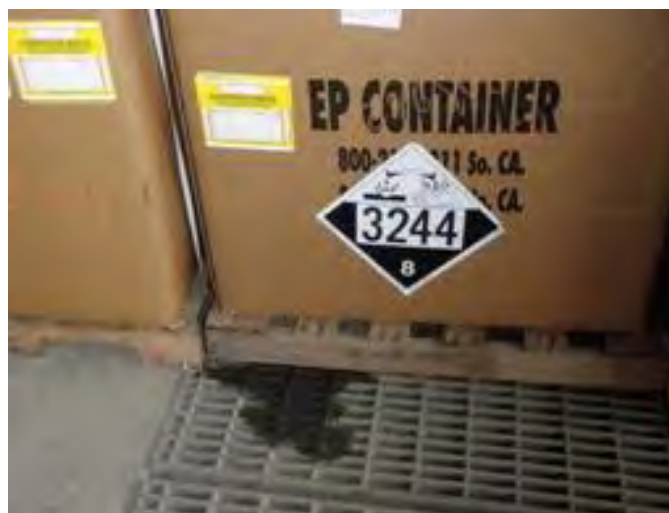
DSHA Area 2 is located in the northwestern portion of the DSHA, north of DSHA Area 1 and west of DSHA Area 3. At the time of the CEI, DSHA Area 2 contained several rows of double stacked, 55-gallon containers and pallets. In this area, inspectors observed a container holding hazardous waste hydrofluoric and sulfuric acids. Liquid was observed on the sump grate beneath this container. However, the liquid was determined to be rainwater by the facility representatives.

Olympus Stylus 8000, Photo # 16; View of the grate beneath the waste hydrofluoric and sulfuric acid container shown in Photo 15. The liquid on the grate was determined to be rainwater.

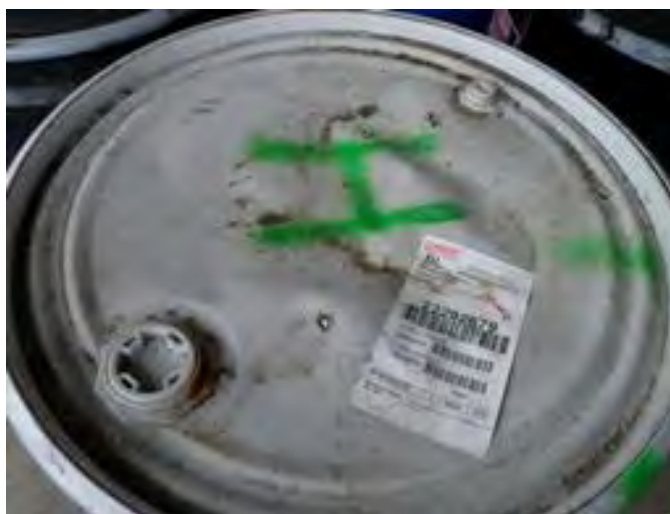
DSHA Area 4 is located east of DSHA Area 2 and north of DSHA Area 3. At the time of the CEI, DSHA Area 4 held two rows of 55-gallon containers, some of which were double stacked (approximately 20 total containers). The only potential concern observed by inspectors was a 55-gallon container of hazardous waste paint chips with a slightly-dented lid. However, the container still appeared to be closed and structurally sound.

Olympus Stylus 8000, Photo # 16; View of a 55-gallon container in DSHA Area 4, holding waste lead paint chips, dated 9/21/10. The lid is dented, but no evidence of leaks or releases.

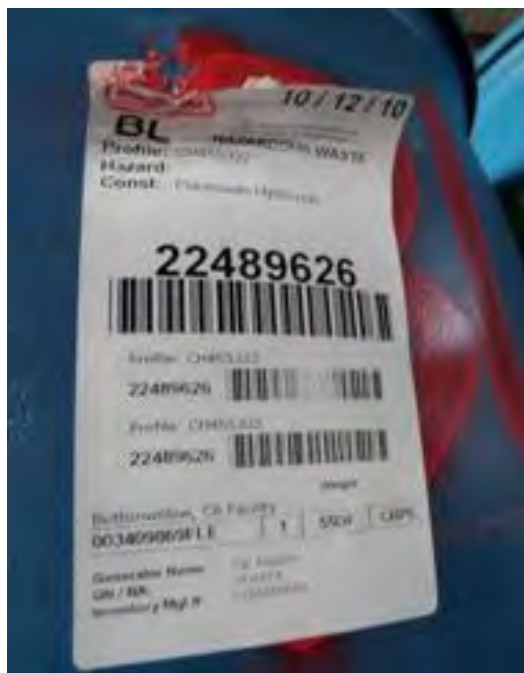
DSHA Area 5 is located east of DSHA Area 3 and west of DSHA Area 6. At the time of the CEI, DSHA Area 5 contained two rows of 55-gallon containers (total of approximately 31 containers). The inspectors identified a label on a container of hazardous waste potassium hydroxide that was affixed, but was starting to peel (photo to the right). Inspectors also observed another container of hazardous waste potassium hydroxide that had an oily liquid on its top. Both of these observations were relayed to Mr. Nielsen as concerns.

Olympus Stylus 8000, Photo # 25; Drum storage area at the STU, Area 5. View of a peeling label on a drum of potassium hydroxide waste, dated 10/12/10.

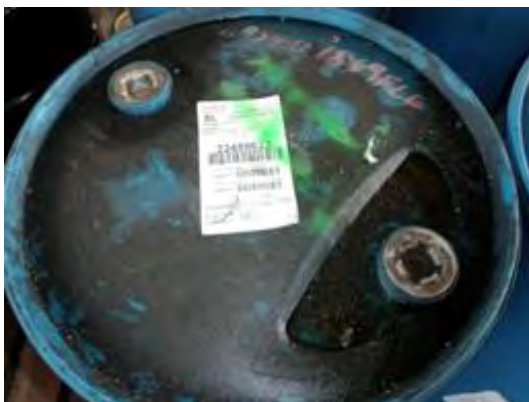
Olympus Stylus 8000, Photo # 26; Drum storage area at the STU, DHS A 5. View of a container of potassium hydroxide waste, received 10/12/10, with oily liquid on top of the lid. No visible leaks or releases.

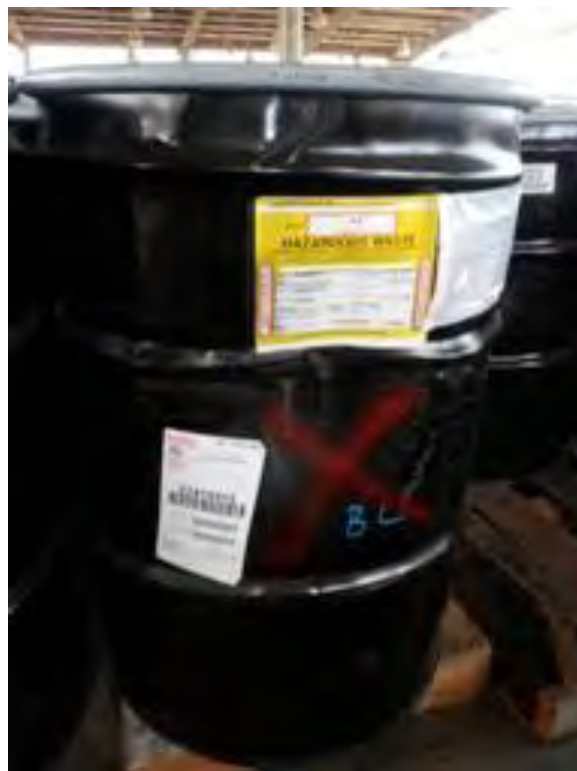
- A dented 55-gallon container of California hazardous waste. However, no visible leaks were observed (refer to Olympus Stylus 8000, Photo #27);

Olympus Stylus 8000, Photo #27; DSHA Staging Area. View of a dented container of a California hazardous waste. No visible leaks or releases.

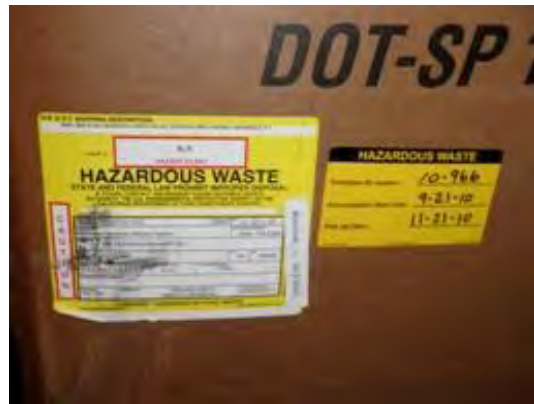
- An incorrect accumulation start date on a California hazardous waste container (refer to Olympus Stylus 8000, Photo #29);

Olympus Stylus 8000, Photo #29; DSHA Staging Area. View of a cardboard container of crushed containers with an incorrect accumulation start date (pickup date) of 11/21/10.

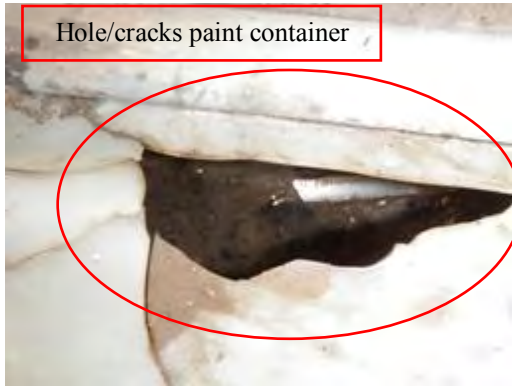
- A plastic and metal container containing California hazardous waste latex paint (refer to Olympus Stylus 8000, Photos #31 and #34 which was in poor condition and had a crack on top);

Olympus Stylus 8000, Photo #34; Close-up view of the top of the plastic container of latex paint shown in Photo #31.

Olympus Stylus 8000, Photo #31; DSHA Staging Area. View of a plastic container of latex paint (California hazardous waste), facing northwest.

The container of latex paint was repaired during the CEI by Clean Harbors personnel (refer to Canon EOS Rebel XSi, Photo #2);

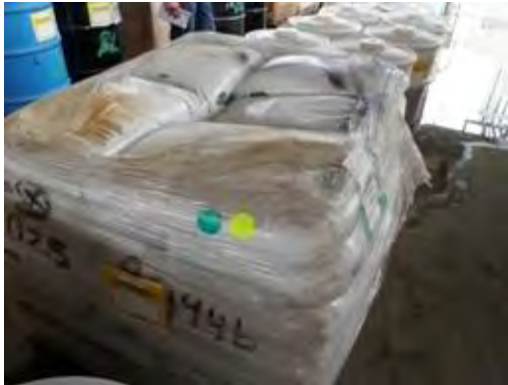
- Two pallets which contained California hazardous waste fertilizer. Both were shrink-wrapped and one of the pallets was loosely covered with cardboard (refer to Olympus Stylus 8000, Photo #35 below). The bags were observed to be releasing small amounts of fertilizer to the surrounding area (refer to Olympus Stylus 8000, Photo #36 and #40 below);

Olympus Stylus 8000, Photo #35; DSHA Staging Area. Shrink-wrapped bags of waste fertilizer.

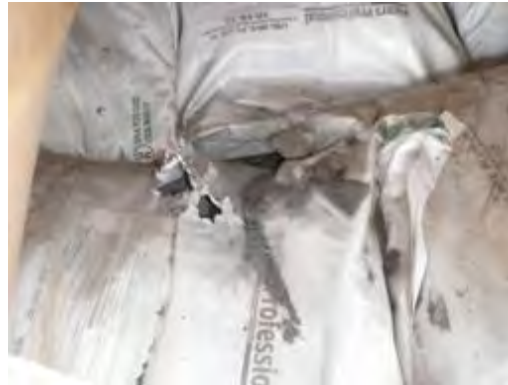
Olympus Stylus 8000, Photo #36: DSHA at the STU, area near the control room. Shrink-wrapped bags of waste fertilizer. Cardboard was loosely covering the top, and bags underneath are torn. A release of a small amount of fertilizer (California hazardous waste) was observed.

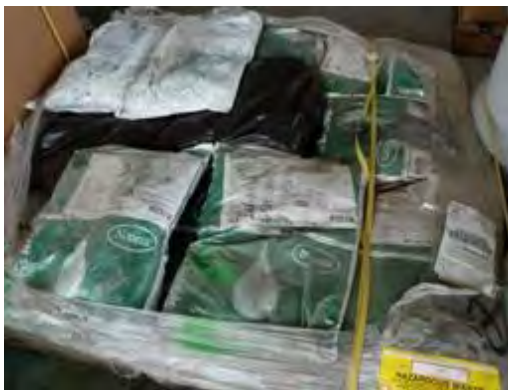
Olympus Stylus 8000, Photo #40; Another view of the waste fertilizer bags (California hazardous waste) shown in Photo 36. Minor rips are present in the bags and the top of pallet is not covered or wrapped. Photo to the left.

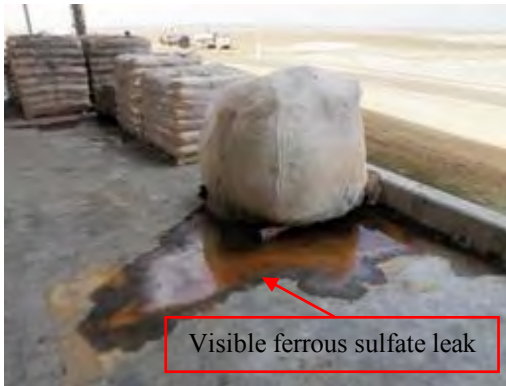
- A pallet of unidentified Excludable Recyclable Material (ERM) under which significant staining was noted (refer to Olympus Stylus 8000, Photo #43 below). The ERM was later determined to be ferrous sulfate, which is used as a product at the STU. The staining beneath the ERM, which was later determined to be ferrous sulfate, was cleaned up during the CEI (refer to Canon EOS Rebel XSi, Photo #4 below).

Olympus Stylus 8000, Photo #43; Stains on concrete floor of STU near a supersack of Excluded Recyclable Material (ERM). ERM later reported to be ferrous sulfate, which is purchased for use as a product.

During the records review portion of the CEI, the inspectors reviewed a material safety data sheet (MSDS) for the ferrous sulfate. According to the MSDS, ferrous sulfate oxidizes upon exposure to moisture, forming a brown coating of extremely corrosive ferric sulfate. Though the ferrous sulfate is an ERM, a spill or release from contact with water would be a waste (potentially a D002 characteristic RCRA hazardous waste).

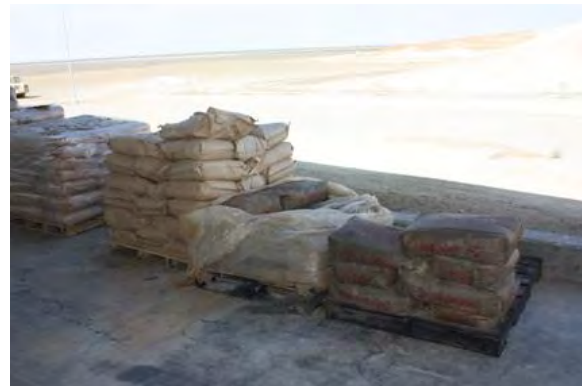
Canon EOS Rebel XSi, Photo #4; Return to compliance verification – cleanup of ferrous sulfate spill/leak in STU.

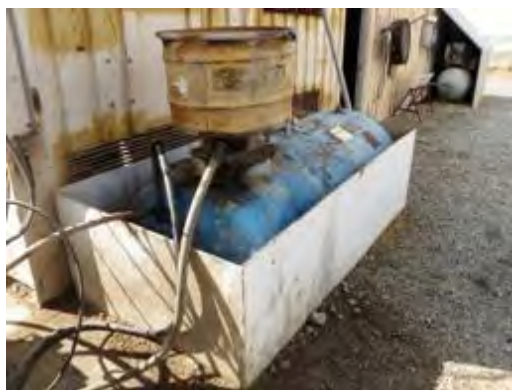
The Used Oil Storage Tank Area is located west of the Heavy Equipment Storage Area and the Maintenance Area. The used oil AST is located within secondary containment, the base of which was covered in liquid (refer to Olympus Stylus 8000, Photo #50 below). At the time of the CEI, the accumulation start date noted on the used oil storage tank label indicated that the 90 day accumulation date would be reached on July 22, 2010 (refer to Olympus Stylus 8000, Photo #51 below). Staining was identified in the area surrounding the used oil storage tank.

Olympus Stylus 8000, Photo #50; View of the used oil storage tank at the maintenance building.

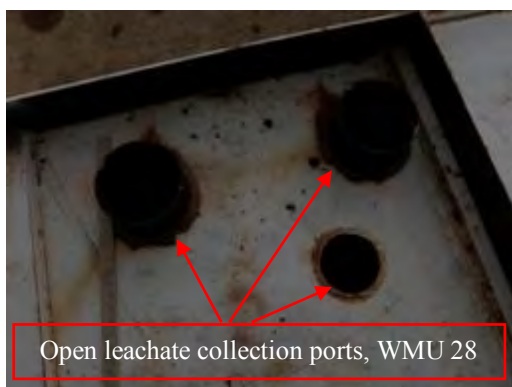
At the time of the CEI, the frac tank was structurally sound, labeled as hazardous waste and dated 9/14/2010. The inspectors observed that the ports on top of the frac tank were not closed. Photos of these open ports can be viewed below.

Olympus Stylus 8000, Photo #74; View of top of the leachate collection frac tank (Frac Tank 3) at WMU 28. Note the open ports.

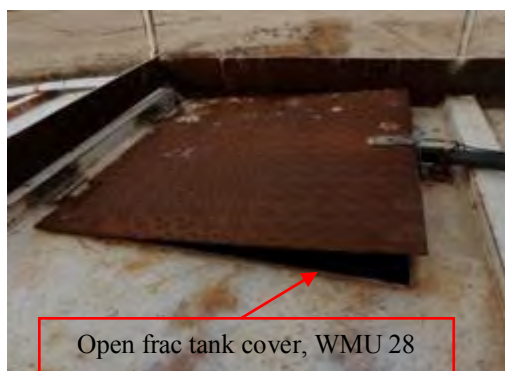
Olympus Stylus 8000, Photo #75; View of top of the leachate collection frac tank (Frac Tank 3) at WMU 28. Note the open cover.

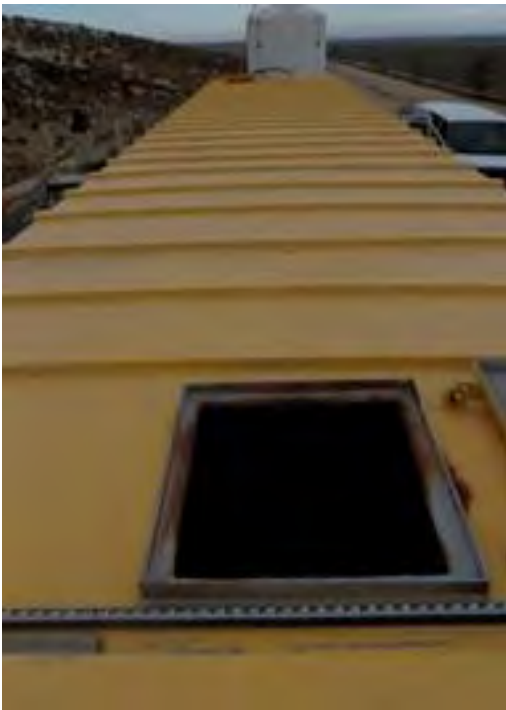
Olympus Stylus 8000, Photo #97; View of the leachate collection frac tank (Tank 80) at WMU 35, Cell #1. Note the top of the container is open.

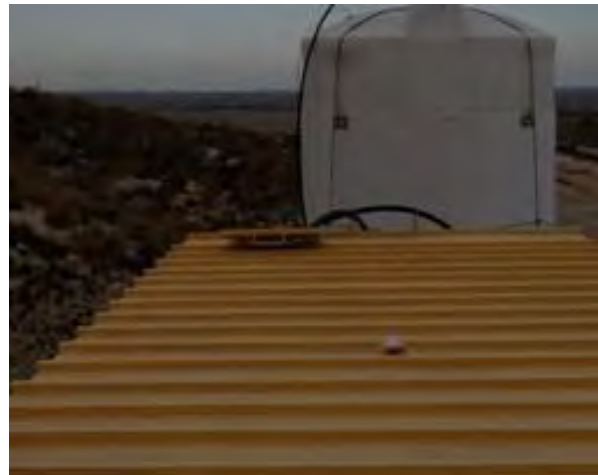
Olympus Stylus 8000, Photo #98; View of the leachate collection frac tank (Tank 80) at WMU 35, Cell #1, shown in Photo 96. Note the top of the container is open.

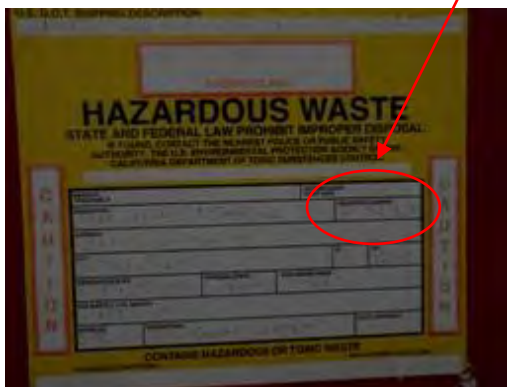
Dates not clearly visible

Olympus Stylus 8000, Photo #104; Label on the red, leachate collection frac tank at WMU 35, Cell #3. Note that the accumulation start date is not clearly visible.

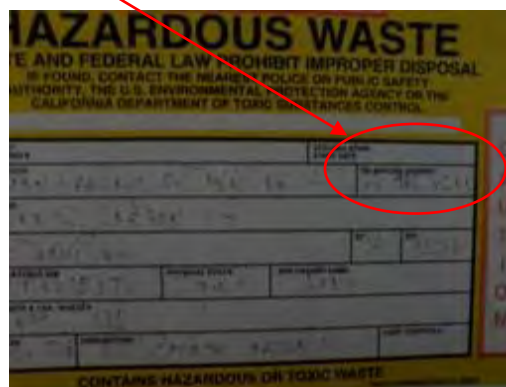
Olympus Stylus 8000, Photo #106; Label on the red, leachate collection frac tank at WMU 35, Cell #3. Note that the accumulation start date is not clearly visible.

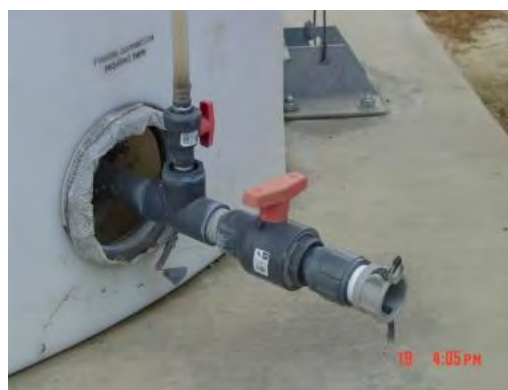
Sony DSC-S75, Photo #12; View of the piping and valve for draining the 5,000-gallon, plastic, leachate collection tank at WMU 35, Cell #3, facing northwest. Note: no secondary containment or cap/plug.

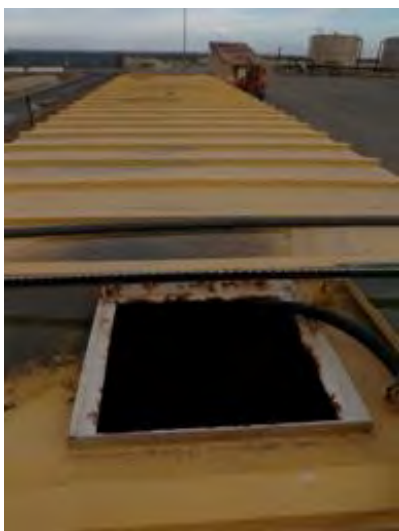
Olympus Stylus 8000, Photo #93; Leachate collection frac tank at WMU 34, near STU. View of the top of the frac tank (open), facing east.

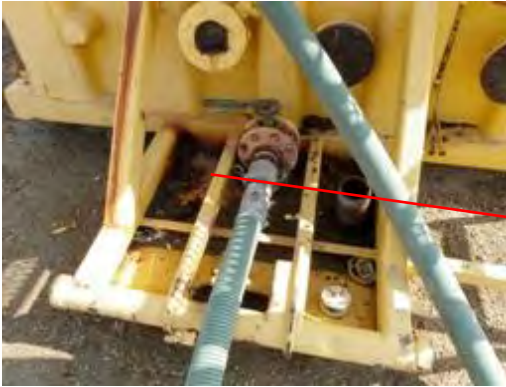
Olympus Stylus 8000, Photo #56; View of the leachate collection frac tank at WMU 34, facing east. Note the stains around the valve area and on the ground.

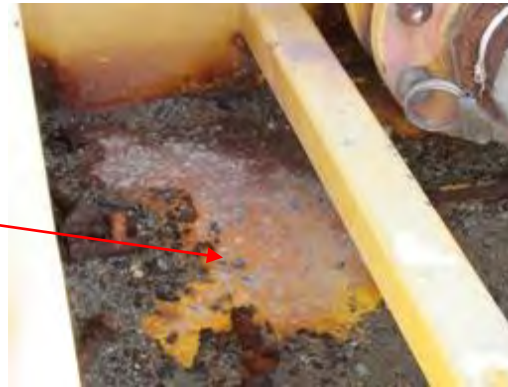
Olympus Stylus 8000, Photo #57; Close-up view of the ground near the valve of the leachate collection frac tank at WMU 34. Note the visible staining.

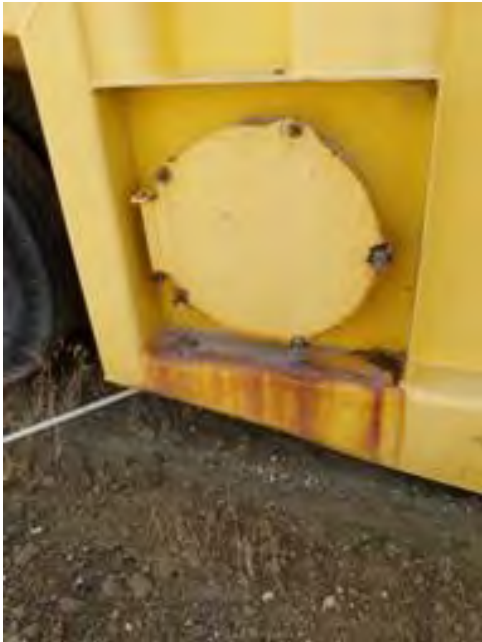
Olympus Stylus 8000, Photo #59; Close-up view of the valve port on the lower northeast corner of the leachate collection frac tank at WMU 34. Note the visible staining below the port.

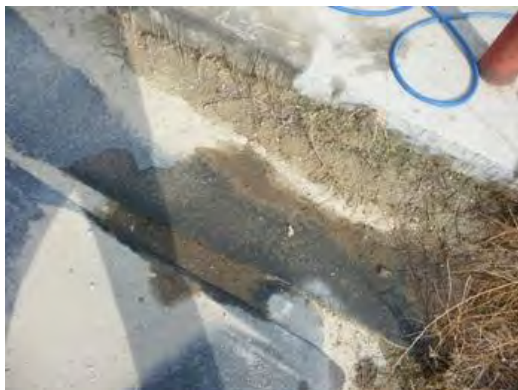
Panasonic Lumix DMC-TZ5, Photo #19; F039 leachate drippage observed on the ground at WMU 34.

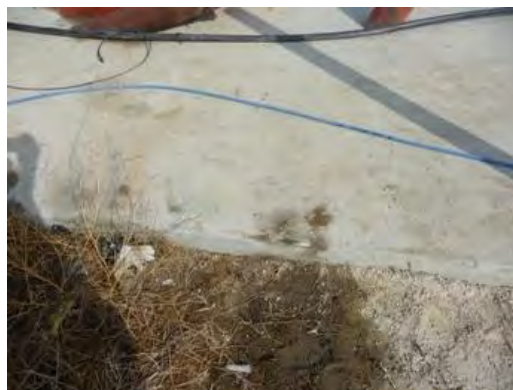
Panasonic Lumix DMC-TZ5, Photo #28; WMU 34; F039 leachate dripping on the ground.

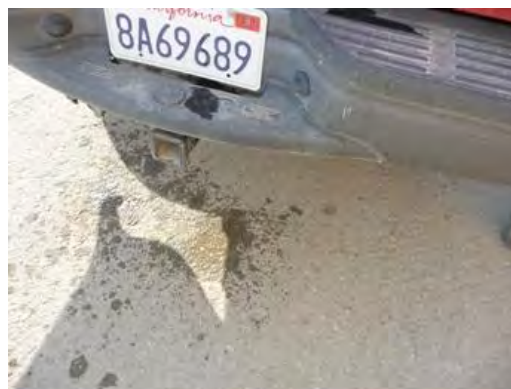
Panasonic Lumix DMC-TZ5, Photo #45; Leachate drippage on the ground from sample transfer into containers.
