## Subject: Findings of Violations and Order for Compliance EPA Docket No. CWA-309(a)-09-006

Alco Iron and Metal Company 2201 West Washington Street, Suite 21 Port Road 22 Stockton, CA 95203-7554 Docket No. CWA 309(a)-09-006

# FINDINGS OF VIOLATION AND ORDER FOR COMPLIANCE

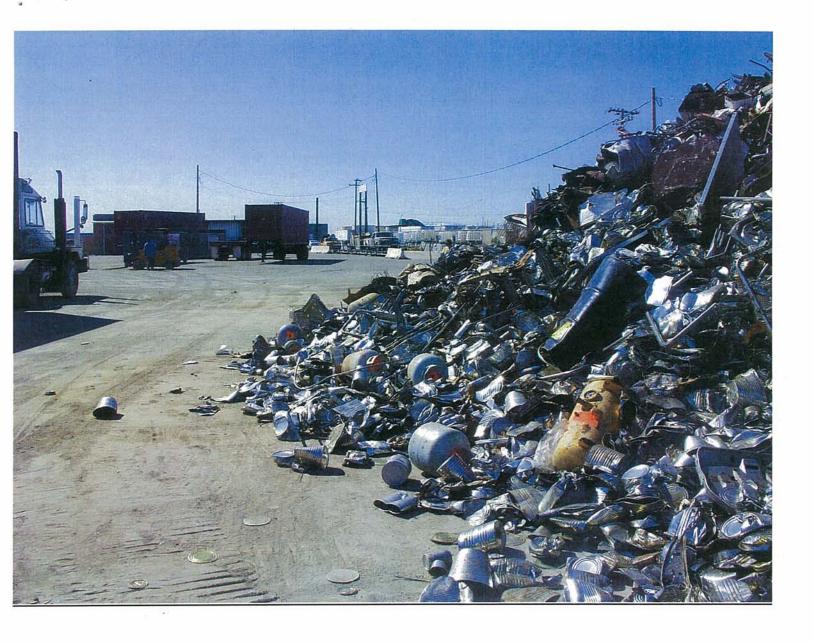
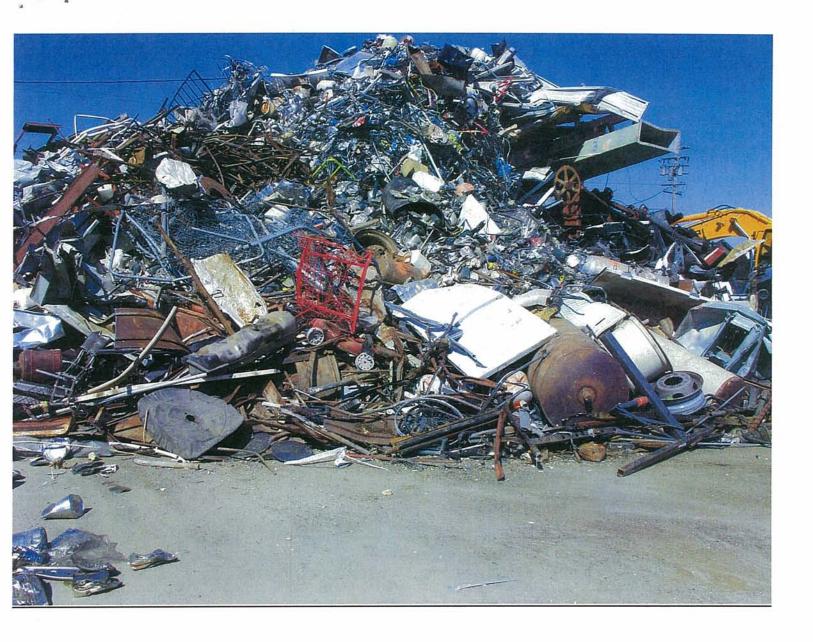
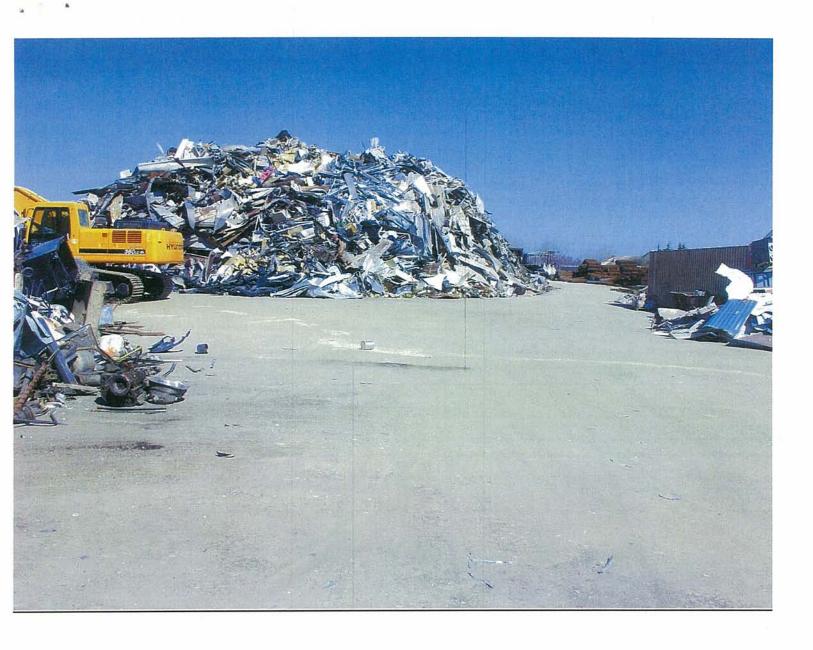
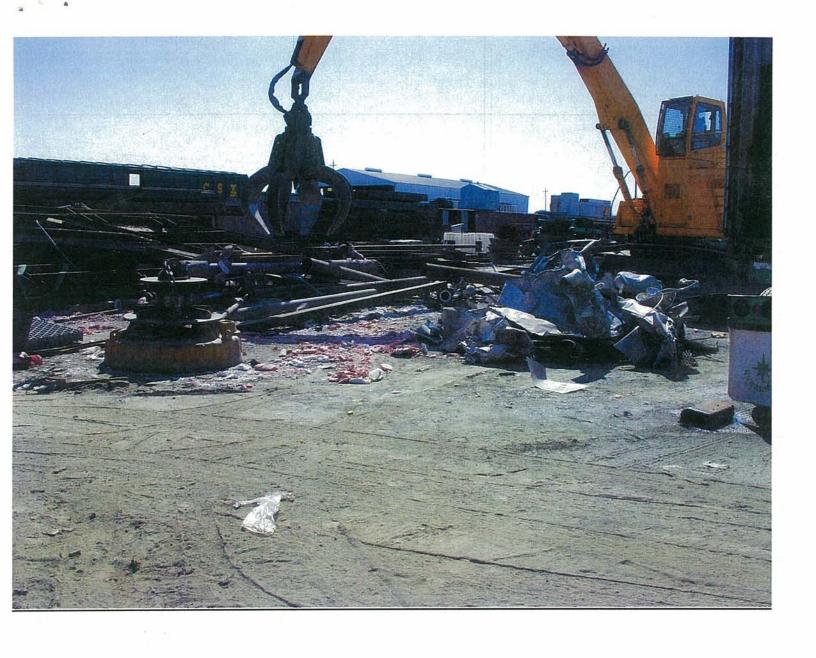
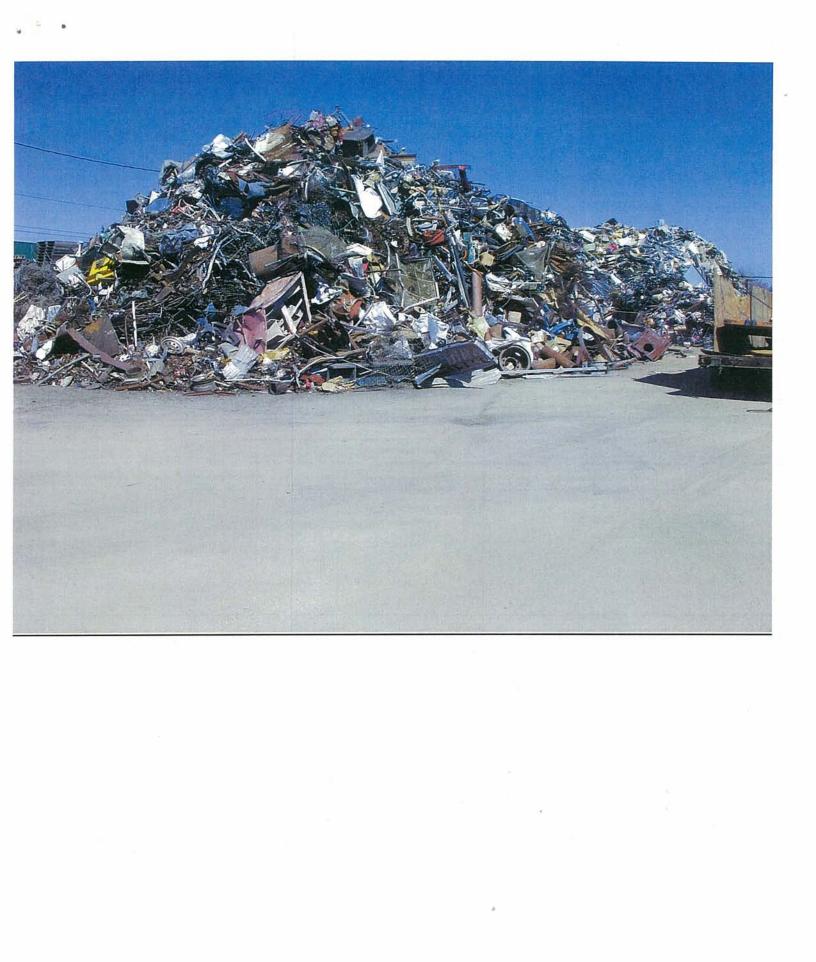
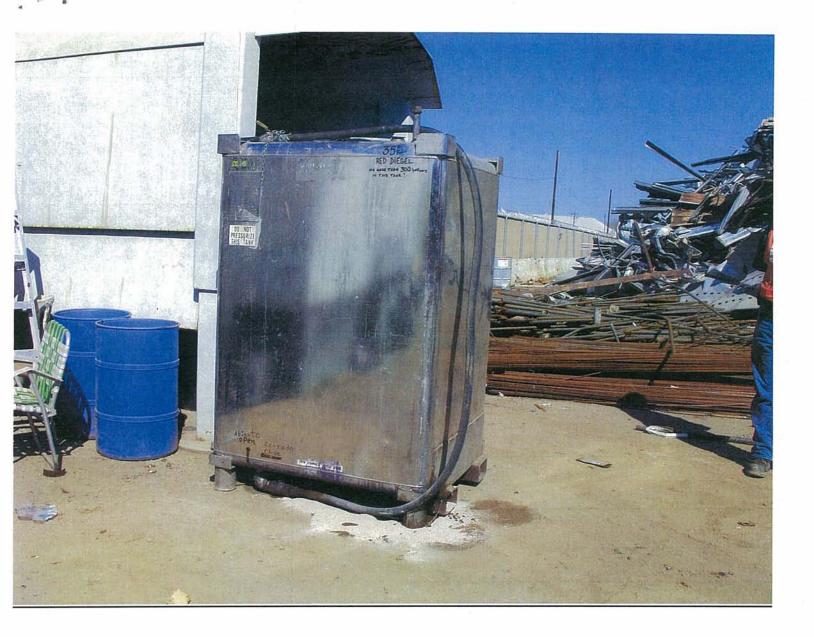
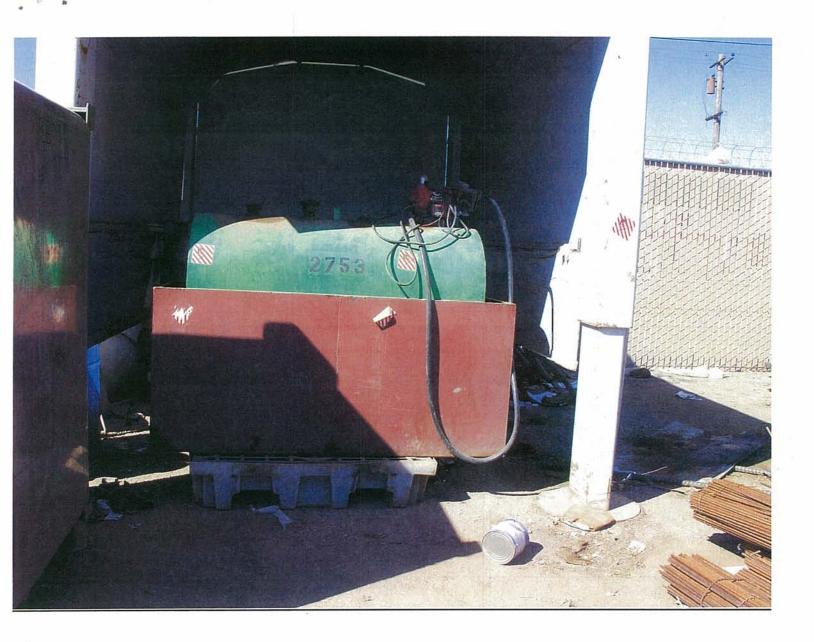
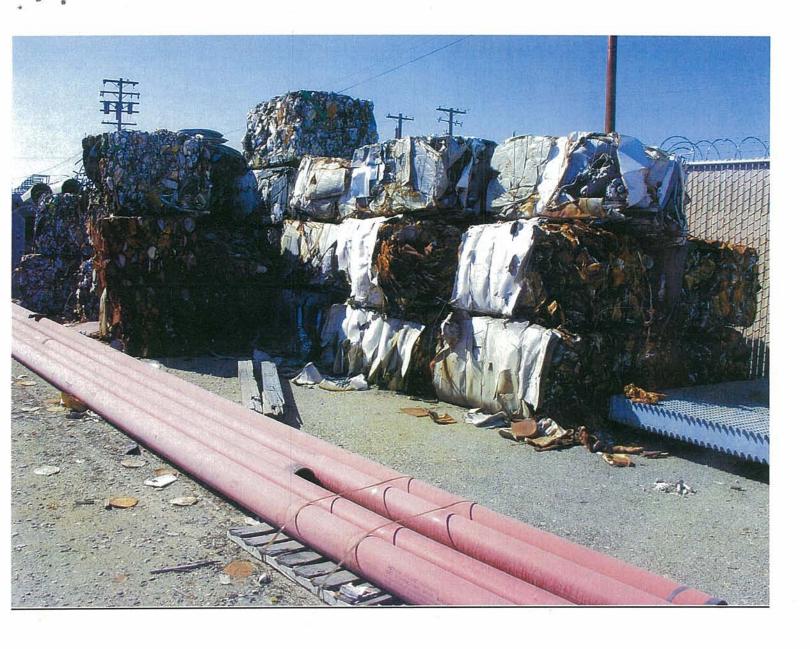
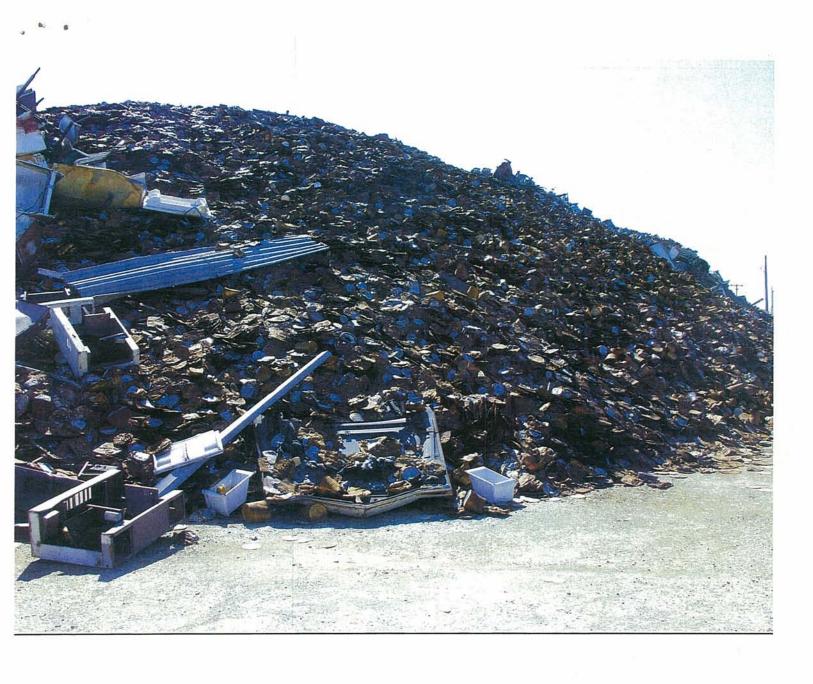
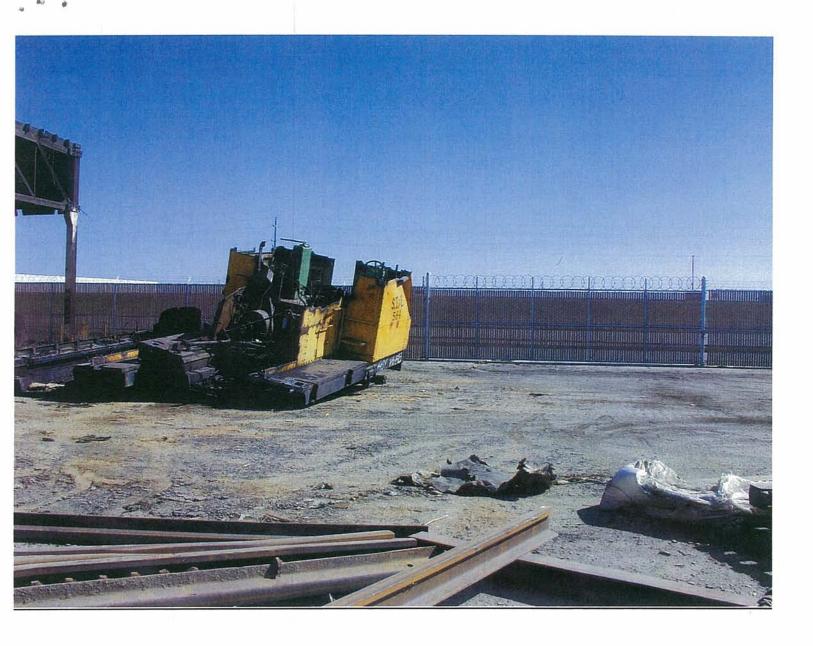
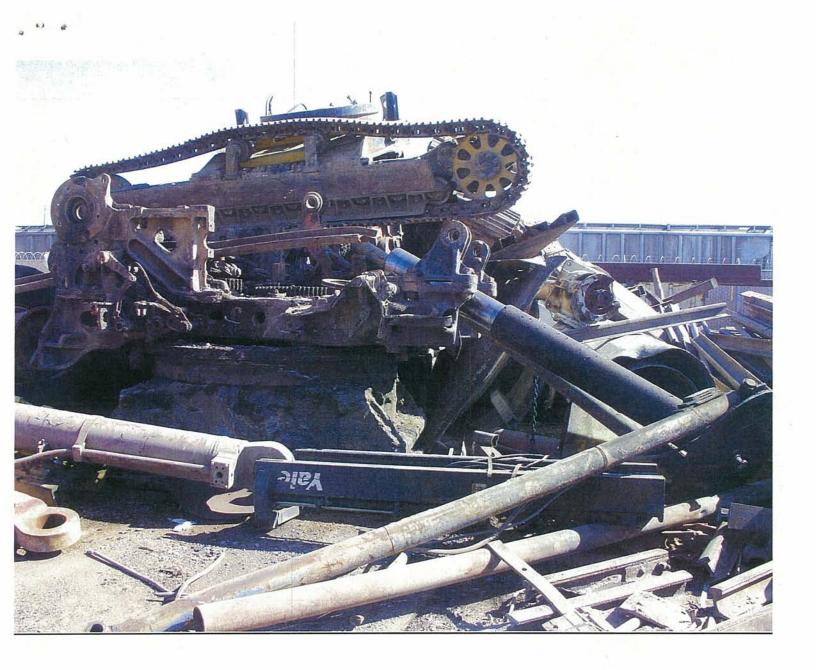
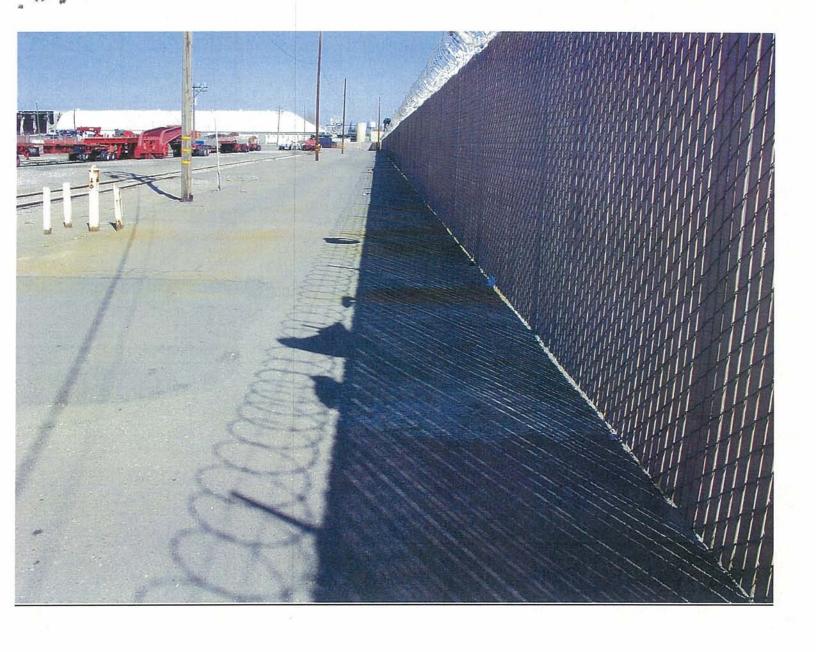
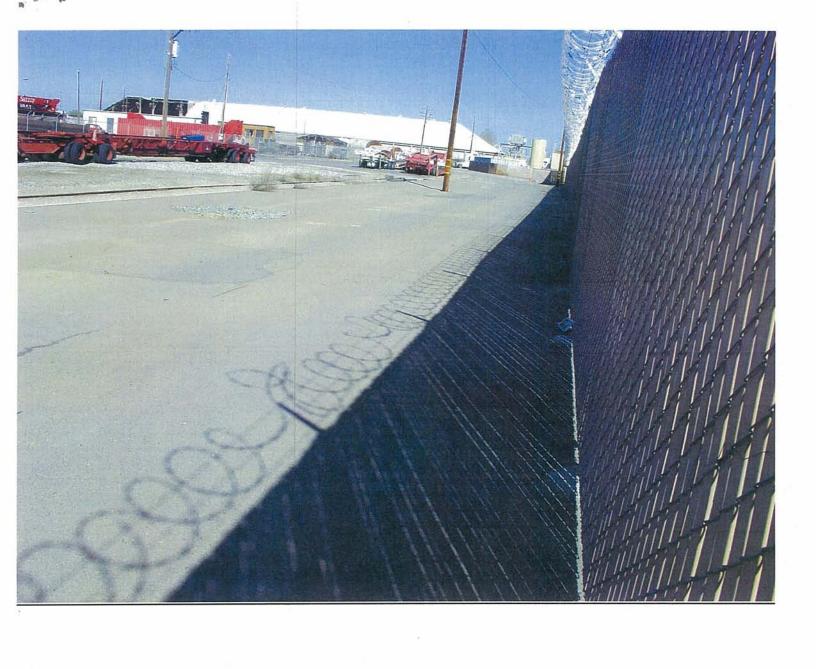
Photo Log		
Image No.	Description	
DSCN0656.JPG	Facing east, metal stockpile with slight grading for in the background, near the red truck trailer.	
DSCN0657.JPG - DSCN0660.JPG	Numerous stockpiles of various metals on the with no protection from pollutant sources.	
DSCN0661.JPG	Fueling area. Steel container with no secondary containment, exposed without cover.	
DSCN0662.JPG	Diesel tank that is fork-lifted to fuel vehicles. Note the compromised palate.	
DSCN0663.JPG	Bales of metal exposed to runoff located on the North perimeter fence of the .	
DSCN0664.JPG	Stockpile of tin.	
DSCN0665.JPG	Exposed metals.	
DSCN0666.JPG	Exposed metals.	
DSCN0667.JPG	North perimeter of ALCO as seen from outside the . Note the discharge stains on the pavement in the foreground.	
DSCN0668.JPG	Same location as picture DSCN0667.JPG	
DSCN0669.JPG	Same location as picture DSCN0667.JPG, showing the proximity of the stormdrain to the North perimeter of the . Note the lack of controls to contain from the runoff of the stockpile.
